| Our reference | HNW 0337 |

**Subject     Grouting monitoring procedure statement**

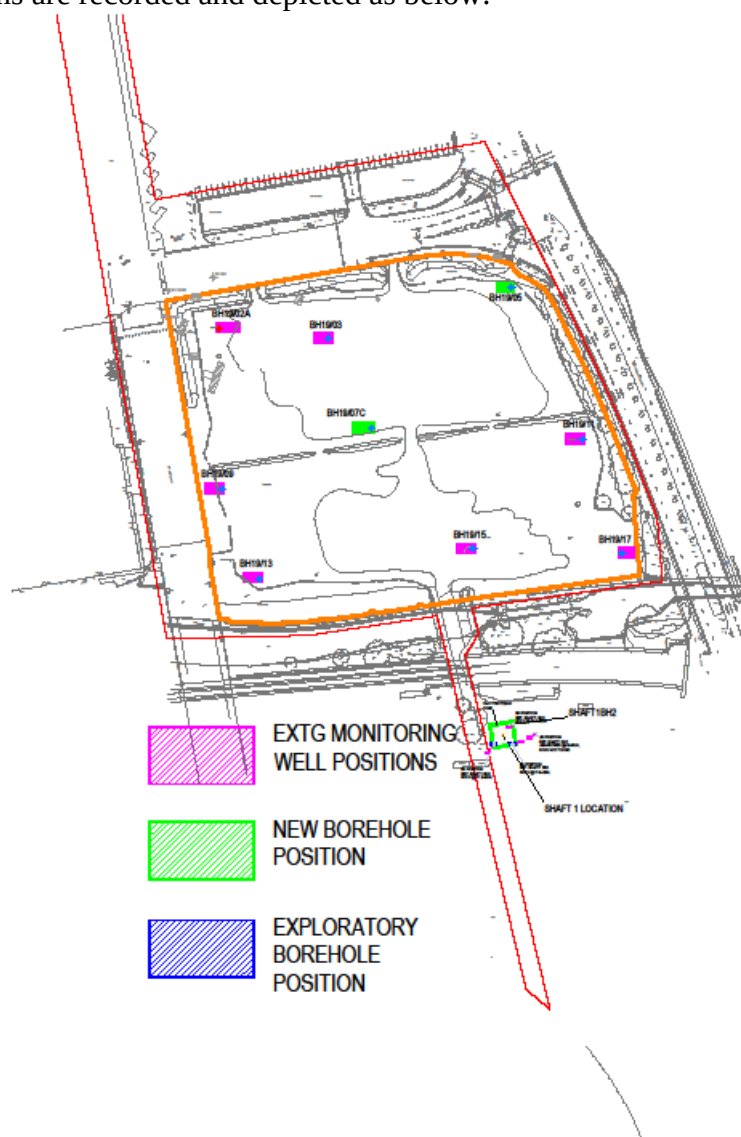
Following the installation of 9No boreholes by others prior to BAM possession of the site, on checking their functionality it was clear some remediation of these installations was necessary in order to recommission before grouting works could commence, the works required were as follows: wells BH19/05 and BH19/13 were re-drilled, boreholes BH19/02A, BH19/03,

BH19/07C, BH19/09, BH19/11, BH19/15 and BH19/17 were flushed out and depth checked. Once functioning correctly, the levels within the boreholes were monitored daily for 4 weeks before grouting works commenced in order to set baseline readings, then, on commencement of grouting operations until 5/2/21 2No samples per day were taken, reducing thereafter to 1No sample per day to 19/2/21, the following were carried out:

Borehole locations are recorded and depicted as below:
