## STRUCTURAL INSPECTION REPORT OF 1830 STATION BUILDING

Science and Industry Museum  
Liverpool Road  
Manchester  
M3 4FP

Contract No: 10539  
Dated: 30 November 2020

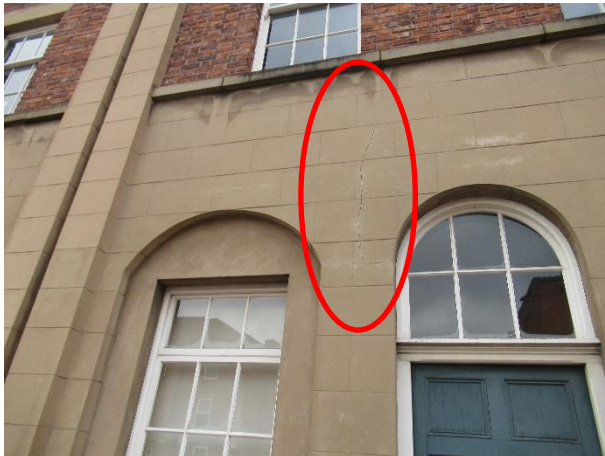
4.1.7

- 4.1.6 Vertical cracking was noted in the render finish between window and door openings at the springing point of the arch over the door and window openings. In general, the majority of the cracking was of equal width as the crack continued higher up the wall. The cracking typically originated from the upper corners of the window or door opening and extended horizontally to the adjacent opening. A vertical crack typically originated centrally on the horizontal cracks and extended vertically up to the stone course first floor level. No cracking was observed in the masonry or the stone course above first floor.

Cracking between window openings to south elevation

6.1.7 The inspection of the structure revealed local, but repetitive, defects to the external façade to the south elevation. The stucco render to the external façade of the south elevation requires remedial works to the cracking observed between the openings. The cracking is assumed to be as a result of thermal contraction of the blockwork substrate behind the render. The damage to the external render is assumed to be aesthetic only however it will allow water ingress into fabric of the building. This defect also occurs in multiple locations to the front elevation of the Ticket Office and Waiting Rooms.

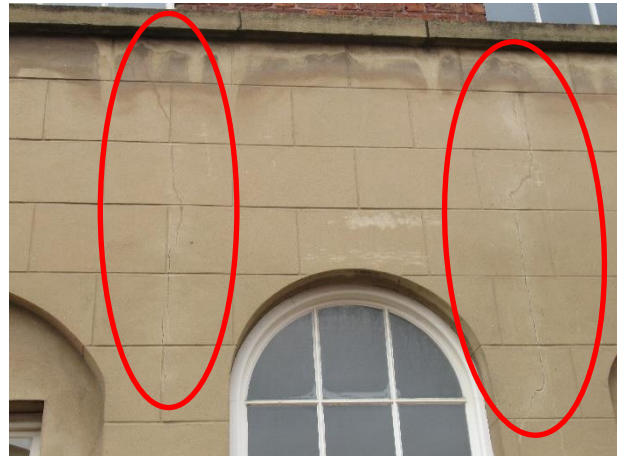
Cracking in render façade to south elevation

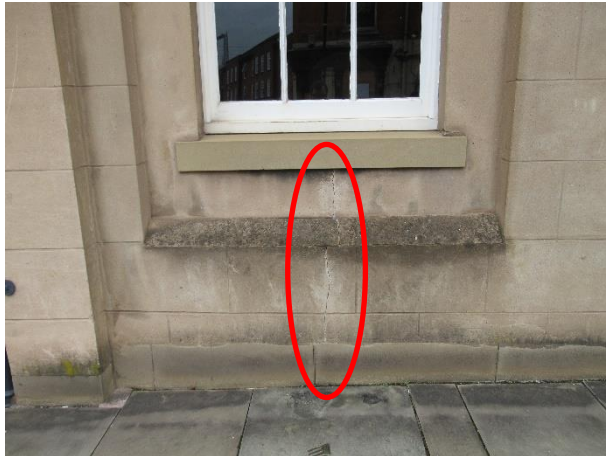
4.1.13

- 4.1.12 Localised cracking was observed below ground floor windows. The cracks typically originated centrally below the windowsill or to the reveal at either side. The cracks extended vertically down to ground level. The cracking was typically 0.5-1.0mm in width and wider under the sill.

Cracking below ground floor windows

6.1.8 Local cracking below the windows on the front elevation is likely due to thermal contraction of the external leaf of blockwork to the south elevation. It is suspected that a similar defect is present in the blockwork substrate to the render in each location of the cracking.

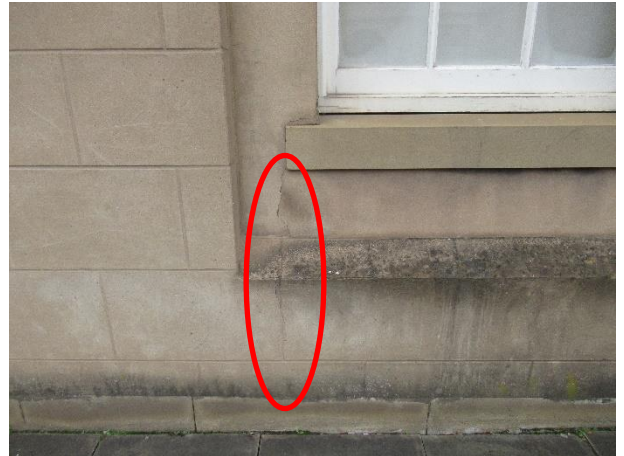
Cracking to window reveals at sill level.

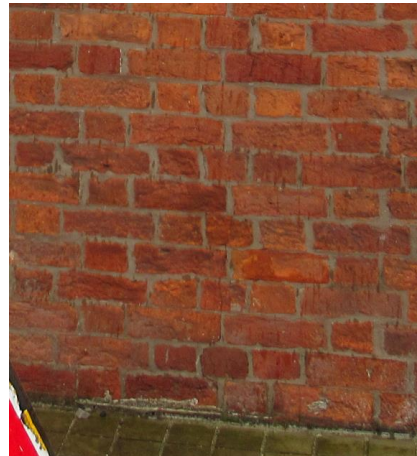
- 4.3.2 Vertical cracking was noted at ground level extending approximately 1m from the south west corner of the building. The crack was hairline in width and terminated nine courses above the external paving level. It was noted that the crack extended through masonry units, including those laid as headers. The crack was wider at the base of the wall becoming narrower higher up the wall.

Cracking in masonry to western façade

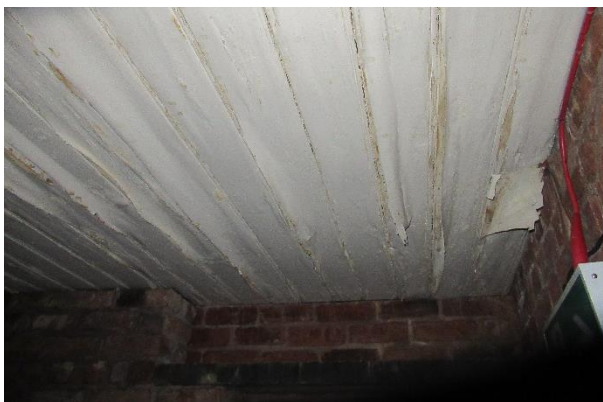
#### 5.1.8

5.1.7 Loose and blown paintwork and staining to the ceiling boarding revealed water ingress to the floor void between the basement and ground floor. The source of the water ingress was not clear from the underside. The defects typically aligned with other signs of water ingress identified at ground floor level.

Loose paintwork to the ceiling in the basement

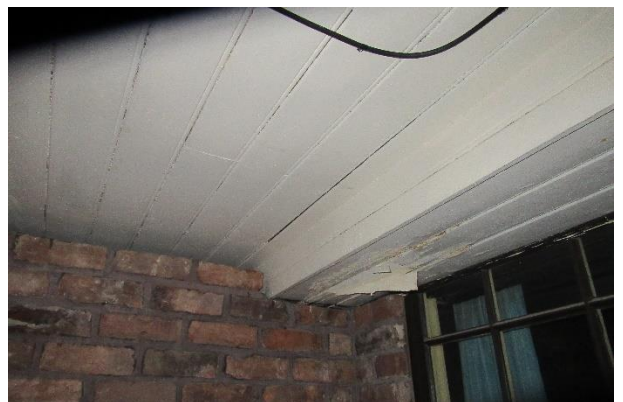
Loose paintwork to downstand beam

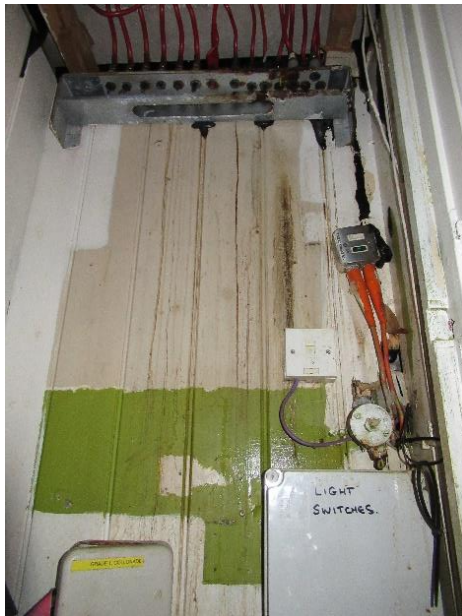
5.1.12

Electrical cupboard to south east corner

5.1.13 An electrical cupboard in the eastern most room of the ground floor had water staining on the back wall. It was raining during the inspection and the wall was wet to the touch.

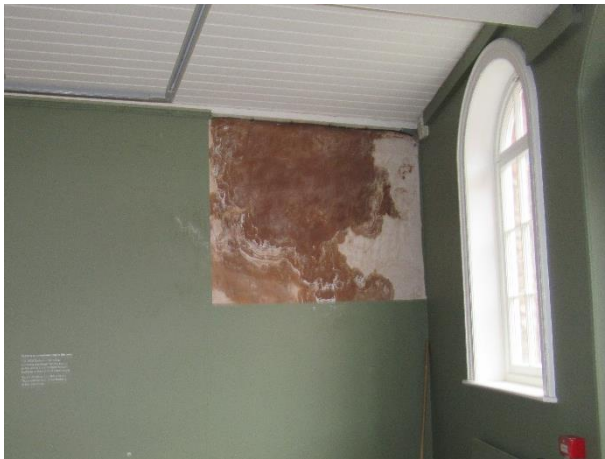
5.1.15

5.1.14 A note on the wall of the exhibit halls indicated that water ingress into the rooms had been a historic issue and not as a result of instantaneous failure or movement. A large area of the finishes were affected by water ingress local to the entrance hall.

Water ingress into entrance hall

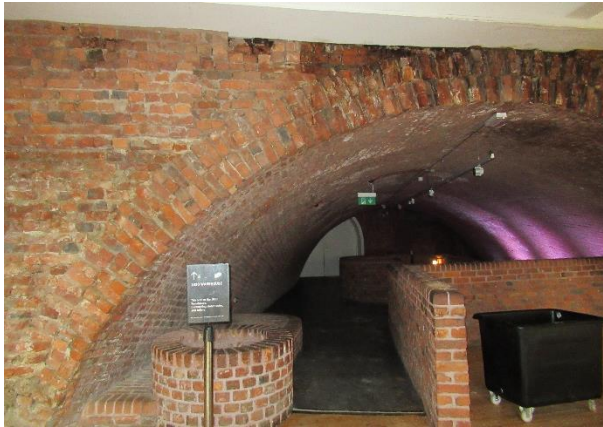
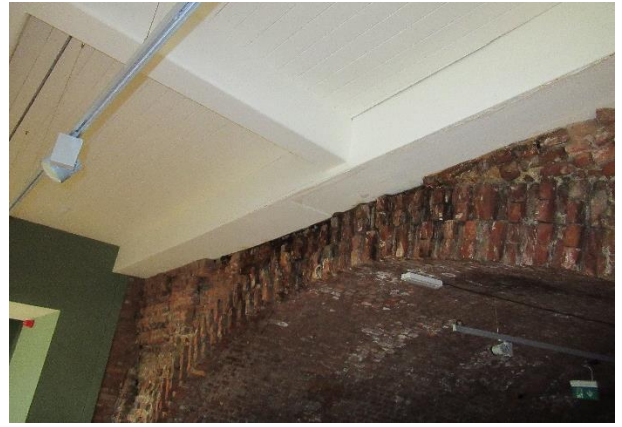
5.1.18

5.1.17 Water staining was noted at the head of the wall, and the masonry of the wall appeared wet. Water staining was noted in several locations along the north elevation. The defect was noted in the surround to the downstand beam, adjacent to the masonry, and the ceiling finishes alongside the wall.

Water staining to masonry over viaduct arch

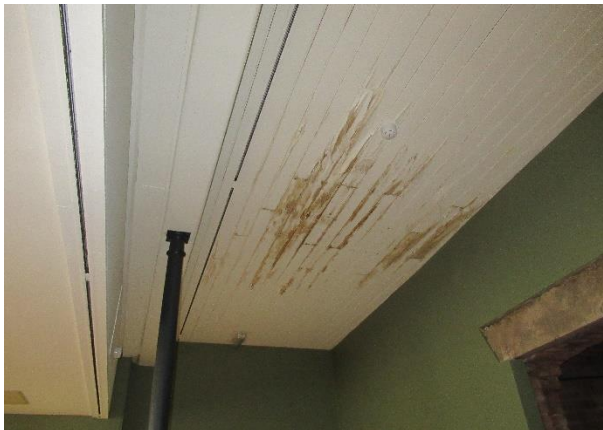
5.1.20

Water staining adjacent to the north wall extended into the room as far as the first internal downstand beam. The boarding to the ceiling showed loss of paint finishes due to water ingress and affected the top of the adjacent masonry.

Water staining and loss of finishes to ceiling

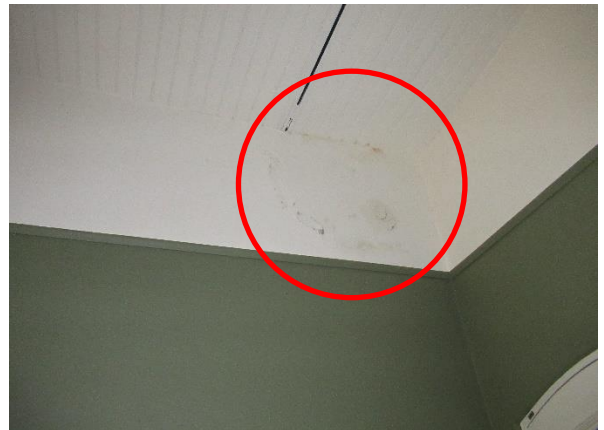
Water staining to wall finishes at ceiling level

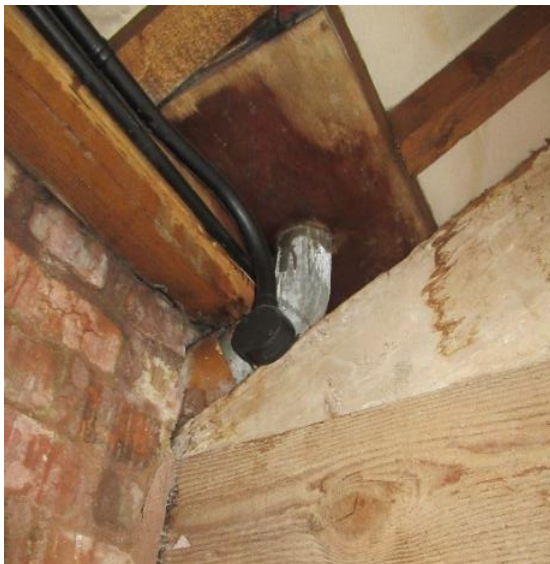
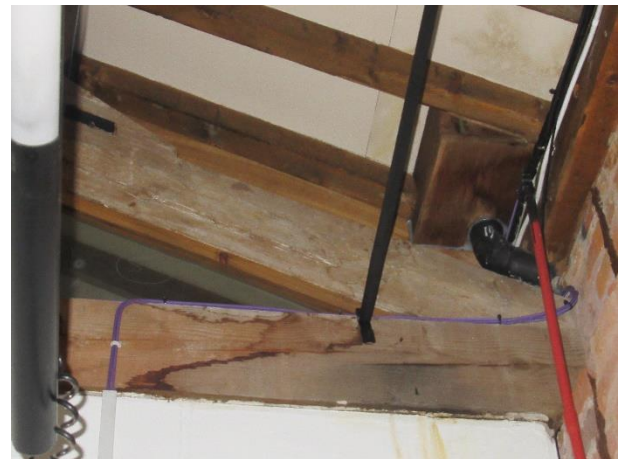
5.1.26

5.1.25 Water ingress was recorded to the finishes at eaves level to the south elevation and the timber at the bearing of the trusses was stained with repeated wetting and drying. Makeshift drainage had been installed to individual trusses on the south elevation to collect water that seeps into the room. Hoppers were located around the internal rainwater outlet which connected to the external rainwater pipes; the internal timber hopper surrounds were wet and stained.

Timber hopper units to drainage outlets behind the parapet

- 6.1.5 Water ingress at the eaves to the structure should be rectified to prevent further degradation of the trusses at their bearing ends. A survey of the roof timbers has been undertaken by a suitably qualified timber specialist and identified higher than average moisture content within the bearing of the roof trusses. Once reroofing works have been undertaken the masonry local to the bearing of the truss should be removed to either side of the timber to aid in drying out the existing timber. Lateral propping between the bottom chord of each truss is required to prevent rotation prior to the bearing being exposed, propping should be anchored to a suitably robust structural element such as a return wall. Once the moisture content has reduced to a desired level, to be indicated by the damp and rot specialist, the masonry around the bearing of the timber truss should be reinstated. Further water ingress to the eaves of the structure risks rotting and weakening of the timber bearing into the south wall.

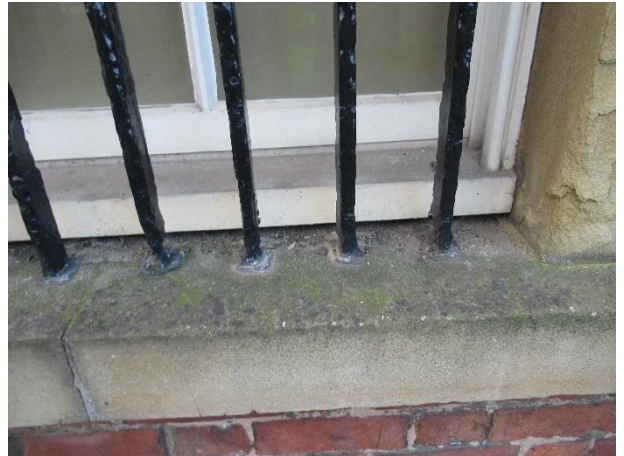
- 5.2.8 External cracking was noted in the sill and head of the windows to the Ticket Office on the north elevation where embedded metal railings were fixed over the windows. The railings exhibited historic corrosion since repainted with loss of section recorded to many of the uprights.

Railings embedded in the stone sill

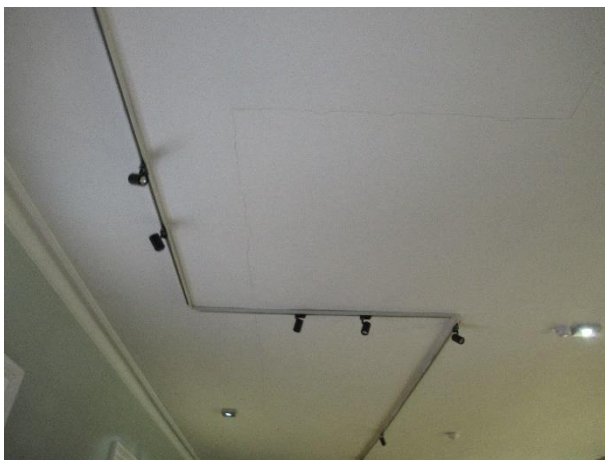
## 5.2.12

5.2.11 Regular cracks in the ceiling, assumed to coincide with the supports in the roof space, persisted across the full area of the rooms. The pattern of the cracks typically followed straight lines intersecting other perpendicular cracks at irregular spacing. The cracks appear to follow the line of the edges of plaster board ceiling panels.

Cracking to the ceilings over the western Waiting Room

6.2.3 The defects in the ceilings of the Waiting Rooms are suspected to be due to thermal movement of the individual plasterboard sheets. The space is heated but the walls are not insulated so there is the means for large variations in temperature of the space over time. It is also expected that if the plasterboard joints were not properly taped before the ceilings were skimmed that any minor thermal movement will manifest itself at these joints.

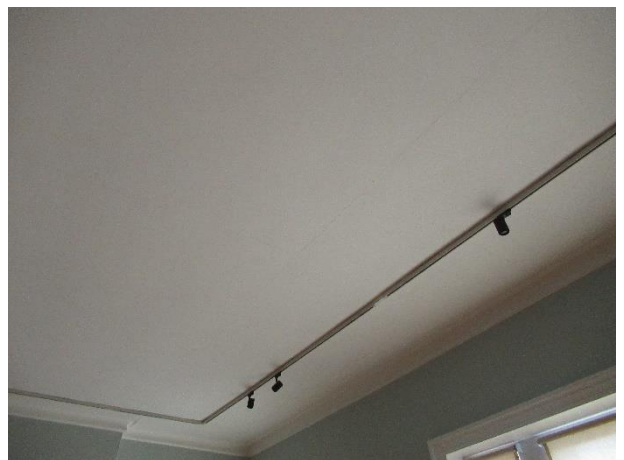
Cracking in the eastern Waiting Room

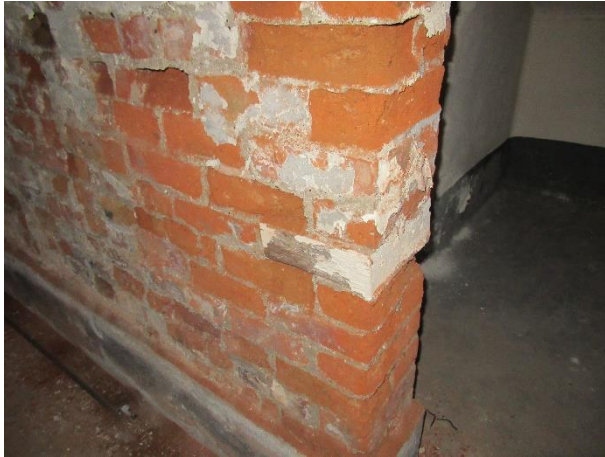
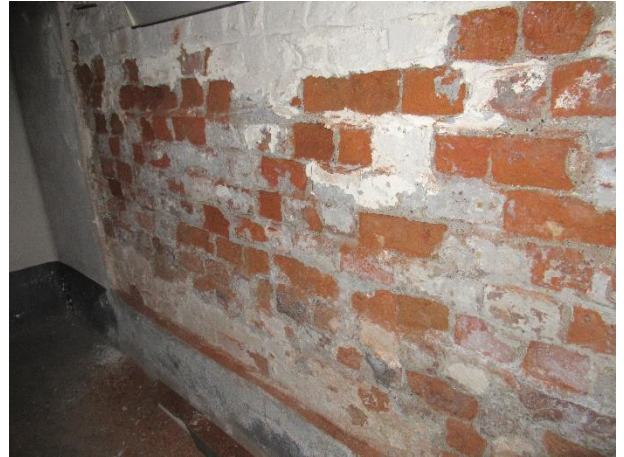
5.3.2

5.3.1 The basement in the Station Master's House showed extensive spalling and erosion to the face of the units. The face of the masonry units can be eroded by light rubbing of the surface by hand. The loss of section of each unit varied between 0-10% of the depth of the brick.

Erosion of masonry in the basement

6.2.2 Spalled and eroded brickwork was recorded to the western end of the basement which appeared to coincide with walls that had been painted or rendered; it is possible that this defect has arisen due to inappropriate surface treatments trapping water in the masonry. The erosion to the face of the masonry units is not considered sufficient to be of structural concern however progressive erosion should be prevented to ensure the issue does not become a more structural matter.

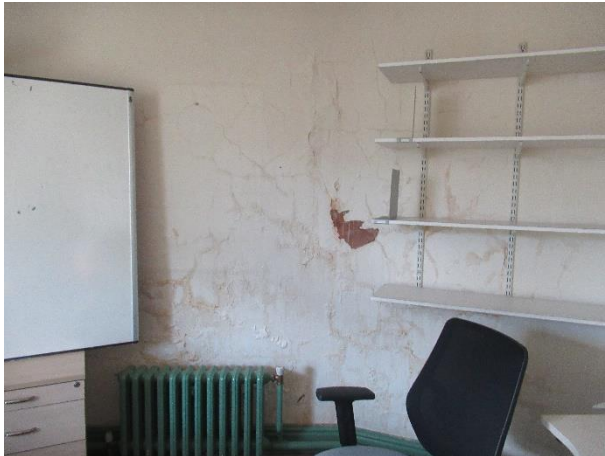
### 5.3.5

5.3.4 Water ingress was recorded to the western curved wall of the Station Masters House. Water staining of the internal finishes was recorded at each floor with the extents of the defect increasing with each floor up the building. Cracking in the internal plasterwork typically exhibited water staining along the length of the crack and the surrounding finishes.

Water ingress at second floor of the Station Masters House

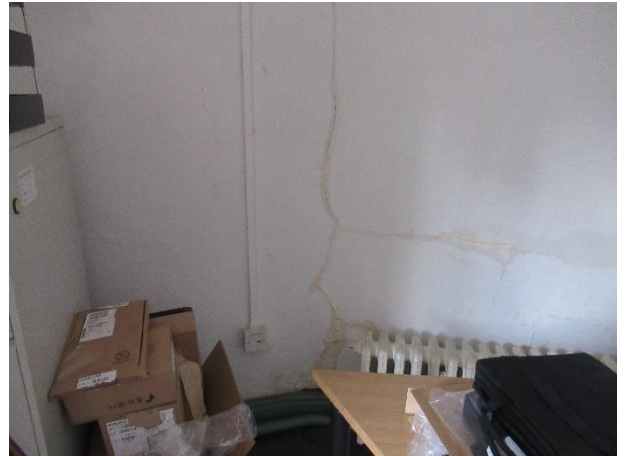
Water ingress at first floor of the Station Masters House
