## Manchester Reform Club

### External fabric project: Mortar replacement & window decoration

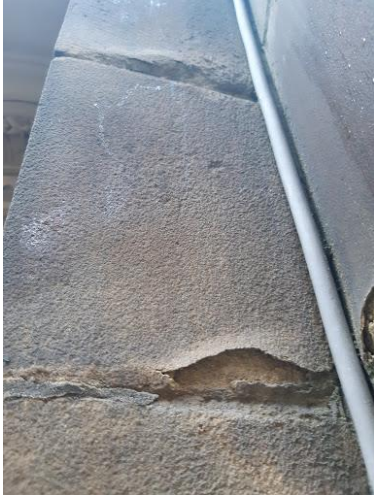
Due to the building being repointed with an inappropriate impermeable cement mortar, this leads to the acceleration of stone decay, this is due to the water being trapped behind the porous stonework. As there is little moisture movement allowed through the joints, moisture is concentrated behind the cement barrier. This forces water to repeatedly move into and through the stone causing the surrounding masonry to deteriorate.

In low temperatures, the water trapped behind the cementitious mortar is subject to freeze thaw action. This is where the water freezes and leads to the surface of the stonework to spall; this poses health and safety risk to the general public as this could happen without any warning if root cause of this issue is not addressed.

| Cementitious mortar leading to sandstone spalling around mortar joint | Heavily stained stonework around cement mortar joints |

- Rake out all cementitious mortar from joints to stonework to a minimum depth twice the width of the joint.
- Where cement mortar is weak to medium strength, mortar to be raked out utilizing hand tools which consist of a sharp masonry scutch and hammer to remove the cement from the delicate stonework. Works to be carried out with due care to avoid any potential damage to sandstone.

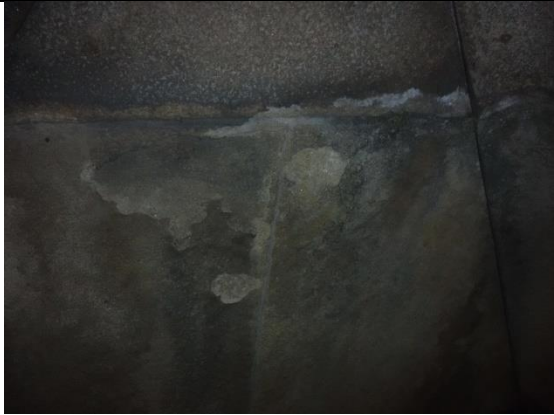
| Spalled sandstone concentrated around mortar joint | Heavily stained stonework around cement mortar joints |

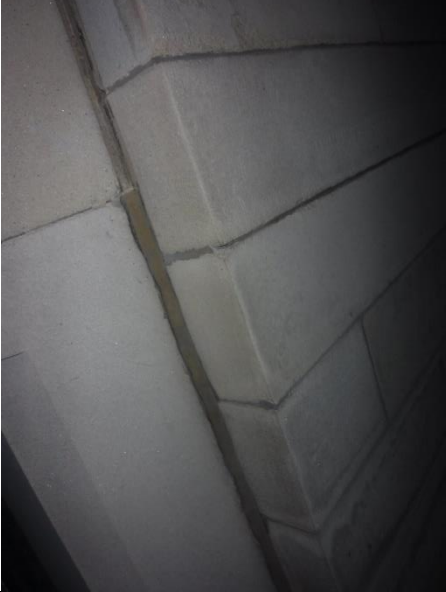
| Failed mortar and signs of decay around joints | Heavy stained sandstone and open mortar joints |

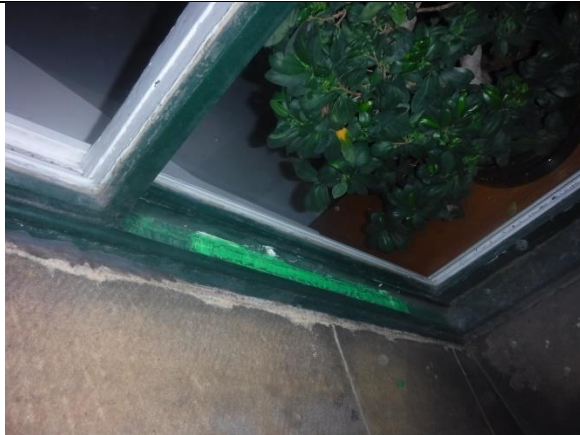
| Signs of poor paintwork condition with previous colour scheme shown | Signs of flaking paintwork throughout the frame |

- Any flaking paint will be carefully removed by hand to minimise loss. In order to provide an appropriate key for repainting, minimal gentle sanding will take place by hand using a fine grit sand paper. This will ensure that historic layers of paint are not affected by the preparatory work. No power tools or heat gun will be used to strip paint. No chemicals will be used

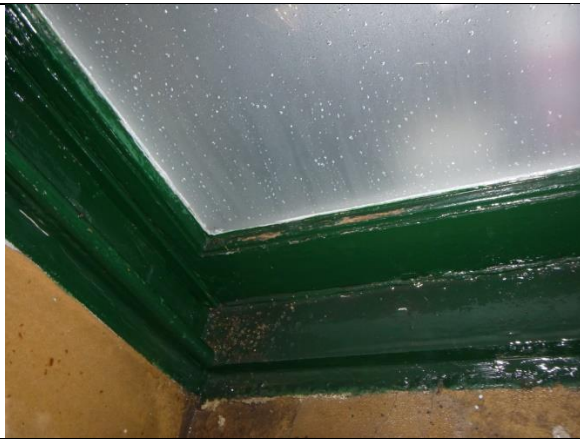
| Signs of flaking paintwork throughout the frame | Heavily flaking paintwork throughout the frame |

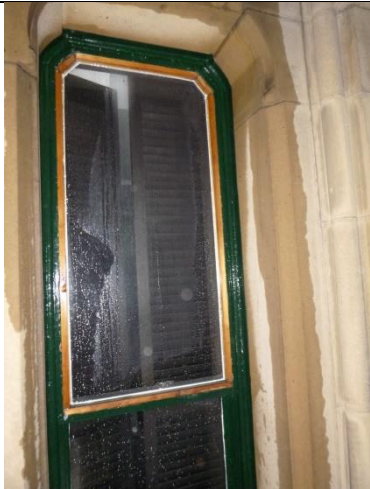
| Previous repair not decorated | Flaking paintwork and heavily soiled window frame |
