Stage 1 / 2  
Structural  
Inspection 32-34  
Laystall Street

32-34 Laystall Street,  
Manchester,

23 October 2020

1/20445/REP/001

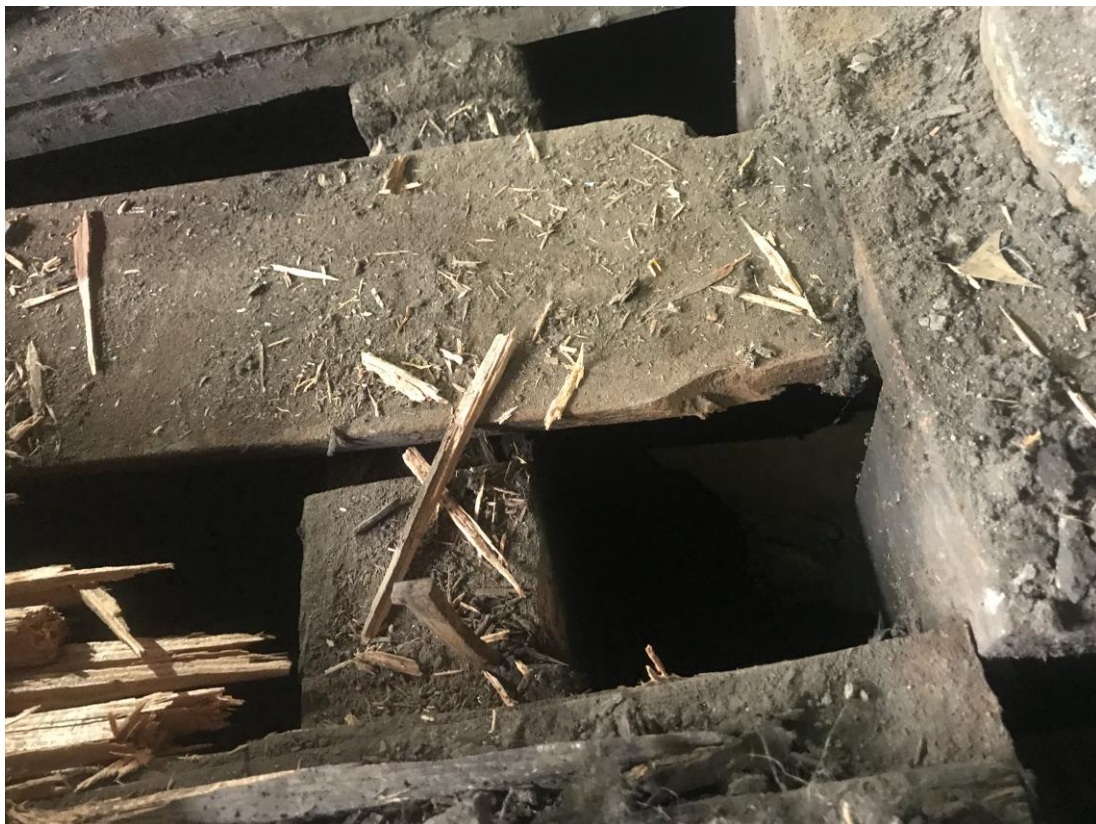
Inspections undertaken on these members through the limited opening up works undertaken on site to date have in one location identified a potential brittle fracture to the top flange of a member at second floor level. This would suggest that these members are most likely to be of wrought iron construction, which would correspond with construction techniques common of the time the property was built.

Photo 1 – Possible Brittle Fracture to Top Flange of Second Floor Beam

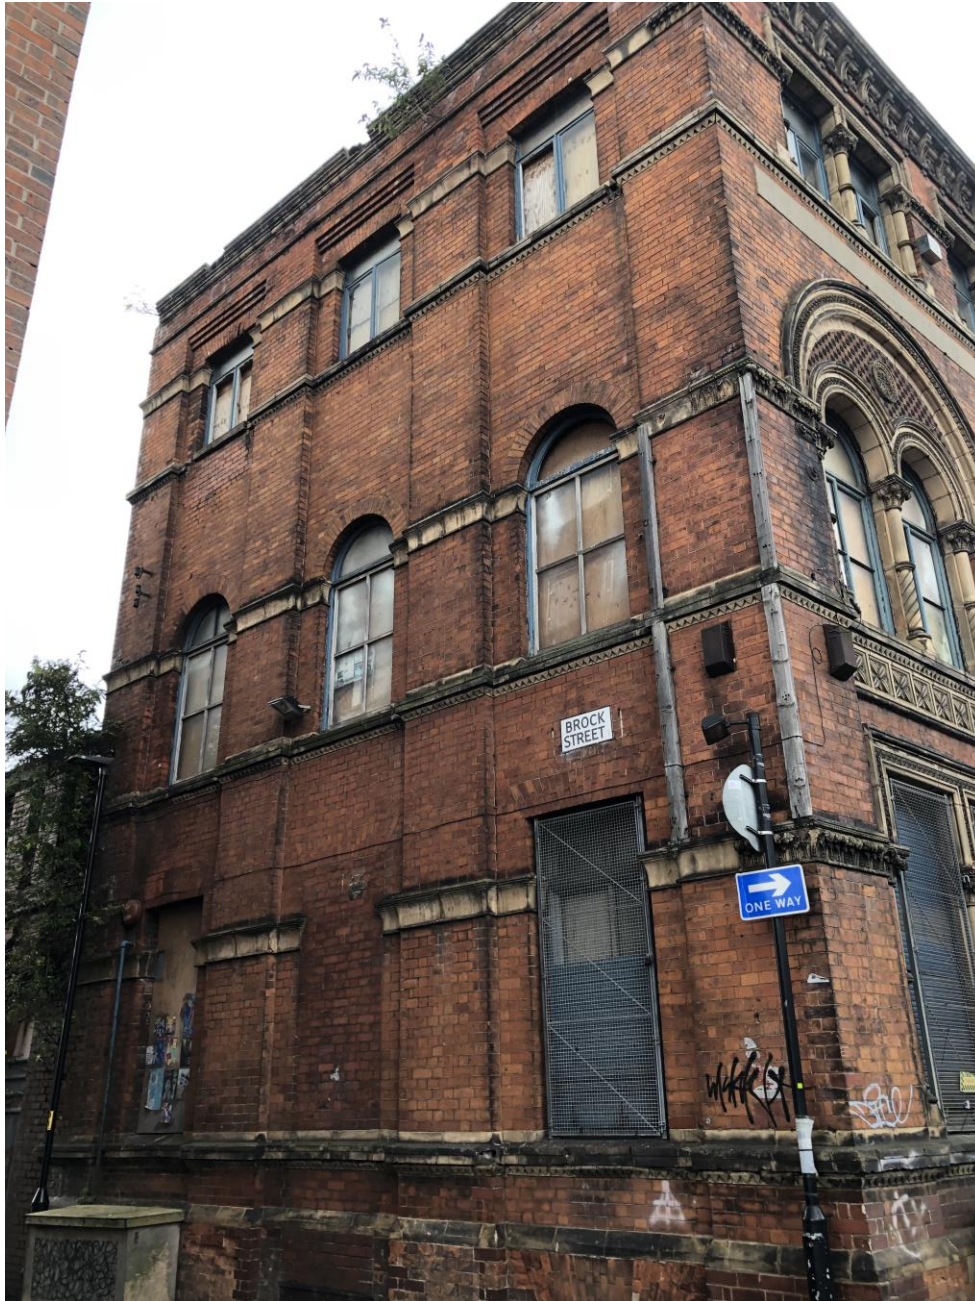
3.1 There is of self-seeded vegetation up the building, and particularly at roof level, which is rooted into the external fabric of the building.

Photo 2 – Vegetative Growth Up External Building Face

As described in the previous text, the external façade has suffered from a general lack of maintenance and self-seeding vegetation is present. Along with its ability to retain moisture, which can then freeze and expand, is likely to have caused physical damage to the external envelope of the building, which will need to be addressed as part of the works.

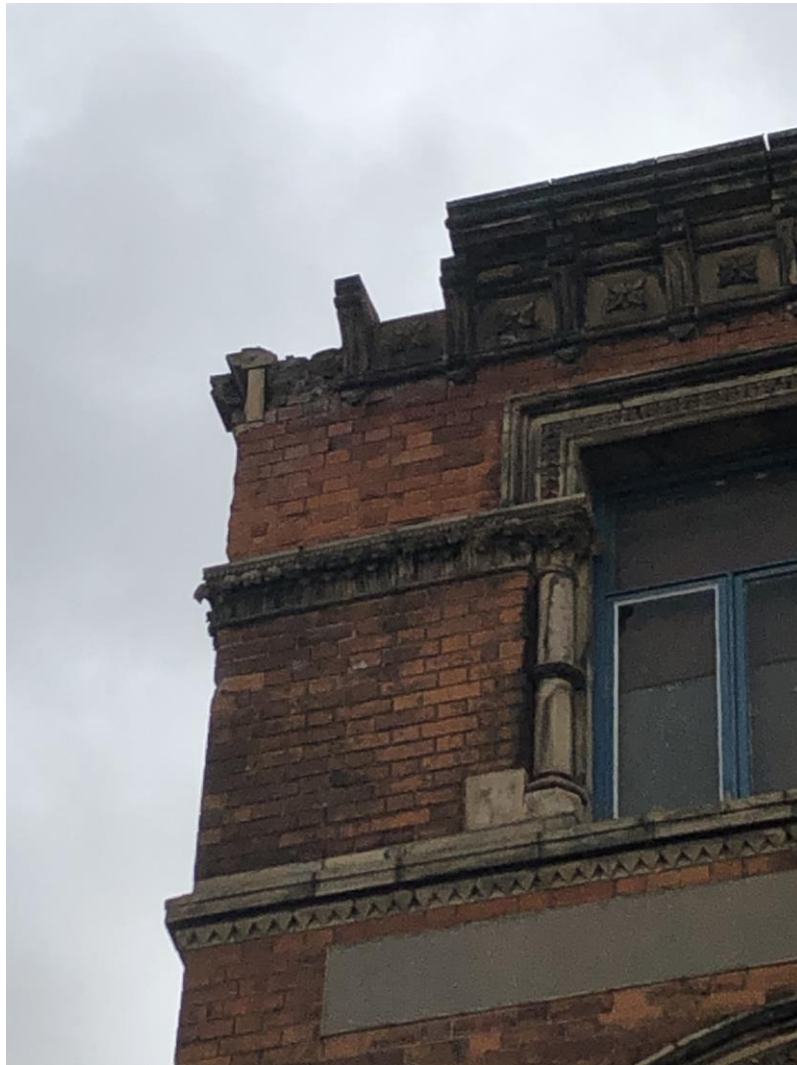
3.2 Displaced and missing masonry and stonework were visible at higher levels where vegetation was most likely once present.

Photo 3 – Missing Terracotta Parapet Moulding

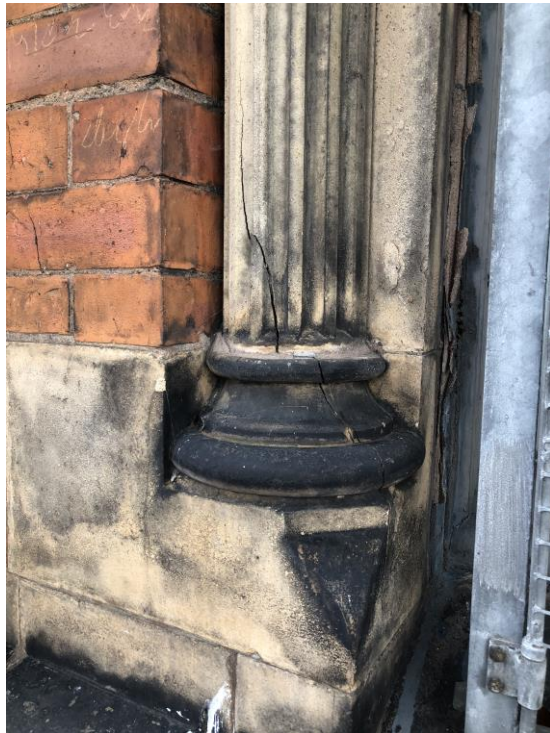
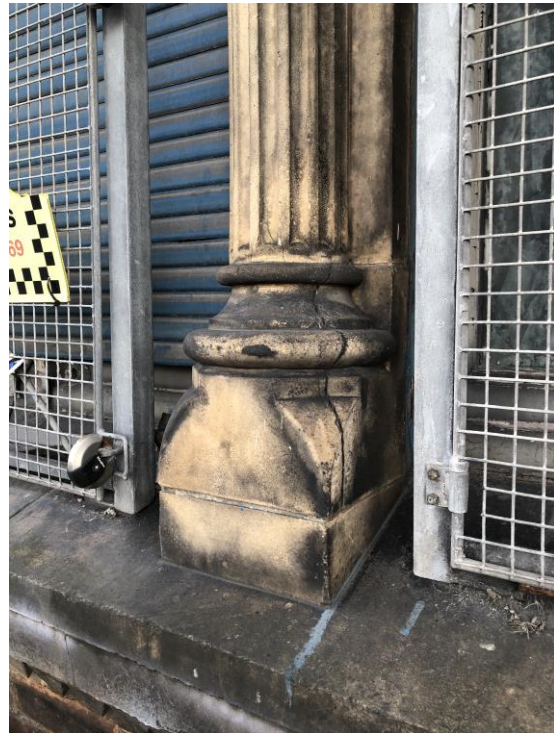
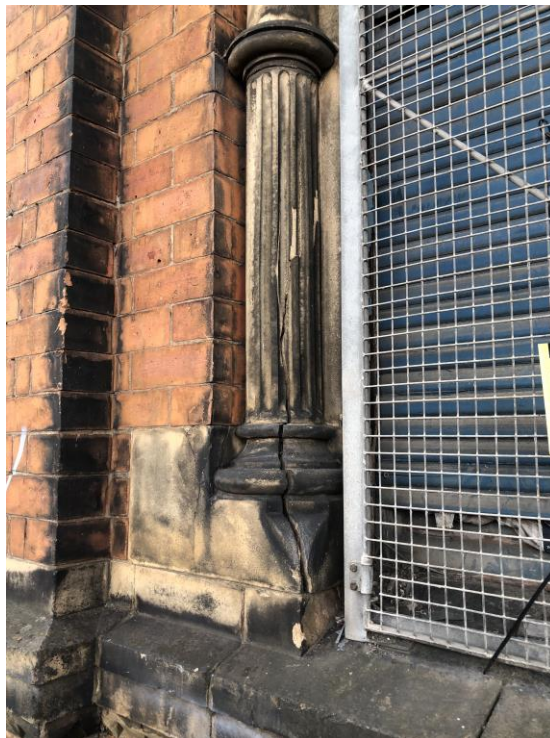
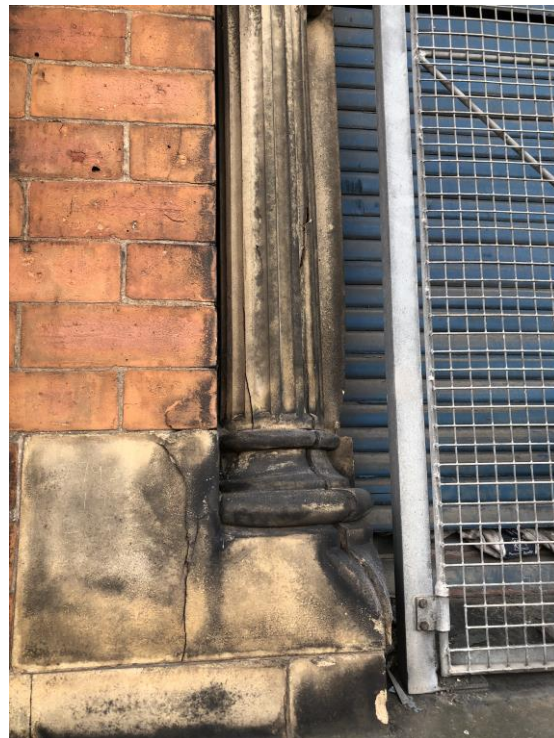
3.3 Throughout the external façade, cracking to terracotta features was observed, principally at first floor cill and ground floor level. This is less evident or conspicuous at second floor level, although closer inspection may reveal this to be present

Photos 4 to 7 – Cracking to Terracotta Castings

In overall terms, the damage to the external terracotta embellishments, although not strictly of structural significance, is likely to be significant in terms of programme duration and reparation costs. Some of this damage is likely to have occurred as a result of moisture ingress causing corrosion and expansion of ferrous fixings, such as locator dowels, within the body of the terracotta castings. We understand the desire would be for these terracotta items to be repaired or replaced as part of the works. Any items which are too badly damaged to be repaired would likely need to be recast due to their bespoke nature and input should be sought from a specialist in this respect.

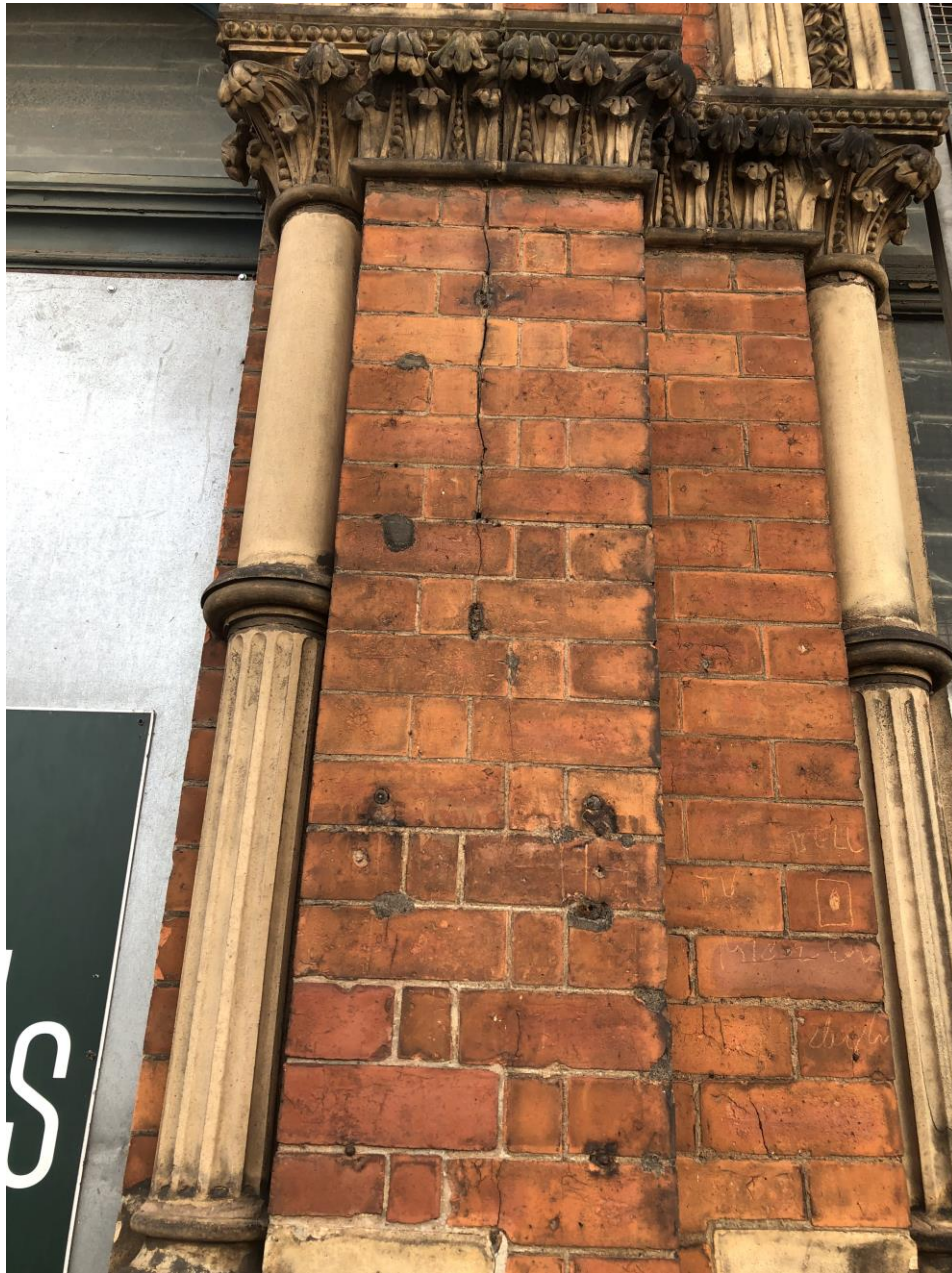
3.5 Throughout the external façade, redundant ferrous fixings were observed, some of which had corroded and caused fracturing of the external masonry or terracotta finishes. Whilst fixings further up the building were less evident from street level, it is likely some exist.

Photo 8 – Vertical Masonry Cracking Due to Corrosion of Ferrous Fixing

We would suggest the removal of any redundant ferrous fixings is undertaken during the restoration work to prevent further damage from the external façade from occurring.

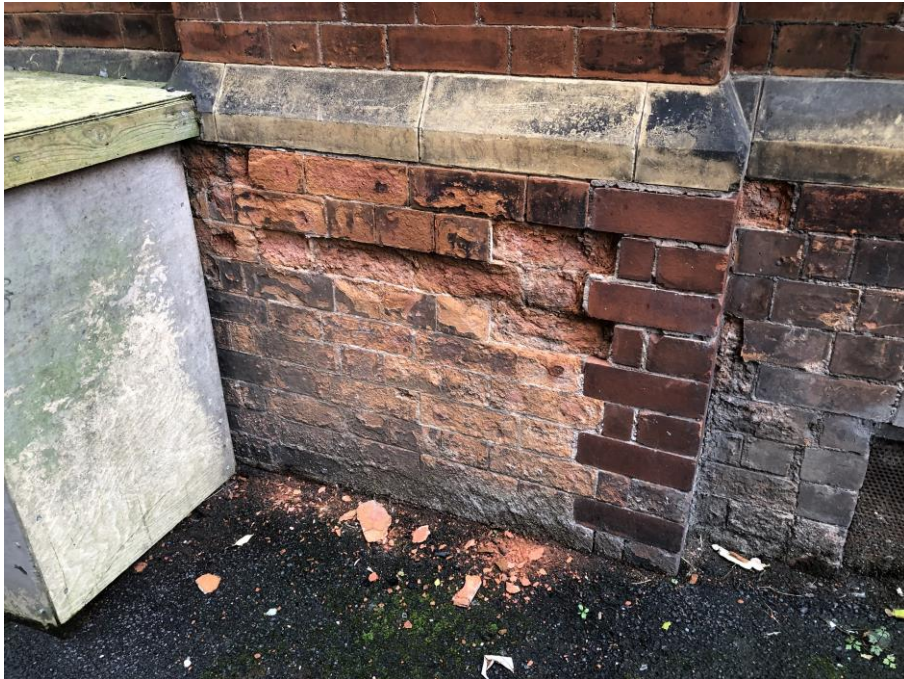
3.6 At lower levels of the building extensive spalling of the brickwork, as a result of freeze thaw action, was observed.

Photo 9 – Lower Level Freeze / Thaw Spawling of Brickwork

Although the current condition of the masonry does not cause structural concern, the delamination of the brickwork over time will inhibit the structural capacity of the wall, as well as being unsightly. We would suggest that any delaminated brickwork at low level is removed and replace with similarly face masonry as part of the wider refurbishment works.

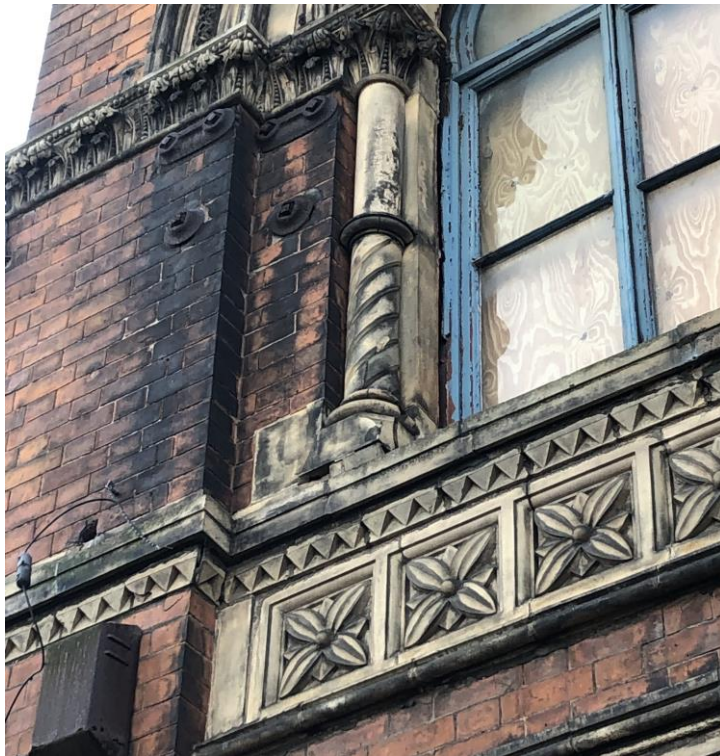
3.7 At first floor level, external pattress plates were visible in the northeast corner of the building, facing Laystall Street. Internal inspections revealed a large cast metal tank stand within the corner of the building, which the pattress plates had clearly been installed to fix back to the masonry corner of the building. Assuming removal of the tank stand, these plates would effectively be redundant.

Photo 10 – External Spreader Plates on Northeast Building Corner

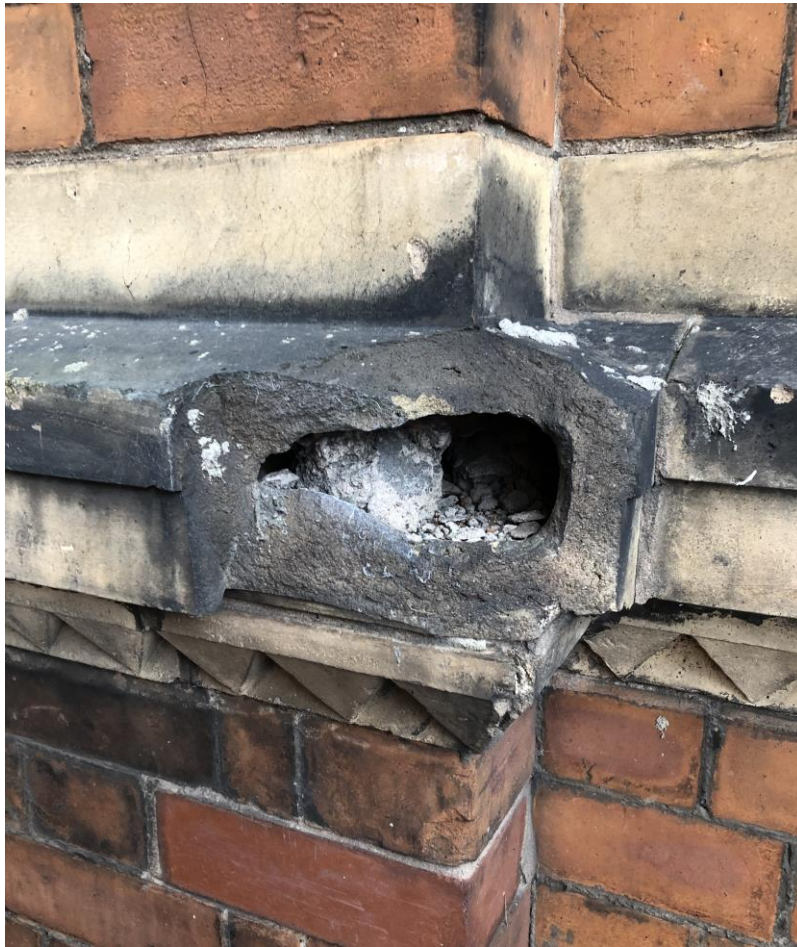
3.8 In several locations the existing terracotta blocks were found to be damaged or missing at cornice level, most likely as a result of vehicle strikes.

Photo 11 – Vehicle Strike Damage to Terracotta on Northeast Elevation

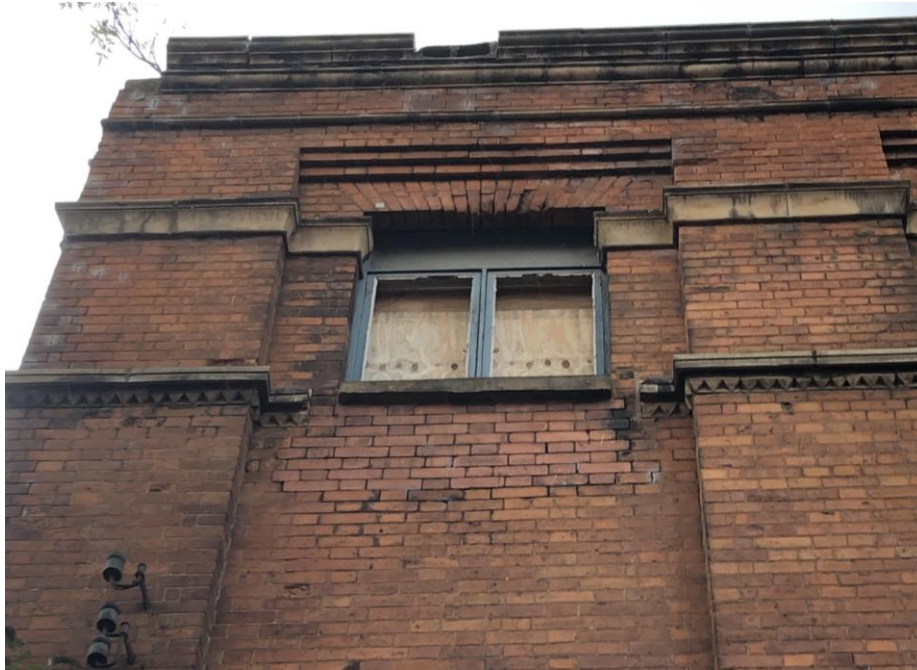
3.9 Noticeably, different brickwork was identified below an existing window on the northeast elevation at second floor level and visual evidence of rope wear to the head of the window suggest that this once formed a larger loading bay, which has since been infilled to form the current window opening.

Photo 12 – Historic Loading Bay at Second Floor – Northeast Elevation

Local repointing of the existing mortar would also be required throughout and this would act to conceal local differences in brickwork finishes slightly, such as at the second floor loading bay, however replacement of the header bricks above the window in this location may be necessary following closer inspection of their condition.

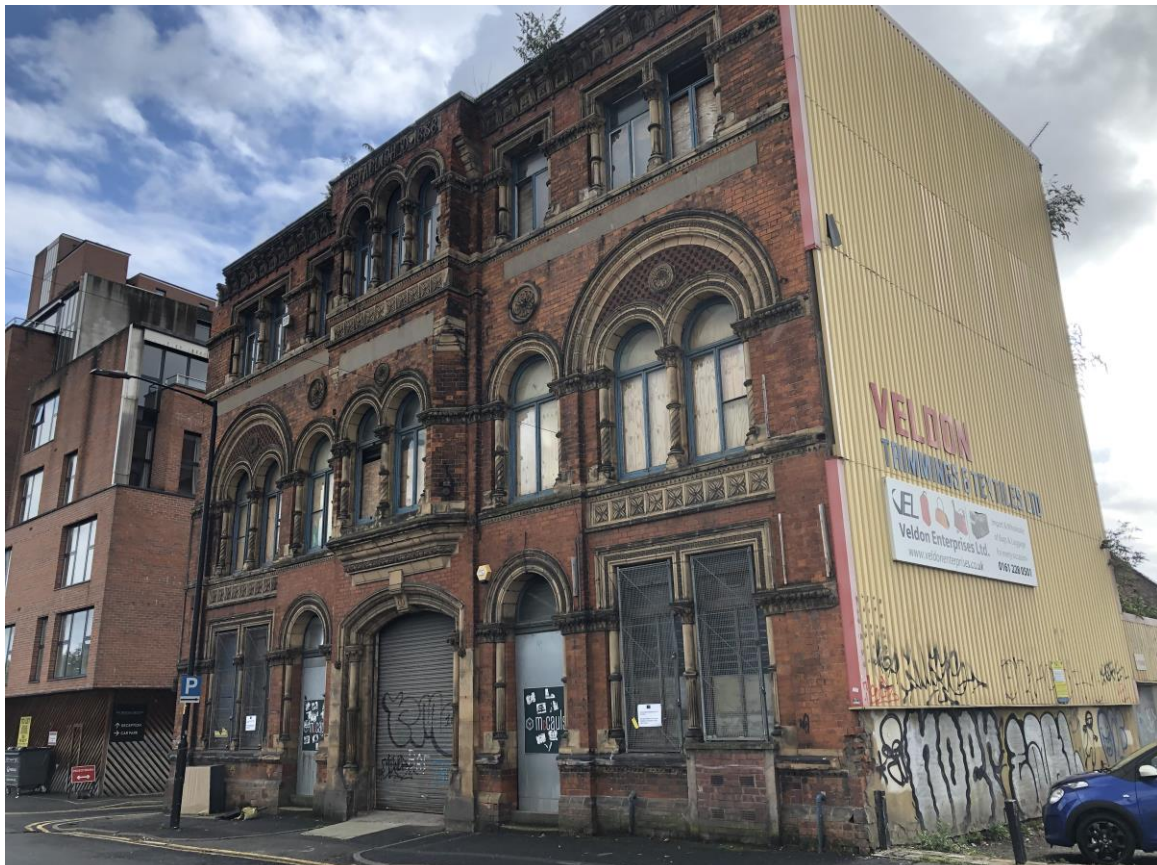
3.10 Almost the entire southwestern building elevation was over-clad in a profiled metal sheet or over-rendered at the lower levels. It was therefore not possible to fully observe the original fabric of the building in this location.

Photo 13 – Profiled Metal Cladding to Southwest Elevation

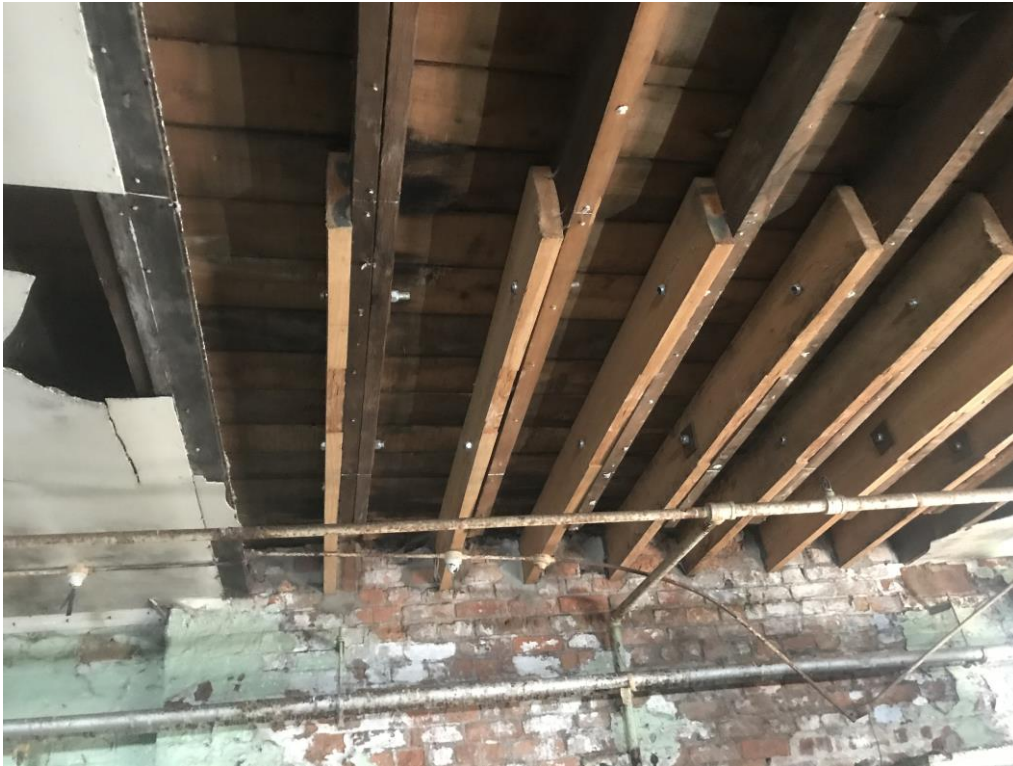
Photo 14 – Existing Splice Connection Detail to Roof

4.1.4 At the northeast corner of the building, a section of the timber joists had been subject to a splice repair in the past. Existing joist ends had been removed, most likely due to wet rot of the timber in the wall, and new timber members have been fixed. These new timbers have been built into the wall with a DPM wrap to the ends to prevent further damage and new brickwork installed around tight up to the new timber.

4.1.5 Observations of the connections between the original timber joists and the new spliced additions identified significant displacement of the bolts, which appear inadequate in number. There is a general lack of steel spreader plates (although some are present) which has allowed the bolts to locally crush the timber resulting in the joists slipping out of alignment with the other joists on the same building line. We would suggest that the roof in this area should be replaced as part of the wider works and to facilitate the proposed new roof coverings.

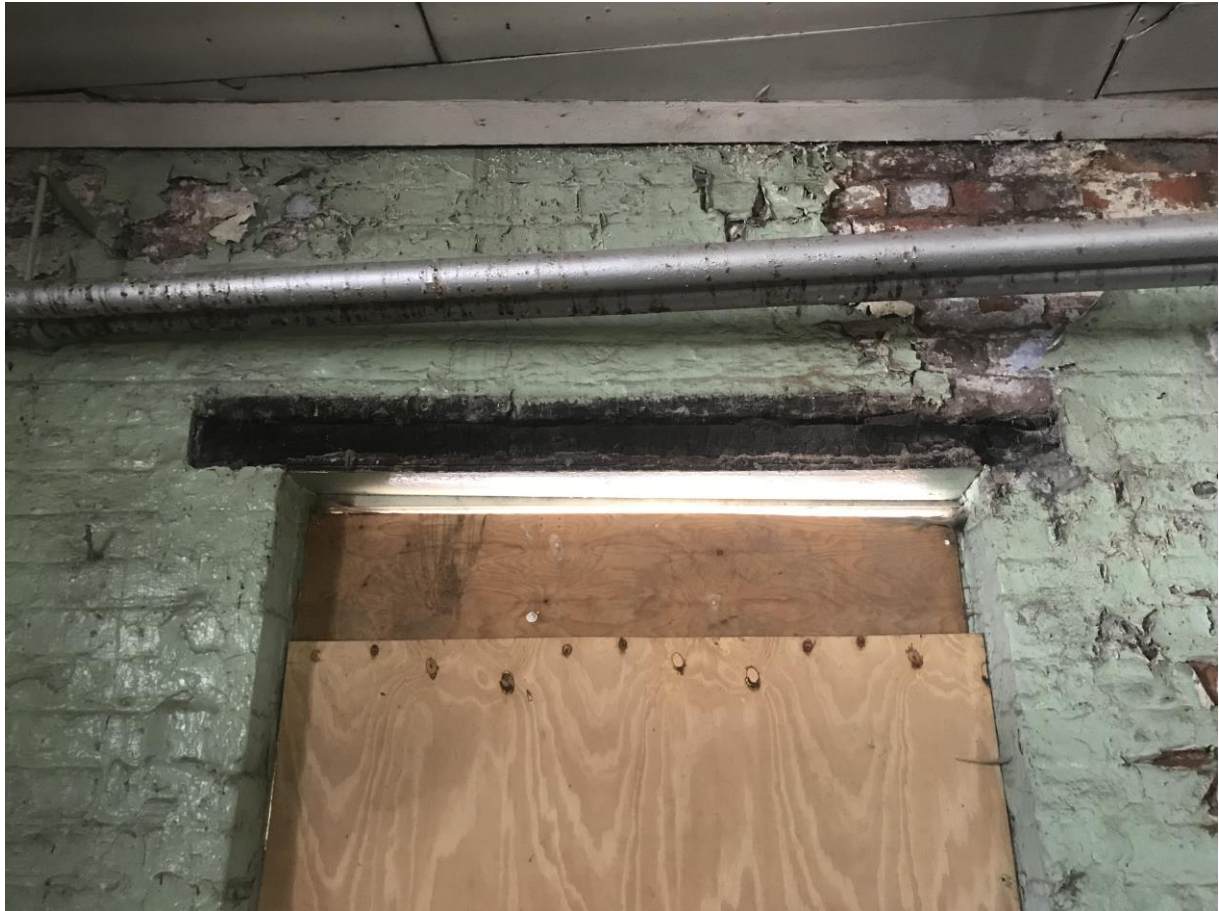
4.2.3 One lintel was exposed by removal of a fascia board and found to have been subject to fire damaged, with charring present on its exposed internal faces. This may have affected the structural integrity of this lintel however the charring affect will have afforded some protection to the loss of significant sectional area.

Photo 15 – Existing Fire-Damaged Timber Beam to Northeast Elevation

The structural integrity of the existing timber lintels may have been compromised by the historic damage caused by the previous building fire and ingress of water into the building. Any loss of sectional capacity would no doubt have been mitigated by the arching affect the brickwork would have over the opening, preventing any form of local or global failure of walls. We would recommend a thorough review of the existing structural members as part of the refurbishment works, with structural defects addressed on a case-by-case basis as and when they are uncovered.

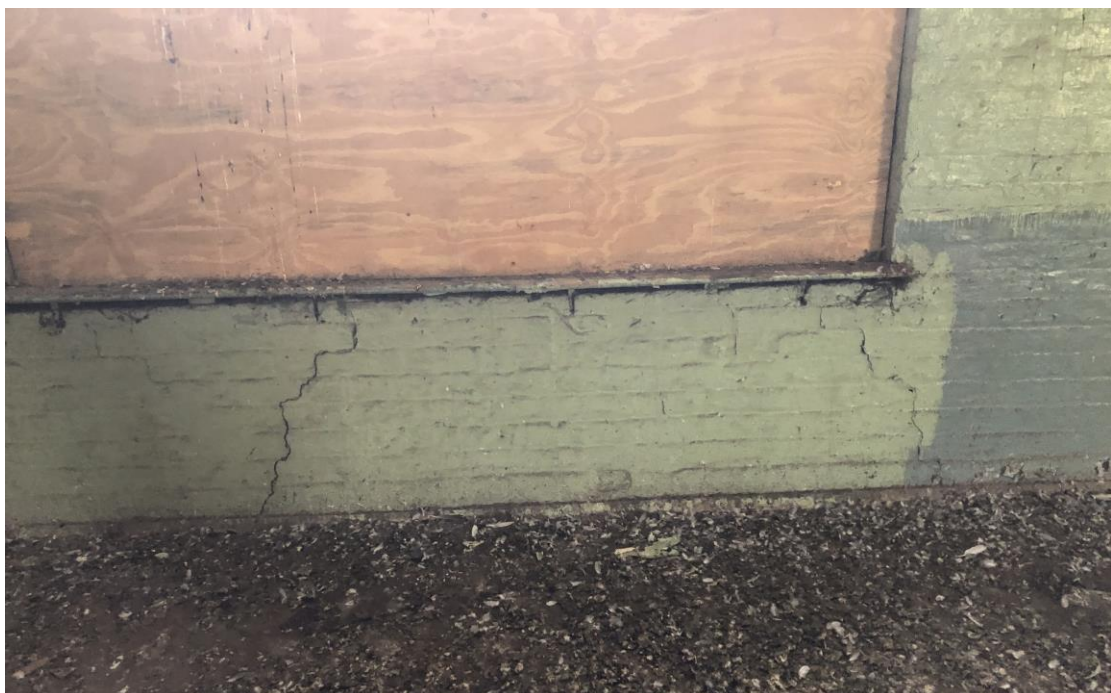
4.2.4 There is vertical cracking beneath window openings, which generally follows the line of the mortar joints.

Photo 16 – Vertical Cracking Below Window Opening to Northwest Elevation

Vertical cracking through the masonry mortar joints to the front building elevation are likely a result of contraction of the brickwork at the larger masonry panels, which has manifested itself as movement cracks at the location where the minimal brickwork exists. This is not of any structural significance and local repairs should be undertaken as part of the wider refurbishment works.

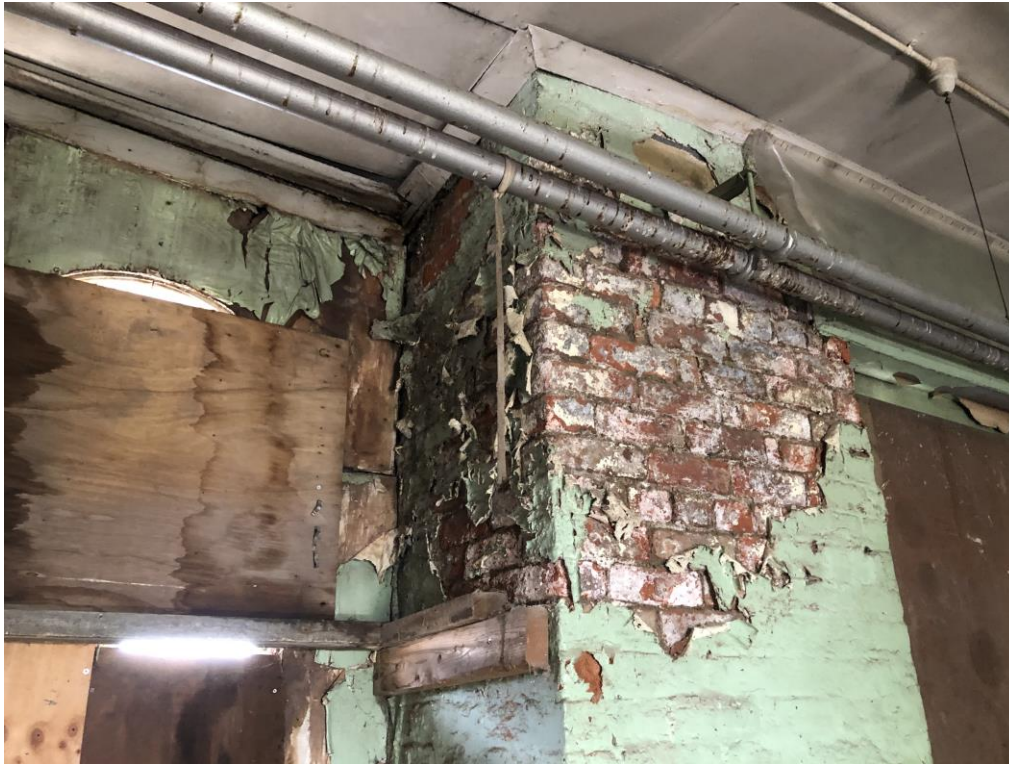
4.2.5 Throughout the building there is evidence of damp having penetrating through from the roof, with damage to plasterwork and paintwork throughout. Some efforts have been made to arrest this water ingress and plastic sheeting was evidence at the second-floor level which appears to be conducive with this.

Photo 17 – Evidence of Water Ingress at Second Floor Level

4.2.6 Water ingress may pose a risk to the structural integrity of the timber members built within the external envelope of the building, notably the timber lintels and roof and floor joists throughout.

Ingress of water into the building is also found to have affected ceilings and floors in a number of locations and, although not strictly a structural issue, the floor boarding and joists should be checked in these locations and any damaged members should be removed and replaced.

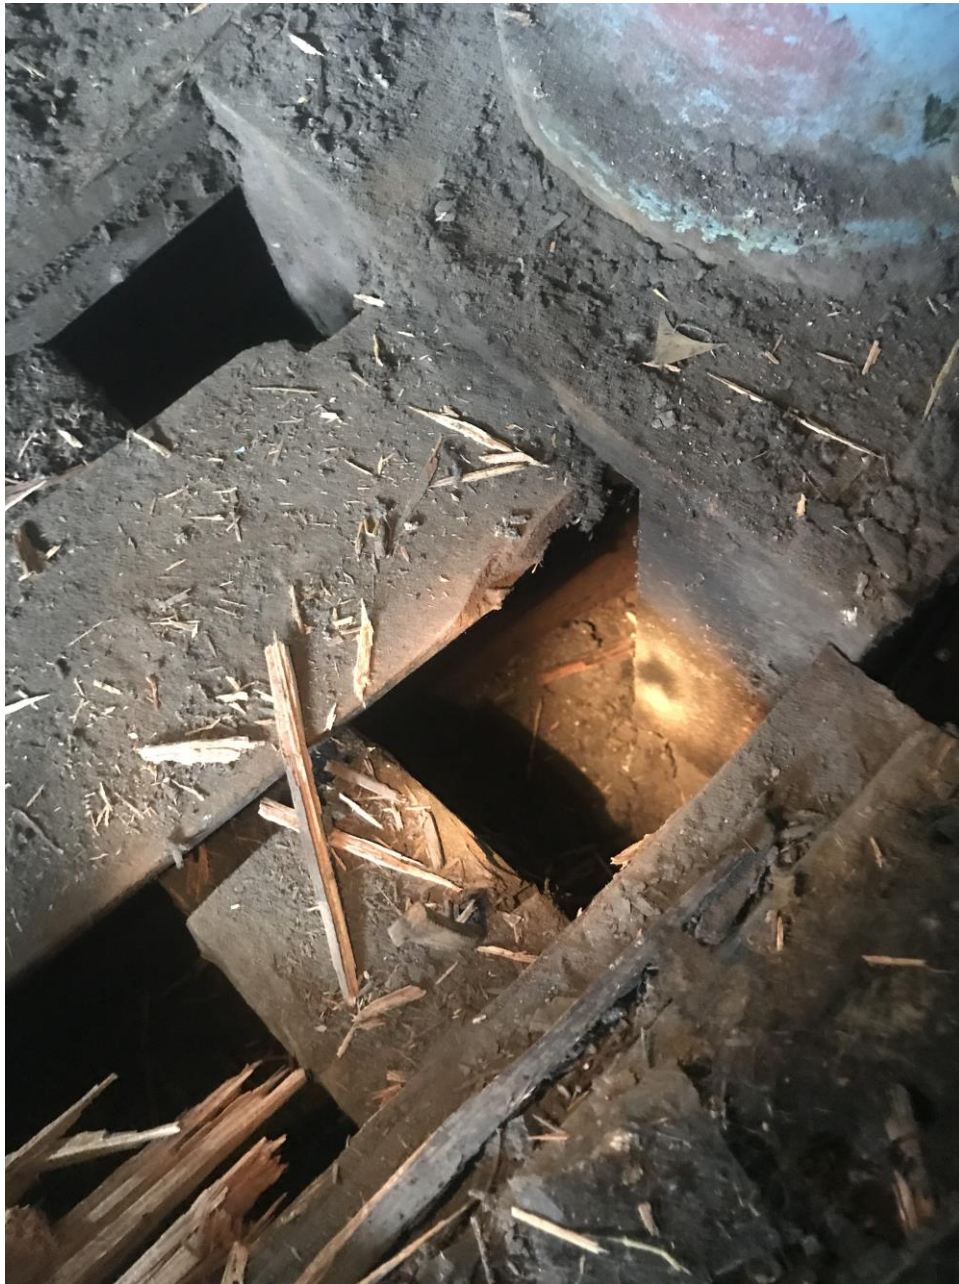
4.2.8 Second floor timber joists span southwest to northeast and were found to be supported on intermediate wrought iron members running from the central line of cast iron columns to the northwest and southeast external building elevations. Some of these members were observed from the floor below as being installed at oblique angles to the external walls in order not to bear over window openings.

Photo 18 – Oblique Wrought Iron Member Bearing on Cast Iron Column at Second Floor

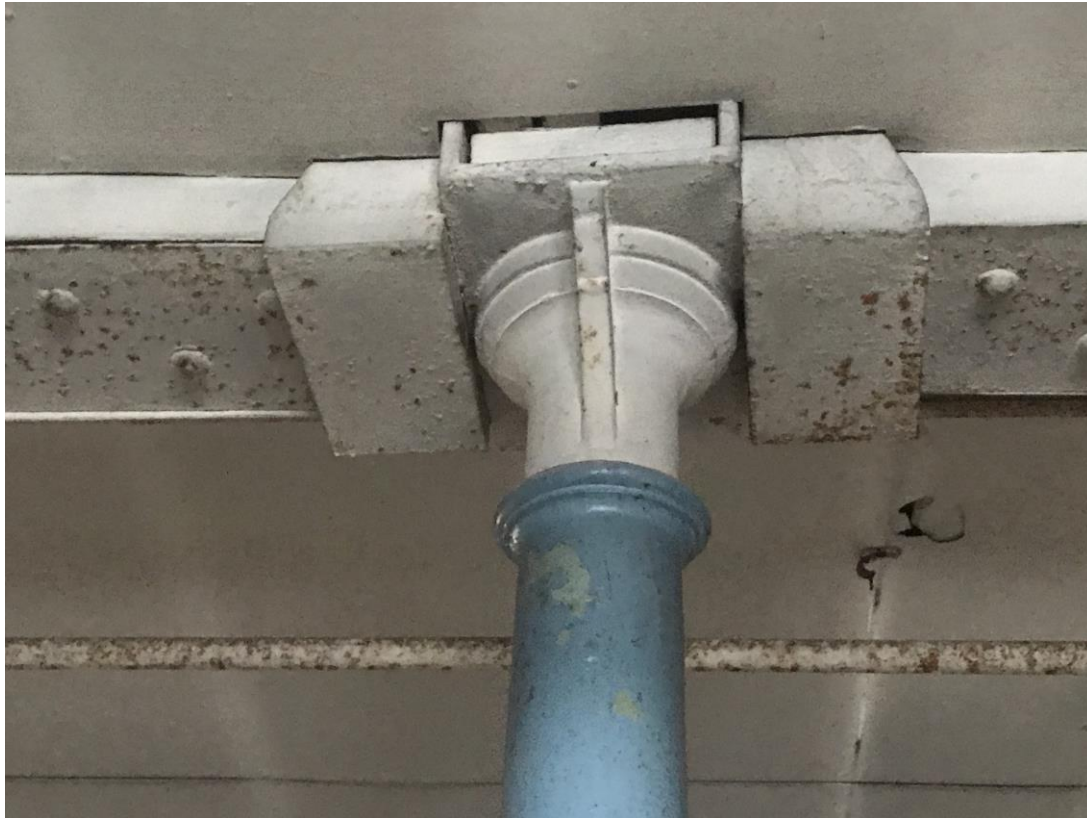
4.2.9 An exposed wrought iron member was measured and found to be approximately 250mm deep by 130mm wide. These wrought iron members were supported on brackets which appeared to be cast as one with the columns, however it was not possible to observe any bolts etc due to the limited extent of opening up works.

Photo 19 – Cast Support Brackets at Column Head Supporting Roof Members

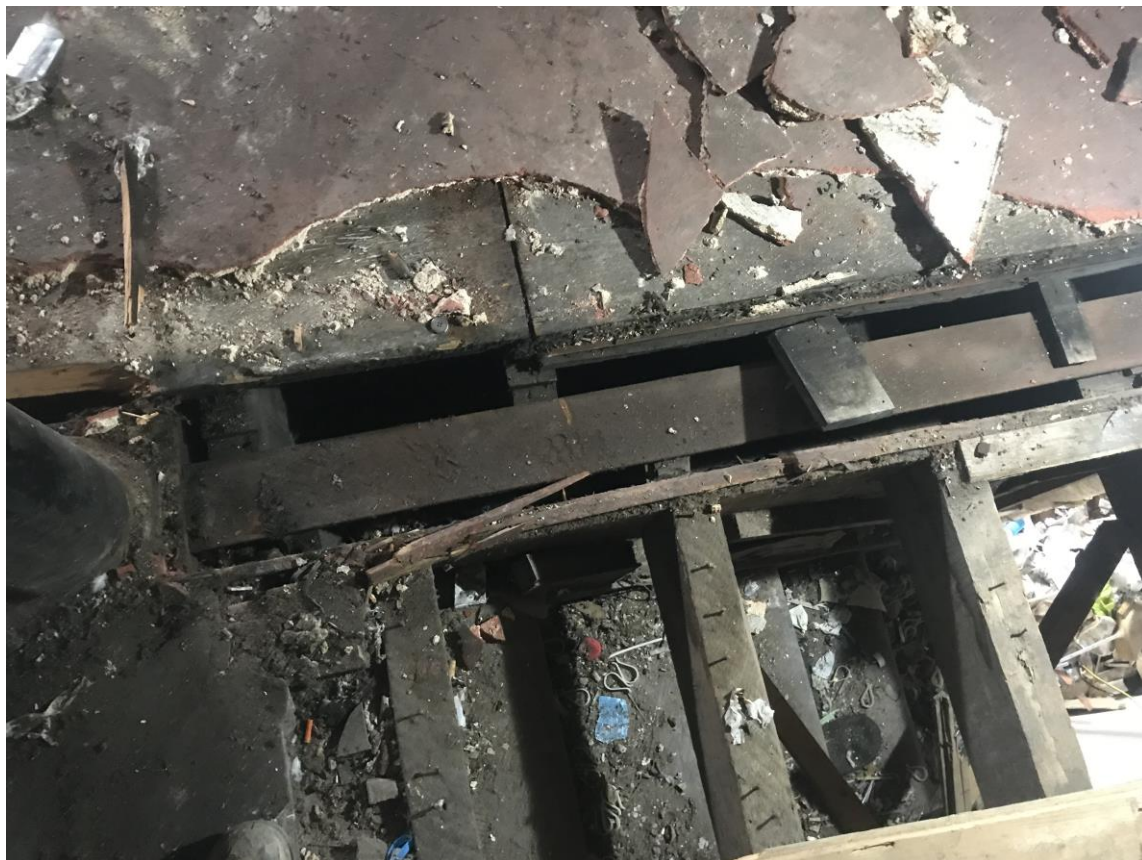
4.3.2 First floor timber joists were found to measure 275mm deep by 75mm wide, installed at 440mm centres and spanning front to back (northeast to southwest). These timber joists supported tongue and groove timber floorboards, which were measured as 50mm thick. These floor joists are assumed to bear into the external walls and be supported on the central line of wrought iron beams, which run through the centre of the building.

Photo 20 – Timber Infill to First Floor Stair Void and Original Trimmer Beam

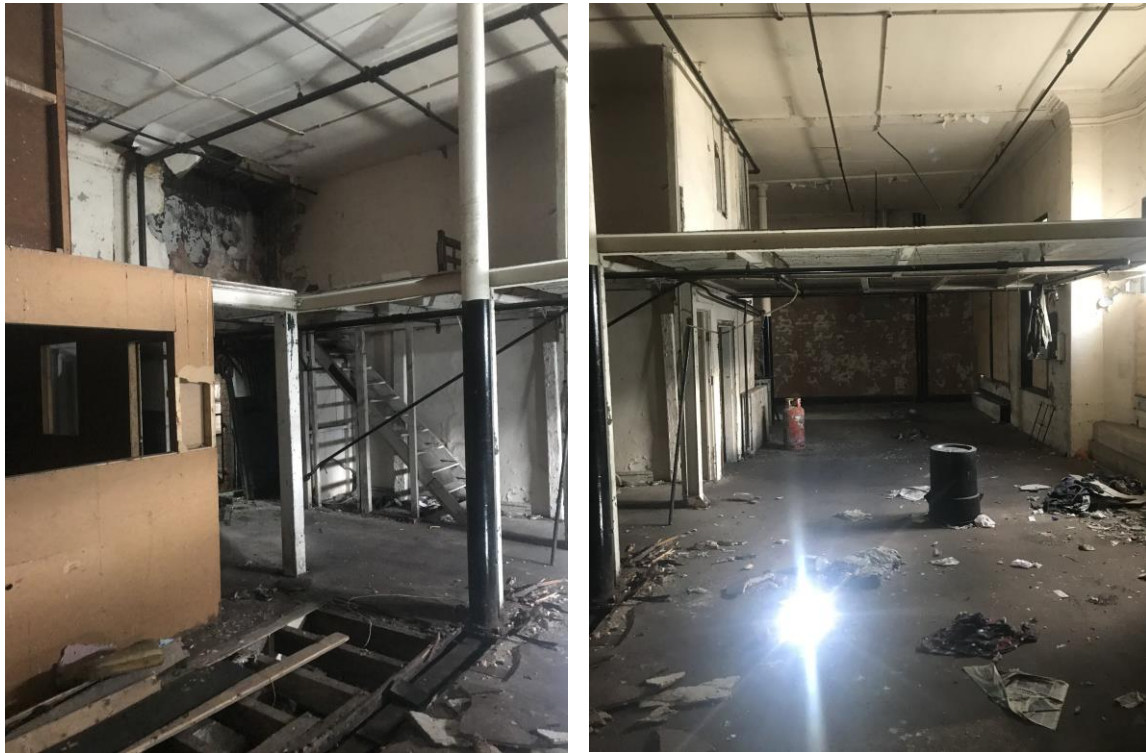
4.3.3 A partial mezzanine floor with restricted head height exists at first floor level. This is formed of timber construction and is accessed via a timber staircase within the main room at this level, which is otherwise largely open plan. Our understanding is that the mezzanine floor will be removed as part of the refurbishment works, in order to provide a larger open space for the new offices.

Photos 21 & 22 – Partial Mezzanine Floor at First Floor Level

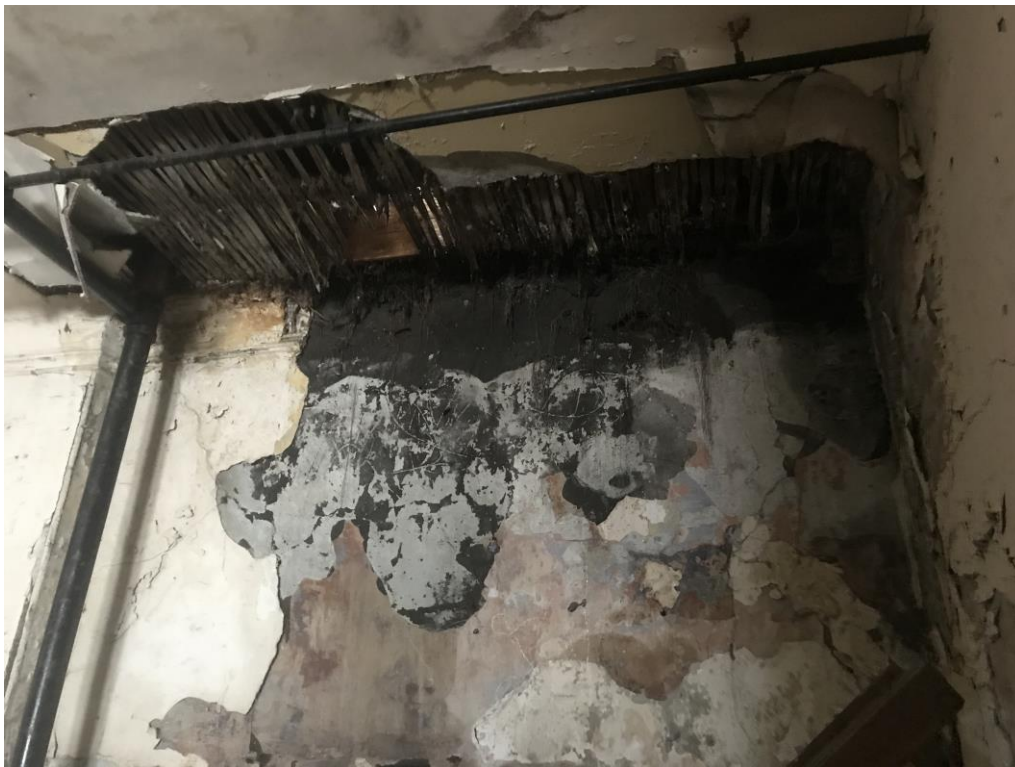
4.3.4 Damp penetration through from the roof level is evident at the top of the mezzanine floor staircase. A large area of plaster and paintwork is damaged, and the ceiling collapsed.

Photo 23 – Collapsed Ceiling Above First Floor to Mezzanine

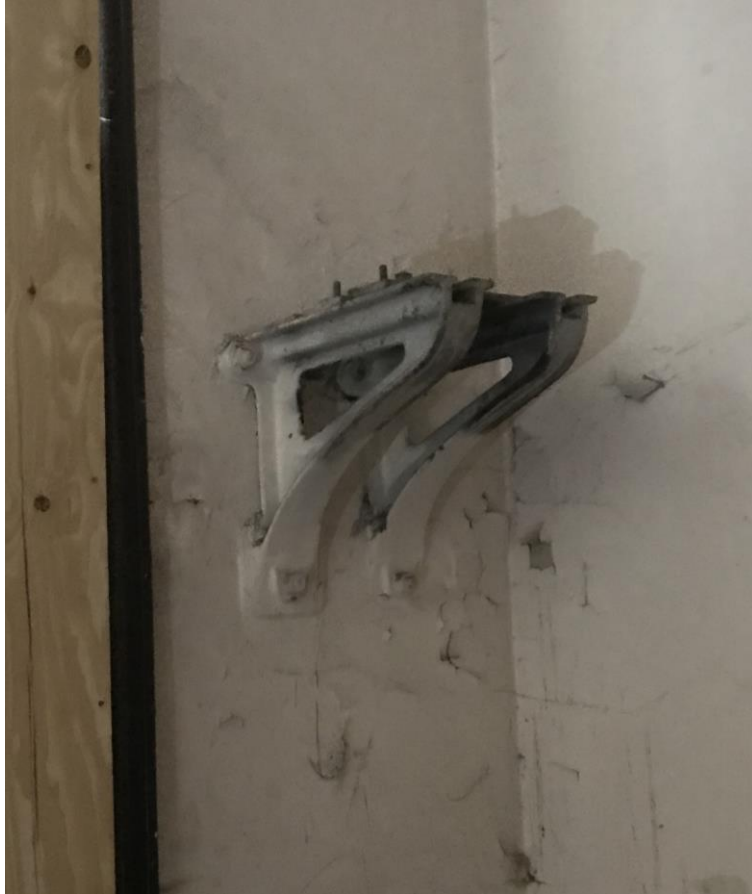
4.3.7 The tank stand, the spreader plates of which were visible from outside, was visible in the northeast corner of the building at this level.

Photo 24 – Former Tank Stand in Northeast Building Corner

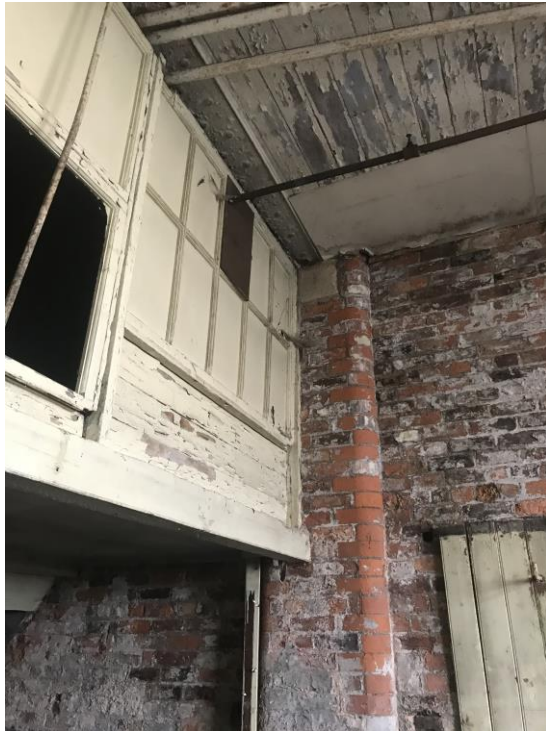
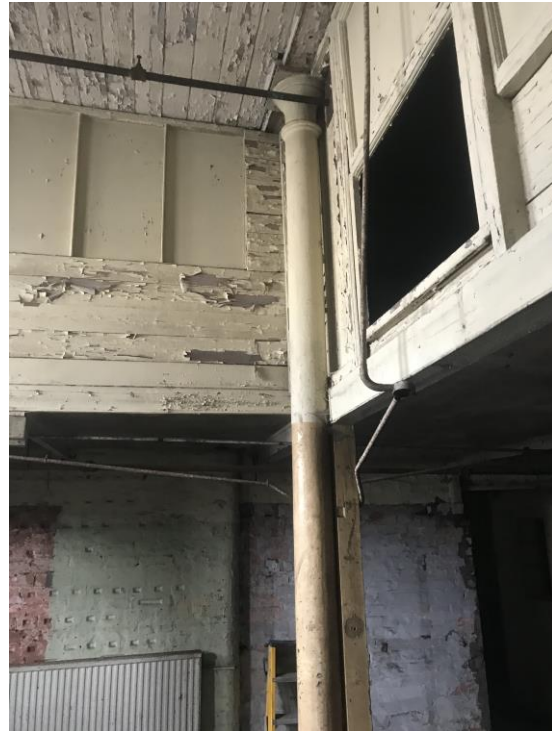
Photos 25 & 26 – Ground Floor Partial Mezzanine with Visible Riveted Beams

4.4.5 Above the front wall of the room at mezzanine floor level the bottom flange of a rivetted wrought iron structural member is visible. This member runs the longitudinal length of the building and supports the first-floor timber joists over.
