Stage 1 / 2  
Structural  
Inspection 32-34  
Laystall Street

32-34 Laystall Street,  
Manchester,

23 October 2020

1/20445/REP/001

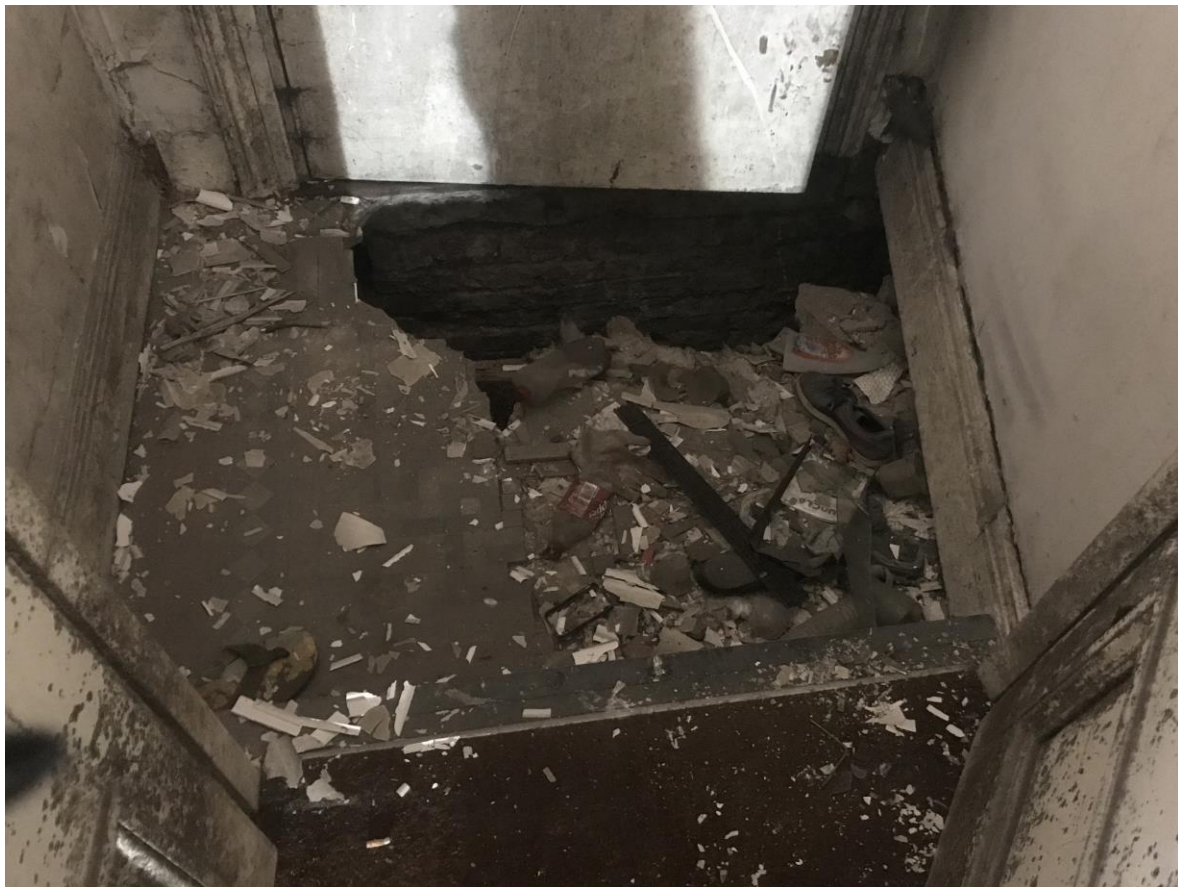
4.4.7 To the northeast portion of the building there is evidence of structural damage through the ingress of water. Timber joists supporting a cast concrete slab and tiled entranceway at the front door has rotted at the bearings and resulted in an area of collapsed flooring at main entrance to left of loading bay.

Photo 27 – Ground Floor Partial Collapse at Laystall Street Entrance Door

4.5.7 From the basement level the collapsed floor at the main entrance to the left of the loading bay can be observed fully. The existing timber ends have rotten and the bearings failed allowing the supported floor over to collapse into the basement.

Existing failed timber joists at the main entrance supporting the original tiling will need to be carefully removed and replaced with new structural timber members, with appropriate protection against moisture, particularly where built into the external walls.

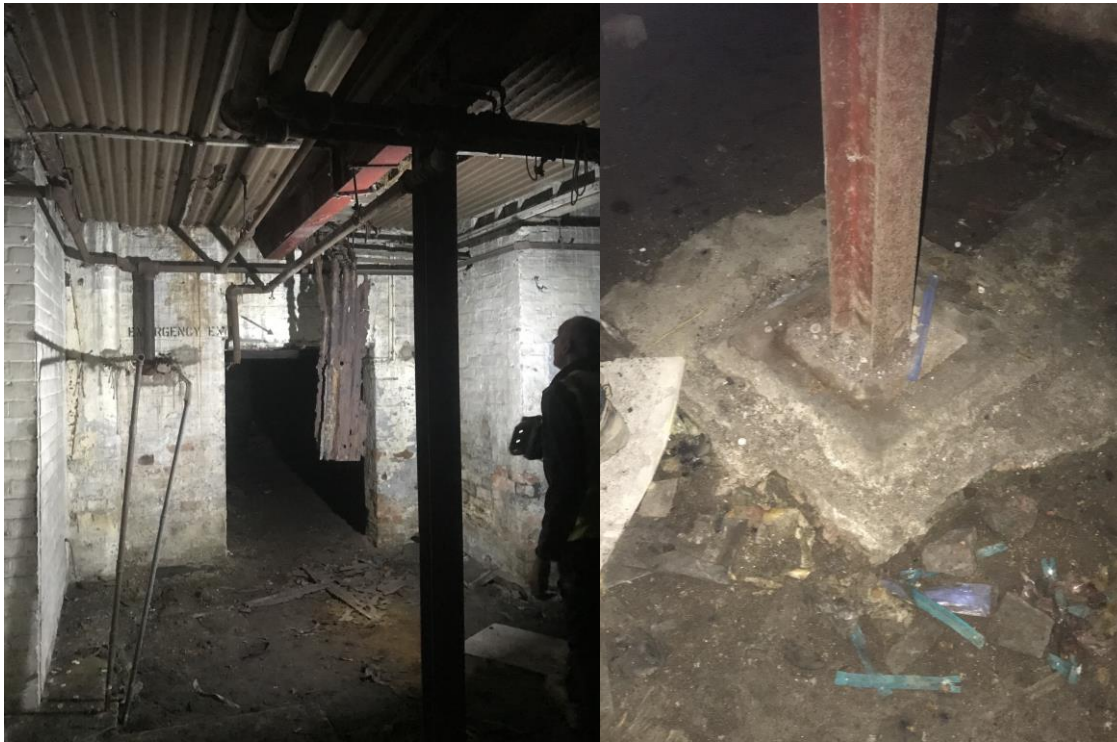
4.5.5 Evidence of previous structural strengthening works to the ground floor were evident in the basement with an additional line of mild steel columns and beams to rear half of the basement. This new steelwork has effectively reduced the span of the existing timber members and will have assisted in its load-bearing capacity and helped reduce deflections. There was no evidence to suggest the joists in this area had been subject to any significant structural failure, so this is likely to be a proactive measure to improve the floors structural

Photos 28 & 29 – Ground Floor Strengthening Works In Basement

4.5.6 Corrosion to these newer mild steel sections was visibly and appeared more severe than the corrosion affecting the older wrought iron members. This adds further to the presumption that the original structural metal members are indeed wrought iron.

Existing steel or wrought ironwork in the basement should be brushed clean of corrosion and treated with a suitable rust preventive treatment to ensure further degradation does not occur.

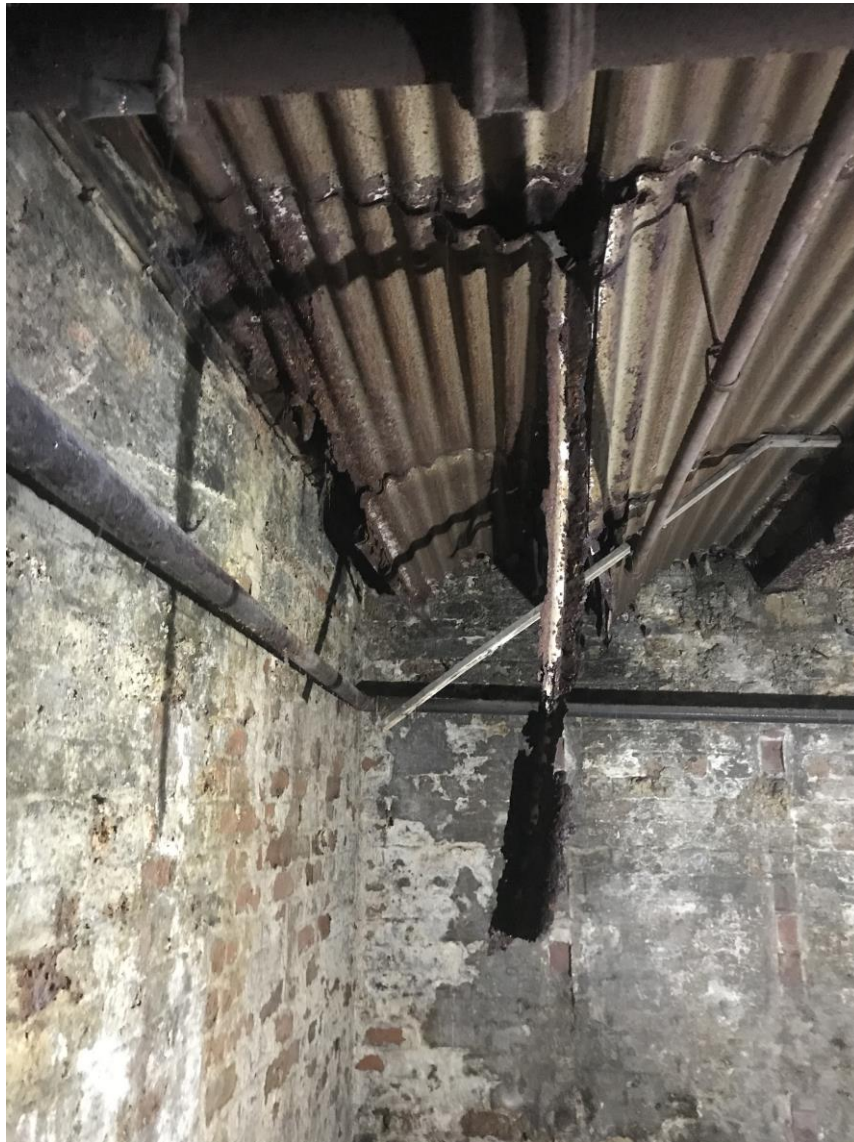
4.5.8 Corrugated sheet metal has been applied to the underside of the original timber joists, perhaps as some form of fire protection, or perhaps just to formalise the ceiling. This metalwork has however rusted and is hanging loose in a number of locations and should be removed and replaced with a suitable fire protective layer, as necessary.

Photo 30 – Partial Collapse of Corrugated Sheet Metal in Basement
