## REPORT ON THE EXTERNAL WALLS

Vulcan Works  
2 Malta Street  
Manchester  
M4 7BH

Residential Management Group  
RMG House  
Essex Road  
Hoddesdon  
EN11 0DR

Contract No: SB/10349  
Dated: 16 October 2020

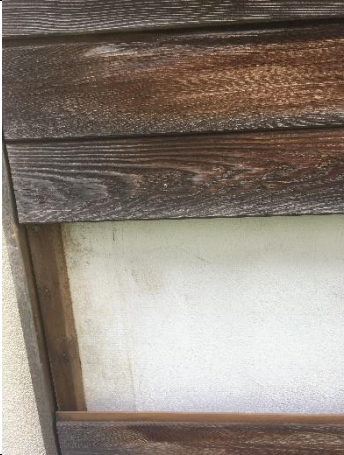
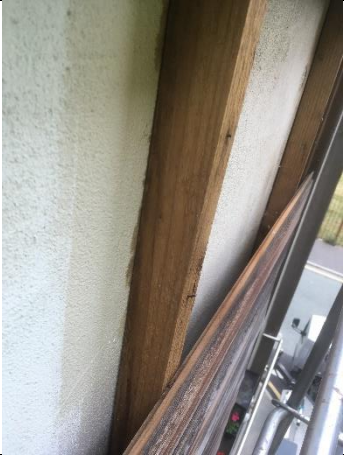
| Photos | | | |
|---|---|---|---|
| Sample A | | Sample A | |

| Sample | Cavity | Horizontal Cavity Barrier | Vertical Cavity Barrier | Protection Around Openings |
|---|---|---|---|---|
| A | Yes | No | N/A at this position | No (Vent) |

- Inspection Locations A & D – Inspection did not include the substrate behind the sheathing board. Location A, at a floor junction, did not penetrate the render system to identify any mineral wool fire break as observed at Locations H & F, for example;
- Inspection Location H (at floor junction) – Inspection did not include the substrate behind the sheathing board. Opening height of circa 150mm did not extend to expected EPS above or below to match Locations D & I as apparent at Location F, for example;
- Inspection Locations I & J – Inspection included the substrate as described for the construction type. From location I, it is understood that the building structure is inbound of the *internal component* but that one flange of the steel column is exposed to the SFS void.

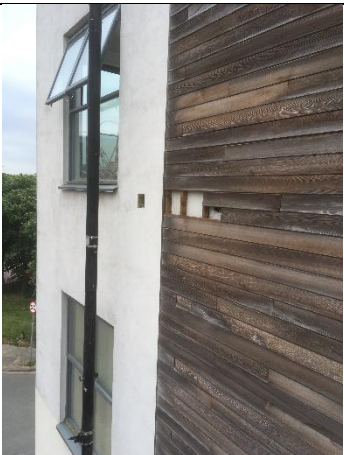
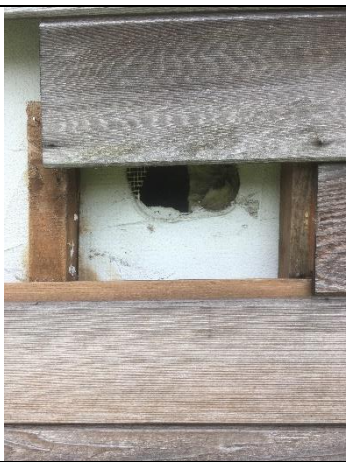
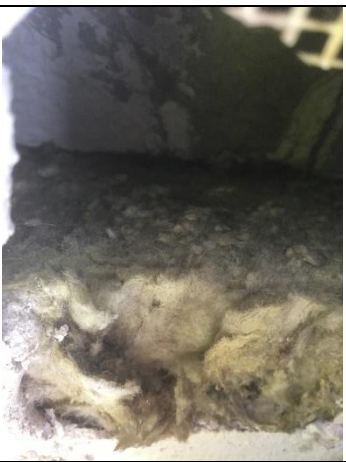
| Photos | | | |
|---|---|---|---|
| Sample D | | Sample H | |

A mineral wool break in the EPS system has been observed at all locations where the render has been penetrated at floor junctions; i.e. Locations B, F, G & H. This has been included as a fire barrier in EPS system that meet BR 135 criteria, see Section 2.2.2.

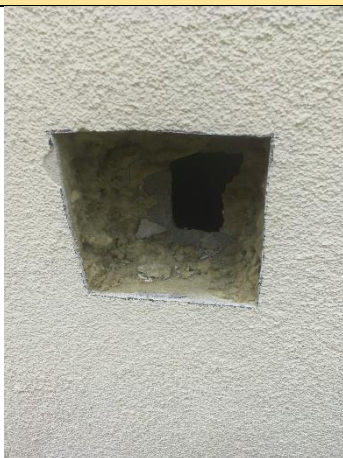
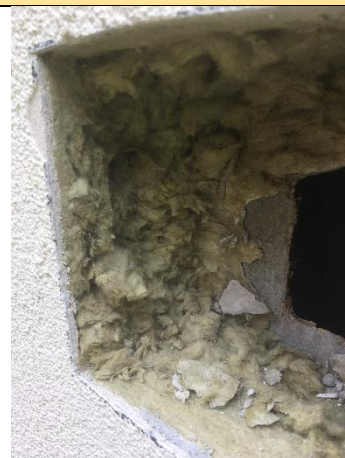
Sample B

| Sample | Cavity | Horizontal Cavity Barrier | Vertical Cavity Barrier | Protection Around Openings |
|---|---|---|---|---|
| B | No | Mineral Wool | N/A at this location | N/A at this location |

- Inspection Locations B – At this location, the substrate accessed was a void to a steel column enclosed by metal plates;
- Inspection Location F – At this location, the substrate access allowed observation of a void to plasterboard but no defined SFS system;
- Inspection Locations G – At this location, primary structure was observed behind the sheathing board. Sufficient access was provided to identify the transition from the mineral wool fire break to the EPS above.

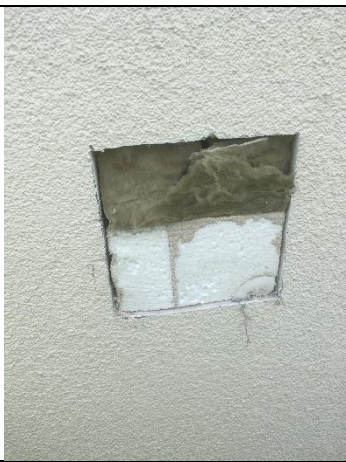
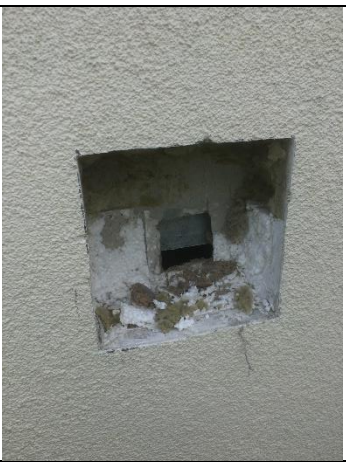
| Sample F | | | Sample F | | |

A mineral wool break in the EPS system has been observed at all locations where the render has been penetrated at floor junctions; i.e. Locations B, F, G & H. This has been included as a fire barrier in EPS system that meet BR 135 criteria, see Section 3.2.2.

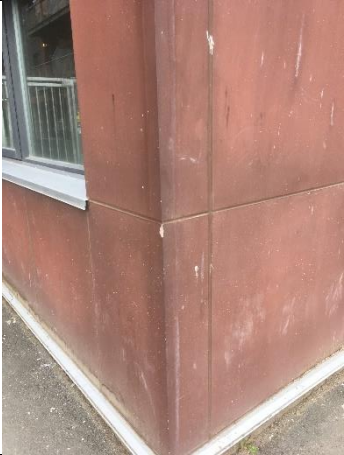
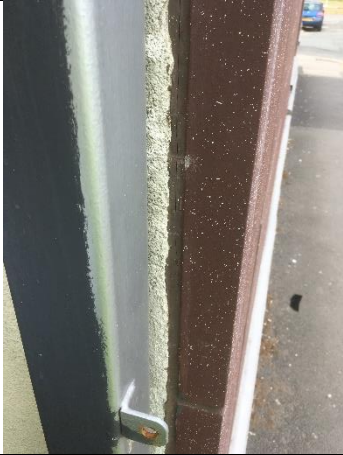
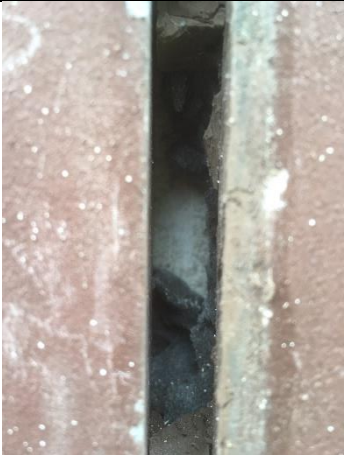
| Photos | |
|---|---|
| Sample A | Sample A |

| Additional Comments |
|---|
| <p>Panels sat on top of render construction.</p> <p>Panels are at ground floor only</p> <p>Void to panel recess</p> |

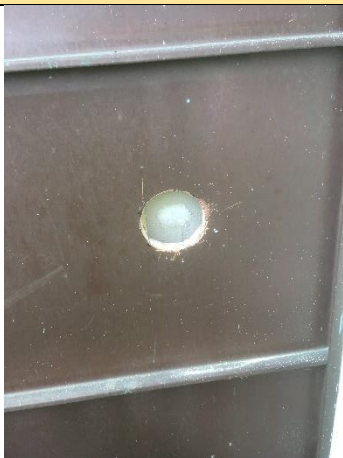
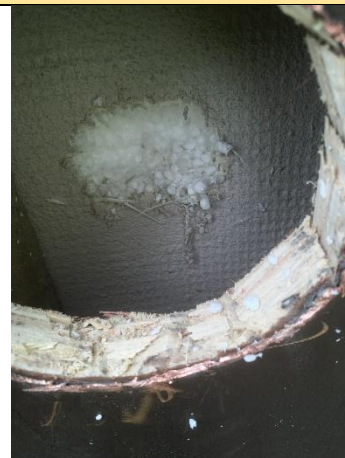
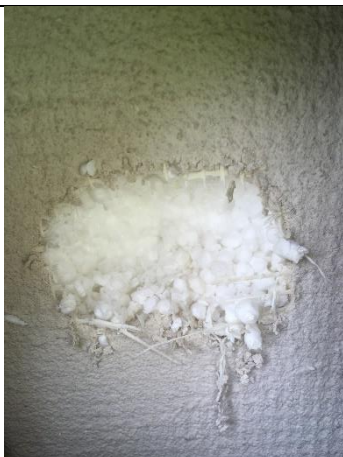
Sample E

No *fire barriers* were observed in the void created by the timber batten voids between the render and copper panels.
