CIS Tower,  
Miller Street,  
Manchester.  
M60 0AL.

## CIS Tower Refurbishment.

Recording Strategy and Photographic Audit of internal & external features.

# APPENDIX 5 – LEVEL 00 INTERNAL.

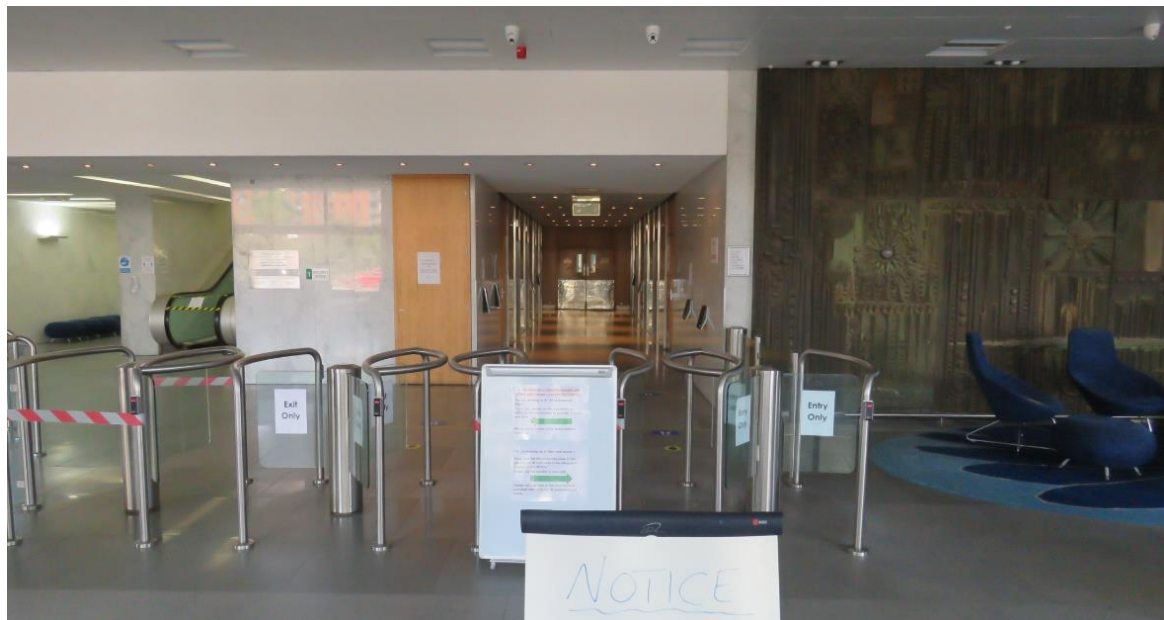
**00-01** Looking south from the revolving doors, showing the security gates and the William Mitchell mural.

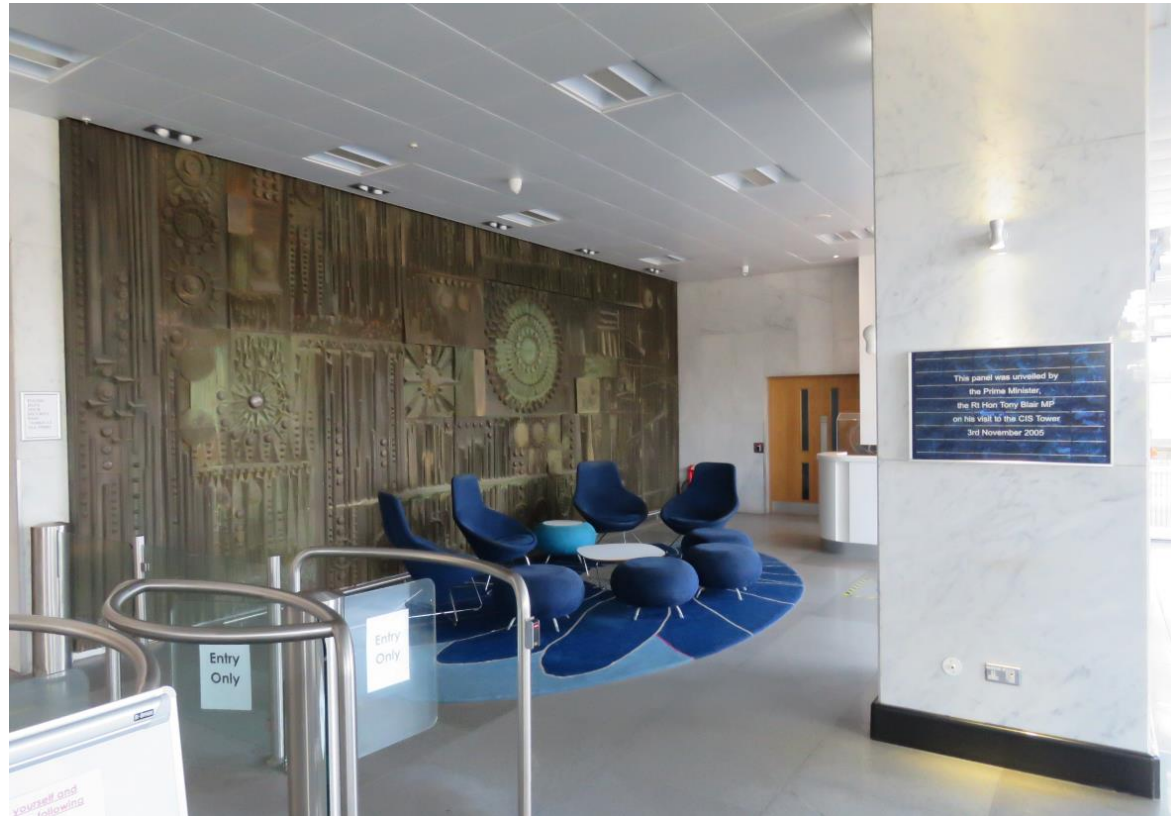
**00-02** Looking south-west toward the William Mitchell mural and the access to the post room.

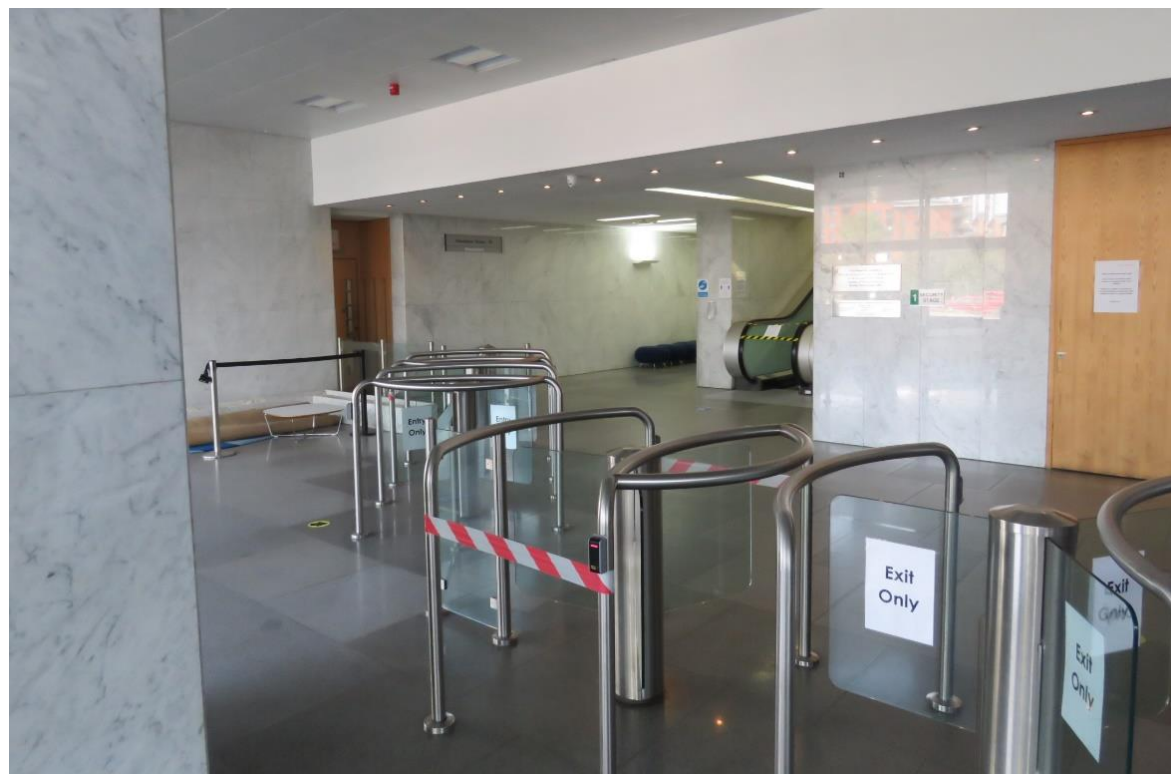
**00-03** Looking south-east towards the escalators.

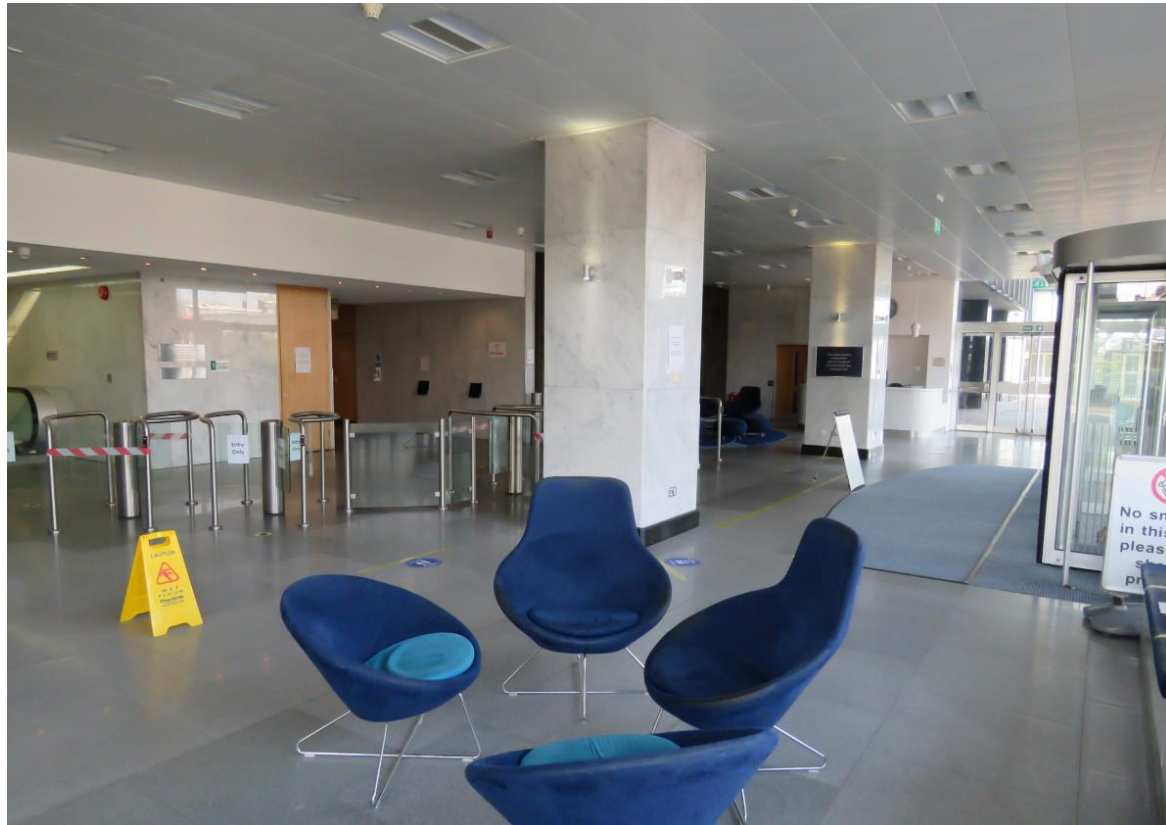
**00-04** Looking south-west across the reception hall showing the inserted ceiling and column cladding.

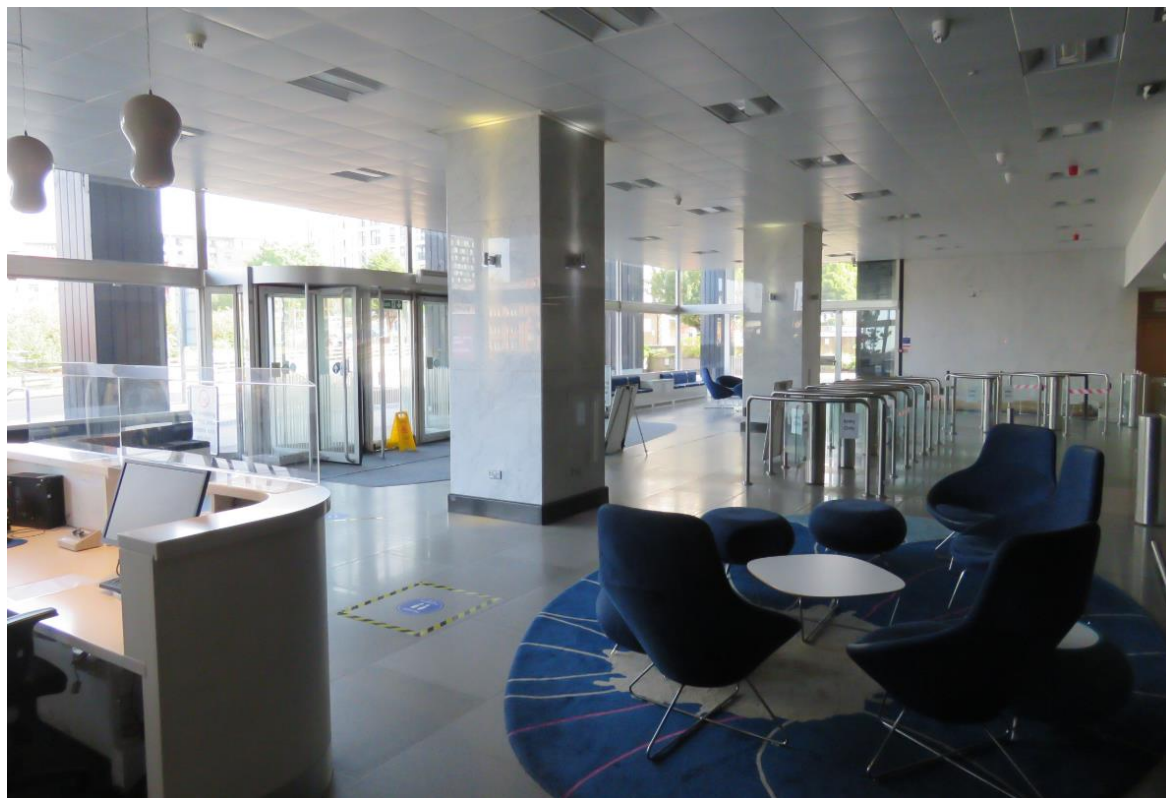
**00-05** Looking north-east from the entrance to the post room showing the replacement ceiling.

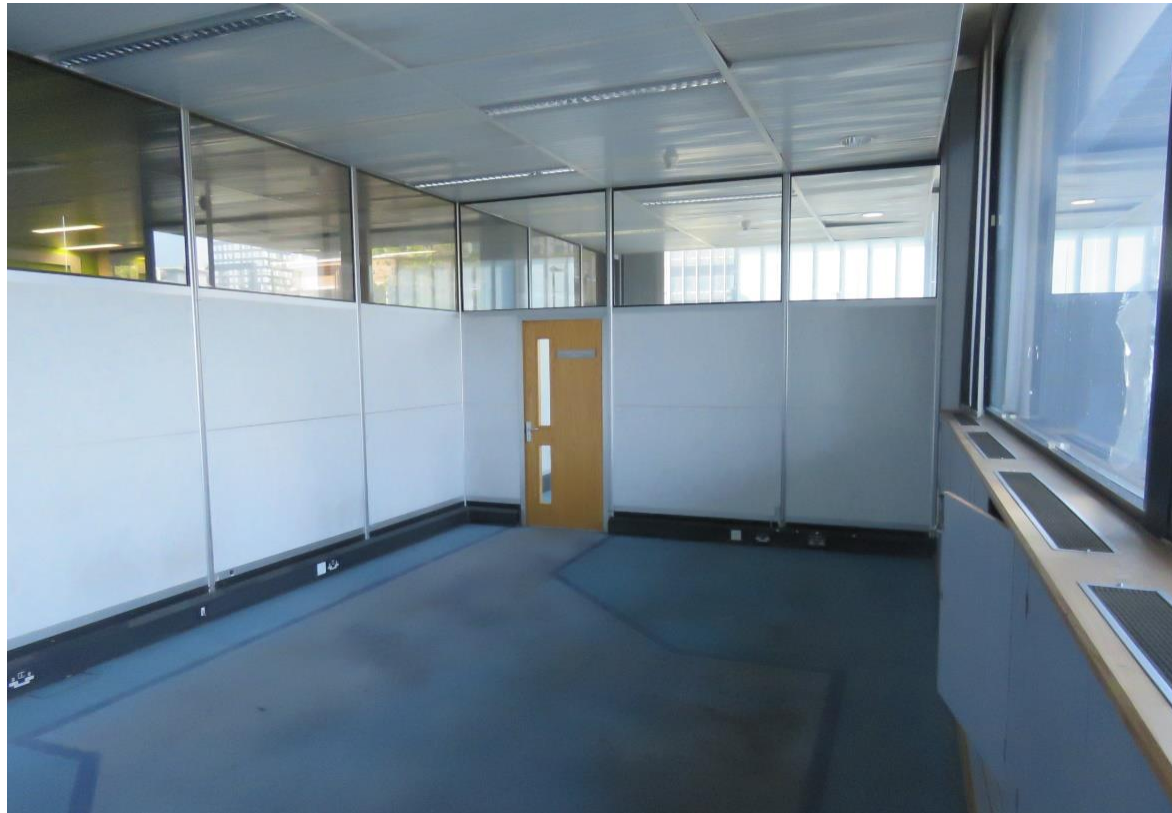
**00-06** Looking south-west within a surviving original office (former post room). Note the high-level Weathermaster system.

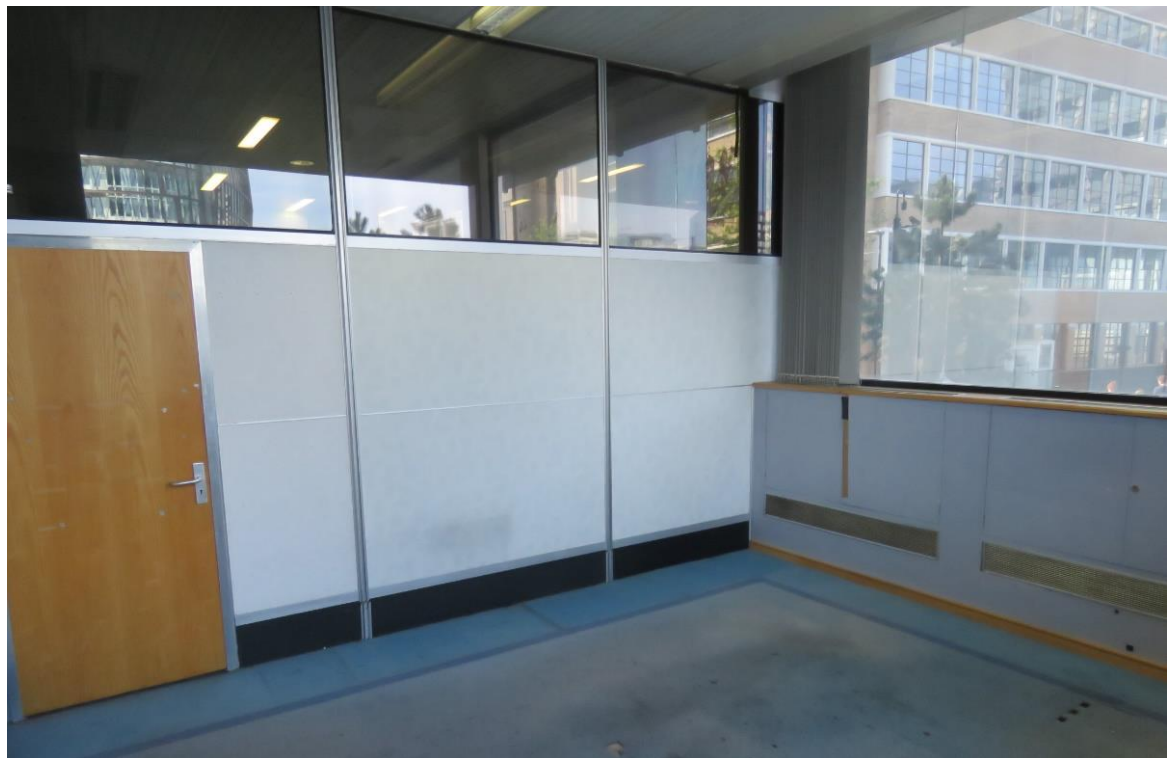
**00-07** Looking south-east within the original corner office, showing the high-level Weathermaster.

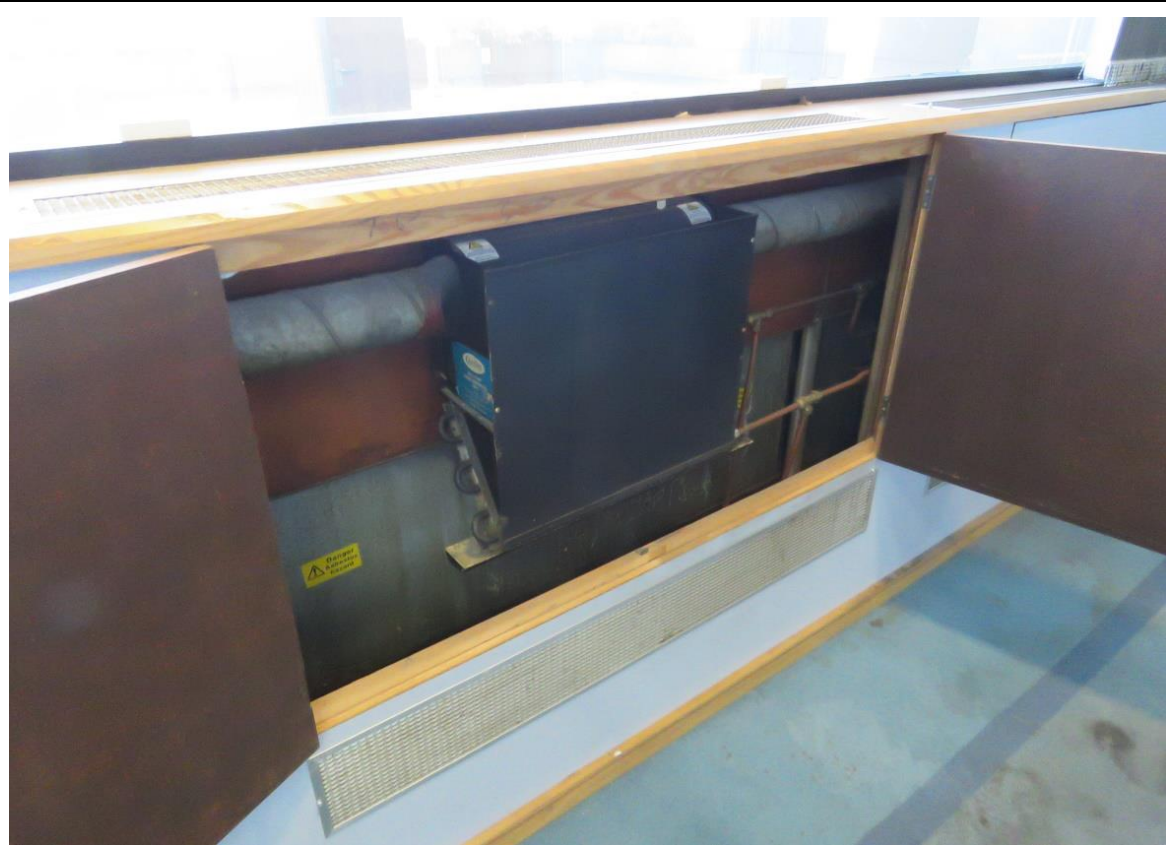
**00-08** Detail of the Weathermaster system.

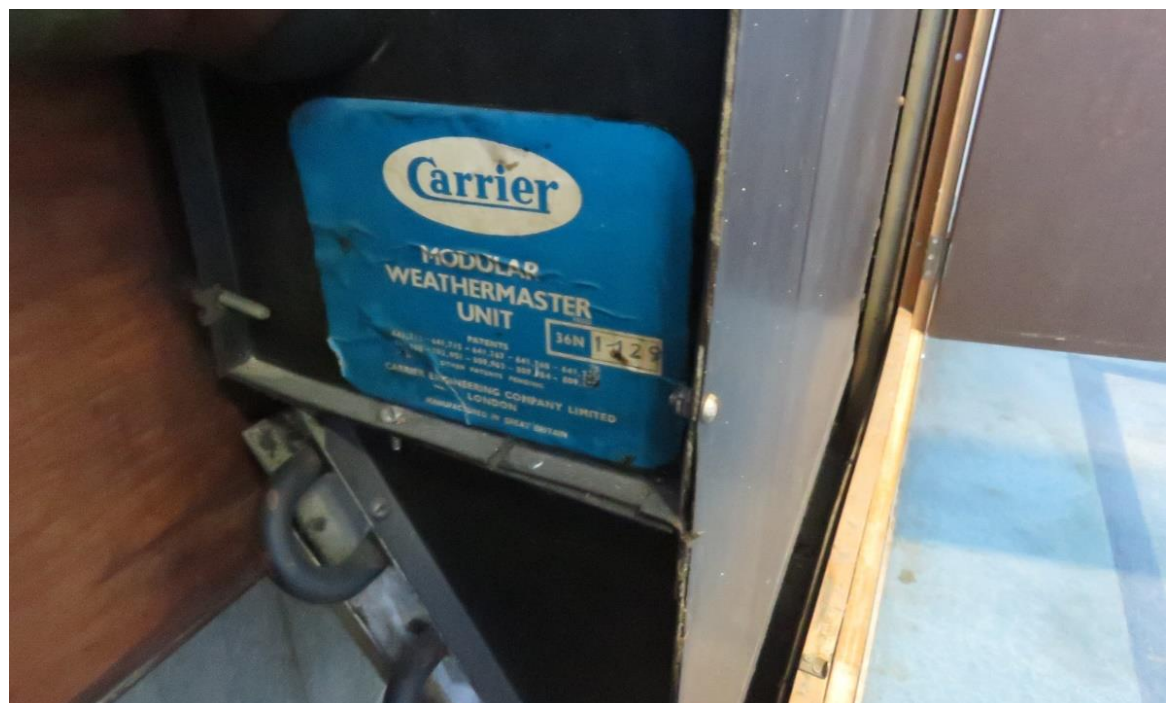
**00-09** Detail of the Carrier Company Weathermaster system.

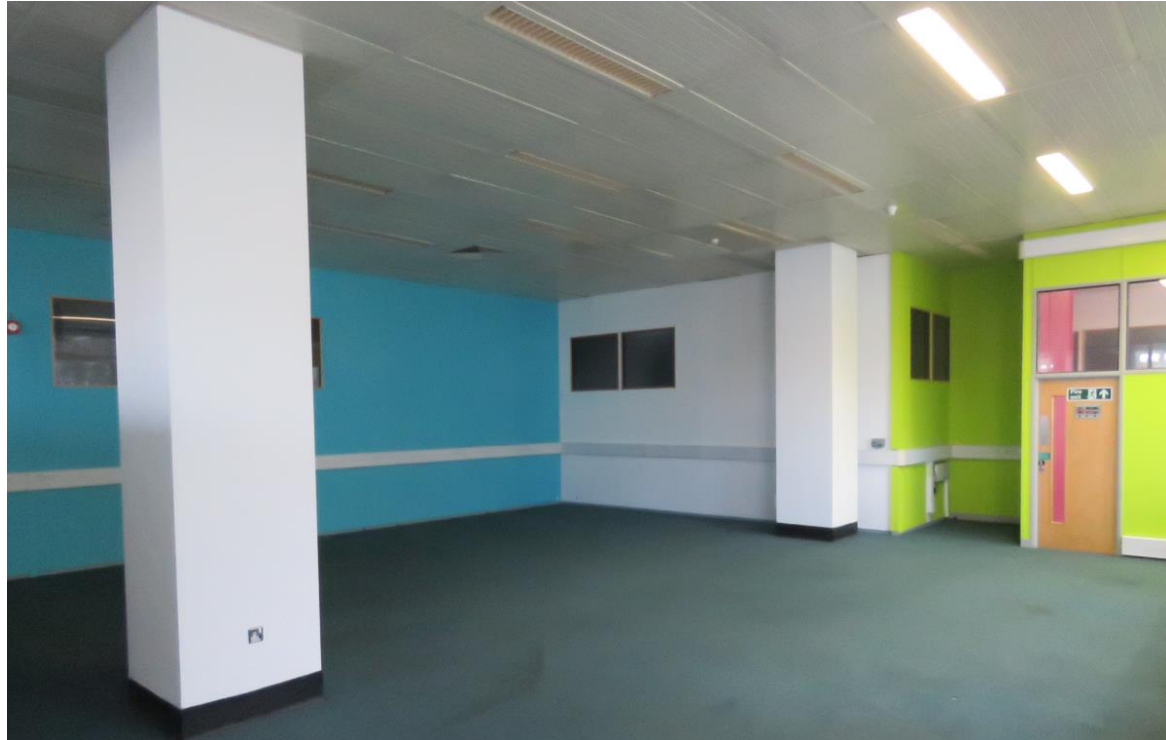
**00-10** Looking south-east across the former post-room areas.

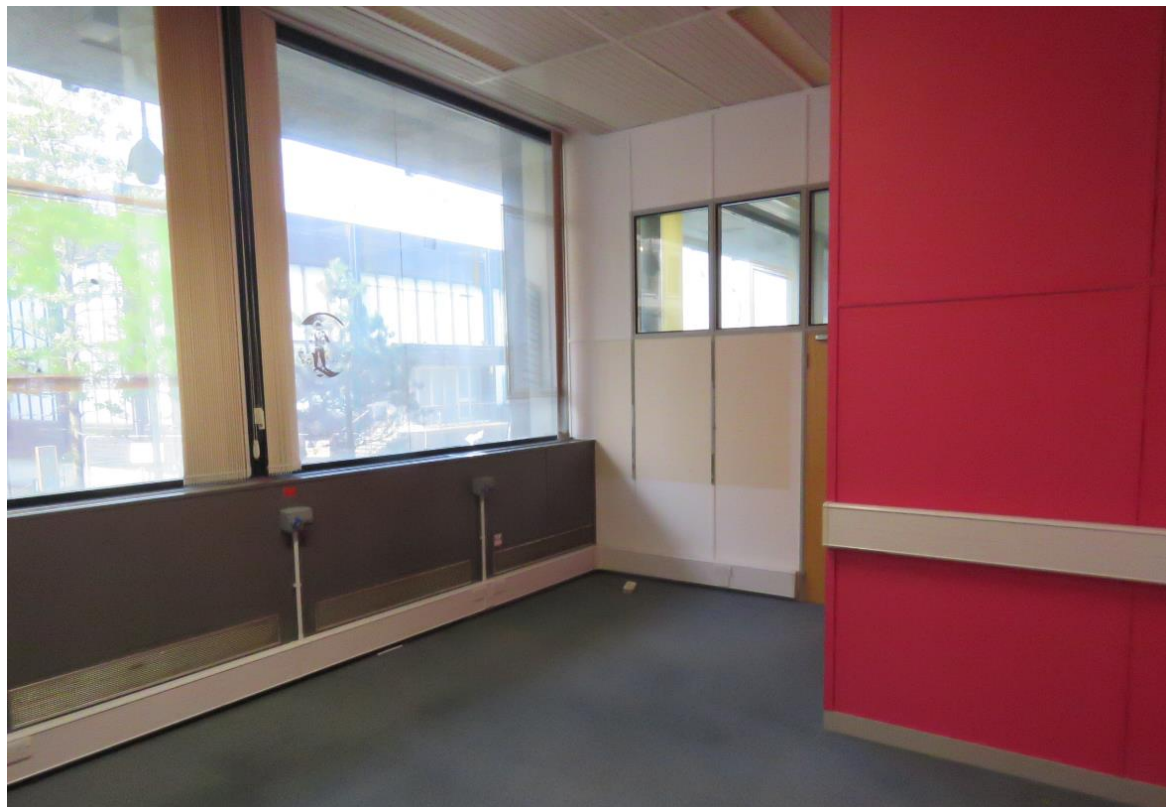
**00-11** Looking north-west within an inserted former post-room office.

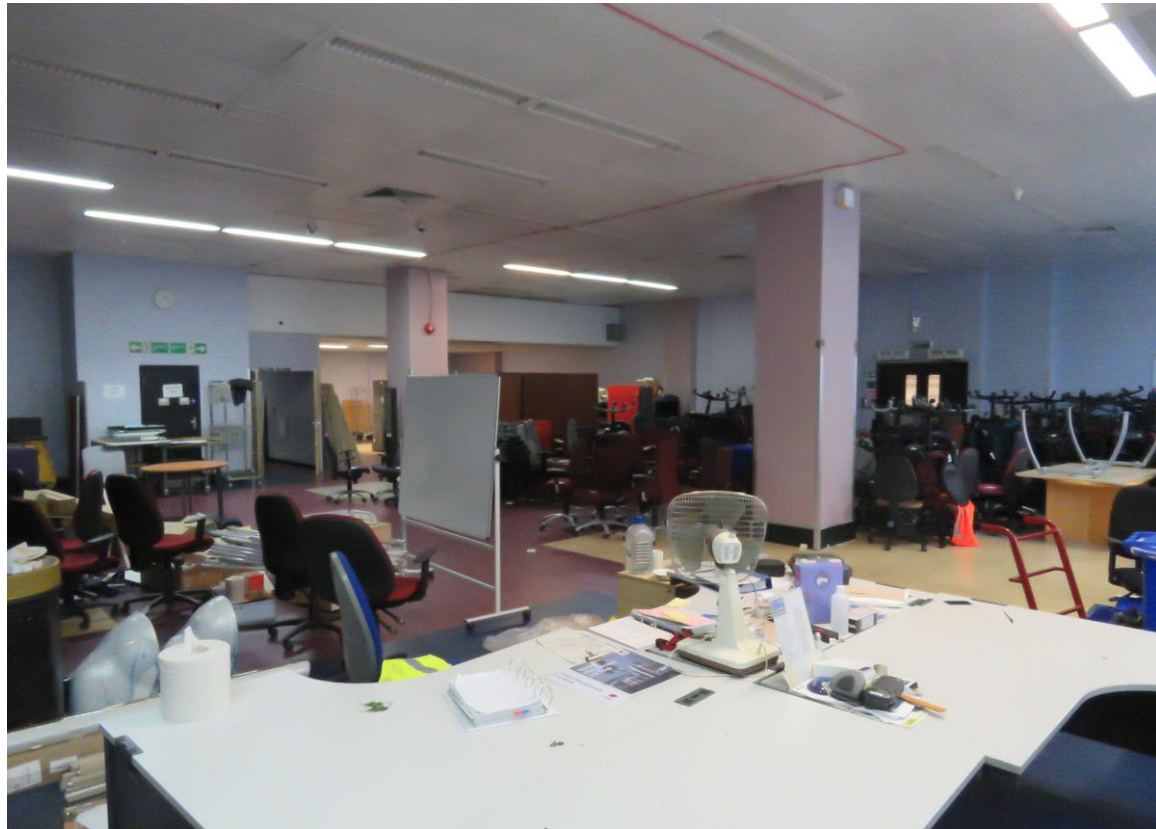
**00-12** Looking south-east across the former post room.

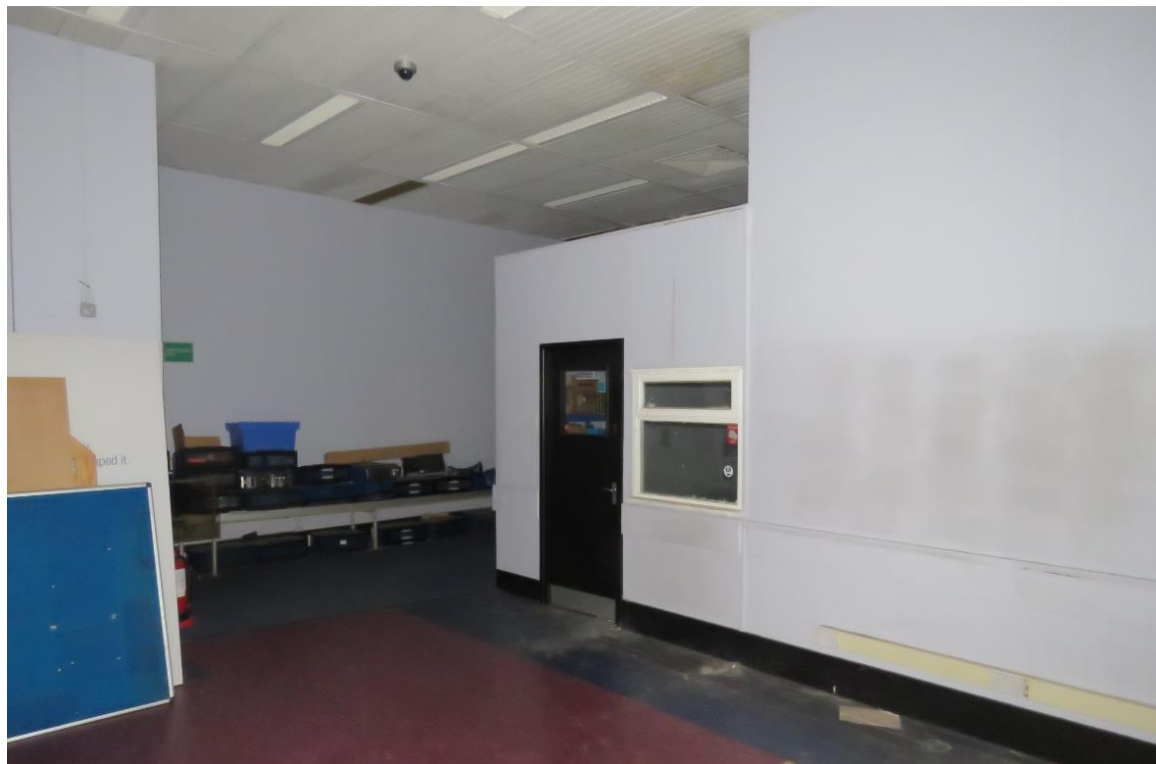
**00-13** Looking north-east towards the Tel lift terminus in the post room.

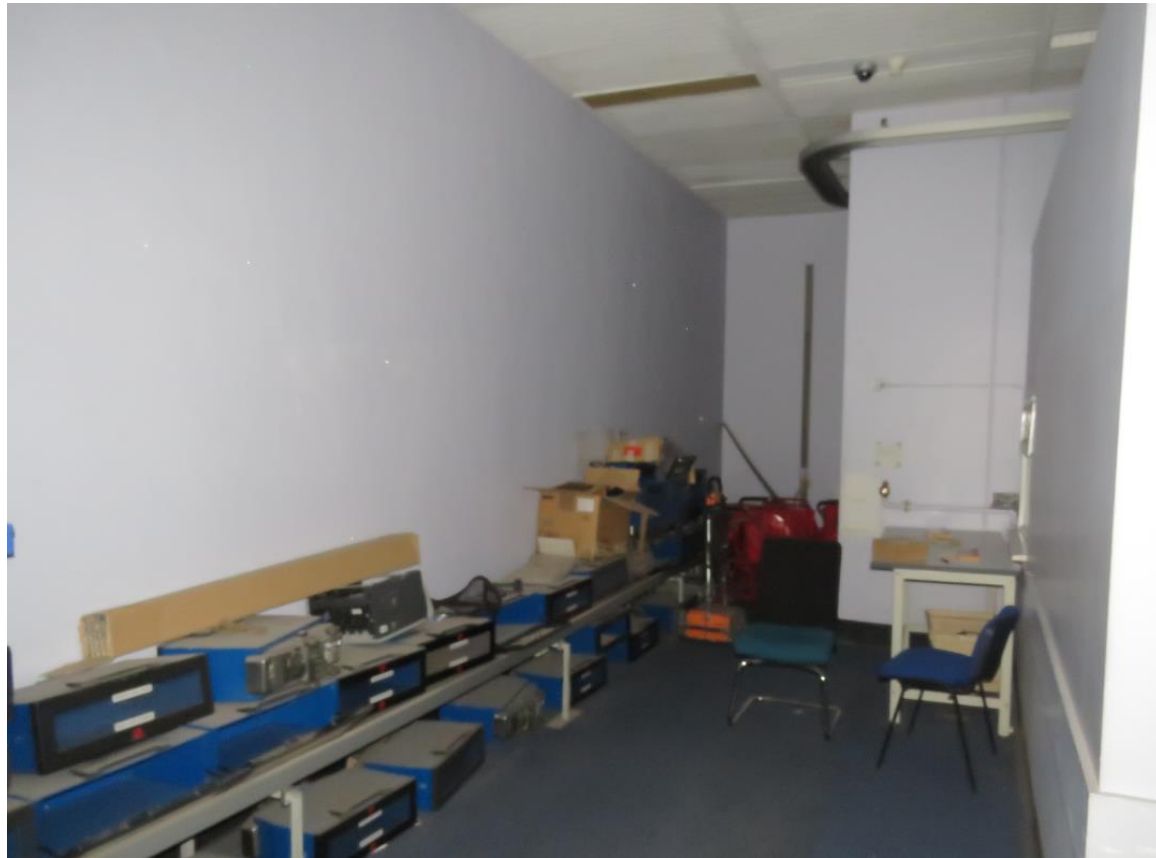
**00-14** The decommissioned Telelift system.

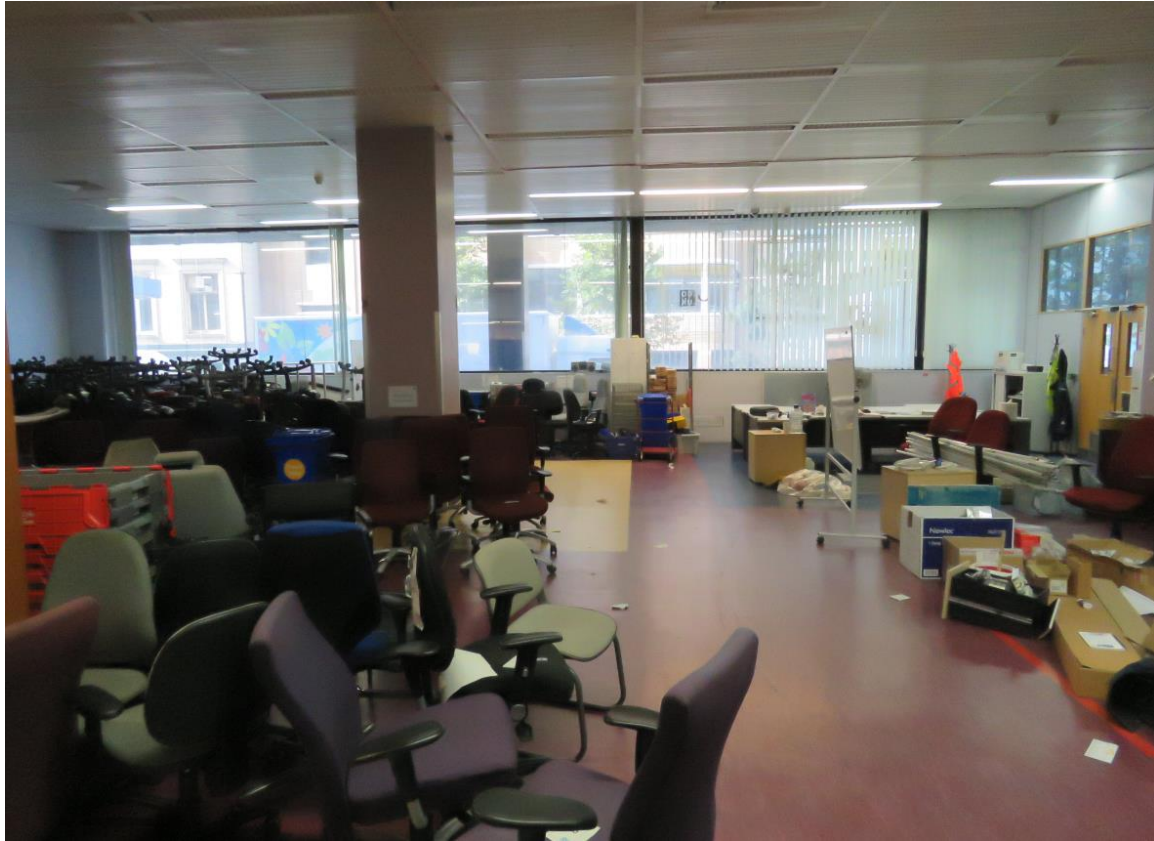
**00-16** Looking south-west across the former post room.

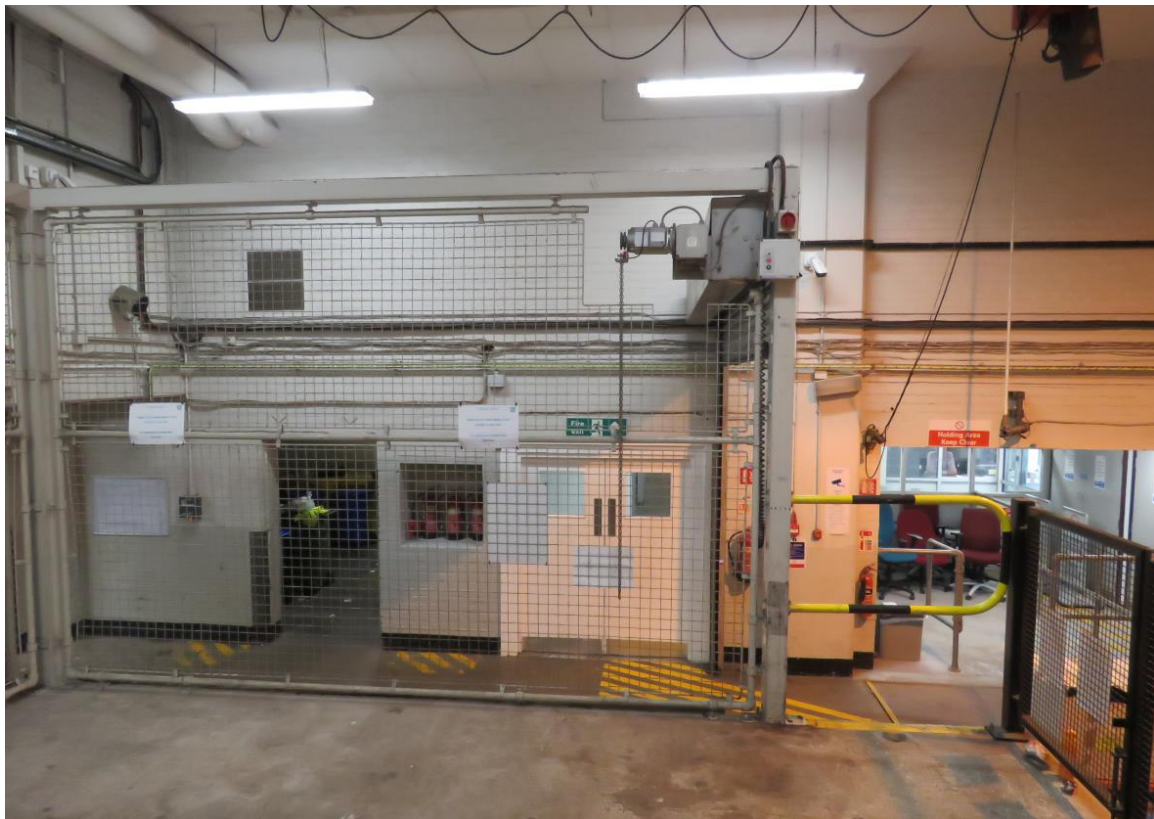
**00-17** Looking out toward the service entry and vehicle dock.

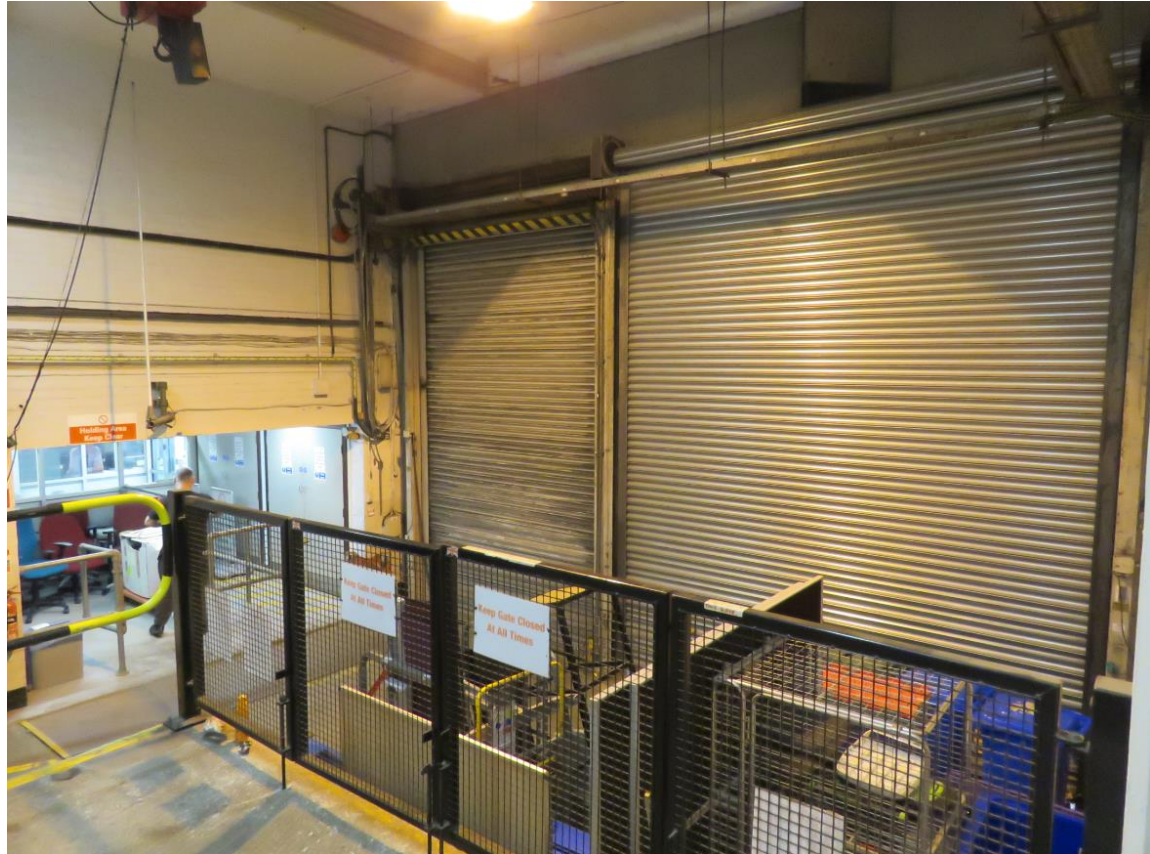
**00-18** Looking south-west towards the Dantzig vehicle entrance.

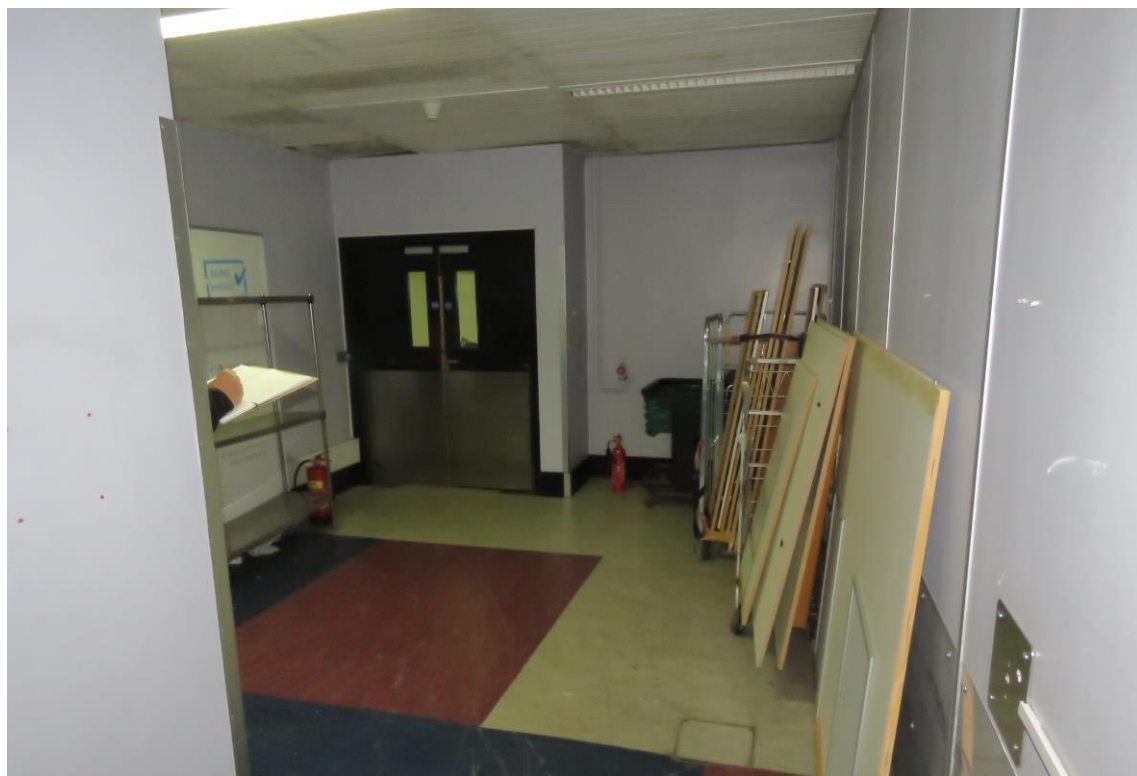
**00-19** Looking north-east towards the central corridor entrance.

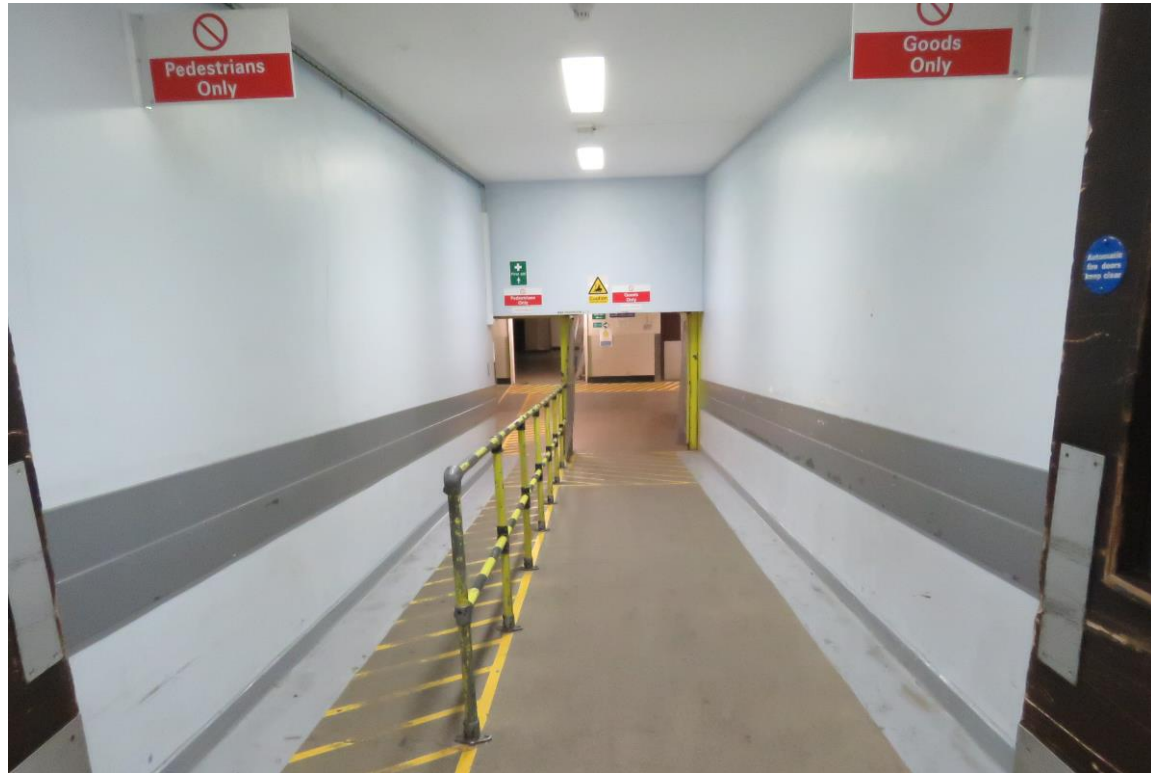
**00-20** Looking south along the service corridor. Note the change in level.

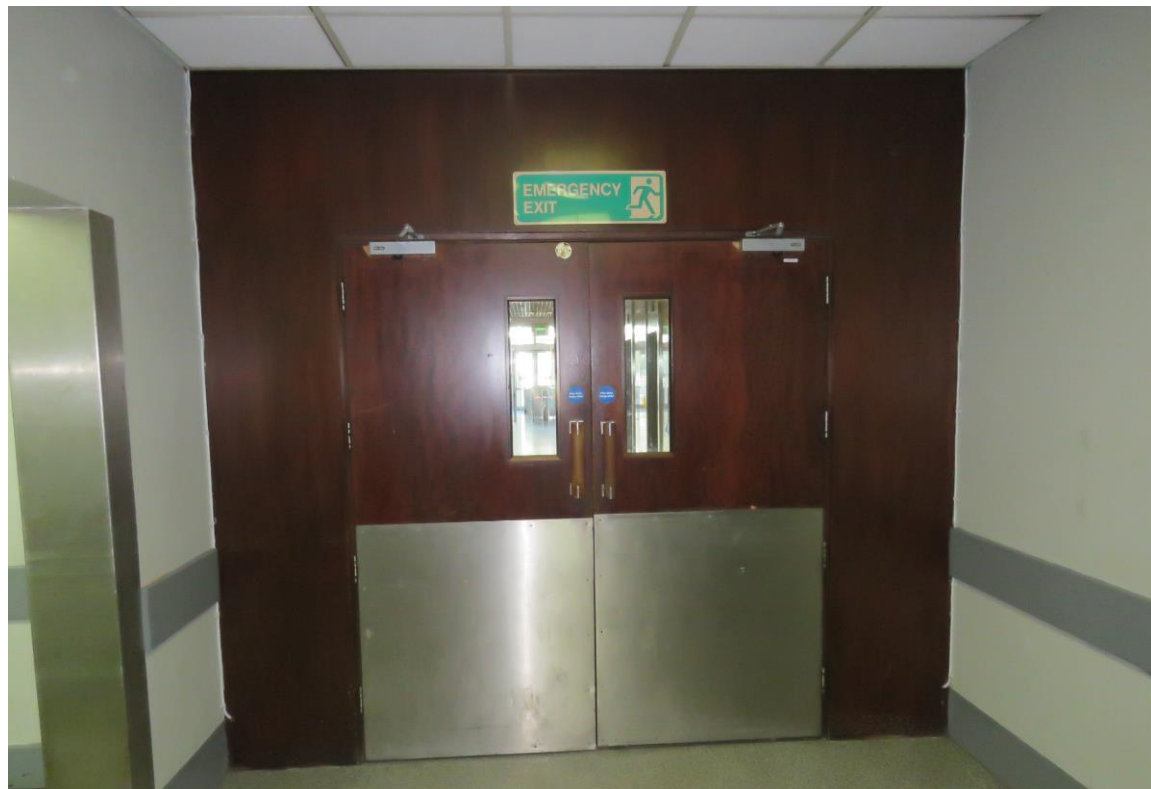
**00-21** Looking north toward the original doors to the lift lobby.

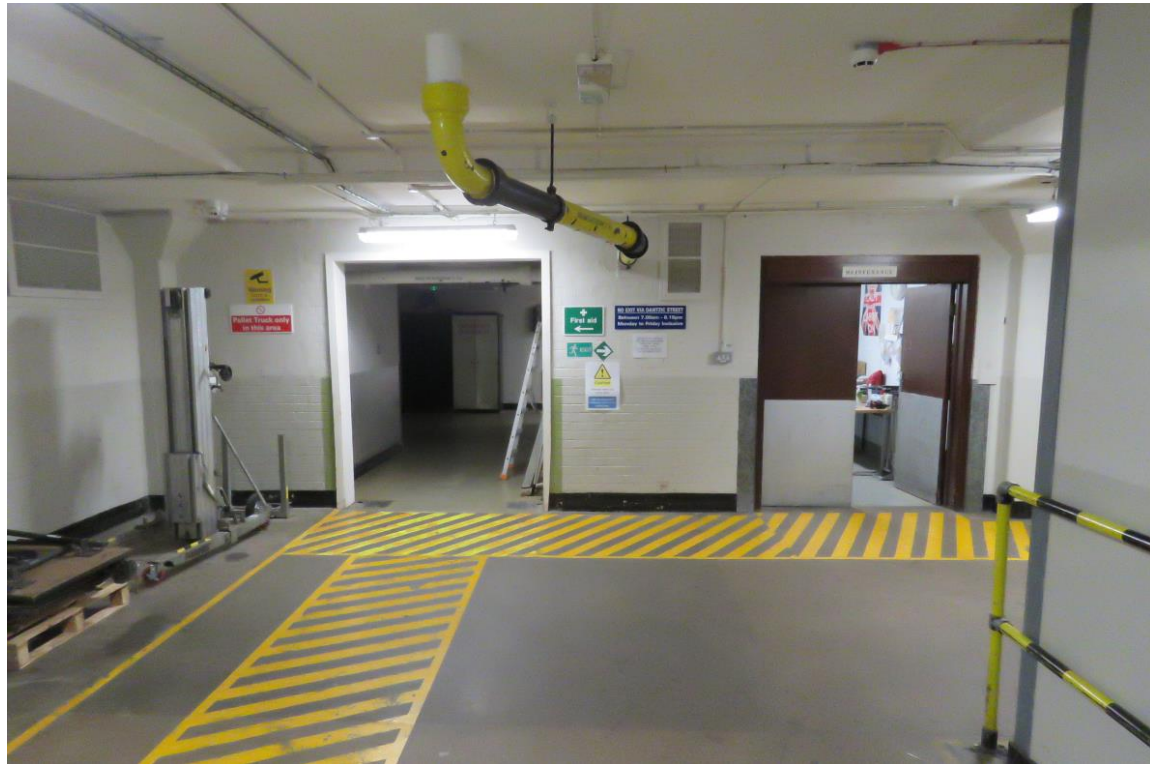
**00-22** Looking south into the service area.

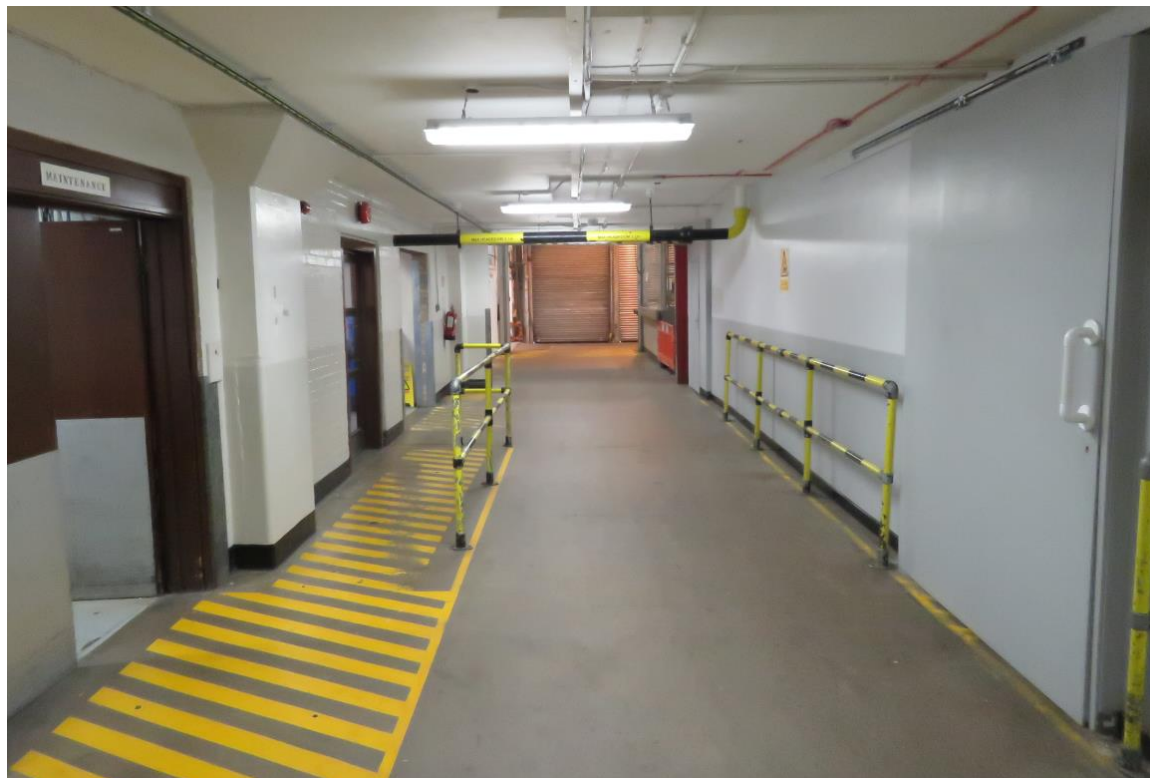
**00-23** Looking west towards the Dantzig Street service entrance.

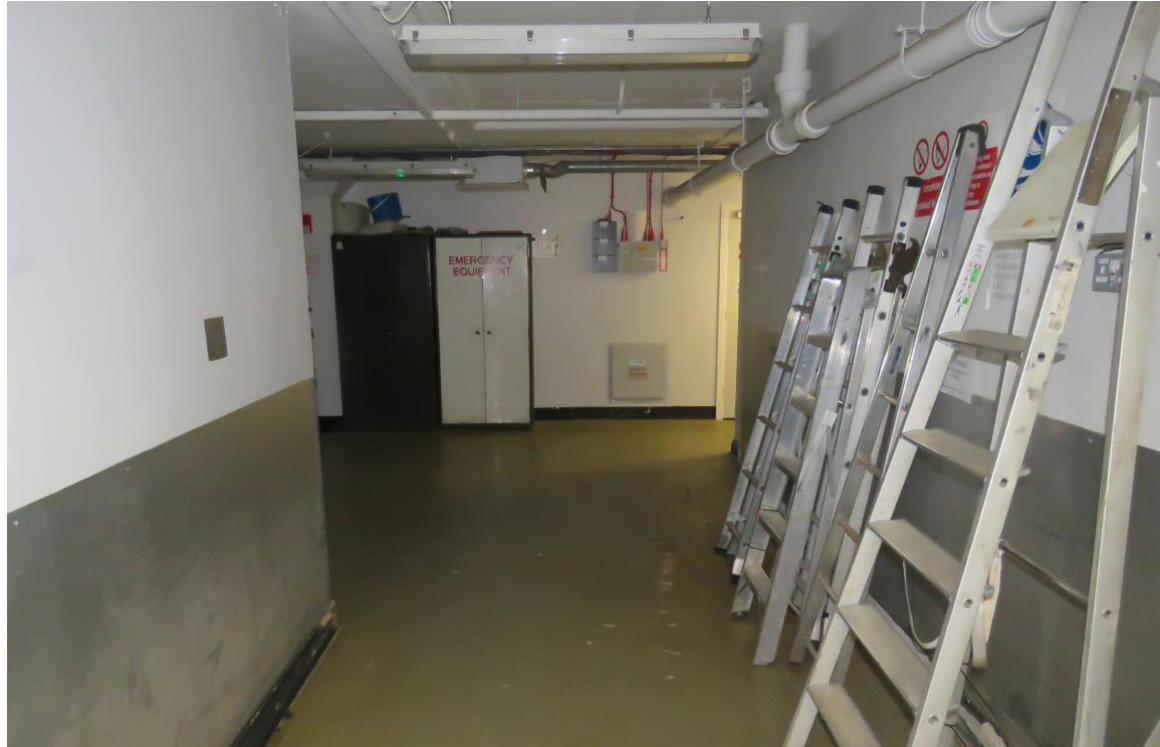
**00-24** Looking south into the service area.

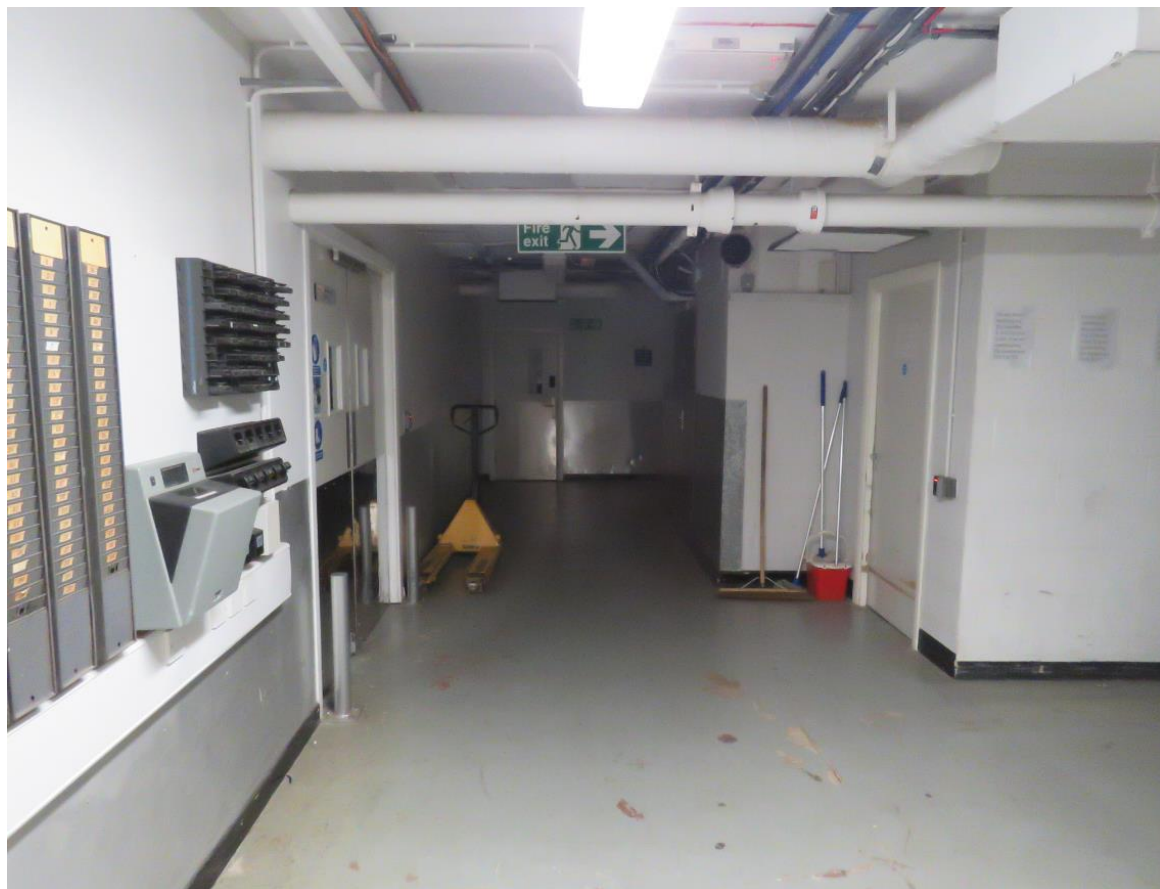
**00-25** Looking east along the service corridor.
