CIS Tower,  
Miller Street,  
Manchester.  
M60 0AL.

## CIS Tower Refurbishment.

Recording Strategy and Photographic Audit of internal & external features.

# APPENDIX 5 – LEVEL 00 INTERNAL.

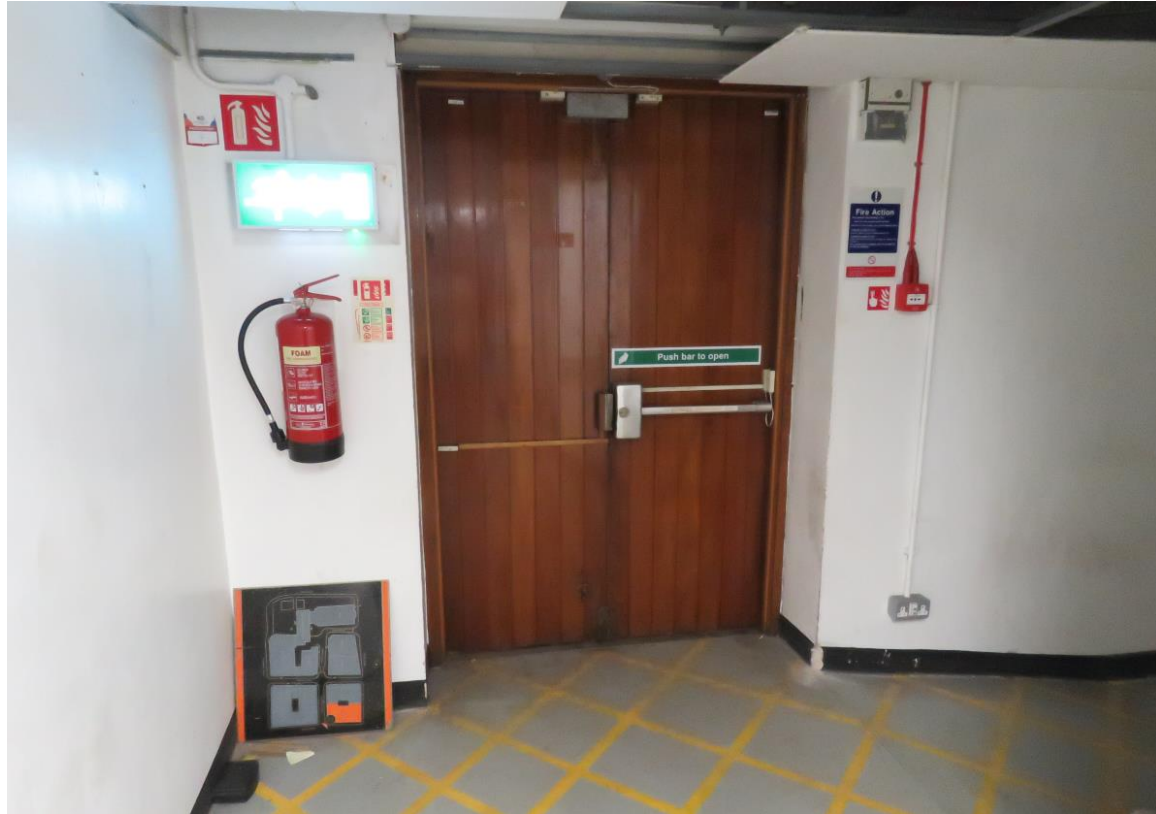
**00-26** Looking south toward an emergency exit.

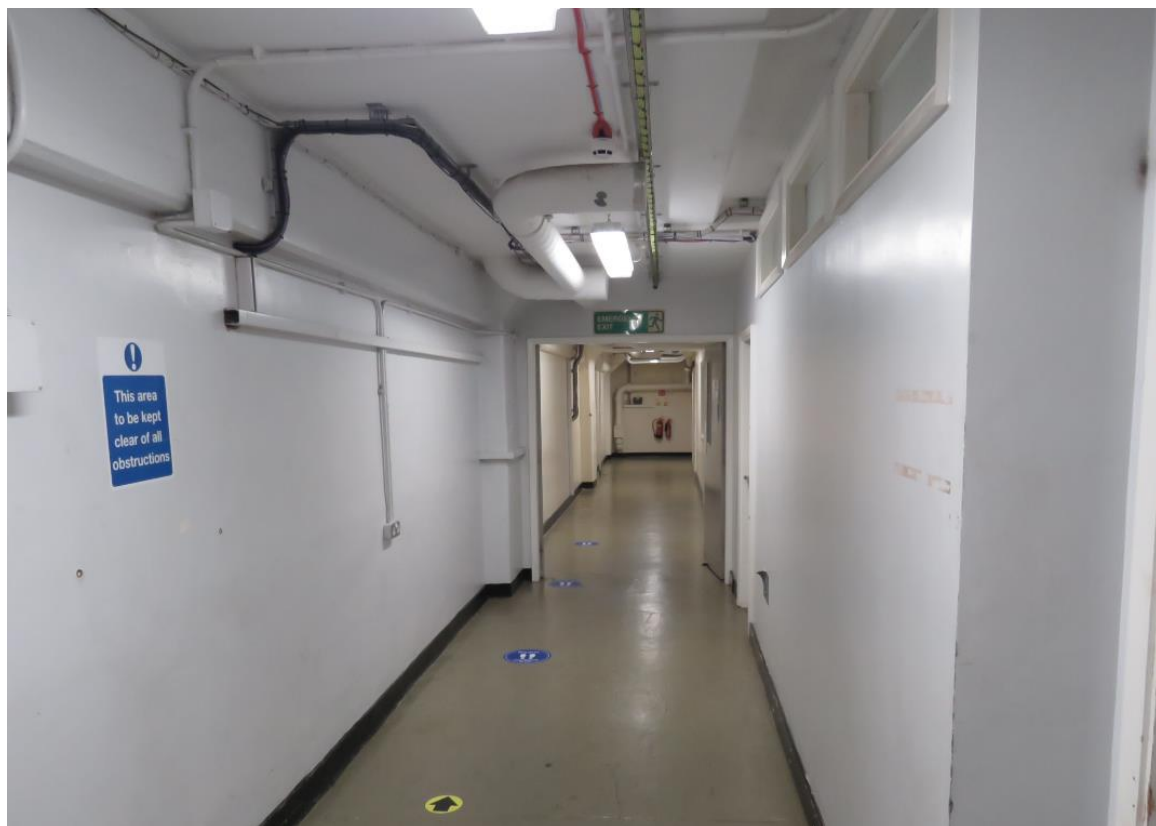
**00-27** Looking east along the central service corridor.

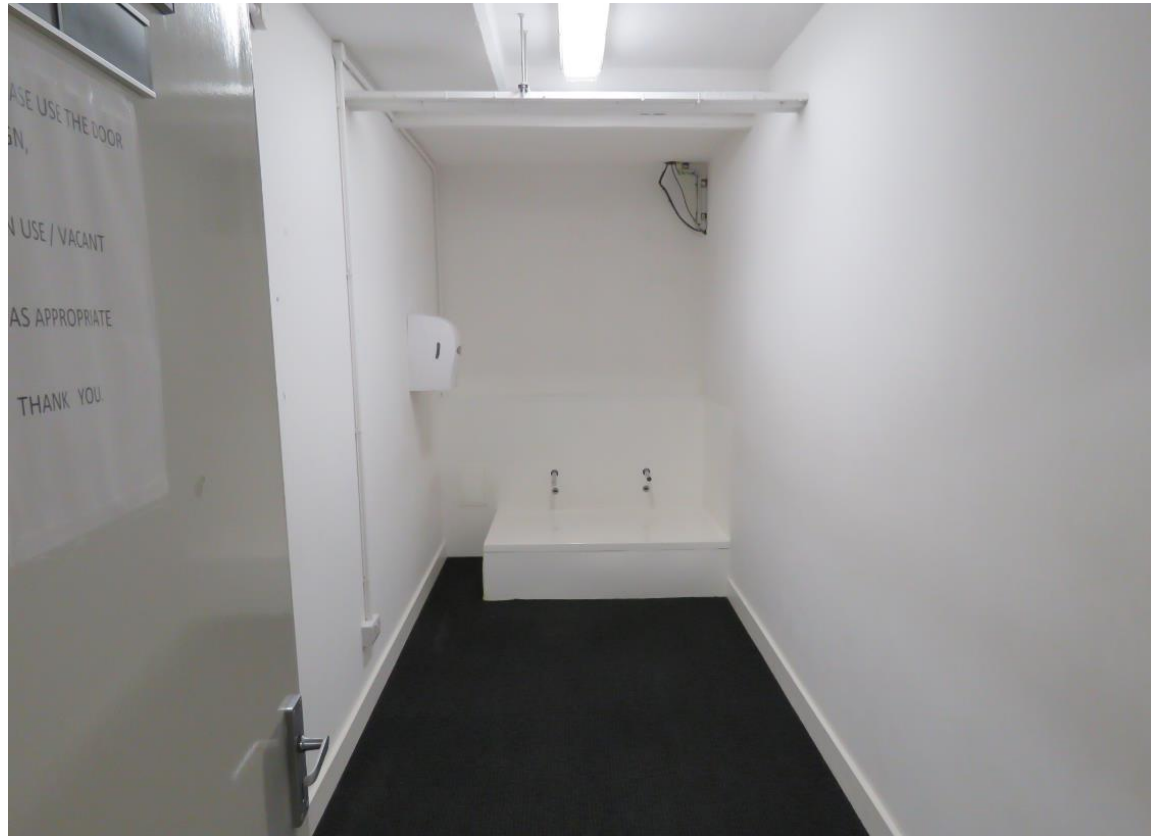
**00-28** Adapted quiet and prayer room.

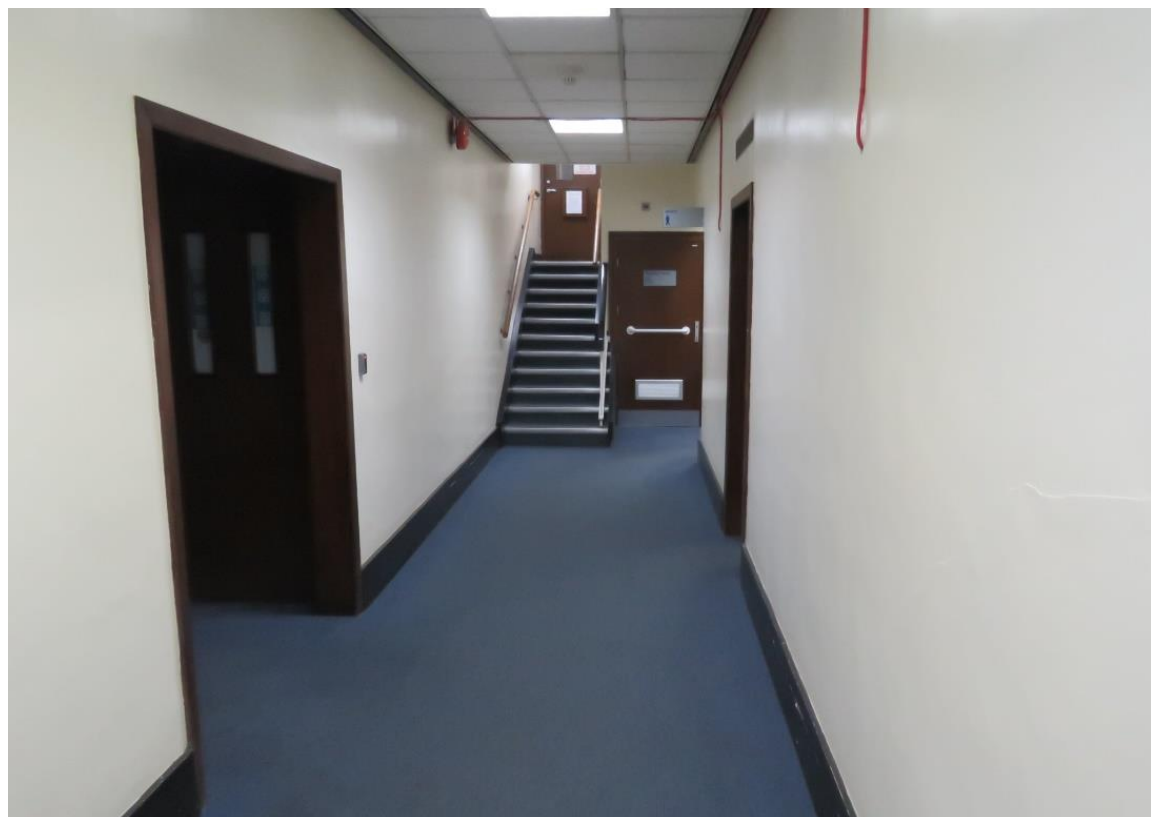
**00-29** Looking south along the access corridor and stair to the mezzanine care-park.

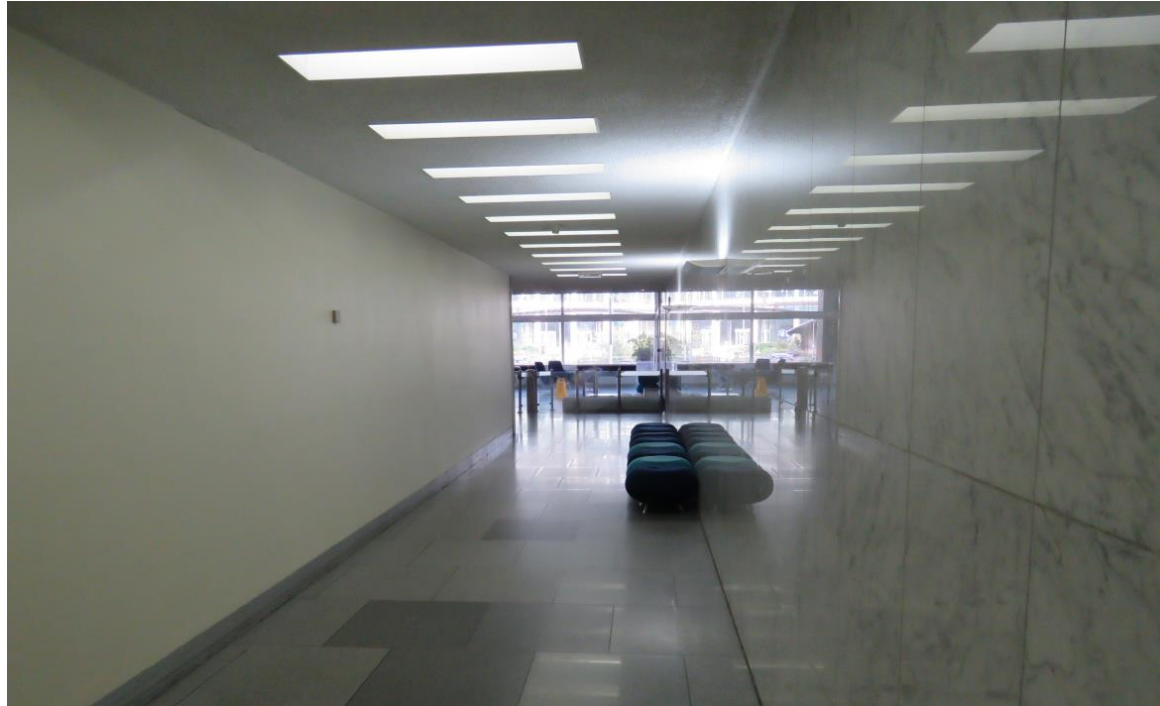
**00-30** Looking north along the east corridor. Escalators enclosed to the left of the view.

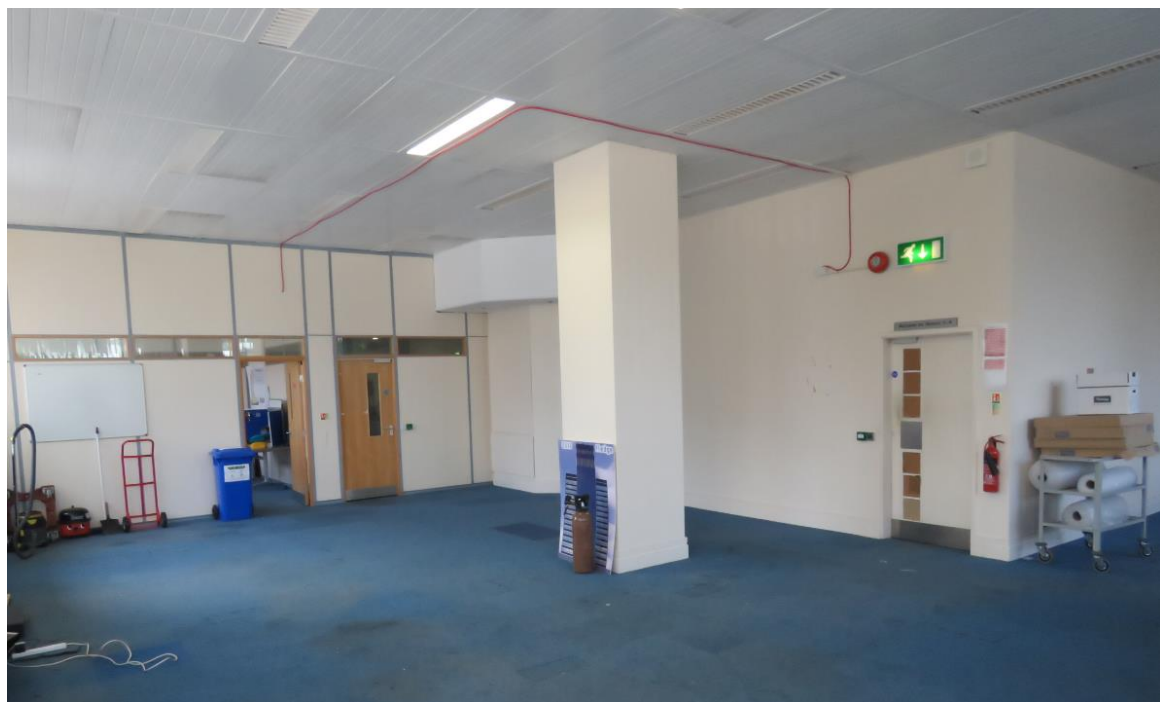
**00-31** Looking south-west within the former branch office facing Miller Street.

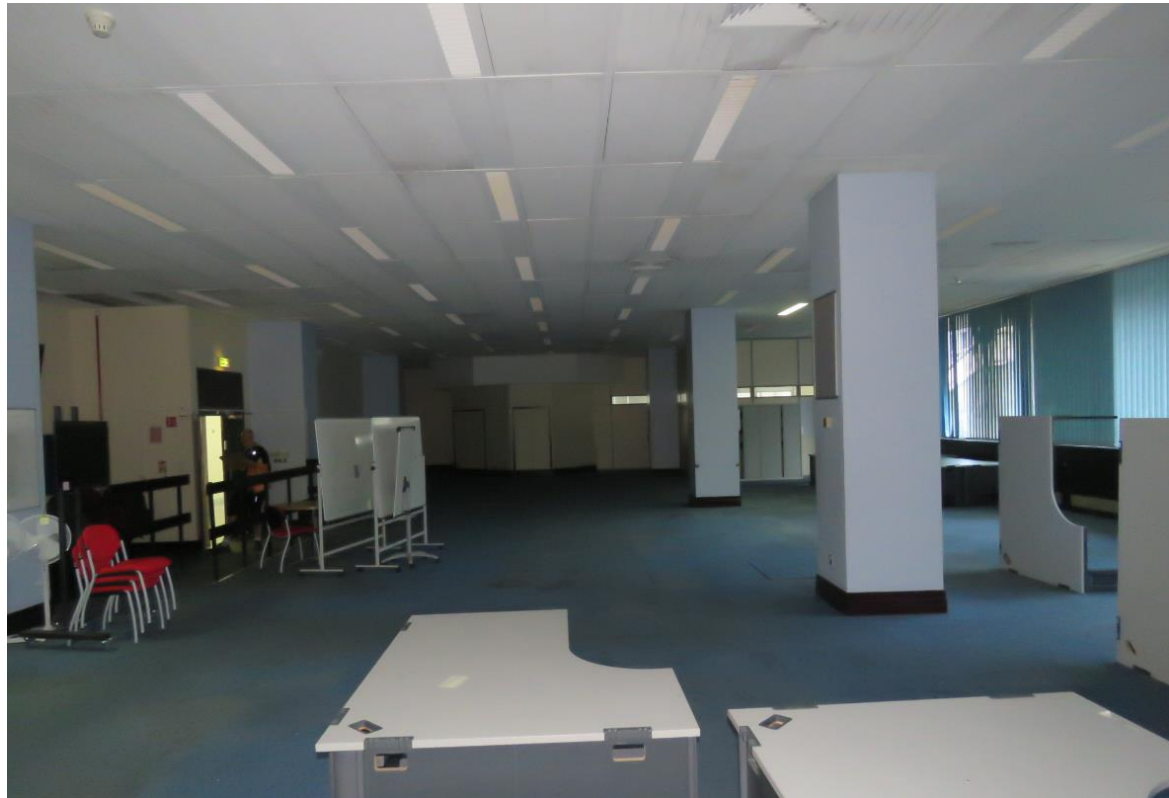
**00-32** Looking north within the sub-divided former branch office.

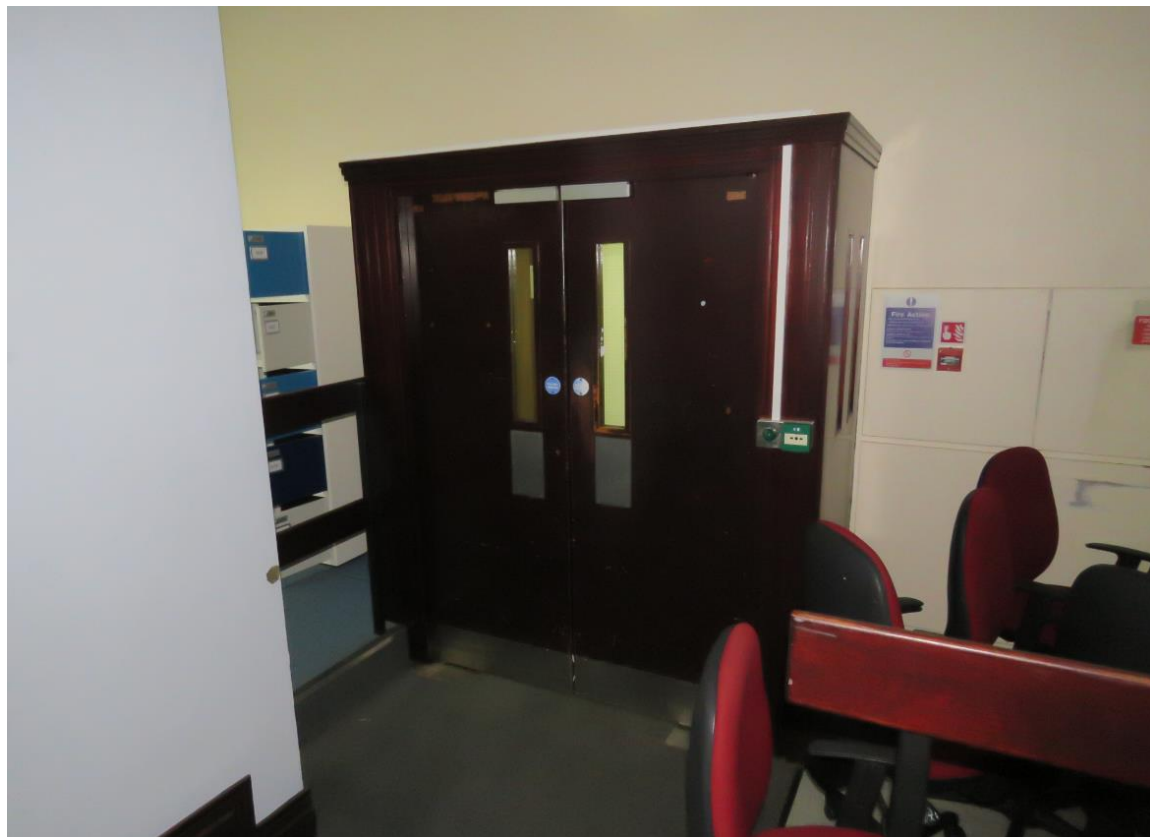
**00-33** View of the entrance doors to the former branch office.

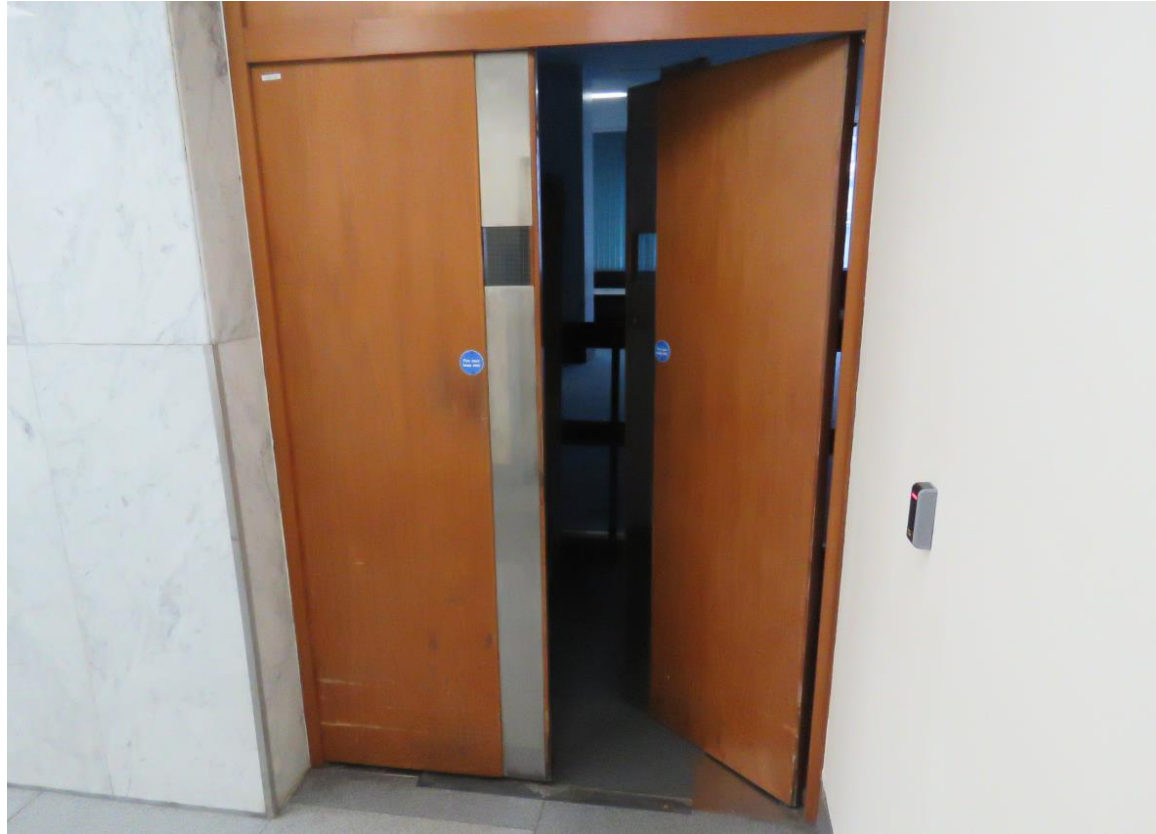
00-34 Entrance to the former branch office.

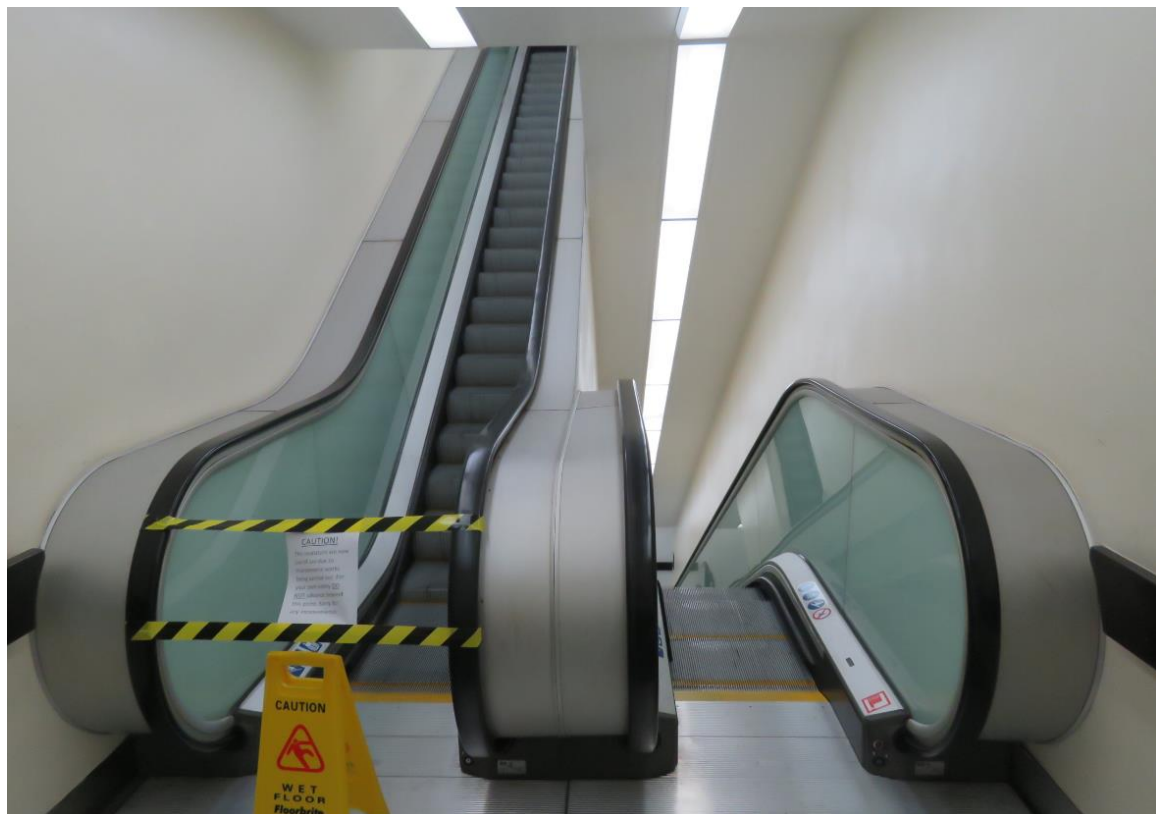
00-35 . View of the escalators. Looking north.

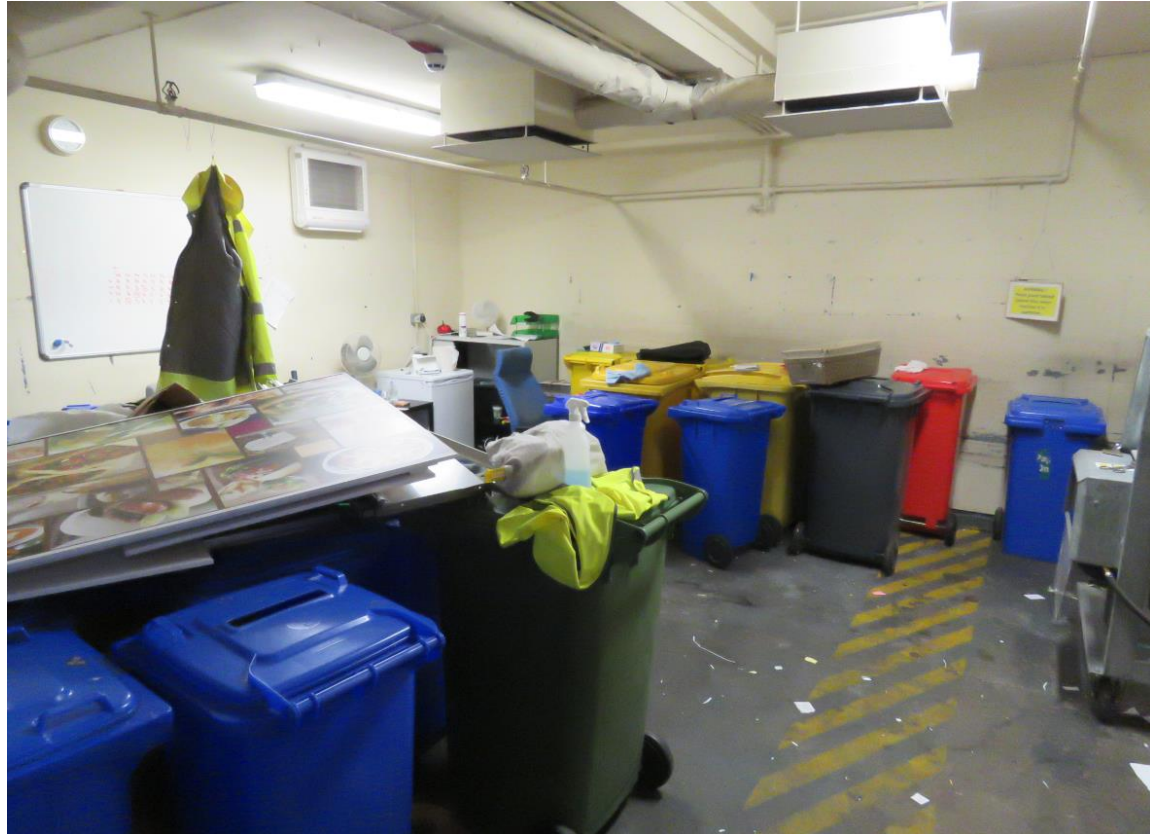
**00-36** Store and recycling room adjoining the Dantzig Street service entrance.

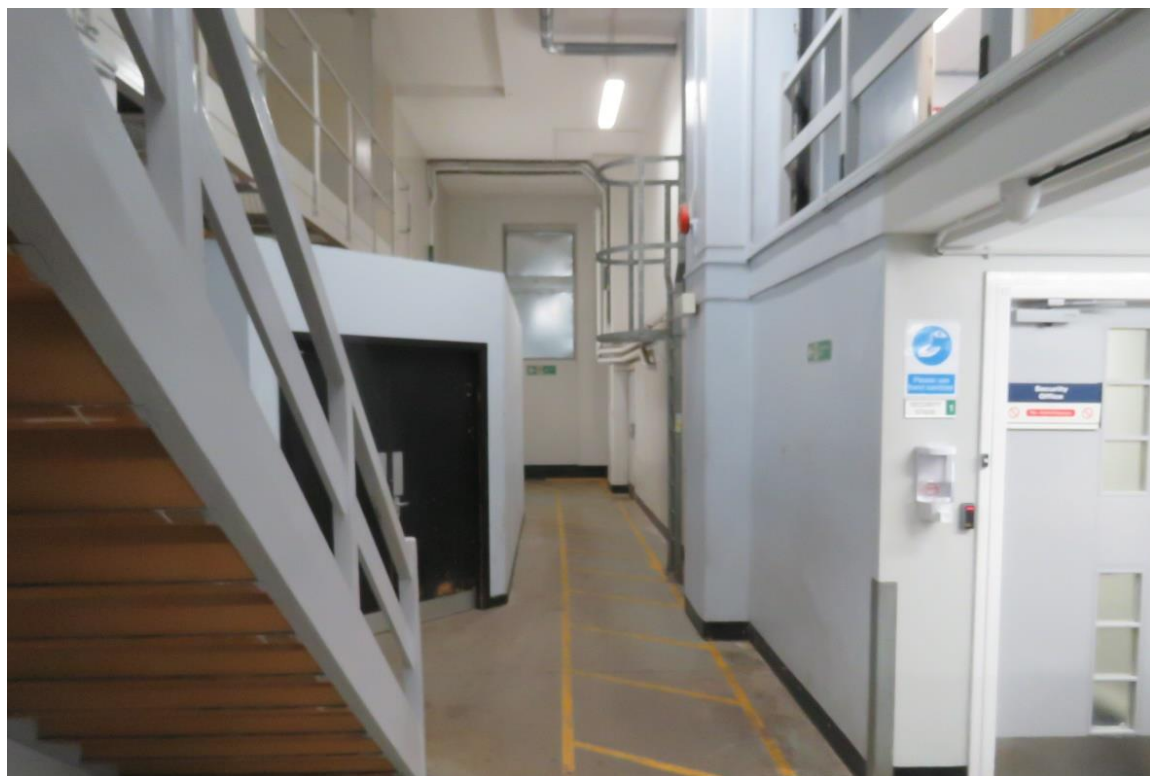
**00-37** Looking south from the Dantzig Street entrance area, showing the raised corridor entrance to the car-park and building manager's office.

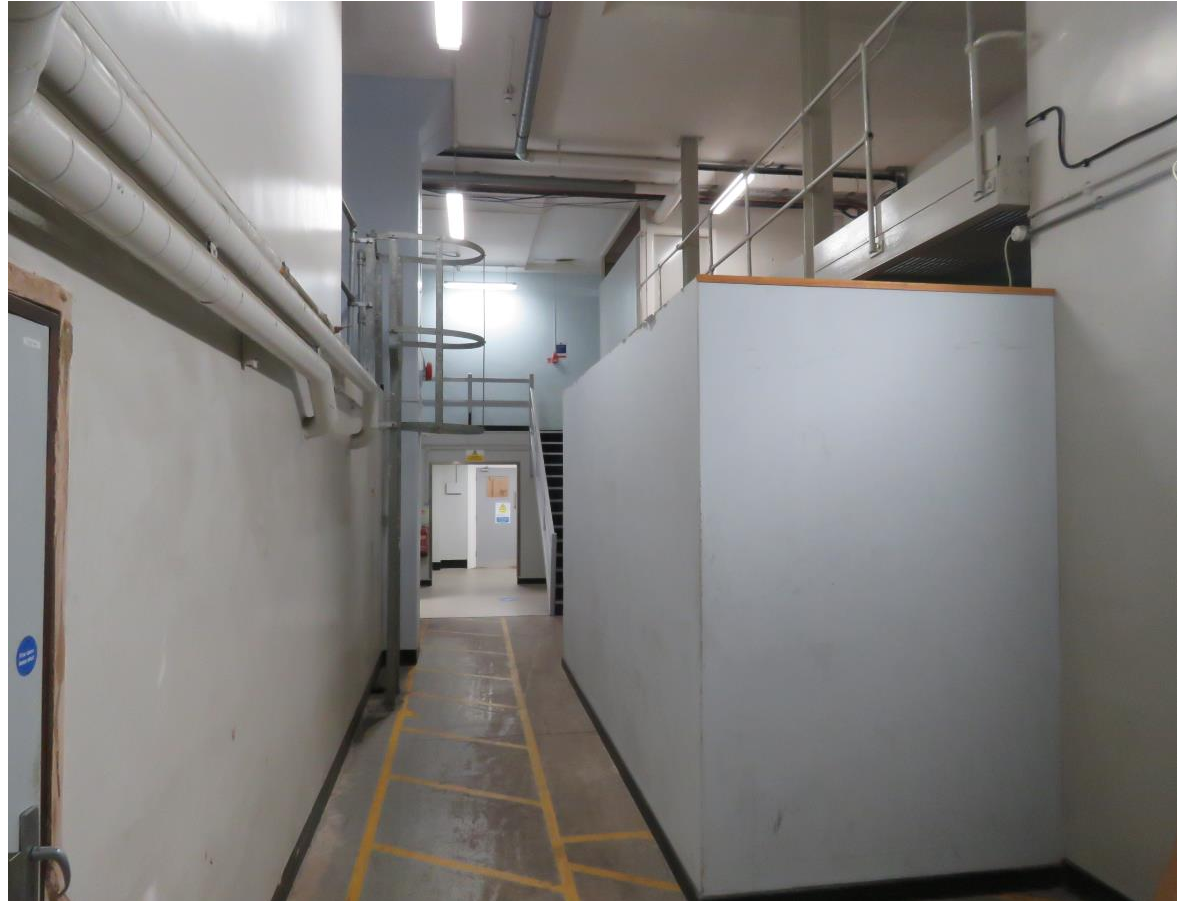
**00-38** Looking north along the service corridor showing the mezzanine entrance to the car-park and building manager's office.
