Project 6-14 Newton Street  
Project Ref 1665  
Revision A  
Date Printed 03/10/2017

| Item | Status | Approach |
|---|---|---|
| <b>Front and Side Elevations of 14-12 – Repair Strategy – to be read in conjunction with drawings C(222), C(201), C(231) and NBS</b> | | |

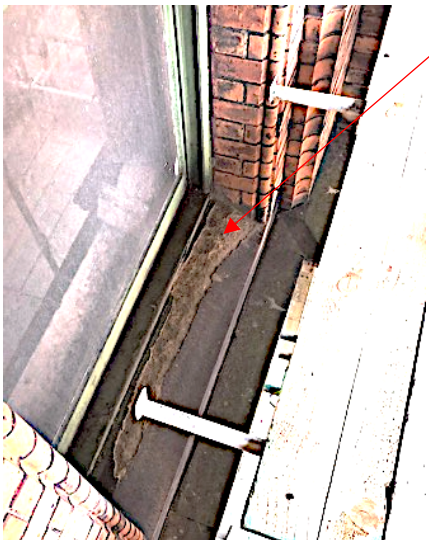
| Item | Status | Approach |
|---|---|---|
| 1 | Stone Delamination where notches have been formed. | <p>Clean loose material, where water is not hindered from running off the face of the sill. Carefully descale and effect a resin repair to prevent water collecting in sill notches and damaging the cills further. Resin to be matching in colour with matching sandstone</p> |

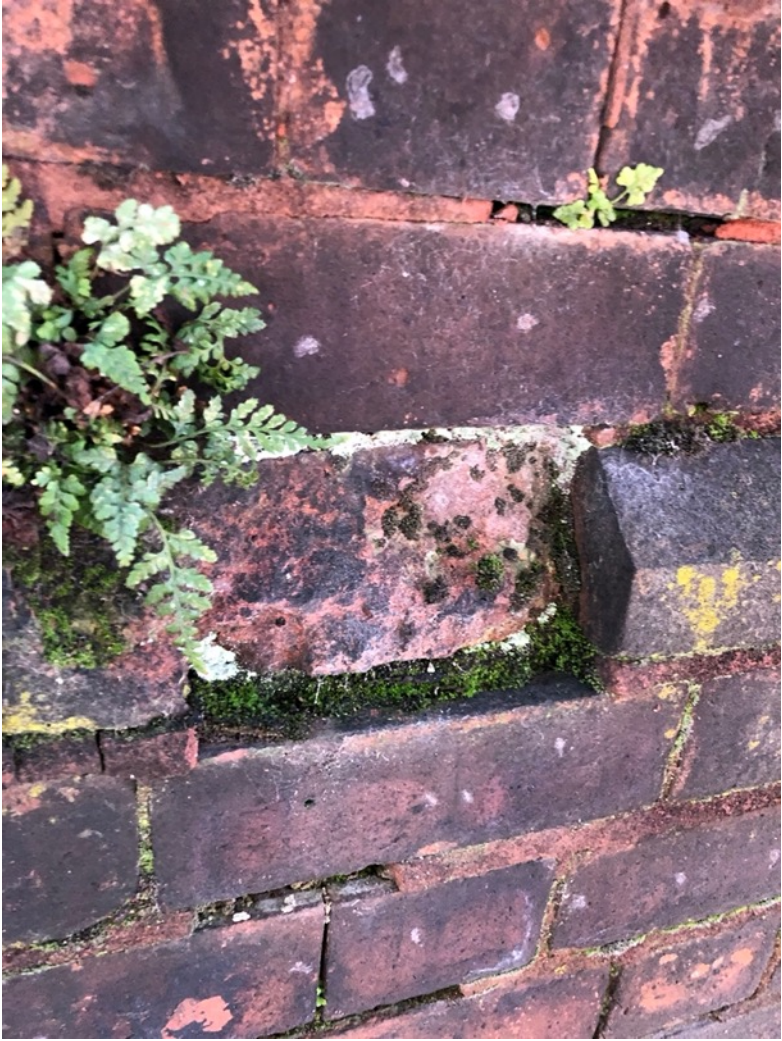
| 2 | Blown brickwork (mainly to Mangle street elevation) | <p>Where existing bricks are identified as perished, these are marked on the elevations drawing. Existing bricks are to be carefully removed taking care not to damage adjoining masonry. Replacement bricks to be sourced, ideally from the existing building, but if this is not possible a sample reclaimed brick to the approval of the Local Authority. The mortar bedding is match exactly the specification of the mortar noted in clause C41/520</p> |

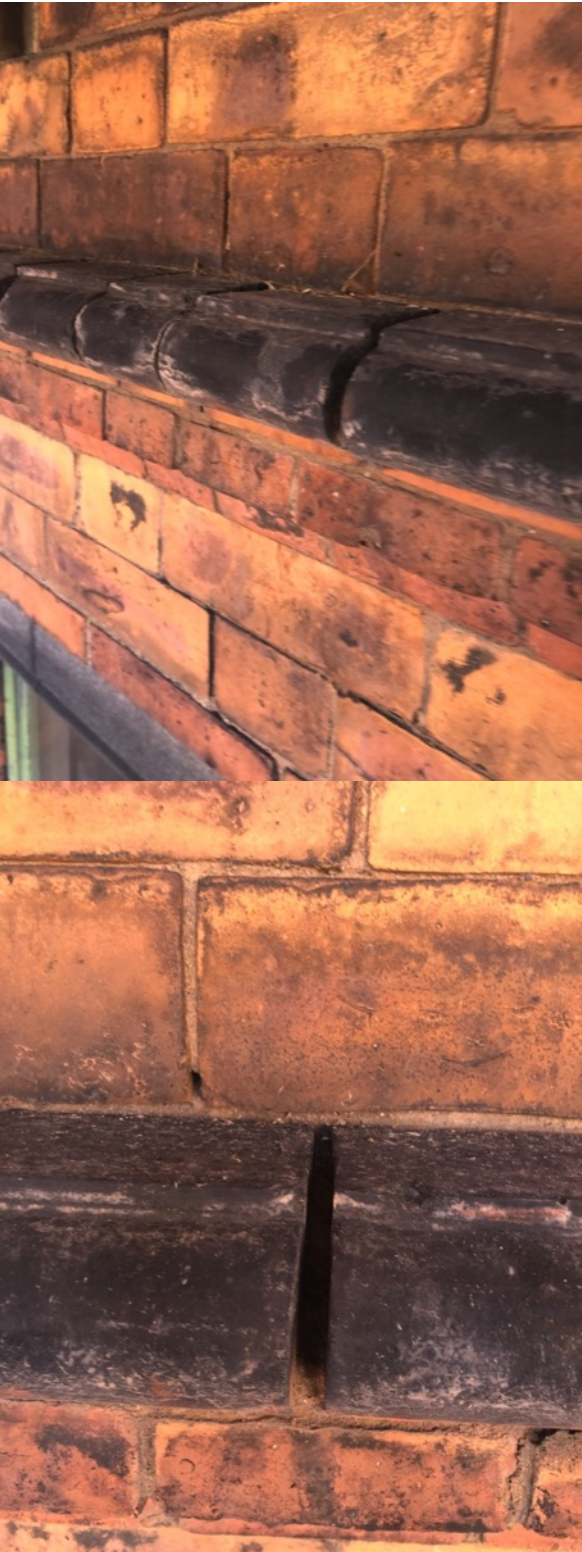
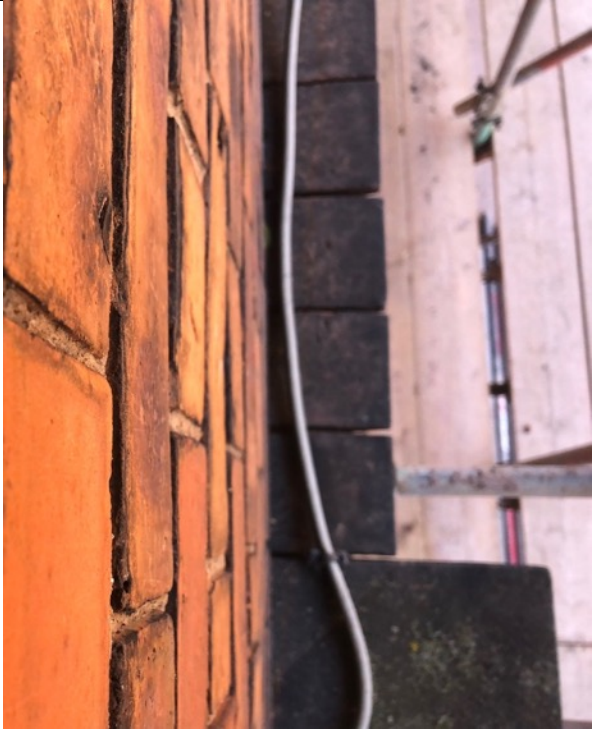
| 4 | Mortar missing from feature projecting courses. | <p>Carefully remove if present. Mortar to be carefully raked out by hand where mortar is loose and/degraded. Do not rake out joints that are sound. Remove all dust and debris. Minimum depth of raking to be 20mm. Carefully repair joints with lime rich conservation mortar in accordance with clause C41/520.</p> |

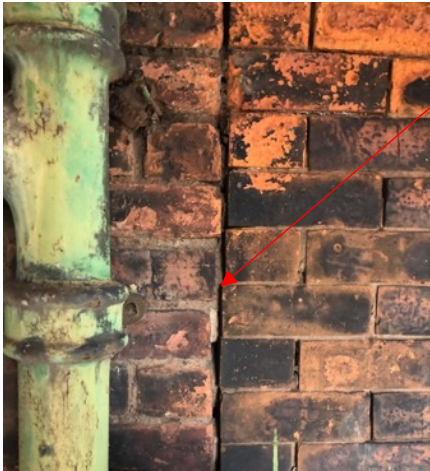
| 5 | Joint between facing brickwork and commons on Paton Street | <p>To be carefully scraped out with hand tools only and pointed with ready mixed lime based mortar to specification. Refer to Clause C41/ 810-860</p> |

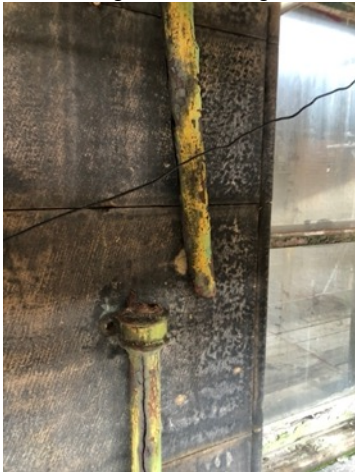
| 6 | RWP and SVP cast iron/lead repairs. | <p>Generally cast iron to be rubbed down prepared, primed and painted in accordance with clause M60 of NBS. The drawings identify where this is not possible. In these instances, the pipework should be carefully removed and replaced with pipes in cast iron matching in size and design to the original.</p> |

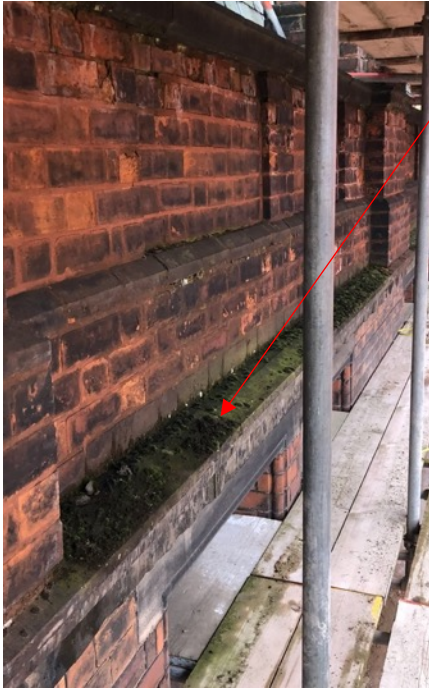
| 9 | Algae and moss growth | Carefully remove and investigate condition. See Items 1.00 for repair strategy.<br><br> |

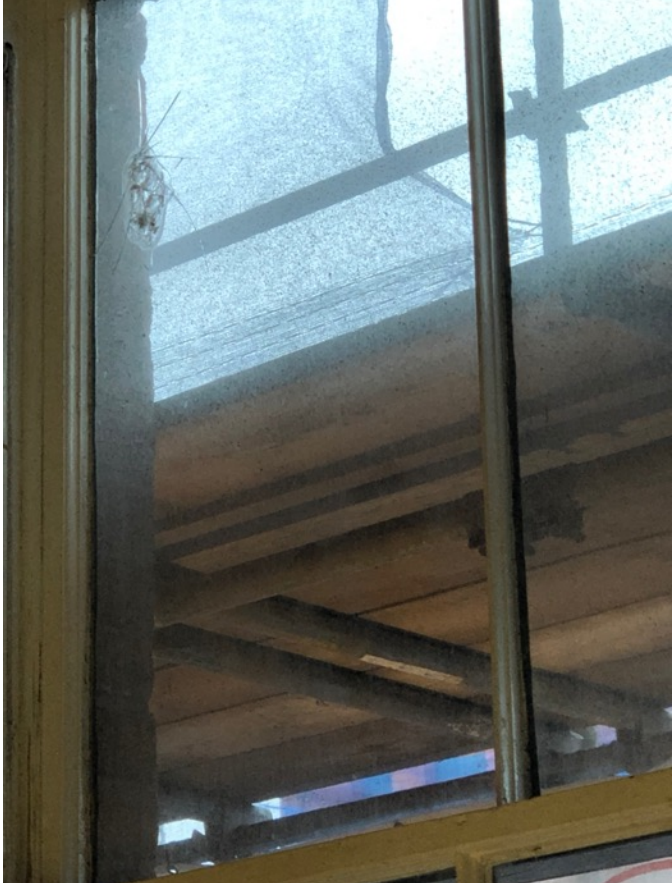
| 10 | Broken glass | <p><b>Window repair type 1 and 2. Broken glazing/ missing glazing/ glazing with services penetrating:</b></p> <p>Carefully smash out remainder of glass to the internal elevation taking care not damage the timber or the mechanisms<br/> Rake out debris and remainder of putty from reveals<br/> Replace with 4mm crown glass in all windows with the exception of the Newton Street façade. On the Newton Street façade replace with Slimlite double glazed units for acoustic treatment of this façade.<br/> Apply linseed oil putty and make good in accordance with clause L40/210 in NBS</p> |

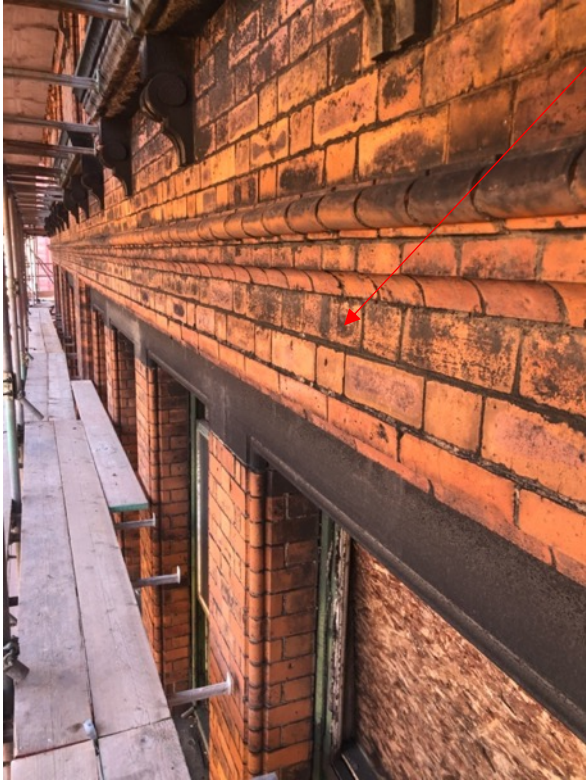
| 12 | Dirt build-up on brickwork | <p>Clean with hot steam. (Doff) process. A sample will be prepared. No chemicals will be used in accordance with clause M40</p> |

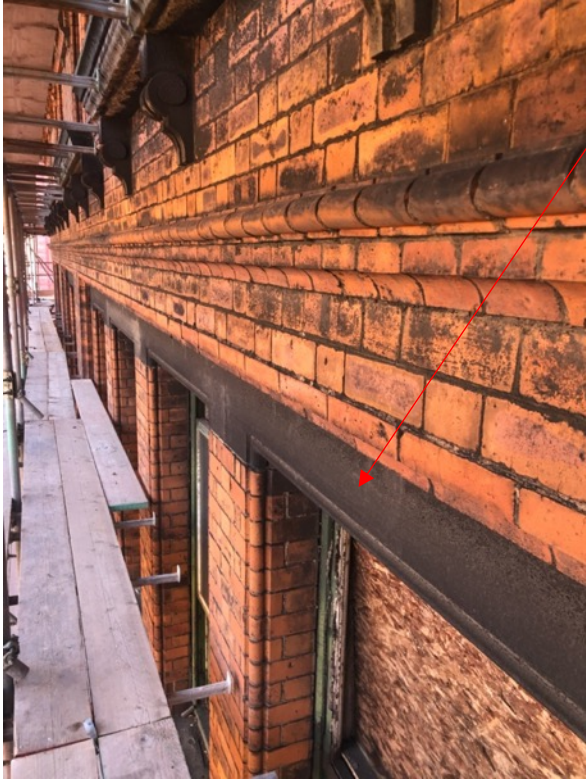
| 13 | Dirt build-up on stonework, both heads and cills | <p>Clean with hot steam. (Doff) process. A sample will be prepared. No chemicals will be used in accordance with clause M40.</p> |

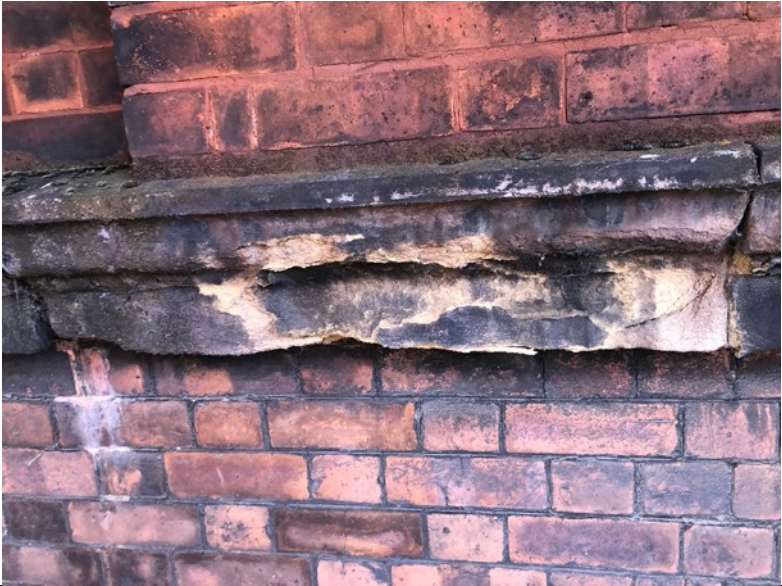
| 15 | Replacement Stone Cill, heads and coursing | <p>Where stone is to be replaced – refer to drawings, then replacement stone sourcing and method in accordance with C41 of NBS.</p> |

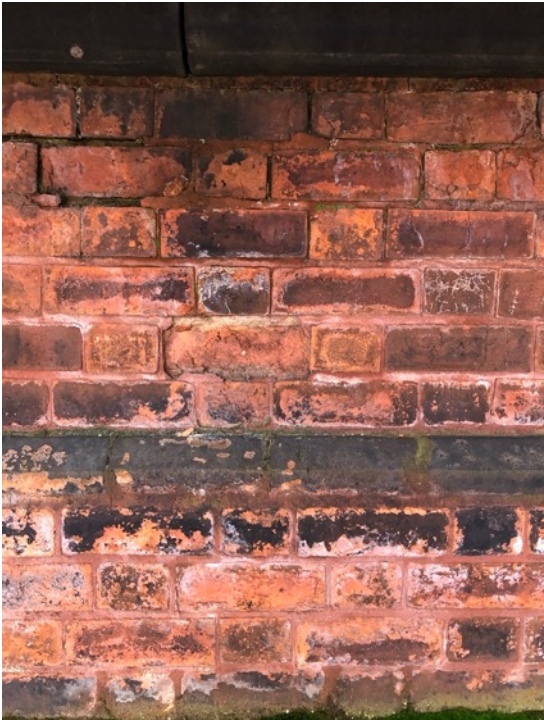
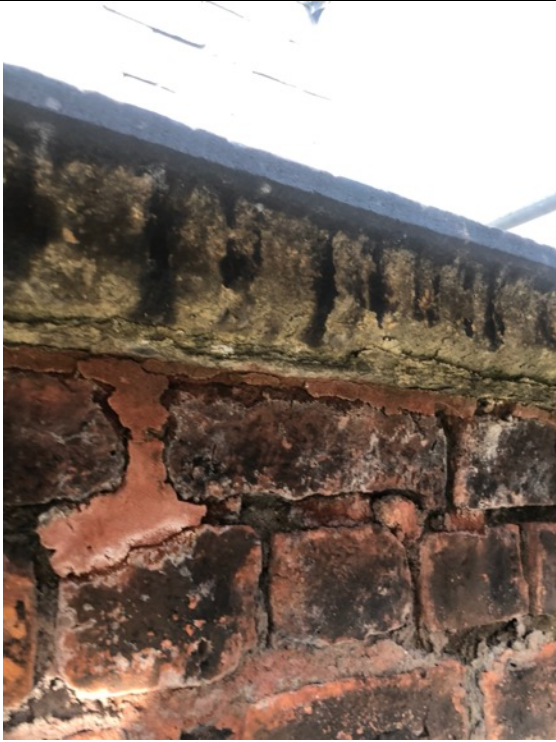
| 16 | Rebuild top parapet | <p>Brickwork at this level in a particularly poor state with inappropriate mortar and approximately 30% of bricks laid. Bricks to carefully removed and reinstated in the English garden wall bond. Mangle Street elevation and part of Dale Street</p> |

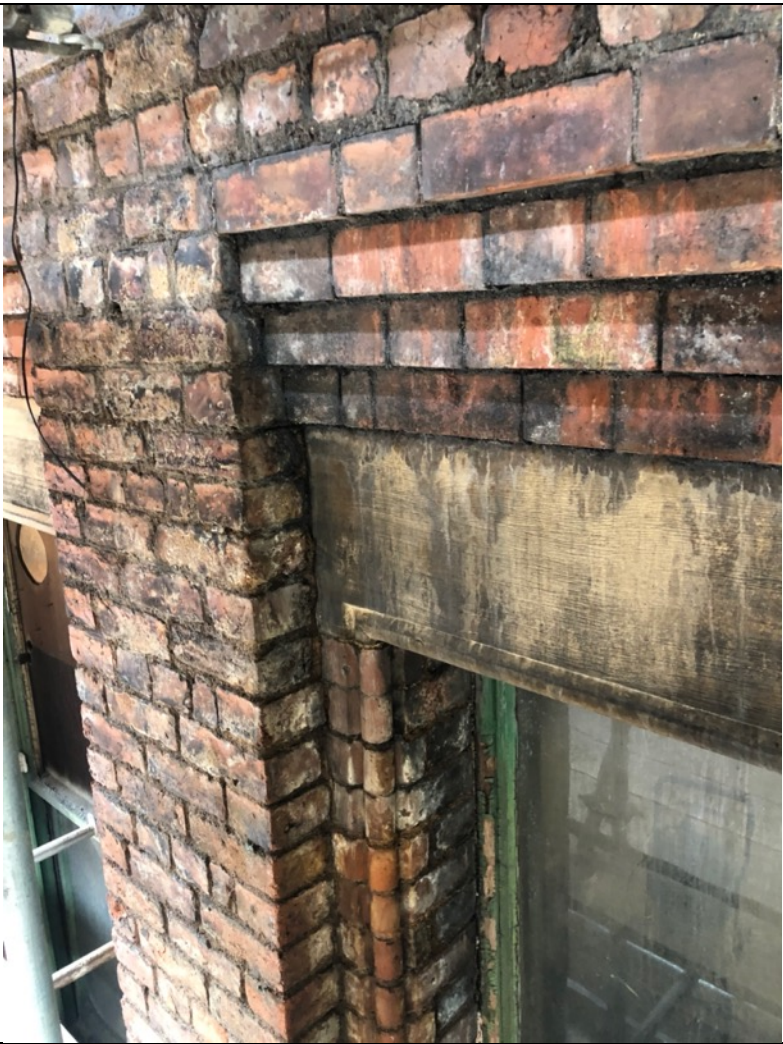
| 17 | Repair recessed brickwork | |
