Heritage defect repair specification and methodology

1-3 Back Turner Street,  
Manchester M4 1FR

Date: 25 November 2020

Reference: 91420/38/JPC/LAP

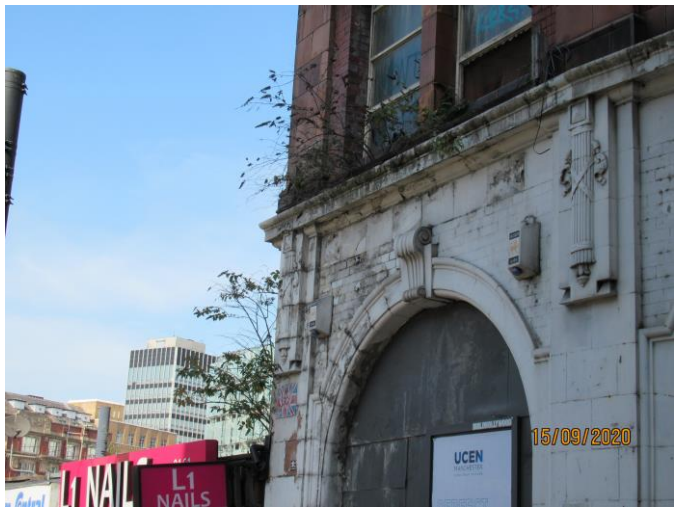
| 4. | Typical view of vegetation growth to the elevation. | |

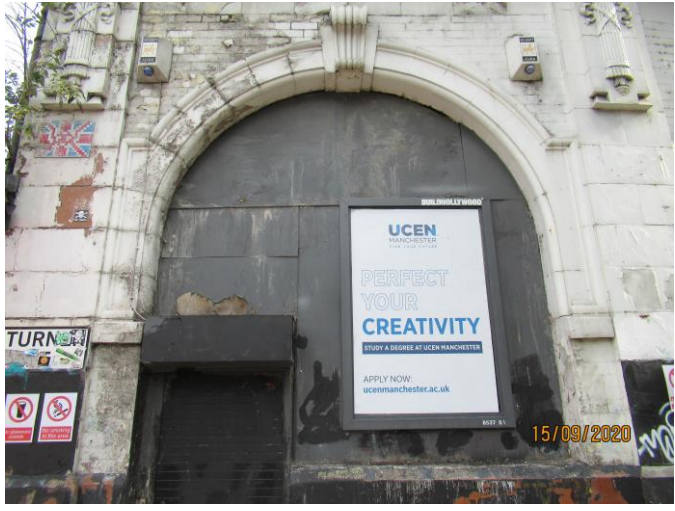
| 5. | General view of carbon sulphation, degraded paintwork and biological staining to arch and brickwork. | |

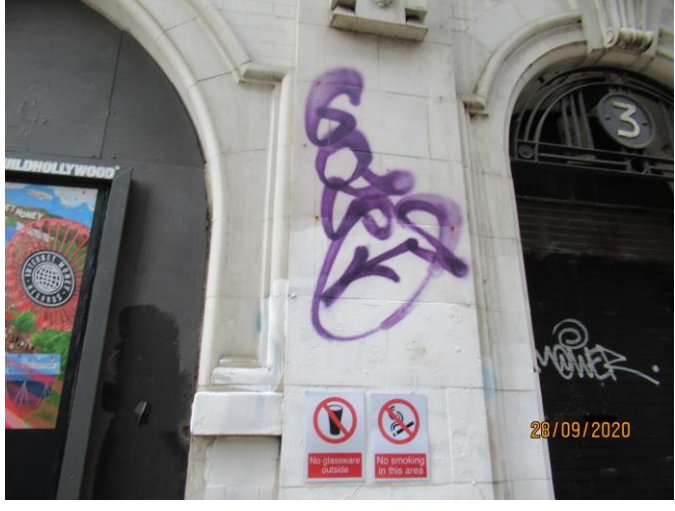
| 6. | Typical view of aerosol graffiti to the painted terracotta pilaster. | |

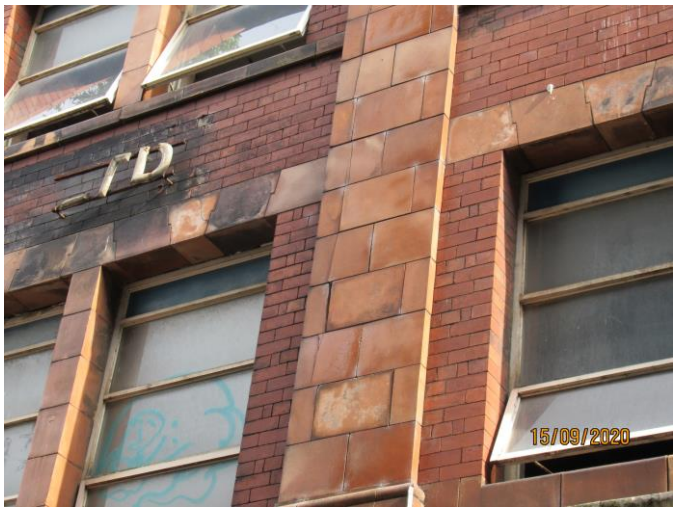
| 7. | View of historic signage fixings to front elevation. | |

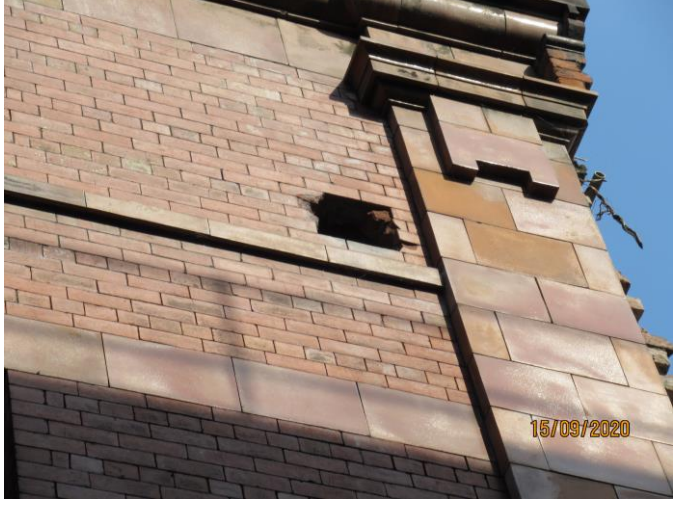
| 8. | View of missing brickwork to the front elevation. | |

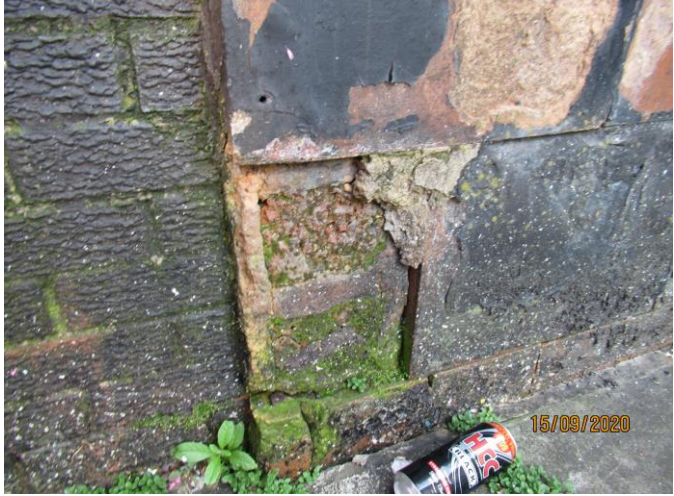
| 9. | View of delaminated sandstone pilaster base to the front elevation. | |

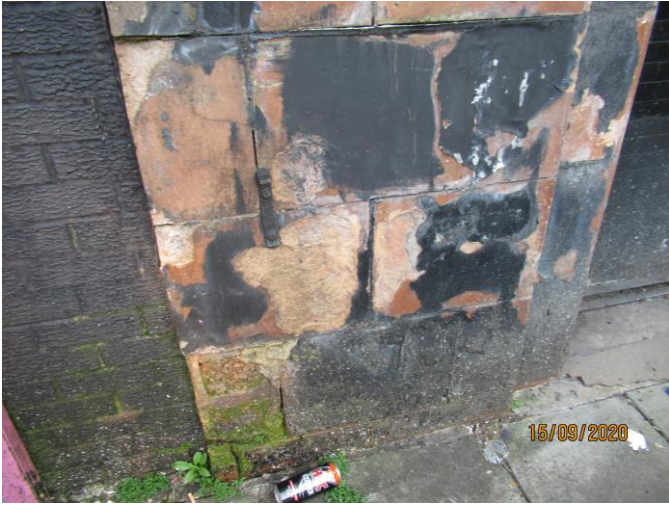
| 10. | View of delaminated sandstone pilaster base to the front elevation. | <p>15/09/2020</p> |

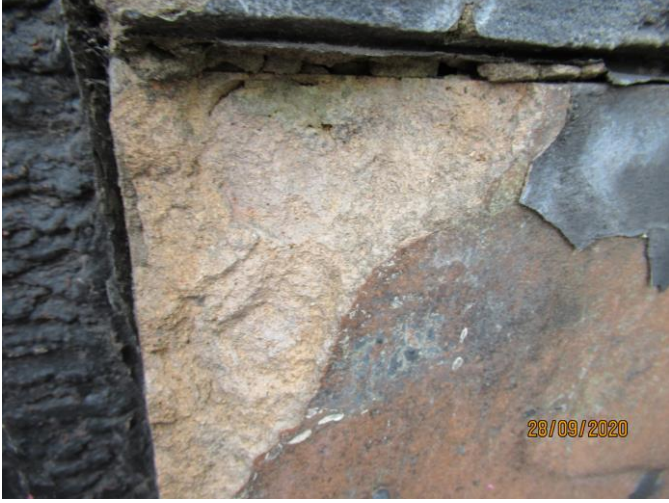
| 11. | View of chipped exposed sandstone stone to pilaster base to the front elevation. | <p>29/09/2020</p> |

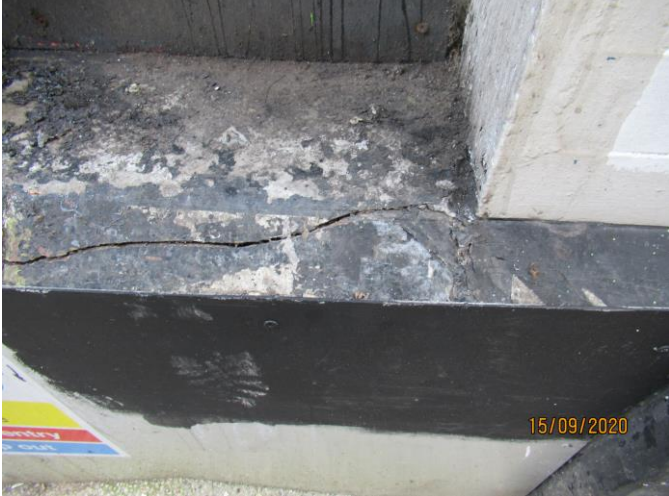
| 12. | View of cracking to the sandstone wall base plinth to the front elevation. | <p>15/09/2020</p> |

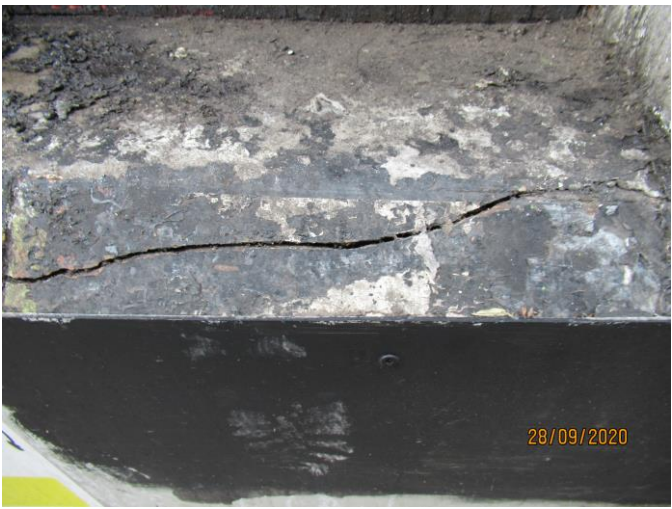
| 13. | View of cracking to the sandstone wall base plinth to the front elevation. | |

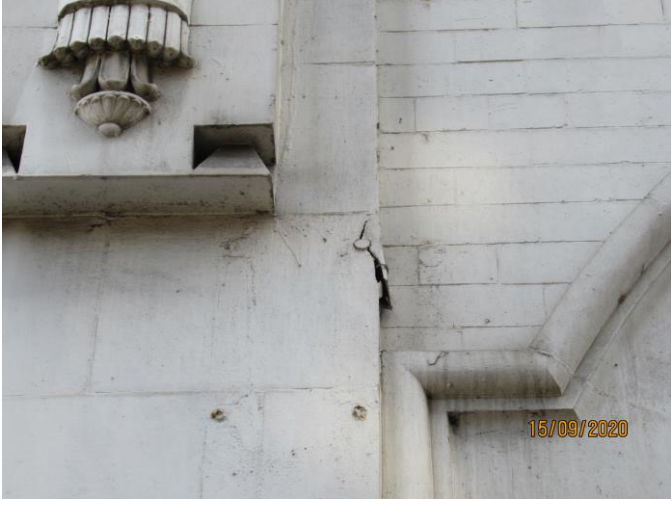
| 14. | View of corroded iron work and delaminated stone work to the front elevation. | |

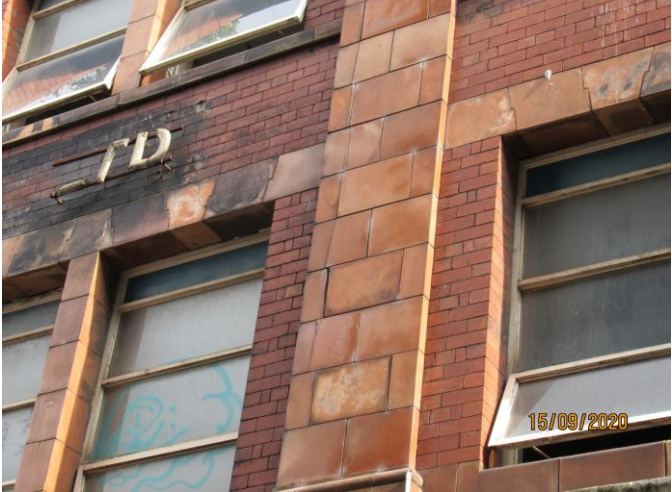
- 1.4.1 Localised investigation works have been undertaken internally to the façade piers to assess the condition of the steel frame. It was found in two piers steel columns are embedded and tightly packed into the façade masonry – a typical detail in buildings of this era which often leads to regent street disease when the façade corrodes. As the location of these steels correlate to the cracking patterns on the terracotta externally, further investigation works externally are required to ascertain the condition of the external flanges of these two columns; it is likely that these are in poor condition and will continue to corrode and crack the terracotta. Unfortunately given that the steels are tightly packed into the façade the front flanges to these columns cannot be exposed or accessed internally, as such these investigations require careful removal and reinstatement of the existing terracotta.

| 15. | Typical view of cracking to terracotta pilaster. | |

- 1.4.2 Given recent experience on previous jobs and based on internal investigations, we anticipate blast cleaning and paint protecting of the embedded steel columns may be required to prevent further damage to the terracotta piers. If left unprotected we are likely to face an ongoing maintenance issue with further cracking, however at this stage this is speculative, and the extent of works required can be confirmed following localised external investigations.

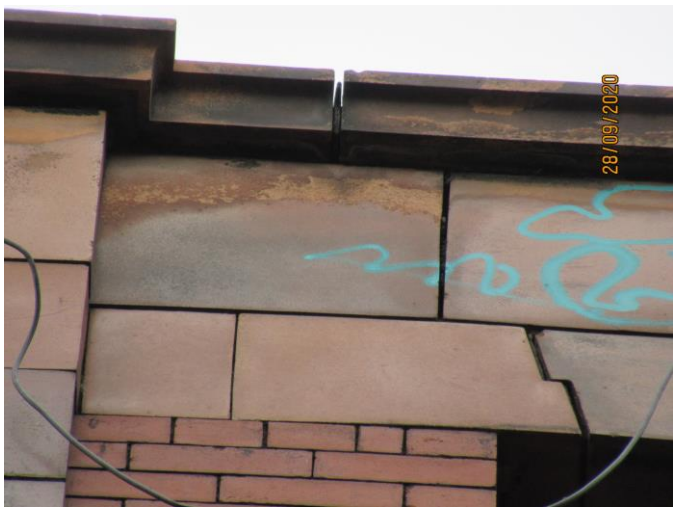
| 16. | Typical view of defective pointing to coping stones. | |

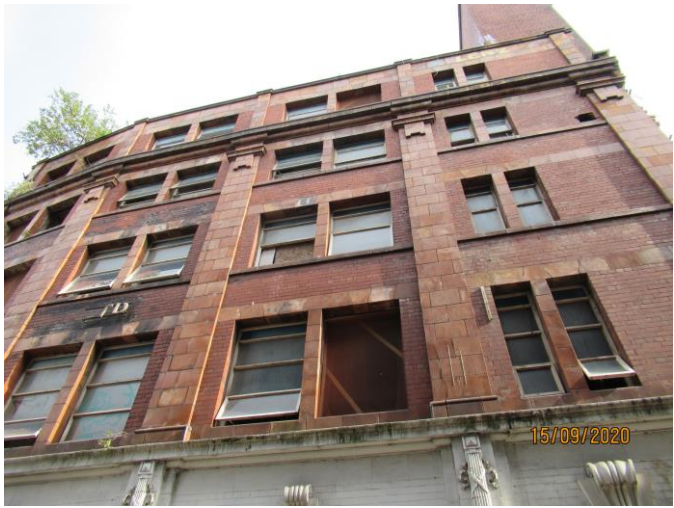
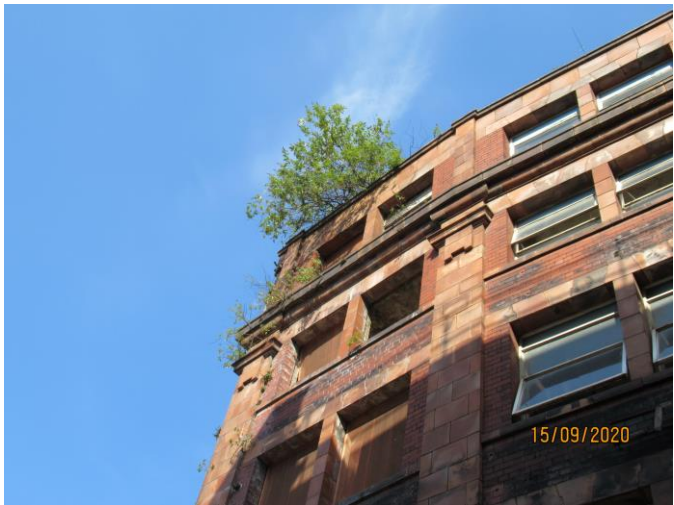
| 17. | Typical view of missing windows to front elevation. | |
| 18. | Typical view of missing windows to front elevation. | |

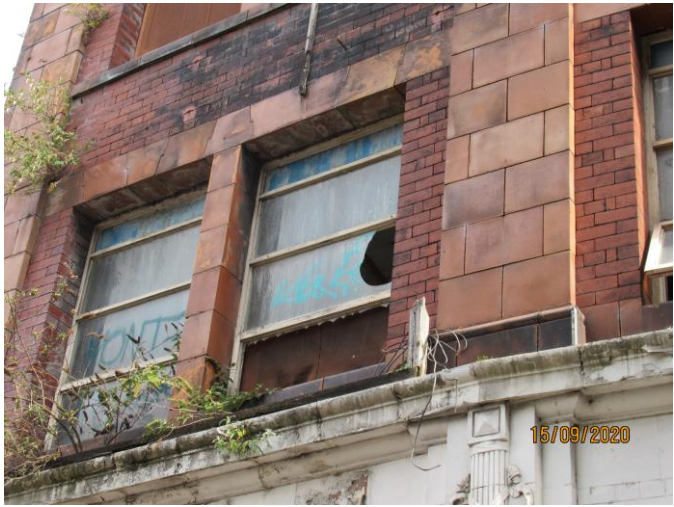
| 19. | Typical view of cracked modern retrofitted timber window to front elevation. | <p>A photograph of a two-story brick building facade. The focus is on a window with a modern retrofitted timber frame. The window is divided into two panes, with the right pane showing significant cracking and damage. The brickwork is a mix of red and brown tones. A date stamp '15/09/2020' is visible in the bottom right corner of the photo.</p> |

1.3.6 We recommend that the existing non-historic windows are replaced with a modern alternative, whilst remaining sympathetic and the design in keeping with the local adjacent buildings. The architect is to submit proposals, in-line with planning condition D, including sectional plans for Conservation Officer/Local Authority approval at the early stages of the development.

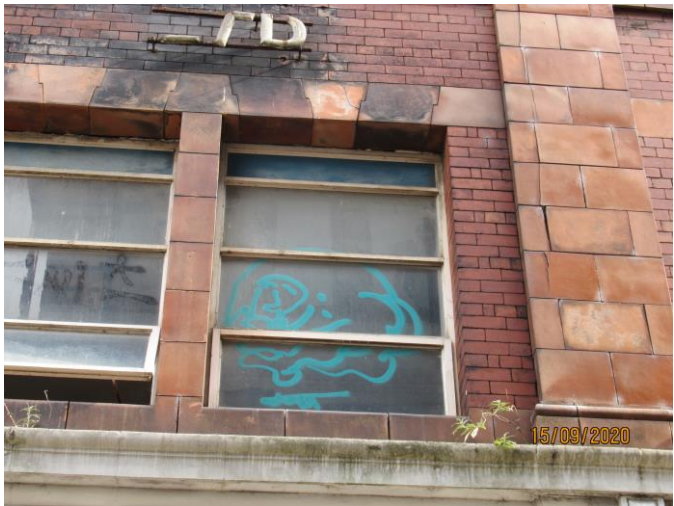
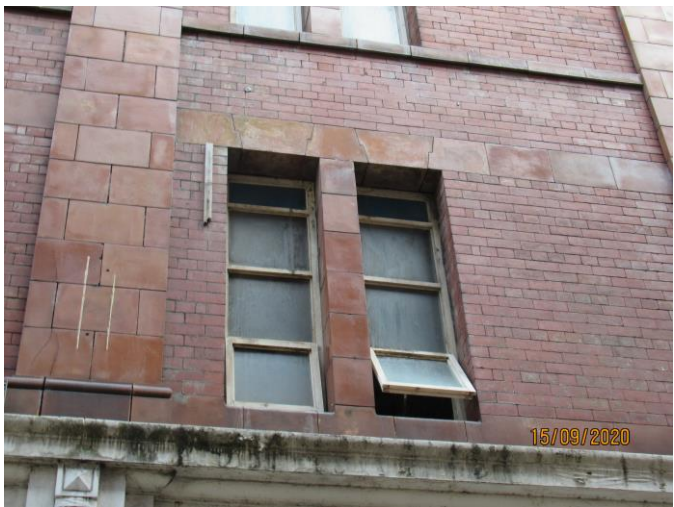
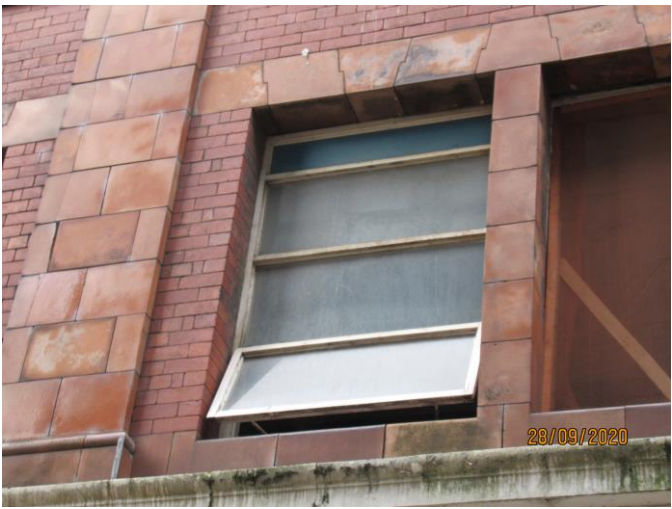
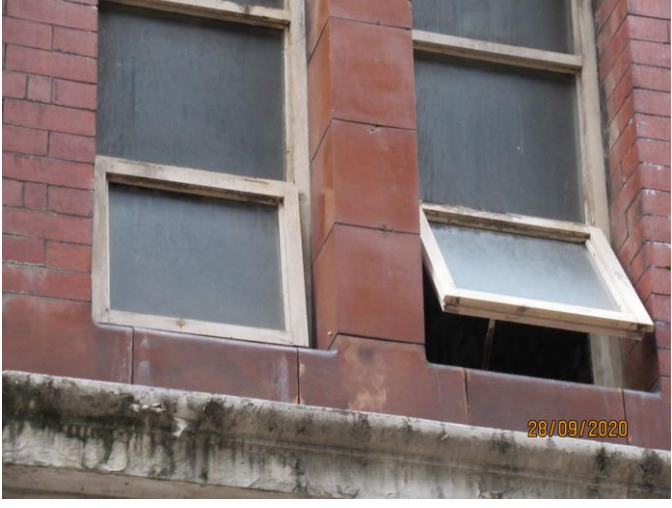
| 20. | Typical view of modern retrofitted timber window to front elevation. | <p>A photograph of a similar window to the one in the previous image. This window also has a modern retrofitted timber frame and is divided into two panes. The right pane shows some graffiti in blue paint. The brickwork is red and brown. A date stamp '15/09/2020' is visible in the bottom right corner of the photo.</p> |
| 21. | Typical view of modern retrofitted timber window to front elevation. | <p>A photograph of a window with a modern retrofitted timber frame, similar to the others. The window is divided into two panes, and the right pane is slightly open. The brickwork is red and brown. A date stamp '15/09/2020' is visible in the bottom right corner of the photo.</p> |

| 22. | Typical view of modern retrofitted timber window to front elevation. | |
| 23. | Typical view of modern retrofitted timber window to front elevation. | |

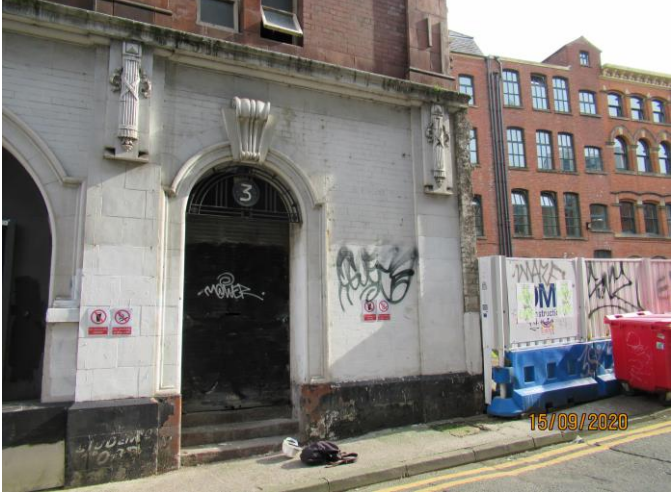
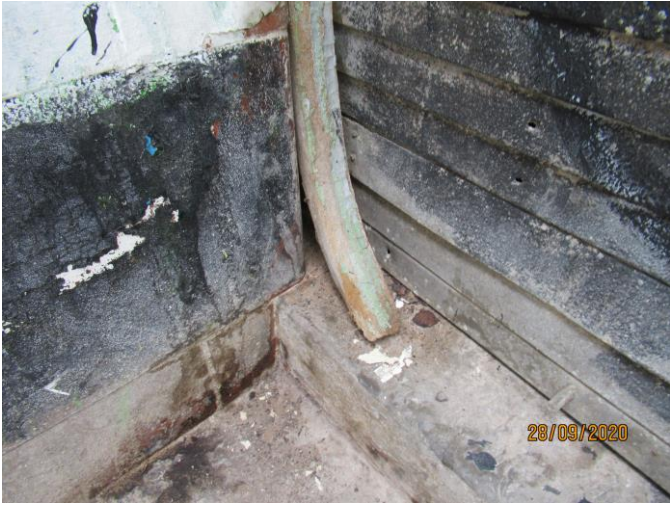
1.3.8 The external doors are generally in poor condition. The retrofitted external roller shutters to both entrances are severally corroded and will require replacement in the short term.

| 24. | Typical view of corroded roller shutter to entrance door. | |

| 25. | Typical view of corroded roller shutter to entrance door. | <p>28/09/2020</p> |

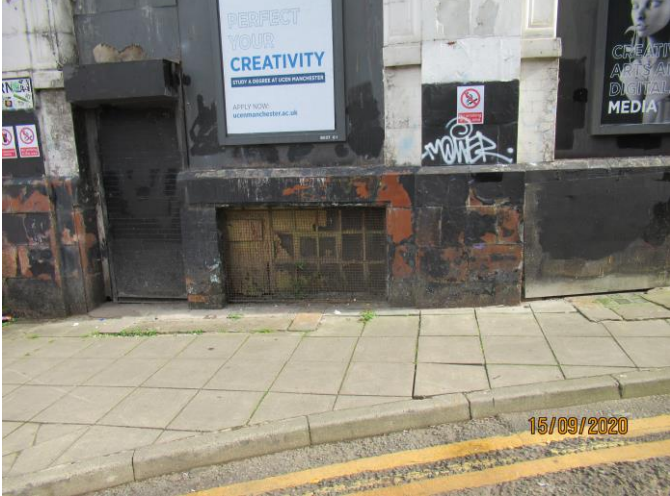
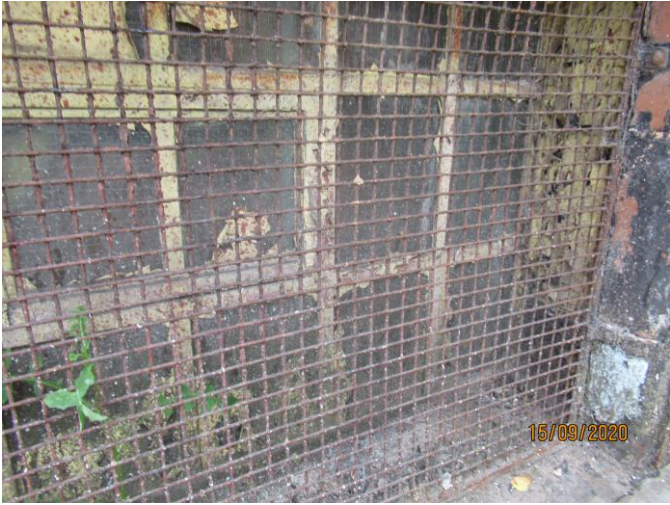
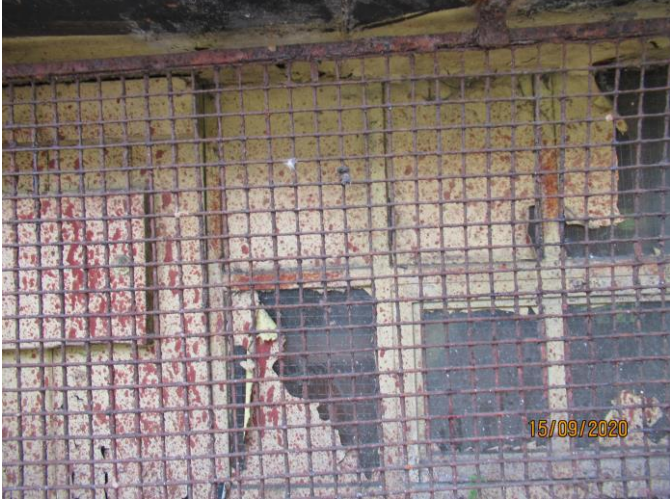
| 27. | Typical view of painted basement windows. | <p>15/09/2020</p> |

| 28. | Typical view of painted basement windows. | |
| 29. | Typical view of painted basement windows. | |

- Elevation – Soap Street.
- 1.4.9 We propose to infill the basement windows (windows 1, 2 & 3) using matching bricks, in a header course brick bond arrangement to match the front elevation. The introduction of the brick infill, including pointing, will be undertaken in line with the Heritage Surveyors recommendation, as documented in Appendix A – A6 & A7.

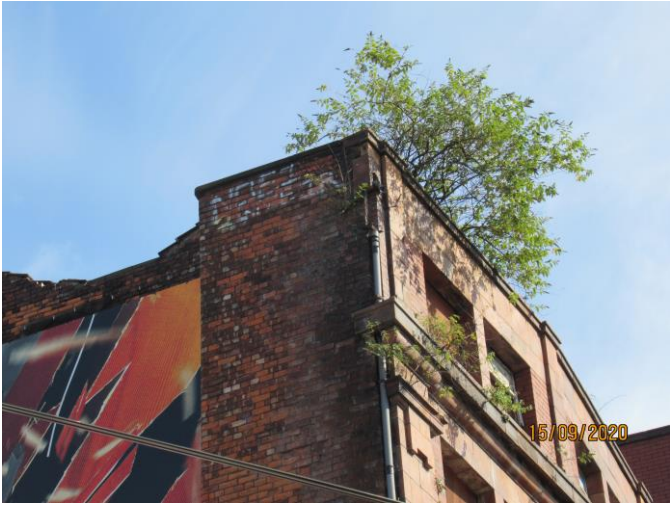
| 31. | View of aerosol graffiti and vegetation growth to defective brickwork. | |

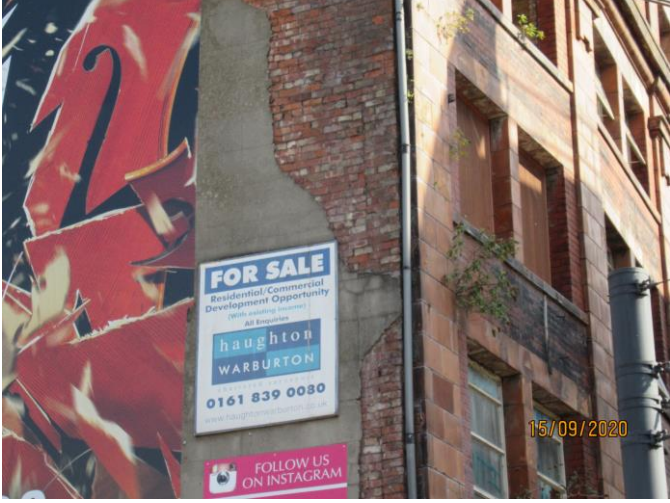
| 32. | Typical view of cement render to elevation. | |

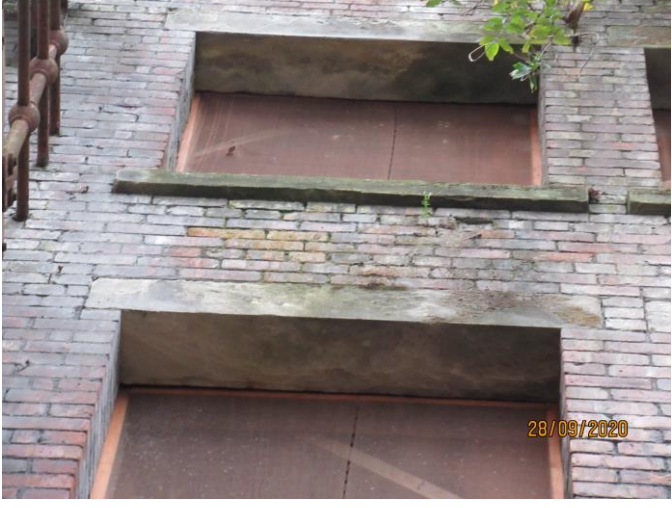
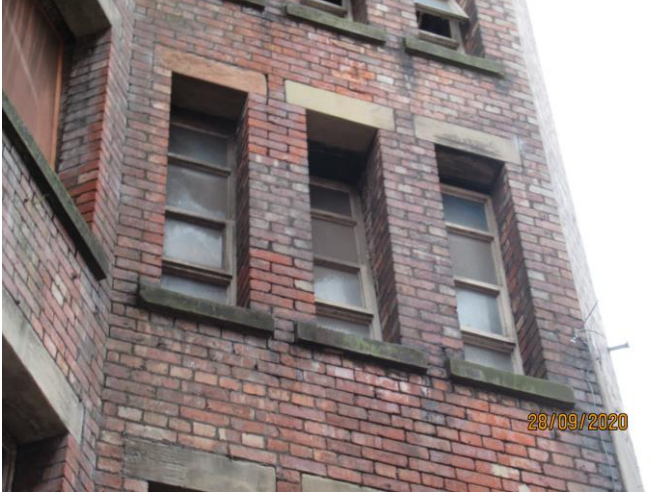
| 35. | Typical view of degraded mortar and brickwork elevations. | |
| 36. | Typical view of degraded mortar and brickwork elevations. | |

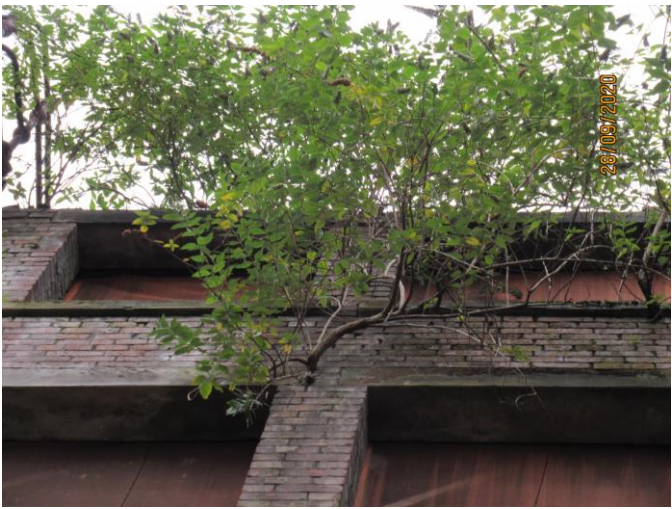
| 37. | View of extensive vegetation growth to brickwork elevation. | <p>A photograph showing a brick wall with significant green foliage growing over it. The date stamp '26/09/2020' is visible in the top right corner.</p> |

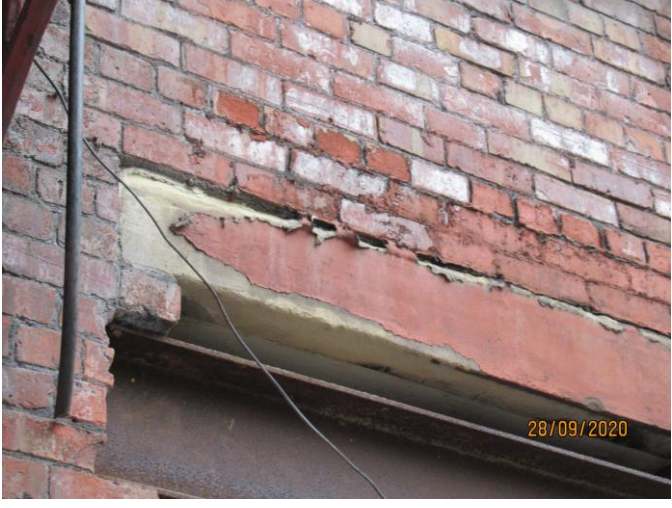
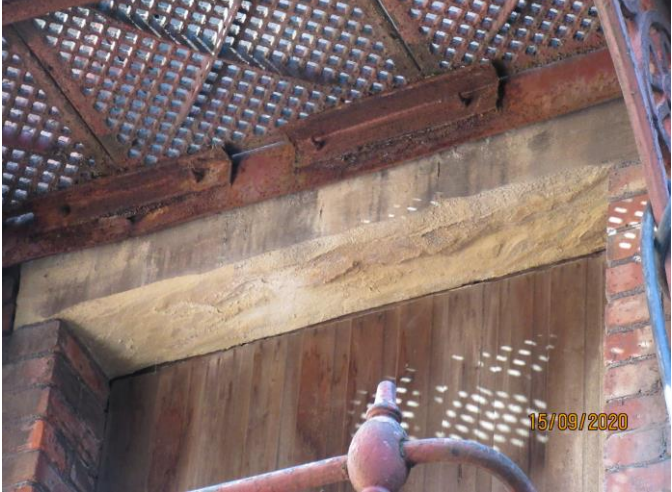
1.3.7 To the rear elevation, there is minor stone decay to isolated lintels caused by general weathering which is normal based on the age and location of the elements. We do not deem any intervention or repairs to these areas at this time due to the decay only being in the early stages. Should any aesthetic repair be required, we can provide an appropriate, sensitive and reversible repair method.

| 38. | View of early stone decay to limestone lintel. | <p>A close-up photograph of a brick wall showing a horizontal section of decayed stone or plaster, revealing a lighter-colored material underneath. The date stamp '28/09/2020' is visible in the bottom right corner.</p> |
| 39. | Typical view of early stone decay to limestone lintel. | <p>A photograph showing a horizontal section of decayed stone or plaster, revealing a lighter-colored material underneath. The date stamp '15/09/2020' is visible in the bottom right corner.</p> |

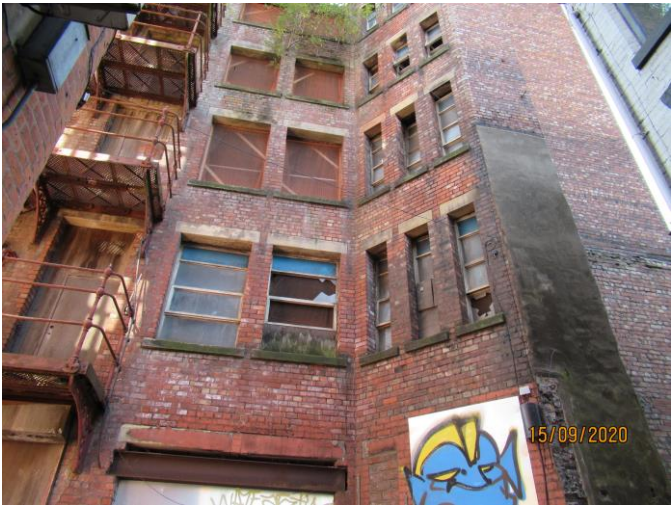
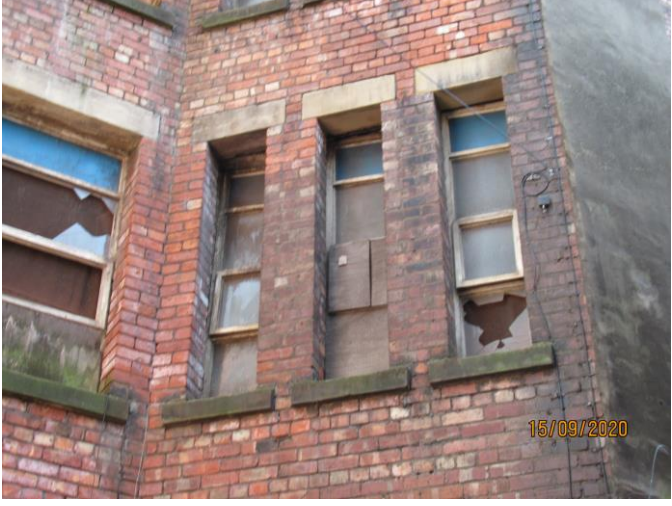
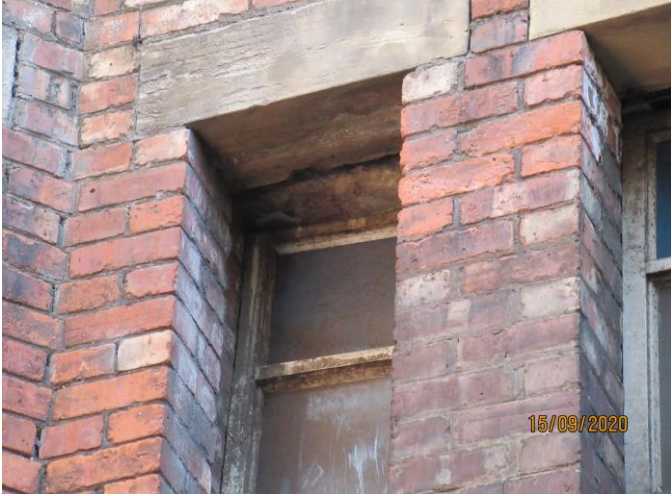
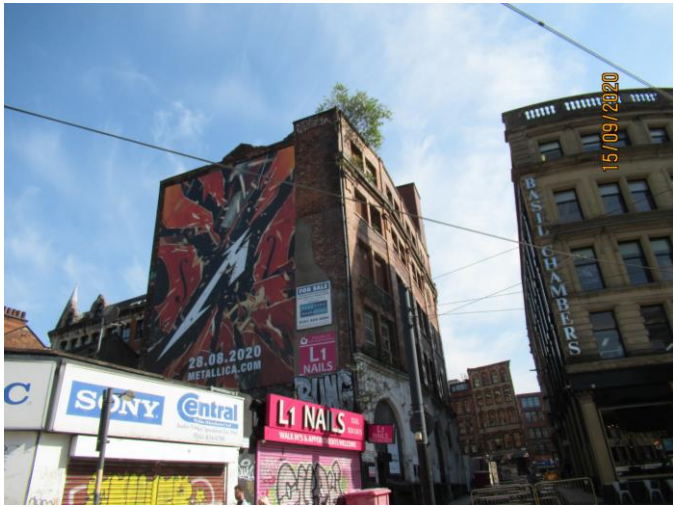
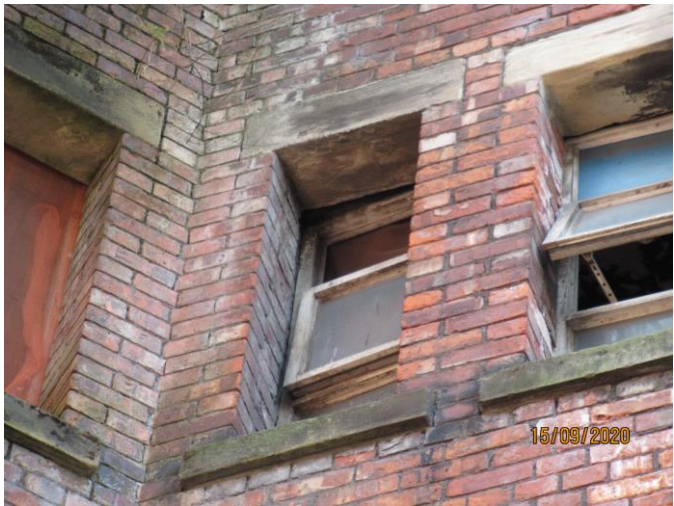
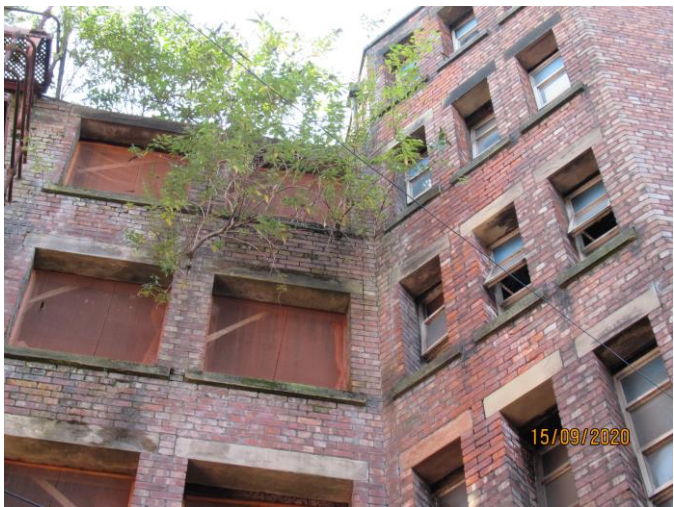
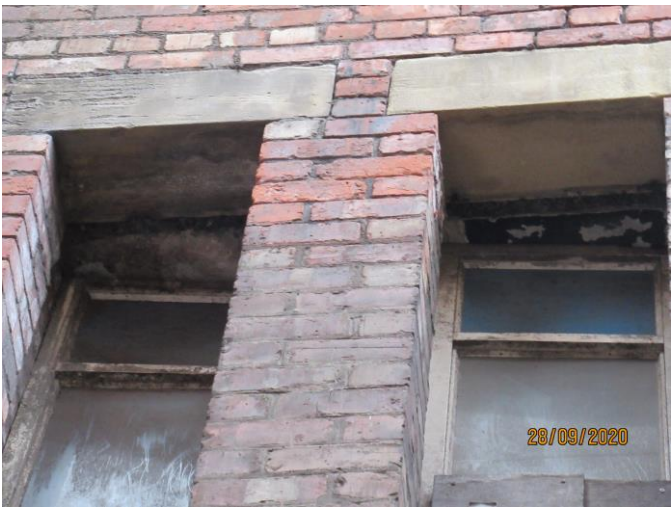
| 40. | General view of modern retrofitted windows to rear elevation. | |
| 41. | Typical view of modern retrofitted windows to rear elevation. | |
| 42. | Typical view of modern retrofitted windows to rear elevation. | |

| 43. | Typical view of modern retrofitted windows to rear elevation. | |
| 44. | Typical view of modern retrofitted windows to rear elevation. | |
| 45. | Typical view of modern retrofitted windows to rear elevation with vegetation growth to elevation. | |

| 46. | Typical view of modern retrofitted windows to rear elevation. | <p>A photograph showing two modern, dark-framed windows installed in a red brick wall. The windows are set within a recessed area of the wall. A date stamp '28/09/2020' is visible in the bottom right corner of the image.</p> |

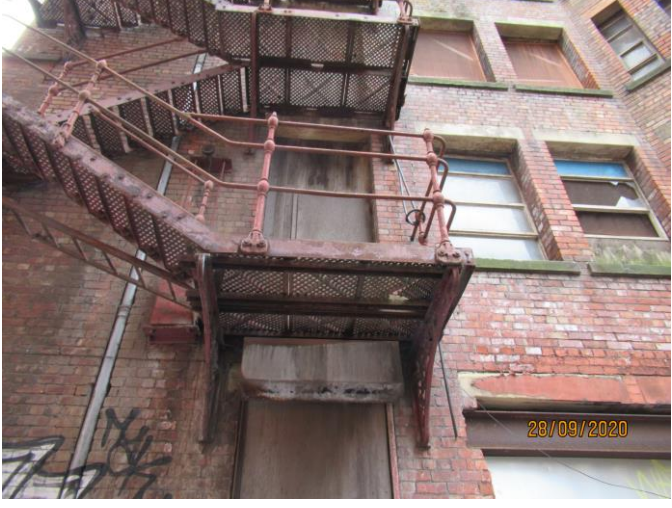
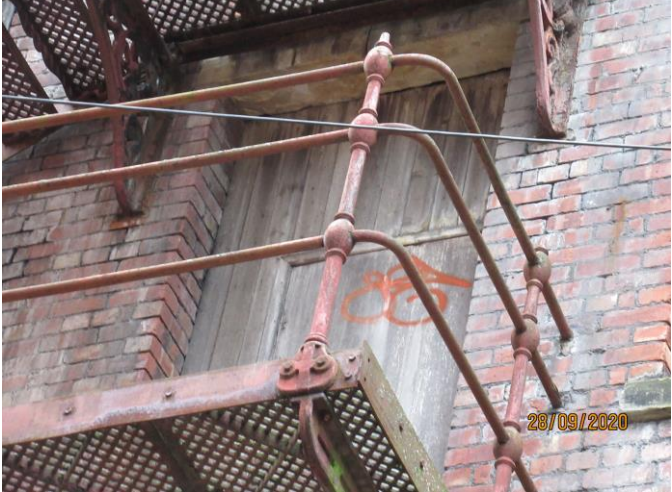
| 47. | General view of corroded iron staircase. | <p>A photograph showing a general view of a rusted, corrugated metal staircase attached to a brick wall. The staircase has a mesh-like structure and is supported by brackets. A date stamp '28/09/2020' is visible in the bottom right corner of the image.</p> |
| 48. | Typical view of corrosion to iron staircase. | <p>A close-up photograph of the rusted metal staircase, showing significant corrosion and structural wear. The metal is heavily pitted and discolored. A date stamp '28/09/2020' is visible in the bottom right corner of the image.</p> |

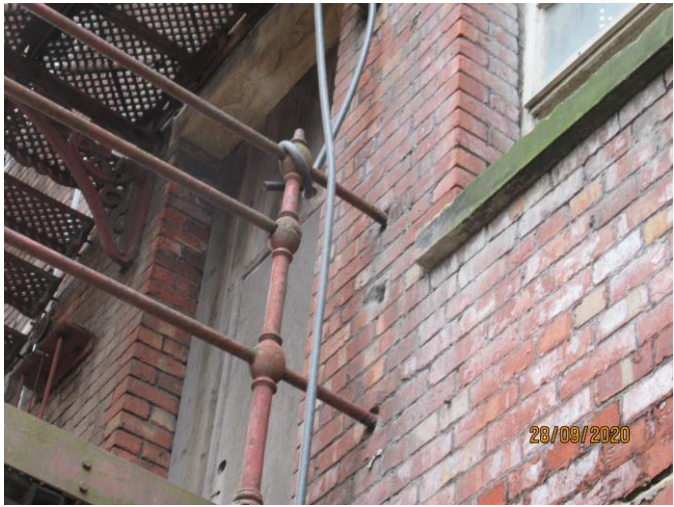
| 49. | View of missing balustrade rail. | <p>A photograph showing a red brick wall with scaffolding. A metal rail is visible, but the balustrade rail is missing. A date stamp '28/09/2020' is in the bottom right corner.</p> |

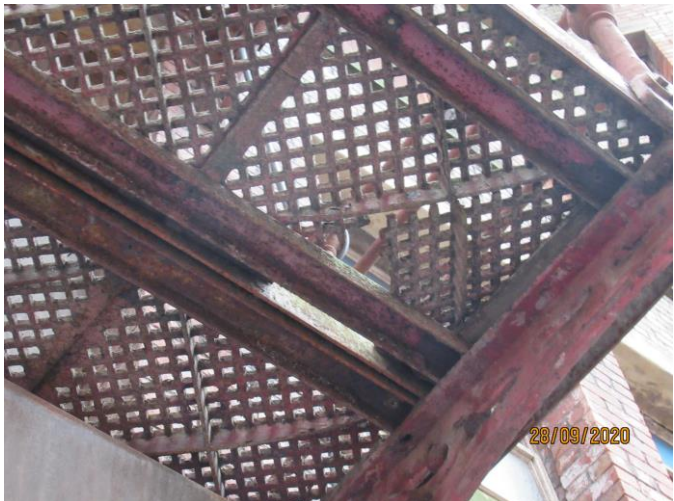
| 50. | View of corroded cast iron floor grille. | <p>A photograph showing a close-up of a corroded cast iron floor grille. The grille is made of a grid of small squares. A date stamp '28/09/2020' is in the bottom right corner.</p> |
