| <b>DW1360</b> | <b>9<sup>th</sup> April 2020</b> |
| <b>Demolition Specification<br/>Greenheys Lane Production<br/>Buildings</b> | |
| <b>Manchester Science Parks Limited</b> | |

| <b>Greenhays Lane Buildings<br/>Structural Inspection Report</b> | |

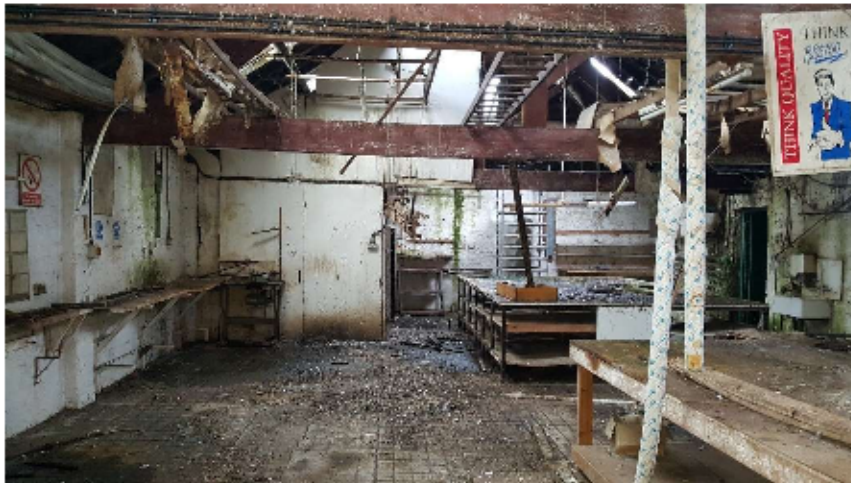
Mezzanine floor with timber truss roof above in 2016

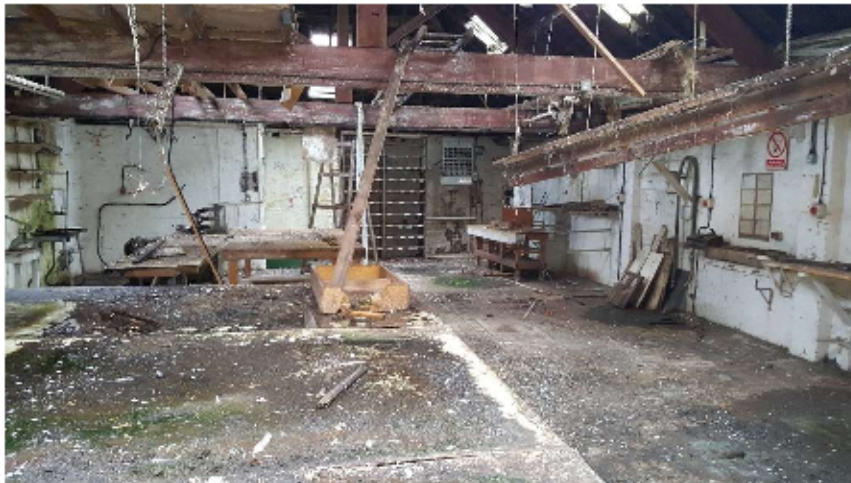
Mezzanine floor with timber truss roof above in 2016

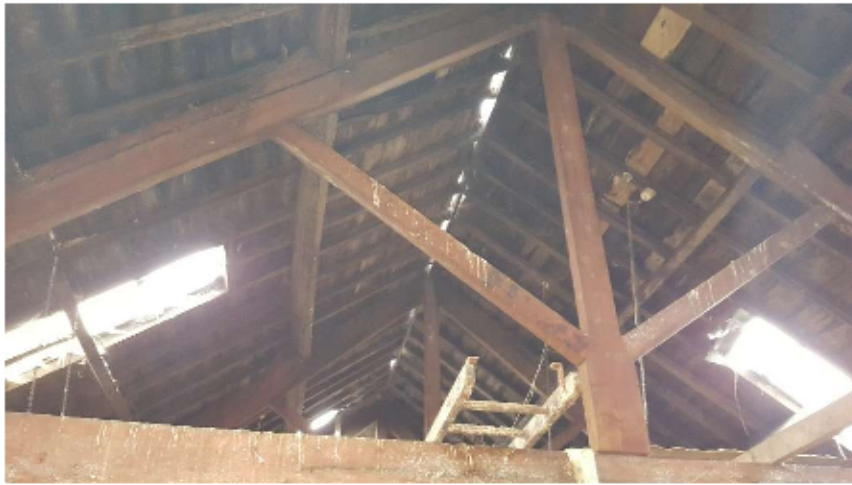
Detailed view of the roof construction in 2017

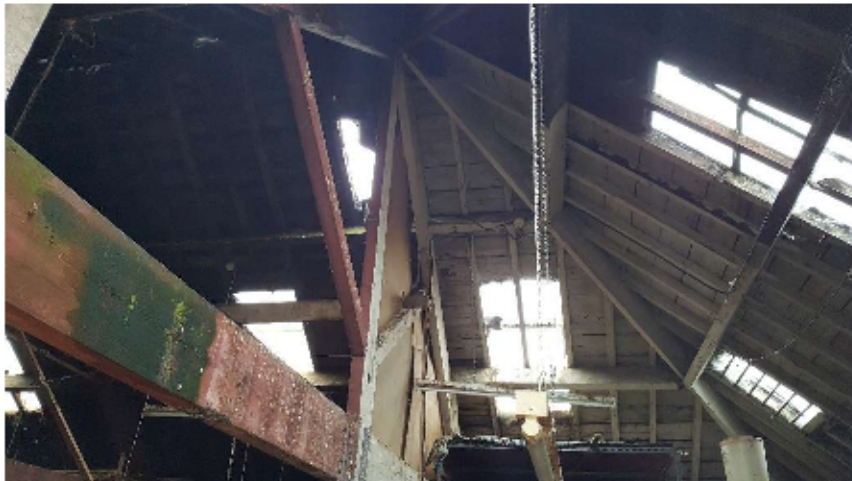
Hipped construction at both ends in 2017

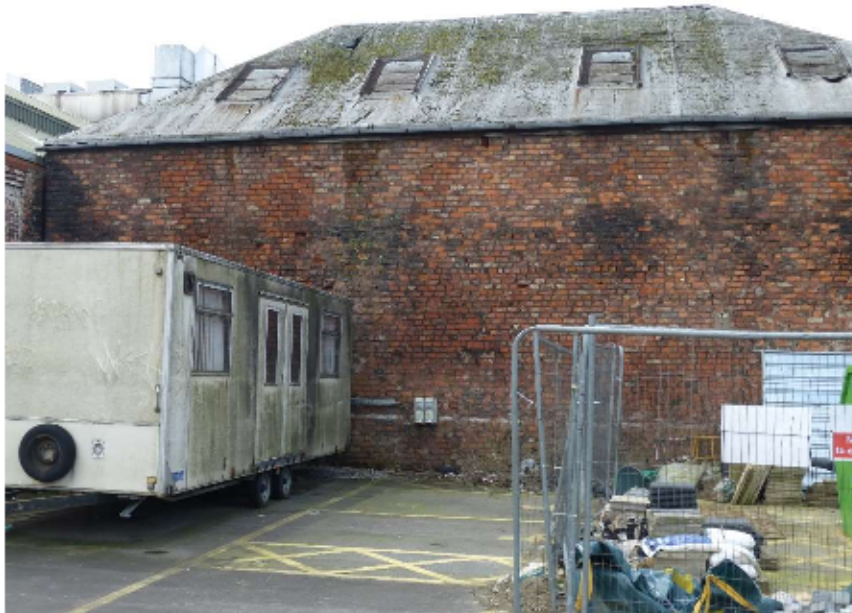
Existing rear (West) elevation to the car park / storage yard

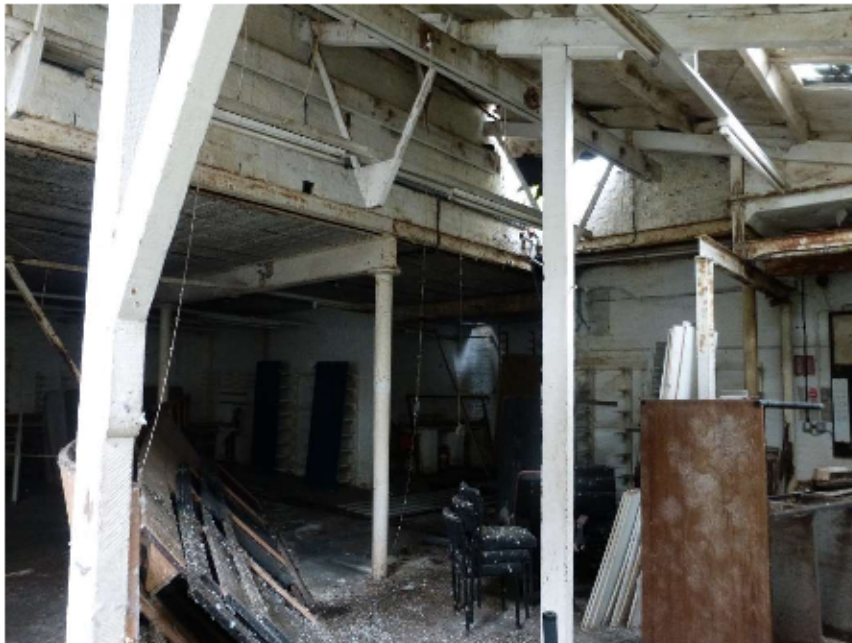
Concrete mezzanine floor supported on steel beams and circular posts together with the timber roof and supporting posts to the lean-to building.

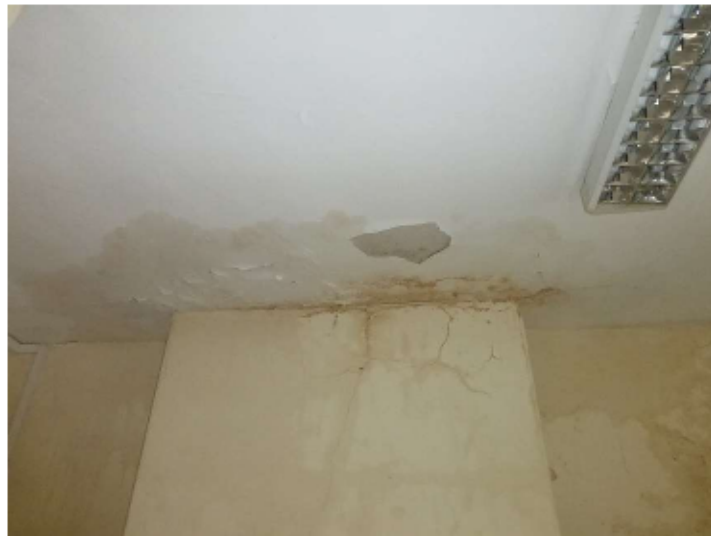
- 3.1 The former office building was found to be generally in good condition with no visible structural issues. Moisture damage was noted against a chimney breast at 1<sup>st</sup> floor level but this was relatively minor.

Dampness on 1<sup>st</sup> floor ceiling at chimney breast

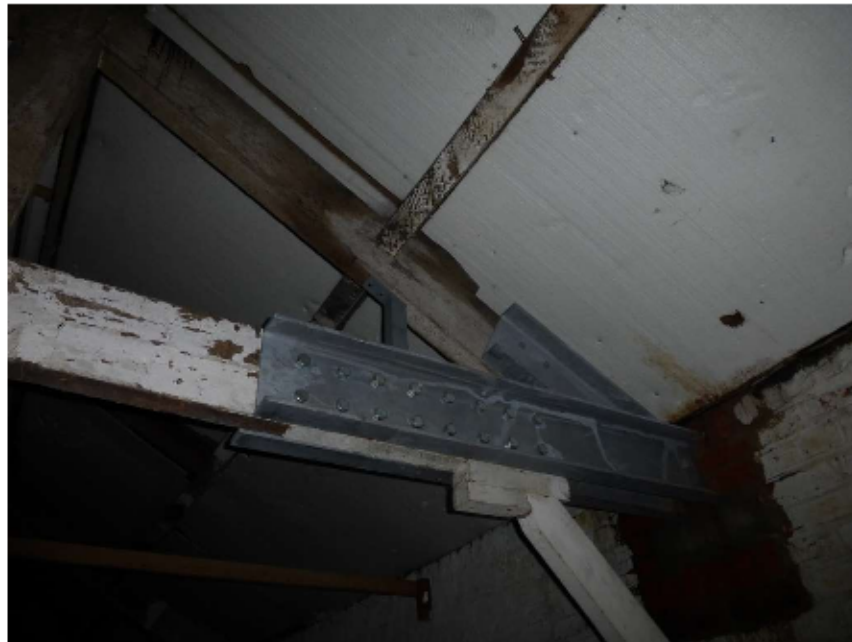
- 3.2 The covered access way is suffering from water ingress with very wet floor boards in some locations. The water ingress appears to be long standing and previous substantial repairs have been carried out to the timber trusses above 1<sup>st</sup> floor.

Covered access – repairs to all timber truss ends

- 4.2 The covered access route has ongoing issues with water ingress at roof level. The main roof structure has been repaired in the past and we consider that the integrity of the roof will not suffer significantly over 5 years if no further repairs to stop the water ingress are carried out.

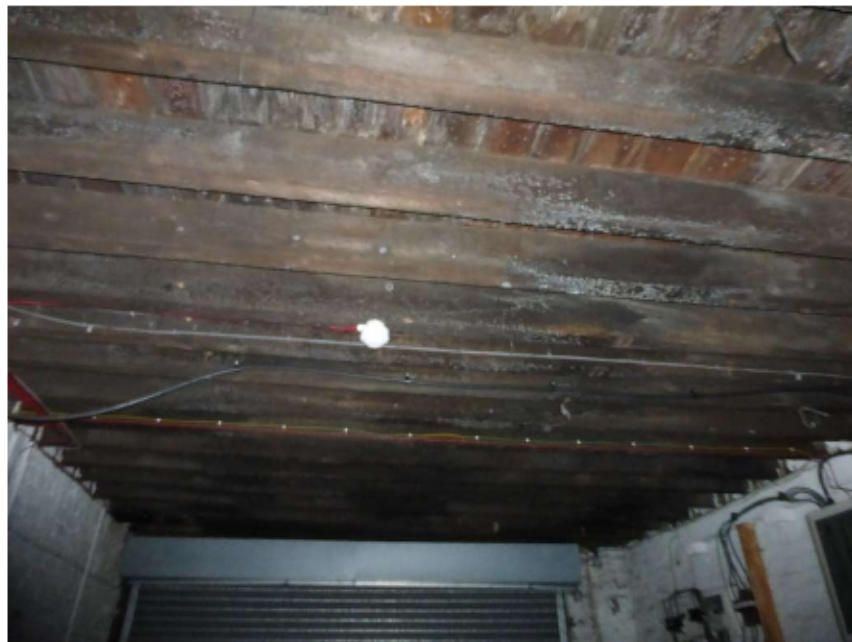
Dampness and mould spores on underside of 1<sup>st</sup> floor over access

- 4.3 The first floor over the access route is suffering from rotting etc. from the water ingress through the roof and it will continue to deteriorate if the water ingress isn't stopped. However, the timber joists at first floor level are supported on timber plates simply bolted to the walls on each side and should the first floor deteriorate to such a degree that it suffers a partial collapse, this would not affect the walls on either side. Should the roof over the access route not be repaired we would advise that the first floor is not accessed as it may very soon become unsafe.

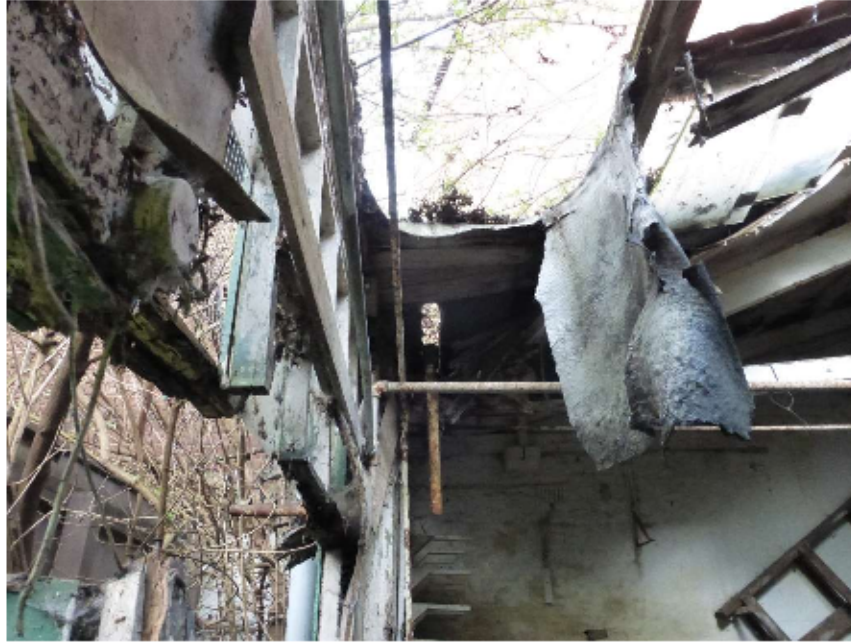
- 3.3 Access to the rear yard leading to the former production buildings was gained through a steel gate. The lean-to building adjoining the main production building is in poor condition; the rear, mainly glazed, wall is in a partial state of collapse, as is the roof where the timber trusses have completely rotted through at the support.

Partially collapsed roof and wall to the lean-to building

- 4.4 The lean-to to the main production building is in a state of partial collapse. The lean-to does not offer any support to the main production building and we would advise that it will continue to deteriorate and collapse further. We would advise that the lean-to is totally beyond repair and should either be left to collapse on its own or, more suitably, carefully demolished under controlled conditions.

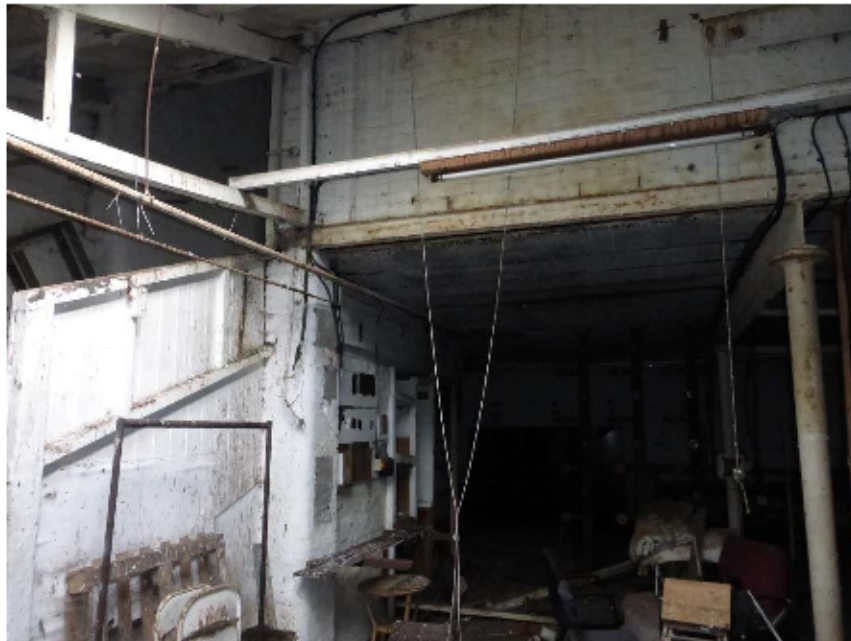
- 3.4 The first floor of the main production building is of concrete construction supported on steel (or cast iron) beams and columns.

Production building first floor beams and columns. Note access ramp to left

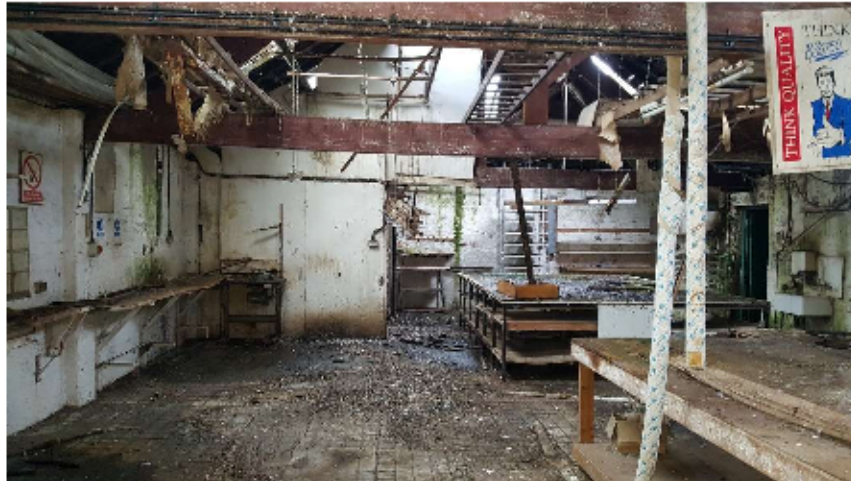
King post trusses

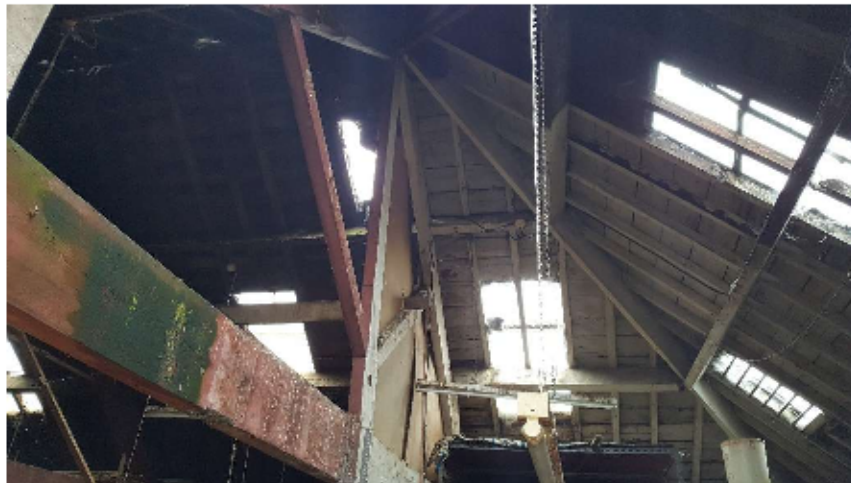
Timber hip members with timber boards to the roof

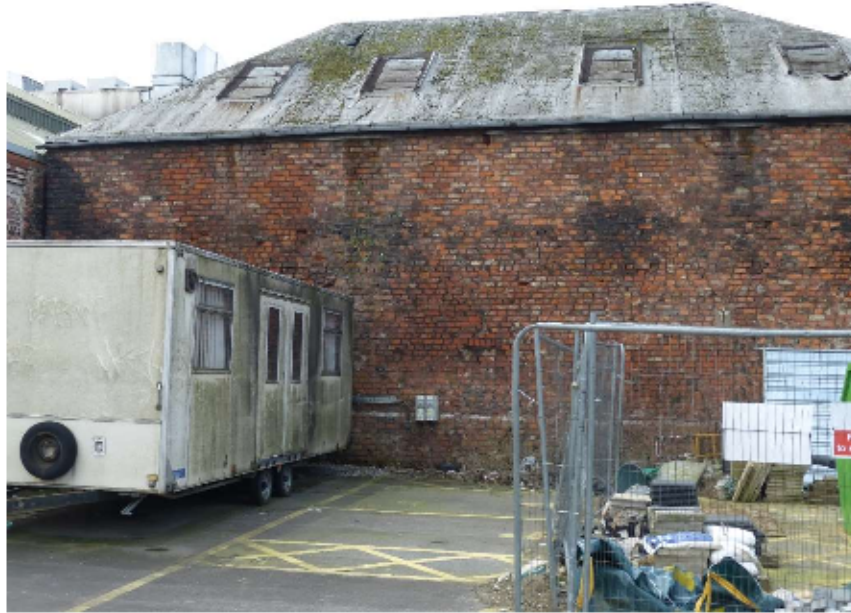
- 3.7 There are several large holes through the roof where the rooflights have fallen in and also where the boards have rotted through. This has resulted in significant water damage to the timber roof structure together with pigeon infestation.
- 3.8 The walls to the main building are generally plumb and whilst large areas have degraded mortar joints the integrity of the walls generally appears to be intact.

Rear roof to production building. Note loss of pointing to brickwork.

- 4.5 The main structure of the production building appears generally sound at this stage, albeit water ingress will be causing damage to the timber roof structure. We would therefore advise that, to ensure stability for the next 5 years the holes in the roof coverings should be repaired by over-sheeting the roof with metal decking securely fixed down to the timber boards & purlins. The over-sheeting does not need to extend to the full roof area but must cover the main holes affecting the main trusses and hips and extend up to, and lap over, the ridge.

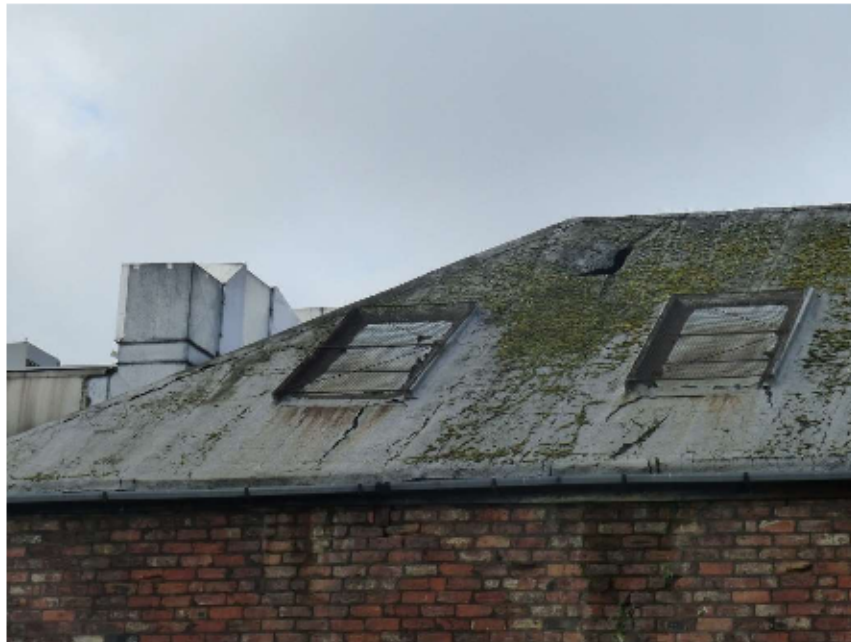
- 3.9 The roof covering to the production building are visible from the rear and from steps adjacent to the lean-to building. This shows the large holes which allow unrestricted water ingress.

Enlarged view on some holes in the roof and roof coverings

- 4.6 To prevent the possibility of storm damage affecting the adjacent buildings and any bystanders we would also advise that, following the over-sheeting noted above that the main production building roof is encapsulated with security netting. The netting can be fixed to the walls at eaves level all around and to the timber boards and purlins at roof level.

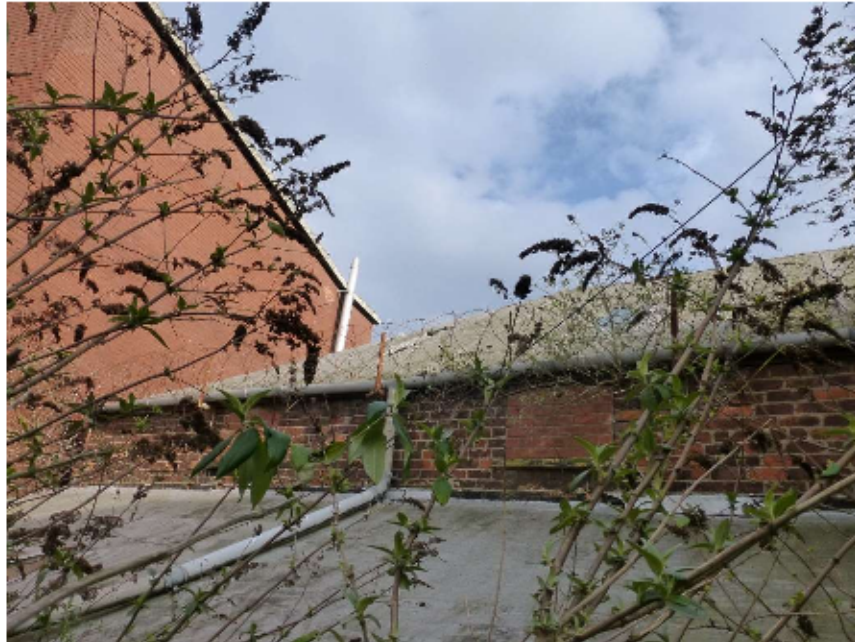
Main production building roof viewed from behind lean-to building.  
Note sagging of lean-to roof where it joins main building wall
