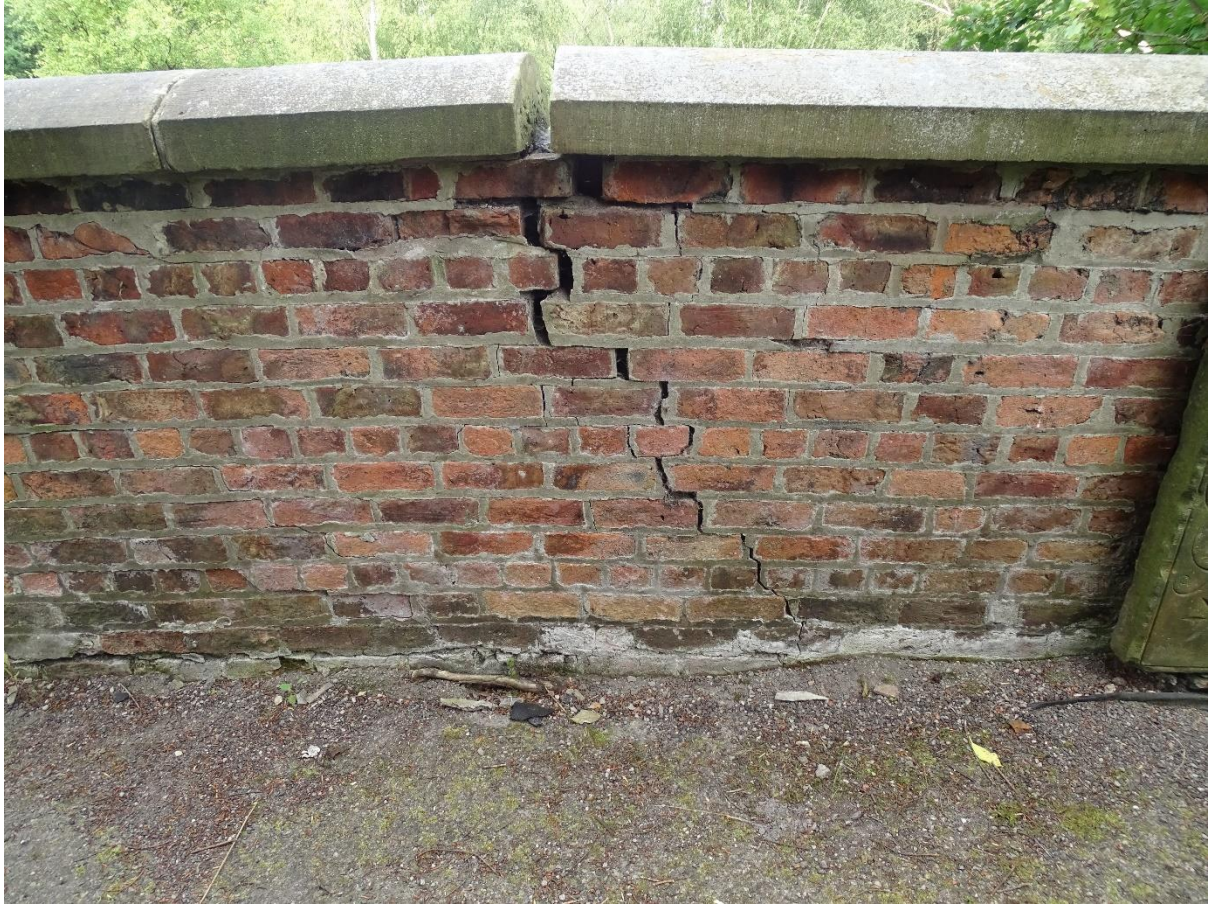
**Photo 1:** St James Church cracking to Parapet Wall damaged by growth of Goat Willow.

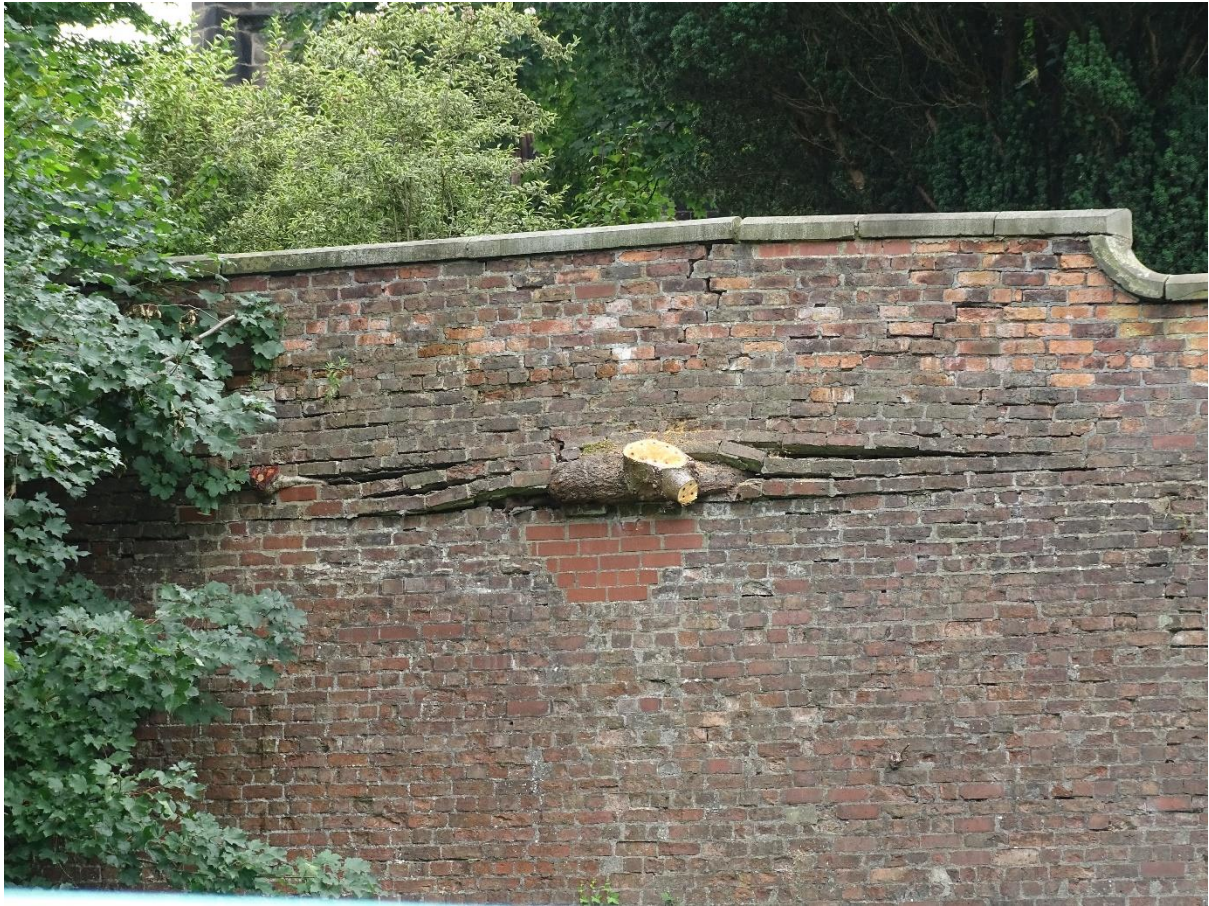
**Photo 3:** Remains of the Goat Willow stump to the joint of the parapet / retaining wall.

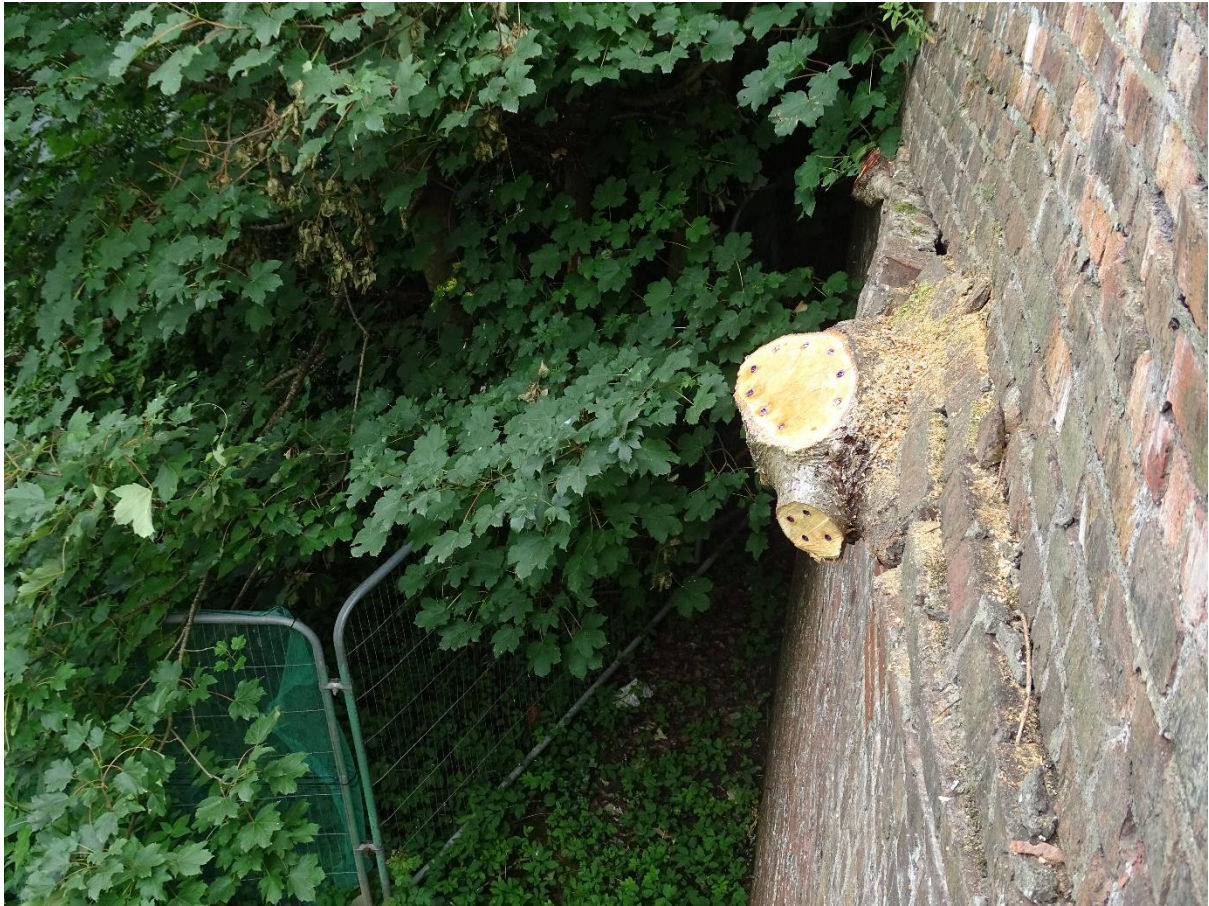
**Photo 4:** Goat Willow stump showing Ecoplugs treatment used to prevent further growth.

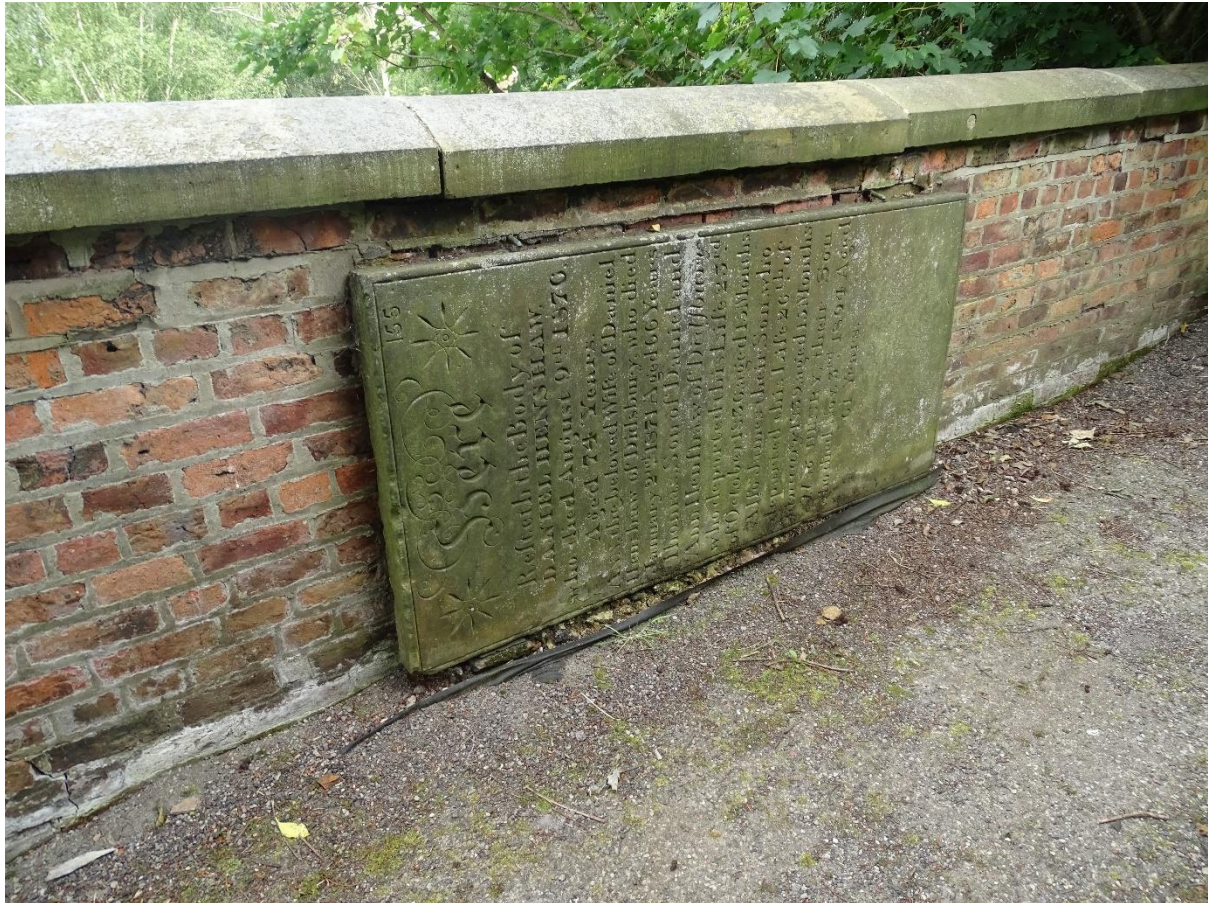
**Photo 5:** Existing Headstone positioned against parapet wall section that requires rebuilding.

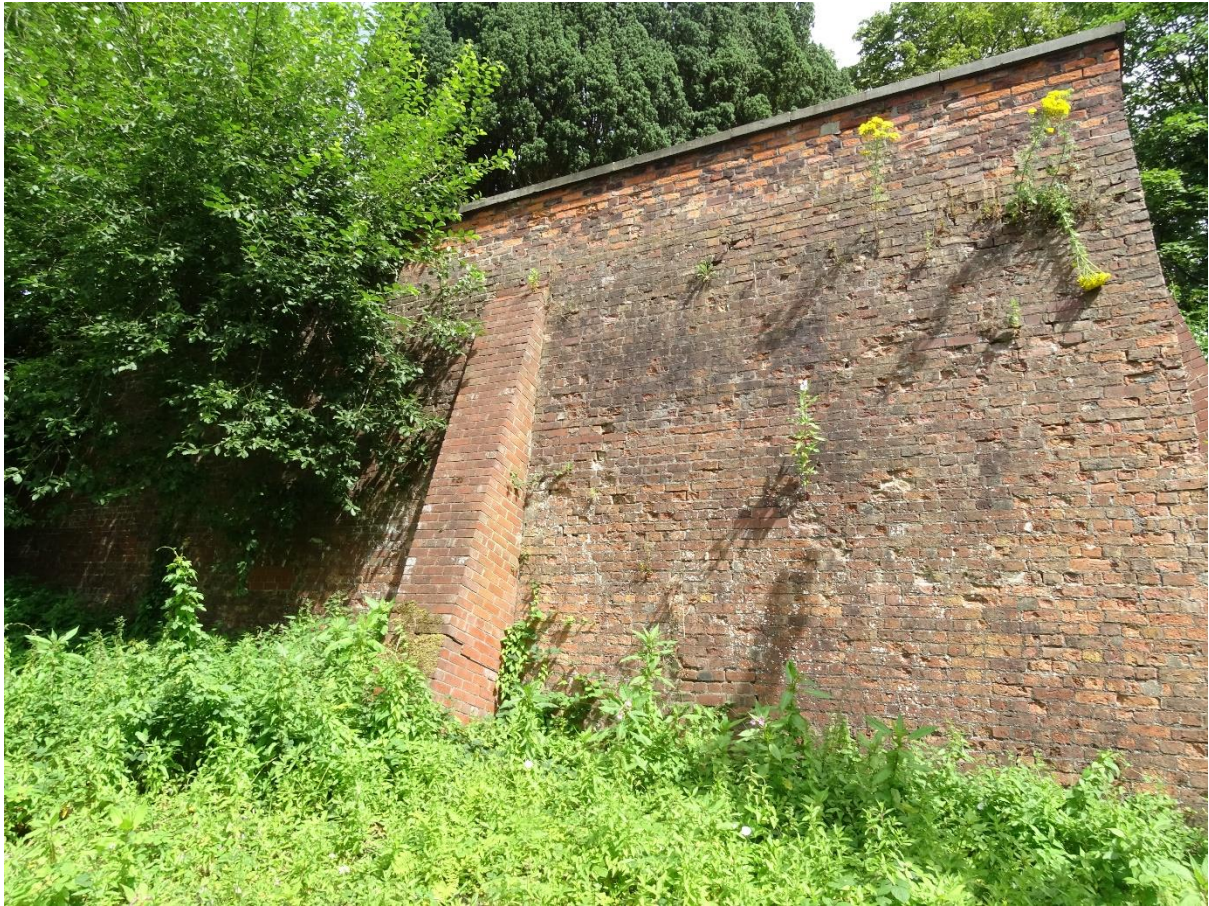
**Photo 6:** Retaining wall (photo taken prior to Goat Willow treatment).

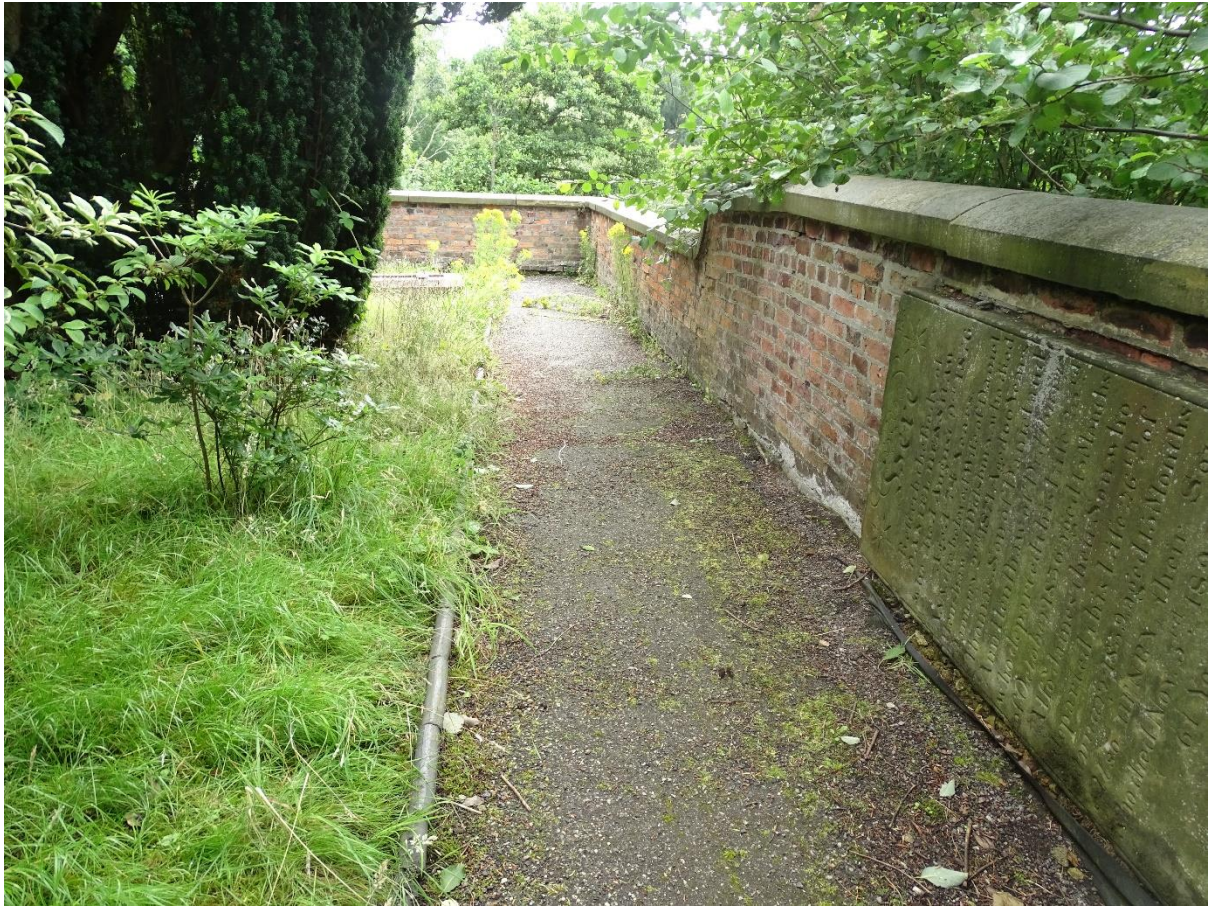
**Photo 7:** Existing tarmac pathway adjacent to wall.

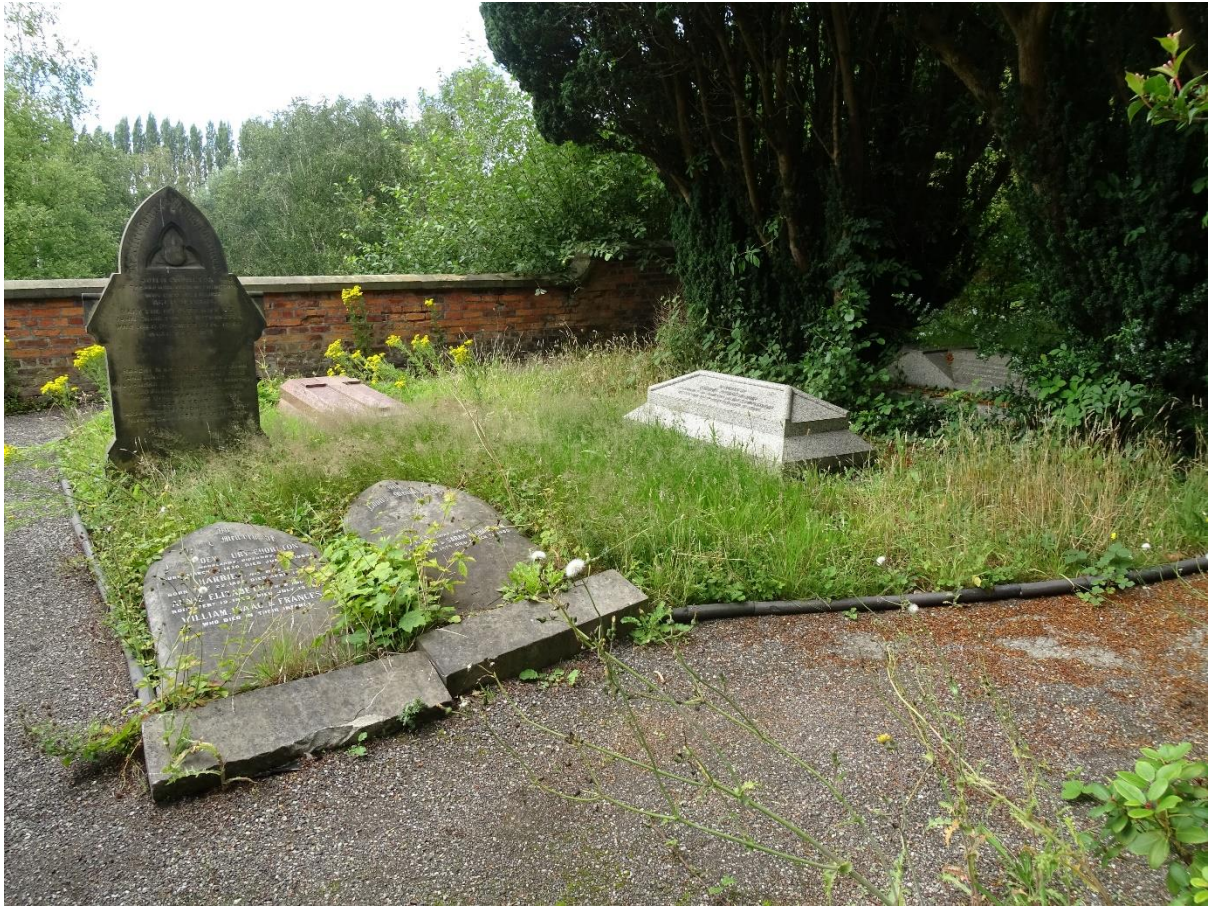
**Photo 8:** Existing headstones at burial grounds adjacent to the boundary wall.

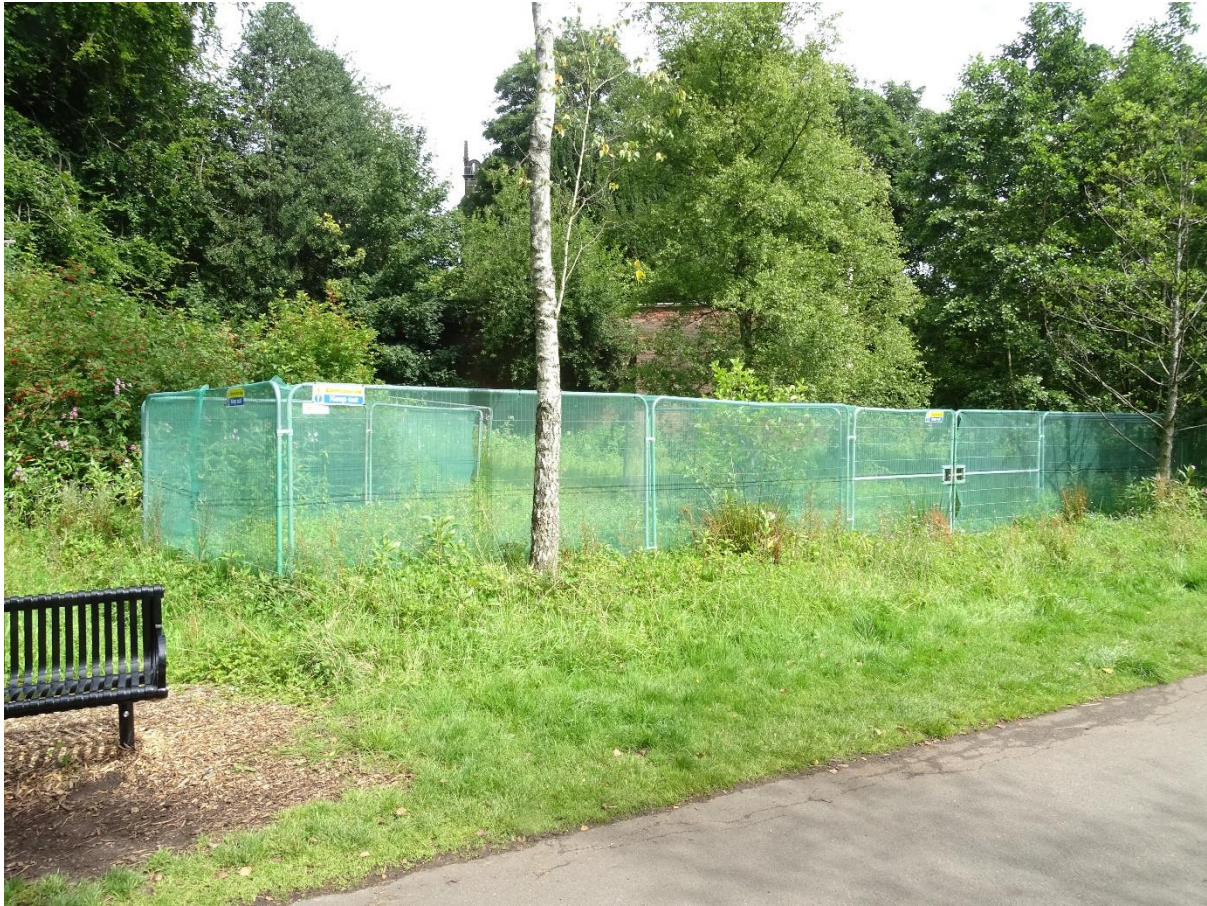
**Photo 9:** Temporary fencing to prevent public access to damaged wall areas

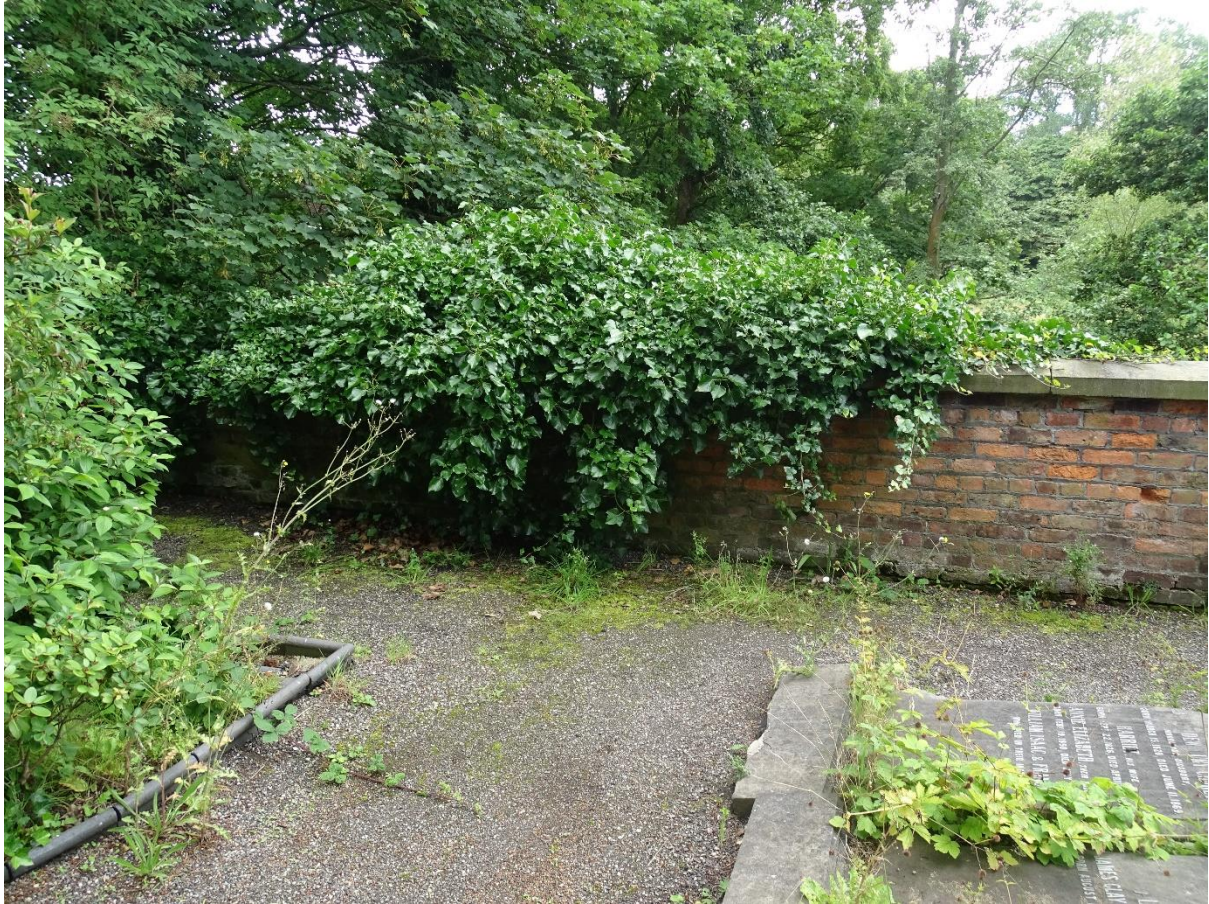
**Photo 10:** Vegetation overgrowth that requires removal from both sides of wall.

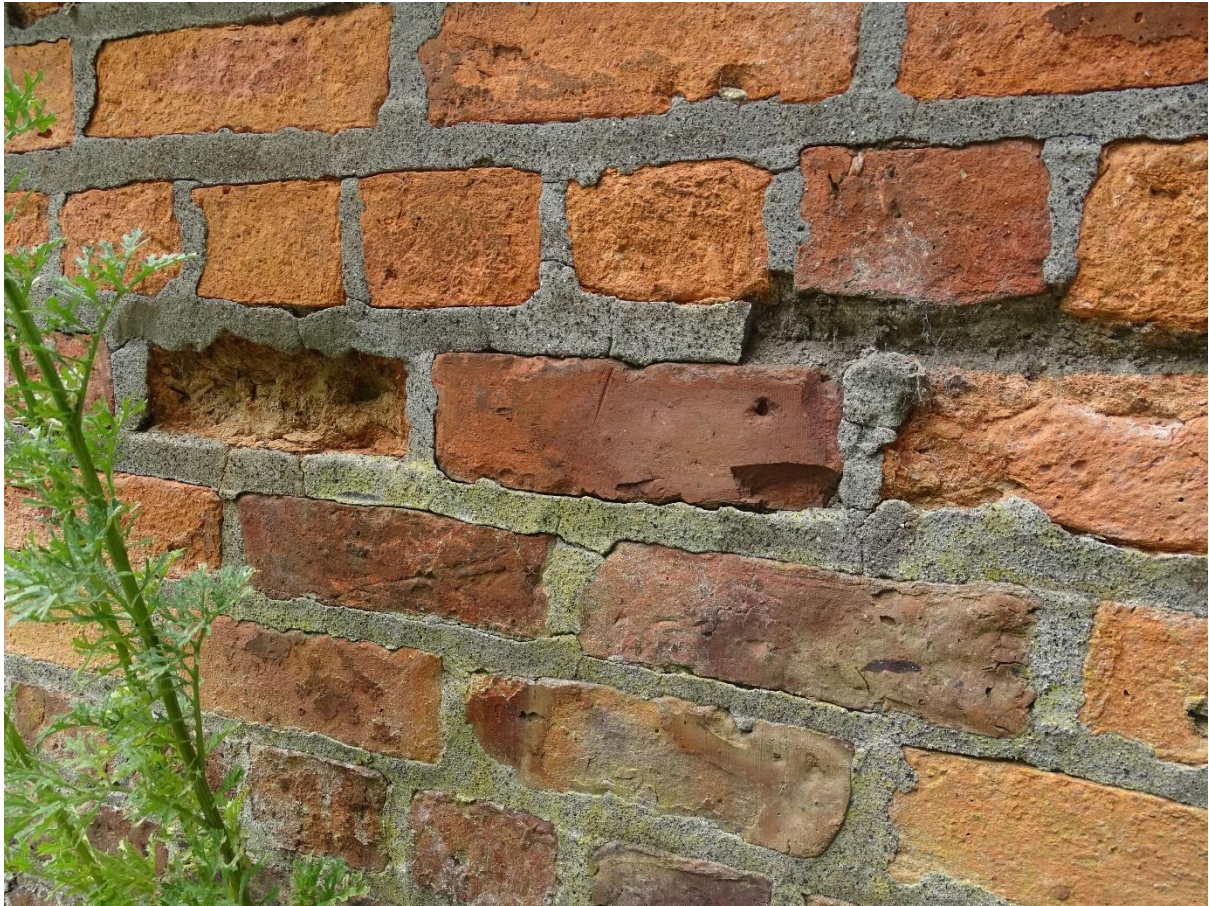
**Photo 13:** Existing parapet wall condition, showing spalling brickwork and loose pointing

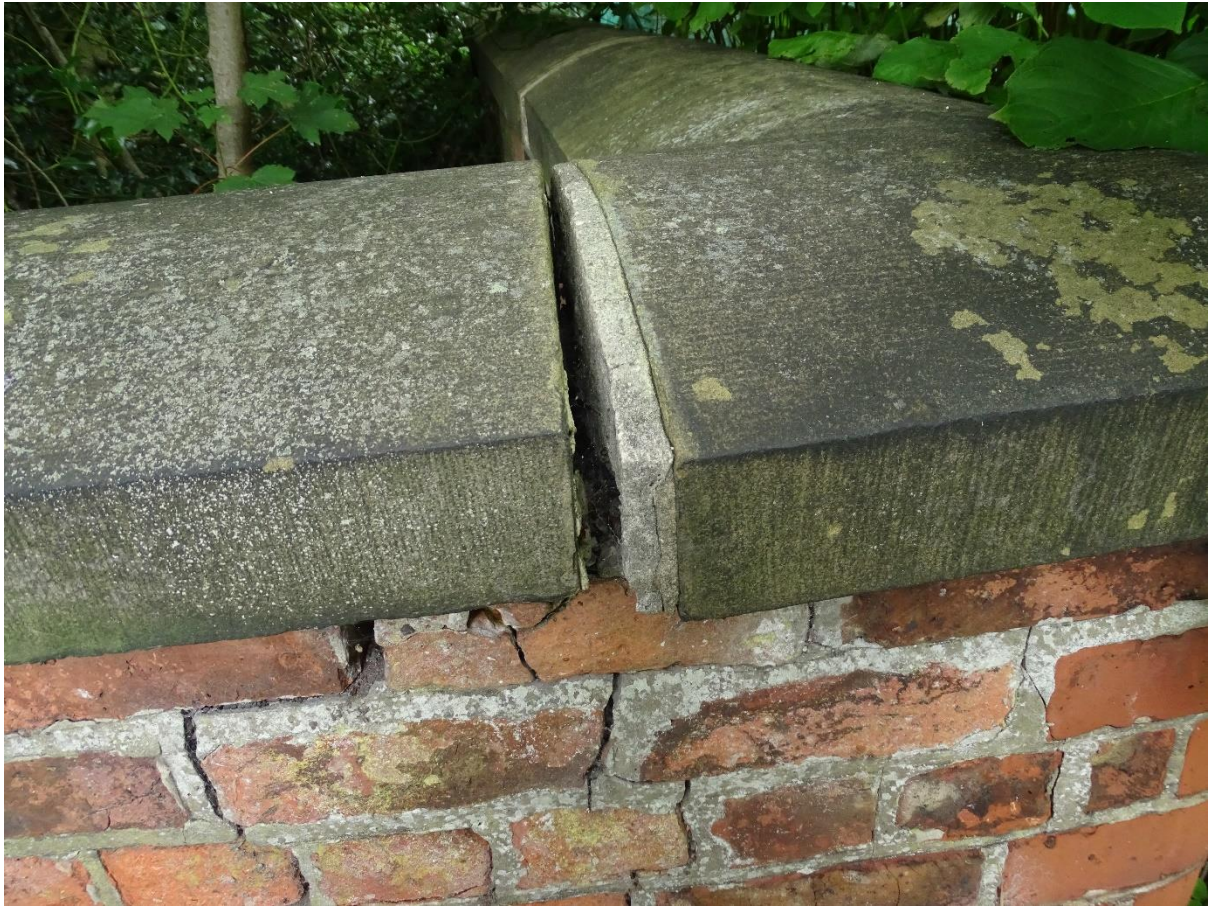
**Photo 14:** Existing coping stone joint.
