# DAYTIME BAT SURVEY OF SPORTS HALL AT MELLANDS SPORTS CLUB, LEVENSHULME, GREATER MANCHESTER

**AUGUST 2020**

**RACHEL  
HACKING  
ECOLOGY**

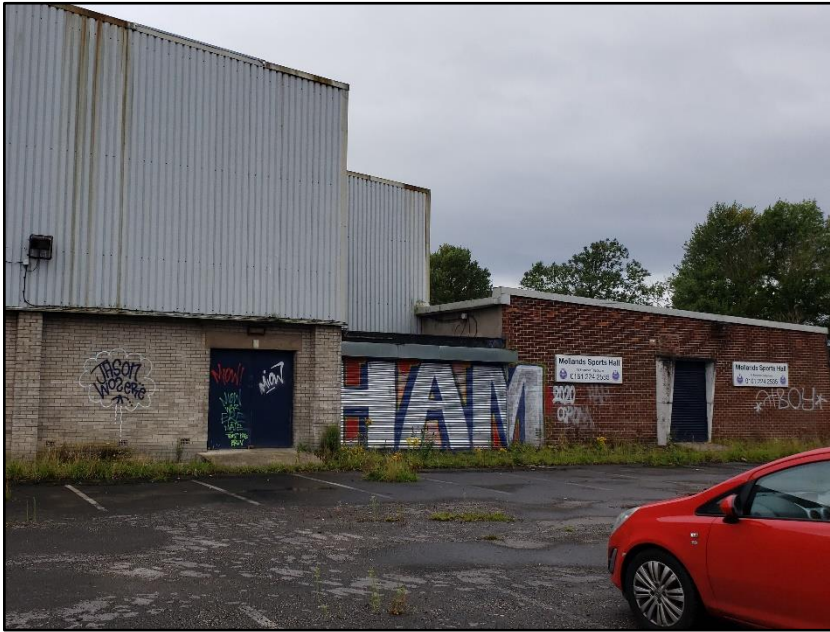
- 3.1 The building is brick-built and in excellent condition with no cracked bricks or recessed mortar (see Photograph 1). The double-height section also features corrugated metal cladding on the upper section which lies flush to the brick walls (see Photograph 2). The building features shuttered doorways and boarded windows which are well sealed to the surrounding masonry.

**Photograph 1 showing the sports hall exterior**

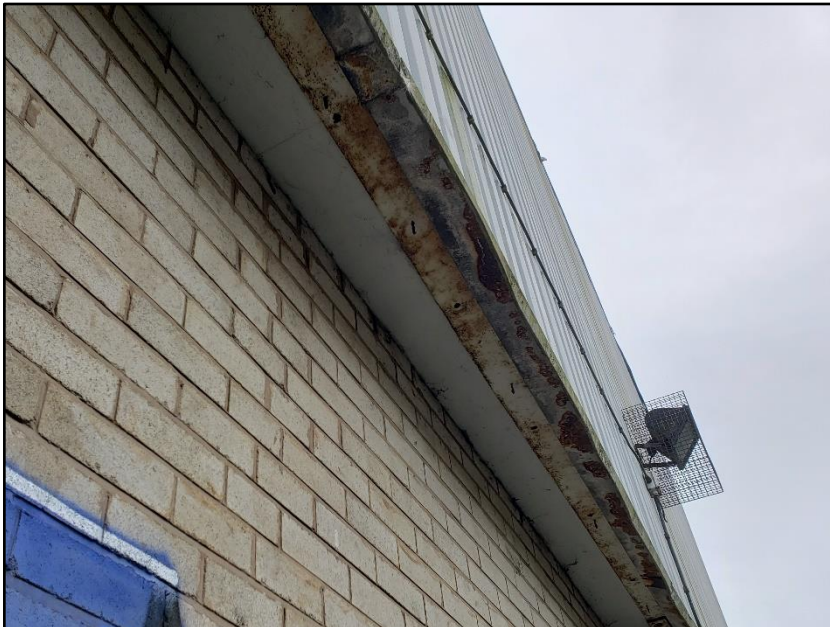
**Photograph 2 showing cladding sealed to the masonry**

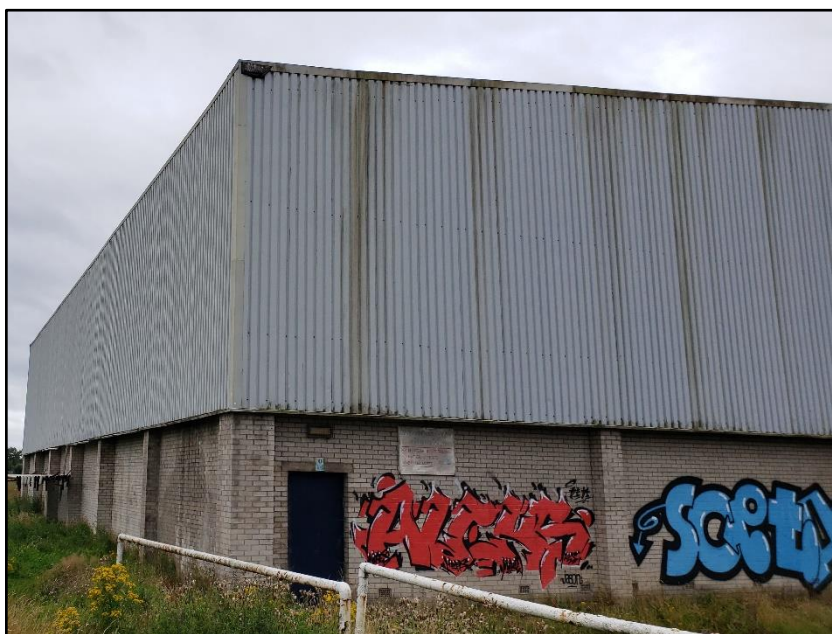
- 3.2 The double-height section of the sports hall which features corrugated metal cladding is well-sealed at the roof and wall edges with metal capping (see Photograph 3). The single-storey, sloped roof section features a parapet wall on

**Photograph 3 showing the roof capping on the double-height section**

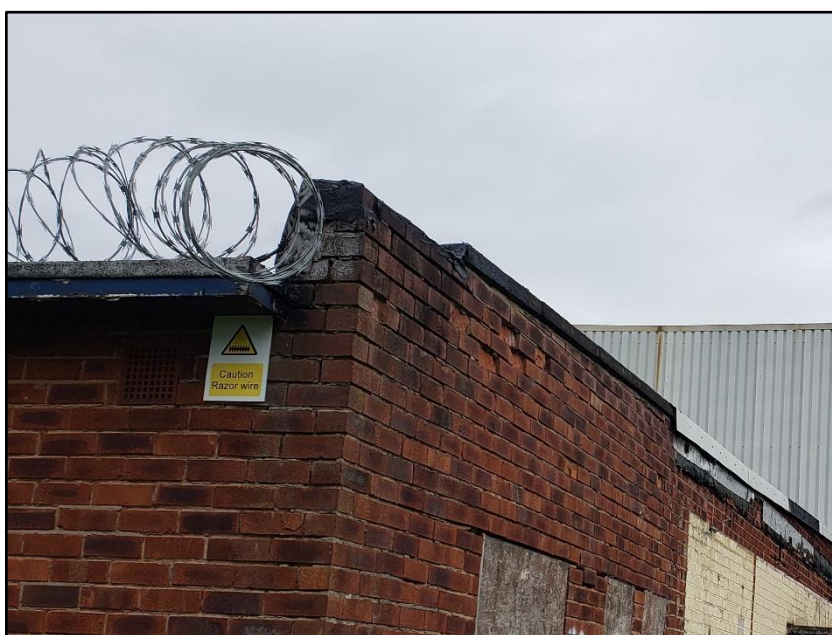
some elevations which is in good condition (see Photograph 4). Some sections of the single-storey section feature metal roof capping at the roof edges. The roof edges lacking parapet walls are also well-sealed with wood and roofing felt.

**Photograph 4 showing the roof edges of the single-storey section**

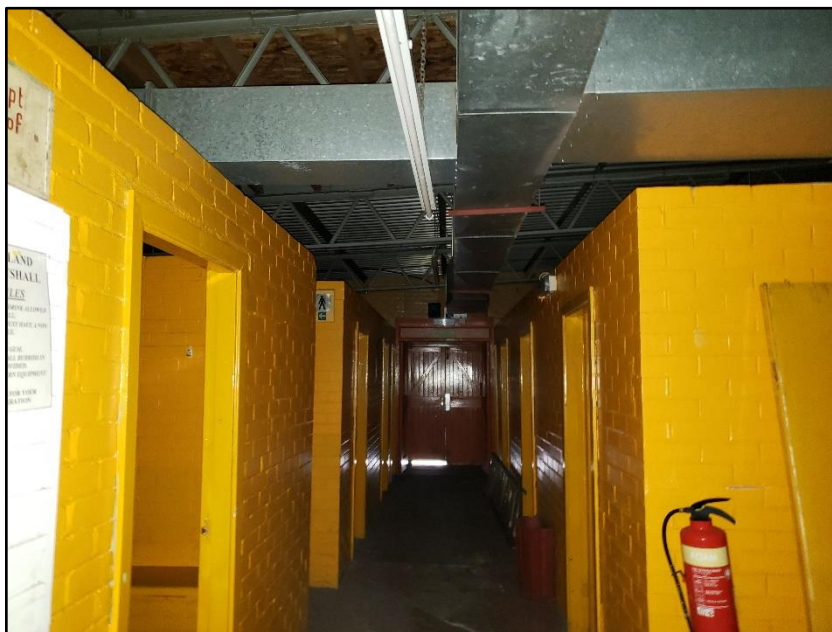
- 3.4 Internally, the sports club is derelict and no longer in use. The single-storey section is built up to the roof which is lined with plywood in some places (see

Photograph 5). The internal masonry is all painted and in excellent condition. The metal roof beams are all intact and the single-storey section provides no potential bat roosting habitat.

**Photograph 5 showing the interior of the single-storey section**

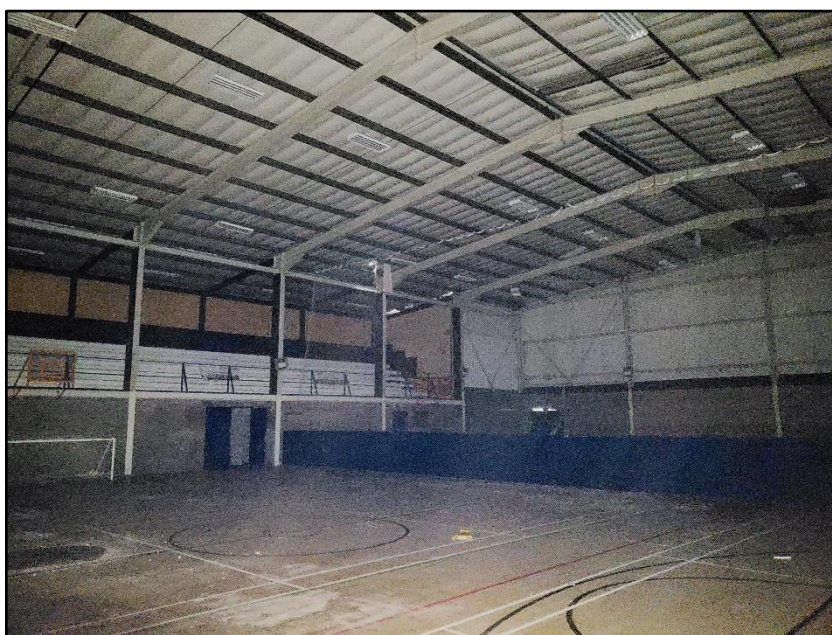
- 3.5 The interior of the double-height section is built up to the roof and is damp and dark (see Photograph 6). The internal masonry and metal roof beams are in excellent condition, providing no potential bat roosting habitat. The underside of the roof is lined with panels and is insulated with rockwool (see Photograph 7). A number of panels are damaged with some leading to the outside of the building therefore letting in rain and small amounts of daylight.

**Photograph 6 showing the interior of the double-height sports hall**

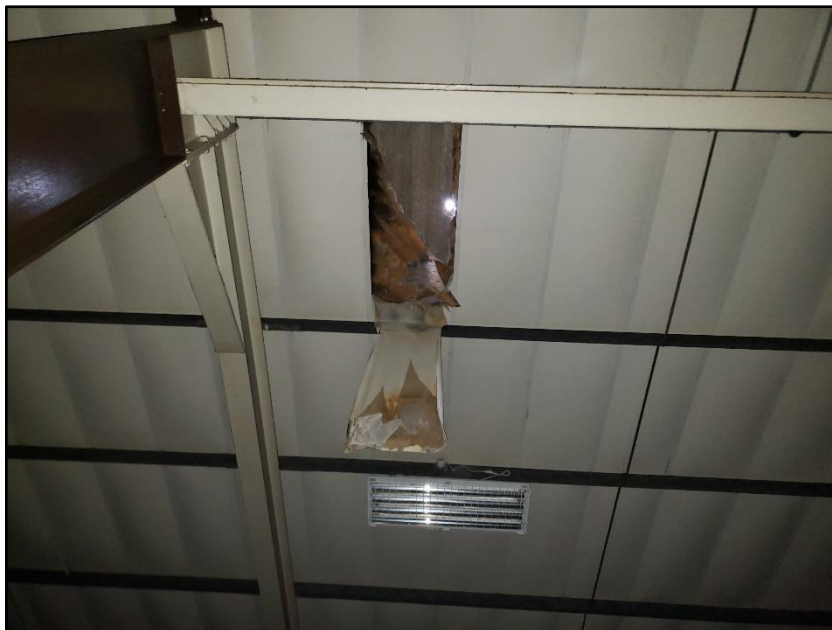
**Photograph 7 showing a damaged roof panel**

- 4.1 No bat droppings or other evidence of bat activity was found within the sports hall at Mellands Sports Club, Levenshulme. The building is mostly well-sealed throughout with only a small number of gaps in the corrugated metal roof of the double-height section. Due to the lack of suitable roosting space, good condition of the building, and lack of any bat activity evidence, the sports hall is considered to offer **negligible** bat roost suitability.
