### STRUCTURAL APPRAISAL

**WESTWOOD COTTAGES  
RABY STREET, MOSS SIDE**

**CORSTORPHINE & WRIGHT  
ON BEHALF OF ONE MANCHESTER**

**Date of Inspection: 17<sup>th</sup> July 2019**

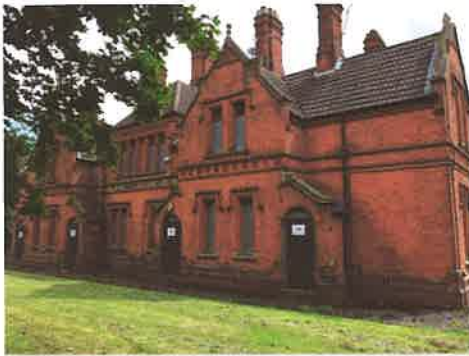
The existing properties are formed of six, two-storey terraced houses which have shared grounds to the front and to each end of the block (Figs.1 & 2), with individual gardens to the rear separated by 2 m high brick walls. At the time of our visit the gardens appeared to be badly overgrown and with locked gates so no access to the rear of the properties was available.

**Fig 1**  
Front Elevation

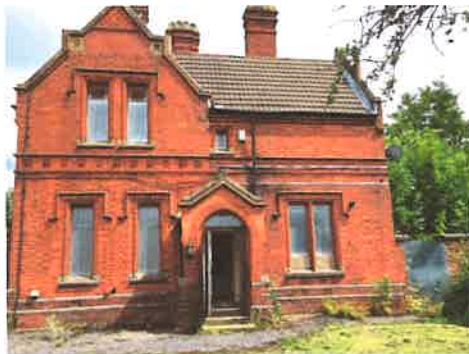
**Fig 2**  
Side Elevation

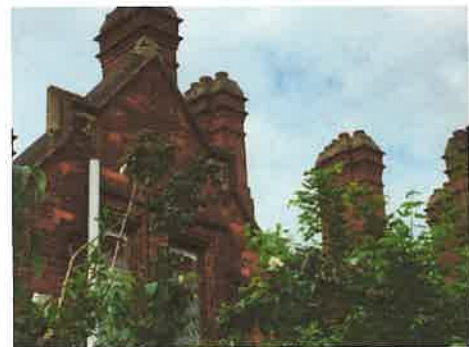
The cottages are understood to be former alms houses and are Grade II listed. A stone memorial feature in the centre of the front elevation indicates the buildings date from 1876 (Fig.3). The structure is of solid brick walls with stone features, cills and copings, together with several brick features around the door and window openings. Access to each of the properties is by means of individual entrance porches which are located on either side of two projecting gables for the central four cottages, and at each end of the building for the end cottages. For the purpose of this report the units are numbered 1 to 6 as indicated in the Corstorphine & Wright floor plans included in Appendix 'A'.

**Fig 3**  
Chimneys from rear

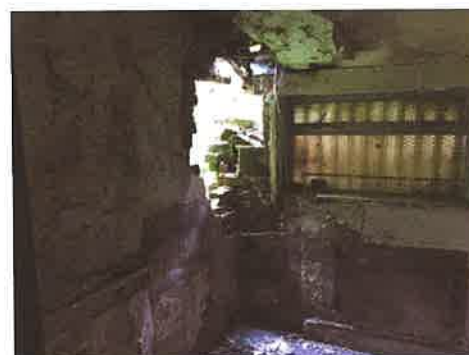
1. The wall to external corner of outrigger to Unit 1 has been partially demolished. This should be rebuilt and the roof structure made good (Fig.4 refers).

**Fig 4**  
Outrigger wall to Unit 1  
Rebuild wall, replace rotten rafters

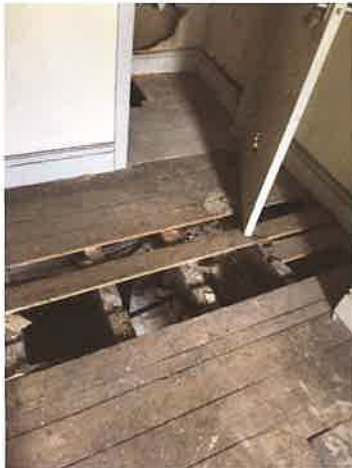
2. Several floorboards have been removed (Fig.5) and are to be replaced.
3. Damp to ceilings, particularly in Unit 2 (Figs 6 to 9) should be investigated by a suitable roofing contractor and a damp survey undertaken. Repair or replace the roof and carry out any damp treatment as necessary.

**Fig 5**  
**Missing Floorboards to Unit 2**  
**Replace**

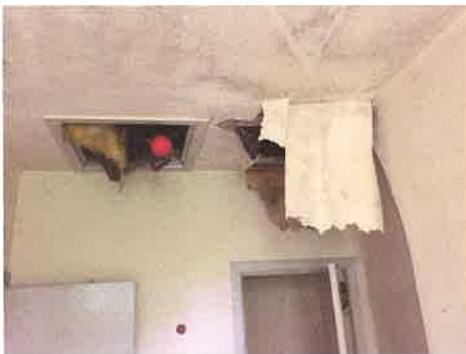
**Fig 6**  
**Water Tank Unit2 blocking hatch**  
**Replace**

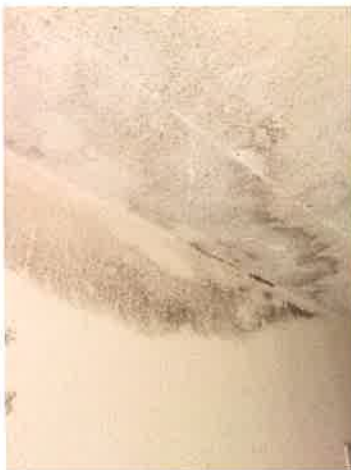
**Fig 7**  
**Damp To Unit 2 ceiling**  
**Check roof flashings etc**

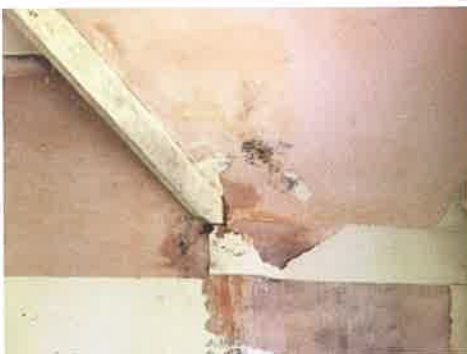
**Fig 8**  
**Damp To Unit 2 ceiling**  
**Check flashings**

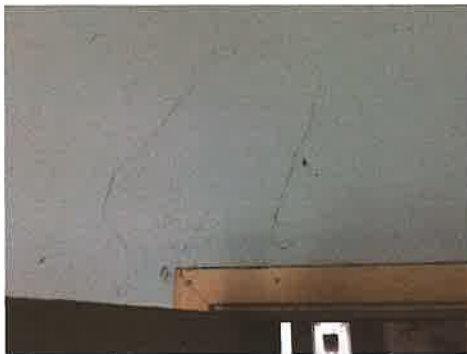
4. Cracking was observed over some of the internal door openings (Fig.10). This is likely to be as a result of movement of the timber lintels, which should preferably be replaced in concrete.

**Fig 10**  
**Cracking over GFL door to Unit 2**  
Replace lintels in concrete

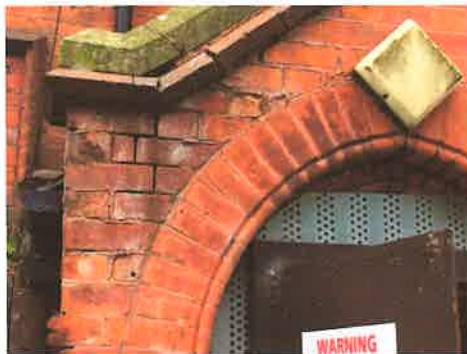
**Fig 11**  
**Damaged brickwork to Unit 3**  
Rebuild

5. Cracking was also observed to the brickwork over some of the brick arches to the front entrances to Units 3 and 4 (Figs 11 & 12), although there is no evidence of significant arch spread. The brickwork should be repointed and any loose bricks replaced.

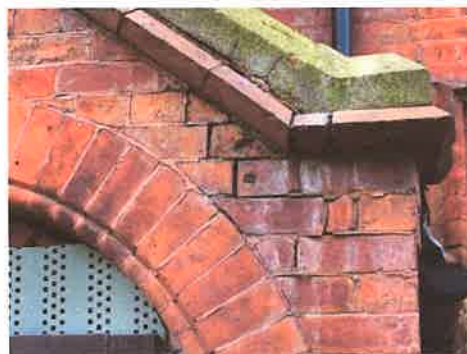
**Fig 12**  
**Damaged brickwork to Unit 4**  
Rebuild

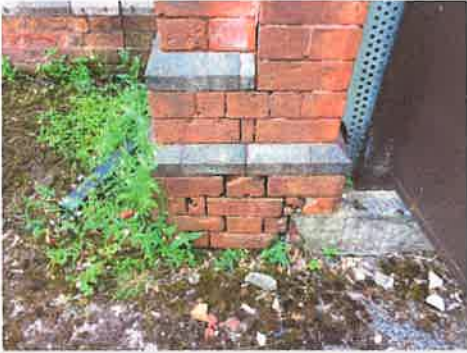
**Fig 13**  
Damaged pointing to Unit3  
Repoint

6. The pointing was generally found to be in poor condition, particularly at low level (Fig.13) and the brickwork should be repointed generally.
7. Cracking was noted to the underside of the pitched roof to Unit 3 (Fig.15). The cracking is consistent with roof spread of the sloping section of the roof and we would recommend galvanised steel BAT straps are installed to rectify this.

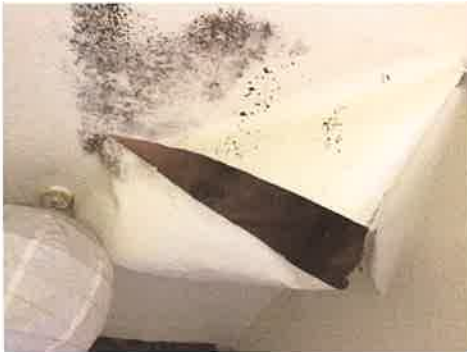
**Fig 14**  
Roof leak to Unit 3  
Repair roofing

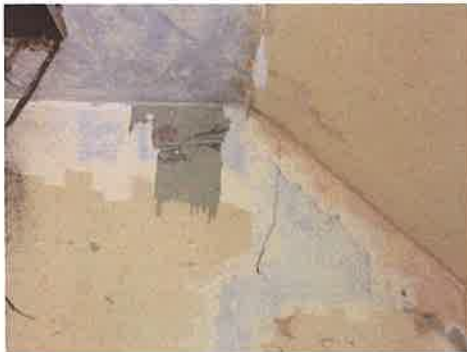
**Fig 15**  
Roof spread to Unit 3  
Install ties

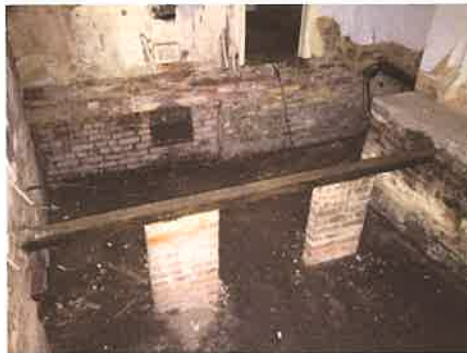
**Fig 16**  
Missing floor joists to Unit 4  
Replace joists

8. The missing floor joists to Units 4 and 5 (Figs.16 & 18) should be replaced.
9. The stone copings over the front entrances have slipped in several of the units (Fig.17). These should be re-fixed using proprietary stainless steel dowels and frame cramps.

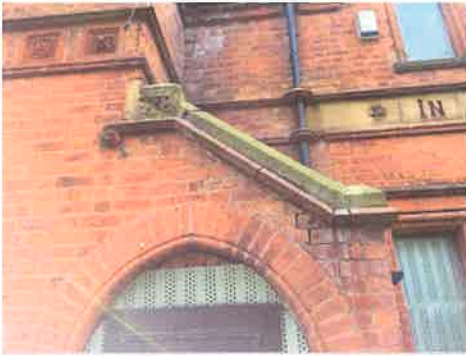
**Fig 17**

**Coping slipped to Unit 4**

Rebuild and tie in with frame cramps

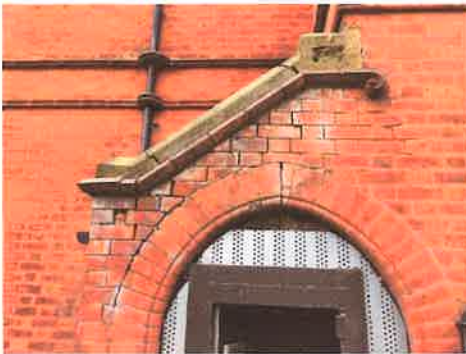
**Fig 18**

10. Similar movement was observed over the entrance to Unit 5, although the arch appears to have dropped slightly (Fig.18). We would therefore recommend the brickwork is rebuilt locally prior to re-fixing the copings.

**Dropped arch to Unit 5**

Rebuild

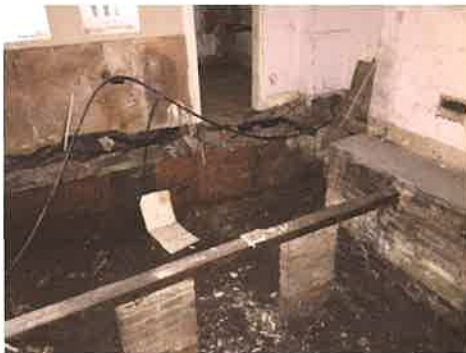
**Fig 19**

**Missing floor to Unit 5**

Replace

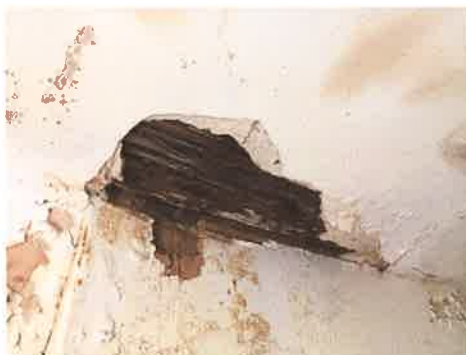
**Fig 20**

**Roof leak to Unit 6**

Check flashings to chimney

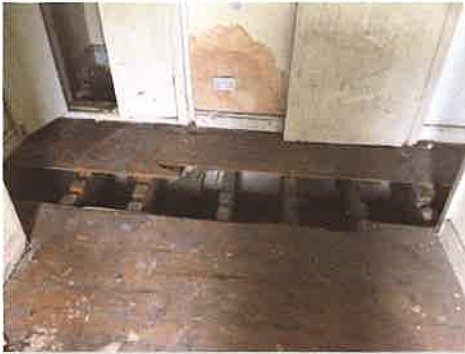
**Fig 21**  
**Missing floorboards to Unit 6**  
Replace

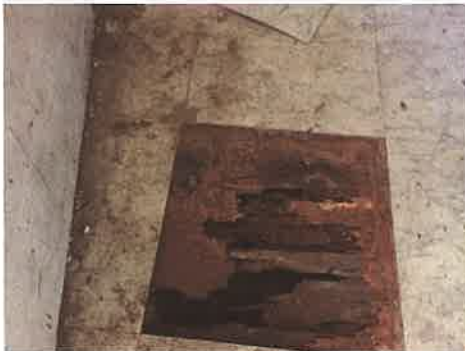
**Fig 22**  
**Rotten floor boards to Unit 6**  
Replace boards and check joists

11. The rotten flooring to Unit 6 (Fig.22) should be replaced, along with any rotten floor joists.
12. The outrigger roof to Unit 6 was found to be damaged (Figs. 23 & 27). This should be repaired locally and the roof repointed.

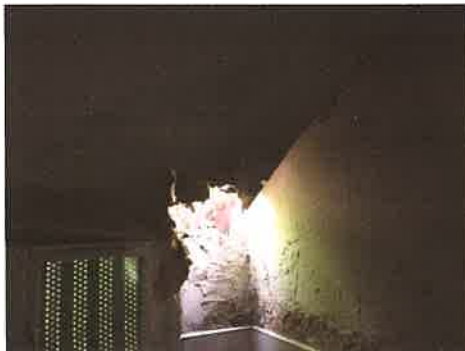
**Fig 23**  
**Damaged roof to Unit 6**  
Reroof lean to at rear

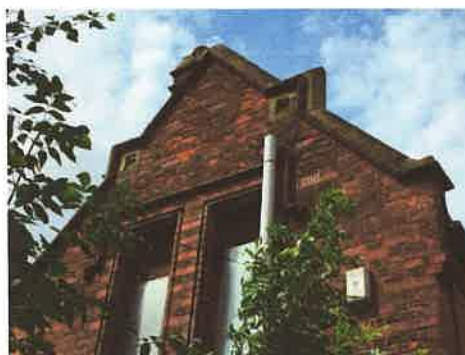
**Fig 24**  
**Perished brickwork to rear pediment of Unit 6**  
Replace perished bricks

13. Several areas of perished brickwork were apparent, particularly to the high level pediment of Unit 6 (Fig.24) and to the end elevation of Unit 1 (Figs. 28, 31 & 33). Any perished or missing bricks should be replaced in order to avoid further deterioration due to weathering.

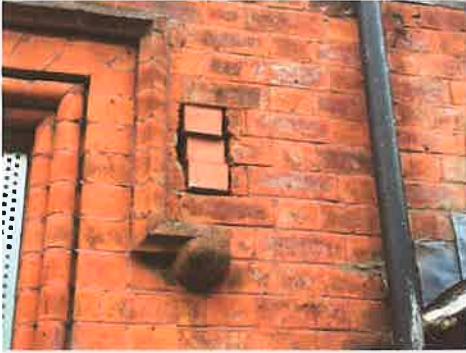
**Fig 25**  
**Missing bricks to Unit 6**  
**Replace**

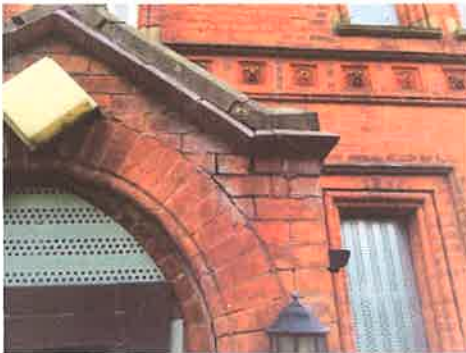
**Fig 26**  
**Damaged brickwork and copings to Unit 6**  
**Rebuild**

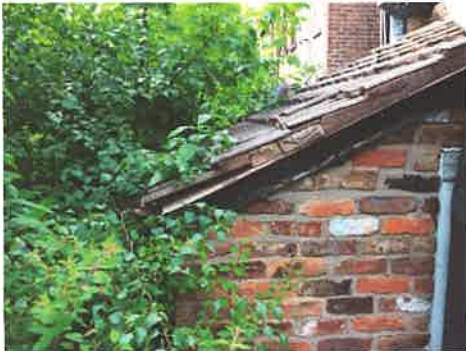
**Fig 27**  
**Tiles missing to lean to roof of Unit 6**  
**Replace lean to roof**

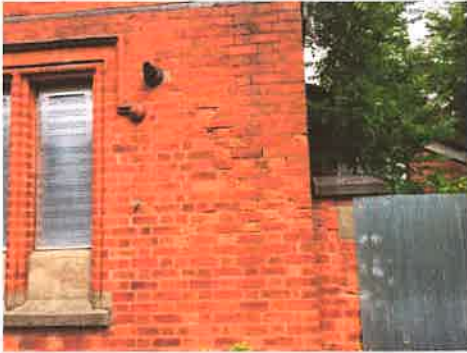
**Fig 28**  
**Perished bricks to Unit 1**  
Replace and repoint

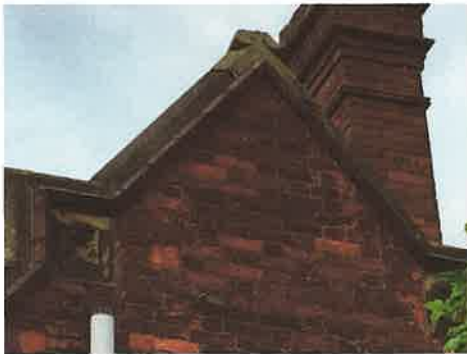
**Fig 29**  
**Copings slipped to Unit 1**  
Refix generally with stainless steel fixings

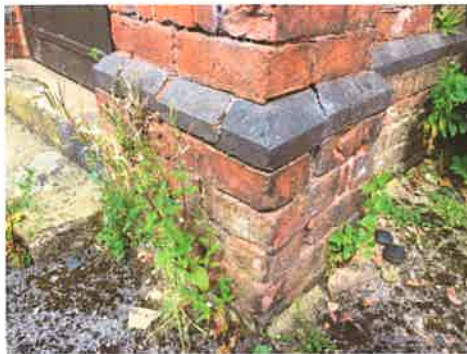
**Fig 30**  
**Poor quality pointing to Unit 1**  
Repoint

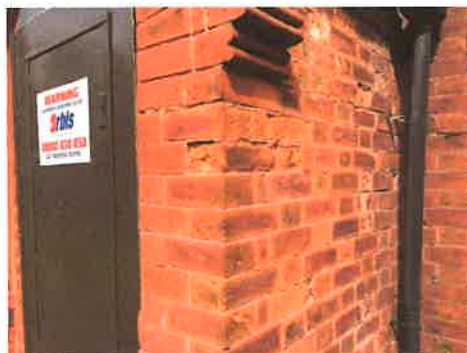
**Fig 31**  
**Perished bricks to Unit 1**  
Replace

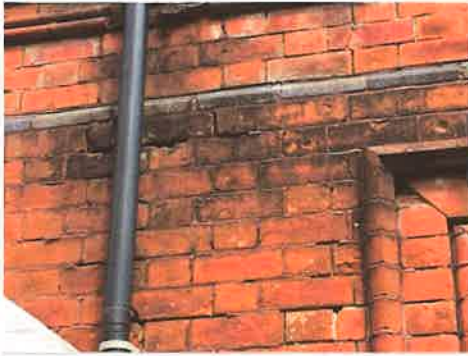
**Fig 32**

Poor quality pointing to Unit 1

Repoint

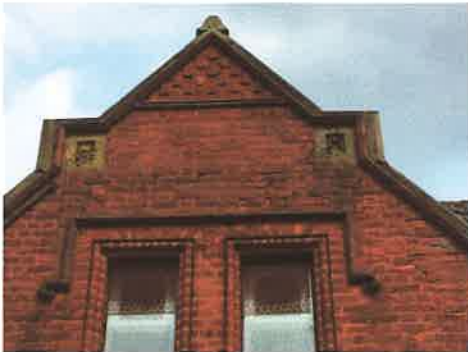
**Fig 33**

Perished brickwork to Unit 1

Replace

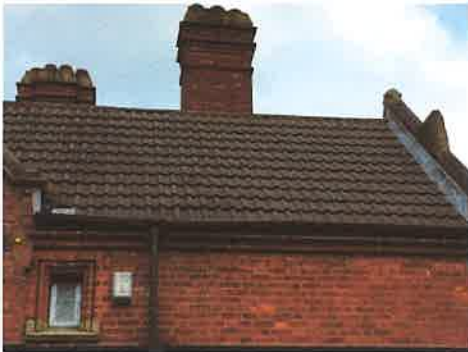
**Fig 34**

Failed pointing to ridge tiles to Unit 1

Repoint ridge
