# Boohoo: 49-51 Dale St

External Fabric Repairs  
Design & Access Statement  
August 2020

Project name: Boohoo Windows  
Project number: 8965  
Client: Boohoo

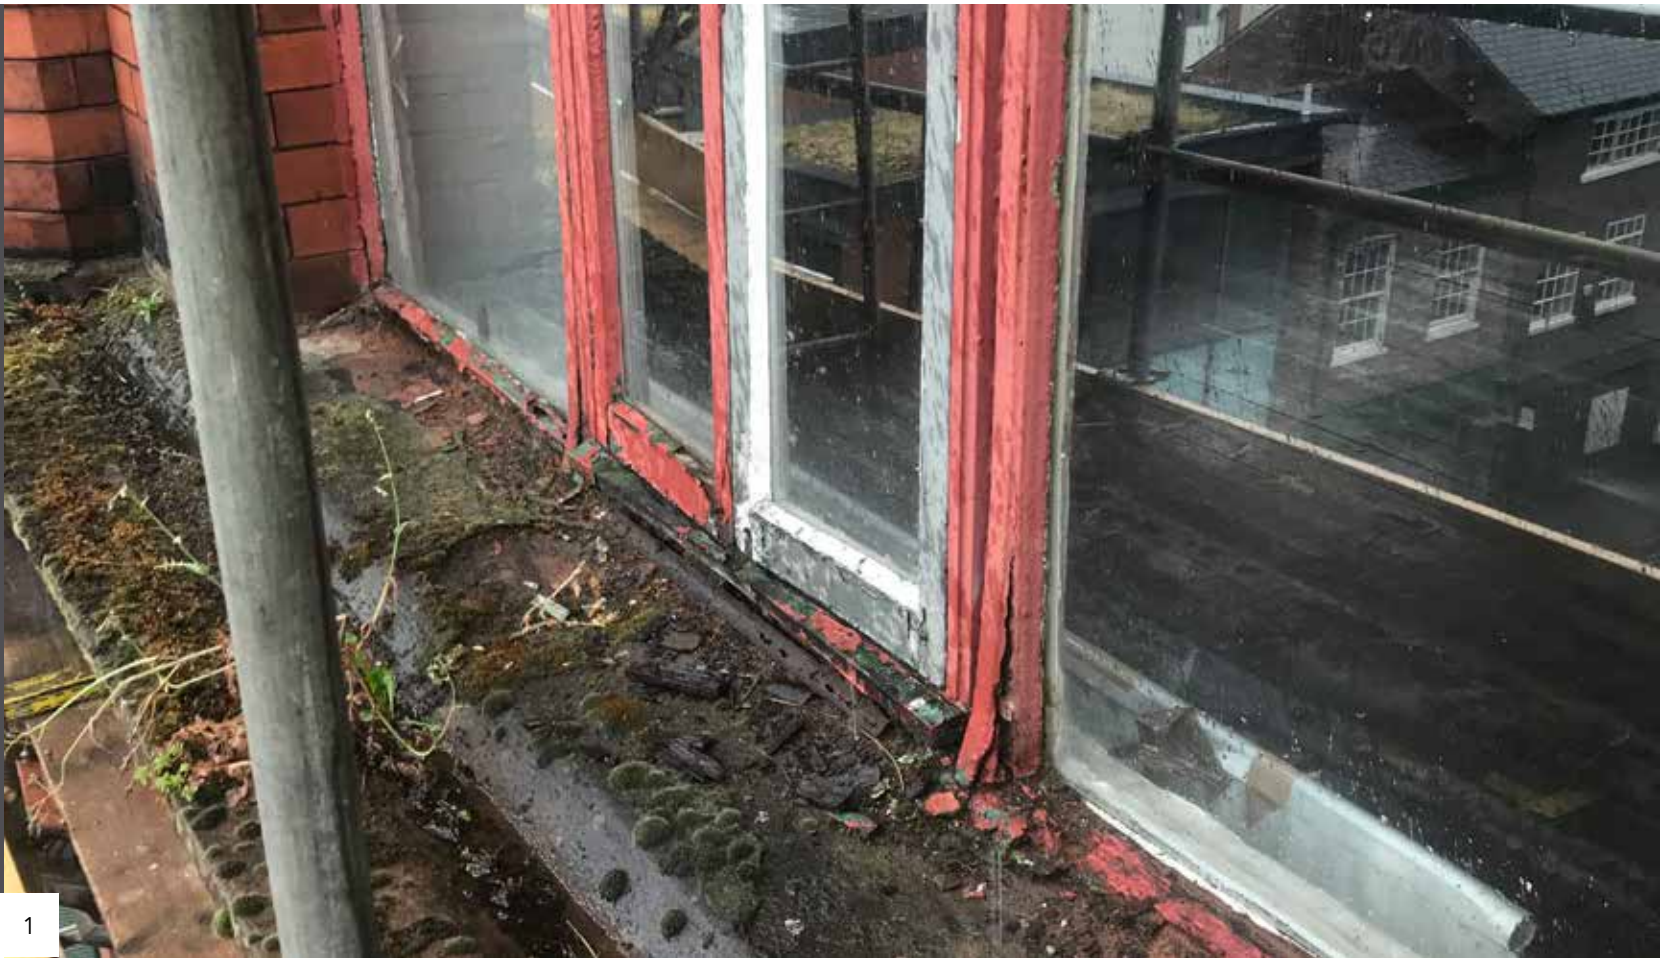
1. Varying degrees of corrosion to metal frames, with mullions/bottom rails distorted
2. Significant corrosion has occurred to numerous windows
3. The corrosion/distortion carries a risk of glazing becoming unsecured/damaged.

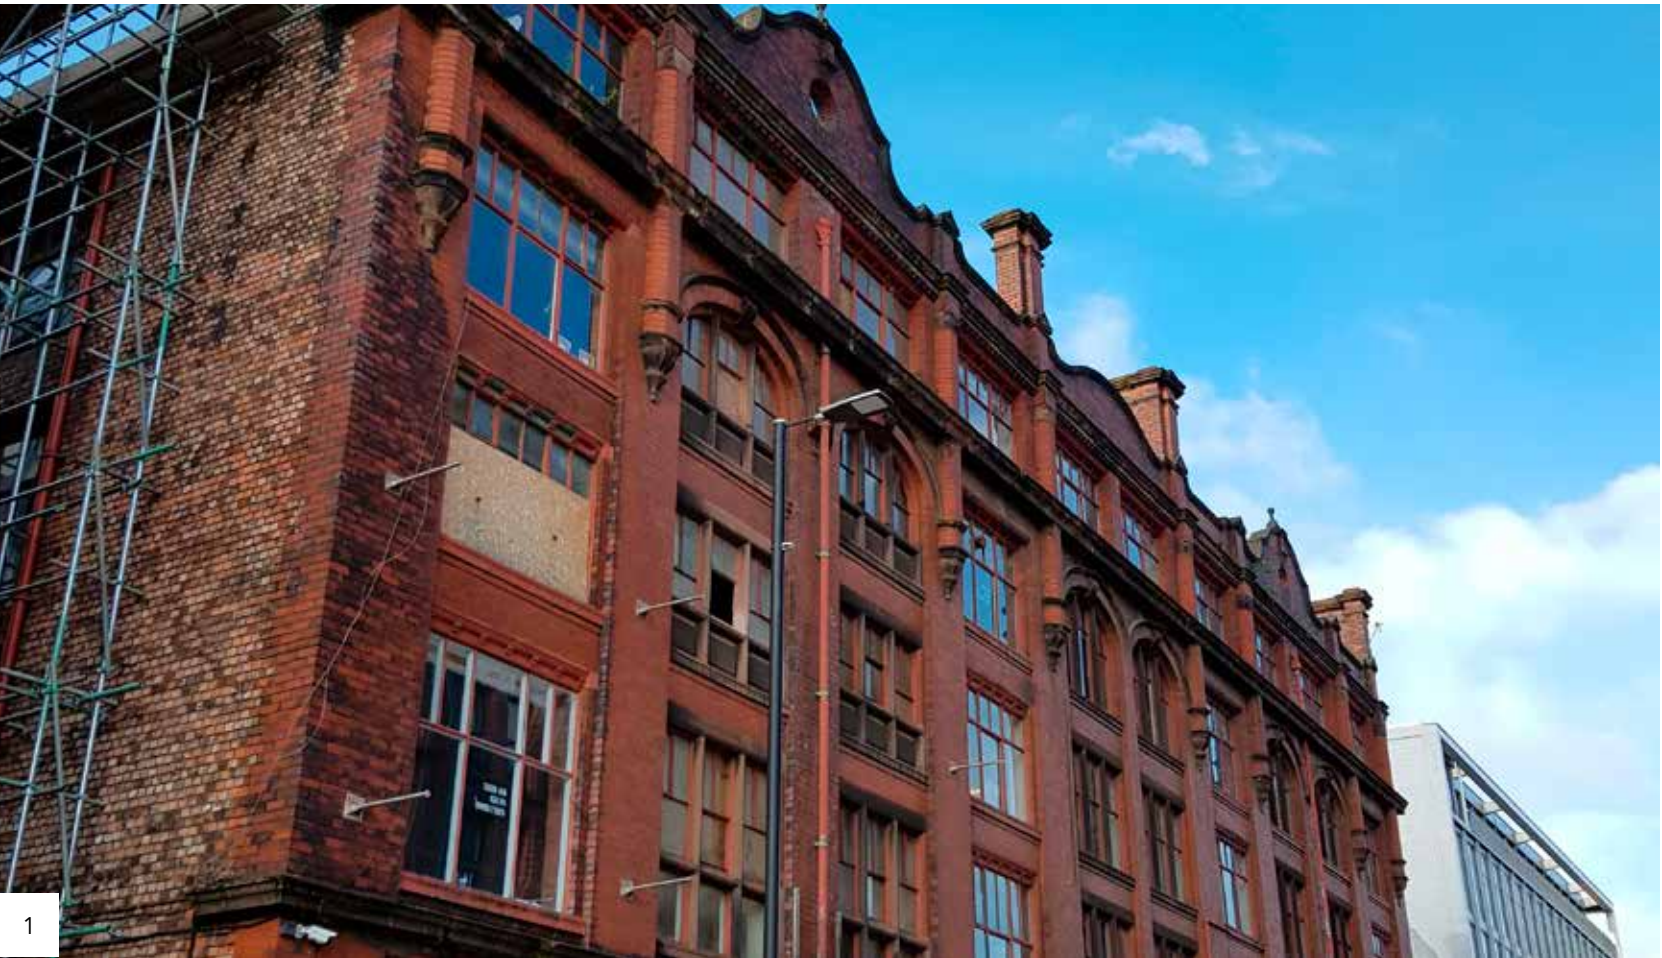
1. Hilton Street elevation, with windows boarded over, due to damage from corroded frames
2. Sample section cleaned off-site, illustrating extent of corrosion to profiles
3. Windows boarded over to Lizard Street Elevations

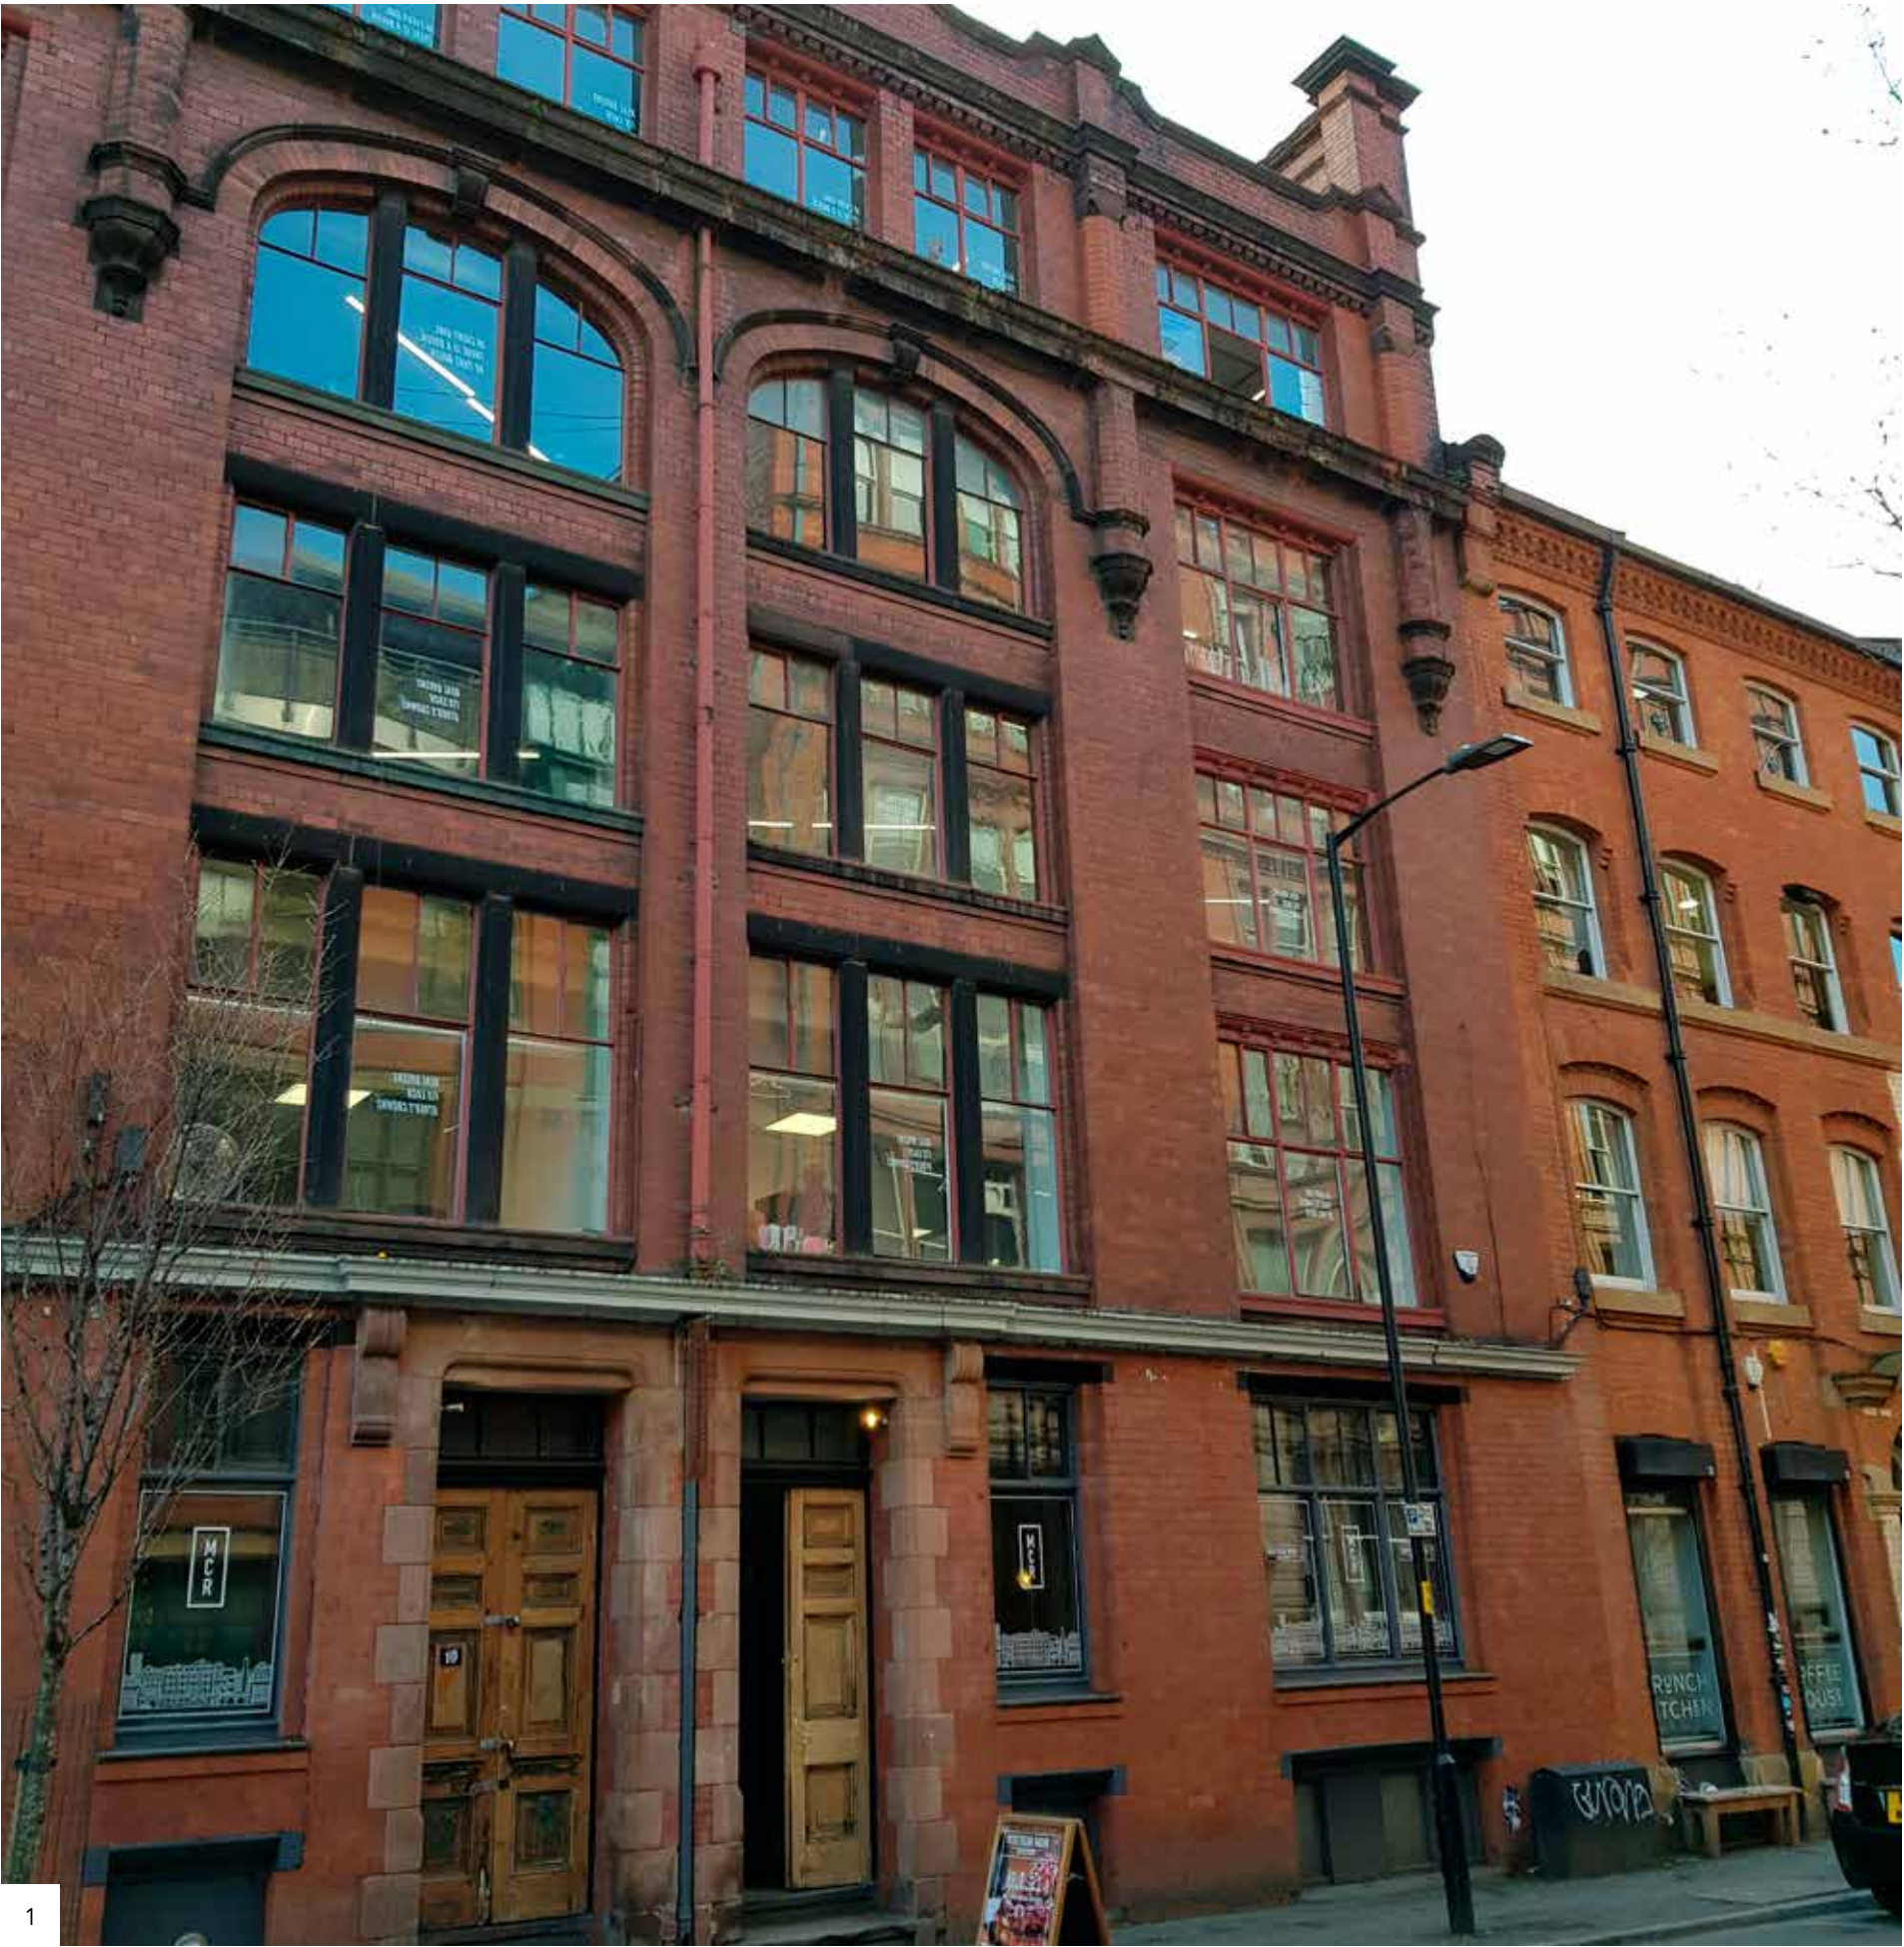
- 1. Tariff Street Elevation There are numerous issues noted to the dressed sandstone elements, particularly on the Tariff Street and Hilton Street elevations. These have arisen from ongoing water ingress and inadequate drainage of rainwater, and are presently contributing to the

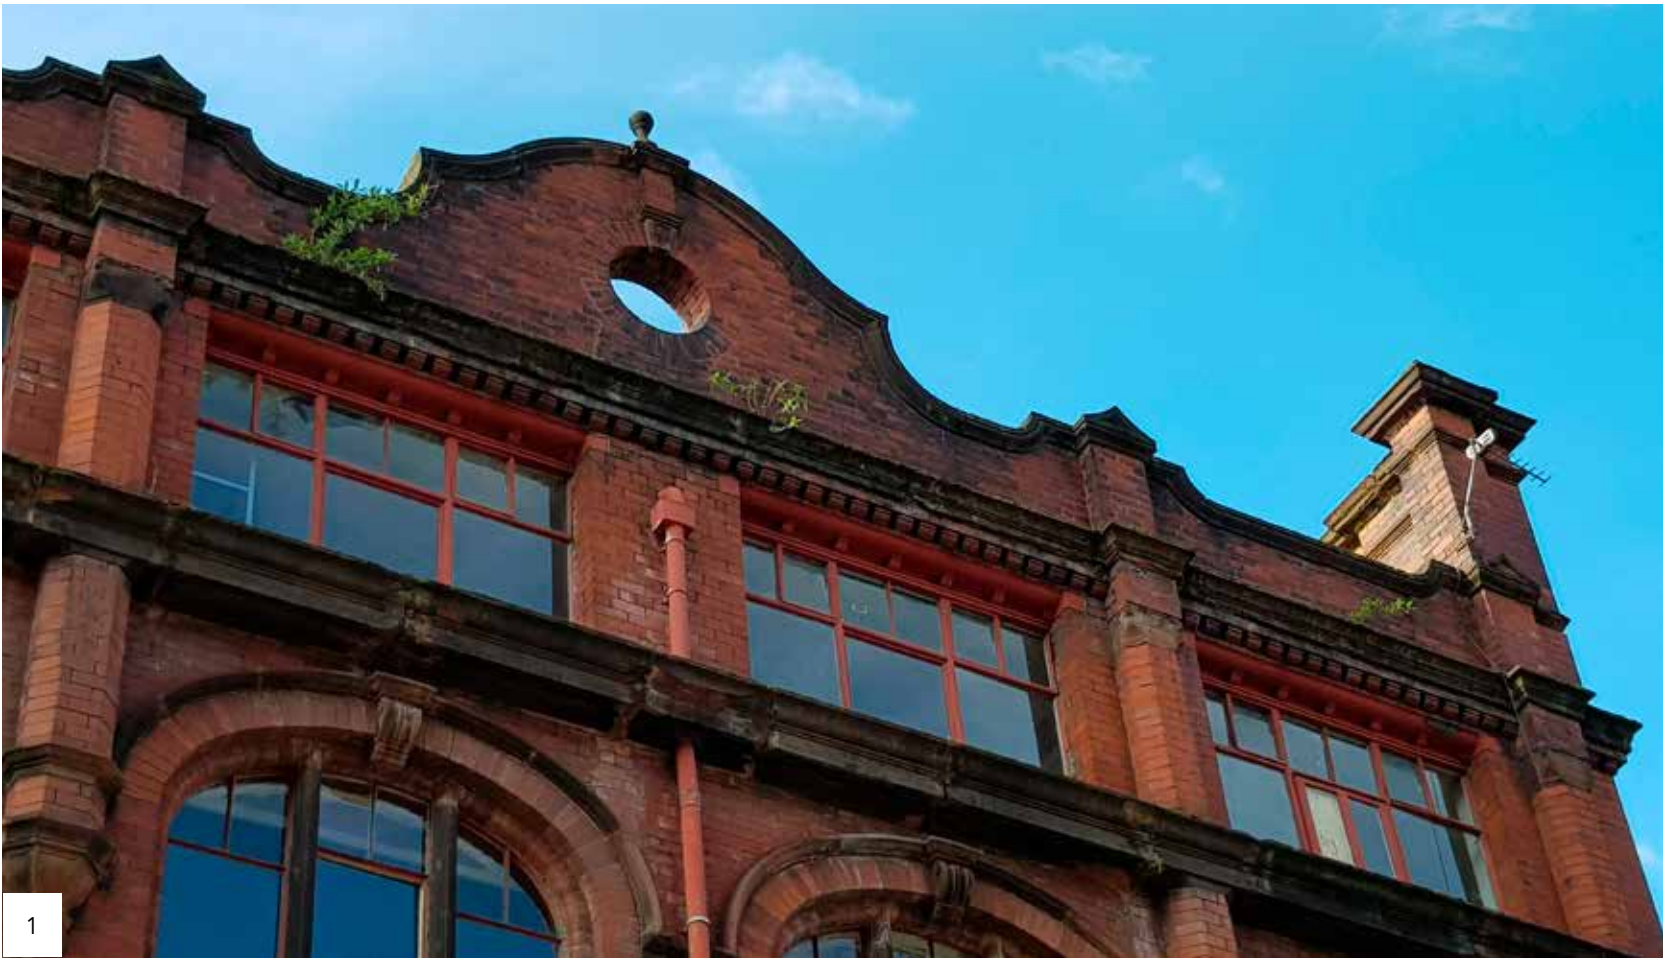
- 1. High level vegetation growth, open joints and run-off staining (Hilton Street)
- 2. Projecting stonework is evidently not shedding water adequately
- 3. Similar issues are noted where drainage channels are holding water and contributing to corrosion of windows

Where sections have eroded to such an extent that it is not possible to disperse water, it is proposed to carefully cut out these sections back to sound material and carry out an appropriate indent repair. Replacement stone will match the existing in terms of colour,

texture and detailing, and will be bedded with stainless steel dowels, with jointing pointed in a suitable lime mortar to match existing. New sections will be cut to original profiles without artificial wearing or ageing to ensure legibility against historic fabric.
