# *Martin Prescott Environmental Services*

3.6.2020

## **Bat Survey of Raza Foundation, 8-16 Park Grove, Longsight, 24.4.2015 and 1.6.2020**

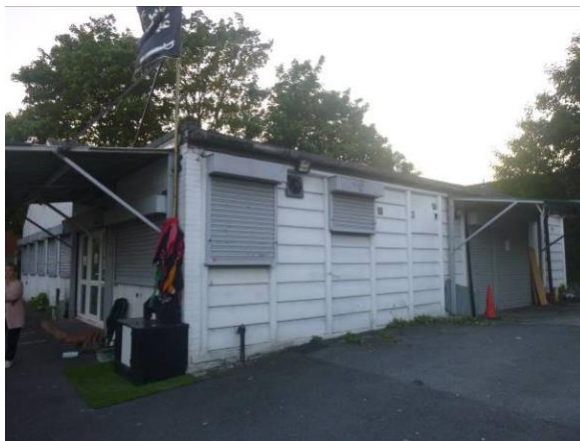
P1 SE corner showing canopies

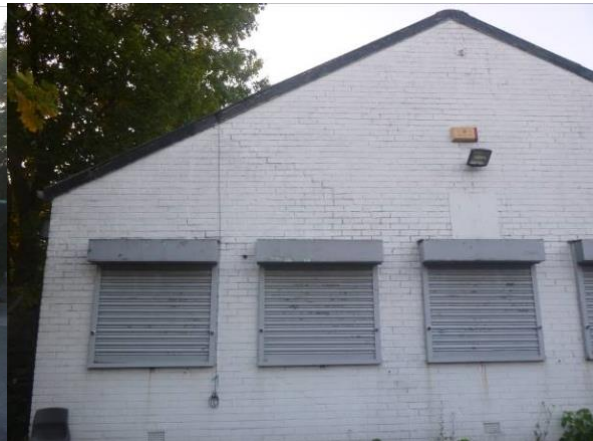
P2 South aspect

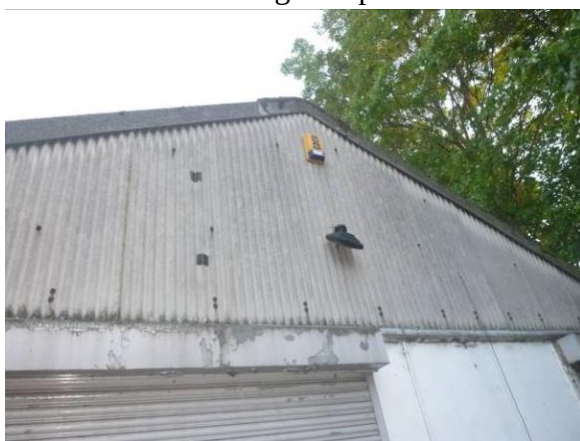
P3 North aspect

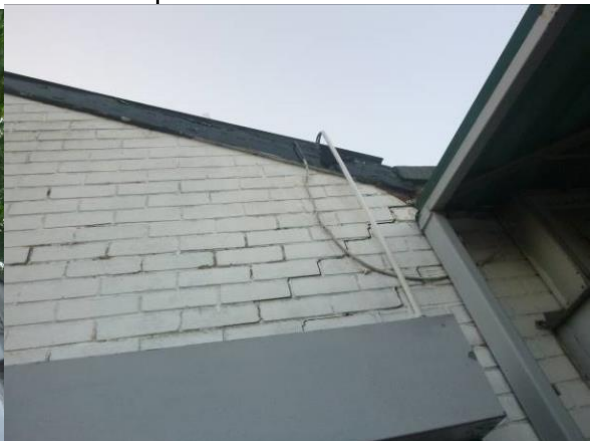
The roofs and eaves were mostly well sealed. There were gaps under barge boards and in the masonry suitable for bat access in the flat roofed section. (see plan and photos)

P4 Gap in masonry

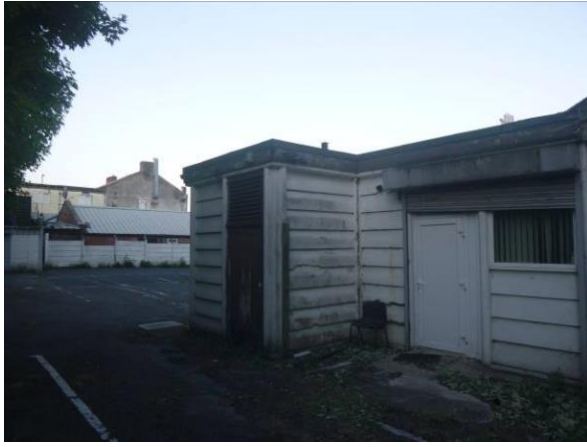
There was a boiler room attached to the rear.

P5 Boiler house

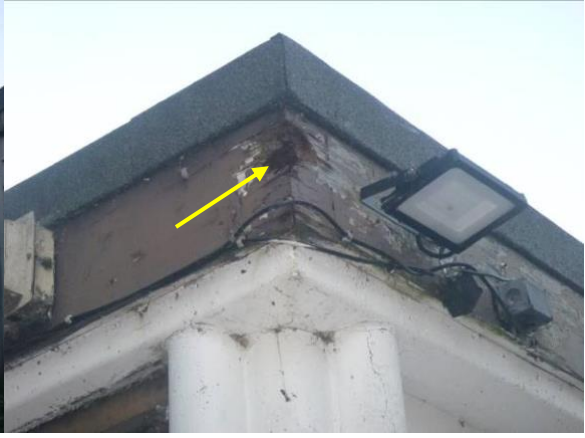
P6 Rot hole, boiler house

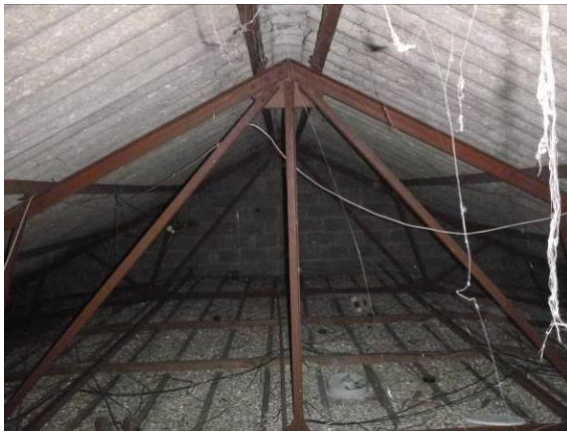
The pitched section had no crevices suitable for roosting bats. The loft was insulated at floor level, clear of clutter and easily searched. The roof was unlined.

P7 Loft showing unlined roof

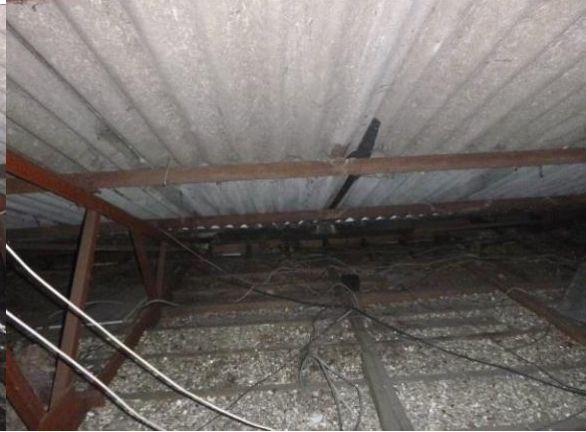
P8 Loft showing daylight at eaves
