| Project: | LONDON ROAD FIRE STATION |

| Drg Title: | SECOND FLOOR OBSERVATIONS<br>SHEET 2 OF 3 |

| 060270 / 10-02-02 | V01 |

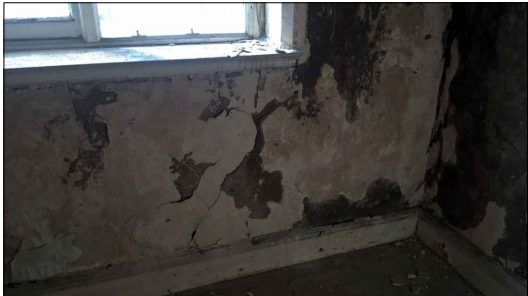
| REF | OBSERVATION |
|---|---|
| 2.2.1 | CRACK TO PLASTER BETWEEN WINDOW CILL AND WALL. |

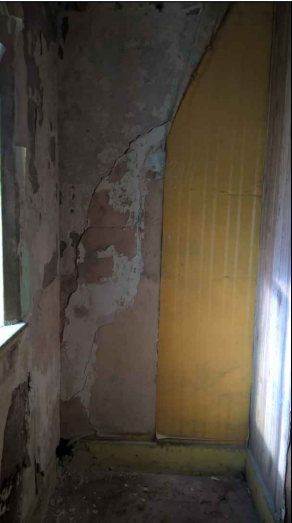
| REF | OBSERVATION |
|---|---|
| 2.2.2 | DIAGONAL CRACK TO WALL EVIDENT TO BOTH SIDES. |

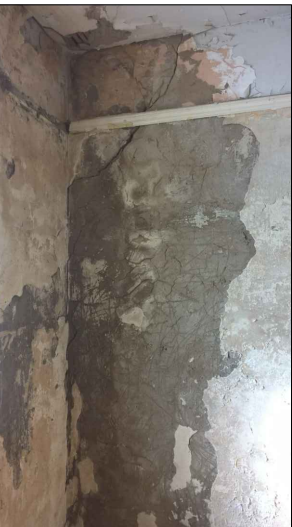
| REF | OBSERVATION |
|---|---|
| 2.2.3 | DIAGONAL CRACK TO WALL EVIDENT TO BOTH SIDES. |

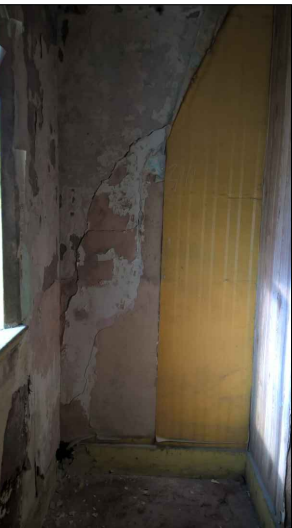
| REF | OBSERVATION |
|---|---|
| 2.2.5 | DIAGONAL CRACK TO WALL EVIDENT TO BOTH SIDES. |

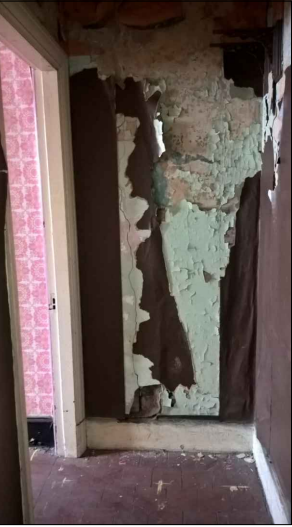
| REF | OBSERVATION |
|---|---|
| 2.2.6 | STRAIGHT LINE CRACK TO PARTITION WALL |

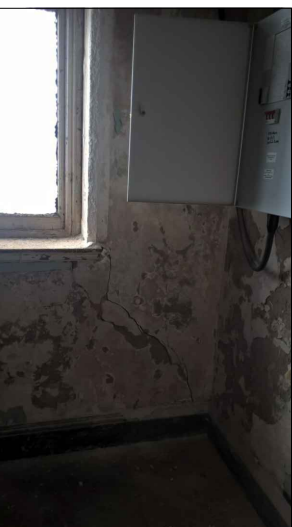
| REF | OBSERVATION |
|---|---|
| 2.2.9 | CRACK TO PLASTER BETWEEN WINDOW CILL AND WALL. |

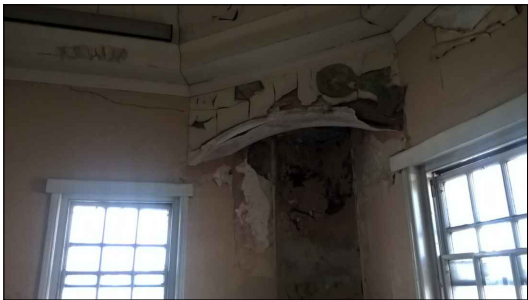
| REF | OBSERVATION |
|---|---|
| 2.2.10 | MINOR CRACKING TO PLASTER AT HIGH LEVEL. SOME EVIDENCE OF PREVIOUS WATER INGRESS. |

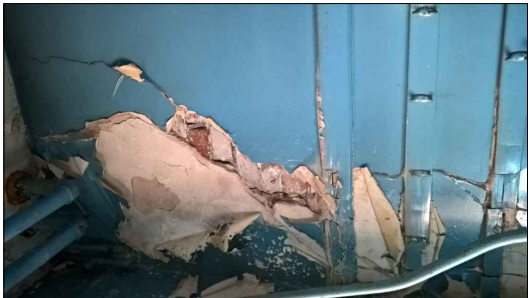
| REF | OBSERVATION |
|---|---|
| 2.2.13 | DIAGONAL CRACK TO WALL EVIDENT TO BOTH SIDES |

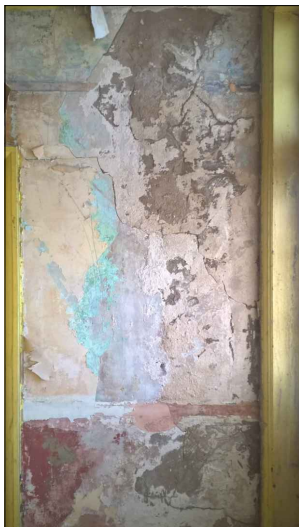
| REF | OBSERVATION |
|---|---|
| 2.2.7 | BRICKWORK HAS BEEN BROKEN OUT TO INSTALL TOILETS |

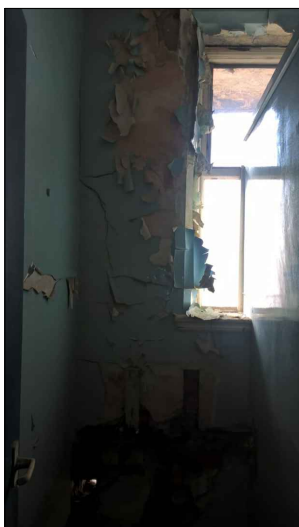
| REF | OBSERVATION |
|---|---|
| 2.2.8 | DIAGONAL CRACK TO WALL EVIDENT TO BOTH SIDES. |

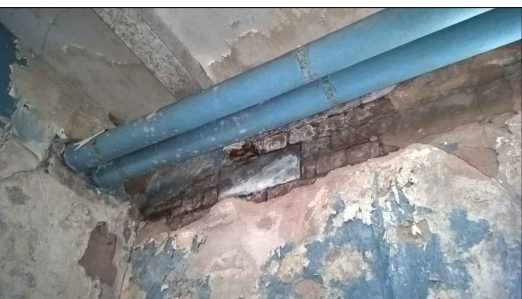
| REF | OBSERVATION |
|---|---|
| 2.2.14 | DIAGONAL CRACK TO WALL EVIDENT TO BOTH SIDES. |

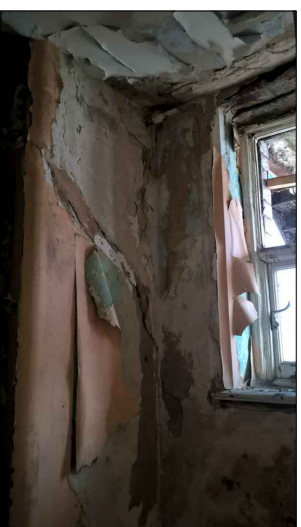
| REF | OBSERVATION |
|---|---|
| 2.2.16 | DIAGONAL CRACK TO WALL EVIDENT TO BOTH SIDES. |

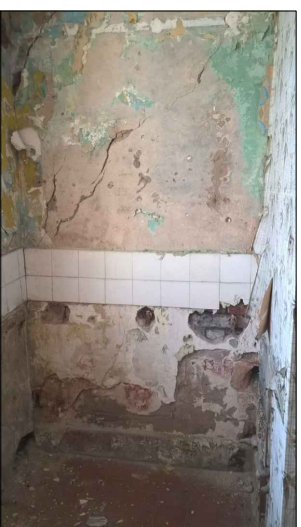
| REF | OBSERVATION |
|---|---|
| 2.2.21 | DIAGONAL CRACK TO WALL EVIDENT TO ONE SIDE ONLY. |

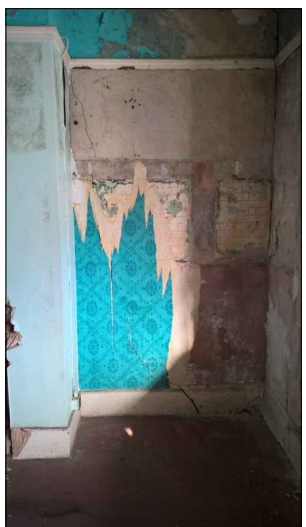
| REF | OBSERVATION |
|---|---|
| 2.2.19 | DIAGONAL CRACK TO WALL EVIDENT TO BOTH SIDES. |

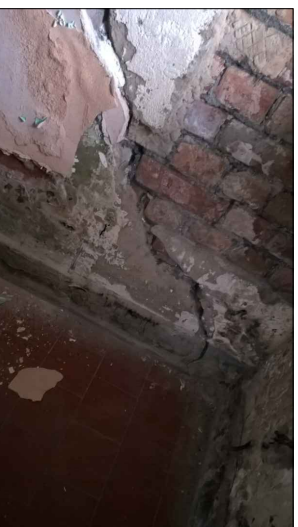
| REF | OBSERVATION |
|---|---|
| 2.2.18 | DIAGONAL CRACK TO WALL EVIDENT TO BOTH SIDES. |
