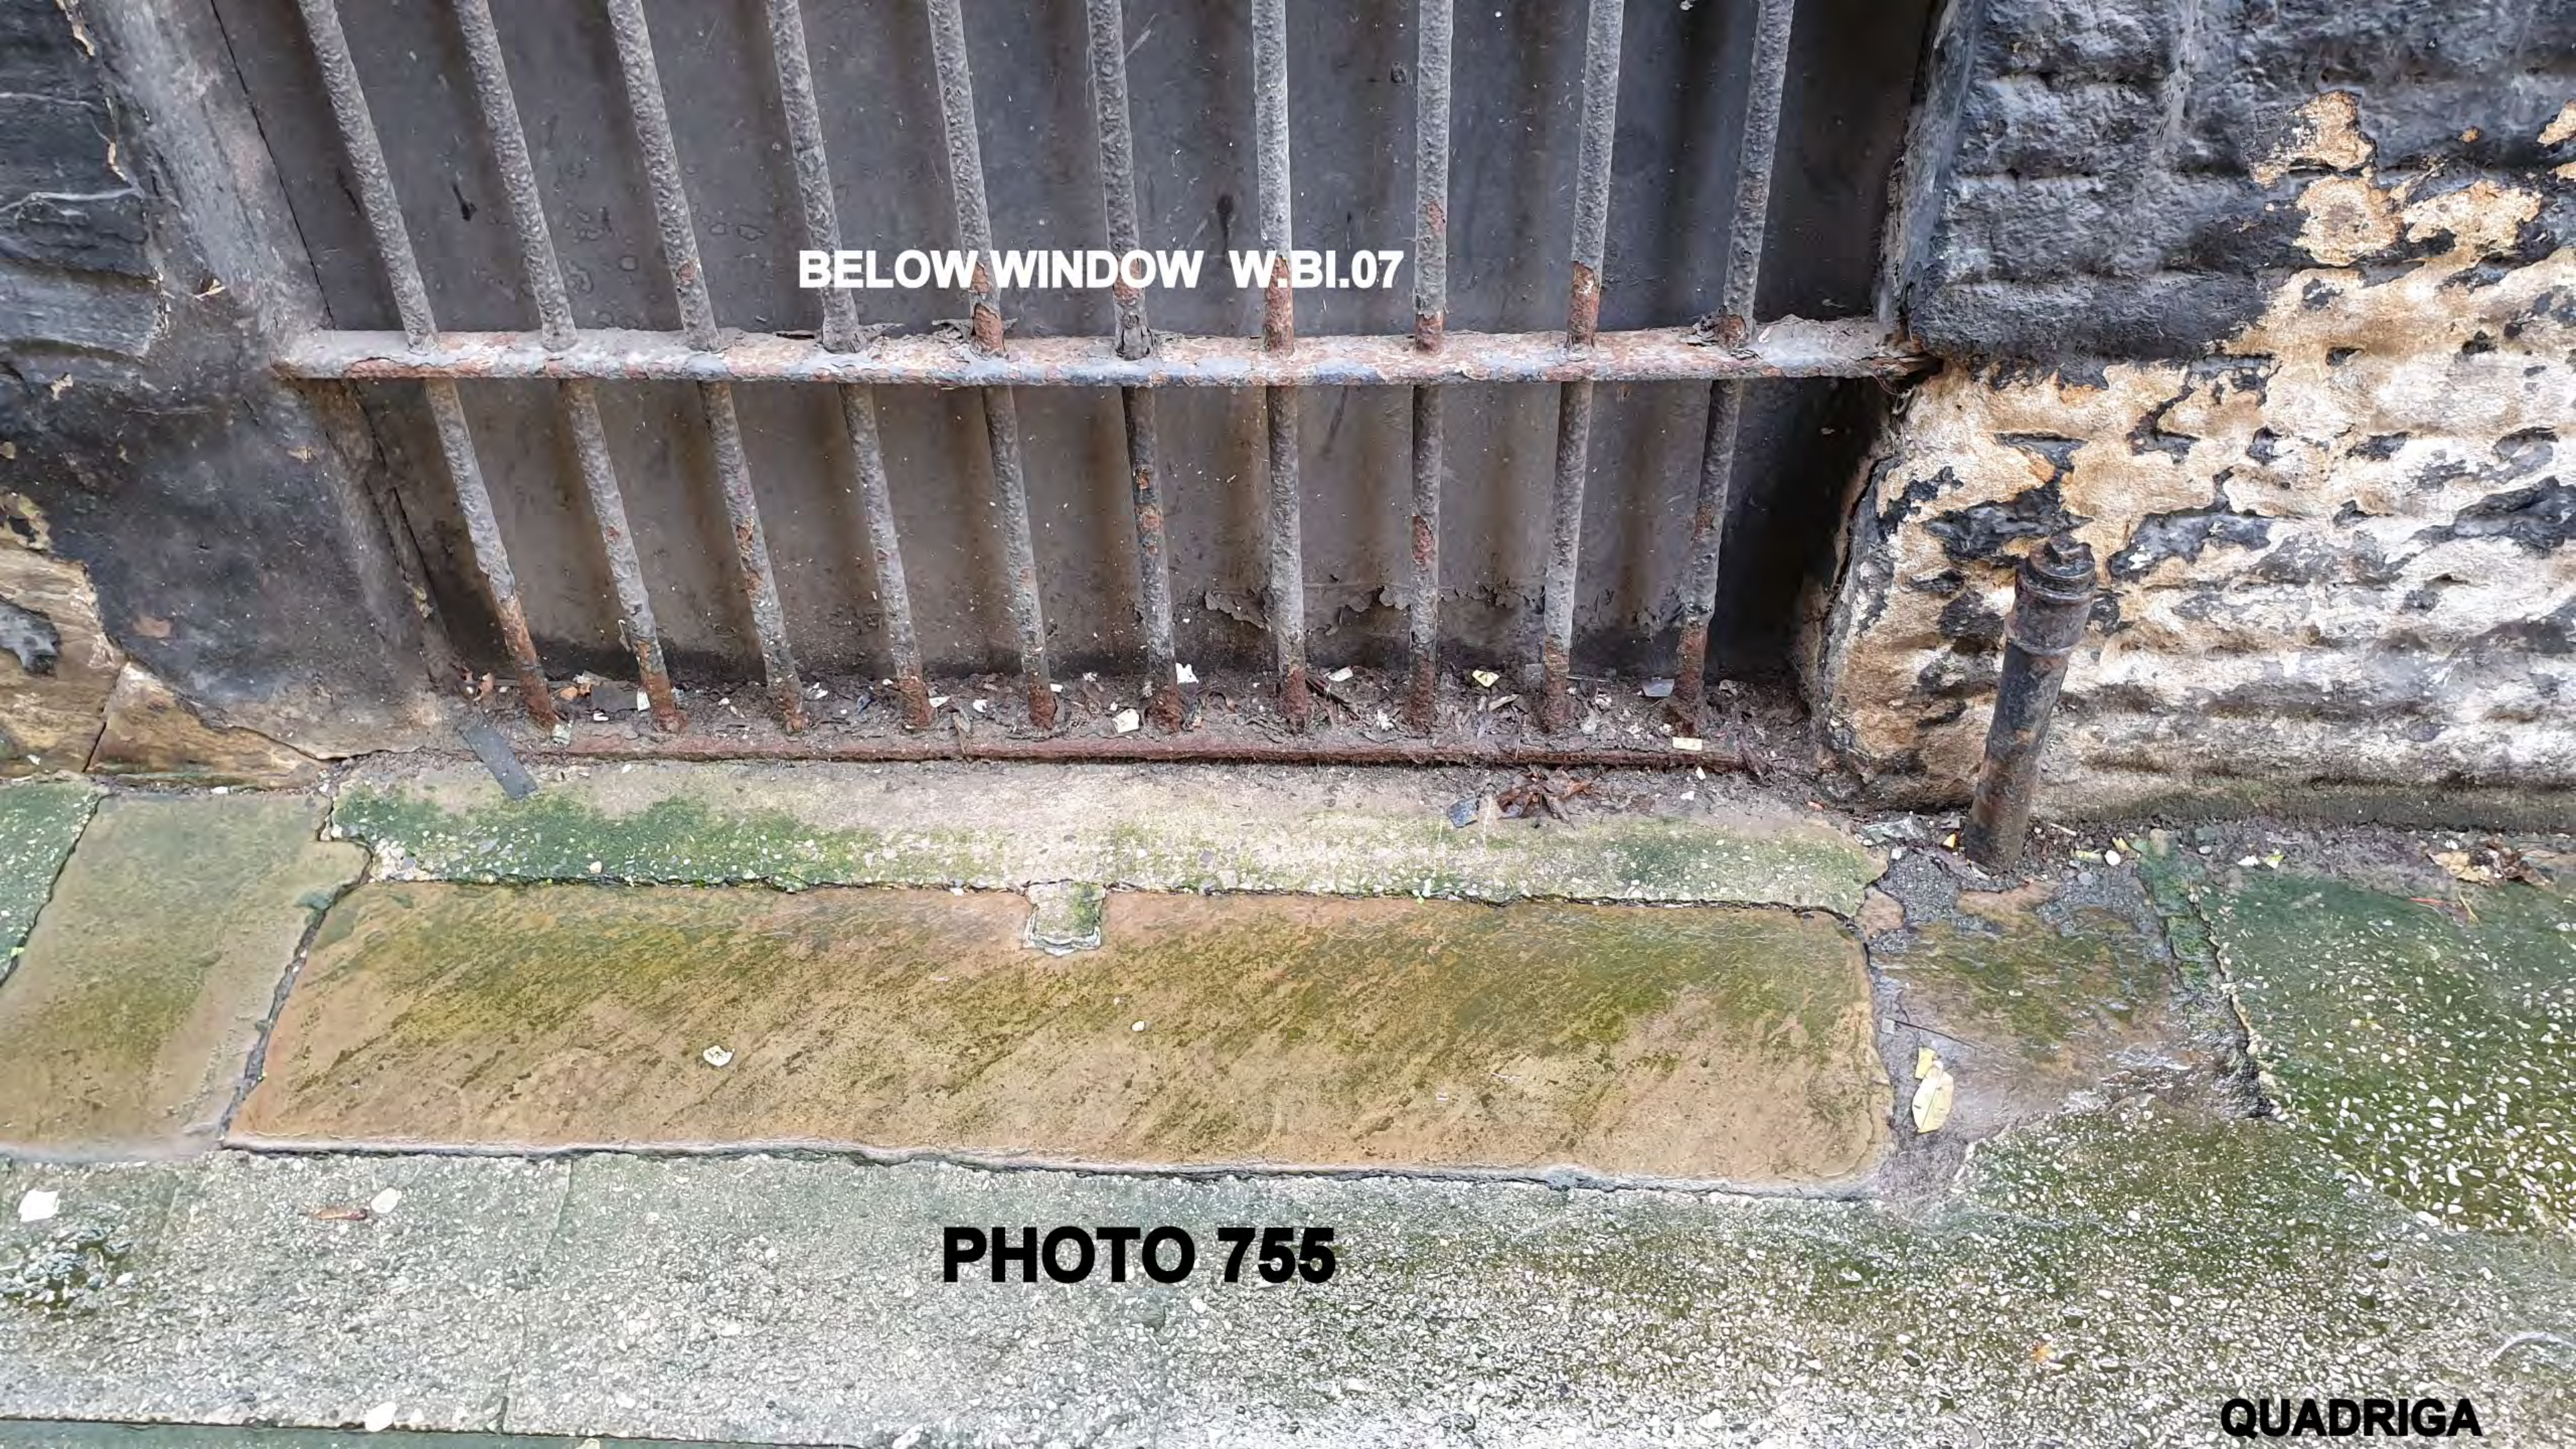
**PHOTO 747**

**BELOW WINDOW B1.07**

**ONLY FULL ORIGINAL PAVEMENT LIGHT INTACT  
CORNER OF PRINCESS STREET AND BACK GEORGE STREET**

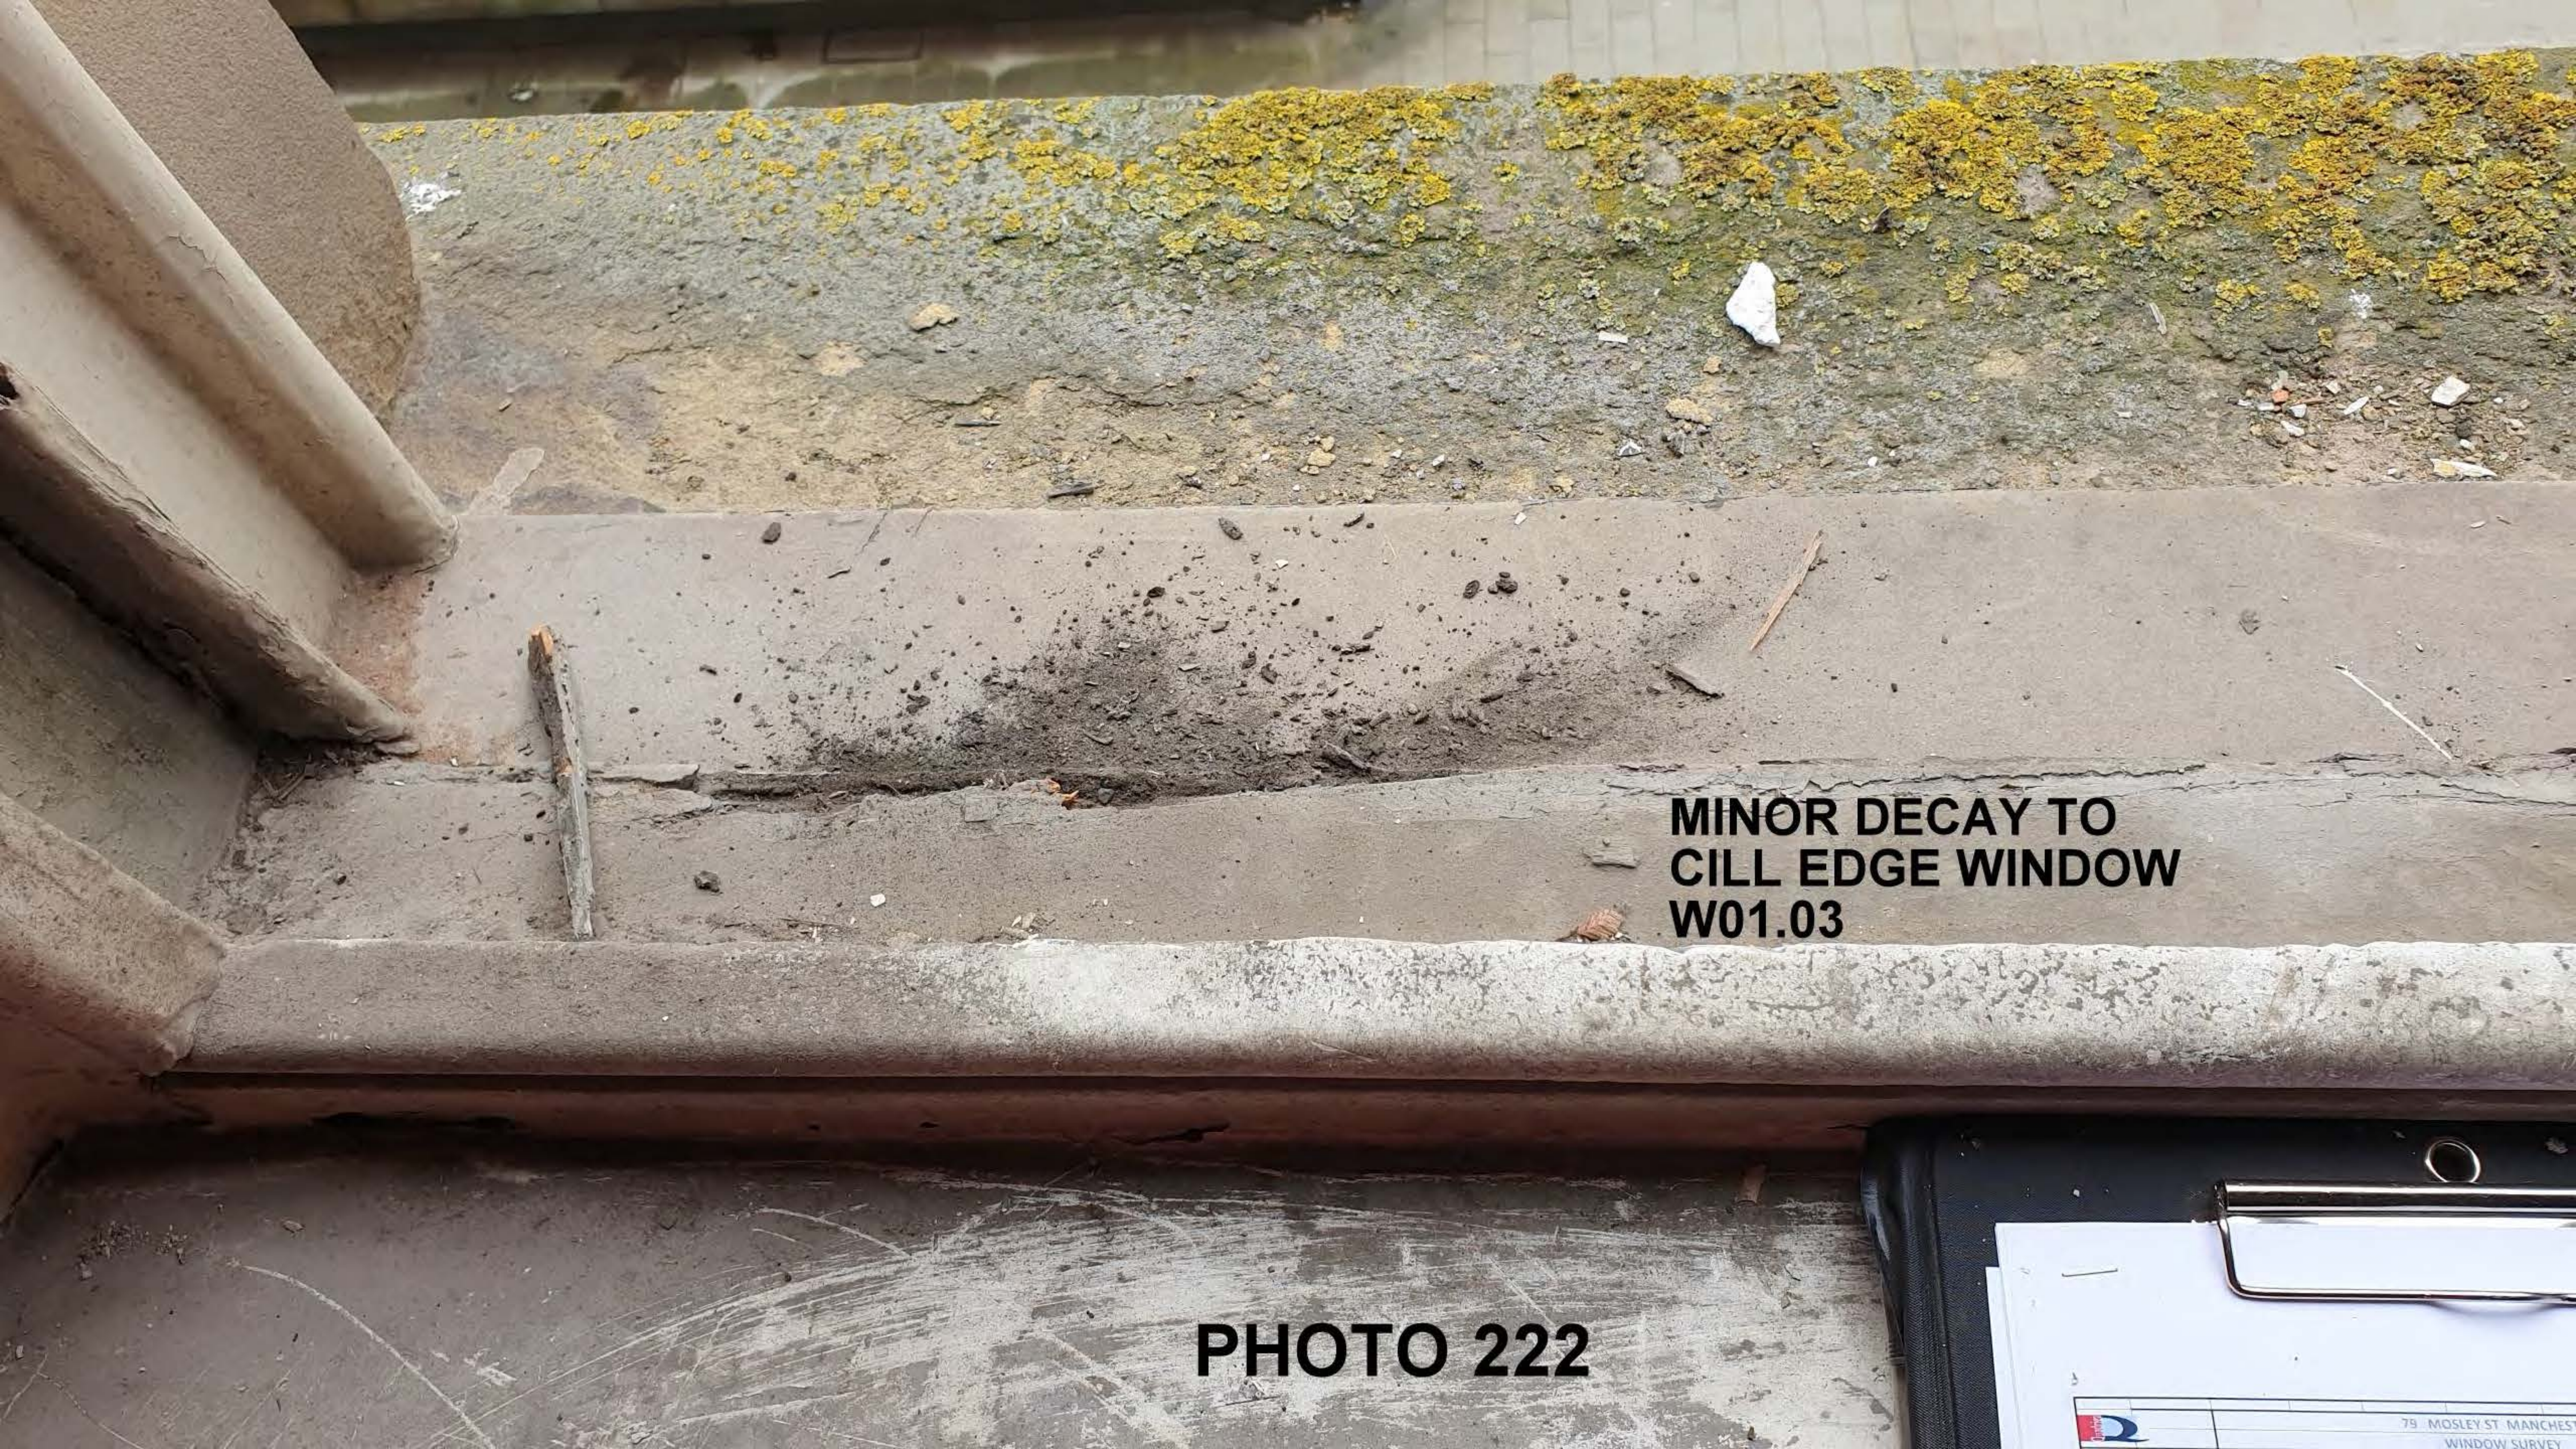
**PHOTO 810**

**BELOW WHAT IS ASSUMED TO BE OLD LOCATION OF  
WINDOW WB1.1  
BACK GEORGE STREET0**

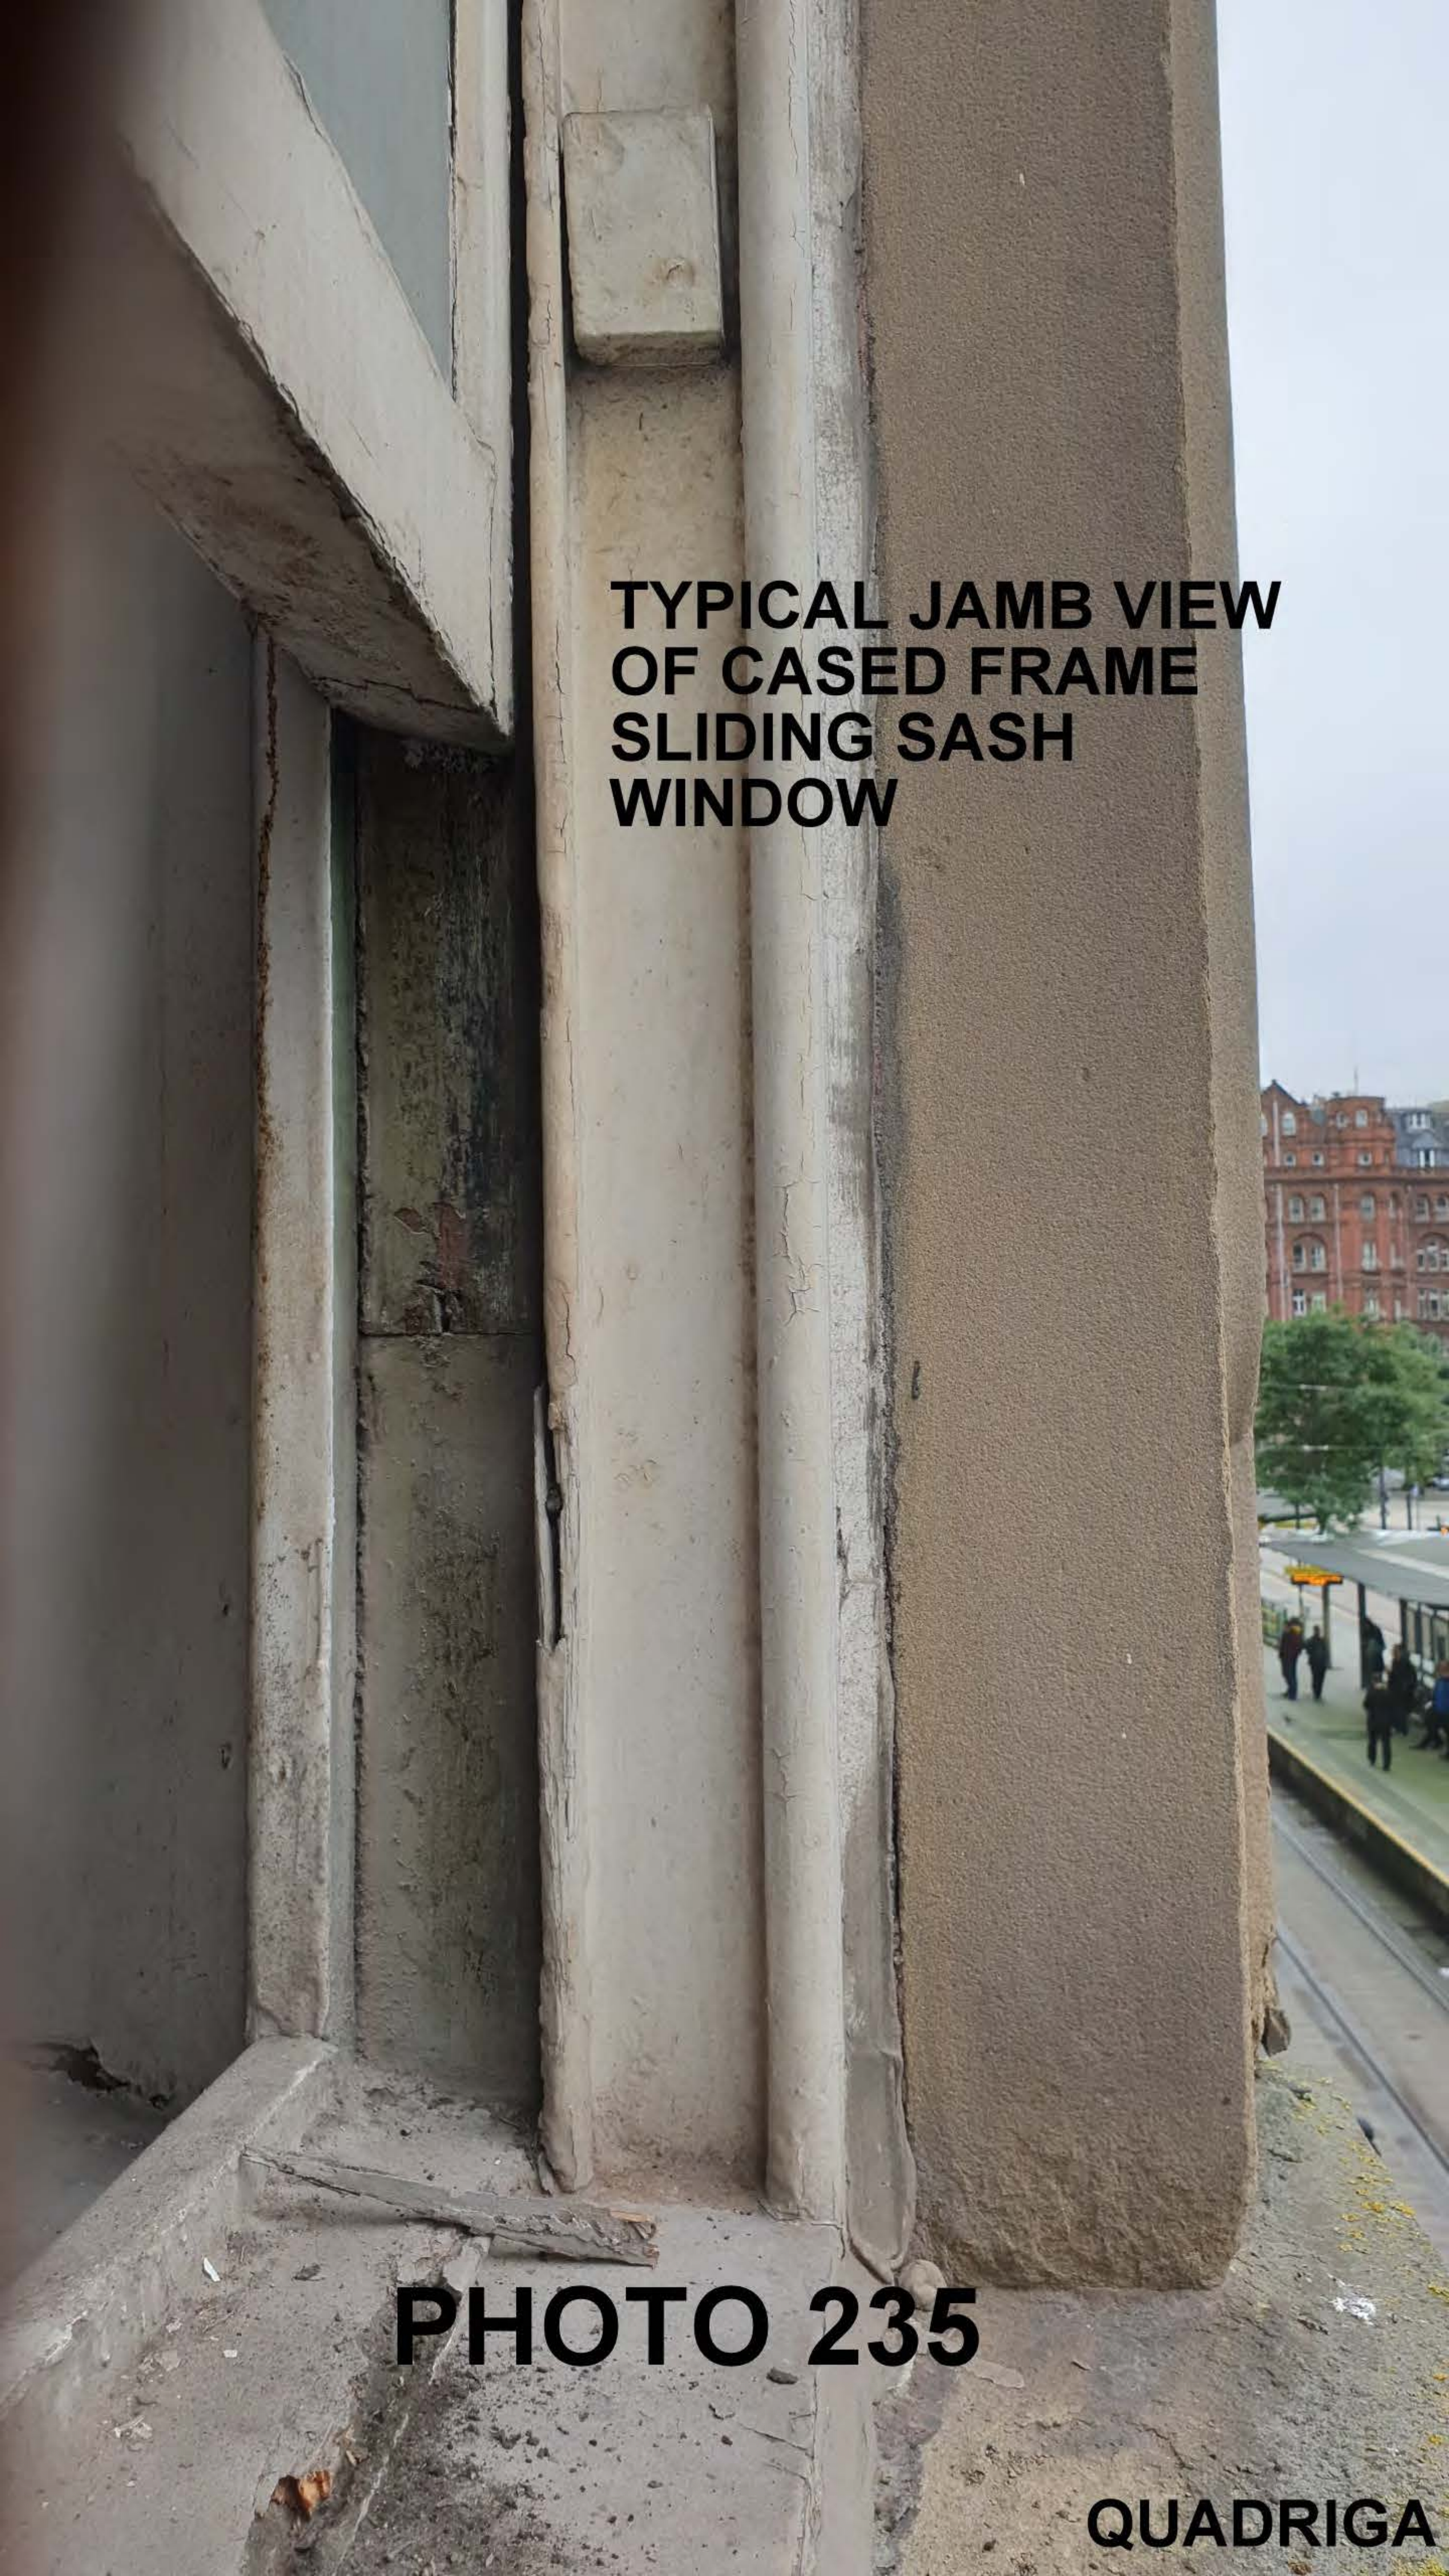
**PHOTO 222**

**MINOR DECAY TO  
CILL EDGE WINDOW  
W01.03**

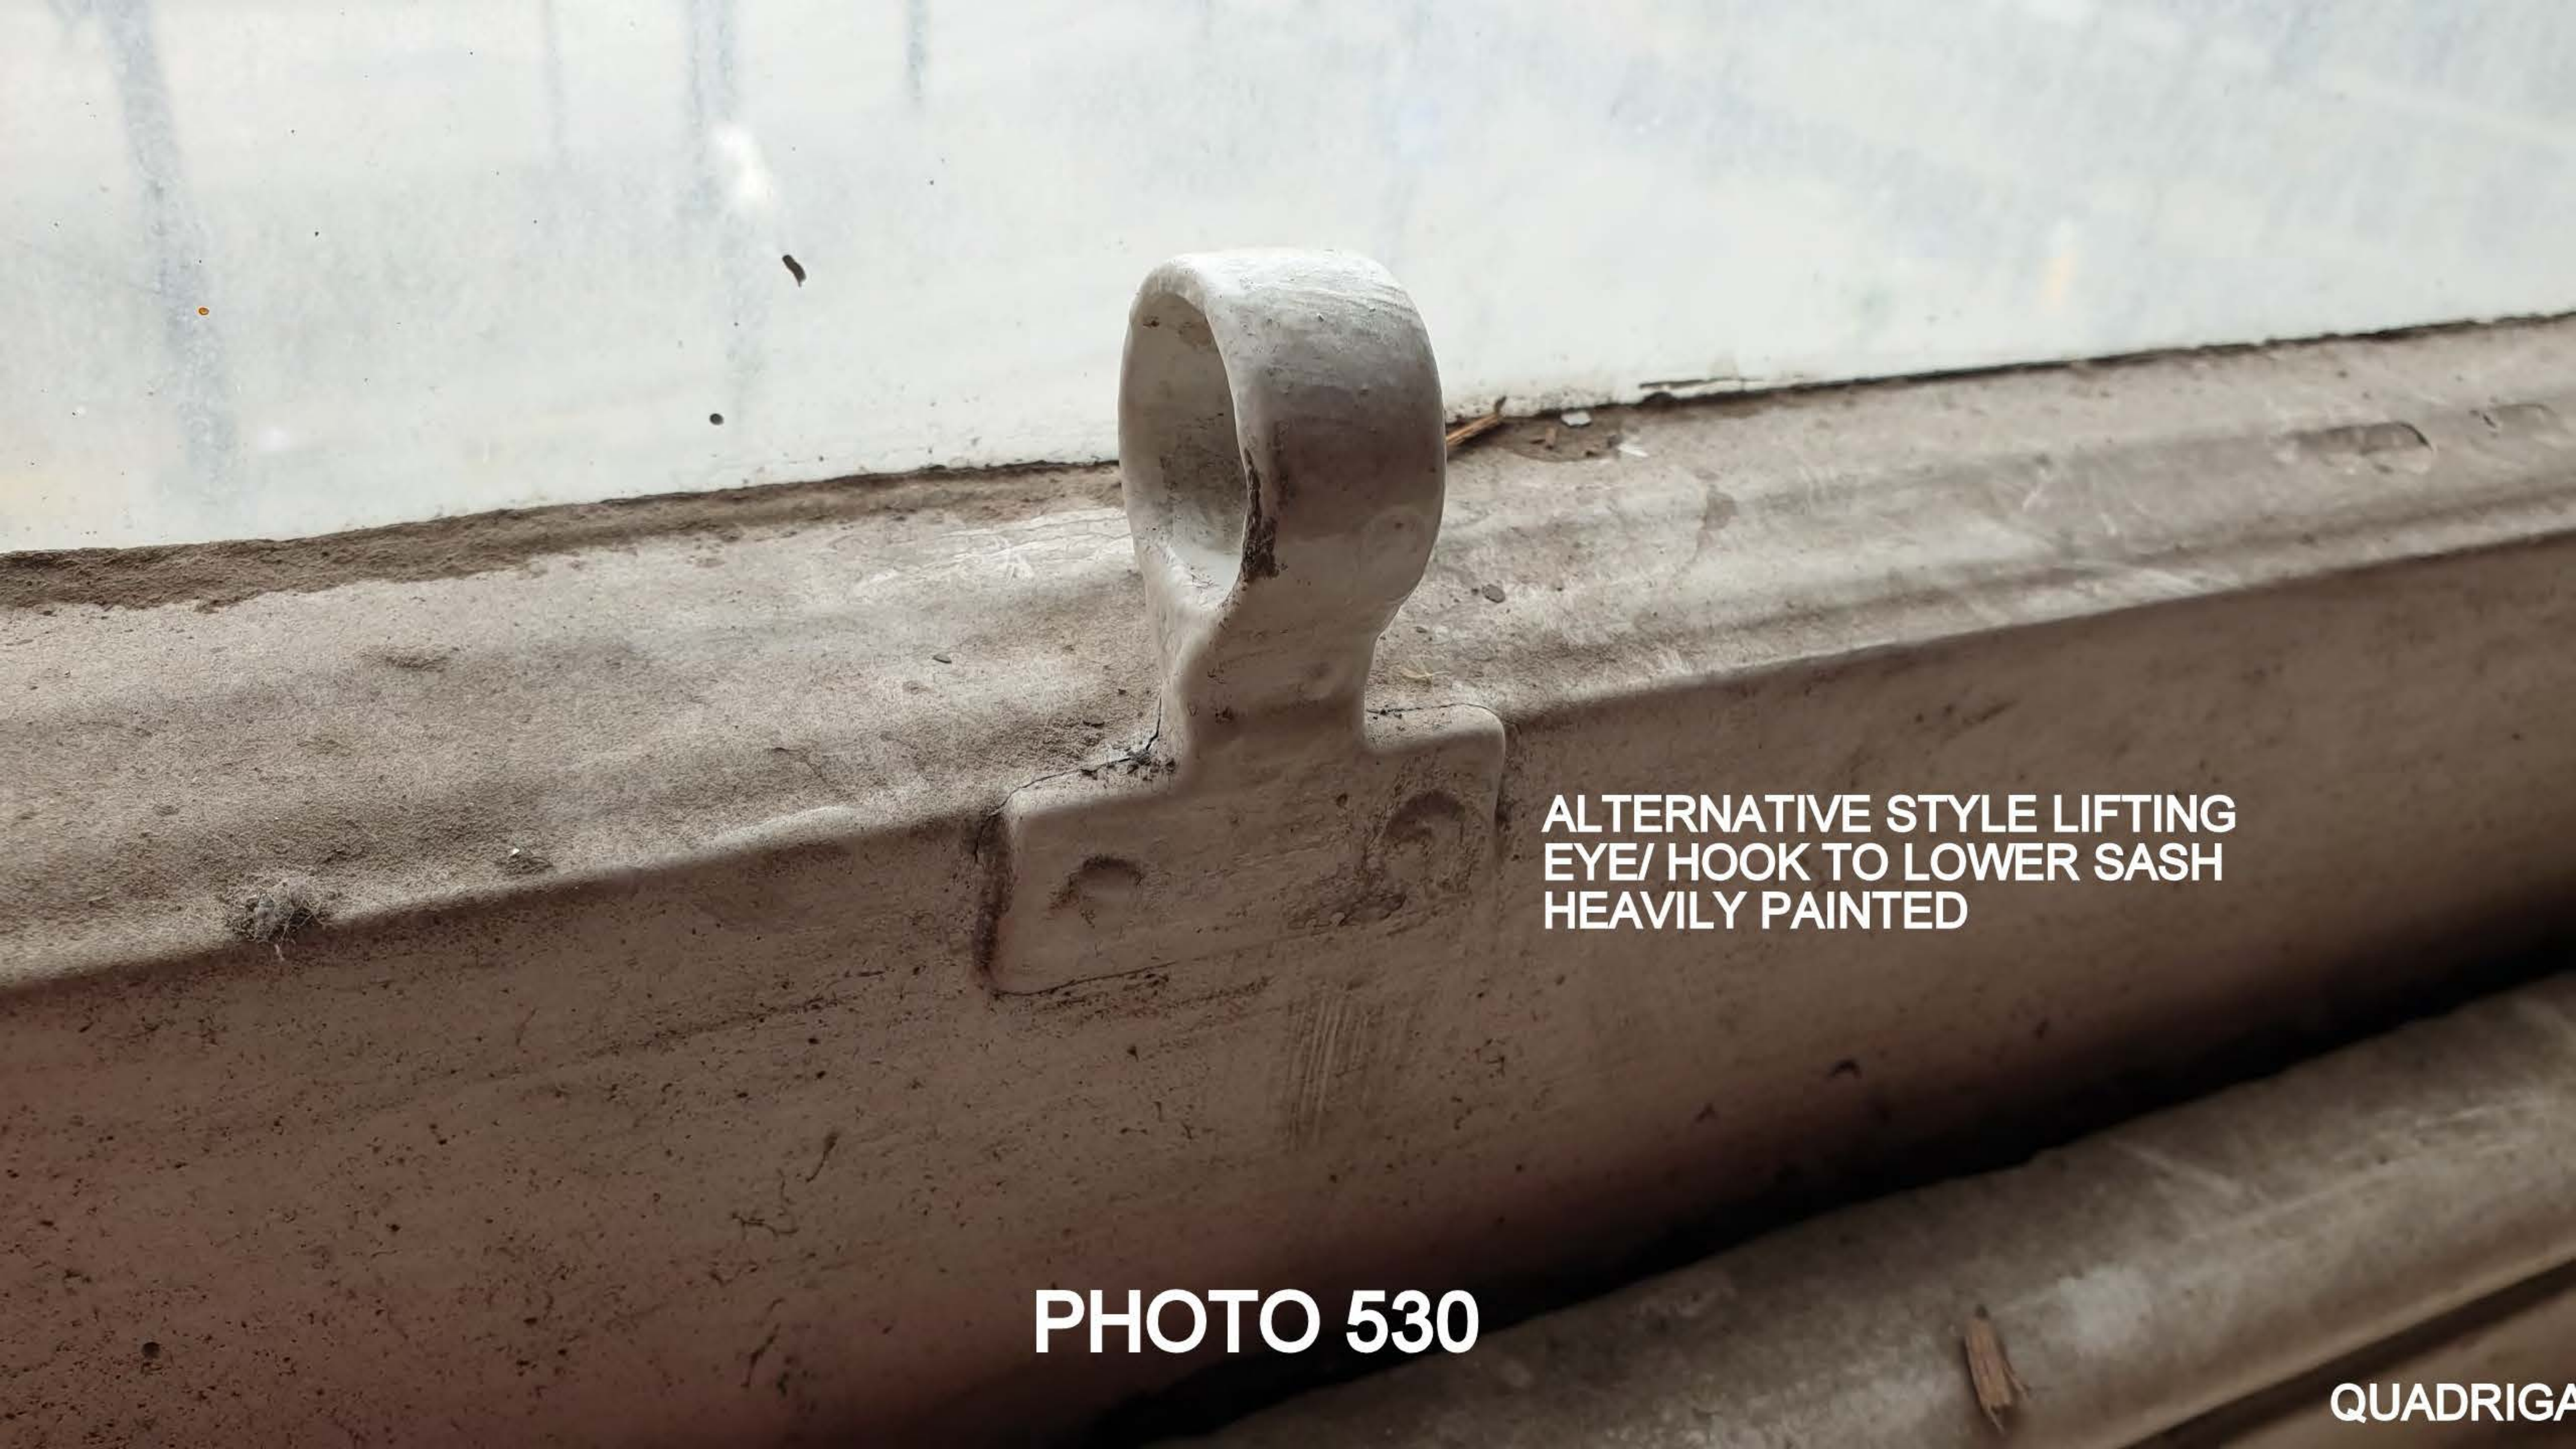
**PHOTO 235**

**TYPICAL JAMB VIEW  
OF CASED FRAME  
SLIDING SASH  
WINDOW**

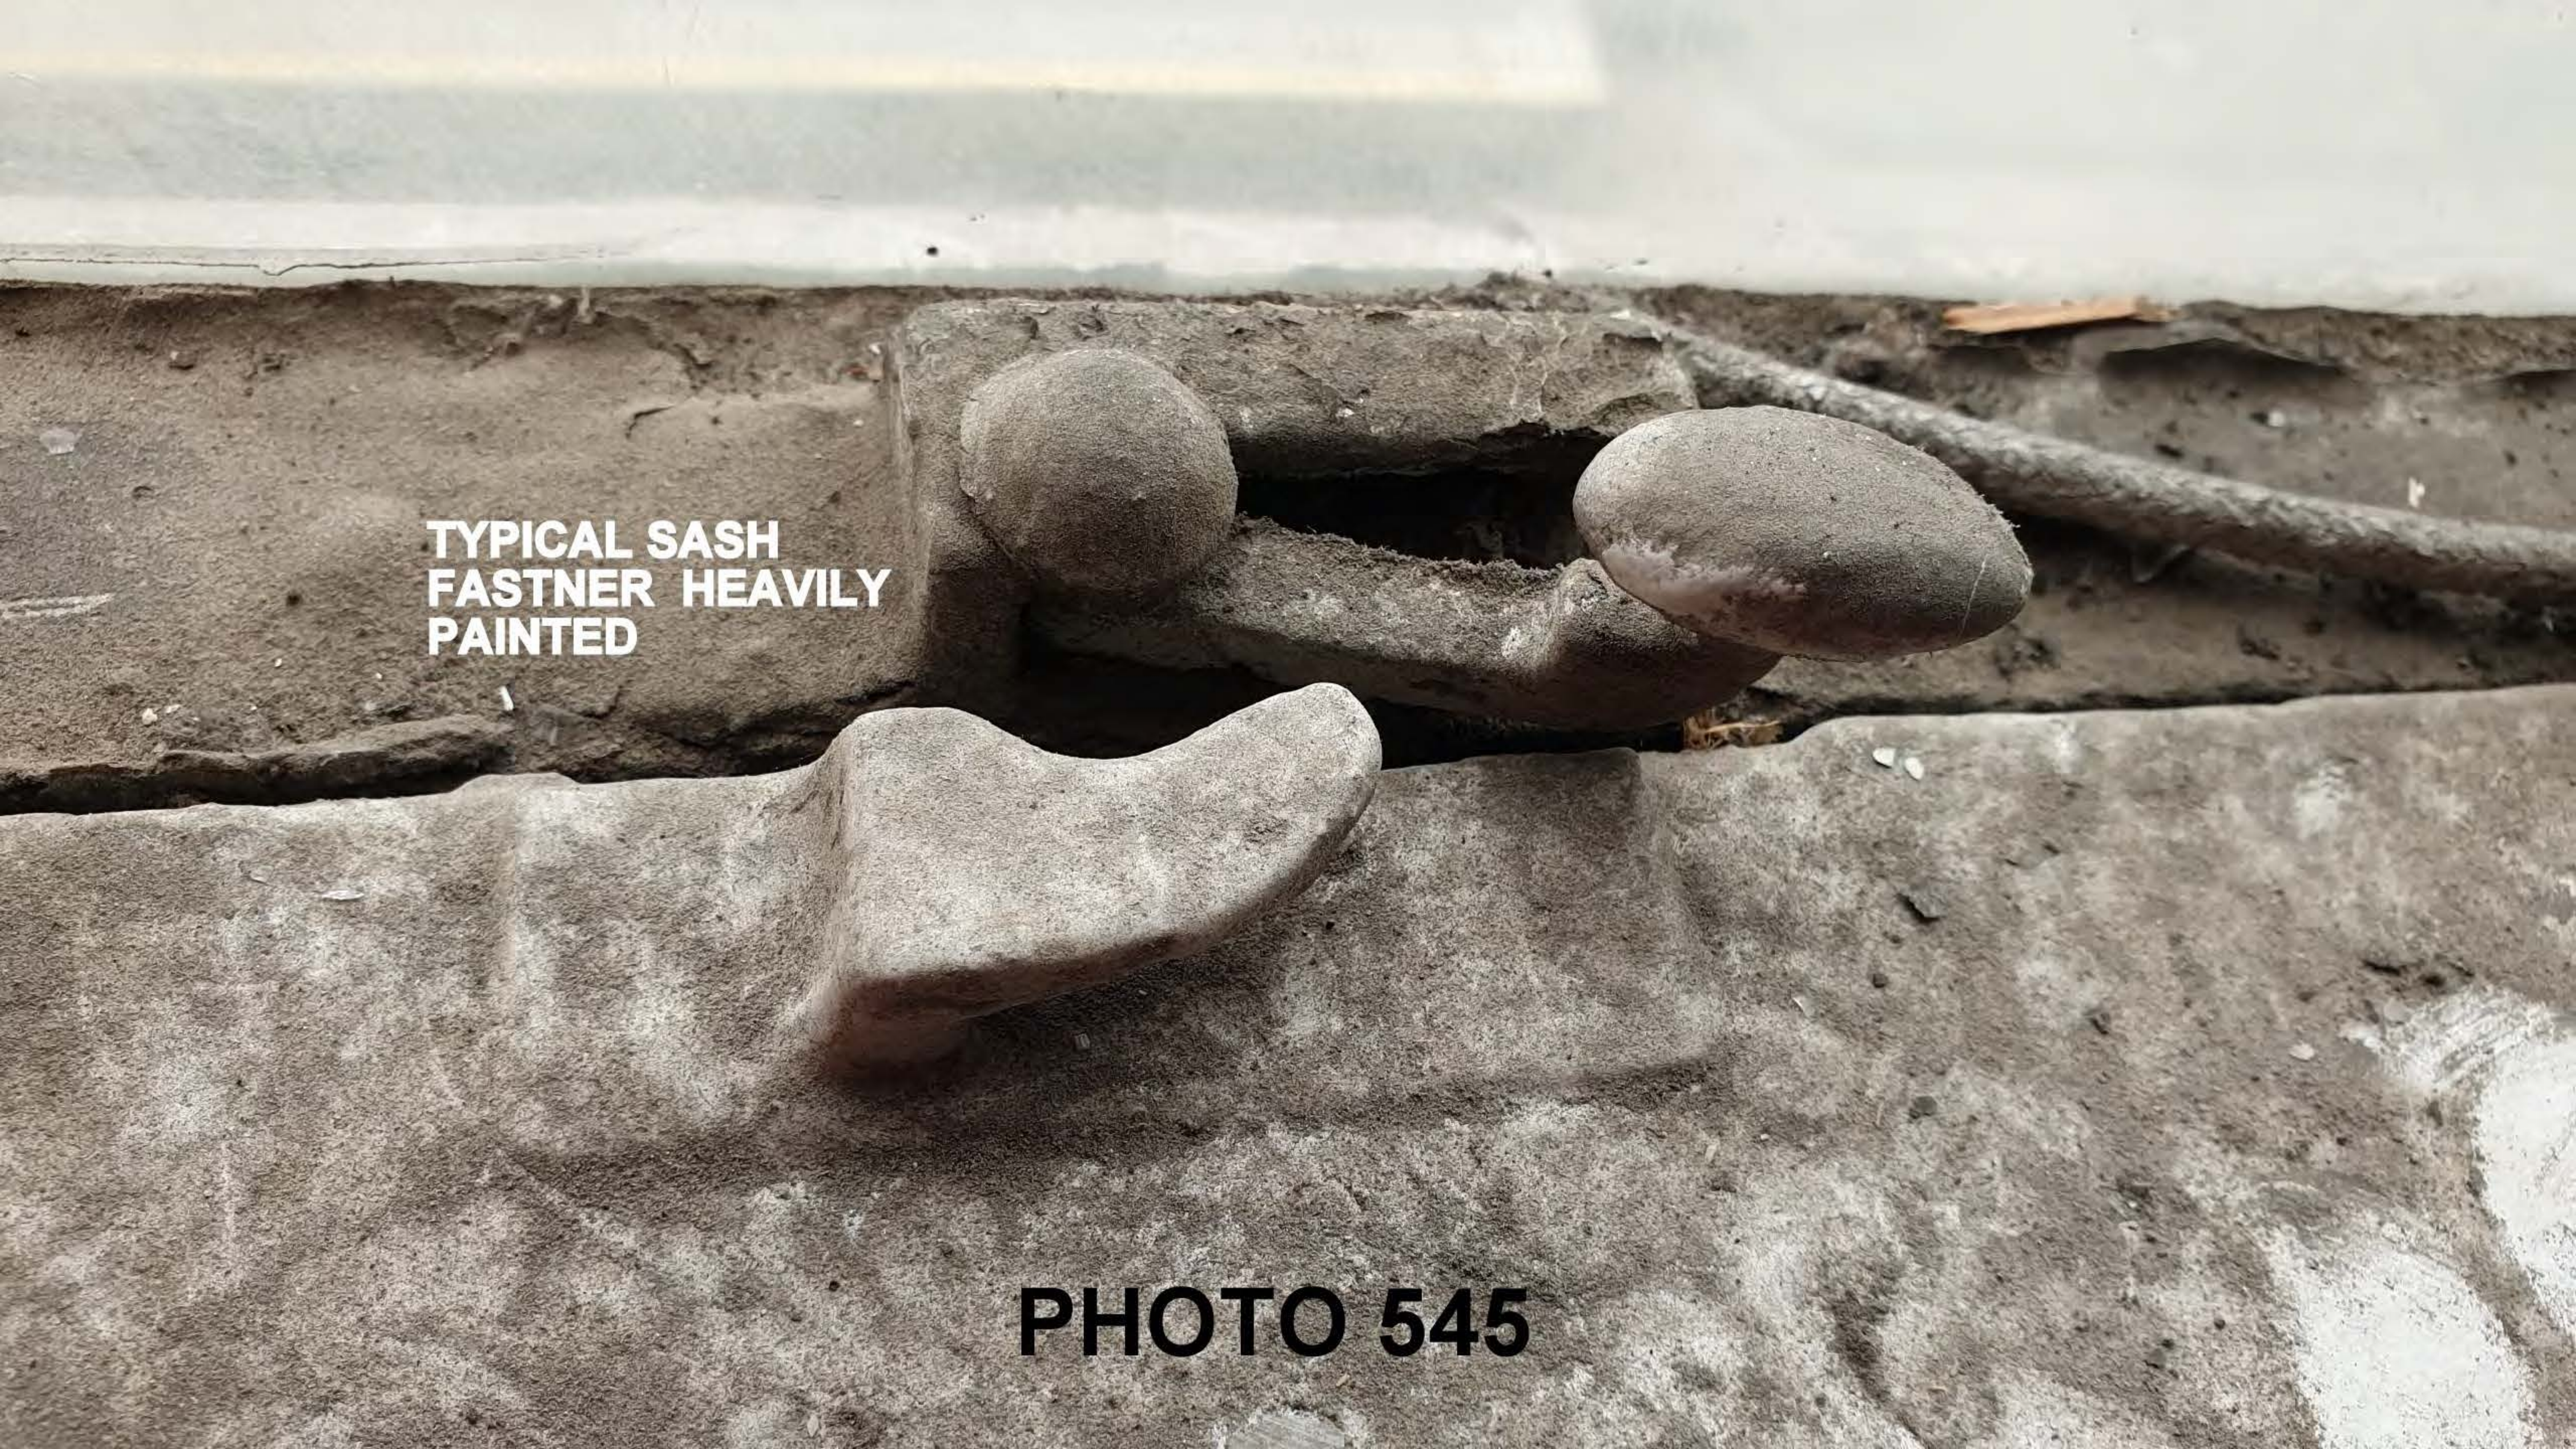
PHOTO 530

ALTERNATIVE STYLE LIFTING  
EYE/ HOOK TO LOWER SASH  
HEAVILY PAINTED

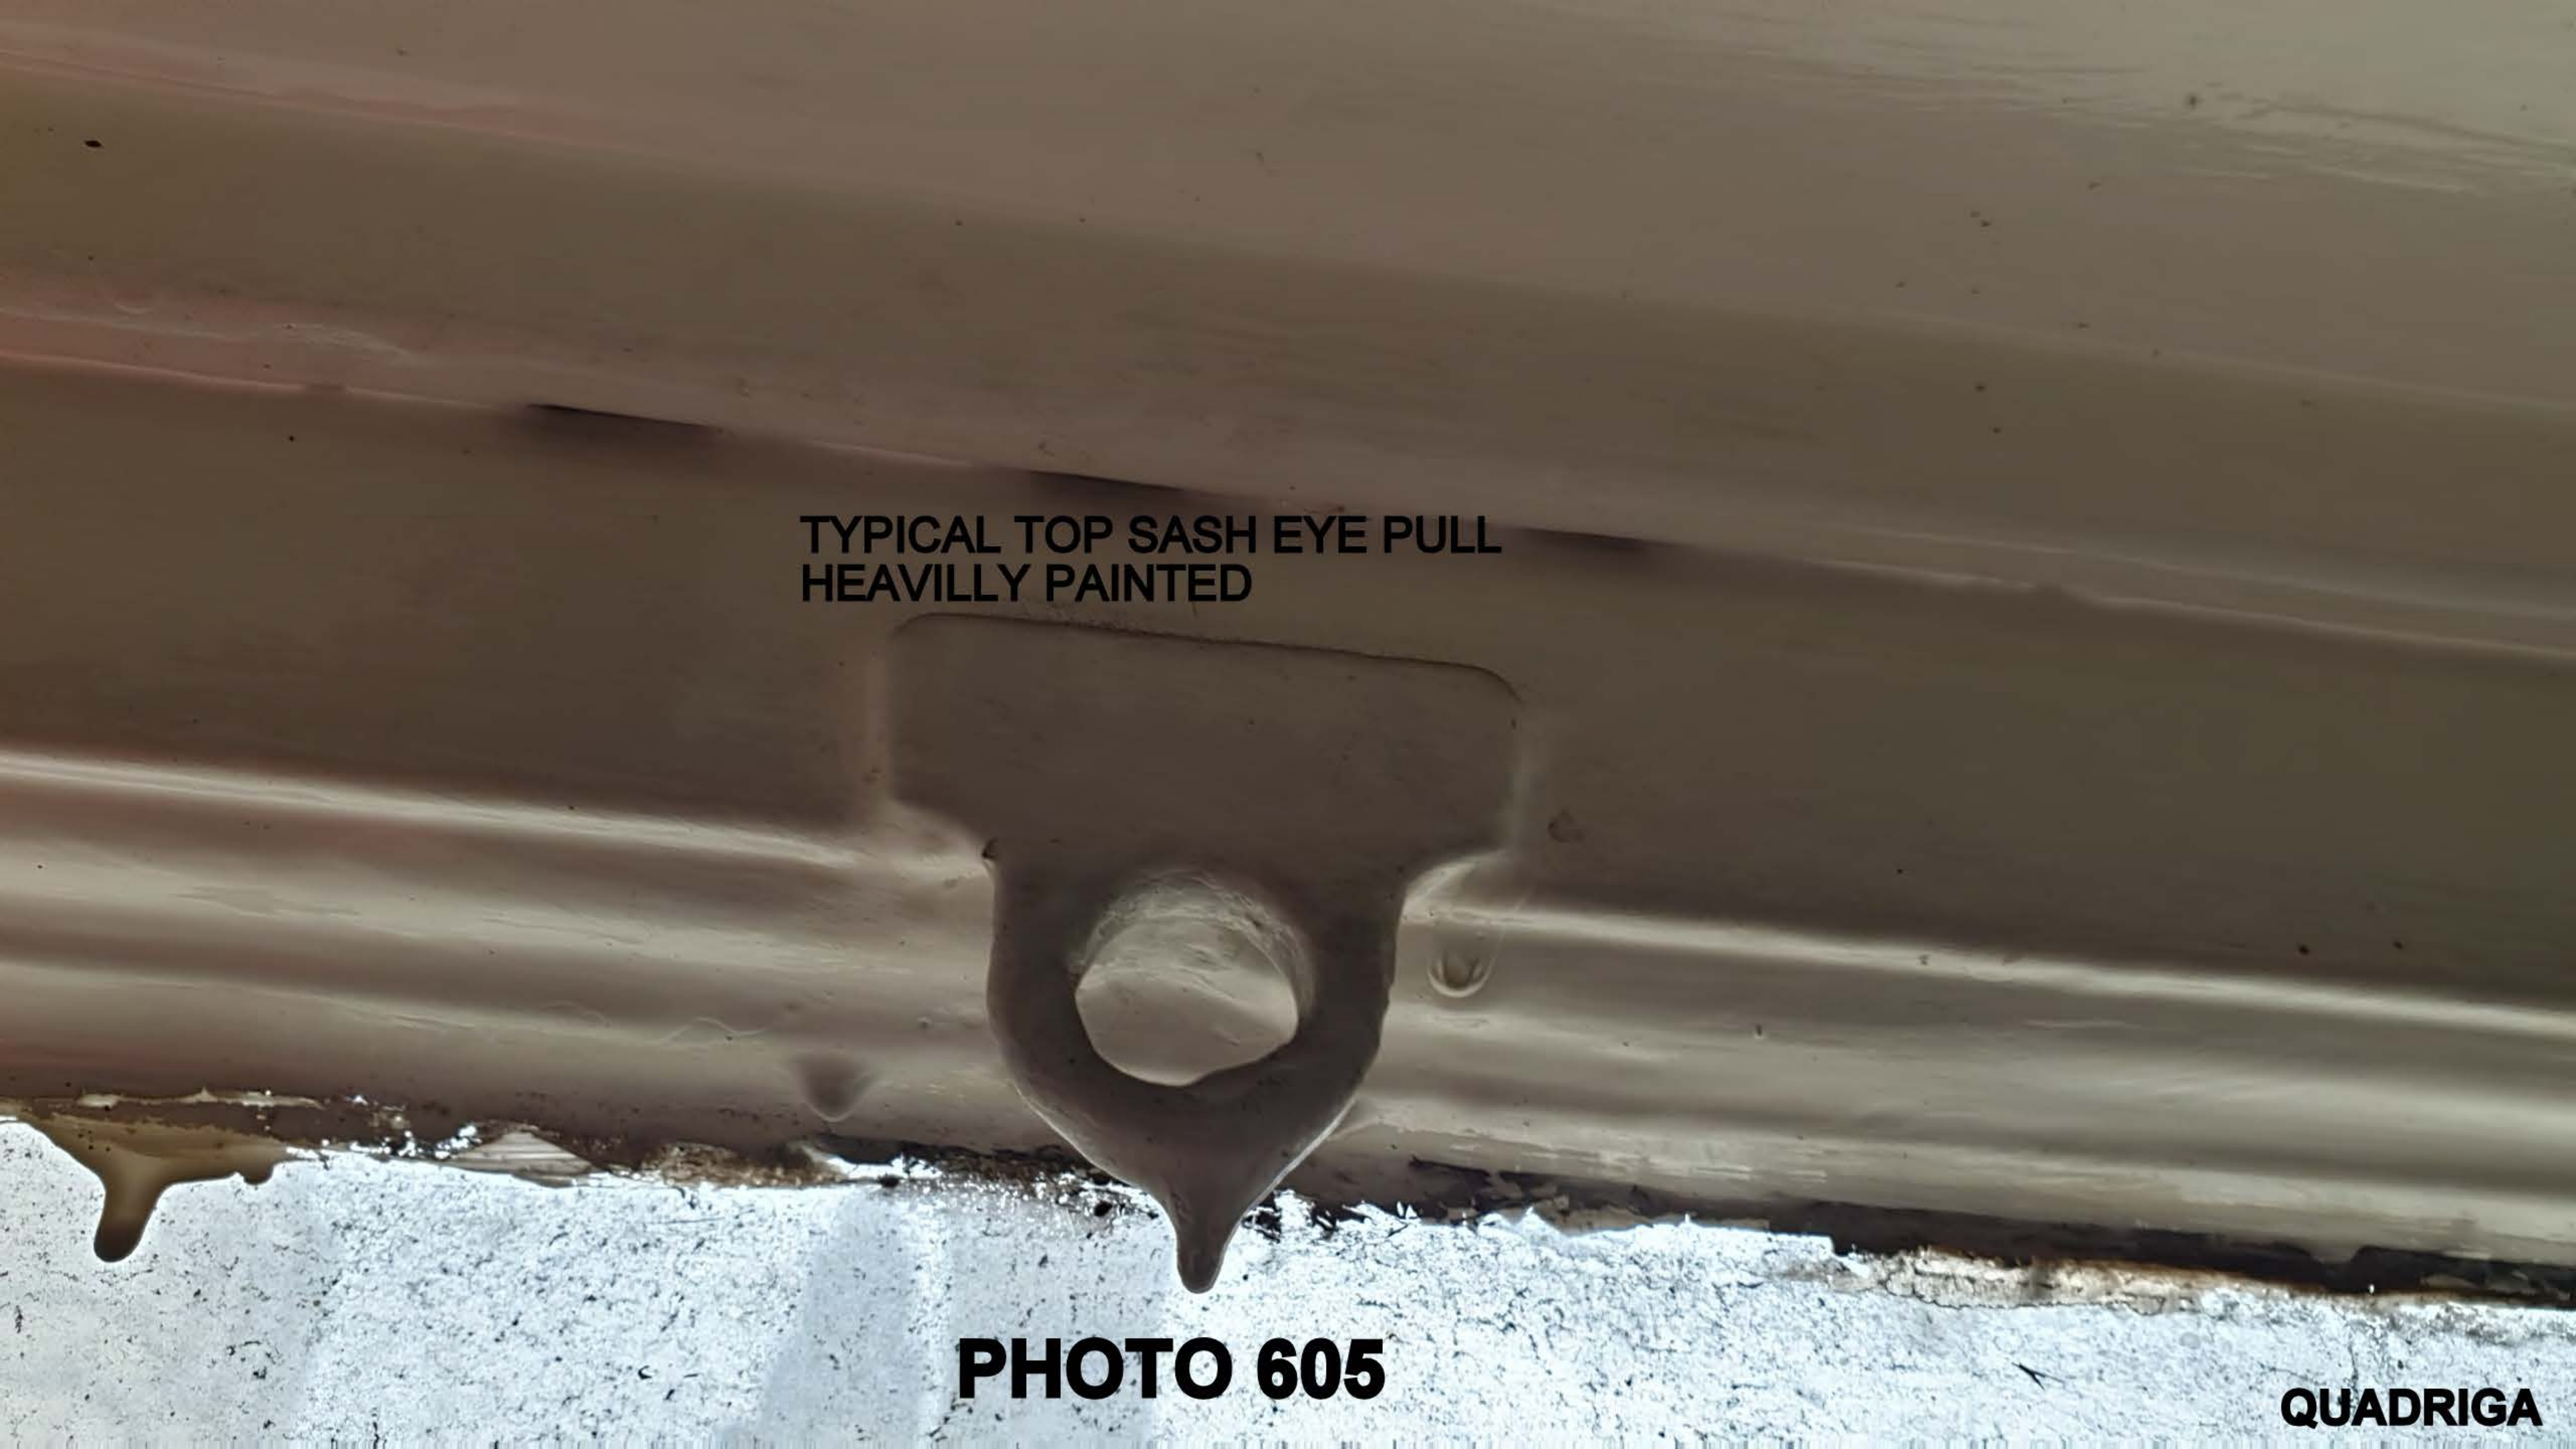
**PHOTO 545**

**TYPICAL SASH  
FASTNER HEAVILY  
PAINTED**
