| Project: | LONDON ROAD FIRE STATION |

| Drg Title: | FIRST FLOOR OBSERVATIONS<br>SHEET 2 OF 3 |

| 060270 / 10-01-02 | V01 |

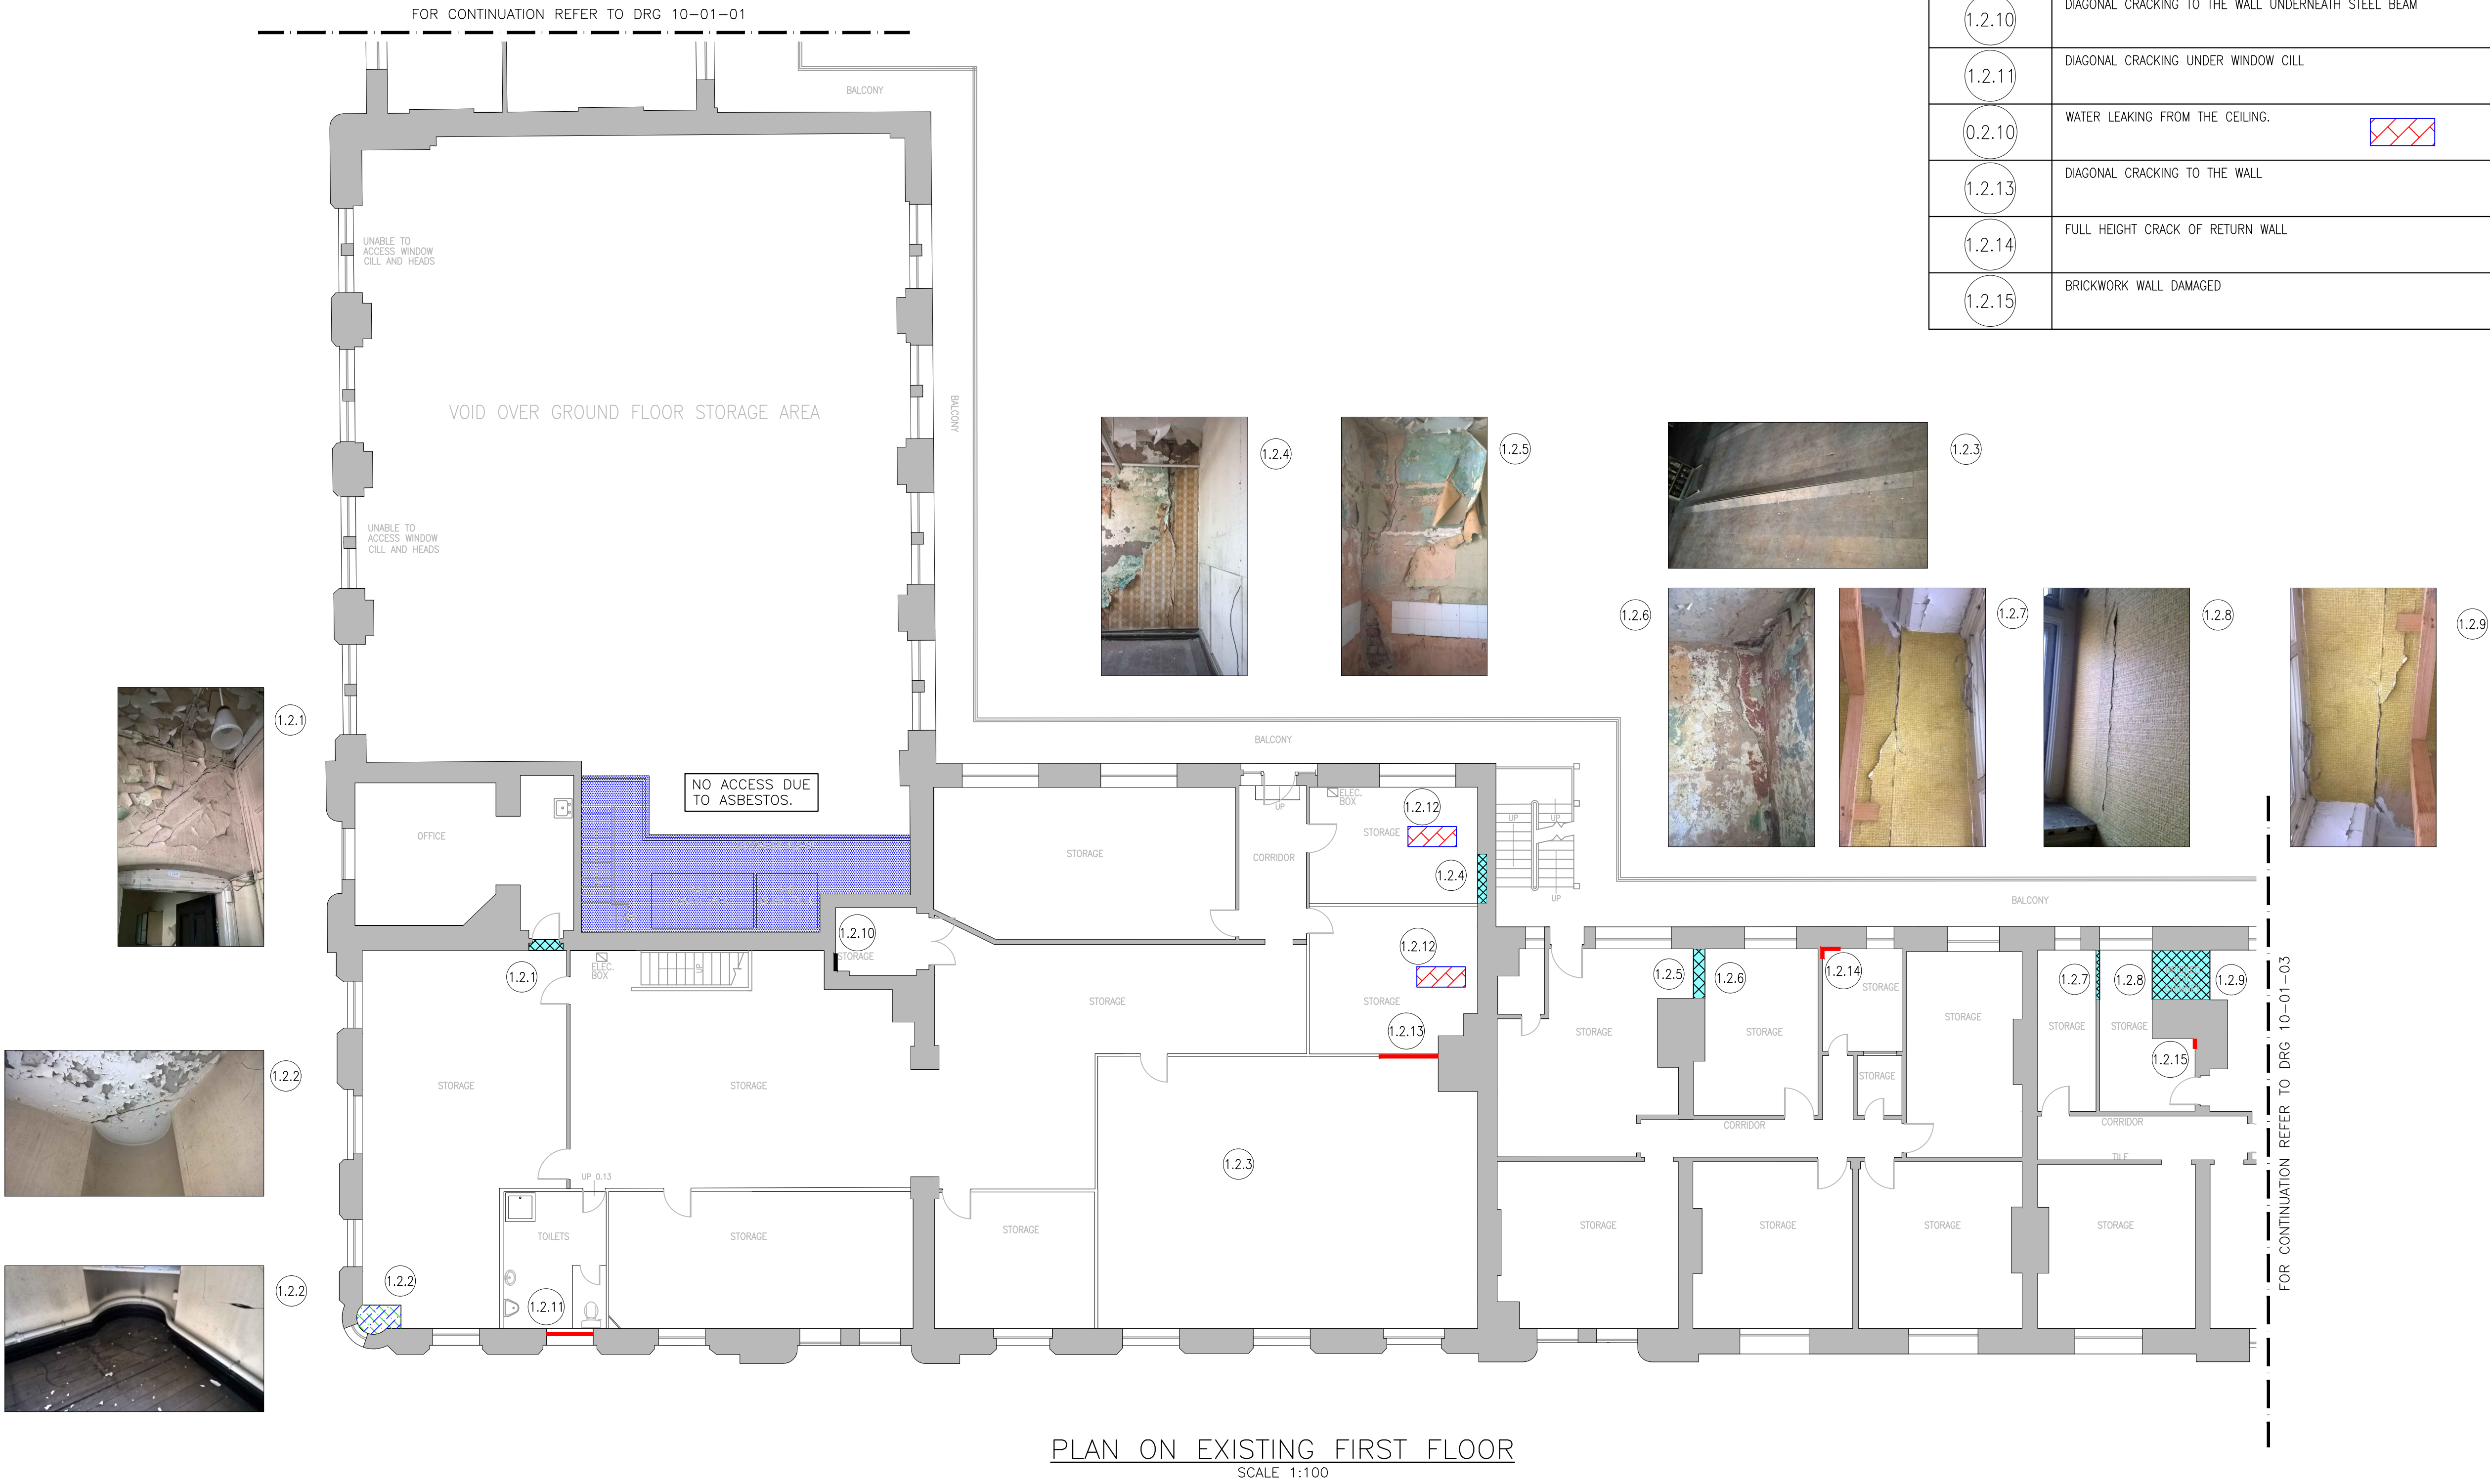
| REF | OBSERVATION |
|---|---|
| 1.2.1 | DIAGONAL CRACK TO BOTH SIDE OF WALL ABOVE DOOR. |
| 1.2.2 | CRACK TO CORNER OF CEILING AND EVIDENCE OF WATER DAMAGE TO TIMBER FLOOR. |
| 1.2.3 | TIMBER FLOOR WARPED DUE TO PREVIOUS DAMP. |
| 1.2.4 | DIAGONAL CRACKING TO WALL EVIDENT TO ONE SIDE ONLY. |
| 1.2.5 | DIAGONAL CRACK TO WALL EVIDENT TO BOTH SIDES. CRACK EXTENDS FULL HEIGHT. |
| 1.2.6 | DIAGONAL CRACK TO WALL EVIDENT TO BOTH SIDES. CRACK EXTENDS FULL HEIGHT. |
| 1.2.7 | FULL HEIGHT STRAIGHT CRACK TO PLASTER TO PARTITION WALL. |
| 1.2.8 | FULL HEIGHT STRAIGHT CRACK TO BOTH SIDES. POTENTIAL VOID BEHIND WALL. |
| 1.2.9 | FULL HEIGHT STRAIGHT CRACK TO BOTH SIDES. POTENTIAL VOID BEHIND WALL. |
| 1.2.10 | DIAGONAL CRACKING TO THE WALL UNDERNEATH STEEL BEAM |
| 1.2.11 | DIAGONAL CRACKING UNDER WINDOW CILL |
| 0.2.10 | WATER LEAKING FROM THE CEILING. |
| 1.2.13 | DIAGONAL CRACKING TO THE WALL |
| 1.2.14 | FULL HEIGHT CRACK OF RETURN WALL |
| 1.2.15 | BRICKWORK WALL DAMAGED |
