# Asbestos Reinspection Survey

**Site Address:**  
South Court  
Sharston Road  
Manchester  
M22 4BB

**MRICode:** ROF042

**Date of Survey:**  
21/11/2017

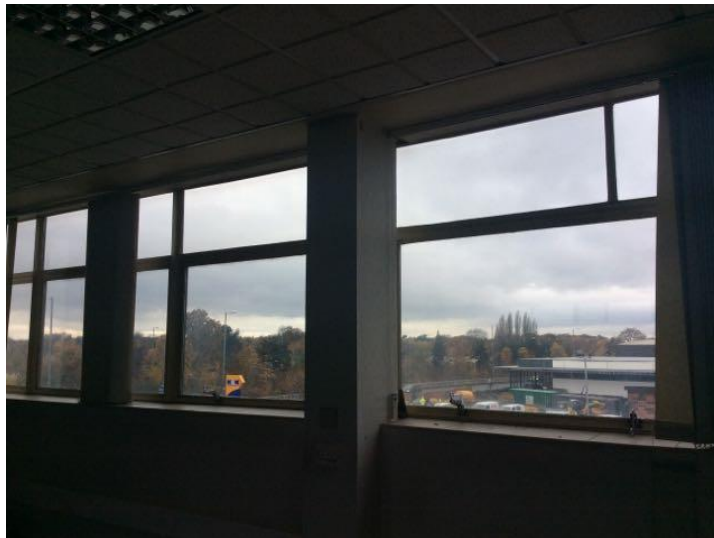
| Sample No. | AS07 | Amount | 140 m <sup>2</sup> |

| Room Name | Vacant Office Block C | Precise Location | Boxing's |

| Condition | Low (Some Minor Damage) | Risk Category | Low |
| Surface Treatment | Sealed | | |
| Comments | Leave in situ and do not disturb. Ensure all employees, contractors and tenants who are likely to come into contact with the ACM are made aware. | | |

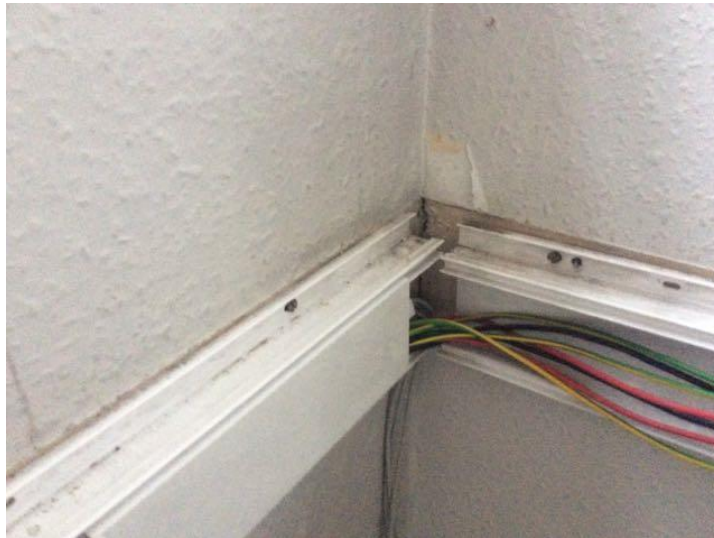
| Sample No. | <b>S19562-07</b> | Amount | 50 m <sup>2</sup> |

| Room Name | Vacant Office Block C | Precise Location | Boxing to corner of Office |

| Condition | Medium Damage | Risk Category | <b>Medium</b> |
| Surface Treatment | Partially Unsealed | | |
| Comments | <p>Encapsulate using a licensed asbestos contractor and do not disturb. Ensure all employees, contractors and tenants who are likely to come into contact with the ACM are made aware.</p> <p>Small damaged area needs attention.</p> | | |

| Sample No. | Location<br>(Building, Floor, Room) | ACM | Risk Category | Action | Comments |
|---|---|---|---|---|---|
| S19562-07 | Main, 2nd Floor, Vacant Office Block C | Insulating Board, Boxing's to corner of Office | Medium | Encapsulate | Encapsulate using a licensed asbestos contractor and do not disturb. Ensure all employees, contractors and tenants who are likely to come into contact with the ACM are made aware.<br><br>Small damaged area needs attention. |

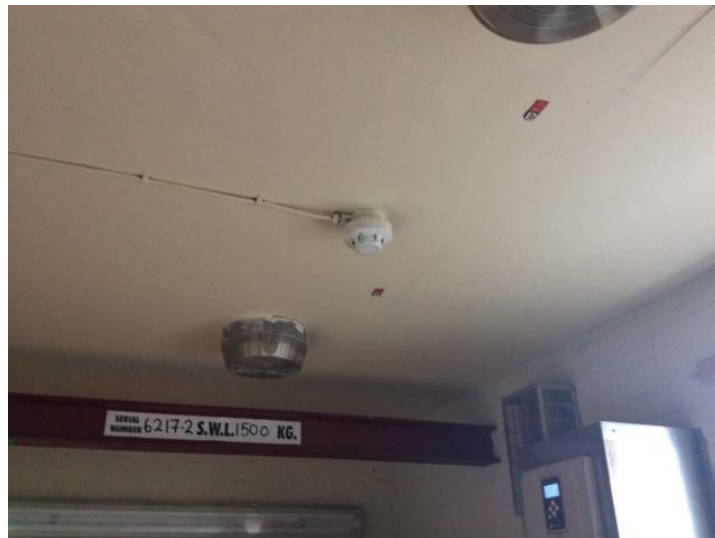
| Sample No. | AS01 | Amount | 20 m <sup>2</sup> |

| Room Name | Lift Motor Room Block B/C | Precise Location | Ceiling |

| Condition | Low (Some Minor Damage) | Risk Category | Low |
| Comments | Leave in situ and do not disturb. Ensure all employees, contractors and tenants who are likely to come into contact with the ACM are made aware. | | |

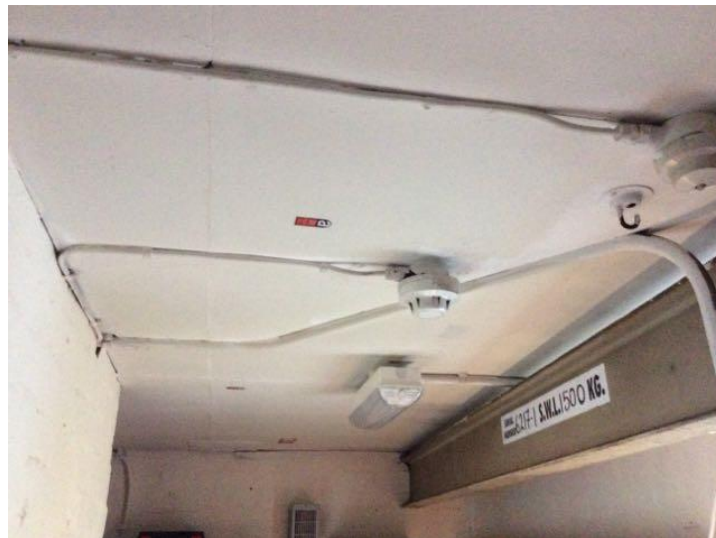
| Sample No. | <b>S19562-01</b> | Amount | 10 m <sup>2</sup> |

| Room Name | Lift Motor Room Block A | Precise Location | Ceiling |

| Condition | Low (Some Minor Damage) | Risk Category | <b>Low</b> |

Leave in situ and do not disturb. Ensure all employees, contractors and tenants who are likely to come into contact with the ACM are made aware.

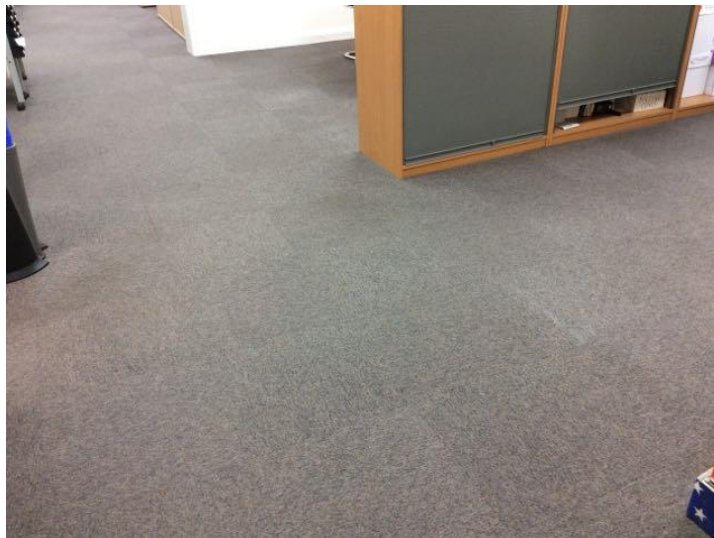
| Sample No. | <b>S9562-06</b> | Amount | 150 m <sup>2</sup> |

| Room Name | Vacant Room 55 | Precise Location | Floor Tile Under Screed |

| Condition | Low (Some Minor Damage) | Risk Category | <b>Very Low</b> |
| Comments | Leave in situ and do not disturb. Ensure all employees, contractors and tenants who are likely to come into contact with the ACM are made aware. | | |

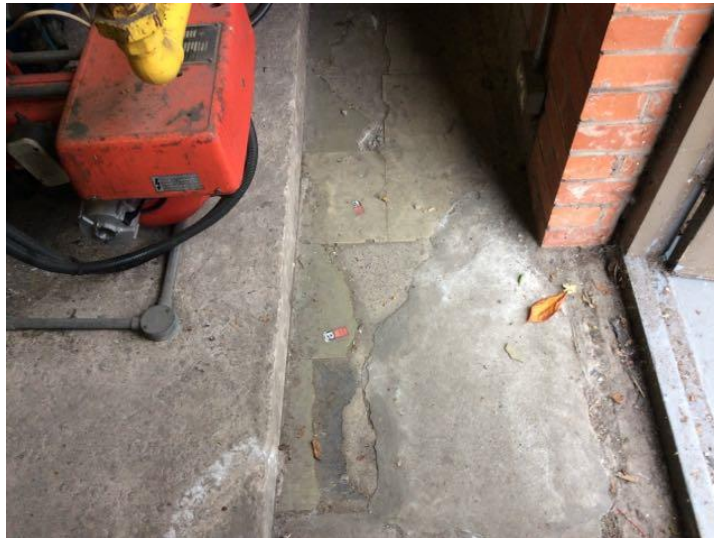
| Sample No. | <b>S19562-02</b> | Amount | 10 m <sup>2</sup> |

| Room Name | Boiler Room Block A | Precise Location | Floor Tiles |

| Condition | High (High Damage / Debris) | Risk Category | <b>Low</b> |
| Comments | Leave in situ and do not disturb. Ensure all employees, contractors and tenants who are likely to come into contact with the ACM are made aware. | | |

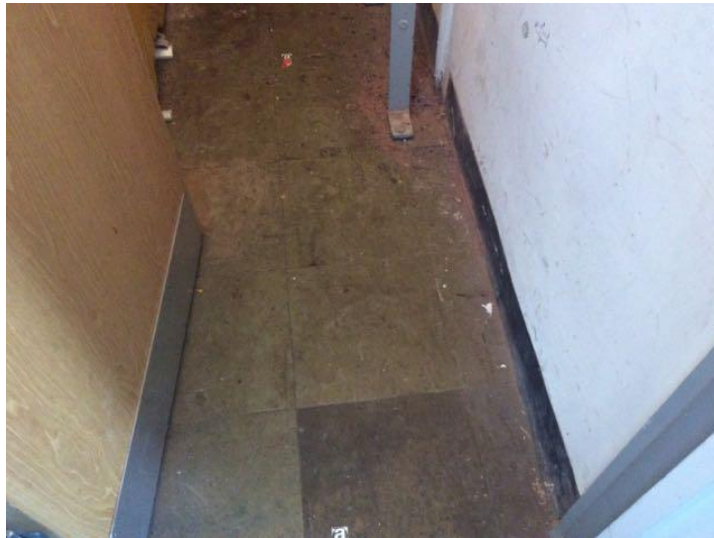
| Sample No. | As 02 | Amount | 2 m <sup>2</sup> |

| Room Name | Access to Lift Motor Room Block B/C | Precise Location | Floor Tiles |

| Condition | Low (Some Minor Damage) | Risk Category | <b>Very Low</b> |
| Comments | Leave in situ and do not disturb. Ensure all employees, contractors and tenants who are likely to come into contact with the ACM are made aware. | | |

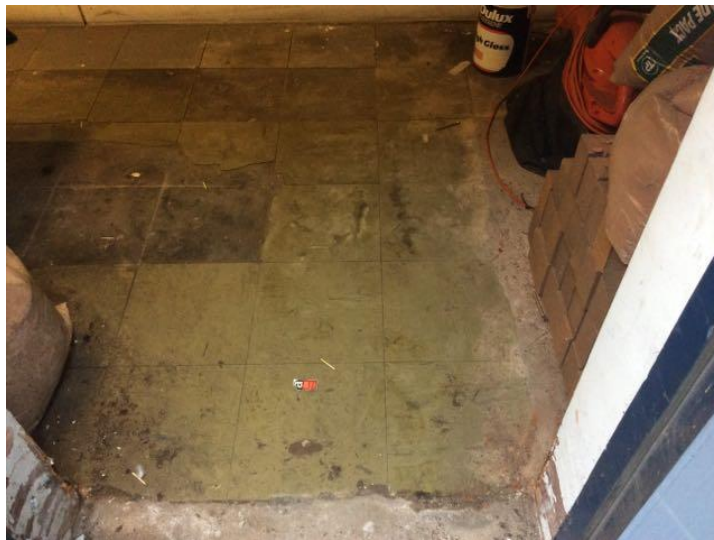
| Sample No. | As 02 | Amount | 12 m <sup>2</sup> |

| Room Name | Electric Intake Room Block C | Precise Location | Floor Tiles |

| Condition | High (High Damage / Debris) | Risk Category | Low |
| Comments | Leave in situ and do not disturb. Ensure all employees, contractors and tenants who are likely to come into contact with the ACM are made aware. | | |

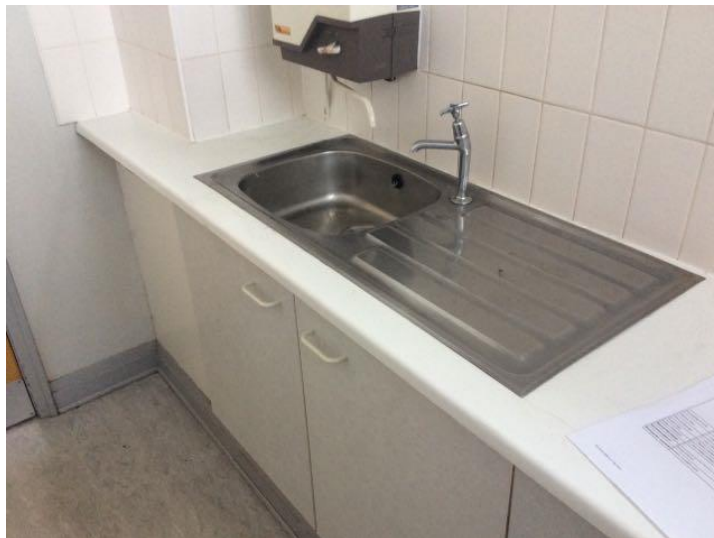
| Sample No. | <b>S19562-08</b> | Amount | 2 no |

| Room Name | Vacant Kitchen Block C | Precise Location | Sink Pad |

| Condition | Low (Some Minor Damage) | Risk Category | <b>Very Low</b> |
| Comments | Leave in situ and do not disturb. Ensure all employees, contractors and tenants who are likely to come into contact with the ACM are made aware. | | |

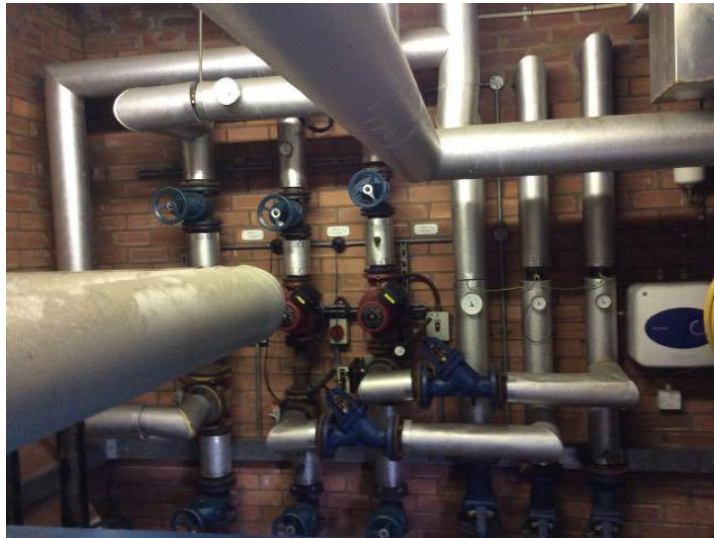
| Sample No. | <b>S19562-04</b> | Amount | 20 no |

| Room Name | Boiler Room Block A | Precise Location | Within Pipe Flanges |

| Condition | Low (Some Minor Damage) | Risk Category | <b>Very Low</b> |
| Comments | Leave in situ and do not disturb. Ensure all employees, contractors and tenants who are likely to come into contact with the ACM are made aware. | | |
