| Project: | LONDON ROAD FIRE STATION |

| Drg Title: | GROUND FLOOR OBSERVATIONS<br>SHEET 3 OF 3 |

| Drg No: | 060270 / 10-00-03 | Rev: | V01 |

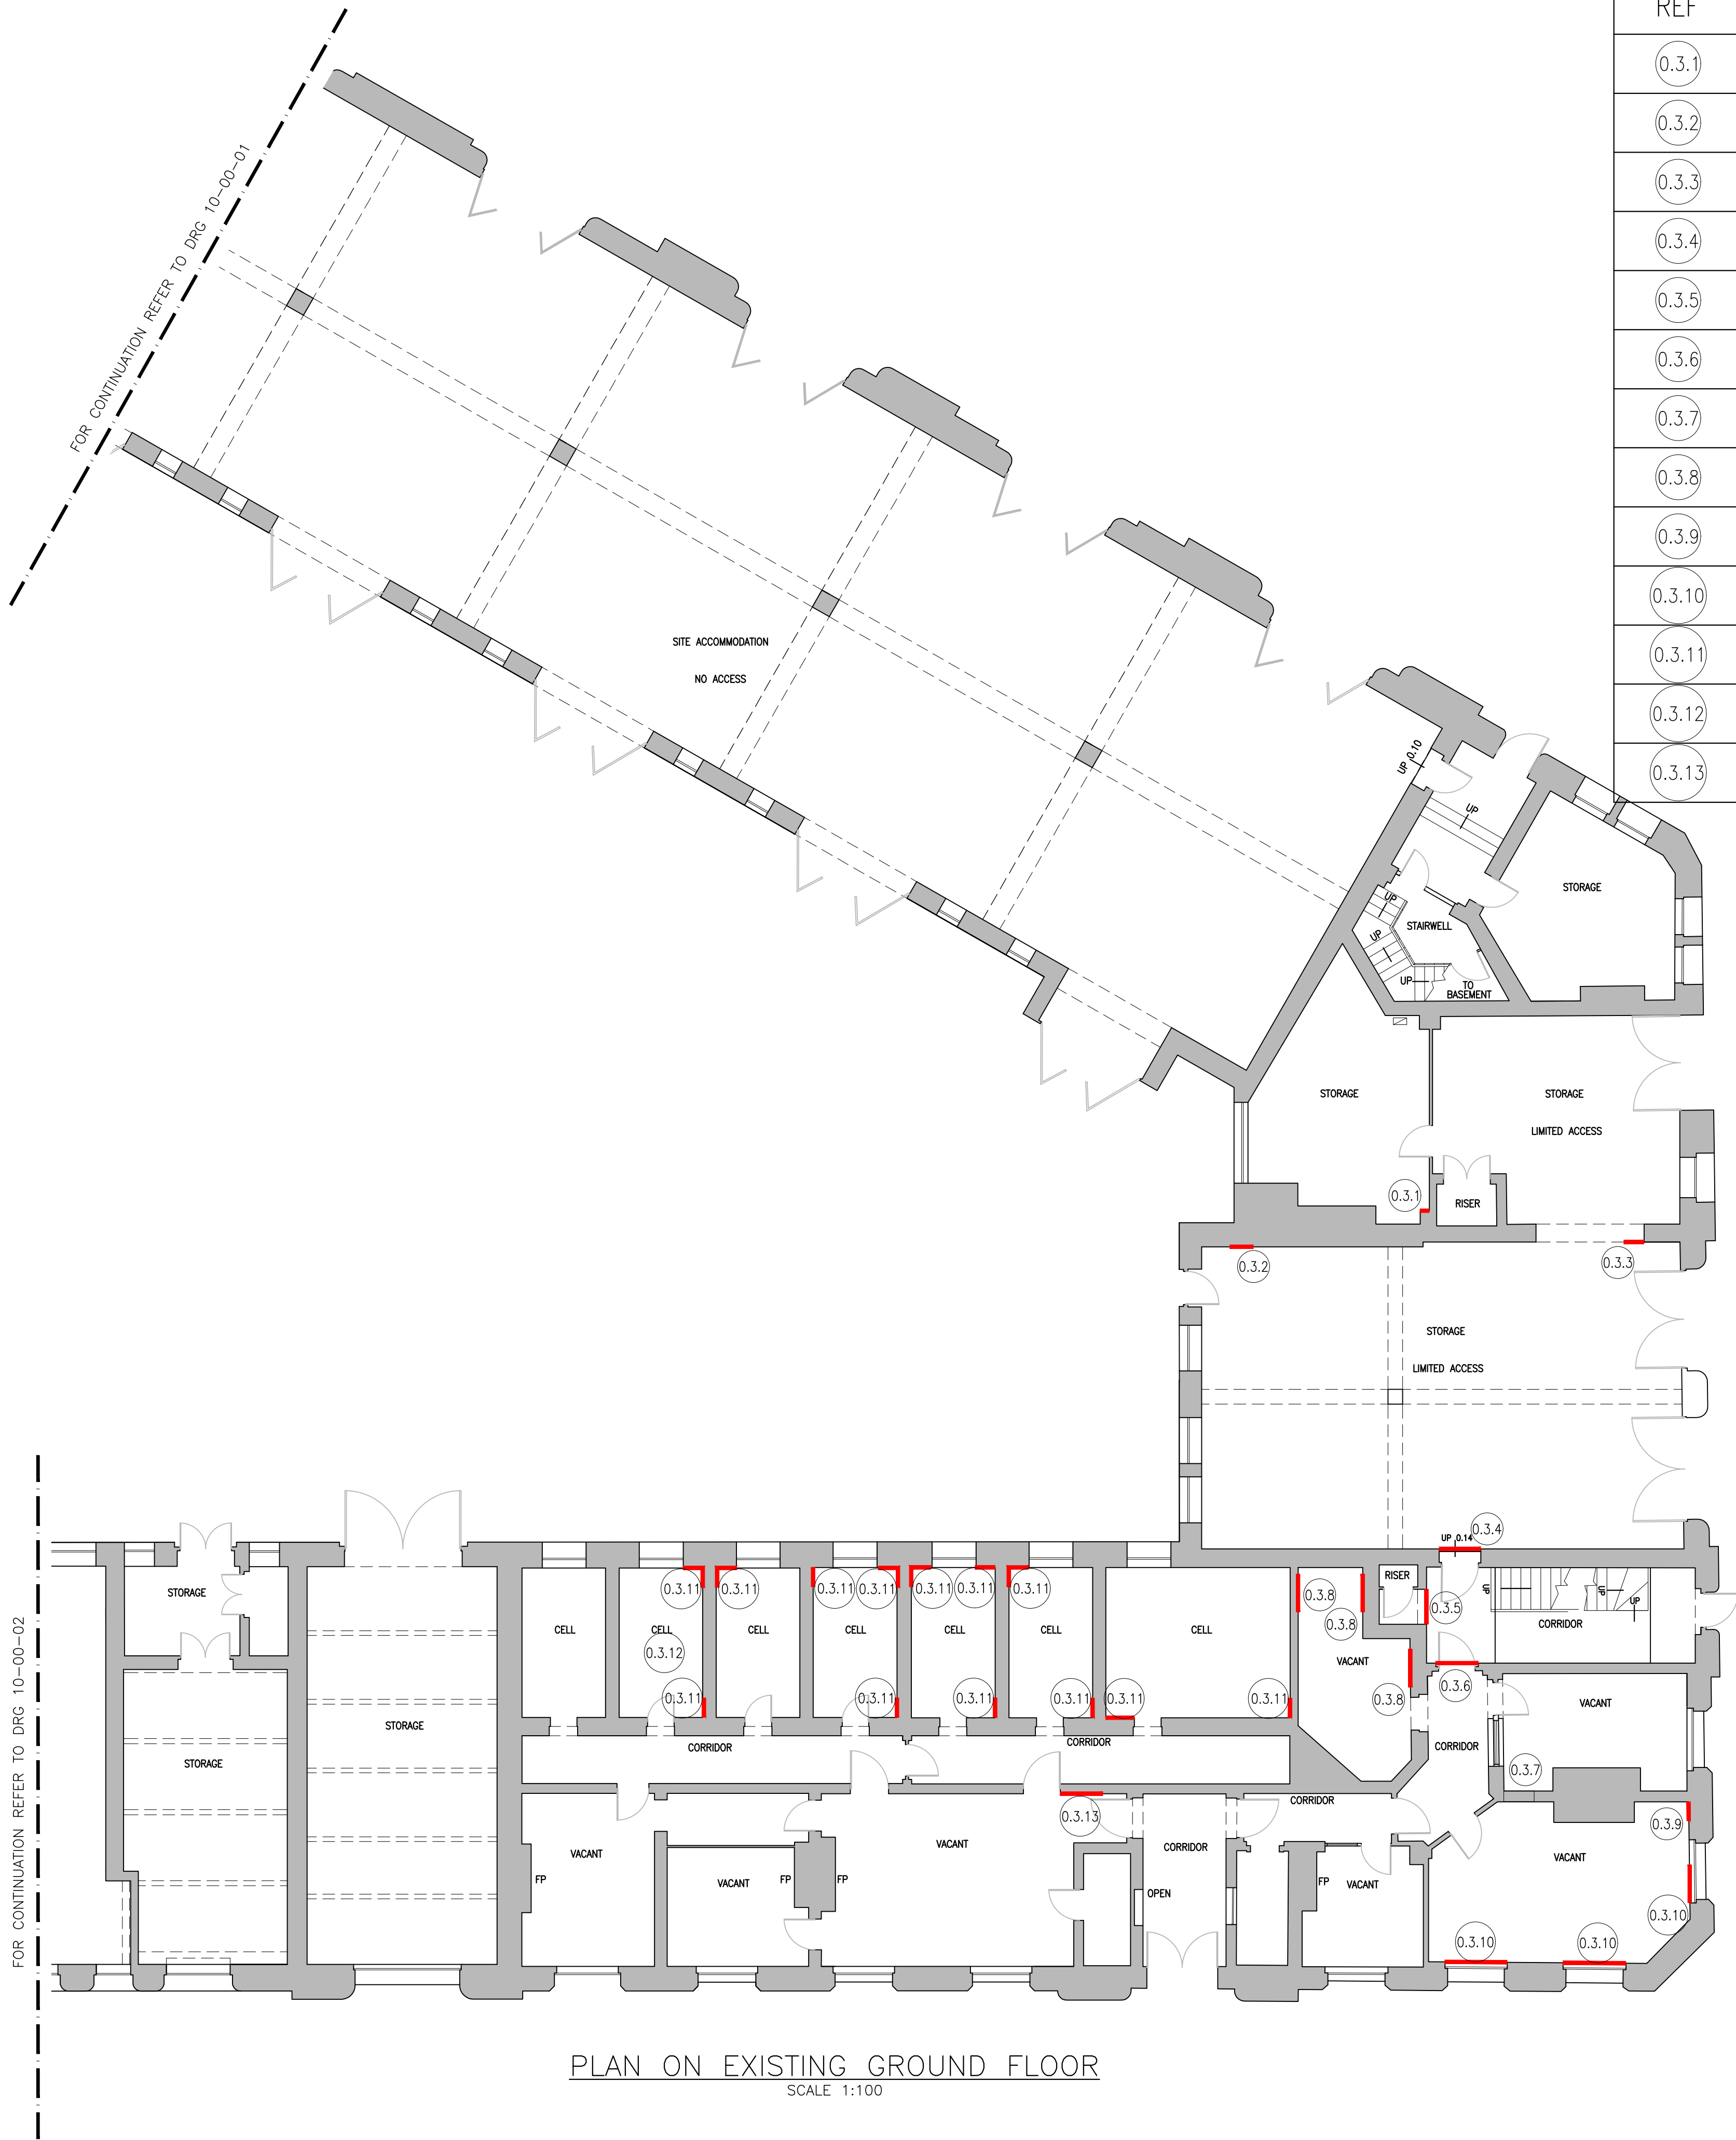
| REF | OBSERVATION |
|---|---|
| 0.3.1 | CRACKING TO THE RETURN WALL |
| 0.3.2 | FULL HEIGHT CRACKING TO THE WALL |
| 0.3.3 | DIAGONAL CRACKING ALONG THE MORTAR JOINTS |
| 0.3.4 | DIAGONAL CRACKING ALONG THE MORTAR JOINTS EVIDENT ON BOTH SIDES |
| 0.3.5 | DIAGONAL CRACKING ALONG THE MORTAR JOINTS FROM THE SOFIT DOWN THE DOOR ARCH |
| 0.3.6 | DIAGONAL CRACKING TO THE WALL |
| 0.3.7 | DIAGONAL CRACKING TO THE WALL FINISHES EVIDENT ON BOTH SIDES |
| 0.3.8 | VARIOUS DIAGONAL CRACKING TO THE WALLS |
| 0.3.9 | DIAGONAL CRACKING TO THE WALL |
| 0.3.10 | DIAGONAL CRACKING ALONG THE MORTAR JOINTS UNDER THE WINDOW CILLS. |
| 0.3.11 | DIAGONAL CRACKING ALONG THE MORTAR JOINTS. |
| 0.3.12 | WATER LEAKING FROM THE CEILING |
| 0.3.13 | DIAGONAL CRACKING TO THE WALL |
