**LONDON ROAD FIRE STATION**

**THIRD FLOOR OBSERVATIONS  
SHEET 3 OF 3**

**060270 / 10-03-03**

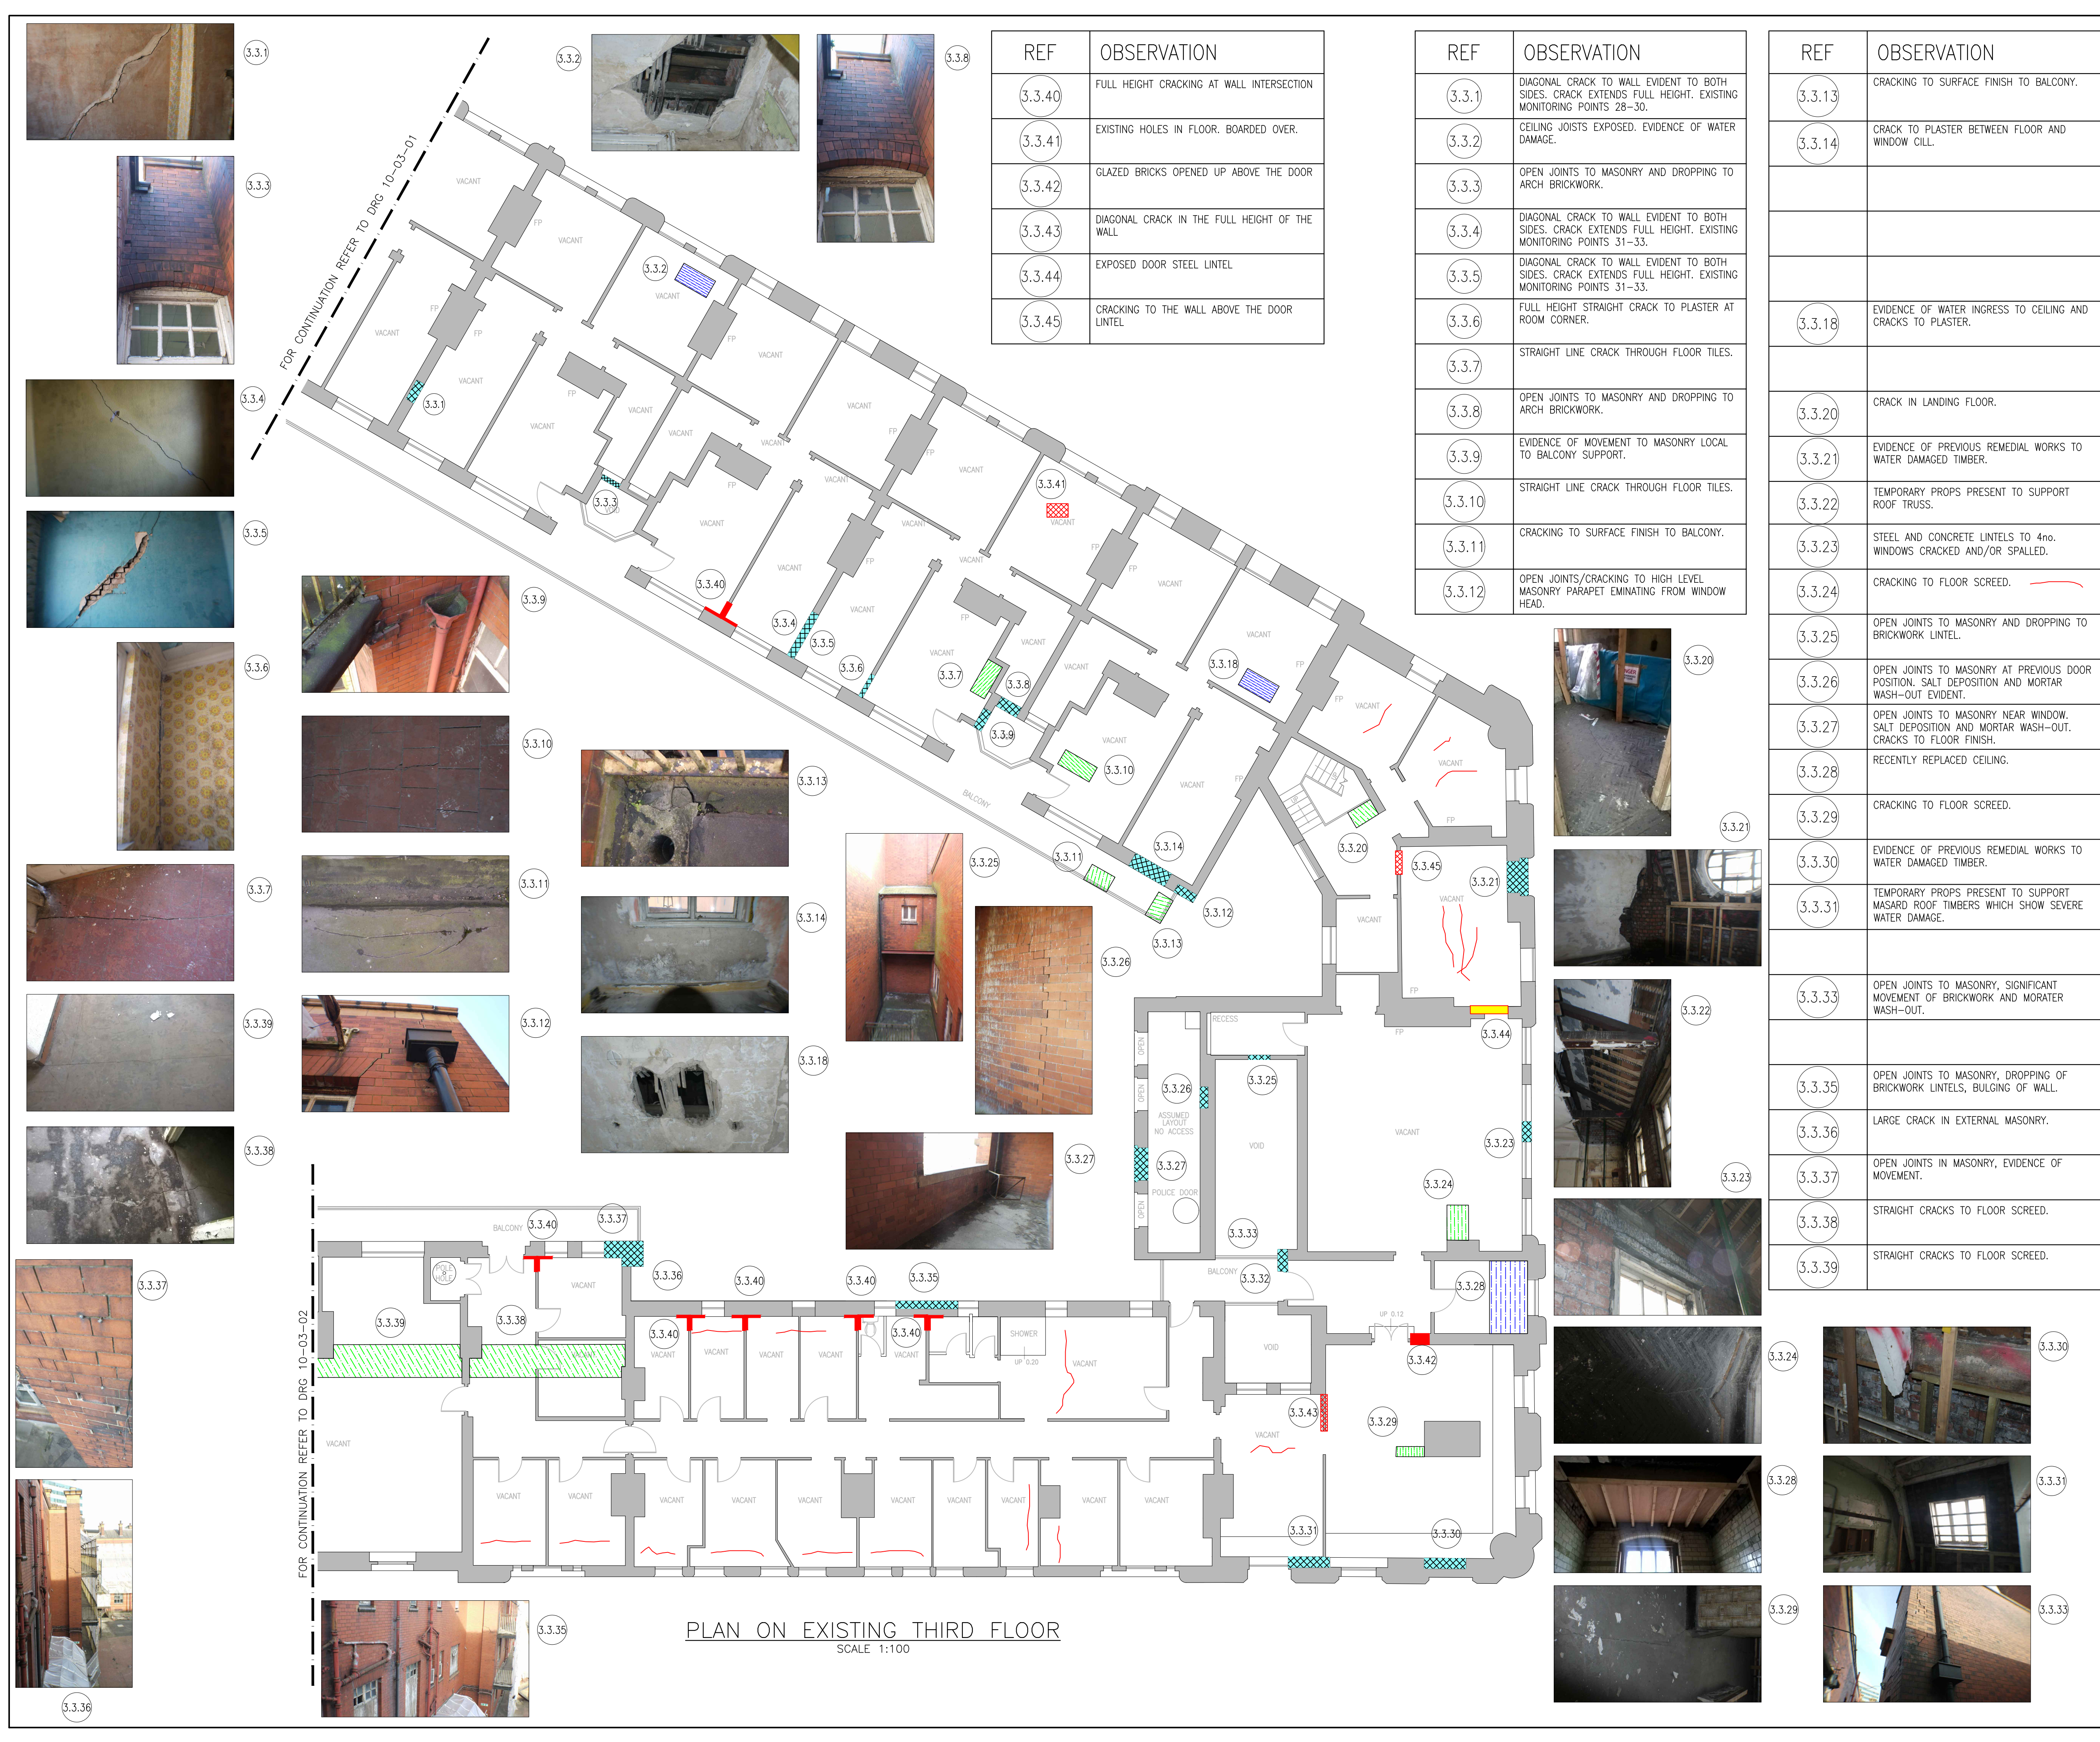
| REF | OBSERVATION |
|---|---|
| 3.3.40 | FULL HEIGHT CRACKING AT WALL INTERSECTION |
| 3.3.41 | EXISTING HOLES IN FLOOR, BOARDED OVER. |
| 3.3.42 | GLAZED BRICKS OPENED UP ABOVE THE DOOR |
| 3.3.43 | DIAGONAL CRACK IN THE FULL HEIGHT OF THE WALL |
| 3.3.44 | EXPOSED DOOR STEEL LINTEL |
| 3.3.45 | CRACKING TO THE WALL ABOVE THE DOOR LINTEL |

| REF | OBSERVATION |
|---|---|
| 3.3.1 | DIAGONAL CRACK TO WALL EVIDENT TO BOTH SIDES. CRACK EXTENDS FULL HEIGHT. EXISTING MONITORING POINTS 28-30. |
| 3.3.2 | CEILING JOISTS EXPOSED. EVIDENCE OF WATER DAMAGE. |
| 3.3.3 | OPEN JOINTS TO MASONRY AND DROPPING TO ARCH BRICKWORK. |
| 3.3.4 | DIAGONAL CRACK TO WALL EVIDENT TO BOTH SIDES. CRACK EXTENDS FULL HEIGHT. EXISTING MONITORING POINTS 31-33. |
| 3.3.5 | DIAGONAL CRACK TO WALL EVIDENT TO BOTH SIDES. CRACK EXTENDS FULL HEIGHT. EXISTING MONITORING POINTS 31-33. |
| 3.3.6 | FULL HEIGHT STRAIGHT CRACK TO PLASTER AT ROOM CORNER. |
| 3.3.7 | STRAIGHT LINE CRACK THROUGH FLOOR TILES. |
| 3.3.8 | OPEN JOINTS TO MASONRY AND DROPPING TO ARCH BRICKWORK. |
| 3.3.9 | EVIDENCE OF MOVEMENT TO MASONRY LOCAL TO BALCONY SUPPORT. |
| 3.3.10 | STRAIGHT LINE CRACK THROUGH FLOOR TILES. |
| 3.3.11 | CRACKING TO SURFACE FINISH TO BALCONY. |
| 3.3.12 | OPEN JOINTS/CRACKING TO HIGH LEVEL MASONRY PARAPET EMINATING FROM WINDOW HEAD. |

| REF | OBSERVATION |
|---|---|
| 3.3.13 | CRACKING TO SURFACE FINISH TO BALCONY. |
| 3.3.14 | CRACK TO PLASTER BETWEEN FLOOR AND WINDOW CILL. |
| 3.3.18 | EVIDENCE OF WATER INGRESS TO CEILING AND CRACKS TO PLASTER. |
| 3.3.20 | CRACK IN LANDING FLOOR. |
| 3.3.21 | EVIDENCE OF PREVIOUS REMEDIAL WORKS TO WATER DAMAGED TIMBER. |
| 3.3.22 | TEMPORARY PROPS PRESENT TO SUPPORT ROOF TRUSS. |
| 3.3.23 | STEEL AND CONCRETE LINTELS TO 4no. WINDOWS CRACKED AND/OR SPALLED. |
| 3.3.24 | CRACKING TO FLOOR SCREED. |
| 3.3.25 | OPEN JOINTS TO MASONRY AND DROPPING TO BRICKWORK LINTEL. |
| 3.3.26 | OPEN JOINTS TO MASONRY AT PREVIOUS DOOR POSITION. SALT DEPOSITION AND MORTAR WASH-OUT EVIDENT. |
| 3.3.27 | OPEN JOINTS TO MASONRY NEAR WINDOW. SALT DEPOSITION AND MORTAR WASH-OUT. CRACKS TO FLOOR FINISH. |
| 3.3.28 | RECENTLY REPLACED CEILING. |
| 3.3.29 | CRACKING TO FLOOR SCREED. |
| 3.3.30 | EVIDENCE OF PREVIOUS REMEDIAL WORKS TO WATER DAMAGED TIMBER. |
| 3.3.31 | TEMPORARY PROPS PRESENT TO SUPPORT MASARD ROOF TIMBERS WHICH SHOW SEVERE WATER DAMAGE. |
| 3.3.33 | OPEN JOINTS TO MASONRY, SIGNIFICANT MOVEMENT OF BRICKWORK AND MORATER WASH-OUT. |
| 3.3.35 | OPEN JOINTS TO MASONRY, DROPPING OF BRICKWORK LINTELS, BULGING OF WALL. |
| 3.3.36 | LARGE CRACK IN EXTERNAL MASONRY. |
| 3.3.37 | OPEN JOINTS IN MASONRY, EVIDENCE OF MOVEMENT. |
| 3.3.38 | STRAIGHT CRACKS TO FLOOR SCREED. |
| 3.3.39 | STRAIGHT CRACKS TO FLOOR SCREED. |
