# DAYTIME BAT SURVEY OF 7 RAINFORTH STREET, LONGSIGHT, MANCHESTER

MARCH 2020

**RACHEL HACKING ECOLOGY**

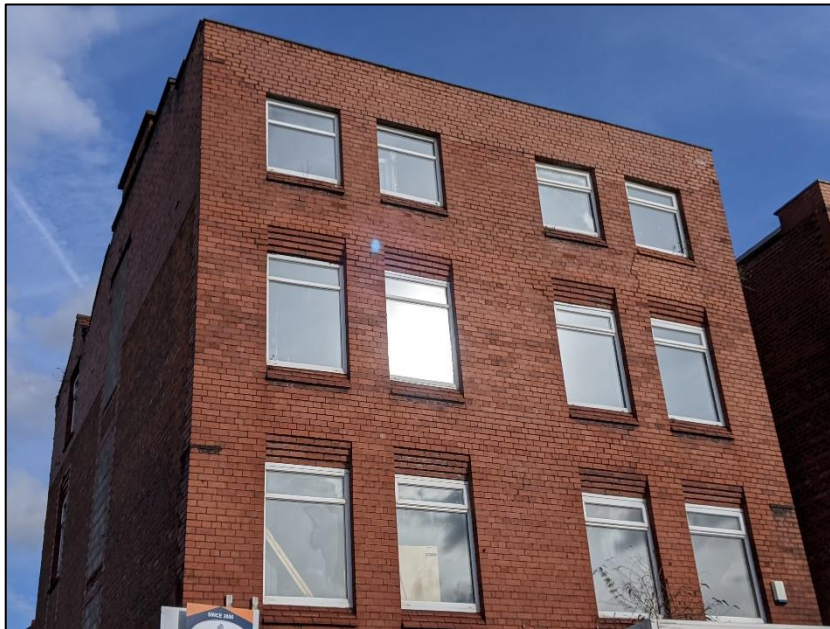
- 3.1 The property is constructed from brick and has a pitched, tiled roof. The external brickwork is complete and intact on the front elevation, with no significantly damaged bricks or recessed mortar. The window frames are flush to the surrounding masonry (see Photograph 1). The brick lintels are complete and intact.

**Photograph 1 showing the front elevation of the property**

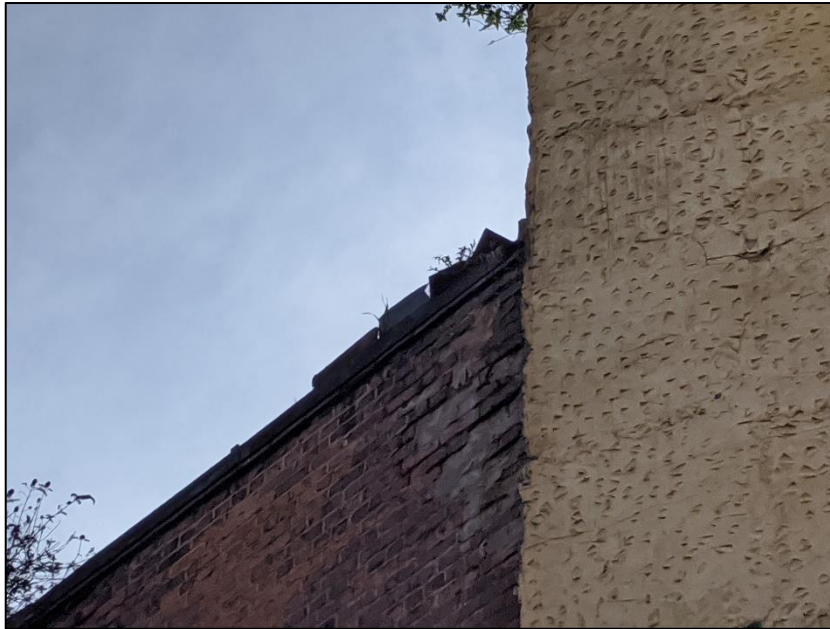
- 3.2 The brickwork on the rear elevation is partially damaged in places, though none of the damaged bricks present cavities suitable for bats to roost within. Vegetation is penetrating parts of the external brickwork. Rainwater is also affecting the brickwork.
- 3.3 The roof is not fully visible at ground-level. Several tiles are damaged at the roof edges (see Photograph 2). The upper brick courses are intact. One elevation has a cement render, which is complete and offers no gaps or cracks for bats to exploit.

**Photograph 2 showing the broken roofing tiles**

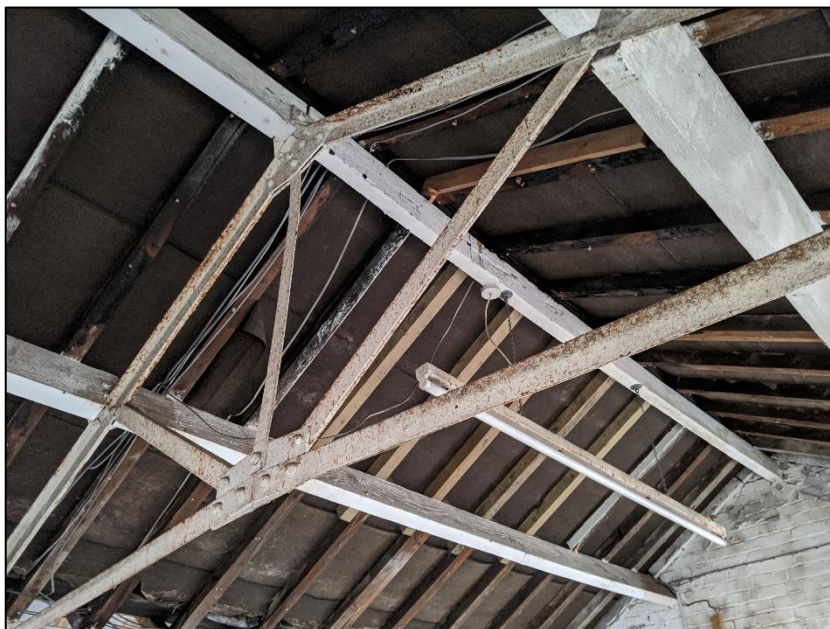
- 3.4 The interior of the property is split over several floors and is currently unoccupied. The ground floors and most of the remaining floors offer no suitable bat roosting habitat. The uppermost floor is open to the roof and has no separate roof void (see Photograph 3). The wooden and metal roof joists are complete and without gaps or cracks for bats to exploit. The roof is lined throughout, with no major tears or rips in the lining. Parts of the roof are lined with roofing felt, with one section lined with Breathable Roofing Membrane (see Photograph 4). Several roof beams are damp, suggesting rainwater is accessing the internal space.

**Photograph 3 showing the roof structure of the upper floor**

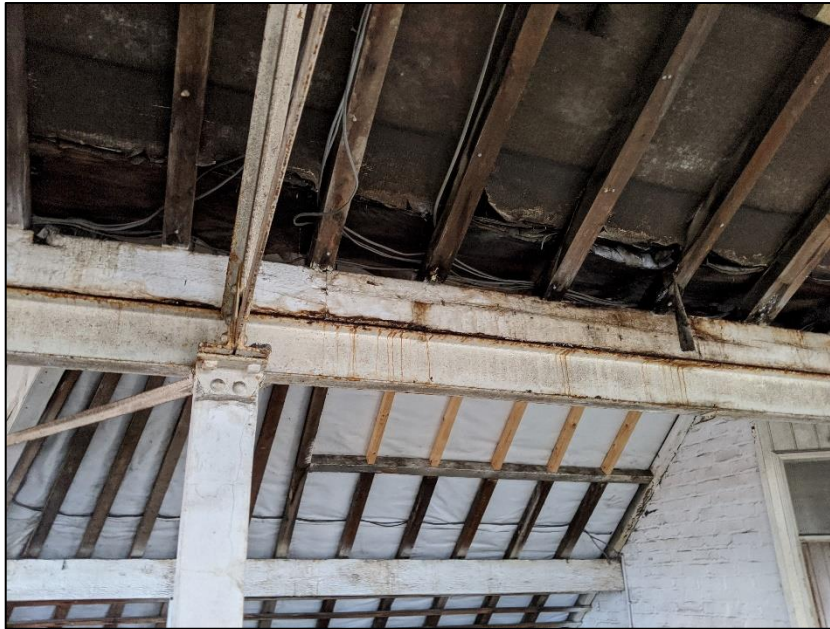
**Photograph 4 showing the roof linings**

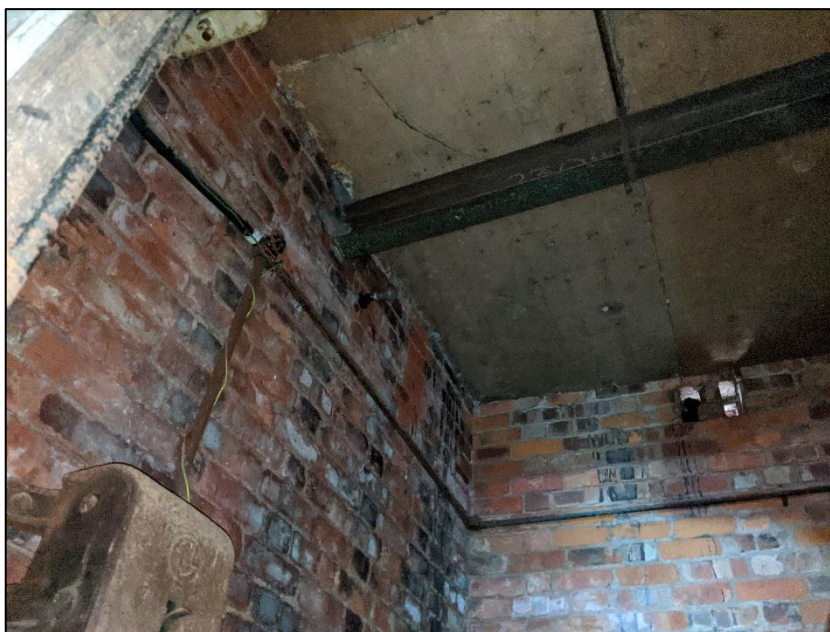
- 3.5 The internal brickwork is complete and intact, offering no gaps in the mortar for bats to exploit. The upper floor is well-lit internally. The roof edges are well-sealed internally.
- 3.6 A section of the roof is elevated and houses the motor mechanism for the lift (see Photograph 5). The lift motor room has a flat roof, and is well-sealed, offering no gaps where the roof meets the internal masonry.

**Photograph 5 showing the lift motor room**

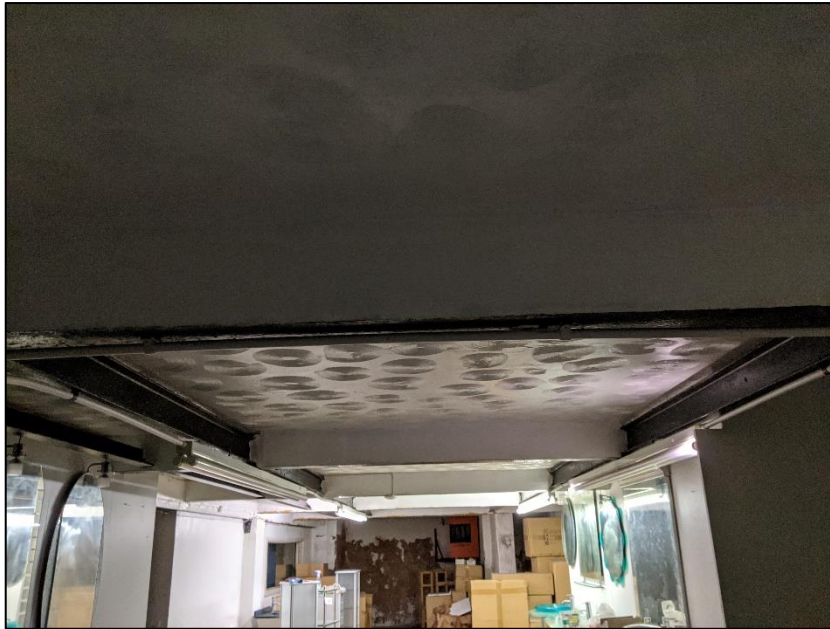
- 3.8 The property has an extensive cellar space (see Photographs 6 and 7). The space is well-lit and offers no suitable bat roosting spaces. The walls are plaster-boarded, and no potential points of entry for bats could be located. No evidence of bat activity was located in the cellar space.

**Photograph 6 showing the basement**

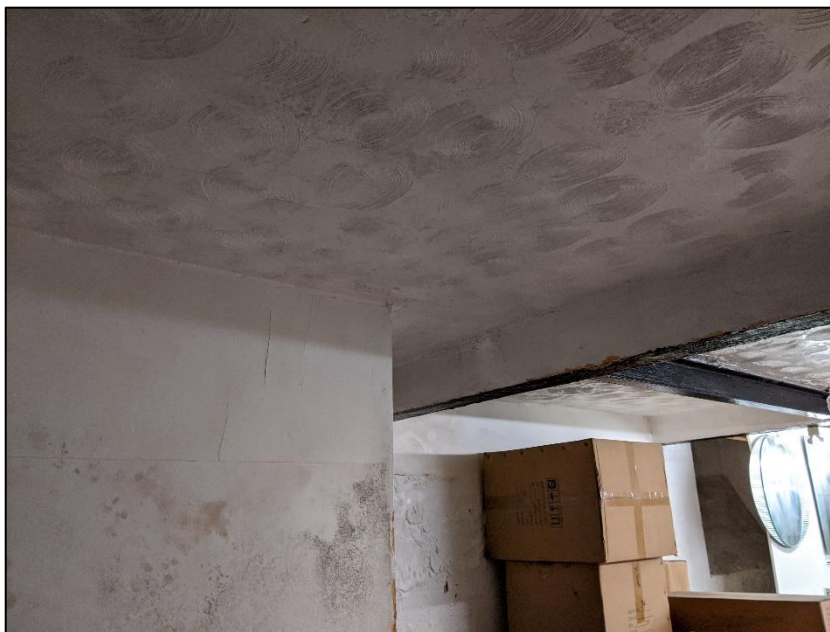
**Photograph 7 showing the basement**
