| Project: | LONDON ROAD FIRE STATION | | | |
| Drg Title: | THIRD FLOOR OBSERVATIONS<br>SHEET 1 OF 3 | | | |
| Drg No: | 060270 / 10-03-01 | | | Rev:<br><br>V02 |

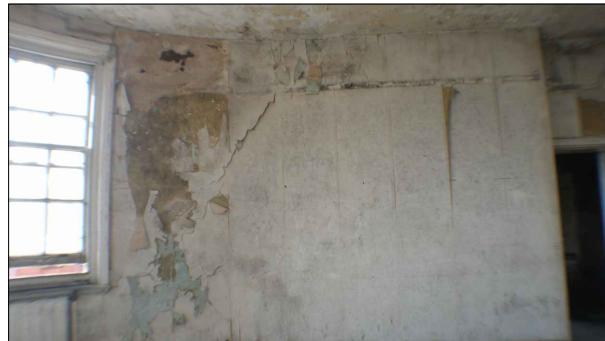
| REF | OBSERVATION |
|---|---|
| 3.1.11 | HIGH LEVEL CRACK TO PLASTER |

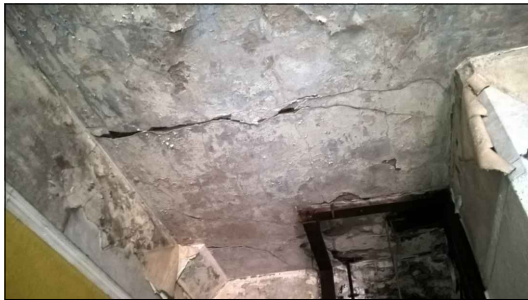
| REF | OBSERVATION |
|---|---|
| 3.1.10 | LARGE STRAIGHT CRACK TO CEILING FINISHES |

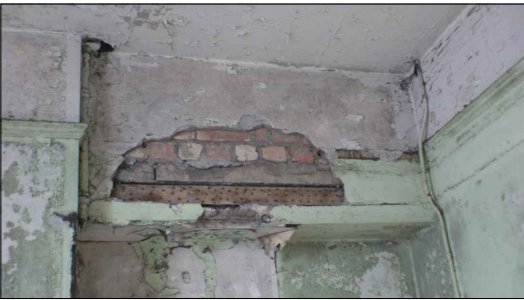
| REF | OBSERVATION |
|---|---|
| 3.1.18 | EXPOSED LINTEL AND MASONRY IN GOOD CONDITION. |

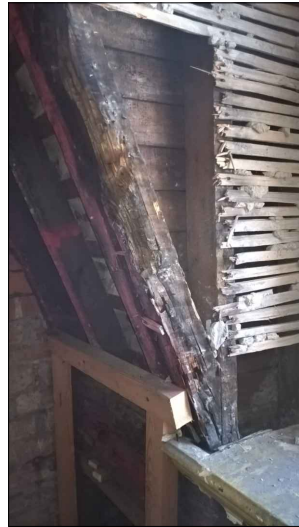
| REF | OBSERVATION |
|---|---|
| 3.1.8 | EVIDENCE OF WATER DAMAGE TO TIMBER RAFTERS TO MANSARD. |

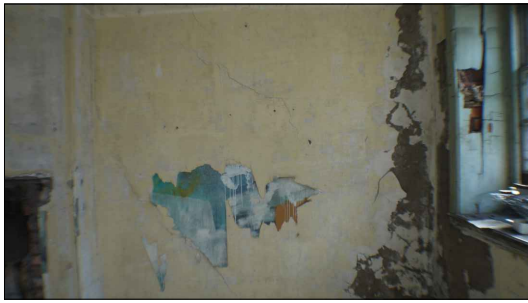
| REF | OBSERVATION |
|---|---|
| 3.1.16 | MINOR DIAGONAL CRACKING TO PLASTER TO ONE SIDE ONLY. |

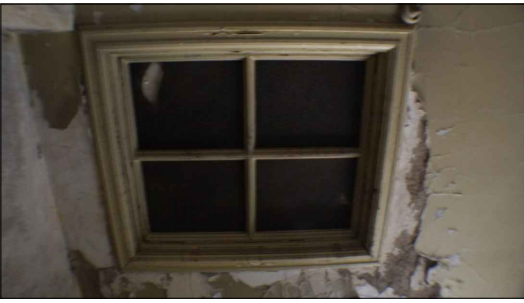
| REF | OBSERVATION |
|---|---|
| 3.1.19 | HATCH INTO ROOF SPACE. UNABLE TO ACCESS (ASBESTOS). |

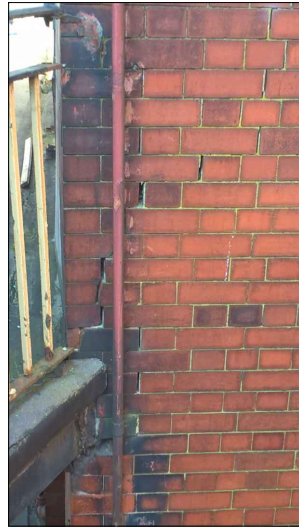
| REF | OBSERVATION |
|---|---|
| 3.1.7 | OPEN JOINTS IN MASONRY ADJACENT BALCONY TRACING PARTLY UP WALL. |

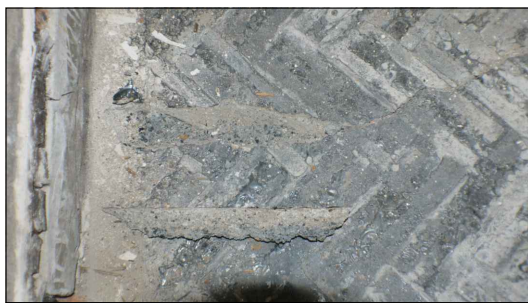
| REF | OBSERVATION |
|---|---|
| 3.1.17 | CRACKING TO FLOOR SCREED. |

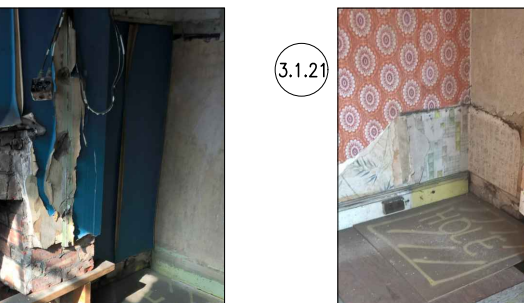
| REF | OBSERVATION |
|---|---|
| 3.1.21 | EXISTING HOLES IN FLOOR. BOARDED OVER. |

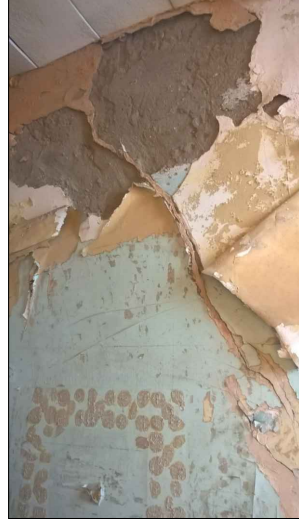
| REF | OBSERVATION |
|---|---|
| 3.1.6 | MULTIPLE LARGE DIAGONAL CRACKS TO PLASTER INTERNALLY. UNABLE TO VIEW EXTERNAL FACE. |

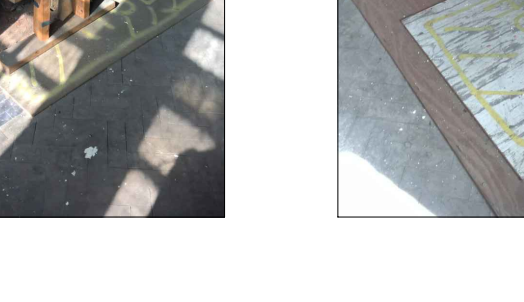
| REF | OBSERVATION |
|---|---|
| 3.1.24 | EXISTING HOLES IN FLOOR. BOARDED OVER. |

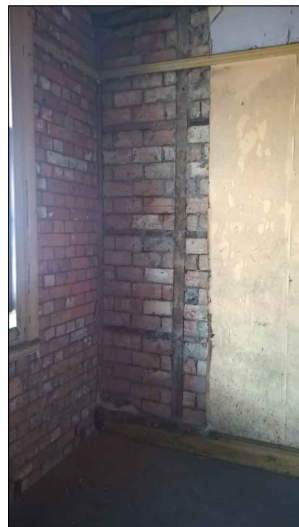
| REF | OBSERVATION |
|---|---|
| 3.1.4 | EXPOSED PARTITION WALL. |

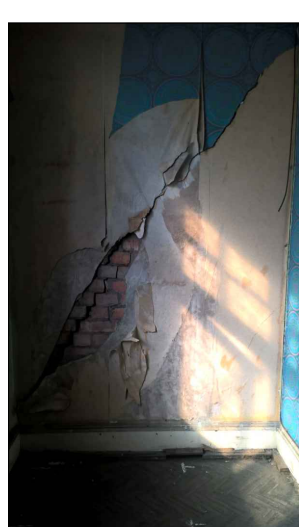
| REF | OBSERVATION |
|---|---|
| 3.1.3 | DIAGONAL CRACK TO WALL EVIDENT TO BOTH SIDES. CRACK EXTENDS FULL HEIGHT. |

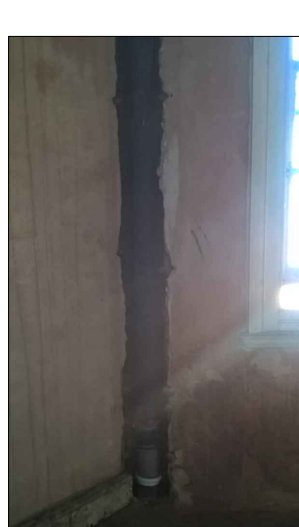
| REF | OBSERVATION |
|---|---|
| 3.1.1 | RAINWATER PIPE CUT INTO WALL. |

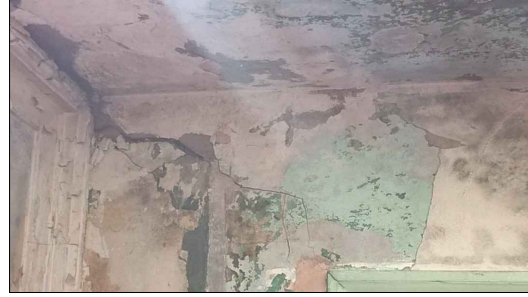
| REF | OBSERVATION |
|---|---|
| 3.1.5 | DIAGONAL CRACK BETWEEN DOOR FRAME AND CEILING. |

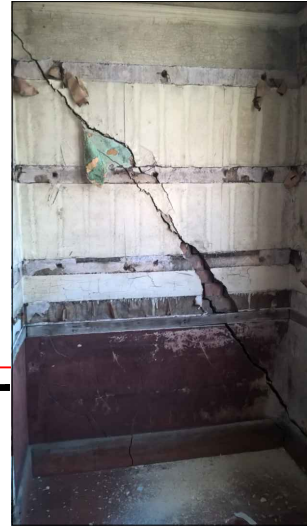
| REF | OBSERVATION |
|---|---|
| 3.1.2 | DIAGONAL CRACK TO WALL EVIDENT TO BOTH SIDES. CRACK EXTENDS FULL HEIGHT. |

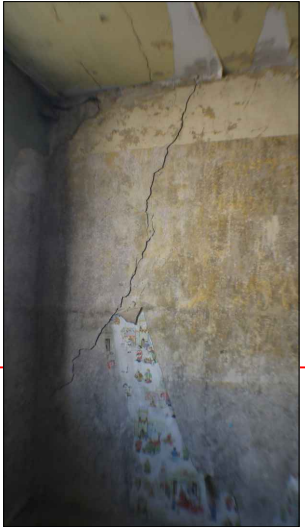
| REF | OBSERVATION |
|---|---|
| 3.1.20 | CRACK TO WALL (ONLY ONE SIDE ACCESSIBLE, ASSUME EVIDENT ON BOTH SIDES) EXISTING MONITORING POINTS 36-37. |

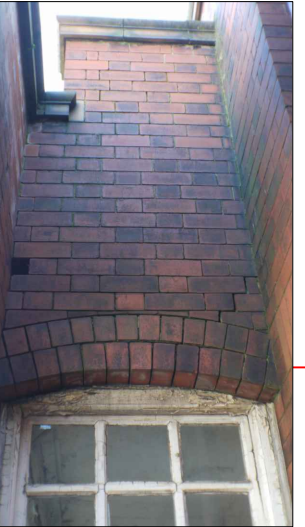
| REF | OBSERVATION |
|---|---|
| 3.1.22 | OPEN JOINTS TO MASONRY AND DROPPING TO ARCH BRICKWORK. |

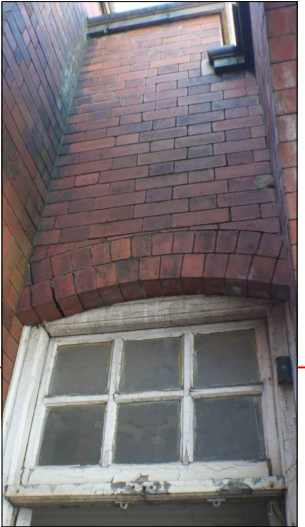
| REF | OBSERVATION |
|---|---|
| 3.1.23 | OPEN JOINTS TO MASONRY AND DROPPING TO ARCH BRICKWORK. |
