## Design and Access Statement

Manchester Central – Painting of gable steelwork

Prepared by Taylor Design Architects Ltd  
February 2020

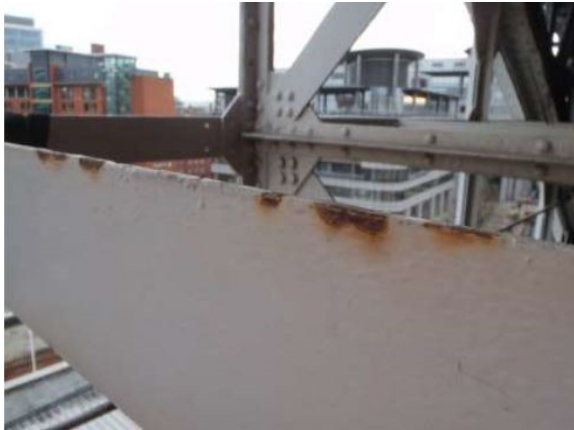
Coating removed by mechanical damage

On the newer sections the condition of the existing coatings appears generally sound with only minor areas of corrosion and coating breakdown noted. The area of corrosion are isolated and mainly found along the horizontal angle sections and where coatings had been removed by mechanical damage exposing the substrate beneath.

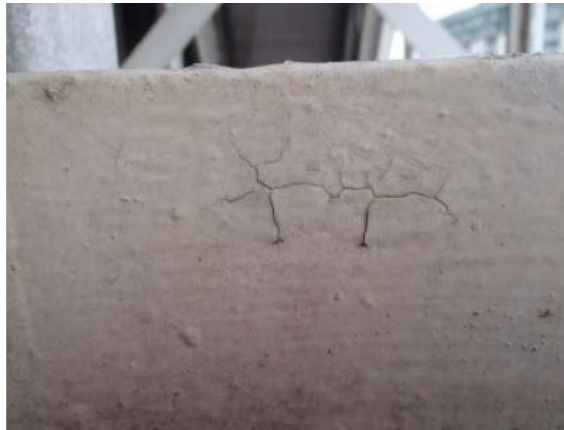
Cracking of the coatings

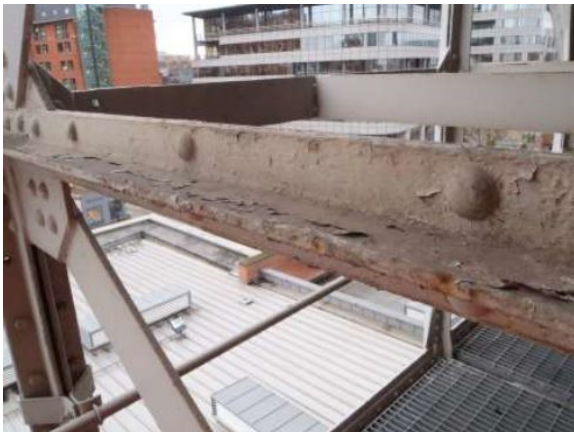
Flaking and delamination of the top coat

Thanks to micro-destructive testing it has been possible to identify in the original sections a total number of 24 coats of paint, varying in thickness and generic type. The failing topcoat was found to be an alkyd type material applied over an epoxy type coating not adequately prepared and which consequently contributed to the delamination witnessed. The survey also highlighted top coat adhesion weaknesses.

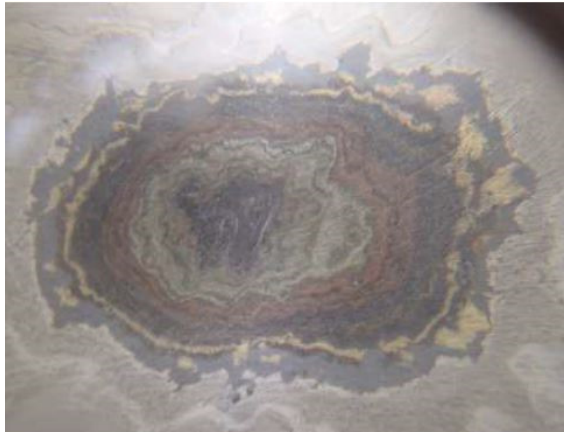
Multi-destructive test to identify number of layers

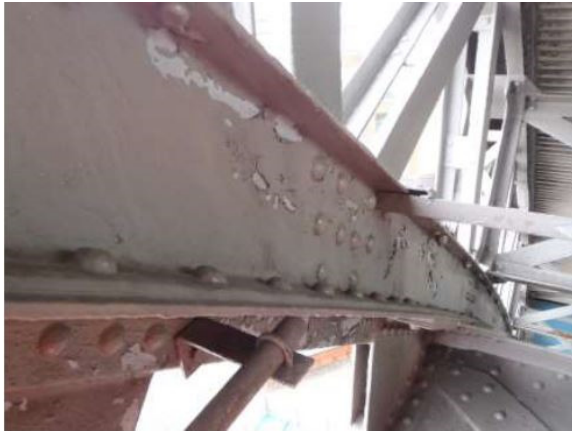
Flaking and delamination of the top coat

Micro destructive testing have identified two coating system present, the first is on the newer angled bracing and it comprises seven layers of paint similar to those found on the front Gable newer sections. The system appears to be an epoxy type material with the exception of the delaminating top alkyd type coating. The adhesion of the coating system on these newer sections ranged from fair to good.

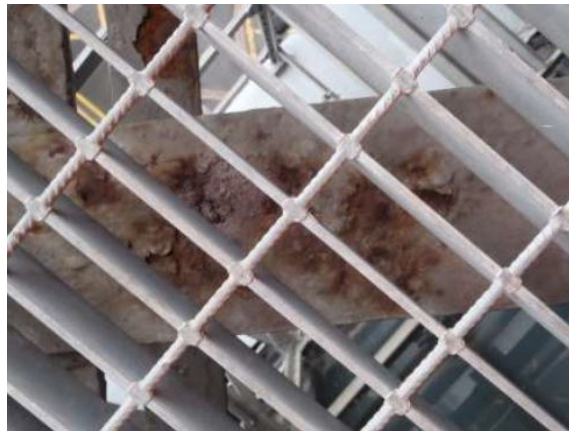
Corrosion under the walkway grating

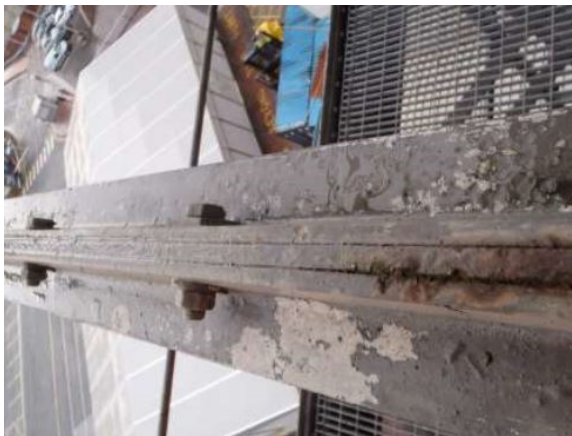
Rust staining in the back to back gaps filled

The survey also highlights that a number of the 'back to back' gaps had been filled with and this had created a moisture trap and rust staining are visible. The only real area of concern has been identified in some isolated patches where the original coating system had not been fully removed and it is possible that lead based coating may still be present. The ornate configuration also appeared to be in good condition with very little breakdown, but where there are plies between the main arch and ornate structure there is clear rust staining present.

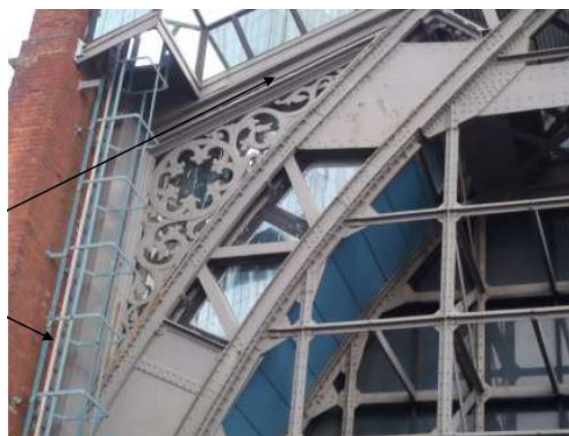
Rust staining on main arch and ornate structure

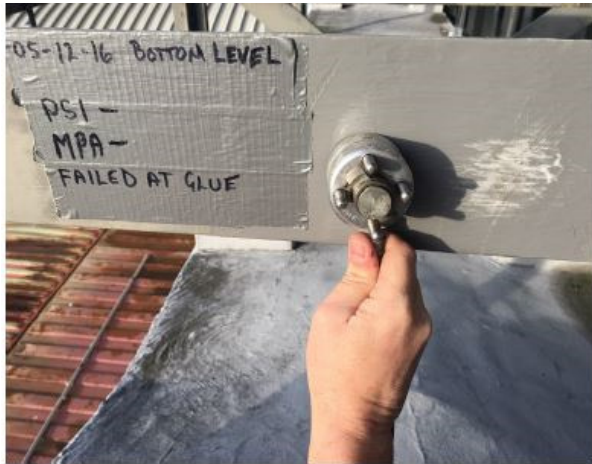
failed at glue (no result obtained)

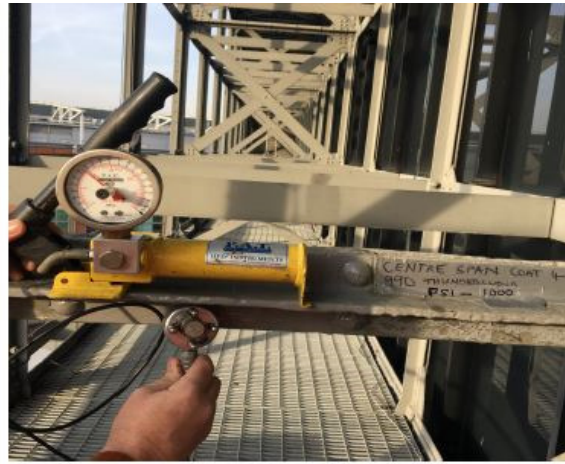
failed at 1000 psi

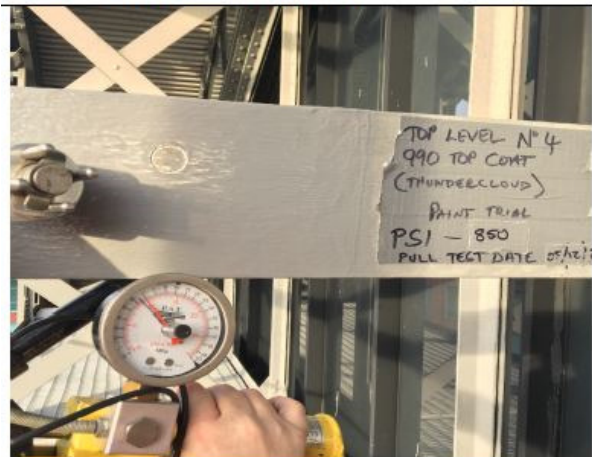
Failed at 850 psi

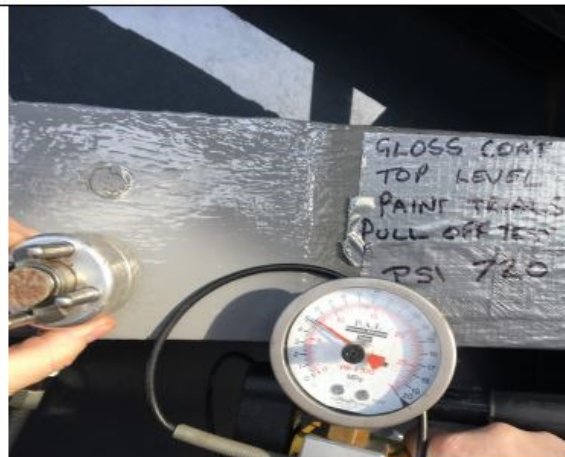
Failed at 720 psi.
