**47 PETER STREET, MANCHESTER**  
**STRUCTURAL CONCEPT DESIGN REPORT**  
**RIBA STAGE 2**

**PSM-REN-00-XX-RP-S-00001**

Date: DEC 2018

Rev: P04

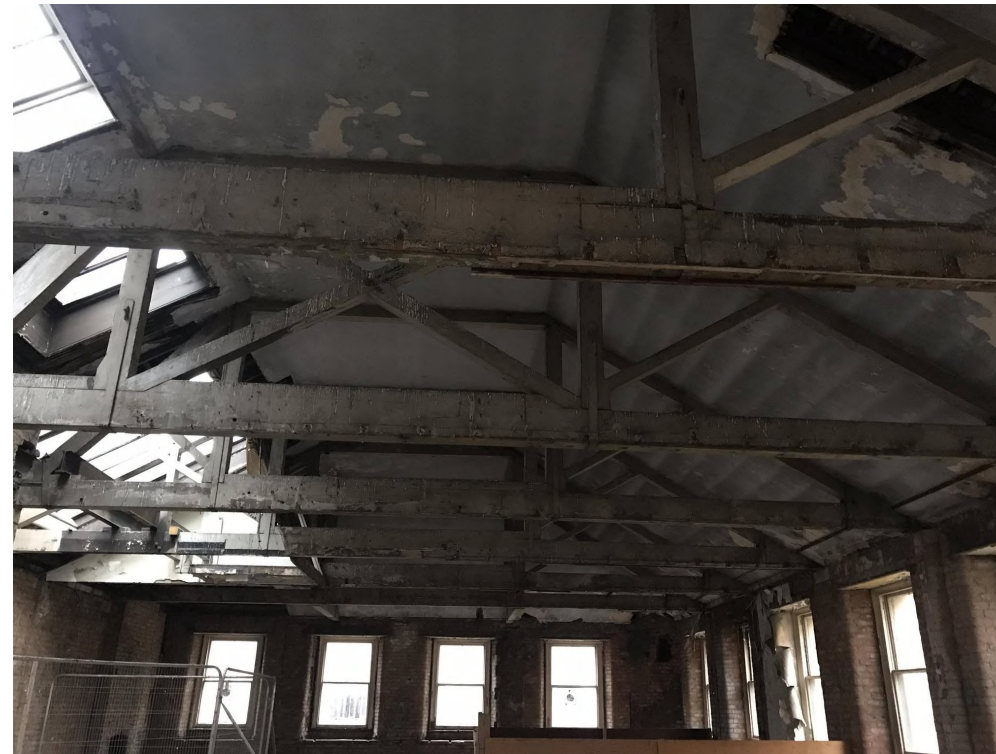
Figure 2.1: Photograph of Roof Trusses

*Roof* - The covering has possibly been replaced in the lifespan of the building to date, though insulation is not present. There are visible signs of water leaks within the roof coverings and these should be addressed as a matter of urgency.

*Water tightness* - Rainwater goods, parapets, flaunching and waterproofing to façade features, etc. to be remediated to Architects and Heritage Architects detail to avoid deterioration of structure.

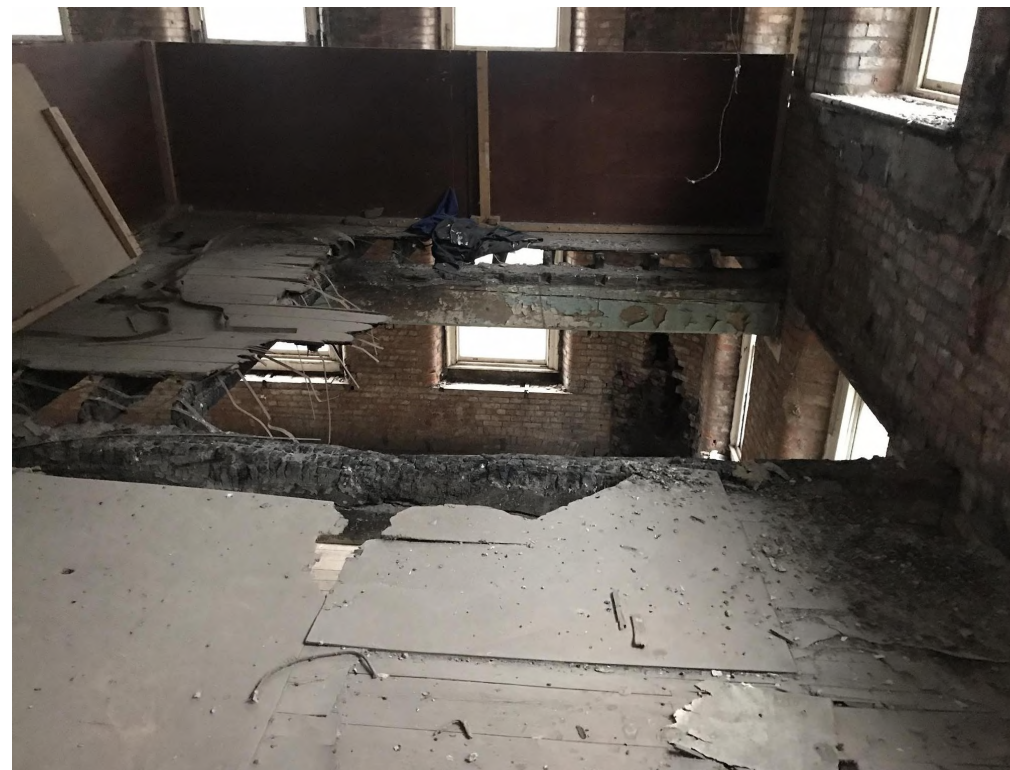
Figure 2.2: Photograph of Fire Damaged Floor at Third Floor

*Fire damaged timber to the underside of third floor* - The timber structure at third floor was fire damaged in 2012. Two bays of timber joists and overlying boards were damaged as well as the primary timber cross beam. This area should be investigated further to determine the exact extent of joists and floor boards required to be replaced.

During the 2012 fire, one of the primary timber beams supporting the third floor was heavily fire damaged and requires remediation as part of the proposed works. The extent of beam which has been affected for half of the width of the building.

The proposal is to provide 2No 8mm x 300mm deep steel plates either side of the existing beam which have the equivalent capacity of the original timber section. In preparation for the plates being inserted, the sections of charred timber are removed and the beam section locally rebuilt in timber.

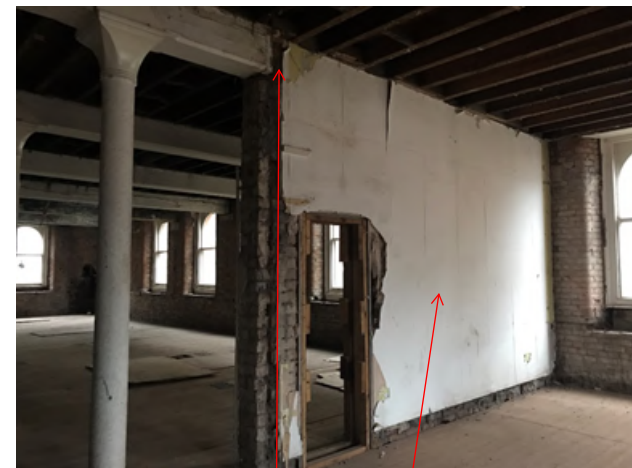
Figure 3.2.2: Proposed Remedial Detail at 2nd and 3rd Floor

When the staircase was added in the late 1800's, a masonry wall was introduced and floor beams cut back at second and third floor level.

The proposals for the hotel require these walls to be removed and therefore the beam sections are to be reinstated. The proposals include the introduction of a flitched timber formed using 4No 63 x 200 C24 timbers with an 8mm x 300mm deep steel plate located centrally. The new beam will bear onto the original stone padstone located in the perimeter wall and be spliced with the original beam section using 2No 8mm x 275mm deep plates.

MASONRY TO BE DEMOLISHED AND  
NEW TIMBER FLITCH BEAM TO BE  
SPLICED ONTO EXISTING BEAM
