# SURVEY REPORT

| Report ref. | REV |
|---|---|
| 2015.01#02 | 3 |

#### Manchester Central Convention Complex-Gable Ends Coating Condition Survey

13/01/2015

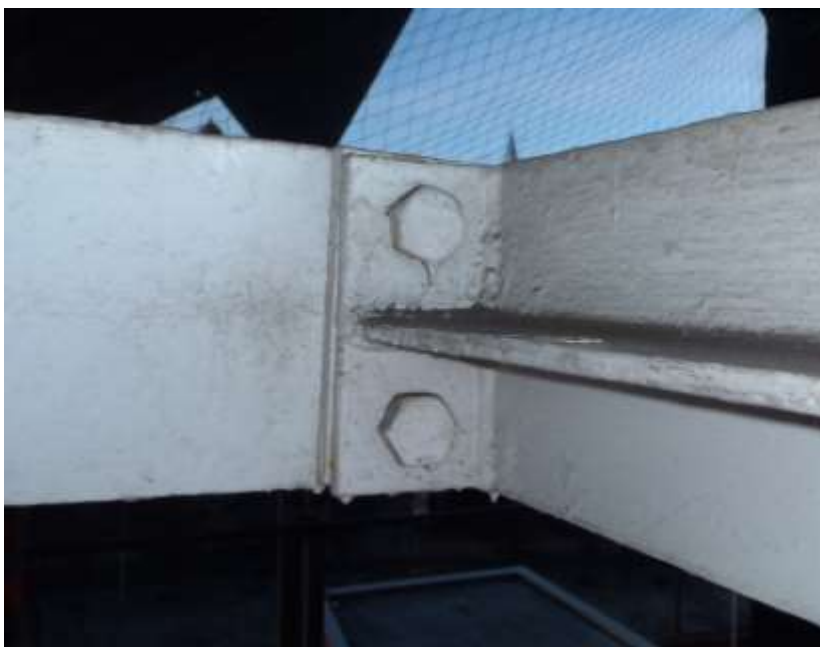
**Fig. 1**

The majority of the sections were fixed by rivets, although a number of bracings were bolted (**See Fig. 1**), these bolted sections, which were mainly on horizontal cross bracings, were newer than the original structure and had been installed, possibly to strengthen the structure, between the outer and inner Gable frames.

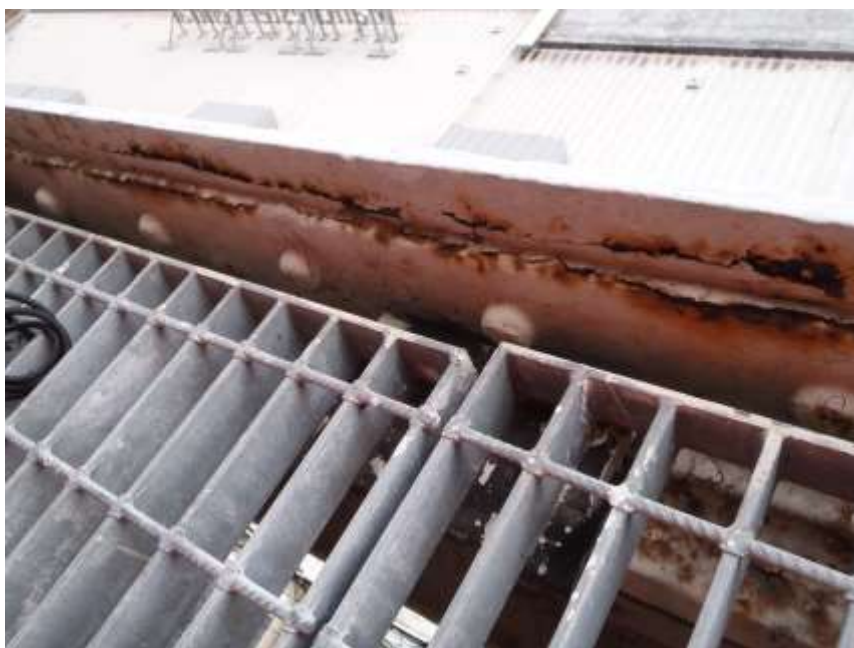
**Fig. 2**

Visually the condition of the existing coatings appeared generally sound with only minor areas of corrosion and coating breakdown noted. The areas of corrosion were isolated and found to be mainly along the horizontal angle sections (**See Fig. 2**) and where coatings had been removed by mechanical damage exposing the substrate beneath (**See Fig. 3**).

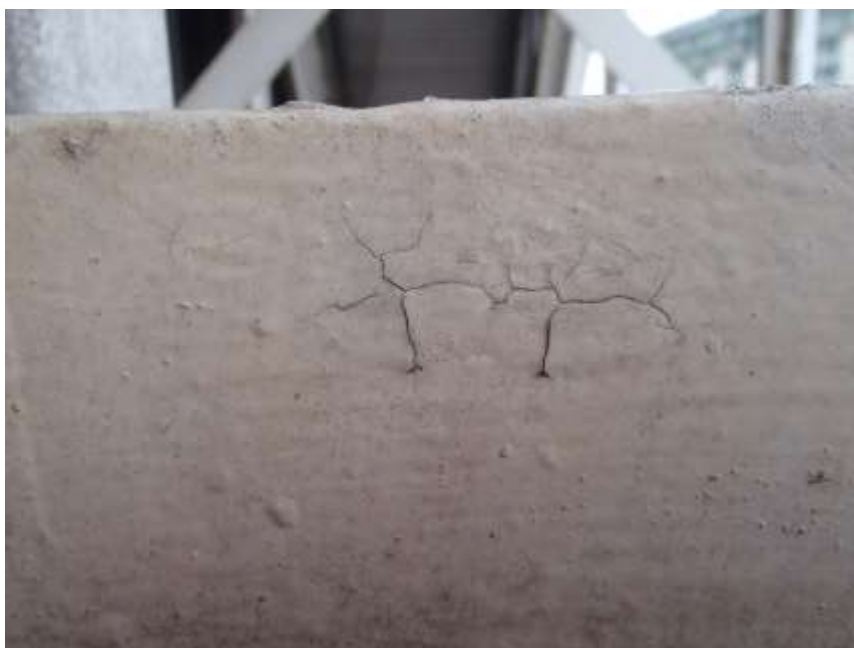
**Fig. 4**

The areas of coating breakdown were however fairly widespread and these included surface cracking of the coatings (**See Fig. 4**) and also extensive flaking and delamination of the white top coat (**See Fig. 5**).

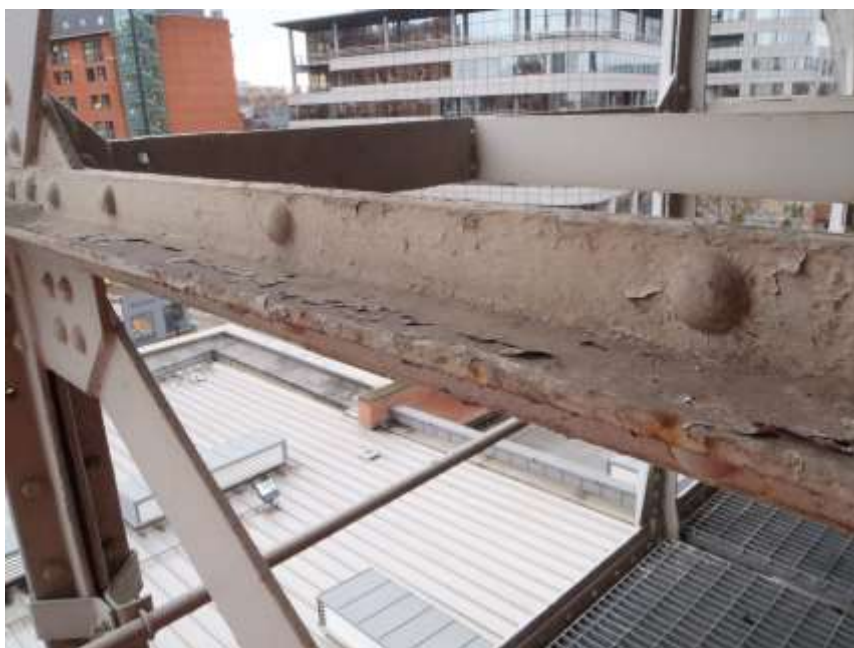
**Fig. 5**

The failing topcoat was found to be an alkyd type material which had been applied over an epoxy type coating that had not been adequately prepared prior to over coating which in turn had appeared to contribute to the delamination witnessed.

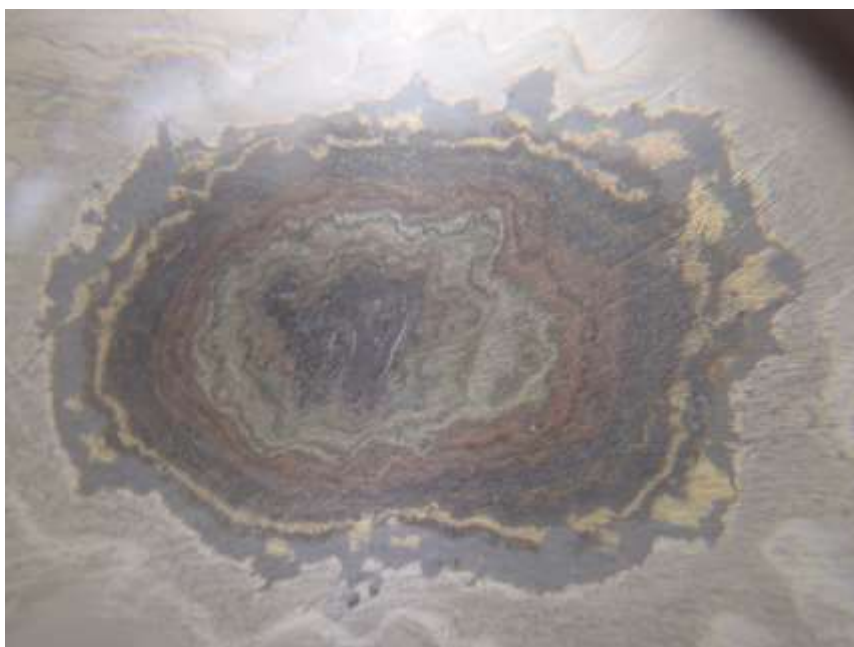
**Fig. 6**

found to vary between the original and newer sections. The original sections were found to have a total of 24 coats of paint of varying thicknesses and generic type (**See Fig. 6**) and when spot tested for the presence of lead there was a reaction indicating there may be toxic materials within the existing system.

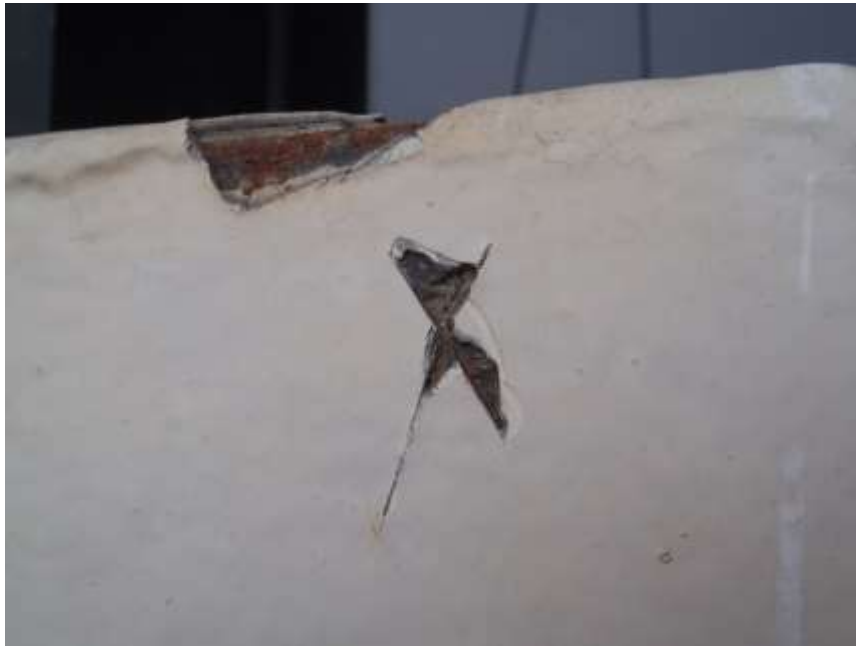
**Fig. 7**

Adhesion of the coatings on the original areas was tested using the St Andrews cross cut method and this identified an embrittlement of the existing system which was affecting the overall adhesion to the substrate. This testing also highlighted the top coat adhesion weakness even where the top coat appeared visibly sound it still showed signs of poor intercoat adhesion (**See Fig. 7**).

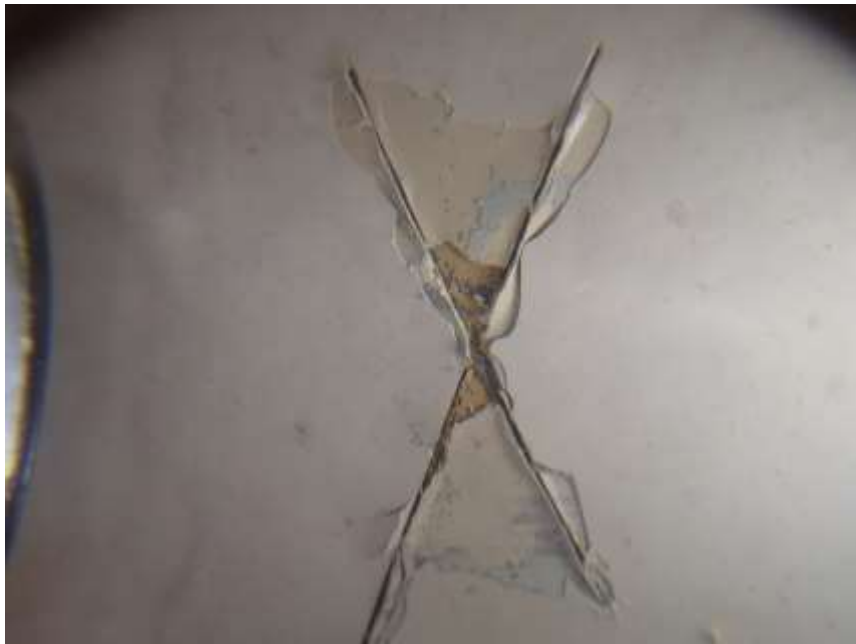
**Fig. 8**

The coating system on the newer sections was found to be an epoxy system, with the exception of the alkyd type top coat which, again was poorly adhered to the underlying paint layer, however the overall adhesion of the remaining epoxy system had fair to good adhesion (**See Fig. 8**). Micro destructive testing identified six layers of paint in total.

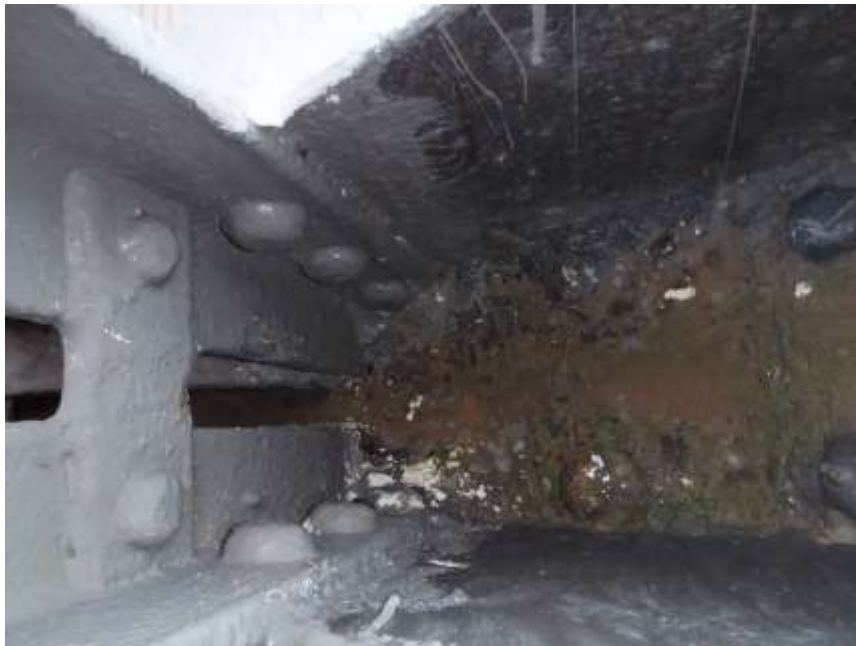
**Fig. 9**

Minor corrosion and coating breakdown was noted within the channel section of the outer main arch, although this was not severe it was clear that moisture and debris was collecting here and accelerating the coating deterioration (**See Fig. 9**).

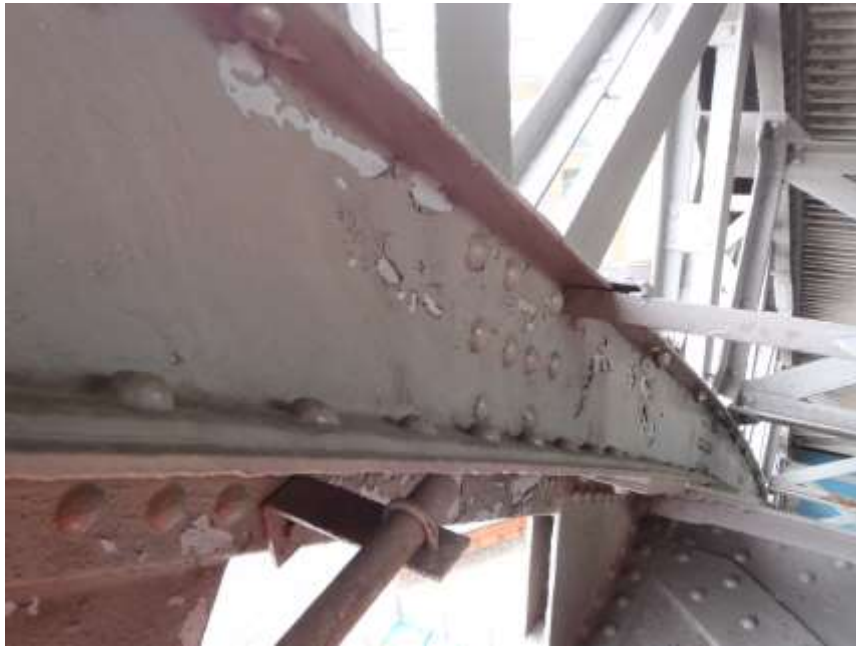
**Fig. 10**

Visually the condition of the existing coatings was found to be fair with minor areas of corrosion and coating breakdown present. There was however noticeable flaking and delamination of the grey top coat (**See Fig. 10**), which had also discoloured in a number of areas.

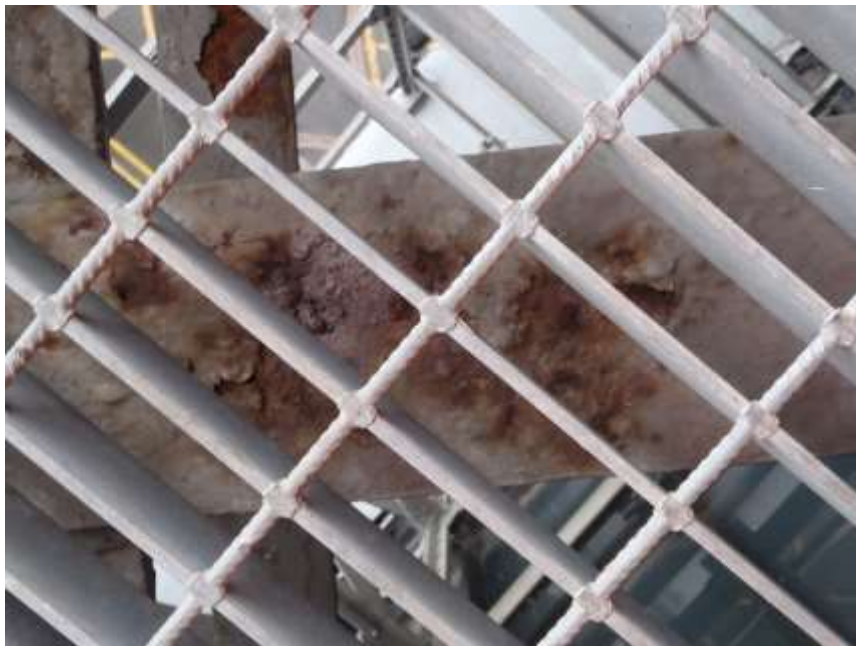
**Fig. 11**

Corrosion was more widespread than that found on the Front Gable end and this was located in numerous areas including under the walkway grating (**See Fig. 11**).

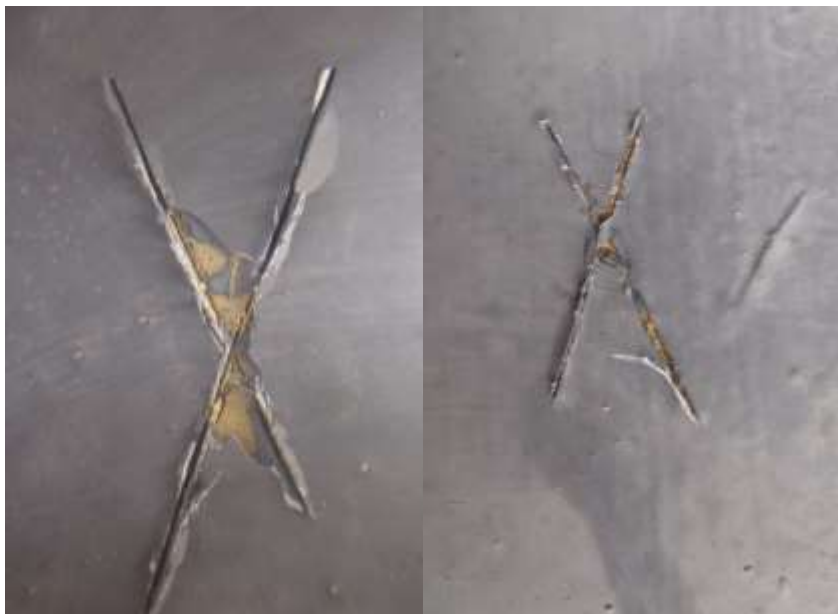
**Fig. 12**

Solvent swab testing found the system to be an epoxy type material with the exception of the delaminating top coat which appeared to be an alkyd type coating. St Andrews cross cut tests revealed that the adhesion of the coating system on these newer sections ranged from fair to good (**See Fig. 12**).

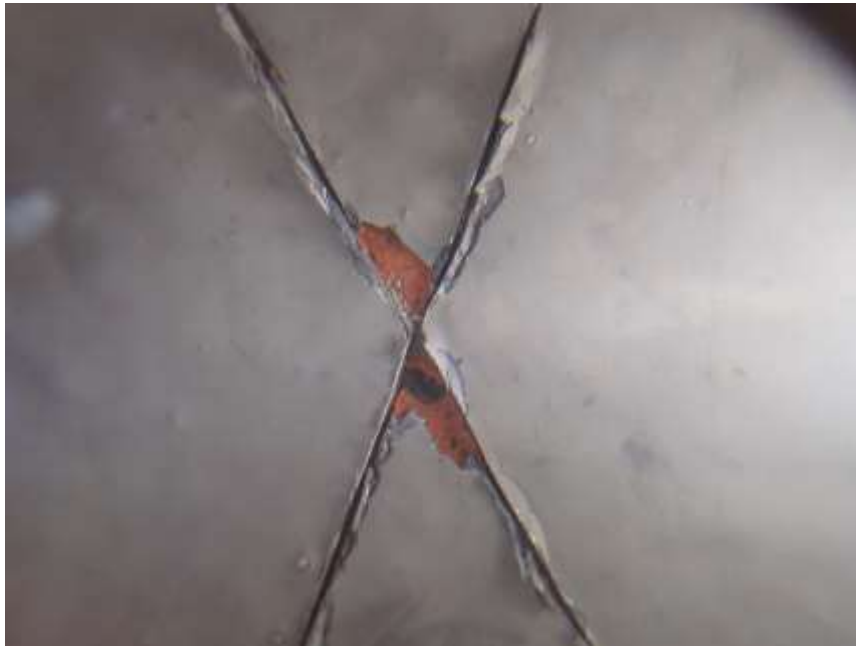
**Fig. 13**

The original sections appeared to have undergone full removal at some point in the past as here micro destructive testing identified a six to seven coat system which was found to be an alkyd type with a grey top coat. The adhesion of this system was good overall with only a slight intercoat weakness between the build and top coat layers where visibly sound (**See Fig. 13**).

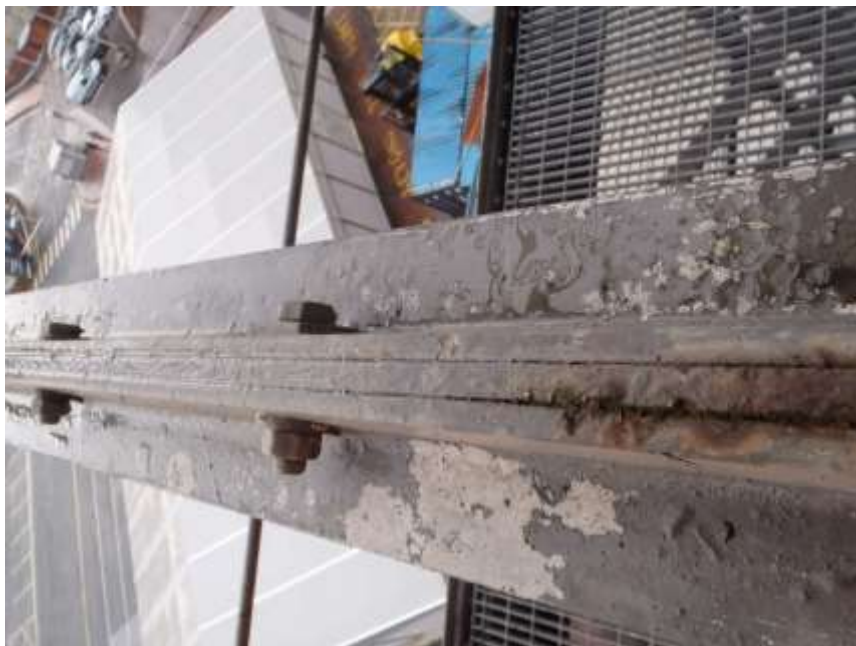
**Fig. 14**

It was also noted that a number of the “back to back” gaps had been filled with and this had created a moisture trap and rust staining was visible in these areas (**See Fig. 14**), where the gaps had been left open no corrosion had occurred.

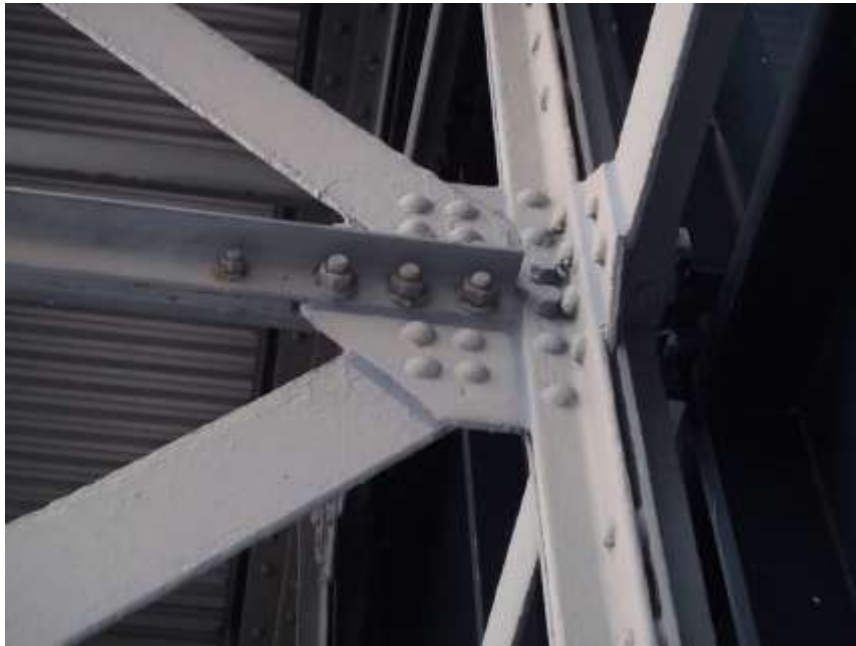
**Fig. 15**

A number of gaps on the Gable end had also been filled/sealed with a fillet of mastic (**See Fig. 15**) which appeared to have performed well as no corrosion was visible from these jointed areas. However in some locations a foam filler had been used and this was now brittle and friable.

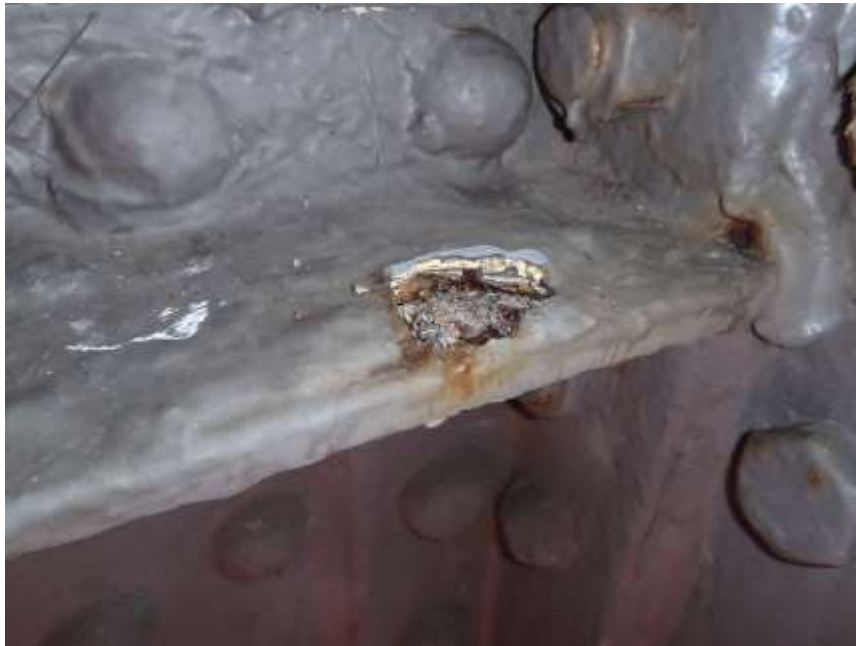
**Fig. 16**

The only real area of concern was noted in some isolated patches and this was where it was thought that the original coating system had not been fully removed (**See Fig. 16**) and here it is possible that lead based coatings may still be present as a slight reaction was detected when spot testing for toxic pigment was carried out.

It should also be noted that any coating preparation work must be in accordance with the Lead at Work Regulations due to the presence of lead based coatings across the structure (**See Appendix 1**).

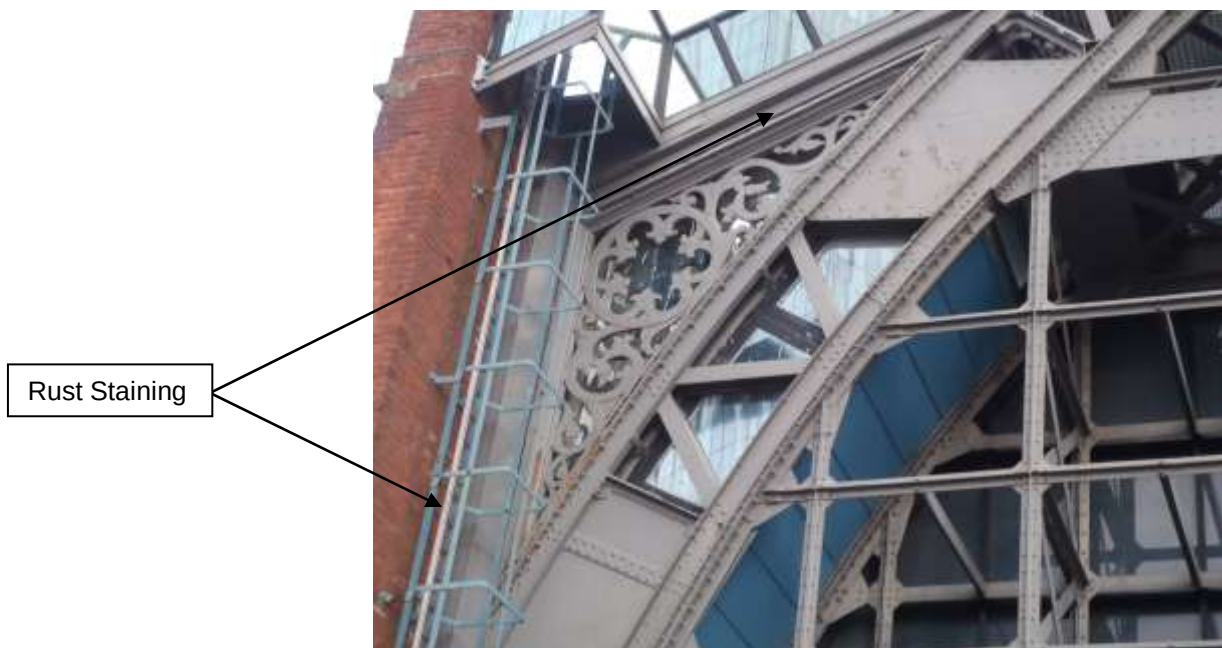
**Fig. 17**

The ornate configuration also appeared to be in good condition with very little breakdown, but where there were plies between the main arch and ornate structure there was clear rust staining present (**See Fig. 17**).
