# Method Statement for Soft Strip Works

**79 Mosley Street  
St Peters Square  
Manchester**

Method statement for Investigative Works and Soft Strip works at No. 79 Mosley Street.

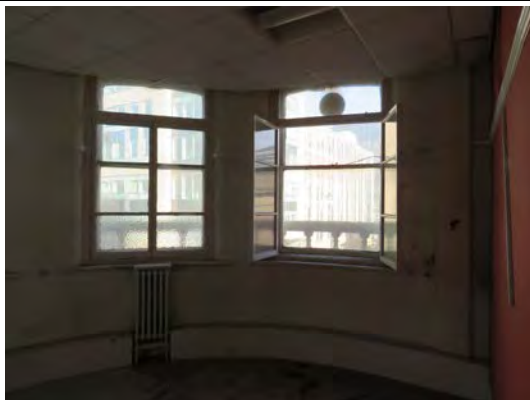
| Room number / area | Element to be removed / significance | Description | Photo |
|---|---|---|---|
| 1 <sup>st</sup> floor | Secondary glazing, of no historic significance | Modern secondary glazing inward opening timber framed casement units to first floor <b>except those units identified in the notes below as being of significance.</b> | |

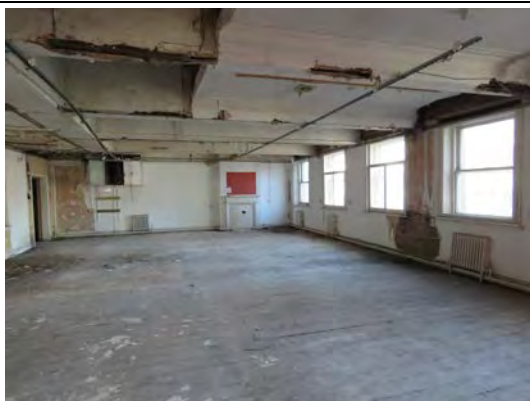
| Room number / area | Element to be removed / significance | Description | Photo |
|---|---|---|---|
| All floors | Local plaster removals to party wall (of some limited significance) | To determine the extent of historic dry rot to upper floors (aligned with the stair) and the construction of the party wall at lower levels in the former restaurant area and ground floor above (rear third of the building line) | |

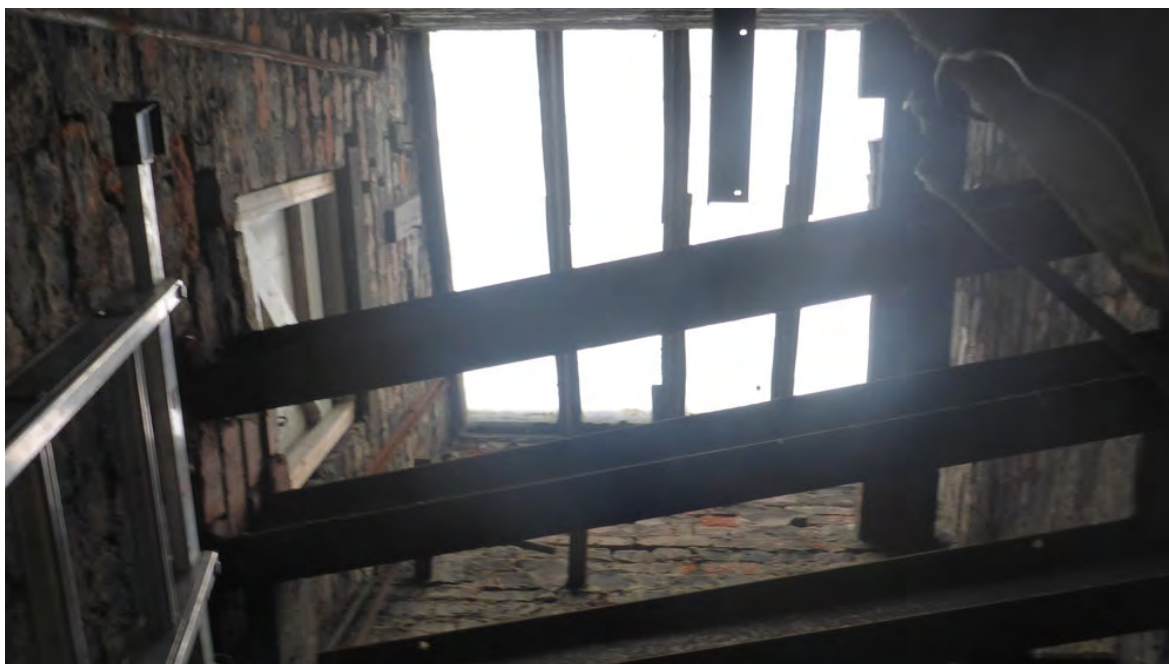
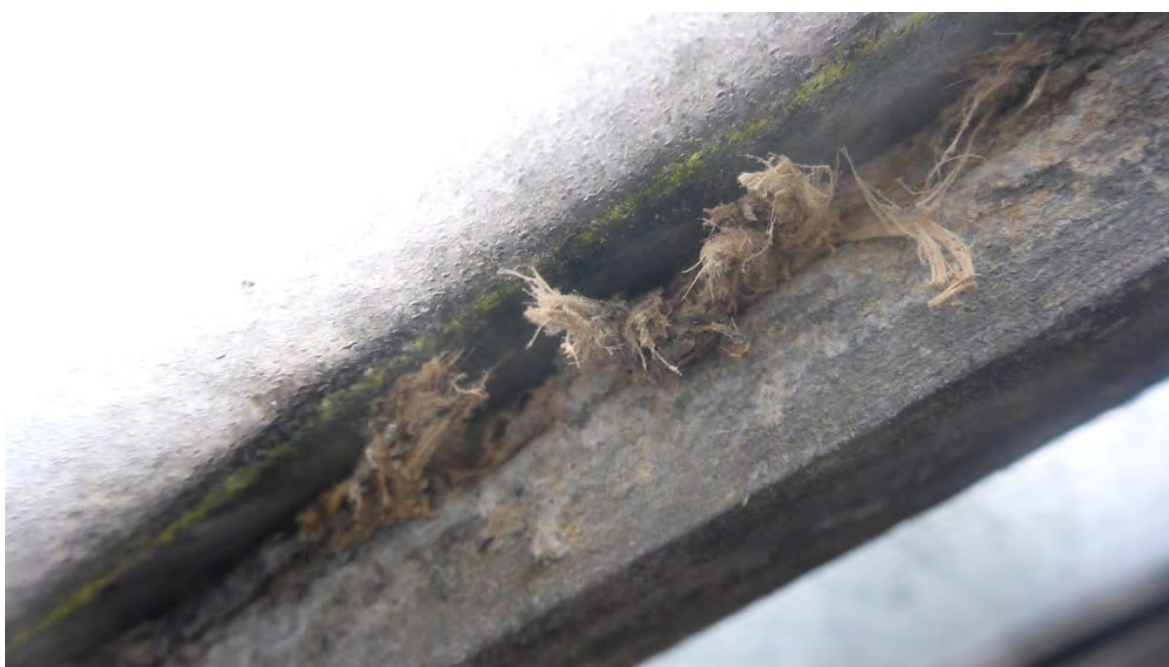
| <b>Asbestos Type</b> | - Chrysotile (White) | <b>Product Type</b> | - Rope |
| <b>Comments</b> | Asbestos rope was identified as bedding to the various roof top skylights. A sample of the material was analysed and the results returned were found to be positive for the presence of asbestos. If works are likely to disturb the material, it should be removed and disposed of as asbestos waste. (S# 32) | | |

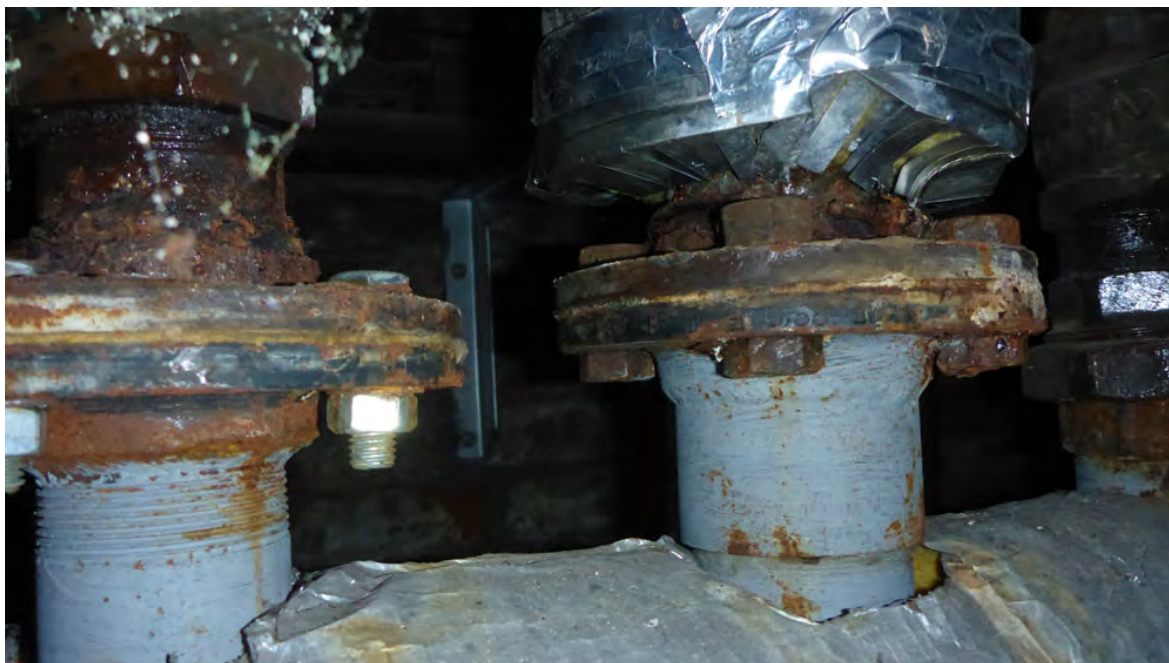
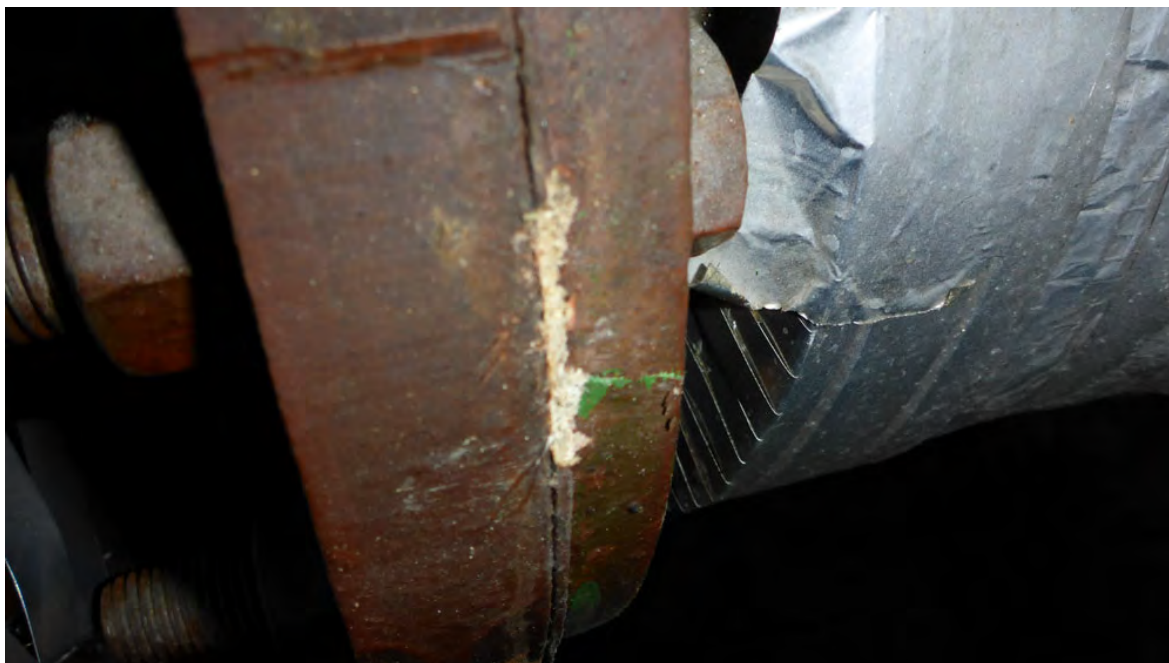
| <b>Floor</b> | - All | <b>Position Description</b> | - Compressed asbestos fibre (CAF) gaskets to pipework flange joints |

| <b>Asbestos Type</b> | - Chrysotile (White) | <b>Product Type</b> | - Gasket |

| <b>Comments</b> | - Compressed asbestos fibre (CAF) gaskets were identified to pipework flange joints throughout the building. A sample of the material was analysed and the results returned were found to be positive for the presence of asbestos. If / when the material is to be removed, it should be disposed of as asbestos waste. (S# 14) |

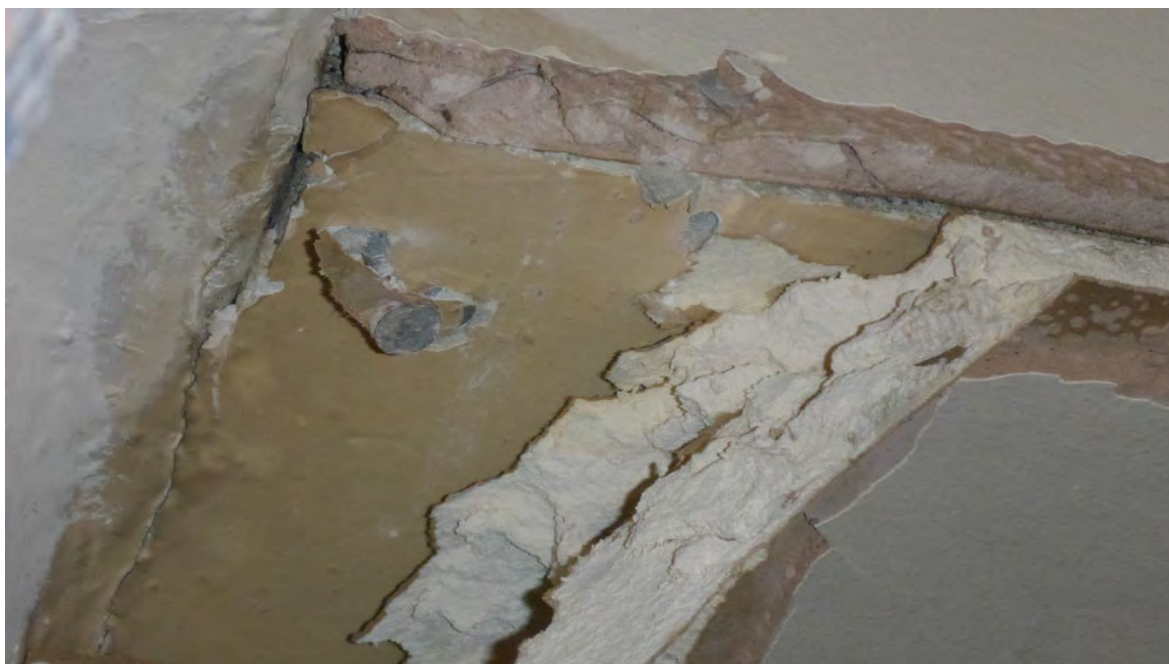
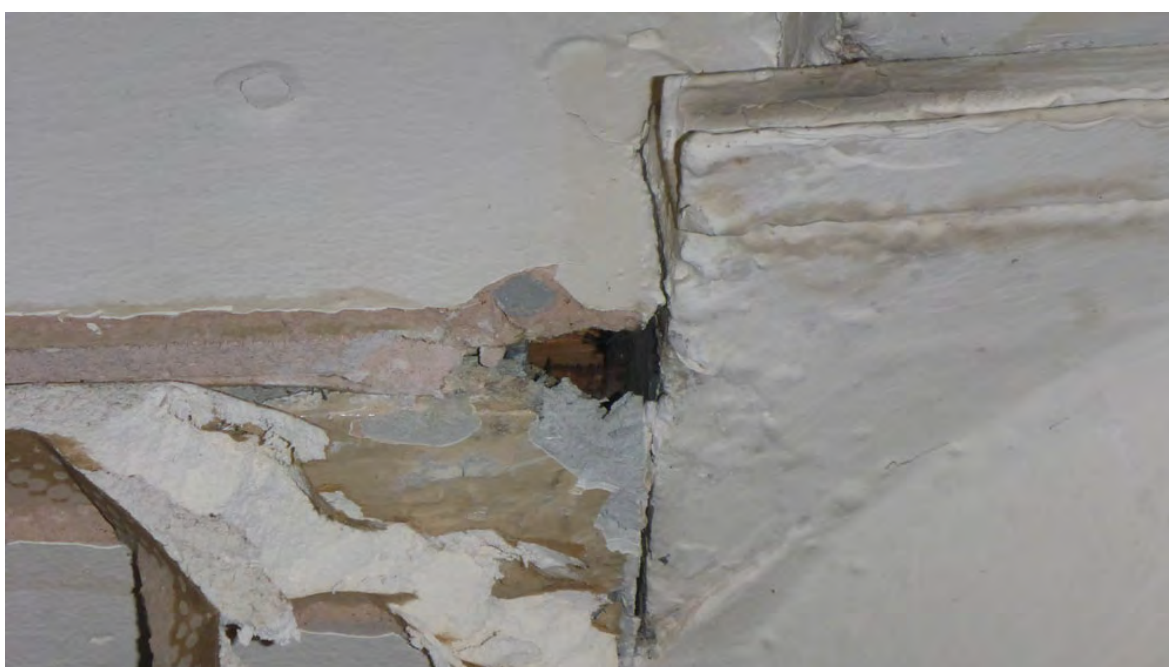
| <b>Asbestos Type</b> | - Amosite (Brown) & Chrysotile (White) | <b>Product Type</b> | - Insulation Board |
| <b>Comments</b> | Approximately 45 Lin m of asbestos insulation board was identified as cladding to the Restaurant Seating Area ceiling beams (please see plan for extent and location). A sample of the material was analysed and the results returned were found to be positive for the presence of asbestos. The material should be removed by a licensed asbestos removal contractor prior to any works in this area. (S# 01) | | |

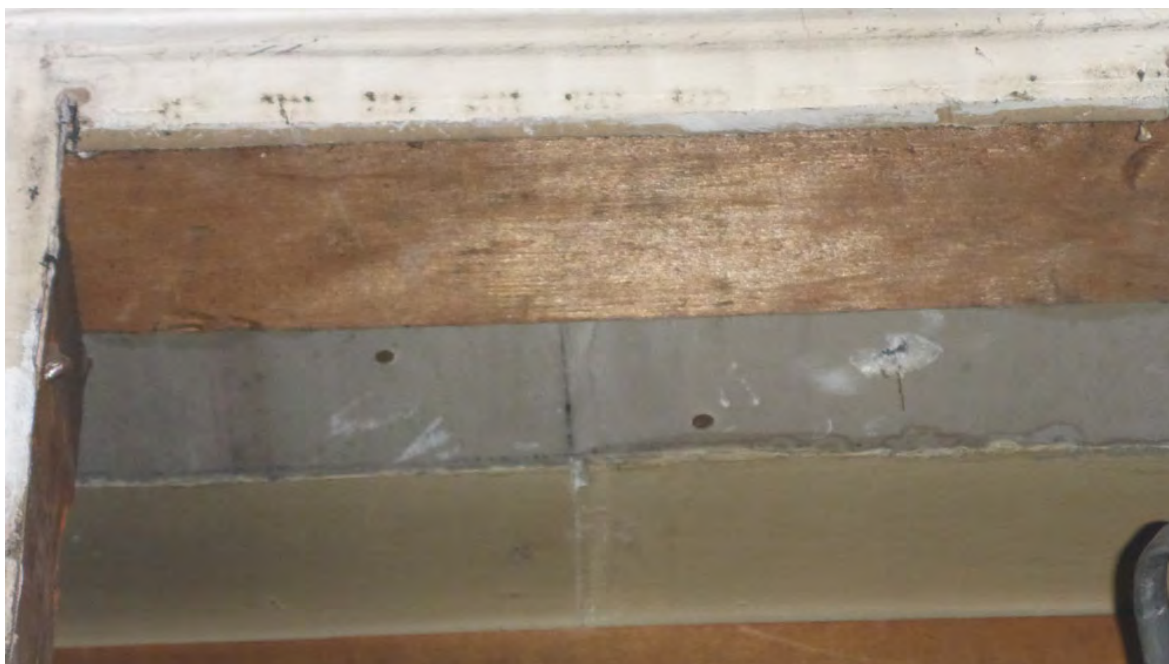
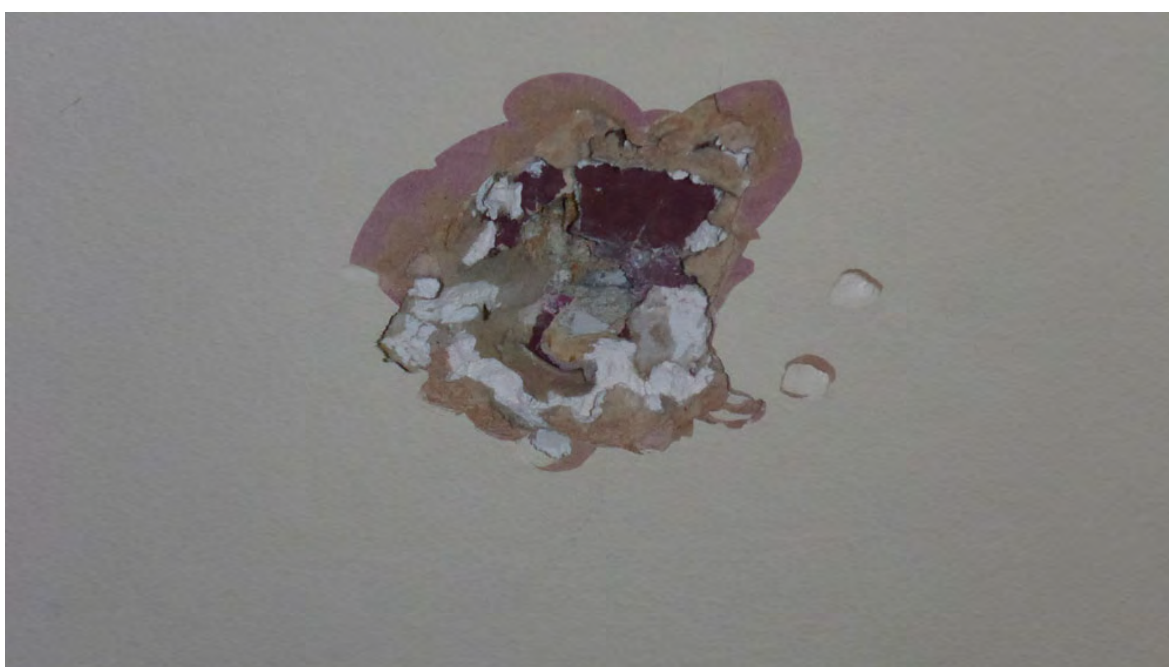
| <b>Asbestos Type</b> | - Chrysotile (White) | <b>Product Type</b> | - Insulation Board |
| <b>Comments</b> | <p>Approximately 20 Sq. m of asbestos insulation board was identified to the Restaurant Seating Area / Entrance ceilings, beyond existing finishes (please see plan for extent and location). A sample of the material was analysed and the results returned were found to be positive for the presence of asbestos. The material should be removed by a licensed asbestos removals contractor prior to any works in this area. (S# 02)</p> | | |

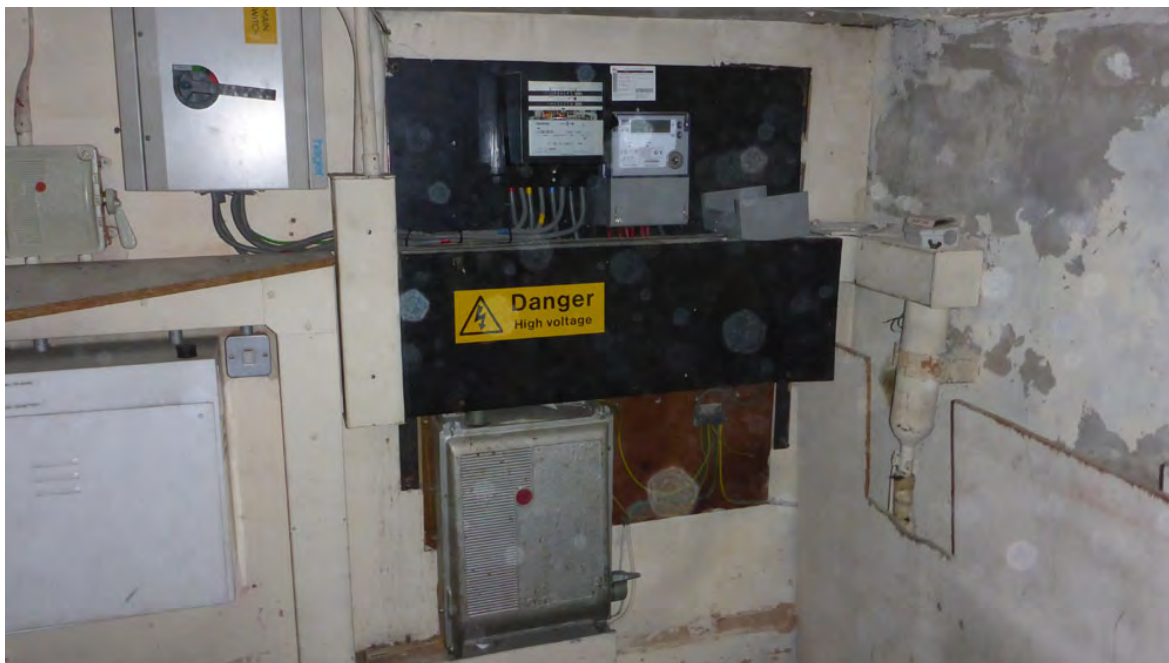
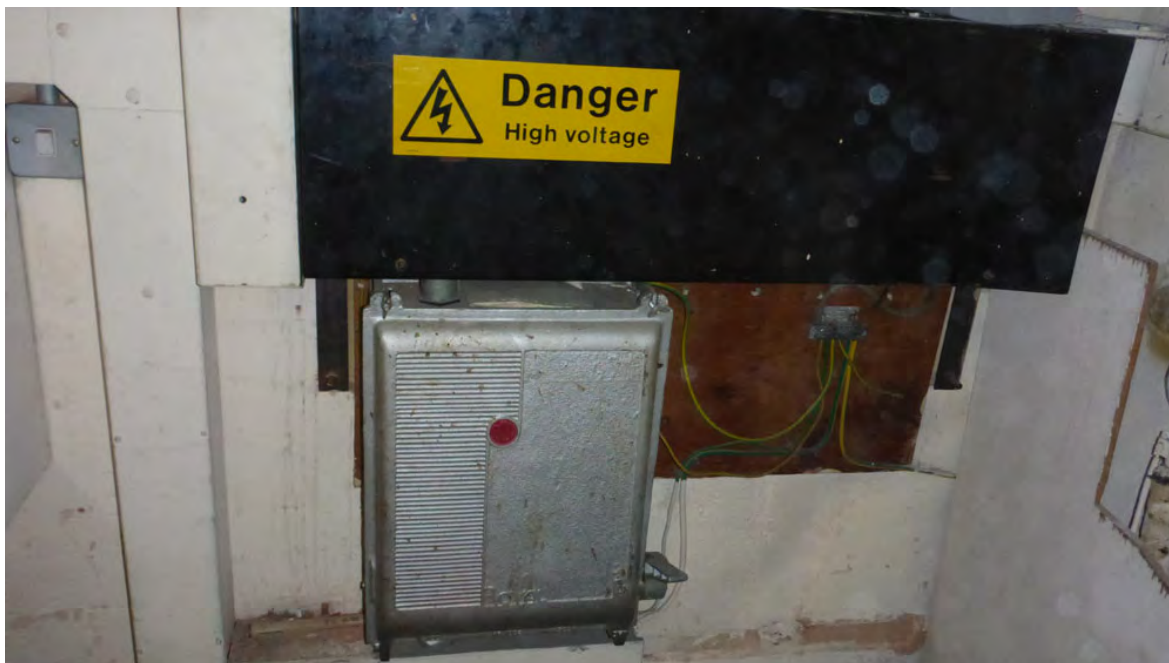
| <b>Floor</b> | - Basement | <b>Position Description</b> | - Concealed asbestos components presumed to the old electrics |

| <b>Asbestos Type</b> | - Chrysotile (White) | <b>Product Type</b> | - Flah Pads, Cement Separators, Rope Seals etc. |

| <b>Comments</b> | - Old electrics to the Restaurant Electrics room wall are presumed to contain concealed asbestos components such as flash pads, cement separators, rope seals etc. If / when the units are to be replaced, they should be removed whole and disposed of as asbestos waste. |

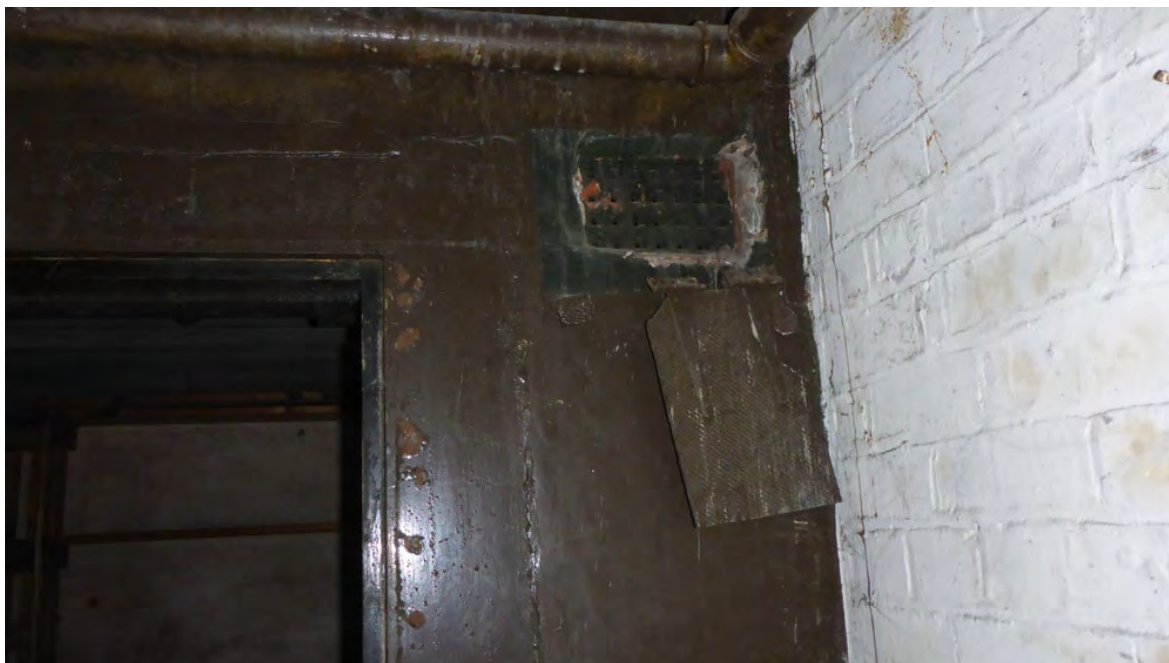
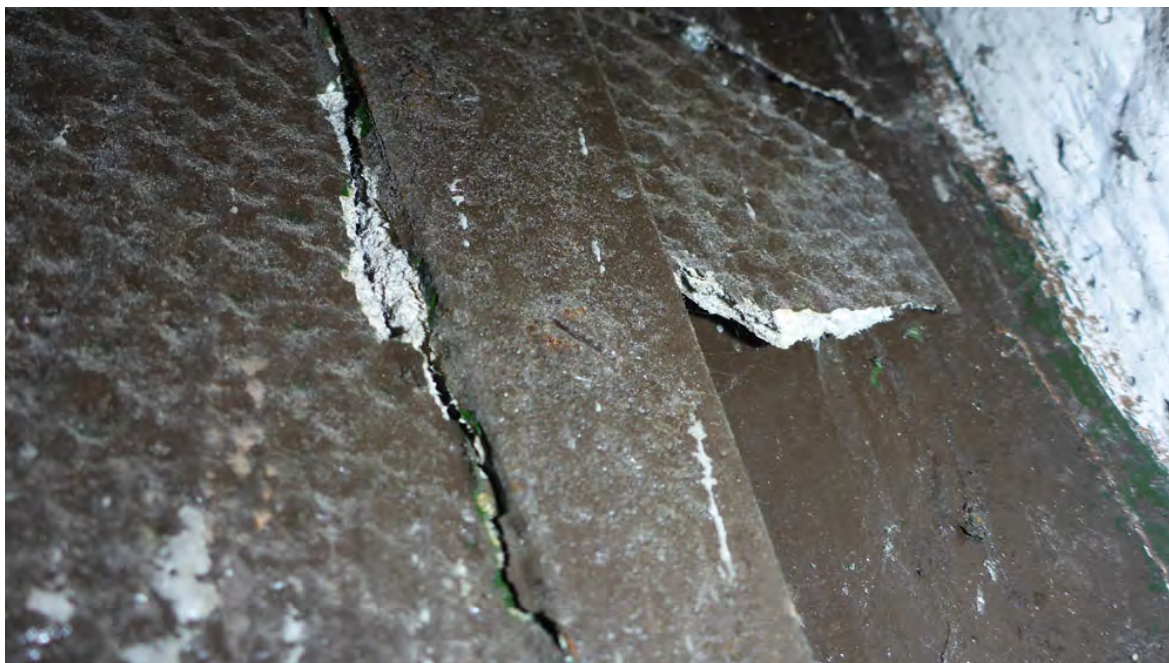
| <b>Floor</b> | - Basement | <b>Position Description</b> | - An asbestos cement board vent cover to the Safe Room |

| <b>Asbestos Type</b> | - Chrysotile (White) | <b>Product Type</b> | - Cement Board |

| <b>Comments</b> | - A small piece of asbestos cement board was identified as an external vent cover to the Safe Room. A sample of the material was analysed and the results returned were found to be positive for the presence of asbestos. The material should be removed and disposed of as asbestos waste. (S# 05) |

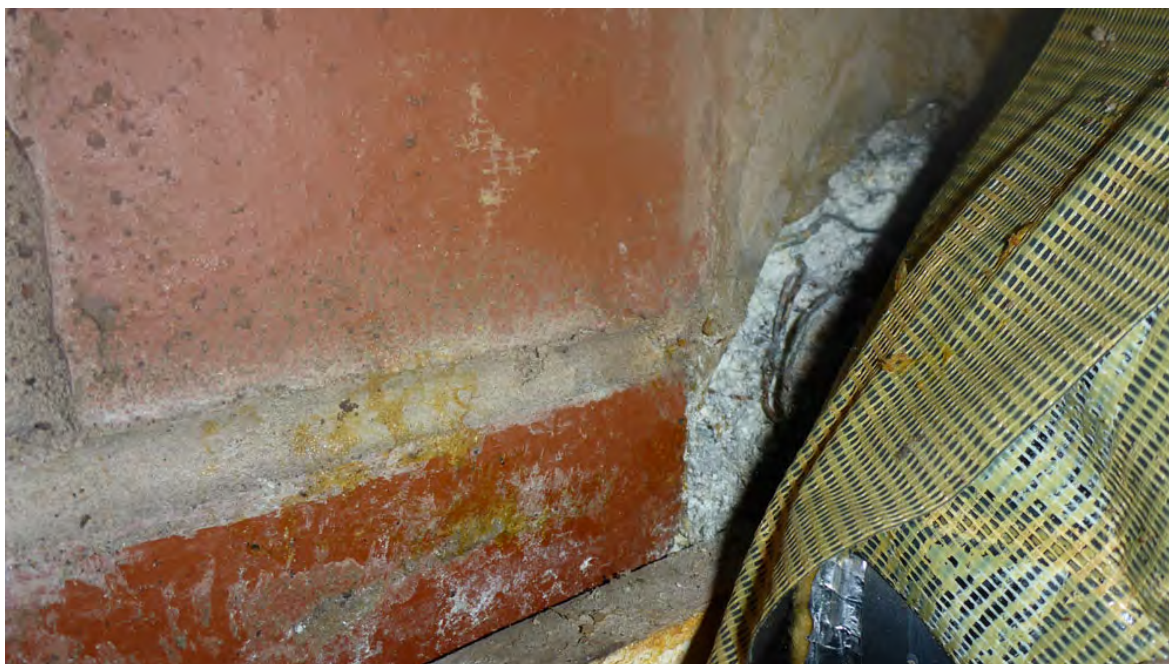
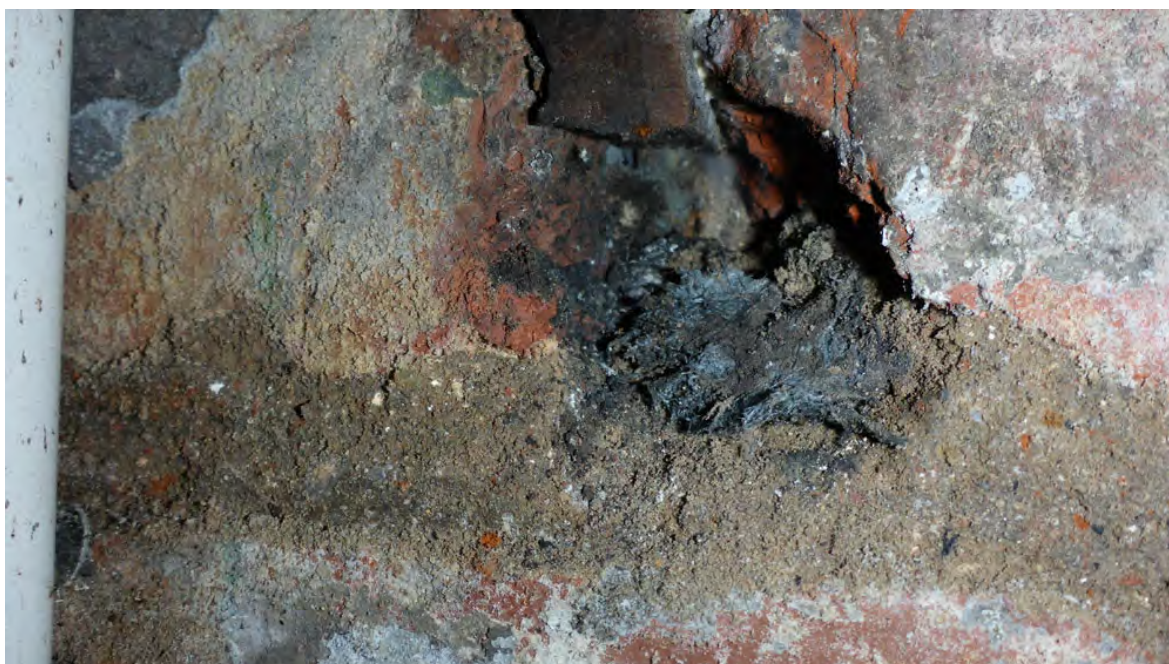
| <b>Asbestos Type</b> | - Crocidolite (Blue), Amosite (Brown) & Chrysotile (White) | <b>Product Type</b> | - Thermal Insulation |
| <b>Comments</b> | Asbestos thermal insulation debris and residues were identified to surfaces, walls, wall penetrations, pipework and brackets (approximately 170 Lin M total pipework) at high and low levels throughout the Lift Lobby / Safe Room Lobby and Plant Room (also above the Safe Room). A number of samples were analysed and the results returned were all found to be positive for the presence of asbestos. Access to the area should be restricted until such time as a full environmental clean can be undertaken by a licensed asbestos removals contractor. (S# 07, 08, 09, 10, 11, 12 & 13) | | |

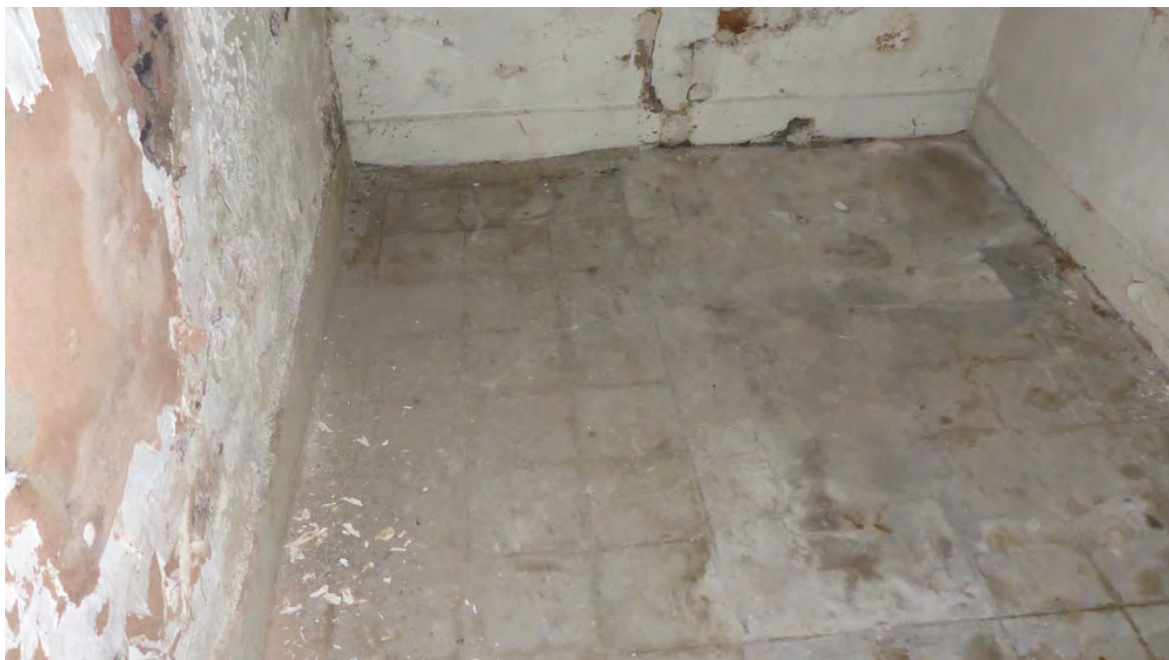
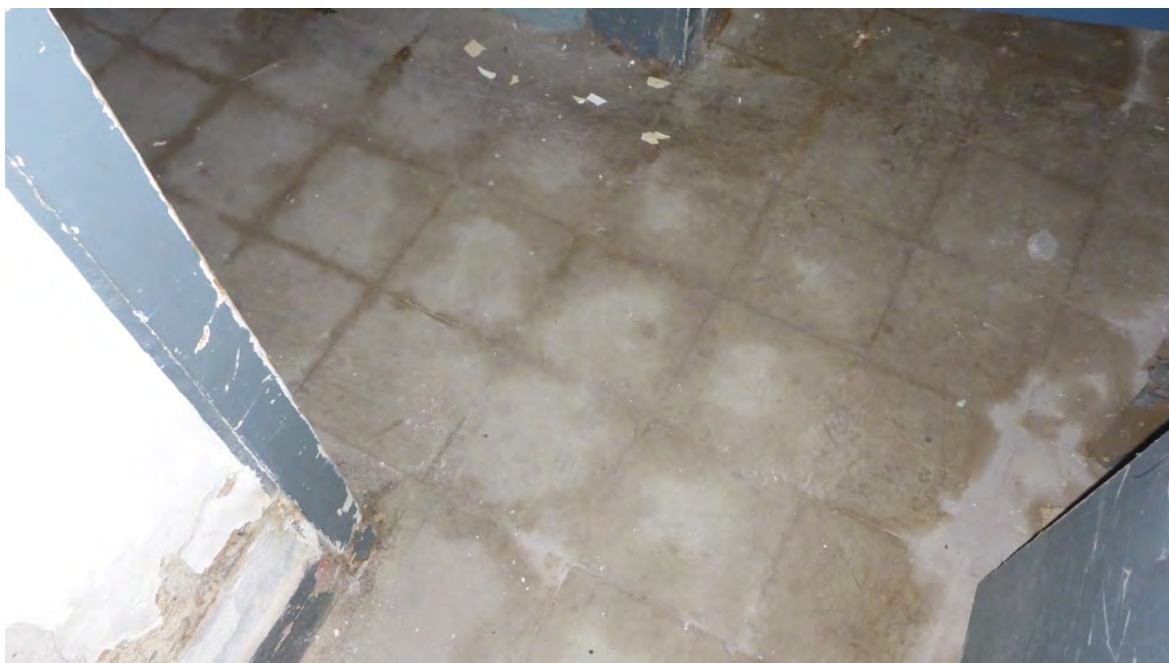
| <b>Floor</b> | - Basement | <b>Position Description</b> | - Asbestos thermoplastic tiles to the floors |

| <b>Asbestos Type</b> | - Chrysotile (White) | <b>Product Type</b> | - Floor Tile |

| <b>Comments</b> | <p>Approximately 8 Sq. m of asbestos thermoplastic beige tiles were identified to the Office floor and seen to continue into the File Store Lobby and File Store. A sample of the material was analysed and the results returned were found to be positive for the presence of asbestos. The material should be removed and disposed of as asbestos waste prior to any works in this area. (S# 16)</p> |

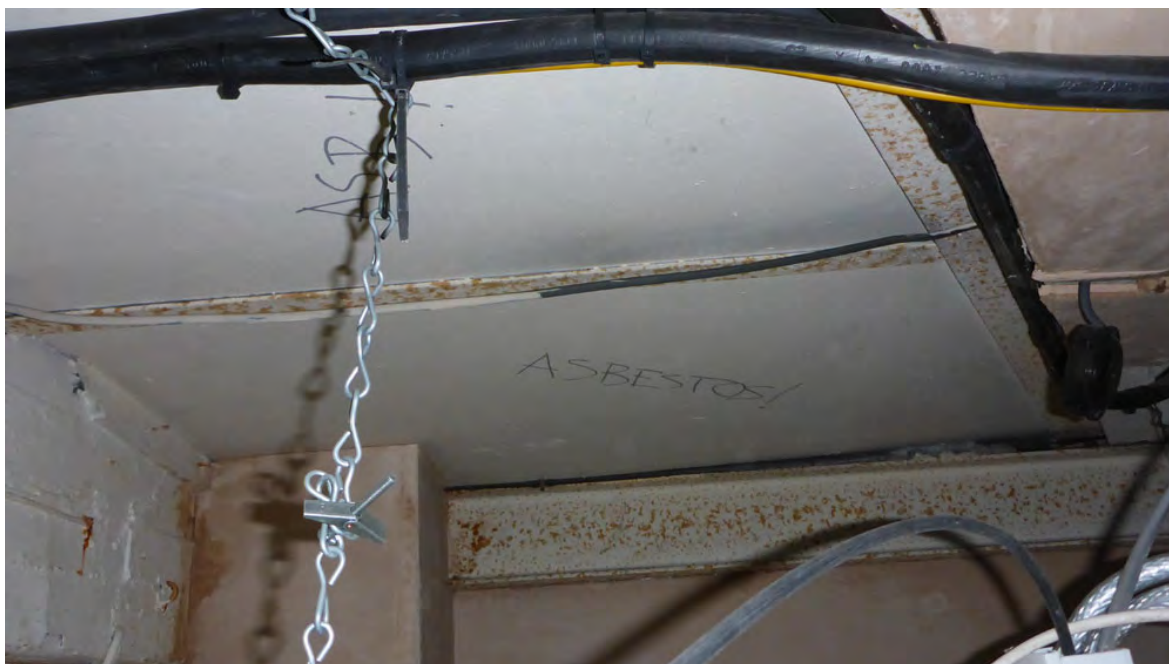
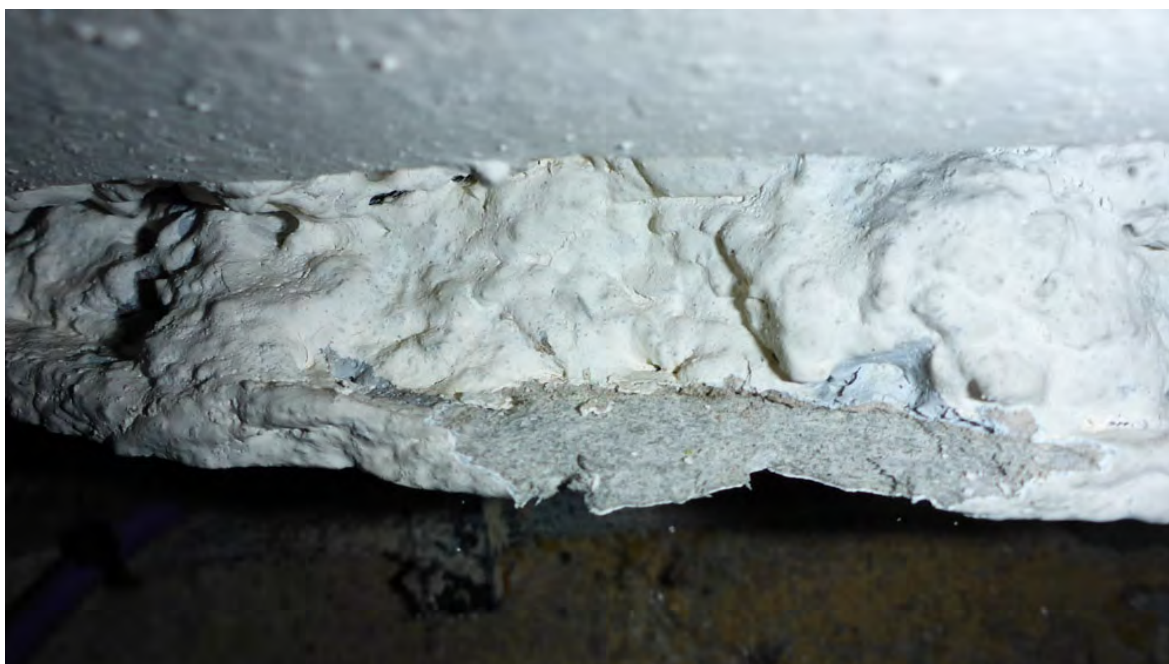
| <b>Asbestos Type</b> | - Chrysotile (White) | <b>Product Type</b> | - Cement Board |
| <b>Comments</b> | <p>Approximately 10 Sq. m of asbestos cement board was identified to a section of the File Store ceiling at the Mosley Street side of the room, passing through into the Server Room (please see plan for location and extent). A sample of the material was analysed and the results returned were found to be positive for the presence of asbestos. The material should be removed and disposed of as asbestos waste prior to any works in this area. (S# 17)</p> | | |

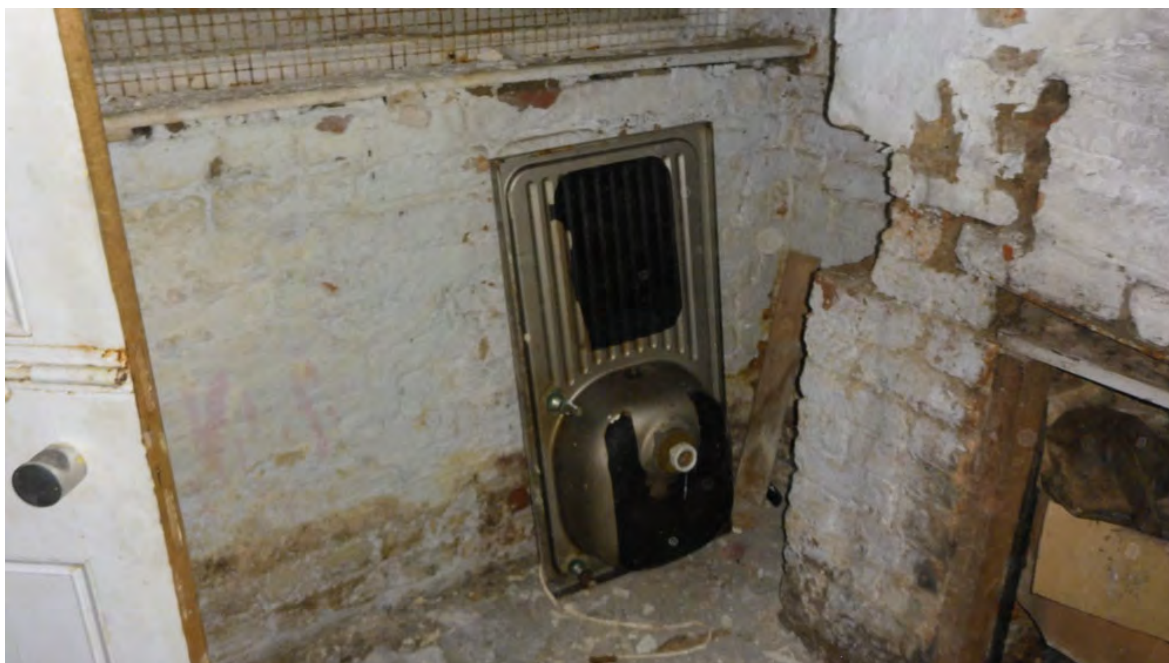
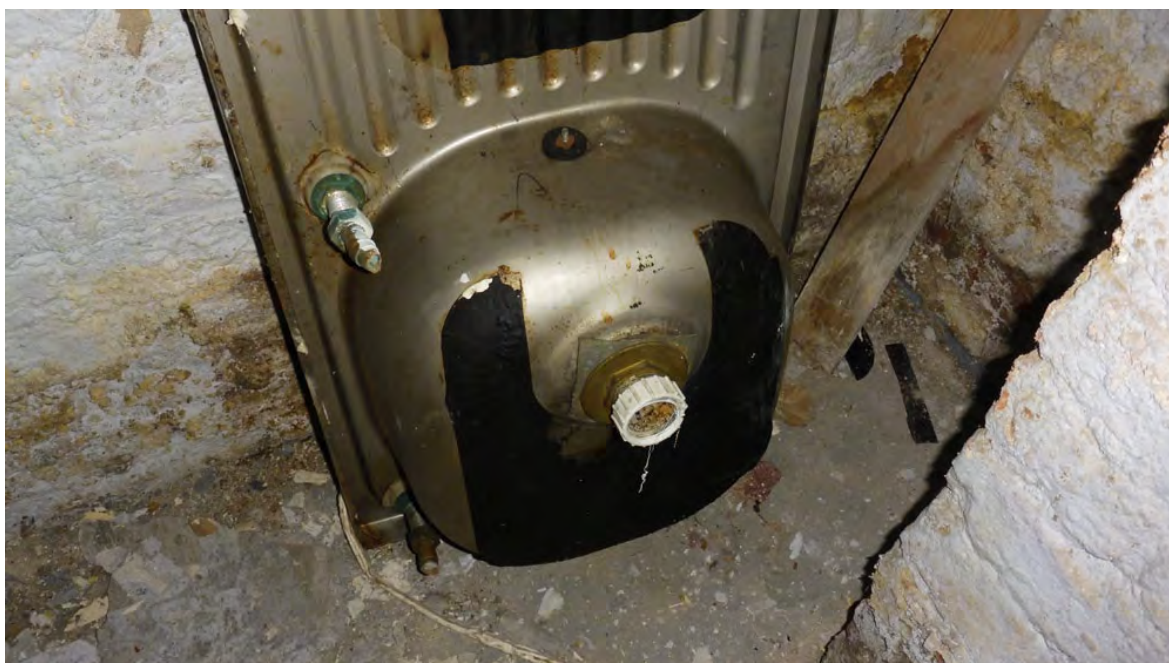
| <b>Floor</b> | - Basement | <b>Position Description</b> | - Asbestos sink pads to the redundant sink unit |

| <b>Asbestos Type</b> | - Chrysotile (White) | <b>Product Type</b> | - Sink Pad |
| <b>Comments</b> | Asbestos sink pads were identified to the loose, redundant sink unit within the basement Toilet Lobby. It is recommended that the sink unit is removed whole and disposed of as asbestos waste prior to refurbishment works commencing. (S# 04; Certificate No. 1811350) | | |

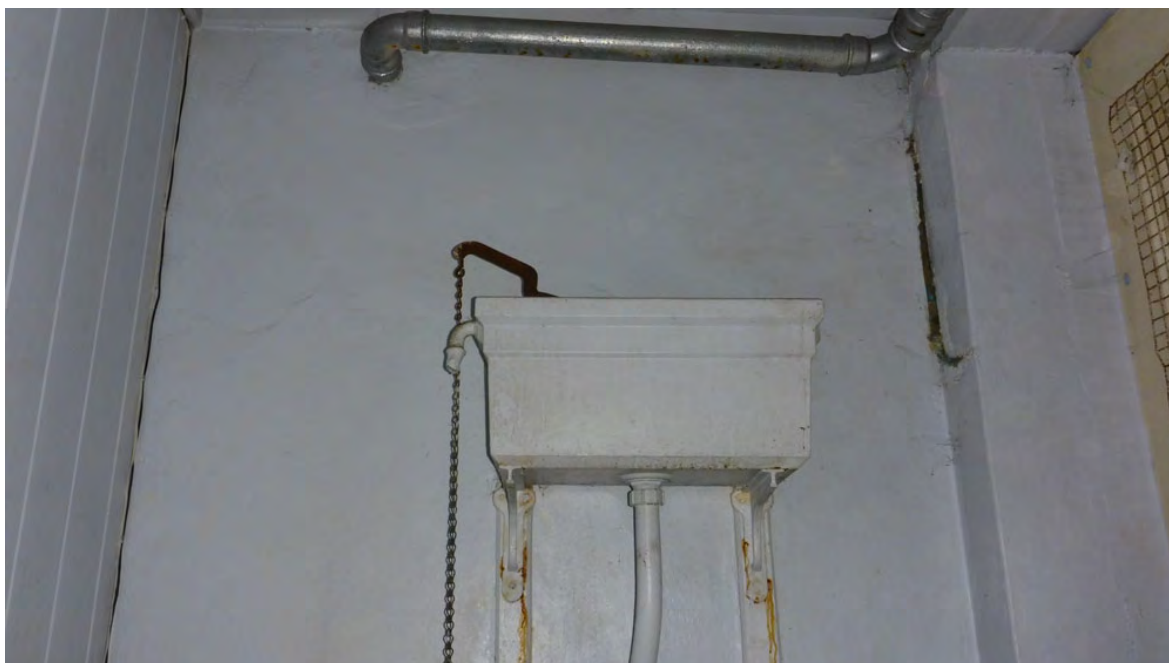
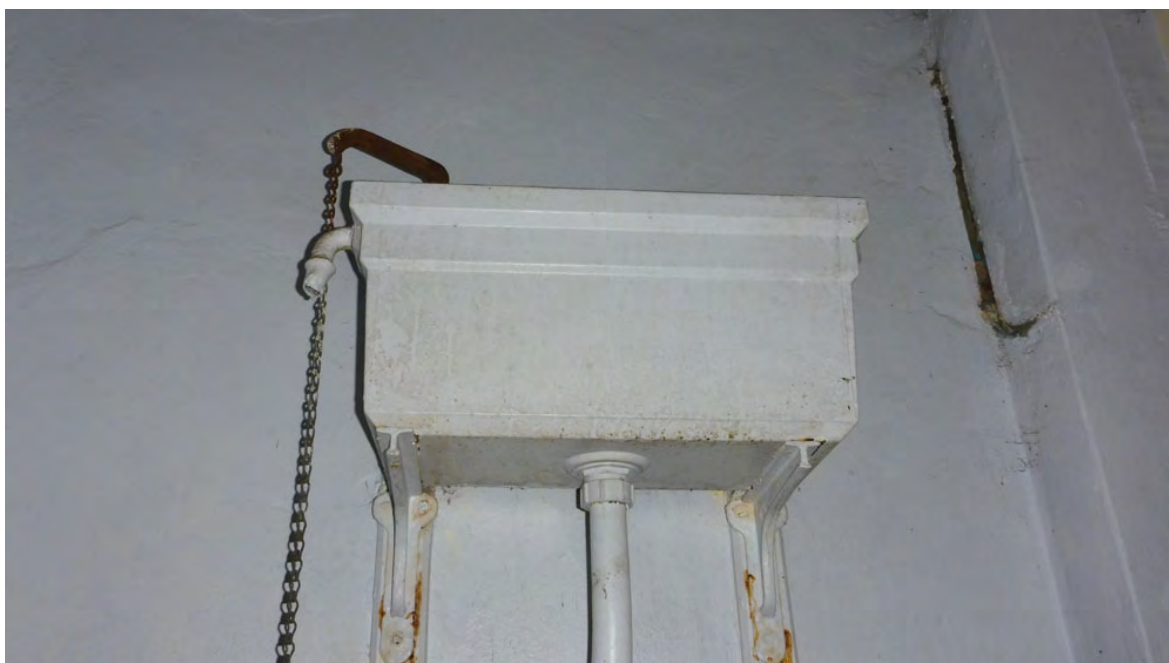
| <b>Floor</b> | - Basement | <b>Position Description</b> | - An asbestos reinforced composite toilet cistern to the wall |

| <b>Asbestos Type</b> | - Crocidolite (Blue) | <b>Product Type</b> | - ARC |

| <b>Comments</b> | - An asbestos reinforced composite toilet cistern was identified to the wall of the basement Toilet. It is recommended that the cistern is removed whole and disposed of as asbestos waste prior to refurbishment works commencing. (S# 03; Certificate No. 1811350) |

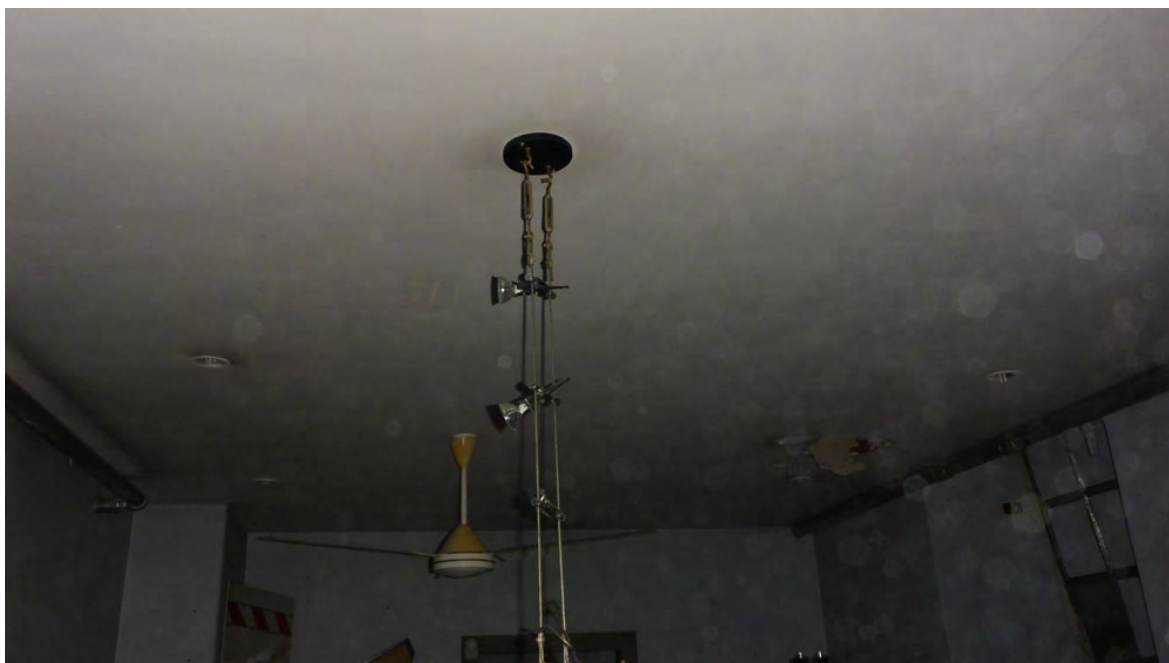
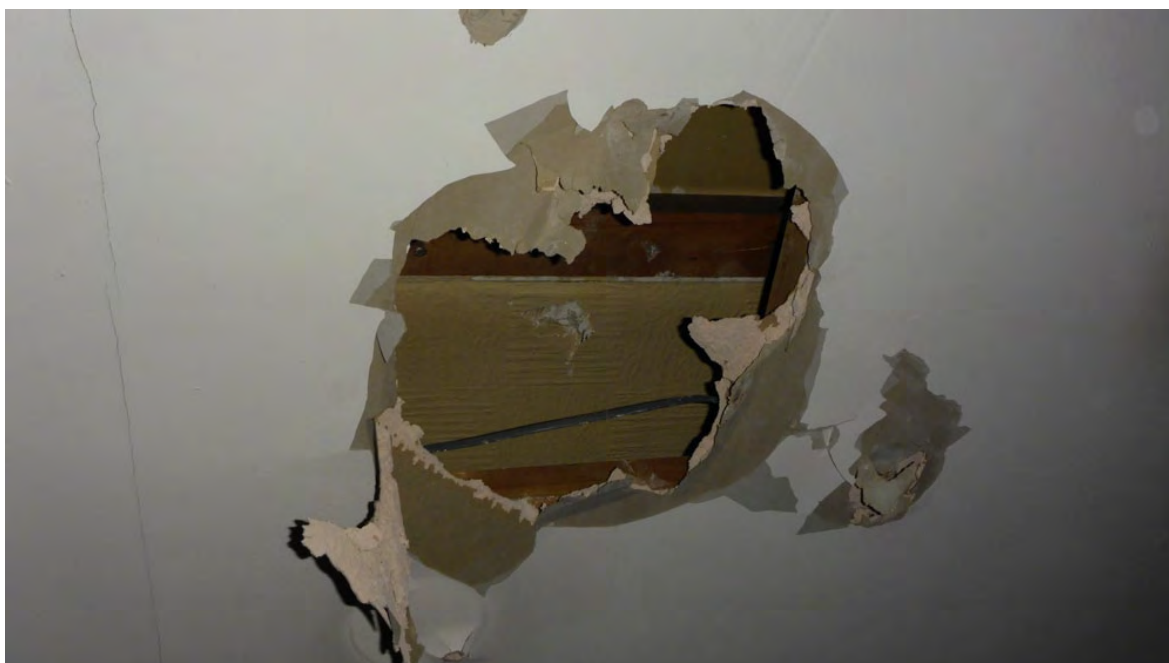
| <b>Floor</b> | - Basement | <b>Position Description</b> | - Asbestos cement boarding to the original ceiling (beyond plasterboard) |

| <b>Asbestos Type</b> | - Chrysotile (White) | <b>Product Type</b> | - Cement |

| <b>Comments</b> | - Approximately 30 Sq. m of asbestos cement boarding was identified to the original ceiling, beyond plasterboard, within the former basement Salon. It is recommended that the boarding is removed and disposed of as asbestos waste prior to refurbishment works commencing. (S# 05; Certificate No. 1811350) |
