# Method Statement for Soft Strip Works

**79 Mosley Street  
St Peters Square  
Manchester**

Method statement for Investigative Works and Soft Strip works at No. 79 Mosley Street.

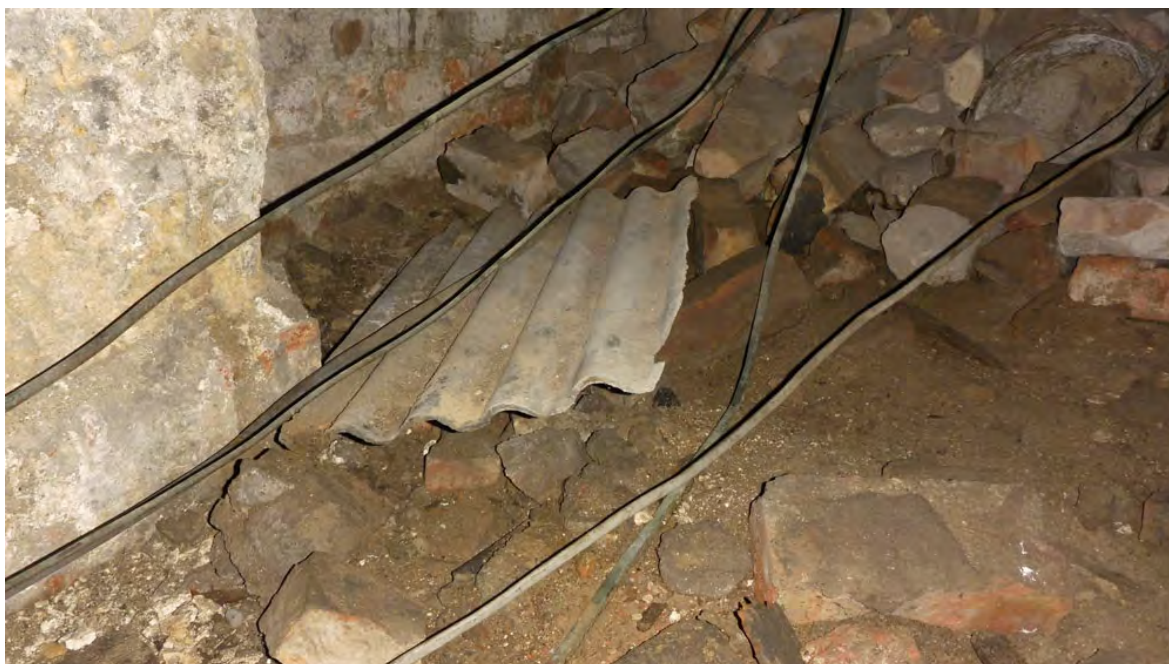
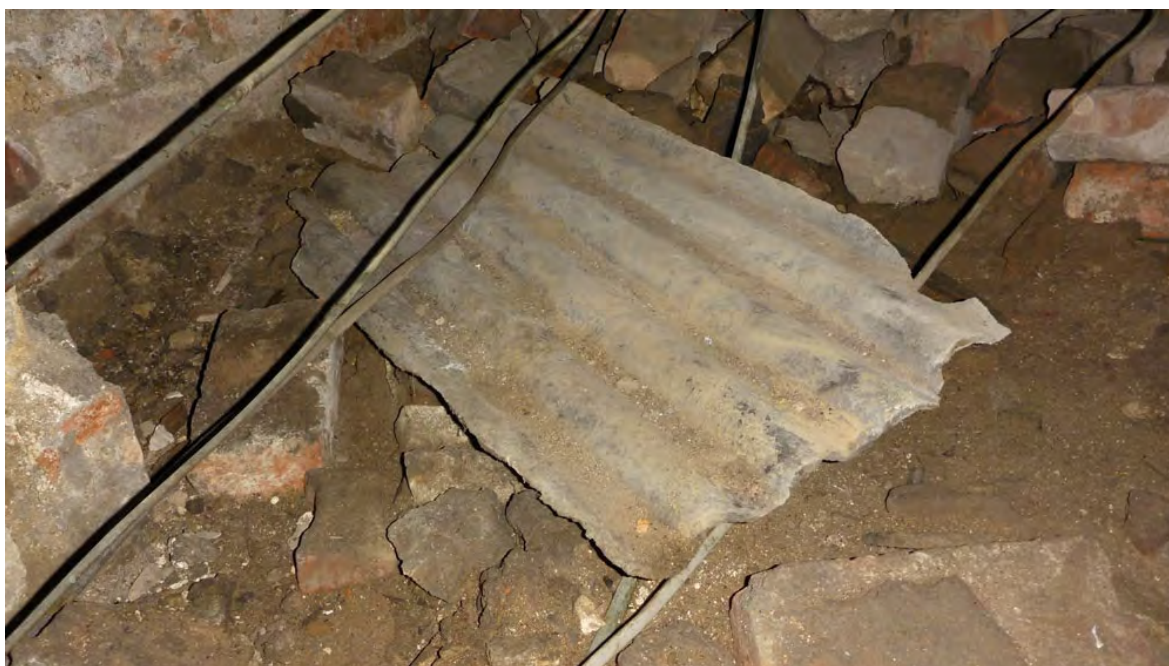
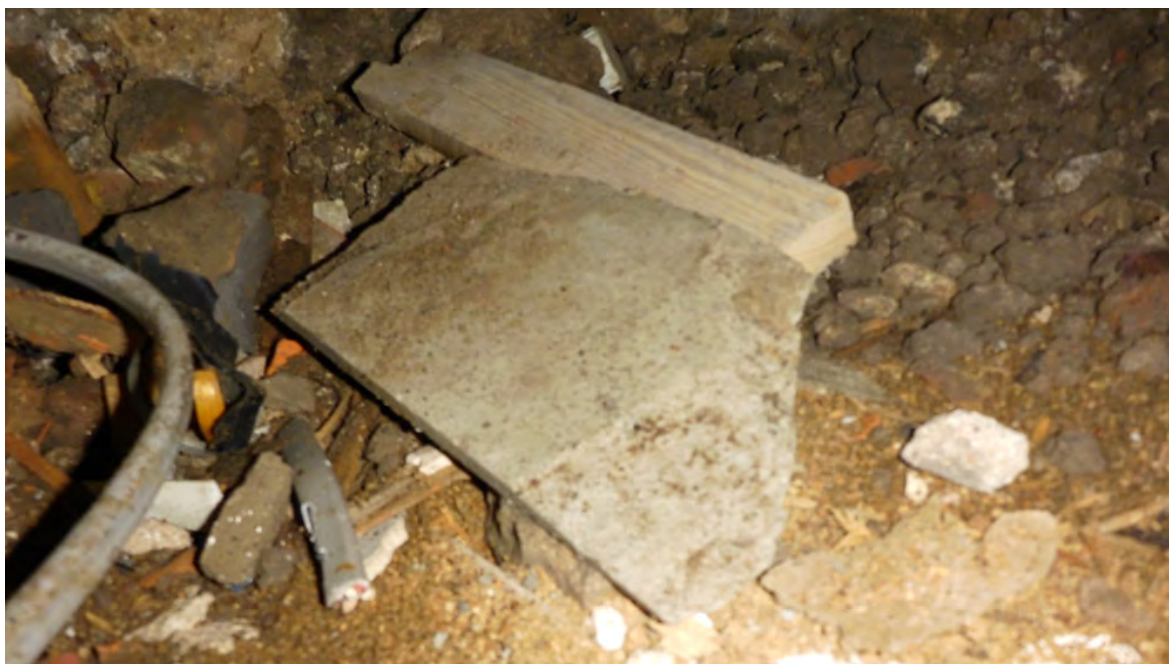
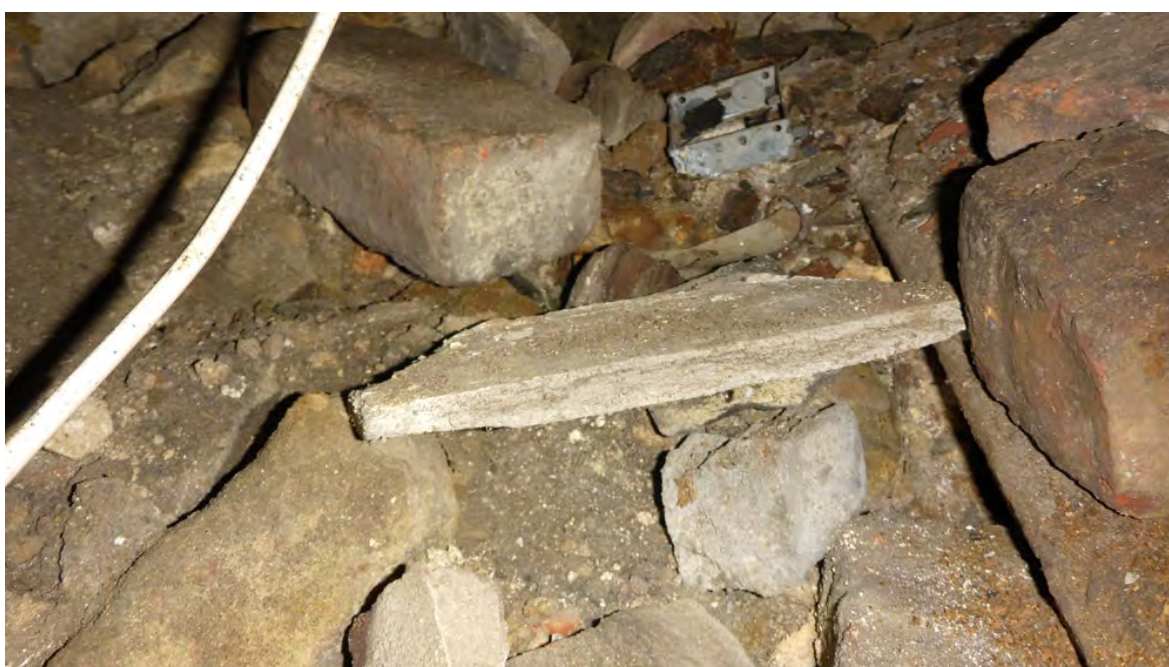
| <b>Floor</b> | - Sub-floor (Basement) | <b>Position Description</b> | - Loose asbestos cement and insulation board debris to the floor |

| <b>Asbestos Type</b> | - Amosite (Brown),<br>Chrysotile (White) | <b>Product Type</b> | - Insulation Board,<br>Cement |
| <b>Comments</b> | <p>Loose asbestos insulation board and asbestos cement debris was identified within the sub-floor undercroft, beneath the Restaurant Kitchen, along with general building waste and rubble. It is recommended that the floor of the Undercroft is environmentally cleaned by a licensed asbestos removal contractor, prior to refurbishment works commencing. (S# 06; Certificate No. 1811350)</p> | | |

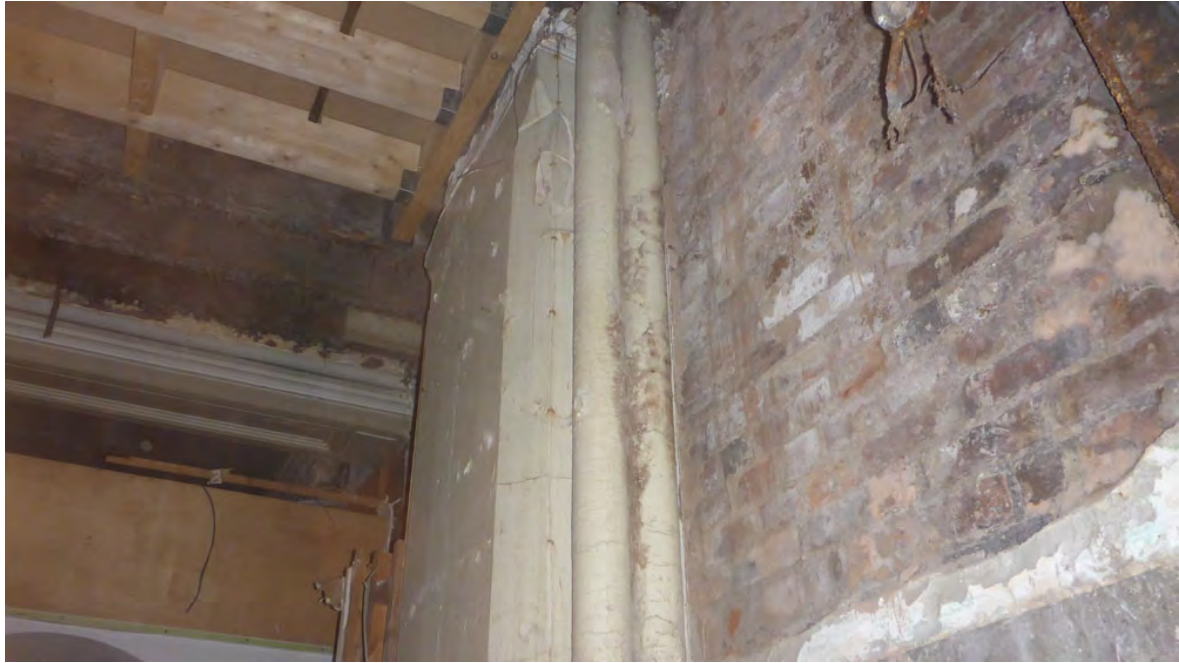
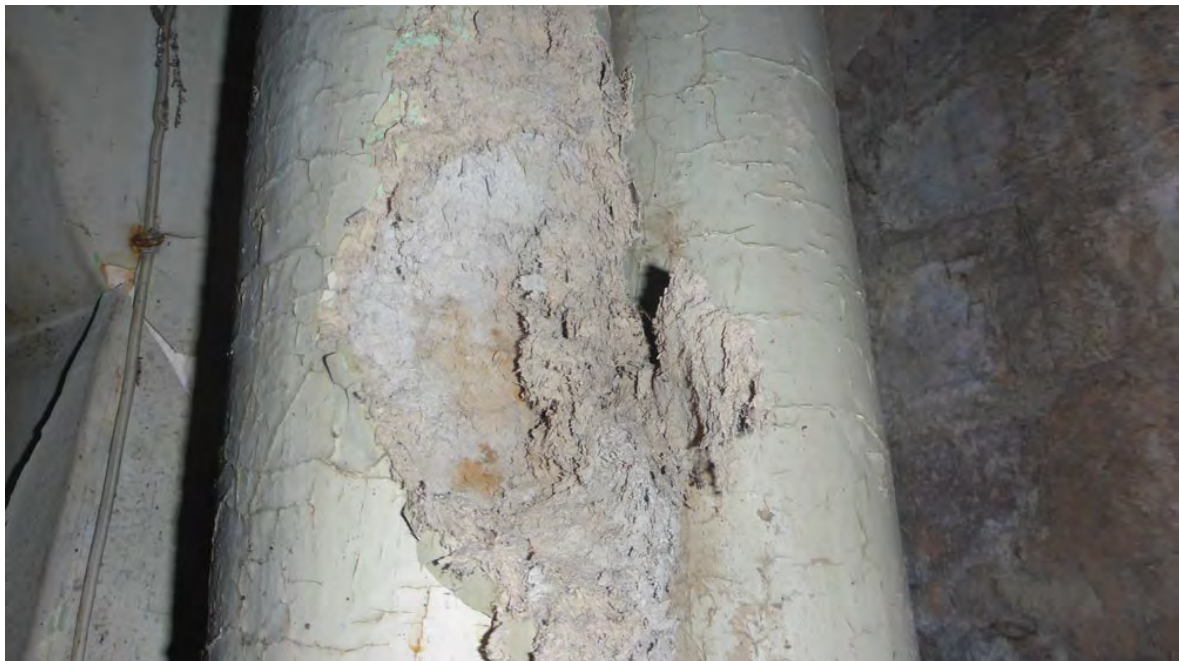
| <b>Floor</b> | - Ground | <b>Position Description</b> | - Asbestos thermal insulation to 2 No. vertical pipes beside the chimney |

| <b>Asbestos Type</b> | - Crocidolite (Blue) & Chrysotile (White) | <b>Product Type</b> | - Thermal Insulation |

| <b>Comments</b> | - Approximately 4 Lin m (each) of asbestos thermal insulation was identified to 2 No. vertical pipes to the right hand side of the Lift Lobby chimney and is presumed to pass through into the floor void. A sample of the material was analysed and the results returned were found to be positive for the presence of asbestos. The material should be removed by a licensed asbestos removals contractor prior to any works in this area. (S# 21) |

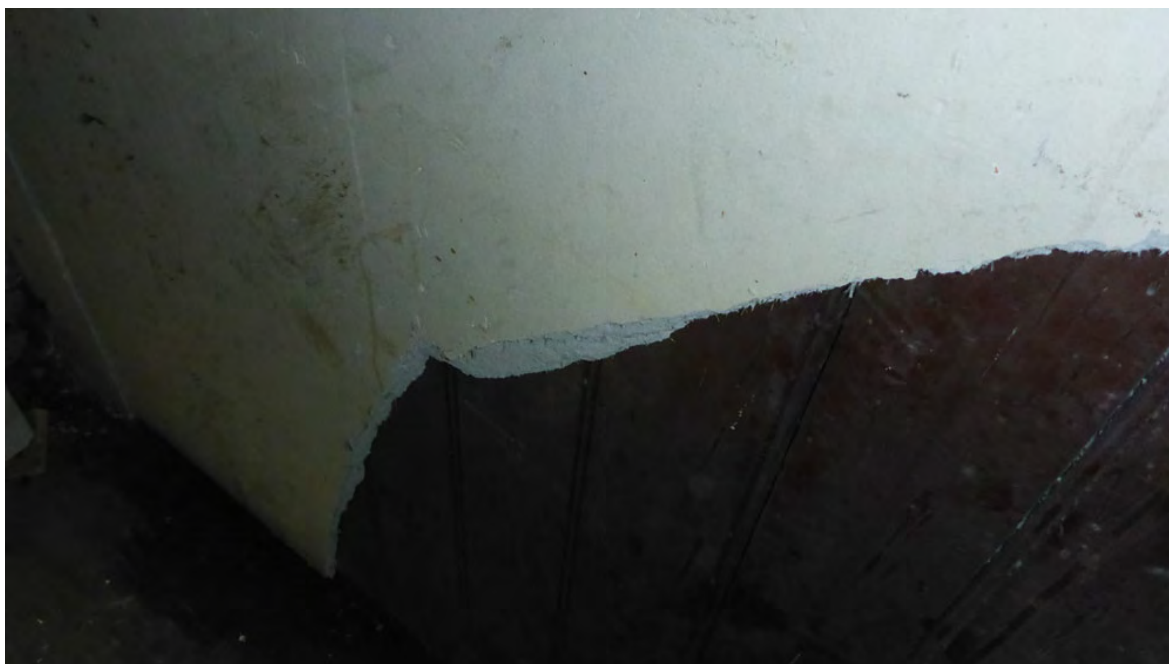
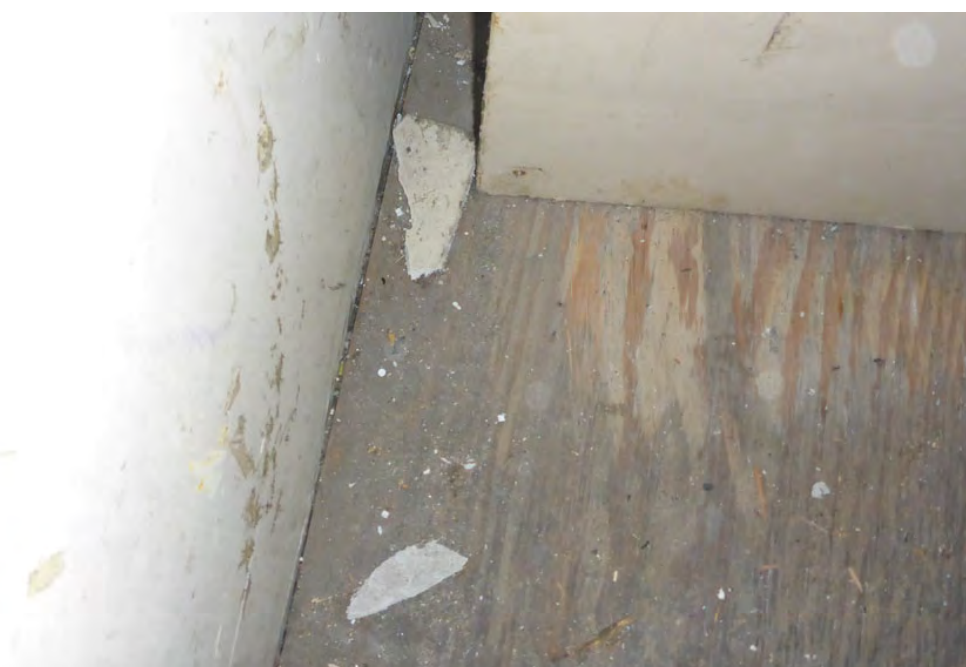
| <b>Asbestos Type</b> | - Amosite (Brown) & Chrysotile (White) | <b>Product Type</b> | - Insulation Board |
| <b>Comments</b> | Approximately 2 Sq. m of asbestos insulation board with associated debris to the floor was identified to the Ground Floor Fire Escape door, door head and Landing, accessed via the Rear Fire Exit. A sample of the material was analysed and the results returned were found to be positive for the presence of asbestos. The material should be removed by a licensed asbestos removals contractor prior to any works in this area. (S# 04) | | |

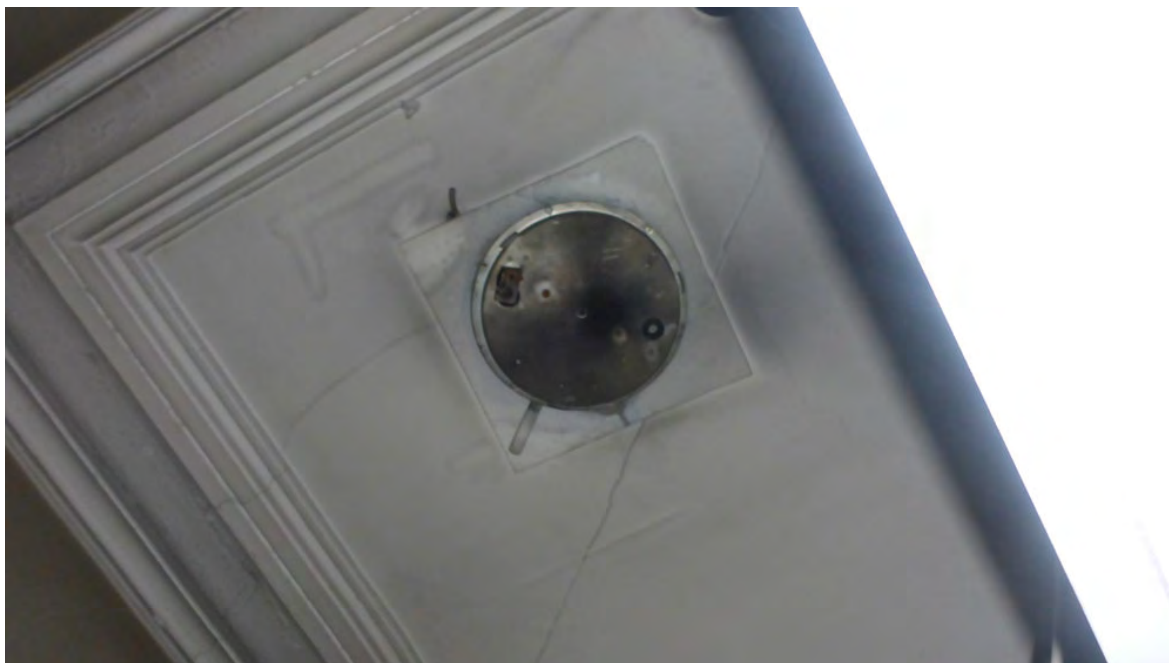
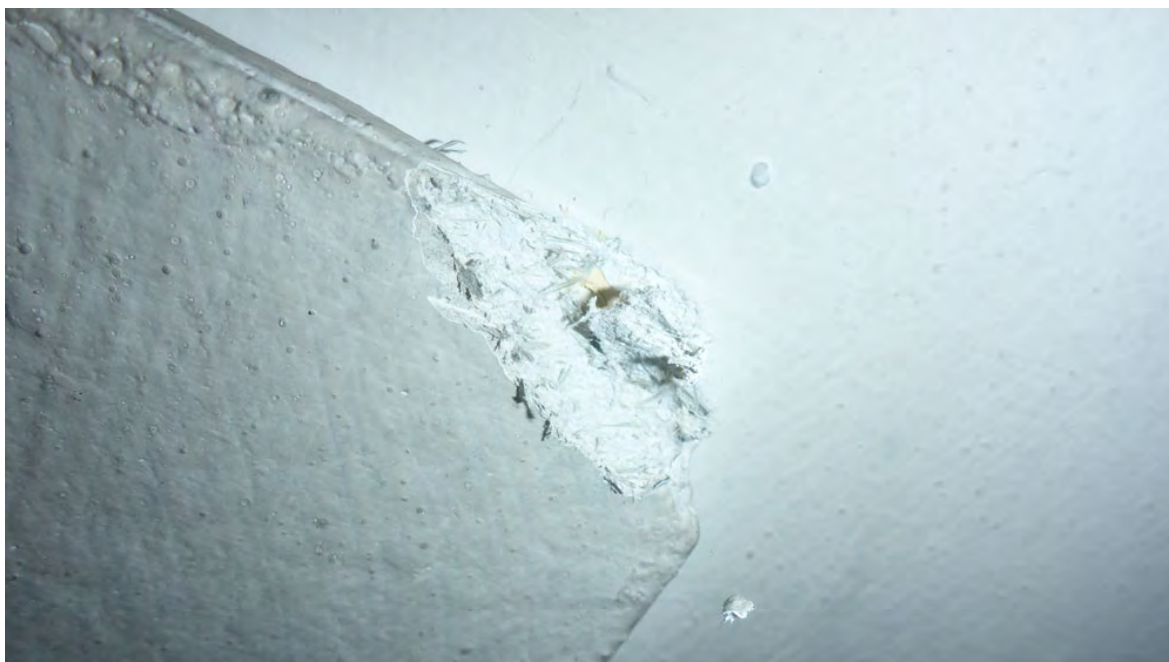
| <b>Floor</b> | - First | <b>Position Description</b> | - A small piece of asbestos insulation board to the half landing ceiling |

| <b>Asbestos Type</b> | - Amosite (Brown) & Chrysotile (White) | <b>Product Type</b> | - Insulation Board |
| <b>Comments</b> | A small piece of asbestos insulation board was identified as a panel to the Lift Stairwell half-landing ceiling. A sample of the material was analysed and the results returned were found to be positive for the presence of asbestos. The material should be removed by a licensed asbestos removals contractor prior to any works in this area. (S# 27) | | |

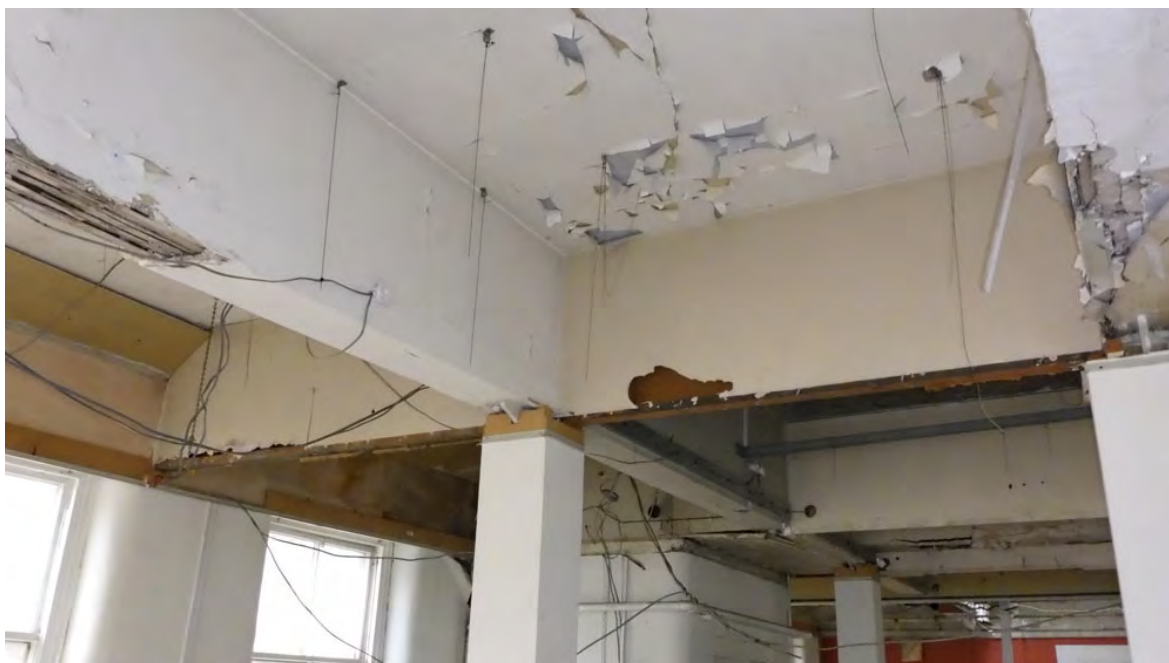
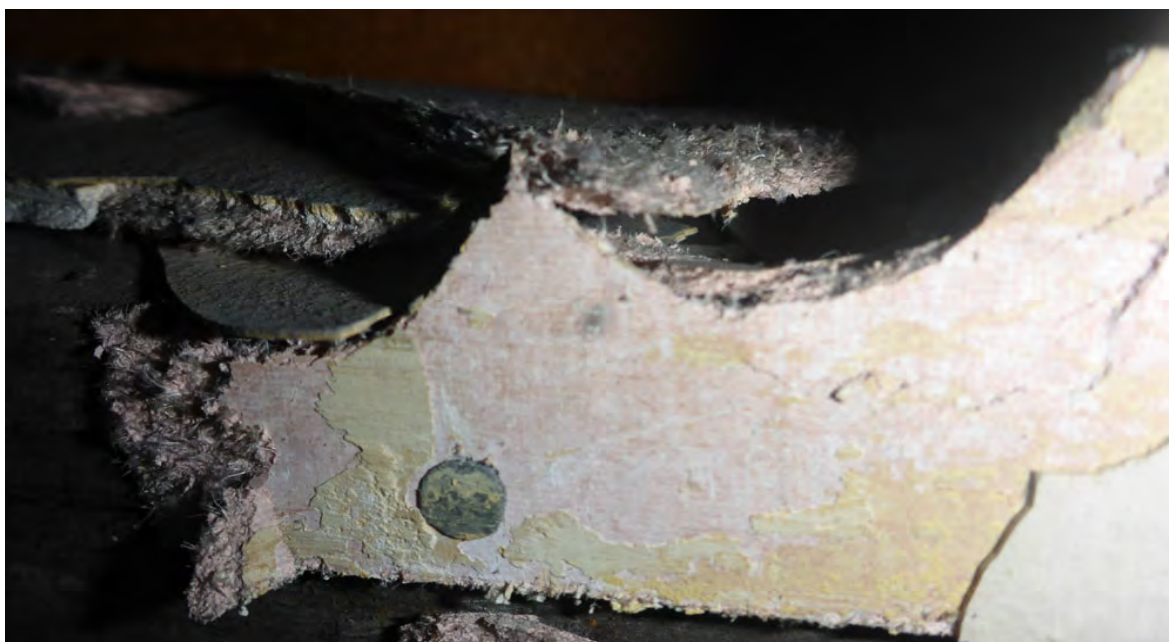
| <b>Floor</b> | - Third | <b>Position Description</b> | - An asbestos insulation board firebreak within the ceiling void between the Main Staircase door and Back George Street |

| <b>Asbestos Type</b> | - Chrysotile (White) | <b>Product Type</b> | - Insulation Board |

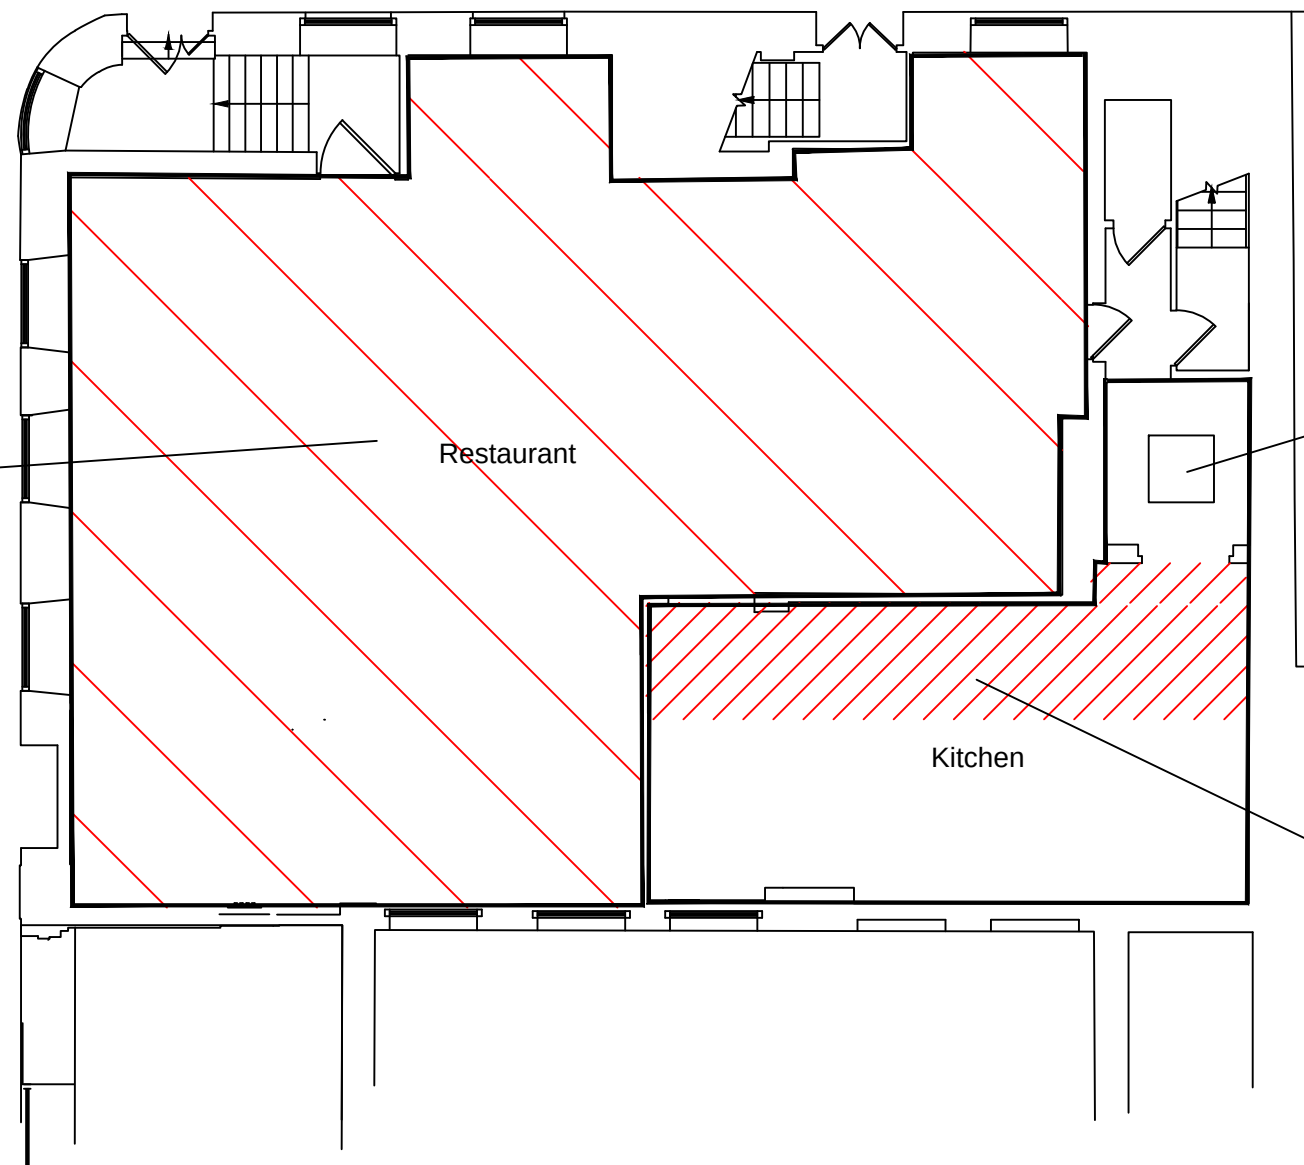
No Access could be gained in to the Undercroft below the former Restaurant area. Asbestos insulation board debris is presumed to be present, along with other general building waste and rubble

This hatch leads in to the undercroft below the Kitchen only

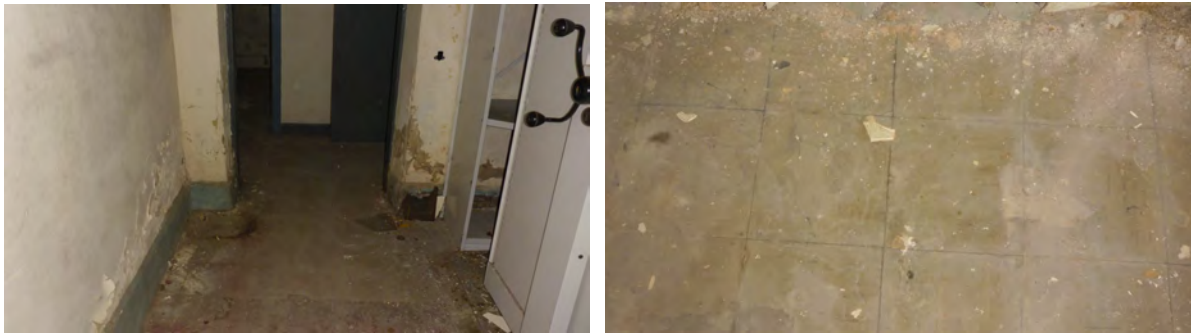
### **Area 09: Basement – File Store Lobby & File Store – Asbestos floor tiles**

Asbestos tiles to the File Store and Lobby floors

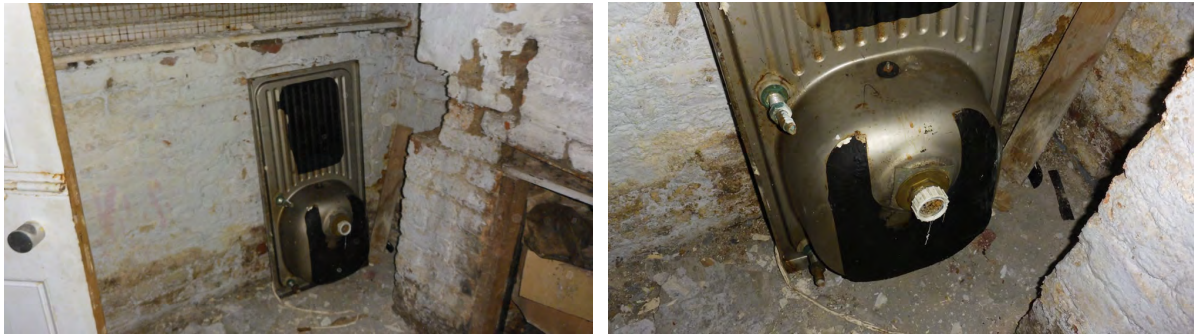
**Area 011: Basement – Toilet Lobby – Asbestos sink pads to redundant sink unit**

Asbestos bitumen sink pads to the loose, redundant sink unit
