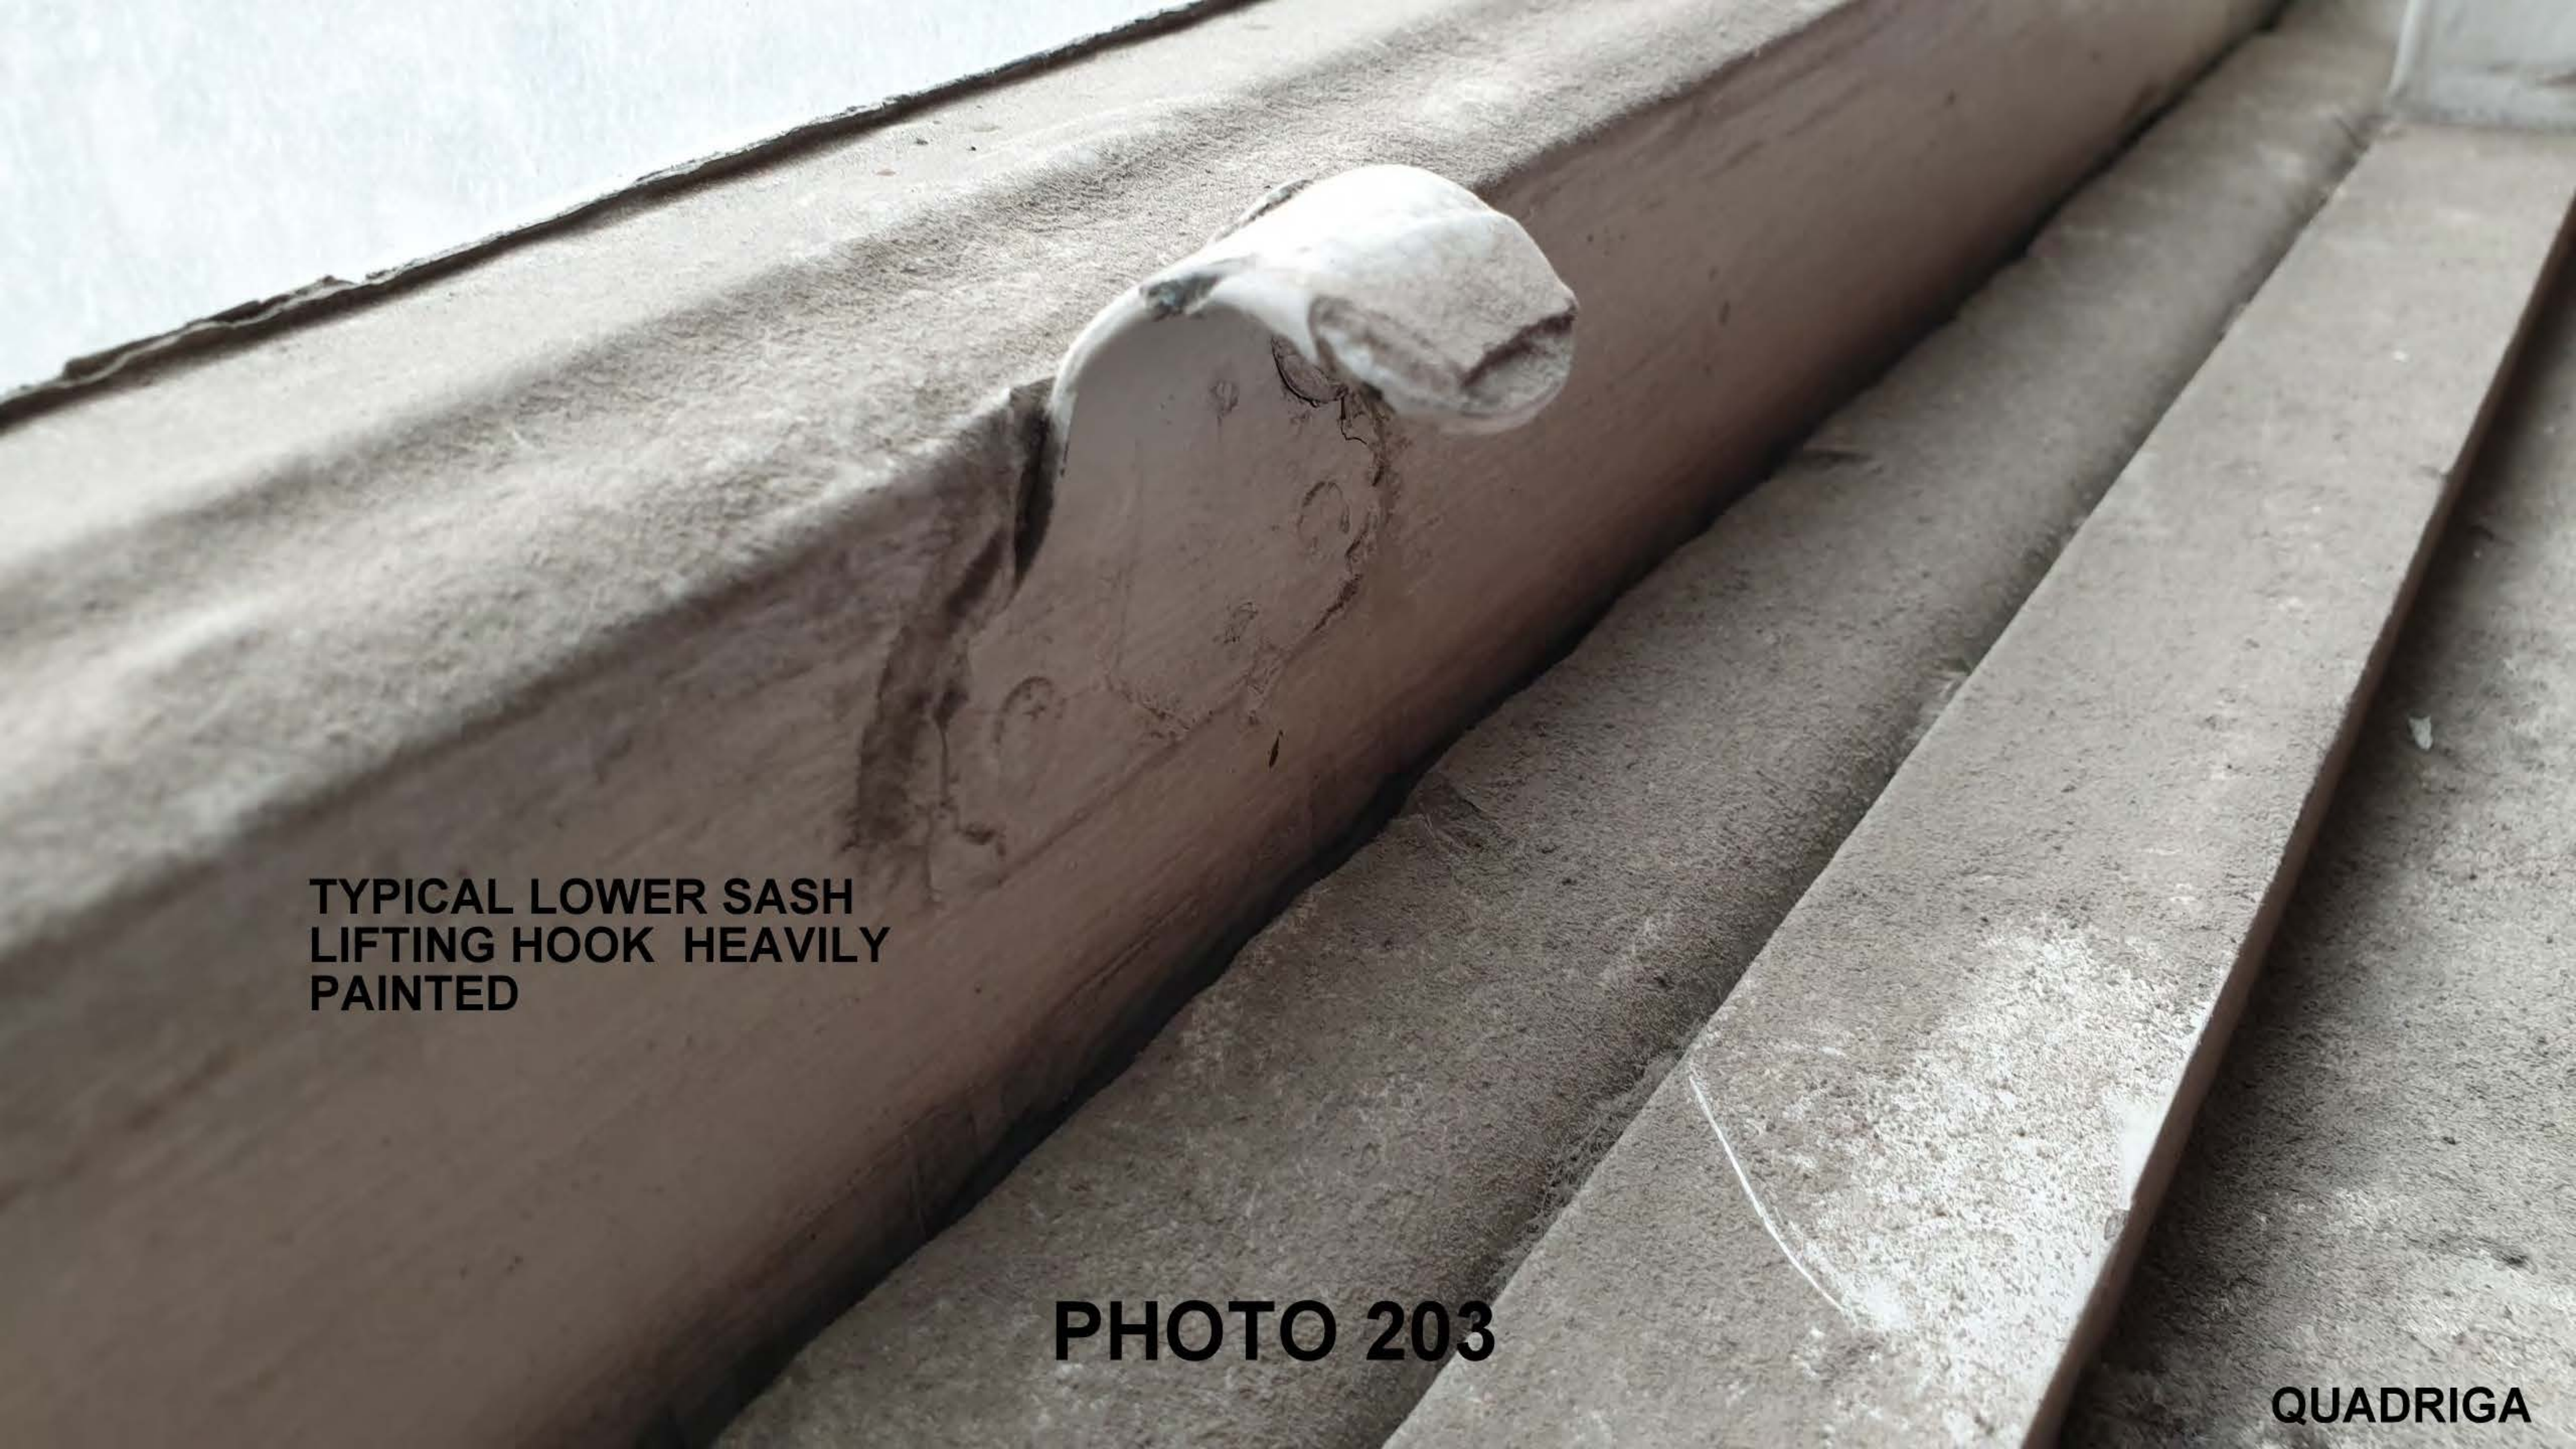
**PHOTO 203**

**TYPICAL LOWER SASH  
LIFTING HOOK HEAVILY  
PAINTED**

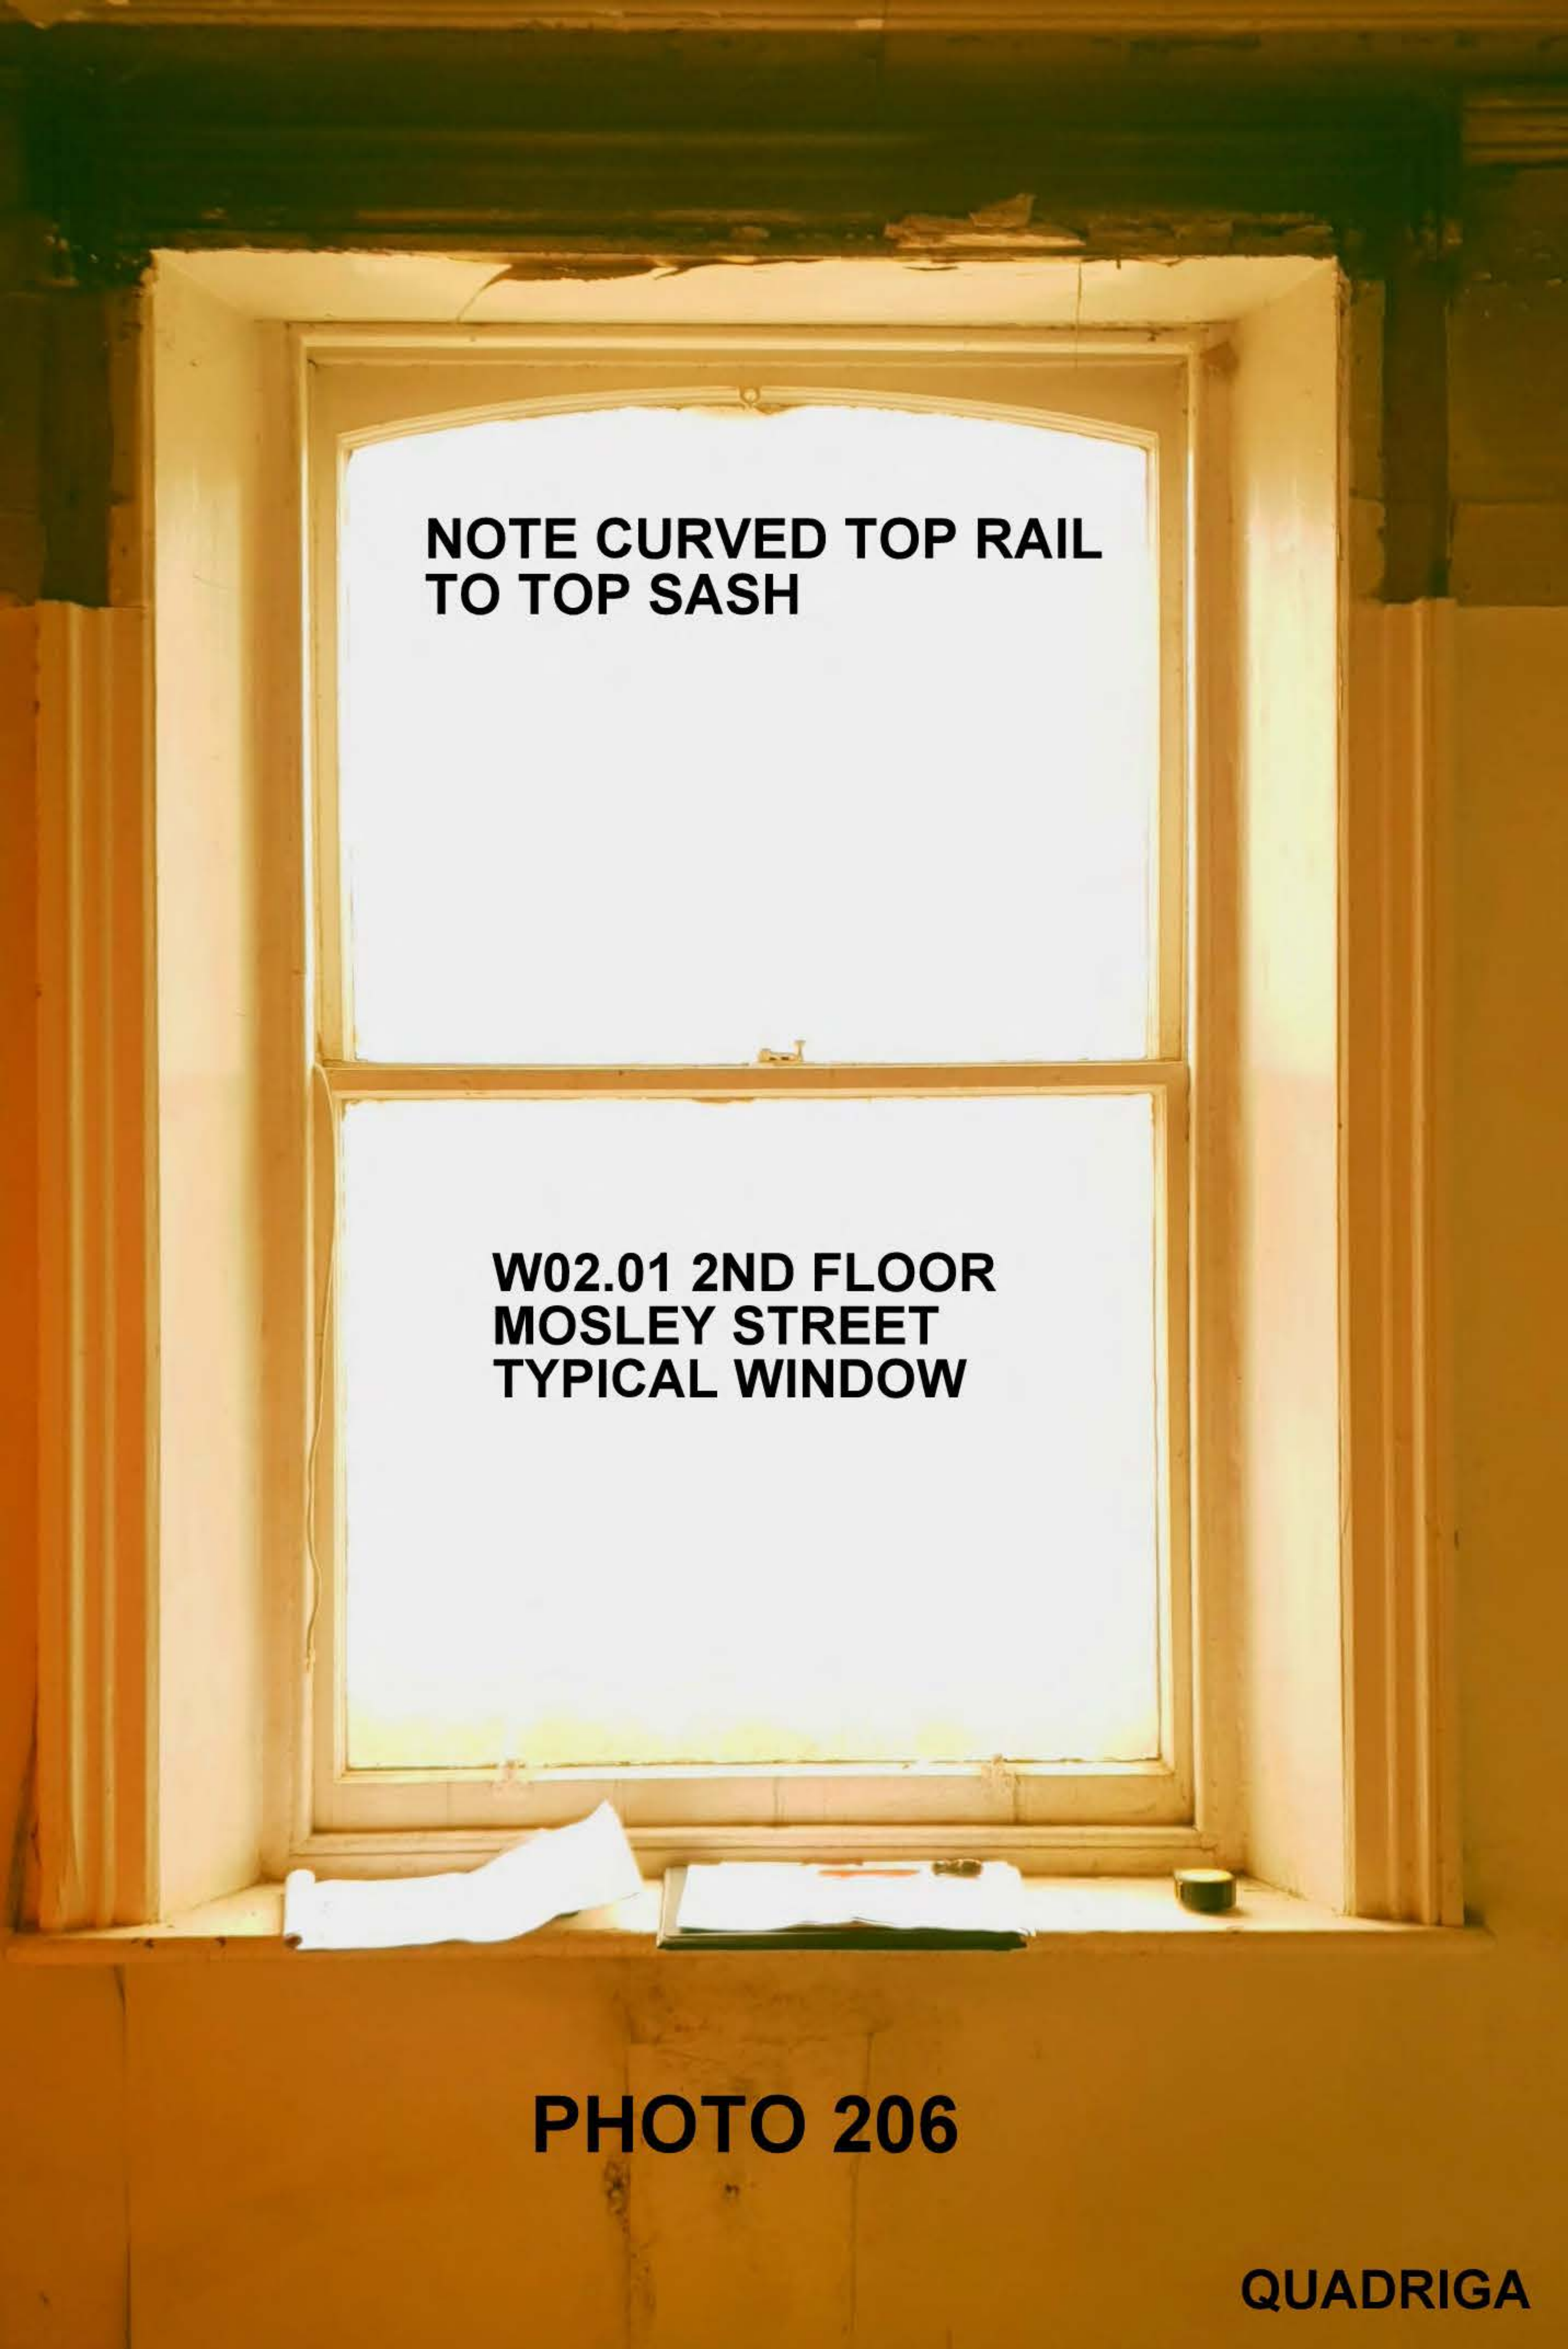
**W02.01 2ND FLOOR  
MOSLEY STREET  
TYPICAL WINDOW**

**NOTE CURVED TOP RAIL  
TO TOP SASH**

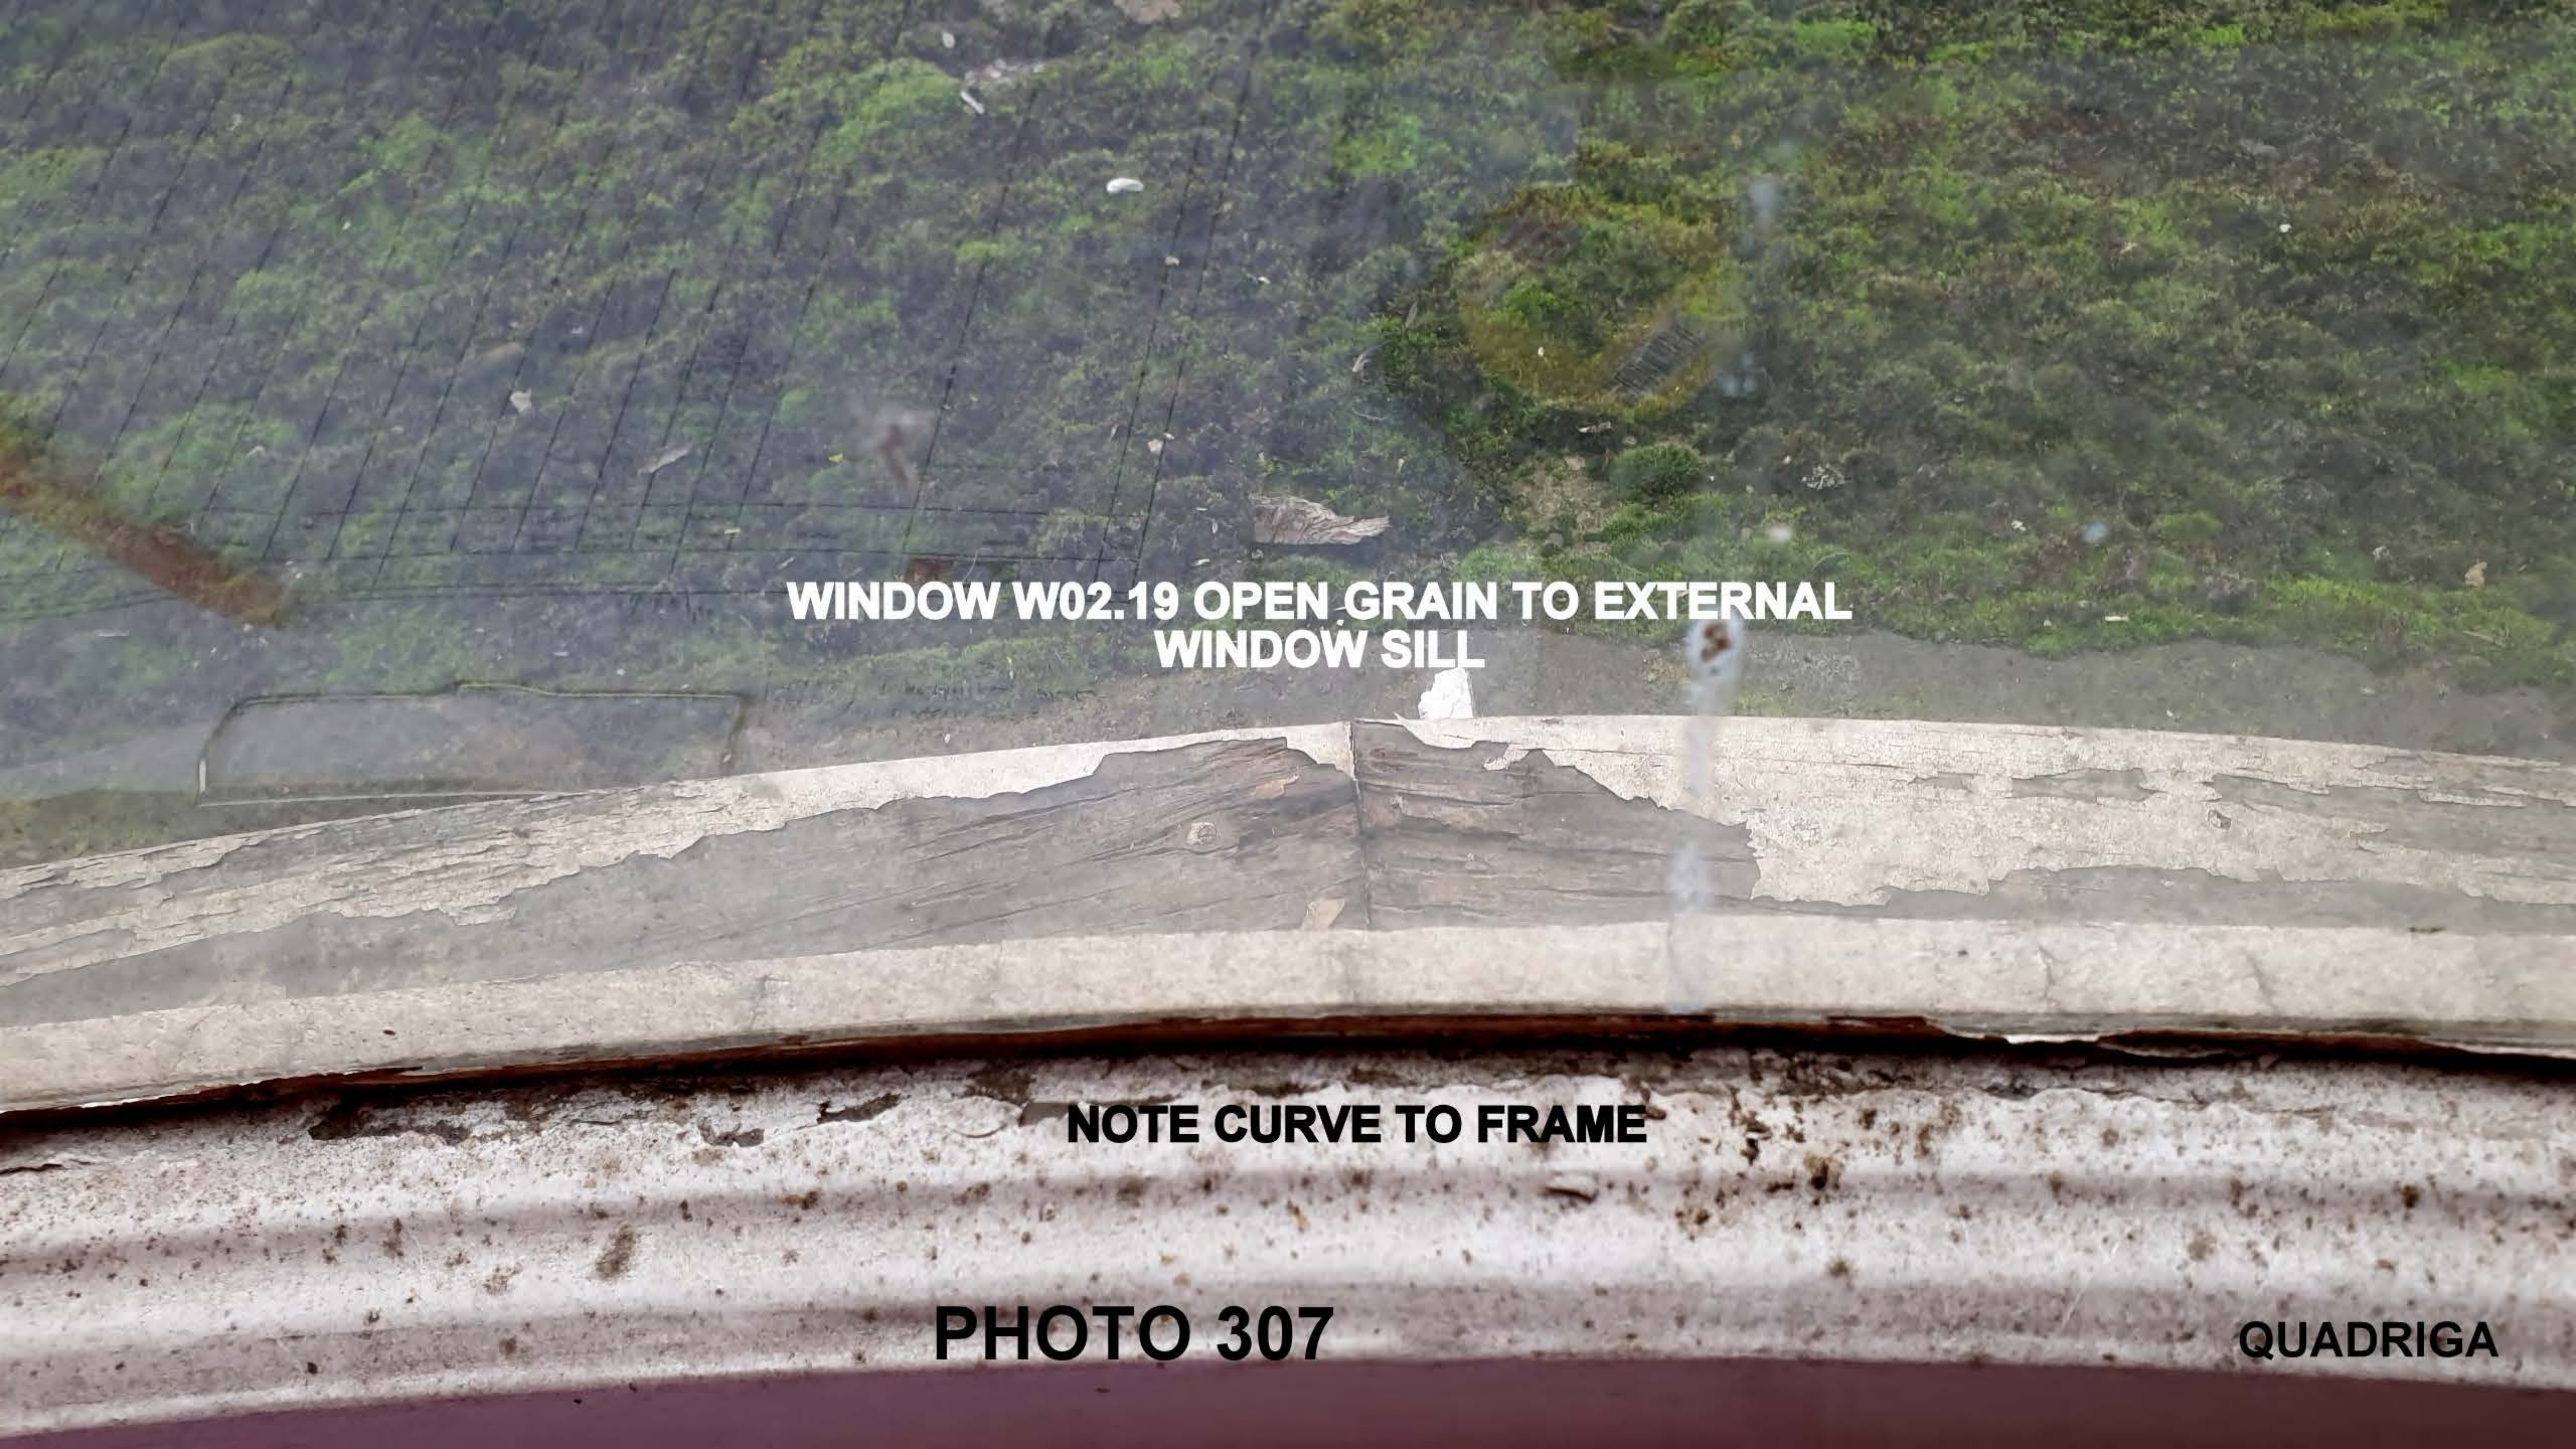
**PHOTO 307**

**WINDOW W02.19 OPEN GRAIN TO EXTERNAL  
WINDOW SILL**

**NOTE CURVE TO FRAME**

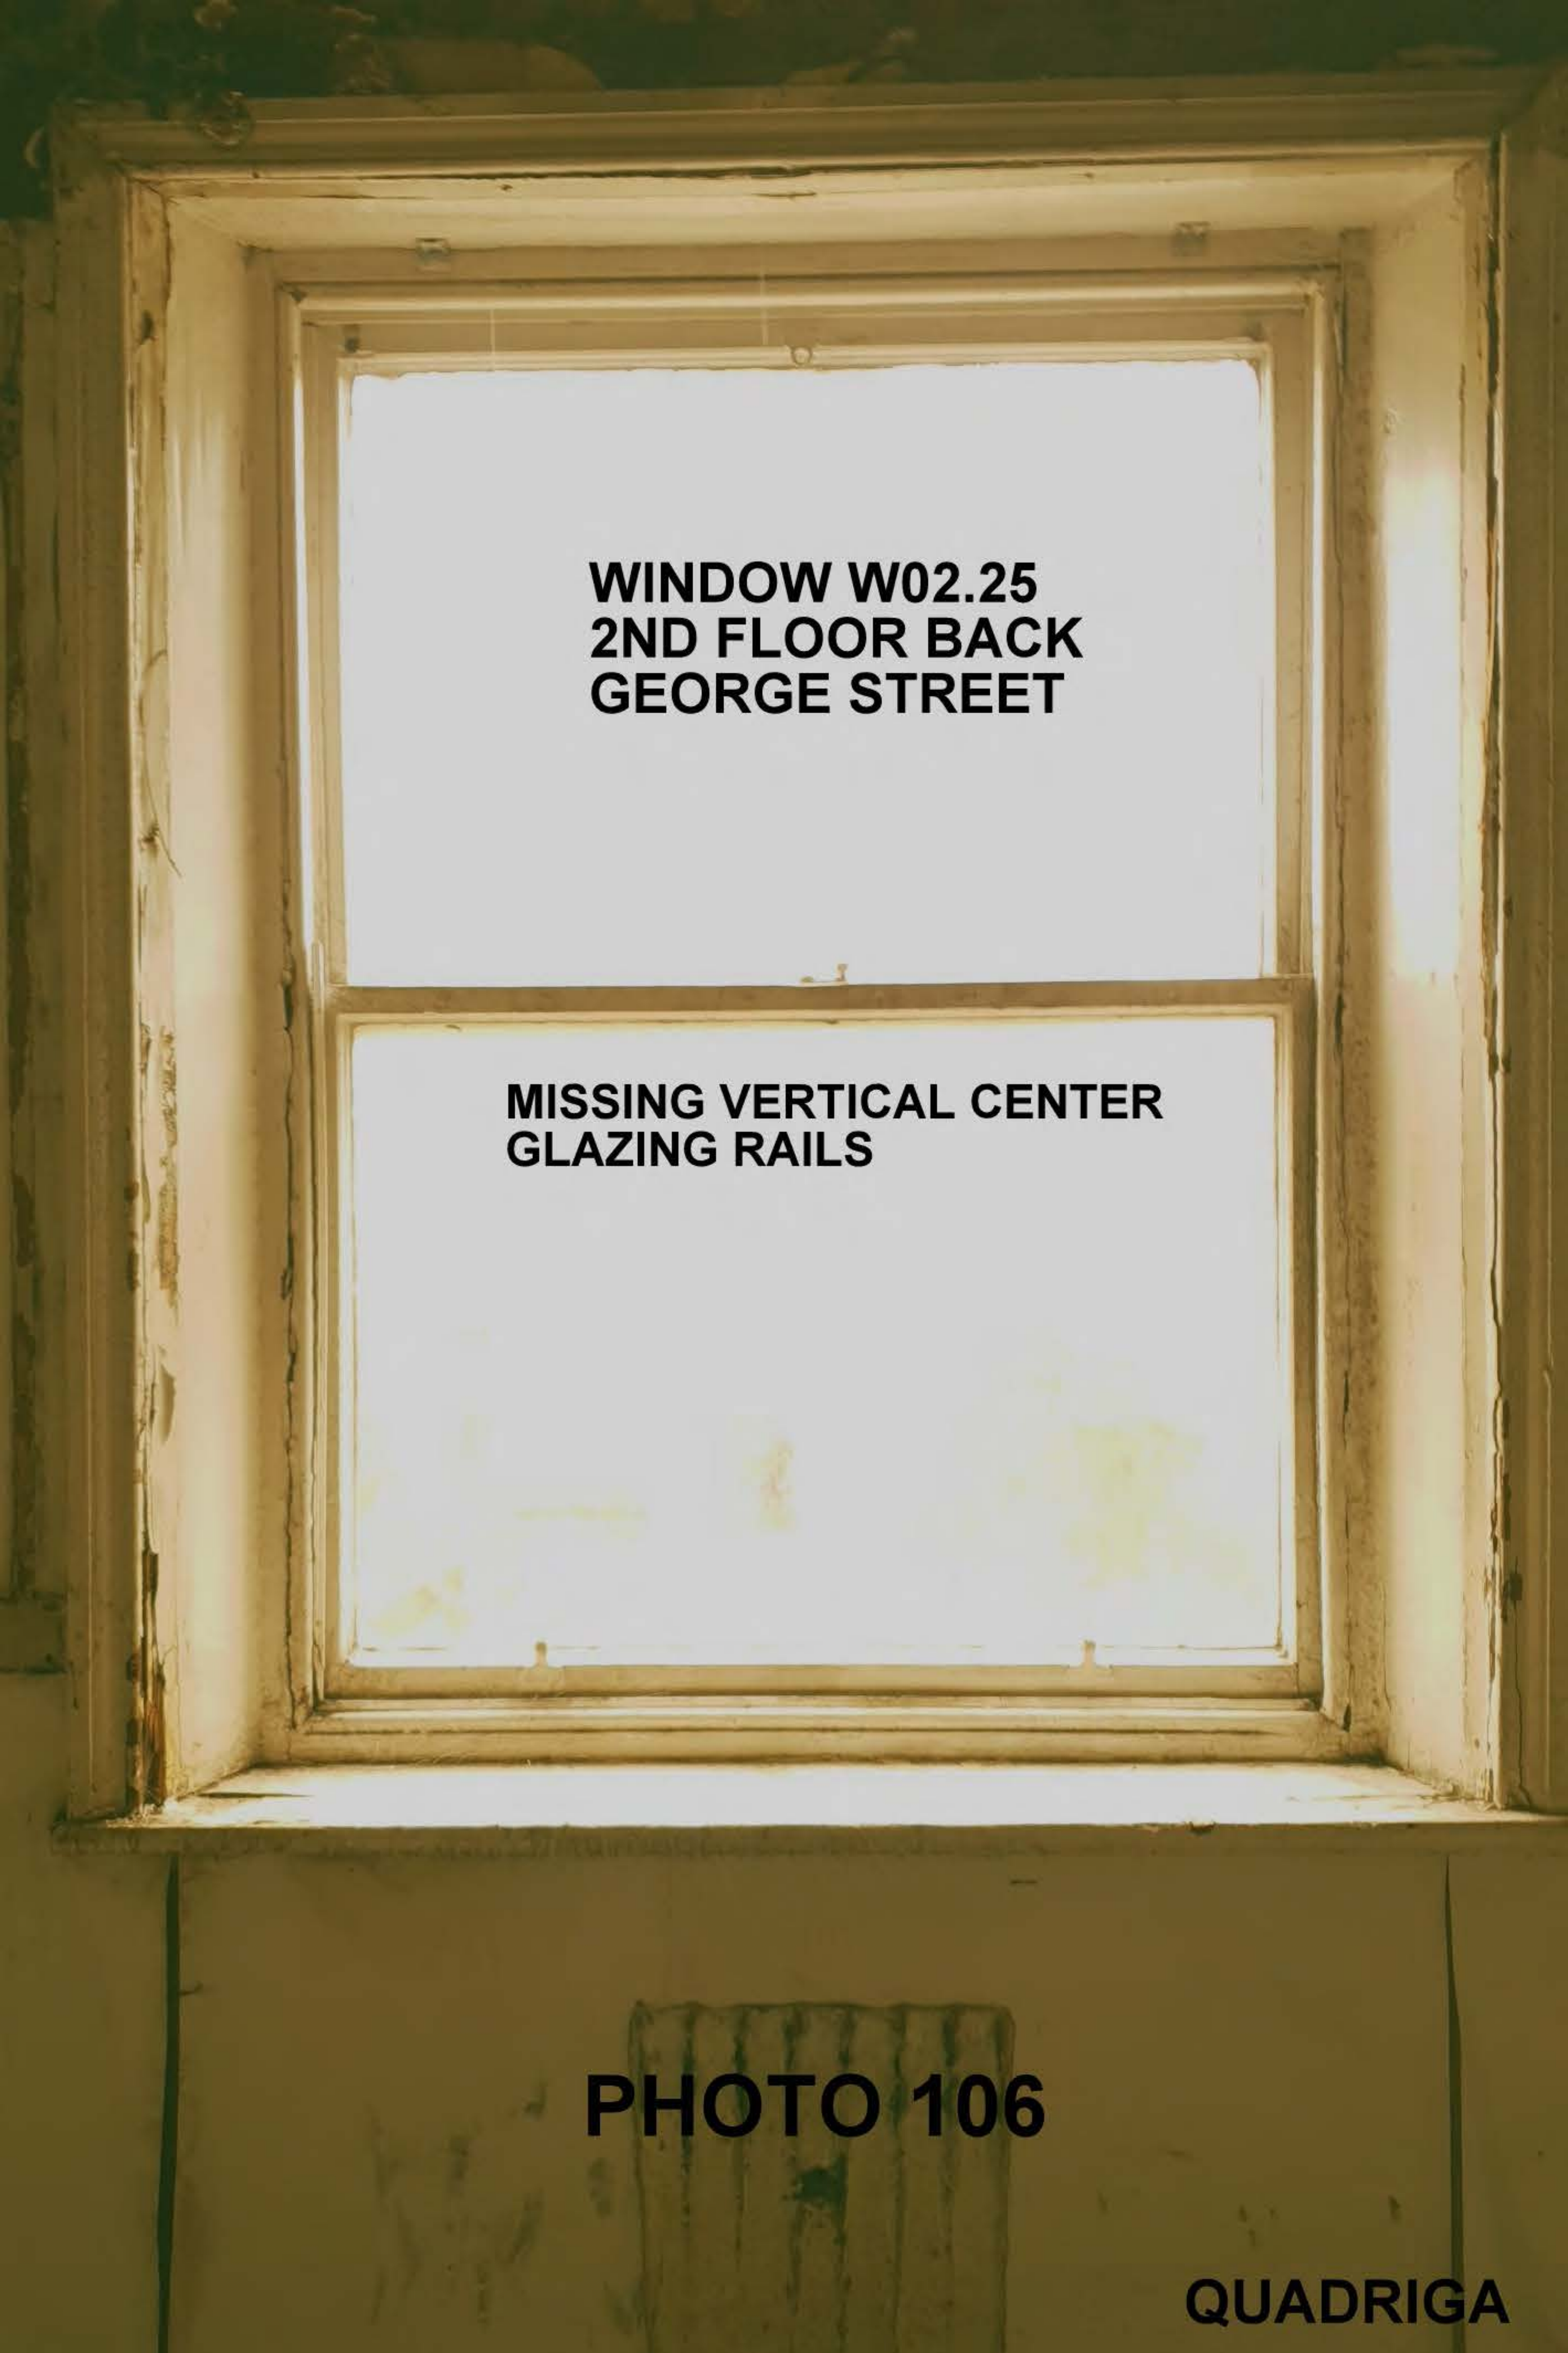
**WINDOW W02.25  
2ND FLOOR BACK  
GEORGE STREET**

**MISSING VERTICAL CENTER  
GLAZING RAILS**

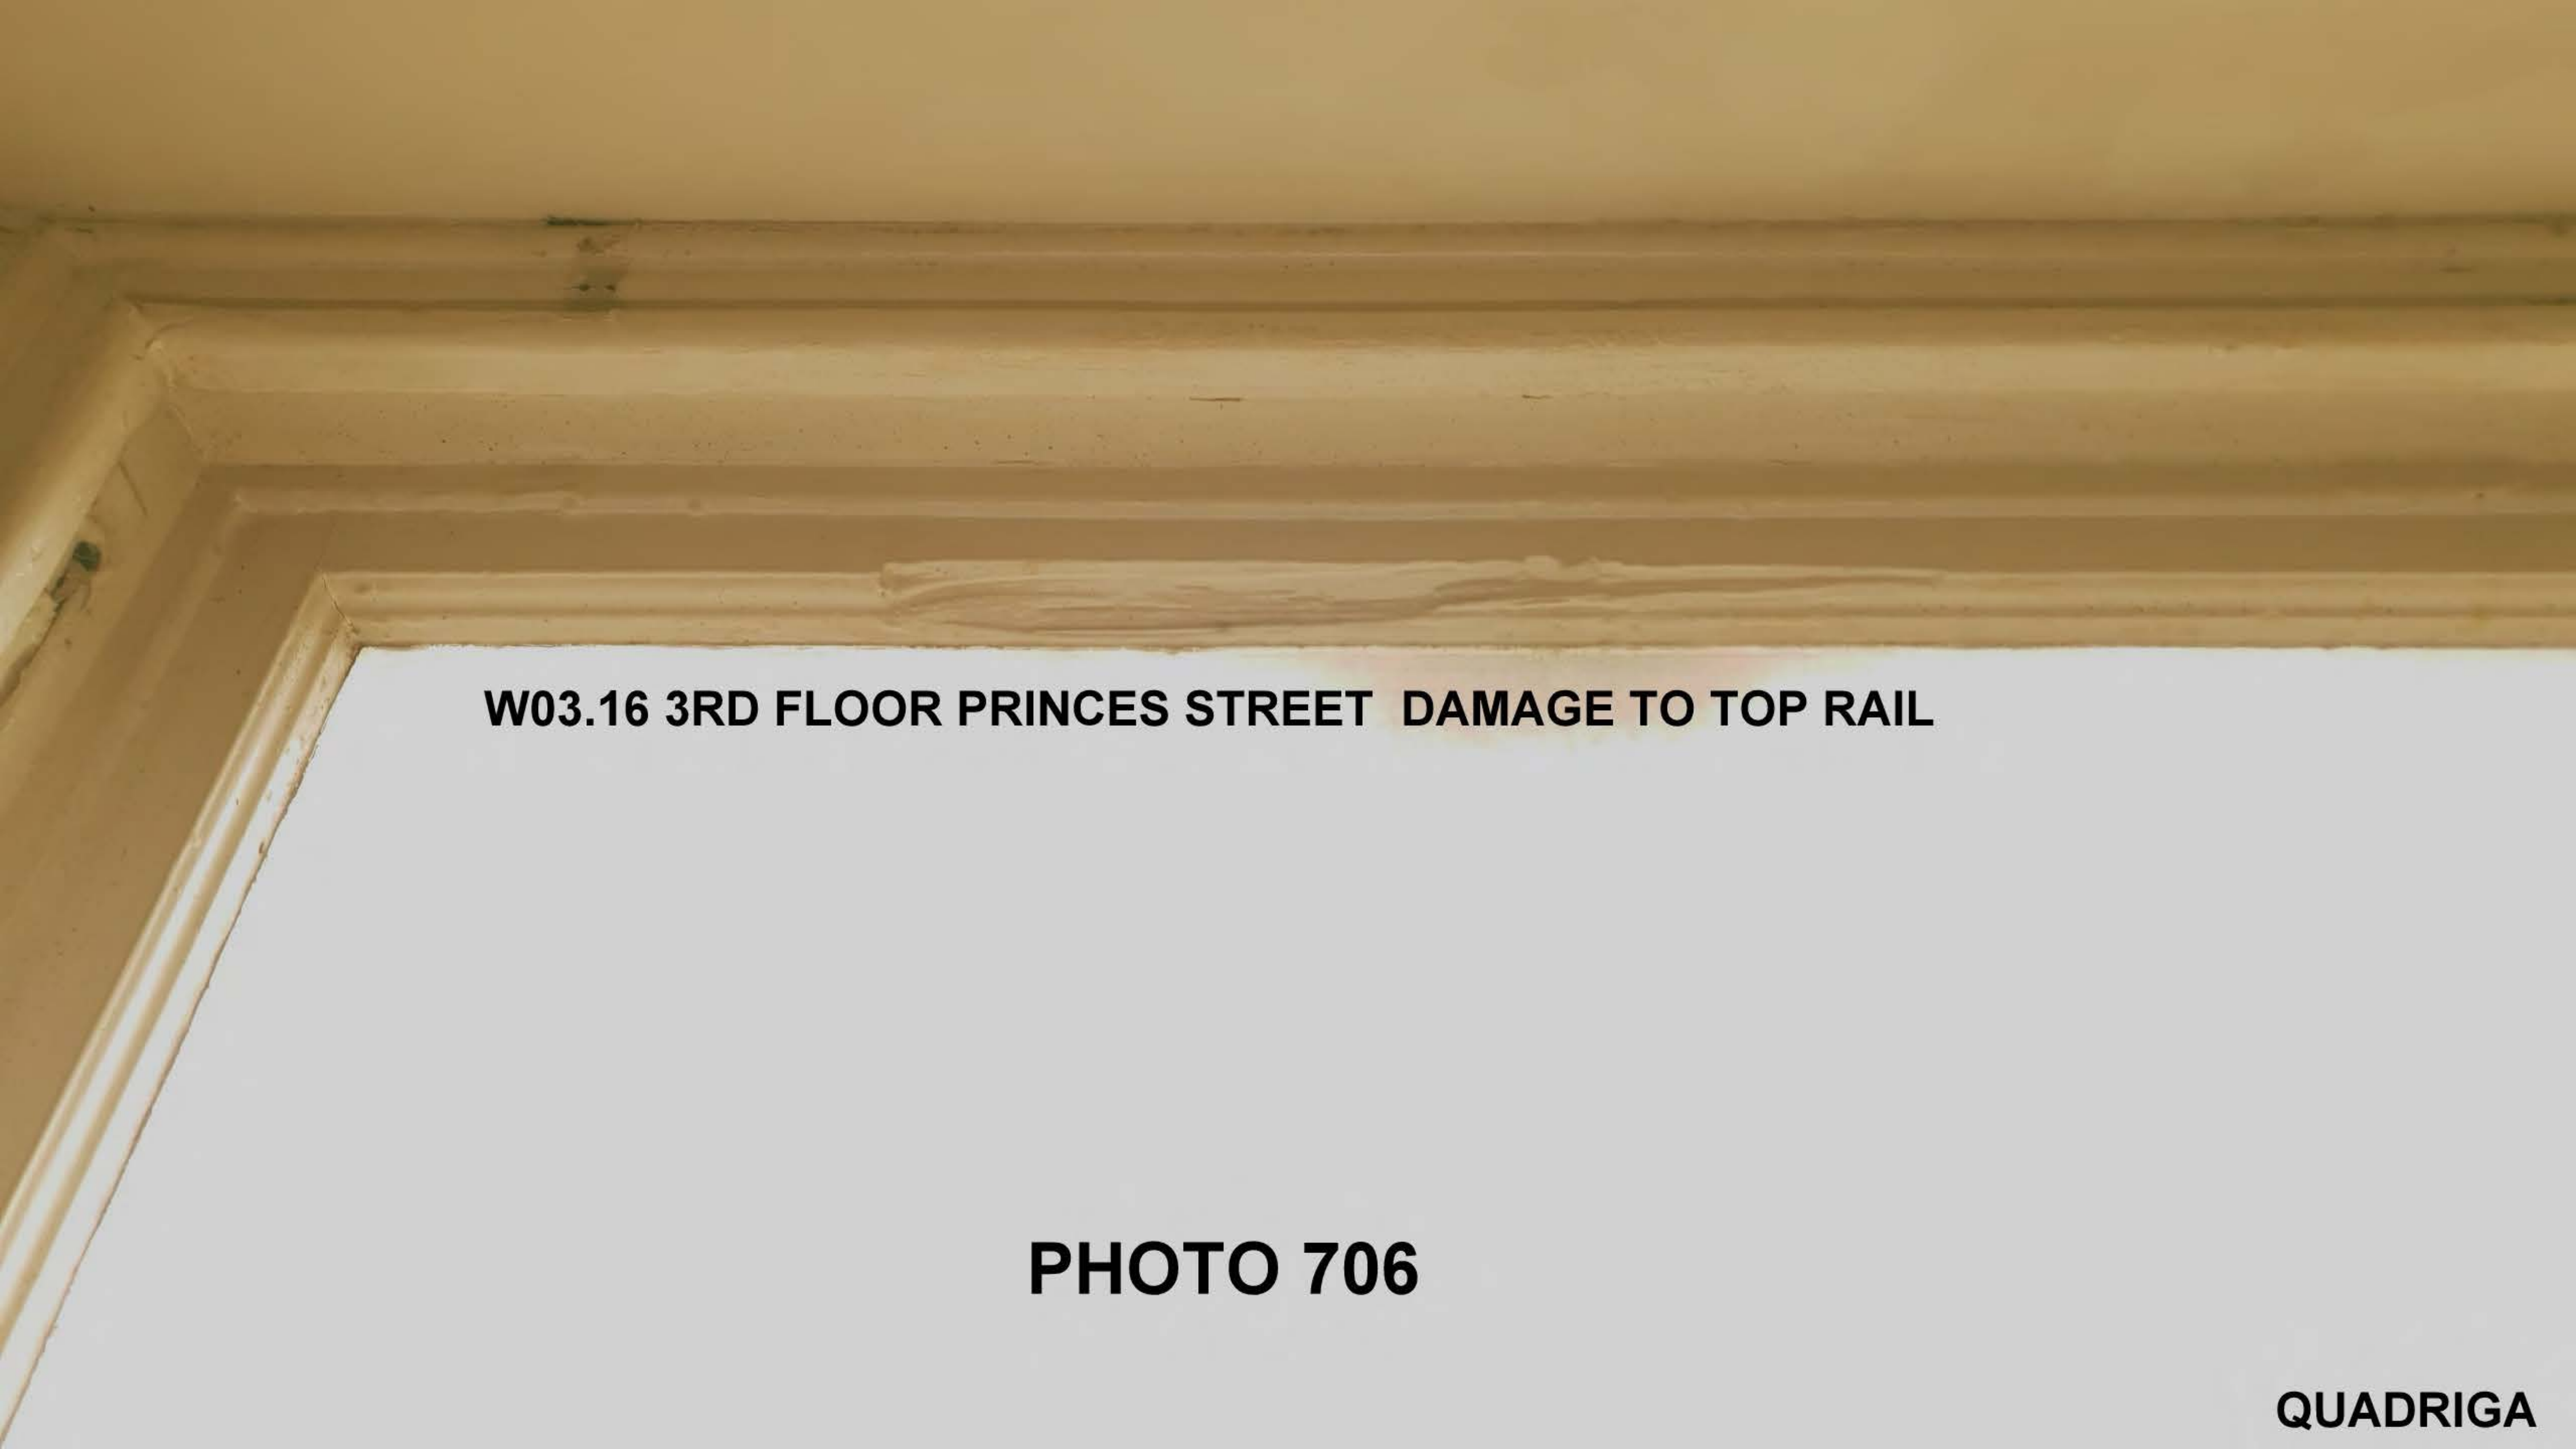
**PHOTO 706**

**W03.16 3RD FLOOR PRINCES STREET DAMAGE TO TOP RAIL**
