1.10.2019

**Daylight Bat Survey of 13 St. Johns Street, Manchester.**

**Surveyor- Martin Prescott (licence no. 2015/15466 CLS)**

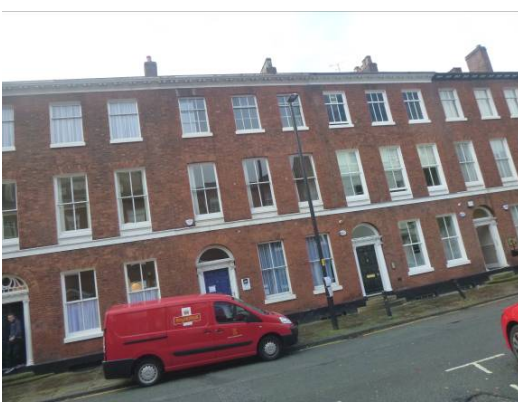
P1 Front aspect – mid-terrace

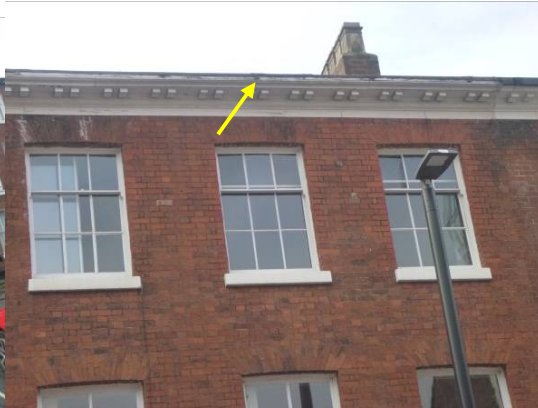
There was a in the soffit at the front aspect, but this was immediately next to a street lamp and therefore unlikely to be used by roosting bats.

P2 Gap in eaves next to street lamp

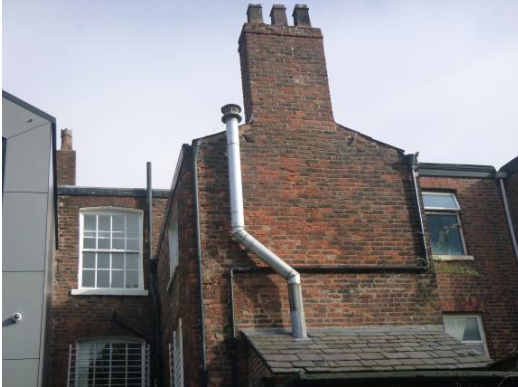
P3 Rear aspect, lit by lights around car park

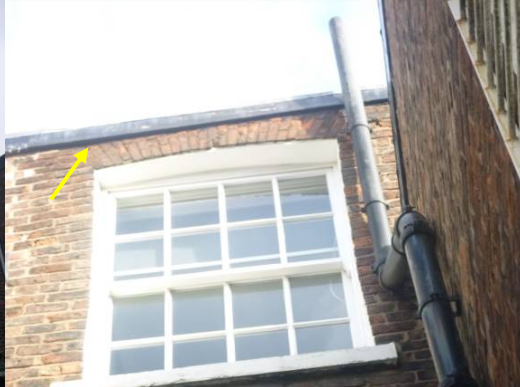
There were gaps under end slates and fascia boards to the rear, but these were similarly lit from lighting for a car park at the rear.

P4 Gap under fascia, to rear

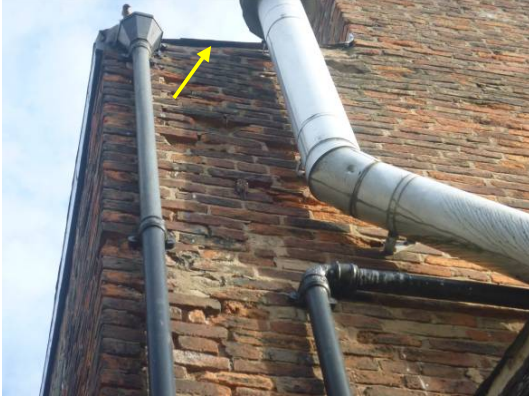
P5 Gap under end slate to rear

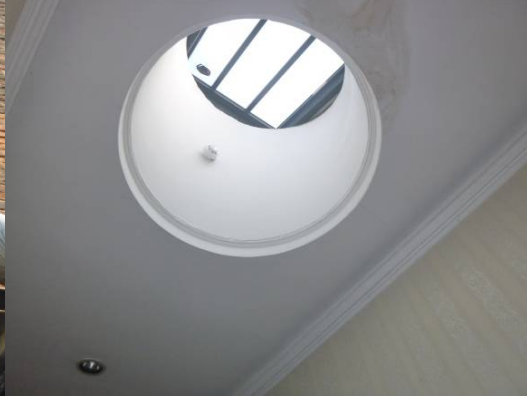
P6 Used area going into roof

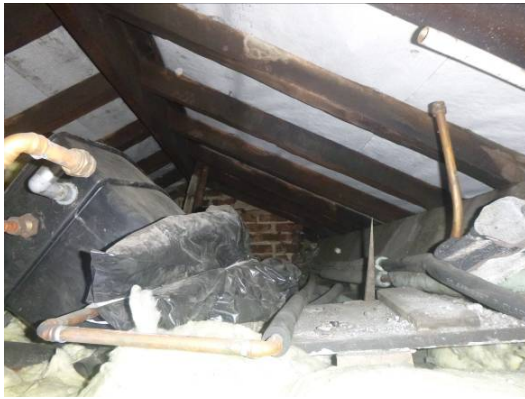
Most of the roof area was converted for use, but there was a small void. This was insulated at floor level and the roof slates were lined.

P7 Small roof void

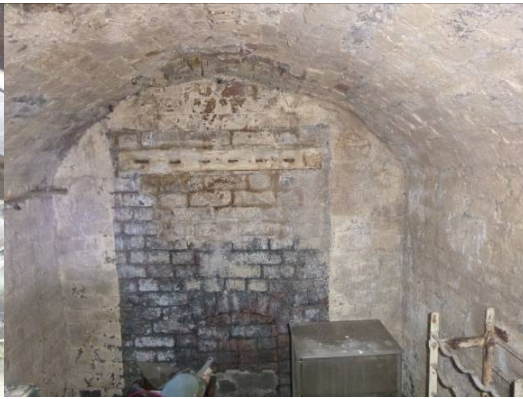
P8 unused section of cellar

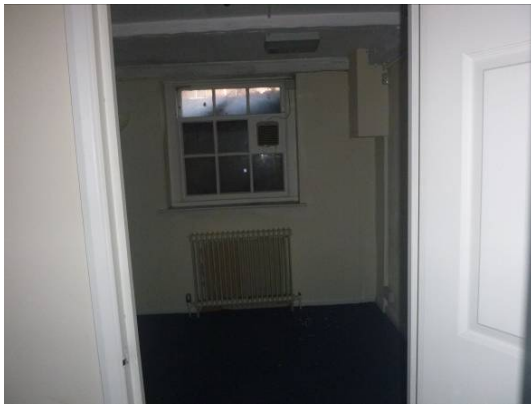
The cellar had been in use and was quite dry. There was no access from the outside available for bats.

P9 Used section of cellar, no outside bat access
