## 13 St Johns St, Manchester

### Gazetteer

### **GAZETTEER**

This gazetteer was compiled in 2019 by The Bernard Taylor Partnership Ltd.

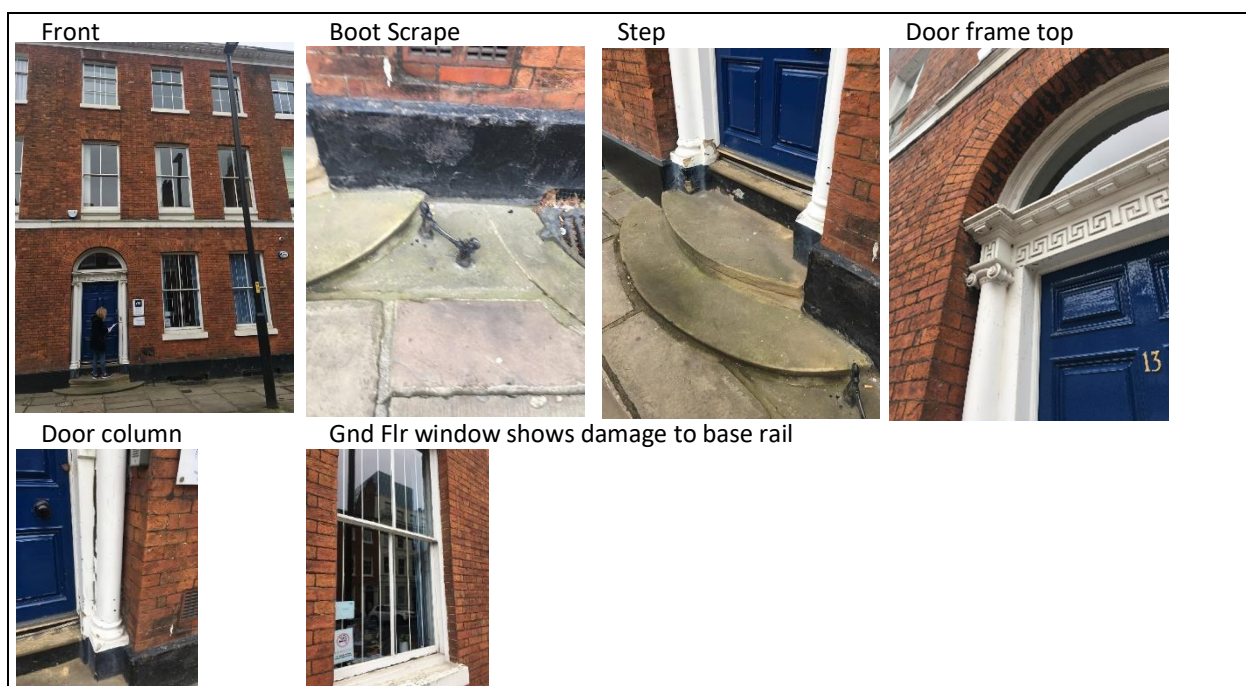
| 13 ST JOHNS ST<br>Front / North Elevation | | Gazetteer item No: 1 |

High Aesthetic Value and historical value as the entrance elevation and retains much original fabric and architectural detail in the Greek revival style.

Repairs need to timber eaves cornice and stone detailing to doorways. Sash windows have been subject to an overhaul, Second floor window fenestration does not match the neighbours

Options for renewing windows, repairs to stone, renewal of paint to stonework, repairs to ironmongery on door, overhaul box gutter and rainwater goods.

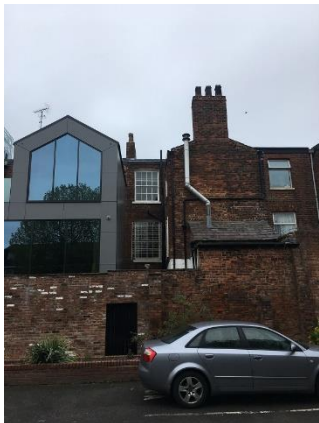
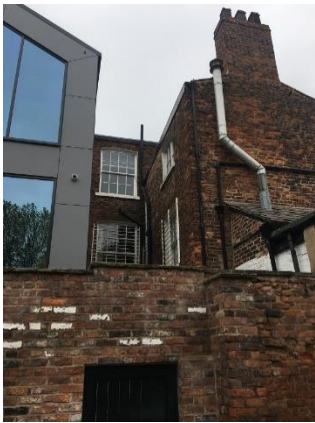
| 13 ST JOHNS ST<br>Rear / South Elevation | | | Gazetteer item No: 2 |

| <p><b>Brief description:</b><br/>English bond every 9<sup>th</sup> course, high percentage perished bricks, bricks with fire skin loss and perished 20<sup>th</sup> Century windows to some apertures, flues and pipework, grills over windows, outrigger in poor condition, settlement. Chimney with original pots.</p> | <p><b>Summary history:</b><br/>Original outriggers and yard rear are original footprint however have been altered at basement level with 20<sup>th</sup> Century stair and doorway. James Place and Holts Place and properties to rear have been cleared. 1891 shows terraces, which have are present until 1938 and cleared by 1948</p> |

| <p><b>Issues:</b><br/>Condition of existing brickwork and pointing, structural checks required to single storey outrigger and chimney stack, plethora of flues and pipework, alterations and openings to rear, windows replaced, sashes overhauled. Adverse aesthetic effect of number 15 extension to yard.</p> | <p><b>Policies/recommendations:</b><br/>Options for renewing windows, repairs to brickwork, overhaul gutter and rainwater goods, assess necessary repairs to fabric. Single storey glazed conservatory to counter the negative impact of the 15 St John Street's tall grey wall. Minor alterations to allow for adaptive reuse back into a dwelling. Removal of grills, flue and pipework.</p> |

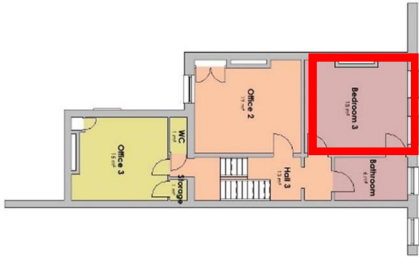
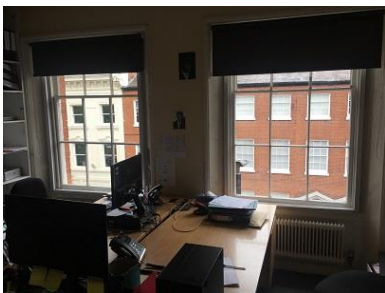
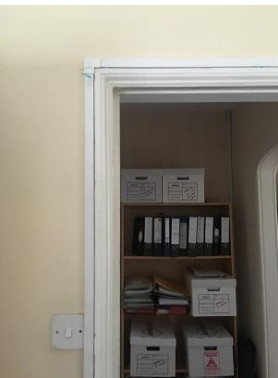
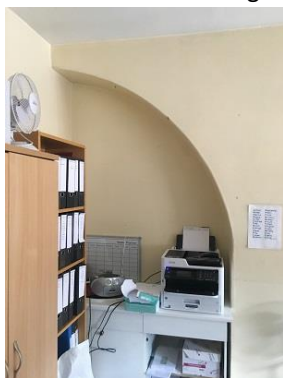
| 13 ST JOHNS ST<br>2 <sup>nd</sup> Floor, Front Office | | Gazetteer item No: 3 |

| <b>Issues:</b><br>Suspect high portion has been re-plastered. Window fenestration does not match neighbouring properties. Modern radiators and surface mounted trunking. | <b>Policies/recommendations:</b><br>Additional bathroom introduction to allow for adaptive reuse for residential, conservation roof light to rear annex. Removal of radiators and trunking, installation of new radiators. Retention of original doors. |

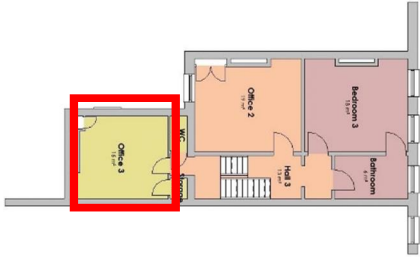
| <p>13 ST JOHNS ST<br/>2<sup>nd</sup> Floor, Office Outrigger</p> | <p>Gazetteer item No: 5</p> <p>Designation:<br/>Grade 2</p> |

| <p>Issues:<br/>Suspect high proportion has been re-plastered. Space has been subdivided, 20<sup>th</sup> Century doors and windows. Chimney breast boxed in</p> | <p>Policies/recommendations:<br/>Replacement of doors and windows with high quality facsimiles. Refine chimney breast. Conservation roof light addition. Removal of radiators and trunking, installation of new radiators/ sockets.</p> |

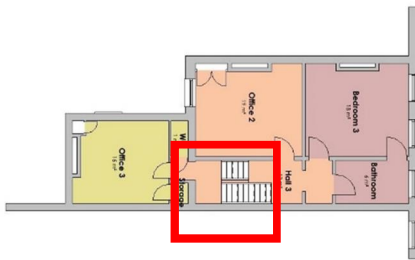
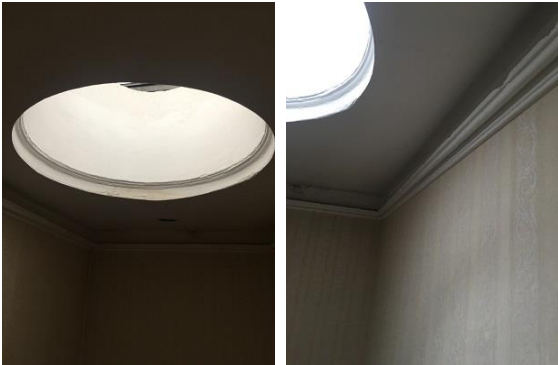
| 13 ST JOHNS ST<br>2 <sup>nd</sup> Floor, Landing & Stairs | Gazetteer No: 7 |

| <p><b>Brief description:</b><br/> Timber handrail swept over slender square balustrades, original doors to front part of the floor. New plaster evident on landing wall. Leaks evident form roof.</p> | <p><b>Summary history:</b><br/> Original staircase and balustrade, original plaster features and light well, with 20<sup>th</sup> Century roof finish.</p> |

| <p><b>Issues:</b><br/> Roof needs repairing/reroofing subject to survey, overhaul of finishes and plaster repairs and paint removal.</p> | <p><b>Policies/recommendations:</b><br/> Closer inspection of roof and timbers for rot, repairs, restore plasterwork and replace all new doors with high quality facsimile. Retain staircase and renew light well cover with appropriate facsimile.</p> |

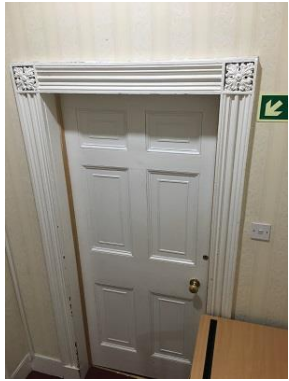
| Brief description:<br>Front room. Original ornate plaster details intact, picture rail, cornice. Deep skirting and window panelling intact. Suspect re-plastering and windows overhauled. | | | Summary history:<br>Original ornate cornice could indicate it was the parlour room, a ladies room. Current use office |
| Issues:<br>Fireplace has been removed, windows function. | | Policies/recommendations:<br>Additional dressing room partitions to allow for adaptive reuse for residential. Removal of radiators and trunking, installation of new radiators. Retention of original doors. Removal of unnecessarily closers. Removal of down lighters in ceiling. | |

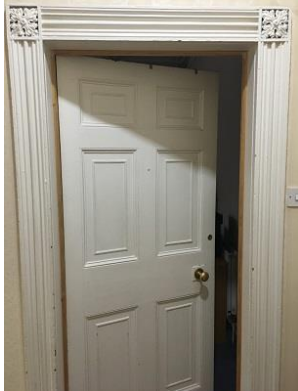
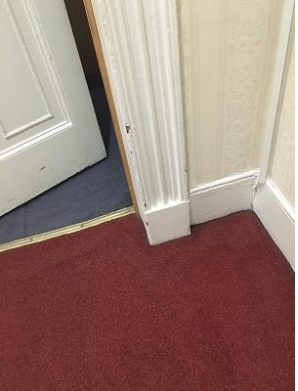
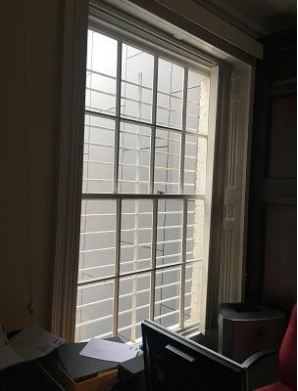
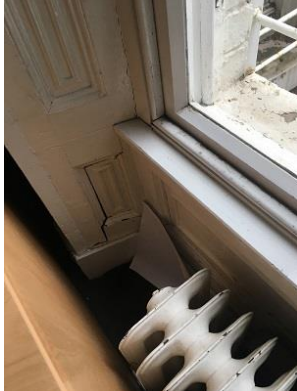
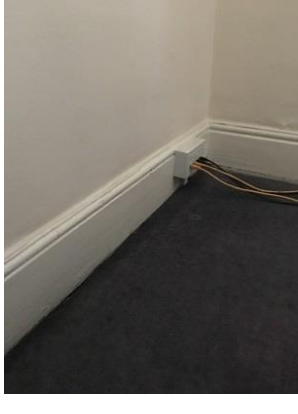
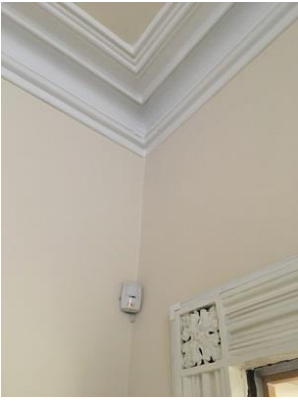
| <p>13 ST JOHNS ST<br/>1<sup>st</sup> Floor, Rear Office</p> | <p>Gazetteer item No: 9</p> <p>Designation:<br/>Grade 2</p> |

| <p><b>Brief description:</b><br/>Rear room. Original ornate plaster details intact, no picture rail, less ornate cornice. Deep skirting and window panelling intact. Suspect re-plastering and windows overhauled/replaced</p> | <p><b>Summary history:</b><br/>Original plaster details. Current use office</p> |

| <p><b>Issues:</b><br/>Built in cupboard chimney breast. Fireplace has been removed, windows function</p> | <p><b>Policies/recommendations:</b><br/>Additional dressing room partitions to allow for adaptive reuse for residential. Removal of radiators and trunking, installation of new radiators. Retention of original doors. Removal of unnecessarily closers. Removal of down lighters in ceiling. Installation of bathroom fittings, new opening below picture rail in front room.</p> |

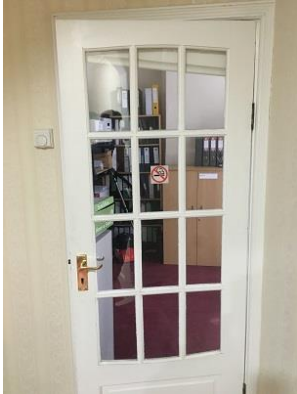
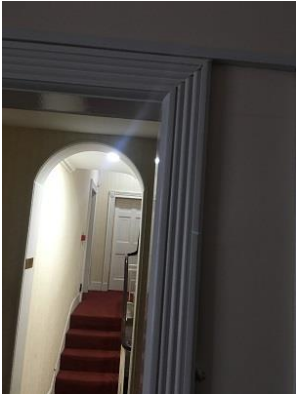
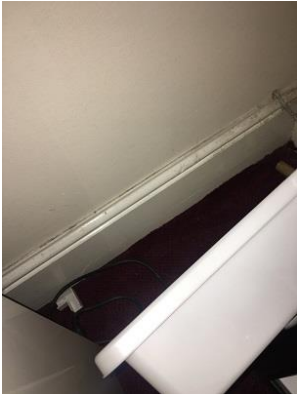
| <p>13 ST JOHNS ST<br/>1<sup>st</sup> Floor, Office Outrigger</p> | <p>Gazetteer item No: 10</p> <p>Designation:<br/>Grade 2</p> |

| <p>Brief description:<br/>20<sup>th</sup> Century doors, architraves and skirting, new plaster throughout, small amount of original architrave and skirting remains, subdivisions and bathroom addition</p> | <p>Summary history:<br/>20<sup>th</sup> Century door, window and plaster. Current use office</p> |

| <p>Issues:<br/>Fireplace has been removed, original features removed, down lighters, ceiling has cracking/deflection</p> | <p>Policies/recommendations:<br/>Reinstate door with facsimile, remove grills to window externally, renew ceiling remove downlighters</p> |

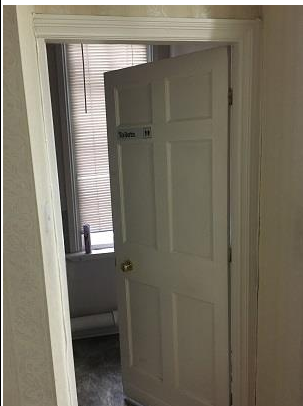
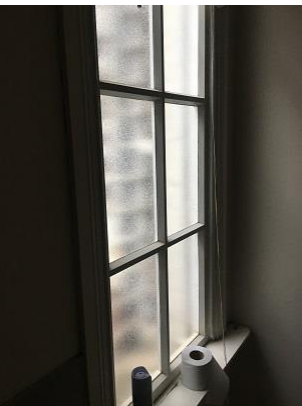
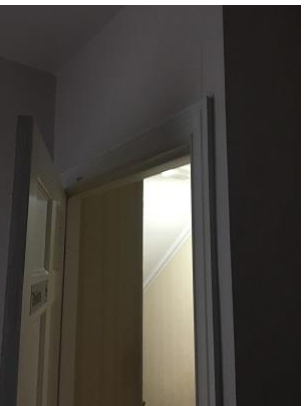
| 13 ST JOHNS ST<br>1 <sup>st</sup> Floor, WC | Gazetteer item No: 11 |

| Brief description:<br>20 <sup>th</sup> Century doors, architraves and skirting, new plaster throughout, partitions and fittings | Summary history:<br>20 <sup>th</sup> Century door, window and plaster to form WC. |

| Issues:<br>Original features removed, 20 <sup>th</sup> Century fittings, re-glazed window | Policies/recommendations:<br>Reinstate door with facsimile, remove grills to window externally, renew ceiling remove downlighters |

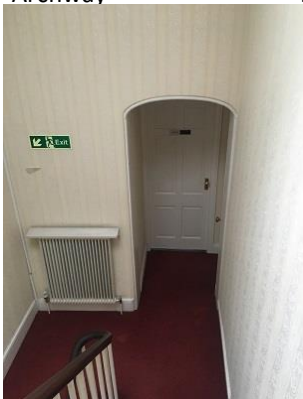
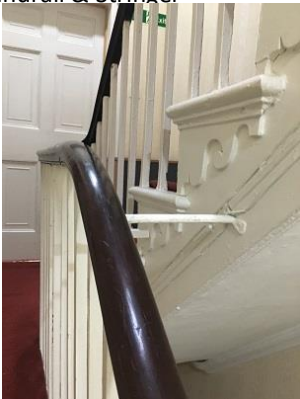
| 13 ST JOHNS ST<br>1 <sup>st</sup> Floor, Landing & Stairs | Gazetteer item No: 12 |

| <p><b>Brief description:</b><br/> Timber handrail swept over slender square balustrades, original doors to front part of the floor. New plaster evident on landing wall.</p> | <p><b>Summary history:</b><br/> Original staircase and balustrade,</p> |

| <p><b>Issues:</b><br/> Overhaul of finishes and plaster repairs and paint removal.</p> | <p><b>Policies/recommendations:</b><br/> Protection to handrail and balustrades whilst works are carried out</p> |

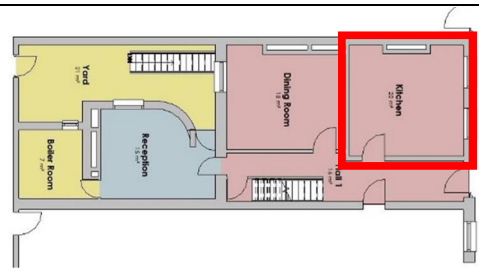
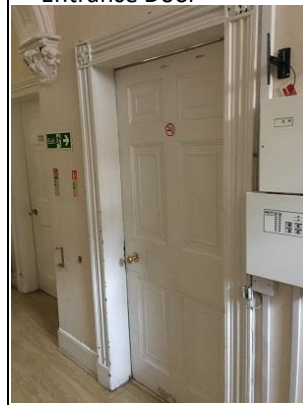
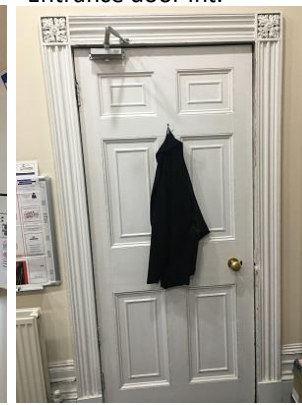
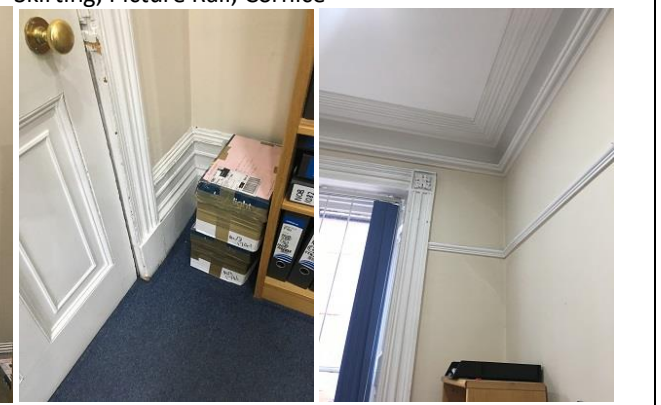
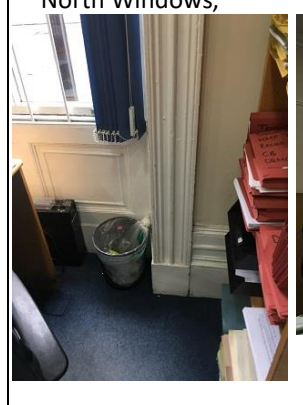
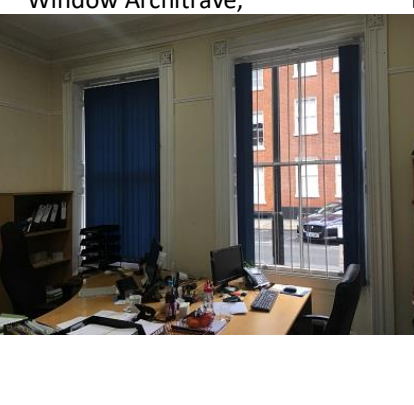
| 13 ST JOHNS ST<br>Ground Floor,<br>Office Front | | Gazetteer item No: 13 |

| <p><b>Brief description:</b><br/> Front room. Original ornate plaster details intact, picture rail, cornice. Deep skirting and window panelling intact. Suspect re-plastering and windows overhauled. Decorative Architrave</p> | <p><b>Summary history:</b><br/> Original ornate cornice could indicate it was a drawing room, Fire place is white, which is associate with ladies' interiors. Current use office</p> |

| <b>Issues:</b><br>Window replacements, alteration to partition | <b>Policies/recommendations:</b><br>Opening in partition to allow for adaptive reuse for residential. Removal of radiators and trunking, installation of new radiators. Retention of original doors. Removal of unnecessarily closers. Removal surface mounted trunking and cabling |

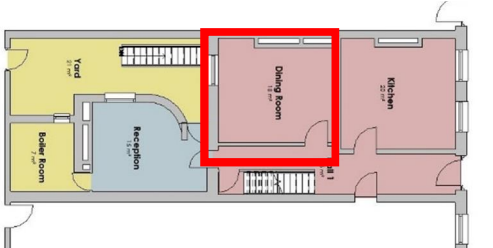
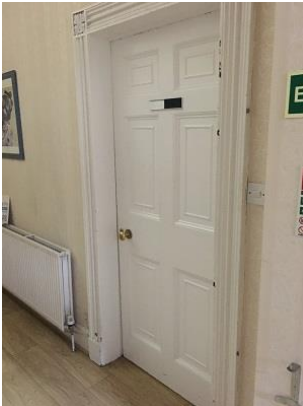
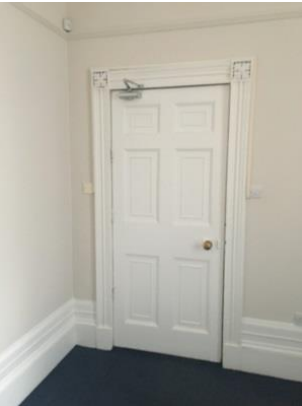
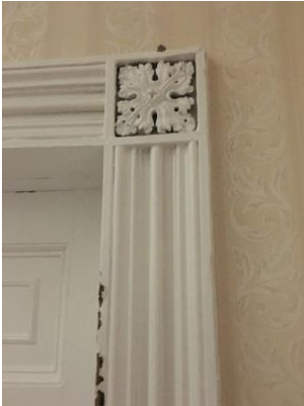
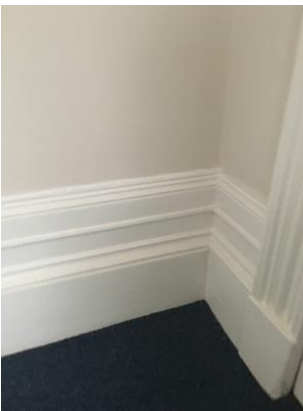
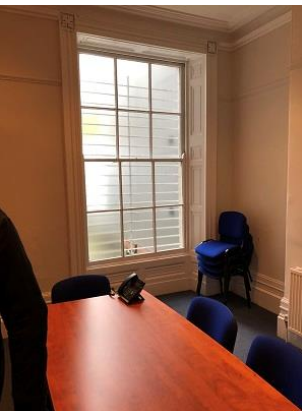
| 13 ST JOHNS ST<br>Ground Floor,<br>Rear Room | | Gazetteer item No: 14 |

| <b>Brief description:</b><br>Original ornate plaster details intact, picture rail, cornice. Deep skirting and window panelling intact. Suspect re-plastering and windows overhauled. Decorative Architrave | <b>Summary history:</b><br>Original ornate cornice could have been the dining room, fire place is missing. Current use office |

| <b>Issues:</b><br>Chimney breast boxed out and original fire place missing | <b>Policies/recommendations:</b><br>Opening in partition and kitchen installation to allow for adaptive reuse for residential. Removal of radiators and trunking, installation of new radiators. Retention of original doors. Removal of unnecessarily closers. Removal surface mounted trunking and cabling |

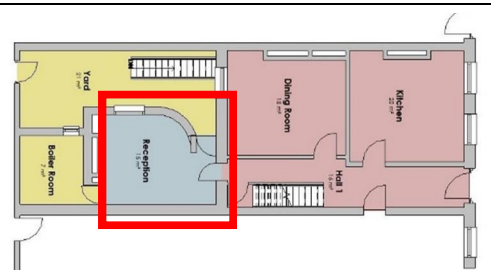
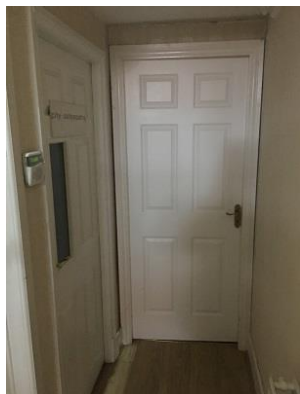
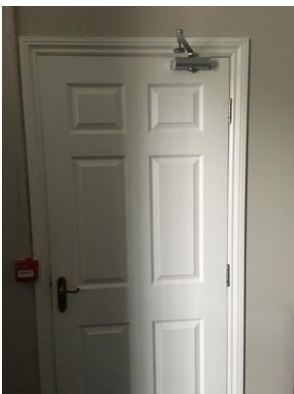
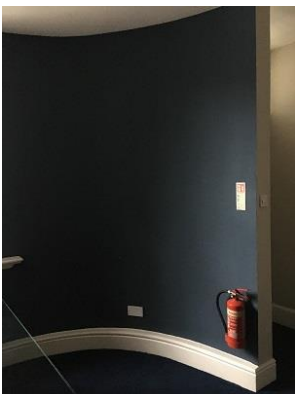
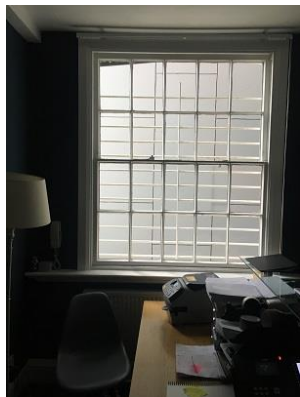
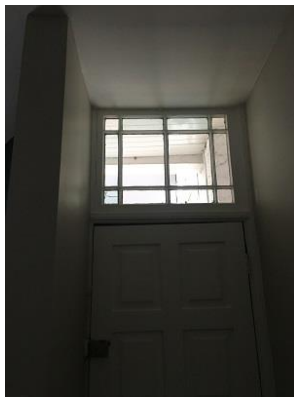
| <p>13 ST JOHNS ST<br/>Ground Floor,<br/>Reception</p> | | <p>Gazetteer item No: 15</p> <p>Designation:<br/>Grade 2</p> |

| <p>Brief description:<br/>Curved external wall, simple interior, re plastered, chimney has been over boarded and infilled</p> | <p>Summary history:<br/>20<sup>th</sup> Century door, plaster. Use as kitchen possibly. Current use reception</p> |

| <p>Significance Level:<br/>Low</p> | <p>Significance values:<br/>Low Aesthetic value, all features removed, original sash windows, astragals in very poor condition, missing in sections.</p> |

| <p>Issues:<br/>Interior details removed, original window in poor condition.</p> | <p>Policies/recommendations:<br/>Retain original fan light above door opening, removal of 20<sup>th</sup> Century doors, remove window and increase opening to floor level to allow for adaptive reuse to residential. Retain curved wall</p> |

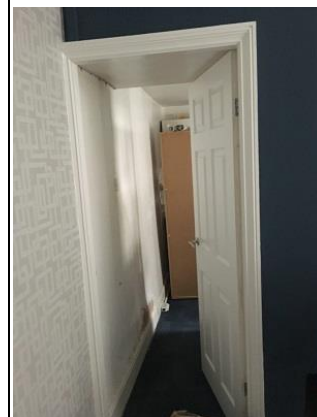
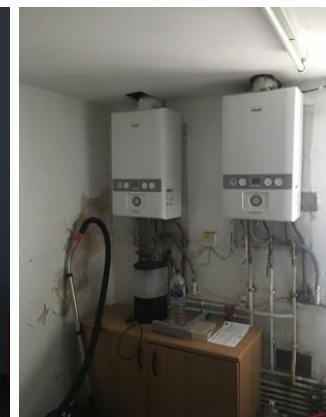
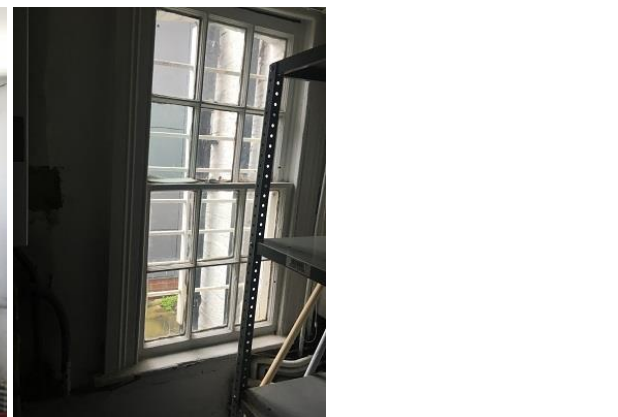
| 13 ST JOHNS ST<br>Ground Floor,<br>Boiler Room | | Gazetteer item No: 16<br><br>Designation:<br>Grade 2 |

| Brief description:<br>Single storey outrigger, re plastered, housing boilers, no historic features remain, simple interior | Summary history:<br>Use as possible Larder, current use |

| Issues:<br>Structural Condition, false ceiling, interior in poor condition | Policies/recommendations:<br>Renew window, remove external bars, existing opening allow for adaptive reuse as porch for residential conversion |

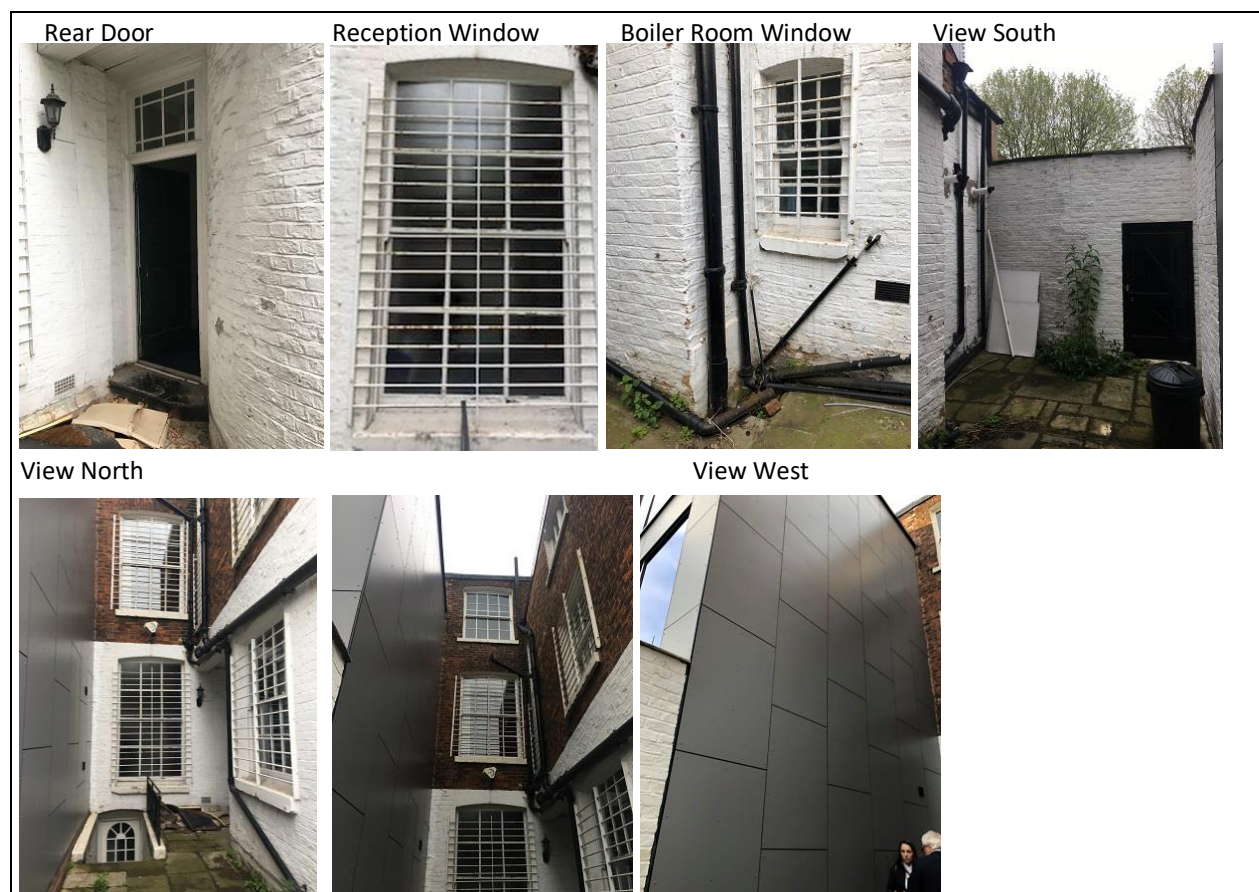
| 13 ST JOHNS ST<br>Ground Floor,<br>Yard | | Gazetteer item No: 17 |

| Brief description:<br>Original stone flags and rear boundary wall, 20 <sup>th</sup> century timber gate, basement steps, balustrades and exit door, flags over lay vault openings in basement. Brickwork painted white at ground floor level. | Summary history:<br>Original footprint, poor 20 <sup>th</sup> century alterations |

| Issues:<br>Extension colour of number 25, overbearing, negative impact on space, condition of drainage, gullies, need further inspection, structural assessment of boundary wall required. | Policies/recommendations:<br>General repairs to brickwork and repointing open joints, re-bedding copings to parapet wall and rebuilding if required, Lift and record rely flags at correct level, (built up) Open up basement window covered and allow alterations for adaptive reuse to residential, using existing voids present. |

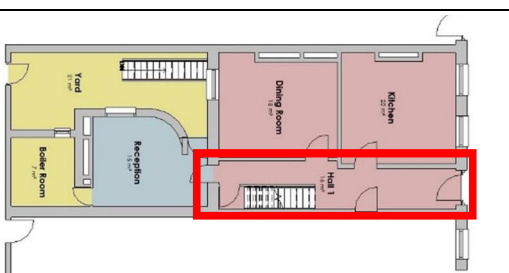
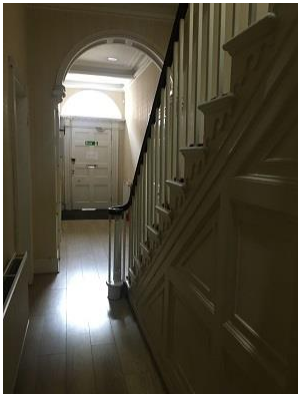
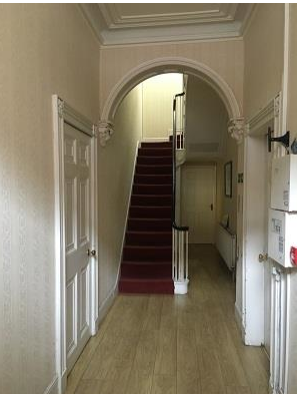
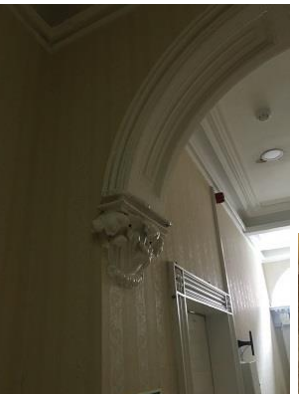
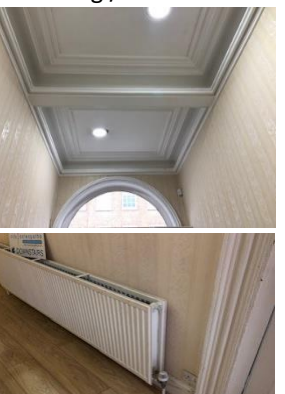
| 13 ST JOHNS ST<br>Ground Floor,<br>Hall | | Gazetteer item No: 18<br><br>Designation:<br>Grade 2 |

| Brief description:<br>Timber handrail swept over slender square balustrades, original doors to front part of the floor. Original plaster details and raised and fielded doors. | Summary history:<br>Original staircase and balustrade, original ornate plaster and original doors to front. |

| Issues:<br>Overhaul of finishes and plaster repairs and paint removal. Removal of radiators and surface mounted | Policies/recommendations:<br>Protection to handrail and balustrades whilst works are carried out |

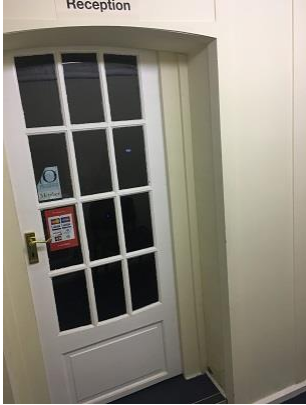
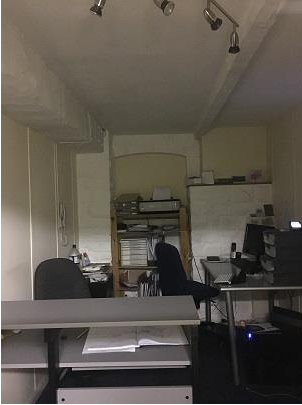
| <p>13 ST JOHNS ST<br/>Cellar Room 4</p> | <p>Gazetteer item No: 19</p> <p>Designation:<br/>Grade 2</p> |

| <p>Brief description:<br/>No original features are evident, 20<sup>th</sup> Century doors, dry lining</p> | <p>Summary history:<br/>Original use of cellars was storage for coal, pantries and staff, 20<sup>th</sup> Century alterations for use as offices</p> |

| <p>Issues:<br/>Structural integrity and damp</p> | <p>Policies/recommendations:<br/>Strip out 20<sup>th</sup> Century dry lining and inspect. New tanking and rebuilding as required</p> |

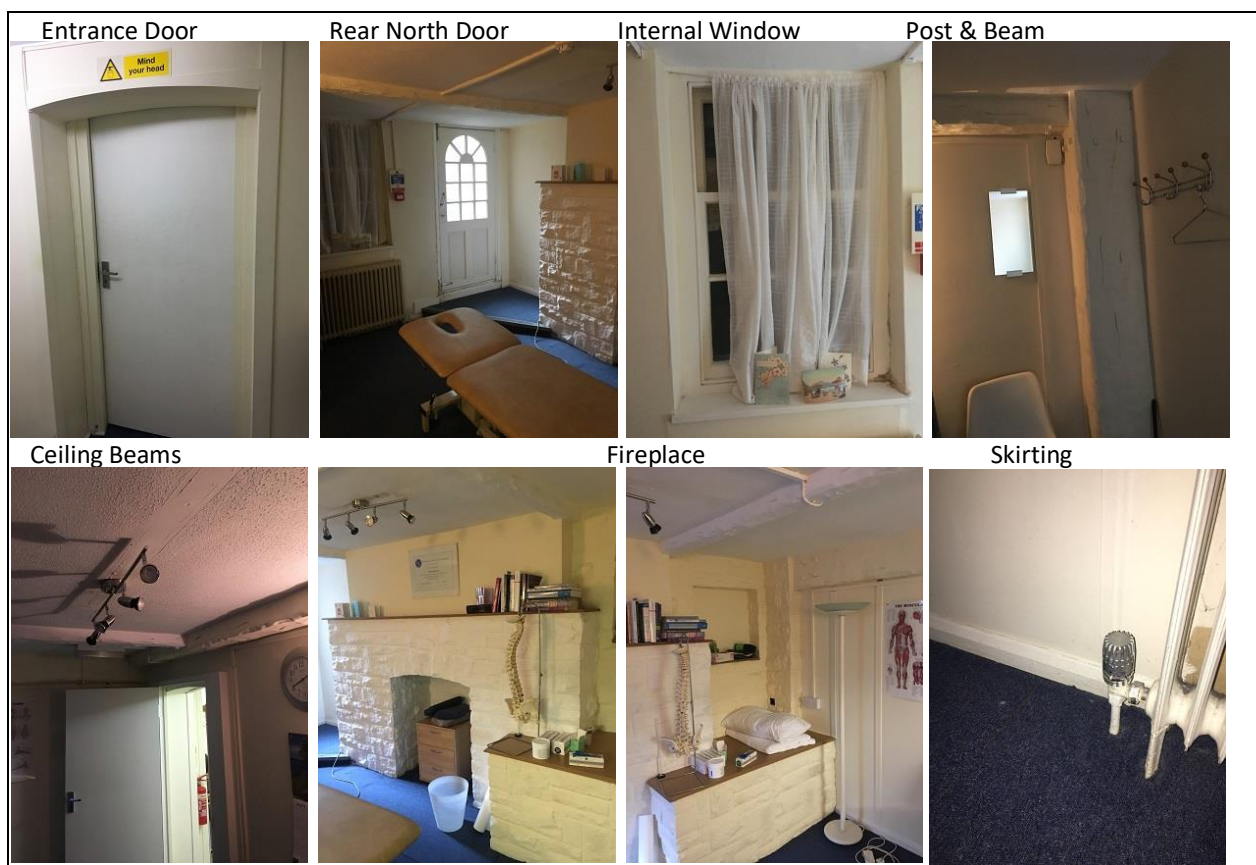
| Brief description:<br>No original features are evident, 20 <sup>th</sup> Century doors, dry lining | | Summary history:<br>Original use of cellars was storage for coal, pantries and staff, 20 <sup>th</sup> Century alterations for use as offices |
| Issues:<br>Structural integrity and damp | Policies/recommendations:<br>Strip out 20 <sup>th</sup> Century dry lining and inspect. New tanking and rebuilding as required | |

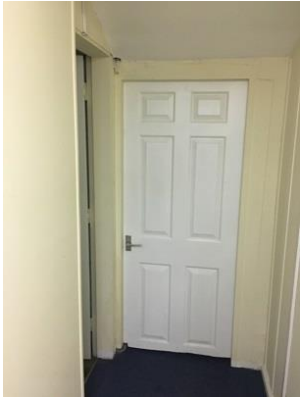
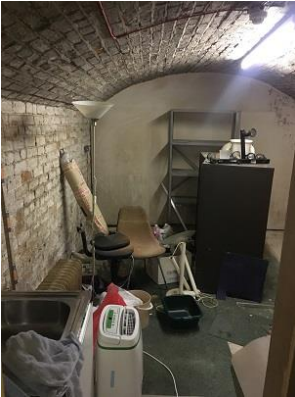
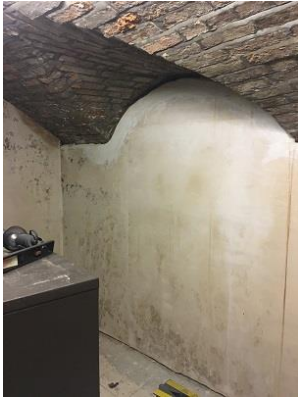
| <p>13 ST JOHNS ST<br/>Cellar Room 1</p> | <p>Gazetteer item No: 21</p> <p>Designation:<br/>Grade 2</p> |

| <p>Brief description:<br/>No original features are evident, 20<sup>th</sup> Century doors, dry lining</p> | <p>Summary history:<br/>Original use of cellars was storage for coal, pantries and staff, 20<sup>th</sup> Century alterations for use as offices</p> |

| <p>Issues:<br/>Structural integrity and damp</p> | <p>Policies/recommendations:<br/>Strip out 20<sup>th</sup> Century dry lining and inspect. New tanking and rebuilding as required</p> |

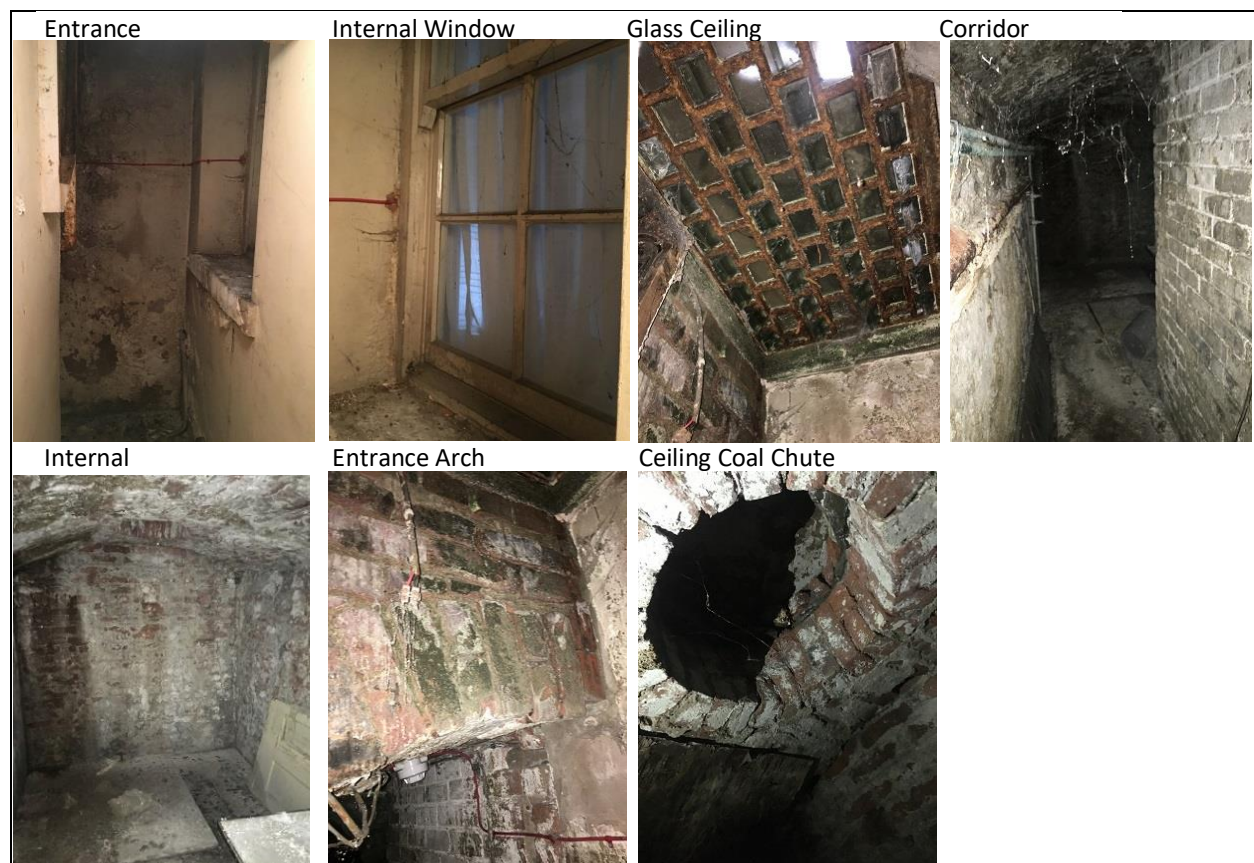
| 13 ST JOHNS ST<br>Cellar Room 2 | | Gazetteer item No: 22<br><br>Designation:<br>Grade 2 |

| Brief description:<br>Brick Vault with 20 <sup>th</sup> Century dividing wall and staircase, with light well and chute from rear yard | Summary history:<br>Original use of cellars was storage for coal, pantries and staff, 20 <sup>th</sup> Century alterations for use as offices |

| Issues:<br>Structural integrity and damp | Policies/recommendations:<br>Strip out 20 <sup>th</sup> Century dry lining and inspect. New tanking and rebuilding as required |

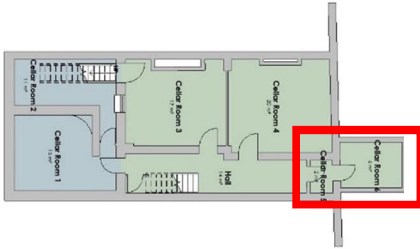
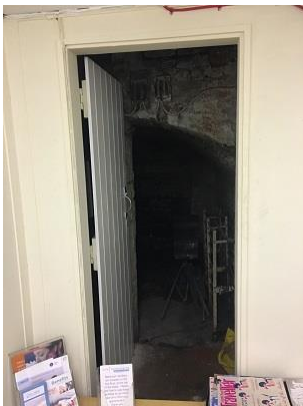
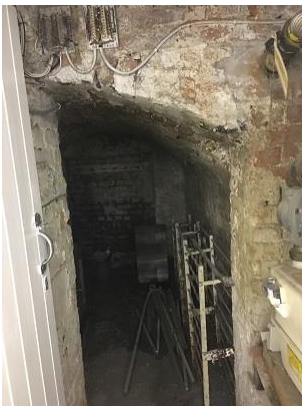
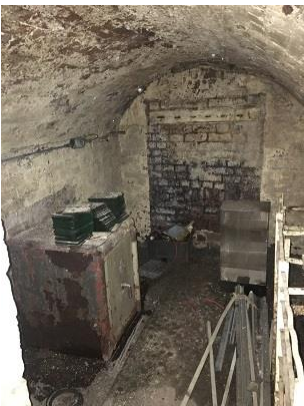
| 13 ST JOHNS ST<br>Cellar Room 5 & 6 | | Gazetteer item No: 23<br><br>Designation:<br>Grade 2 |

| Brief description:<br>Brick Vault | Summary history:<br>Original use of cellars was storage for coal, pantries and staff, 20 <sup>th</sup> Century alterations for use as offices |

| Issues:<br>Structural integrity and damp | Policies/recommendations:<br>Strip out 20 <sup>th</sup> Century dry lining and inspect. New tanking and rebuilding as required |

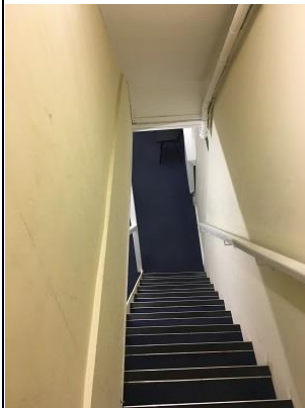
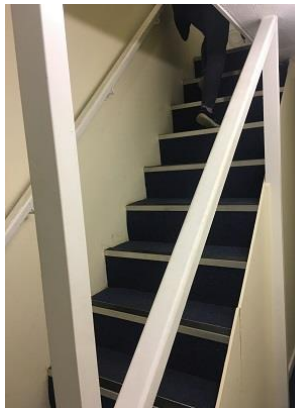
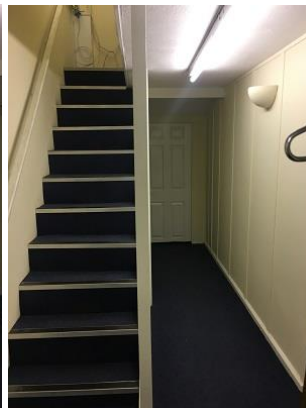
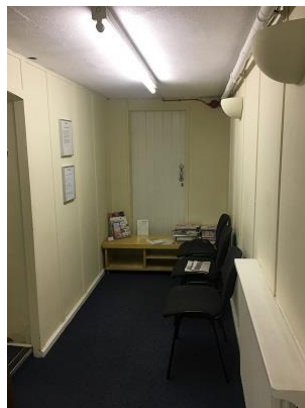
| <p>13 ST JOHNS ST<br/>Cellar Hall</p> | <p>Gazetteer item No: 24</p> <p>Designation:<br/>Grade 2</p> |

| <p>Issues:<br/>Structural integrity and damp</p> | <p>Policies/recommendations:<br/>Strip out 20<sup>th</sup> Century dry lining and inspect. New tanking and rebuilding as required</p> |
