**Project Name:** HEATON ROAD, WITHINGTON

**Project Date:** 08/12/2019

**Inspection Standard:** MSCC5 Sewers & Drainage GB (SRM5 Scoring)

## Section Inspection – 08/12/2019 - MH F12

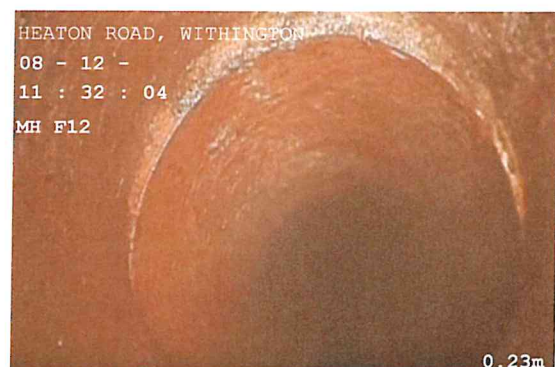
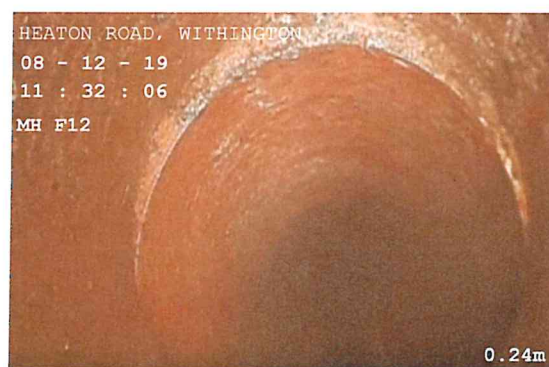
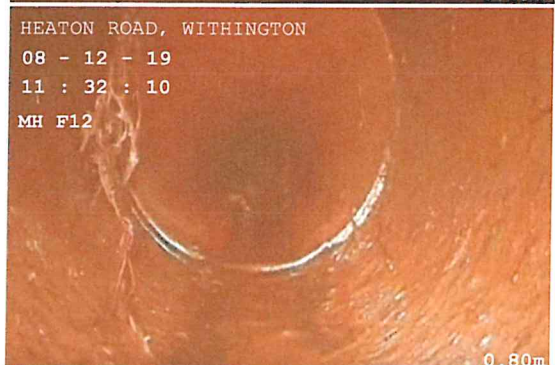
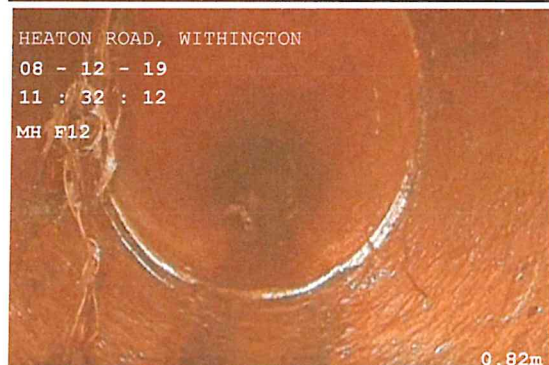
**Comments:** Minor tree root ingress identified at 0.80m MH F12.
