| <b>STRUCTURAL ENGINEERING SURVEY</b> | <b>Date:</b> | 8 Dec 2017 |

| <b>SURVEY AT:</b> | 21 Newton St (Cheetwood House), Manchester M1 1FY |
| <b>CLIENT:</b> | Beech Construction Partnership Ltd |
| <b>IN RESPECT OF:</b> | Further Stair Structure Survey |

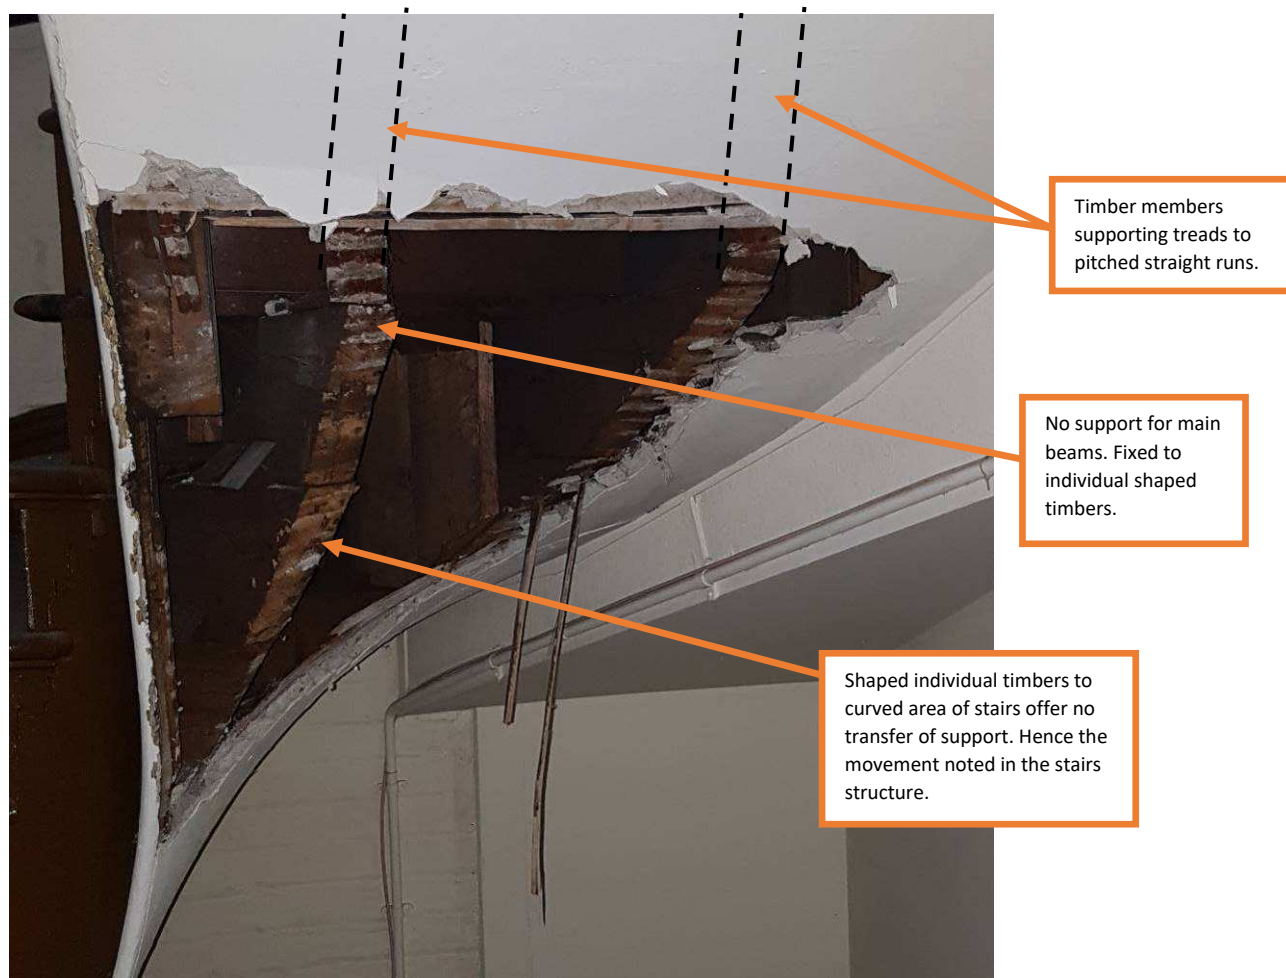
**Image 1 – Existing Structure.**

Exposure of the existing structure has revealed the original stairs have poor positive support under. No continual supporting elements were found, only a series of cut individual members. Given this it is obviously why there has been so much structural displacement.

It is recommended the rear stairs are supported directly under the two main supporting beams that sit under the pitched steps, see notes below.

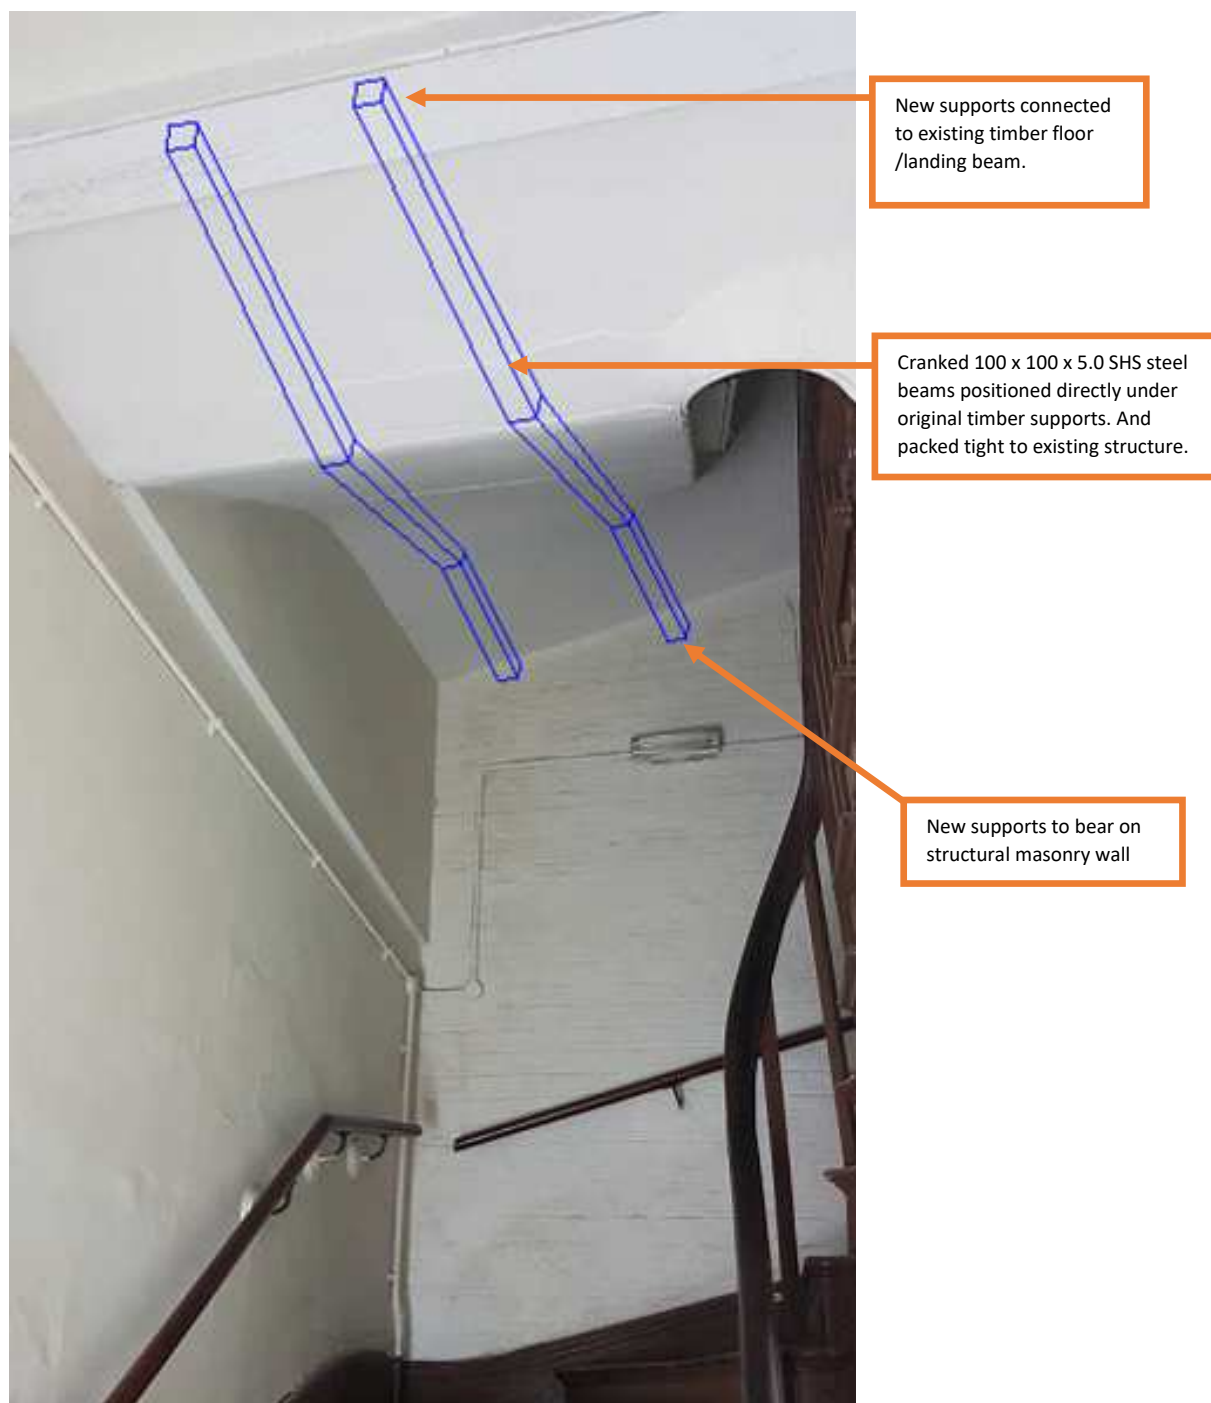
***Image 2 – Remedial works to first rise of each flight.***

extend supports from. As shown below, the only supporting elements are the rear wall (side walls are non-load bearing partitions) and the floor beams to the landing areas.

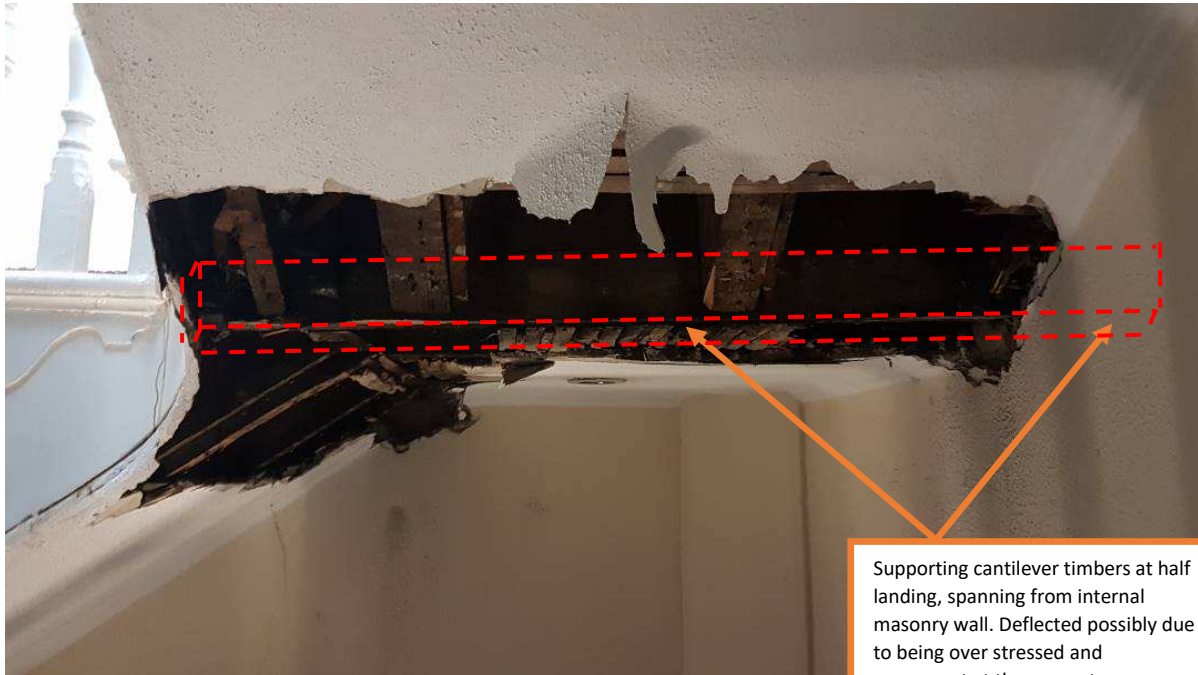
***Image 4 – Existing Supporting cantilevered half landing.***

The central stairs are generally set over two flights between each floor, with a central half landing. Under each flight there are two main supporting timbers, which at floor level appear to be supported by the main floor structure. The half landing locations have been formed by original cantilever timber beams extending from internal load bearing masonry walls, see below. It appears these members have rotated and deflected over time. The bearings have likely also shrunk or crushed to add to the movement. It would be difficult to replace these existing cantilever timbers and it would not be advisable to replace with new timber members, as the issues that have occurred to date will be difficult to prevent from occurring again in the future. The bearing pressure induced at the supports due to the cantilever of the timbers would be significant and would not be suited to an interaction between timber and masonry.

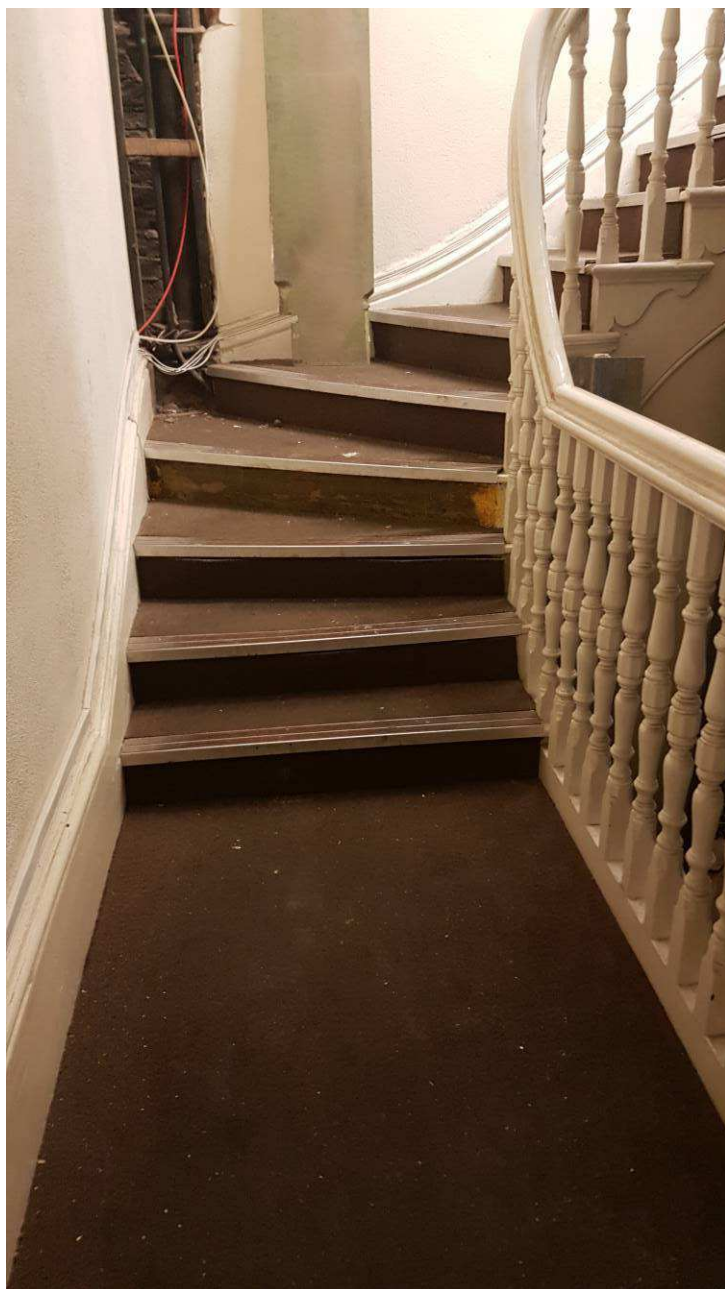
***Image 8 – Ground to first floor stairs.***

The lower flights between ground floor and 1<sup>st</sup> floor appears to be reasonably sound but may require some additional support to the edge of the low landing and under the return. Further exposure and investigation may be required whilst works are carried out.

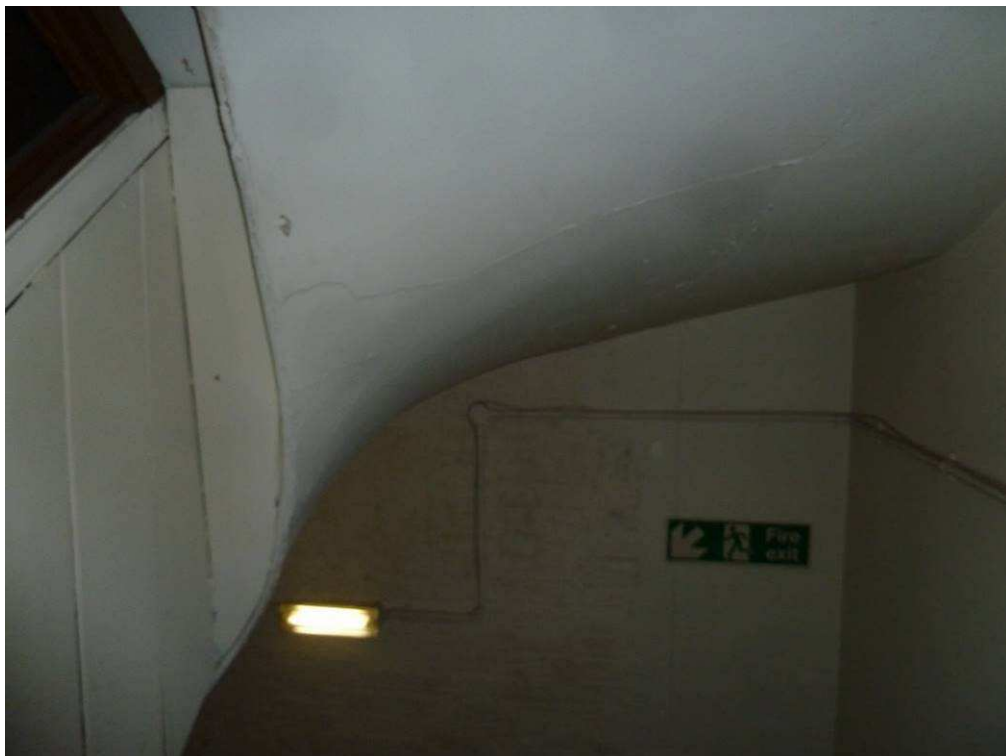
**PHOTO 1:**

The majority of the steps throughout the rear staircase were found to be out of level and to have dipped inwards, in line with the central spiral of the stair structure. The stairs are of timber construction and to the mid-level the steps wind around completely, from the first flight up to the second flight (see Photos 1 to 3).

The construction of the stairs is likely to have been carried out by a carpenter or joiner at site with little thought to the continuity of loading paths and support. The steps are likely sat on a series of individual timbers that are in some way connected to each other. As the stair case is of an age prior to the use of steel in such structural elements, the shape of the stairs and the movement noted, suggests the timber construction has likely only lasted by all the elements and connections working together. The movement noted suggests the structure is coming towards the end of its safe working lifespan.

Rear stairs with mid-winders

The stairs require some form of remedial supports or complete replacement.

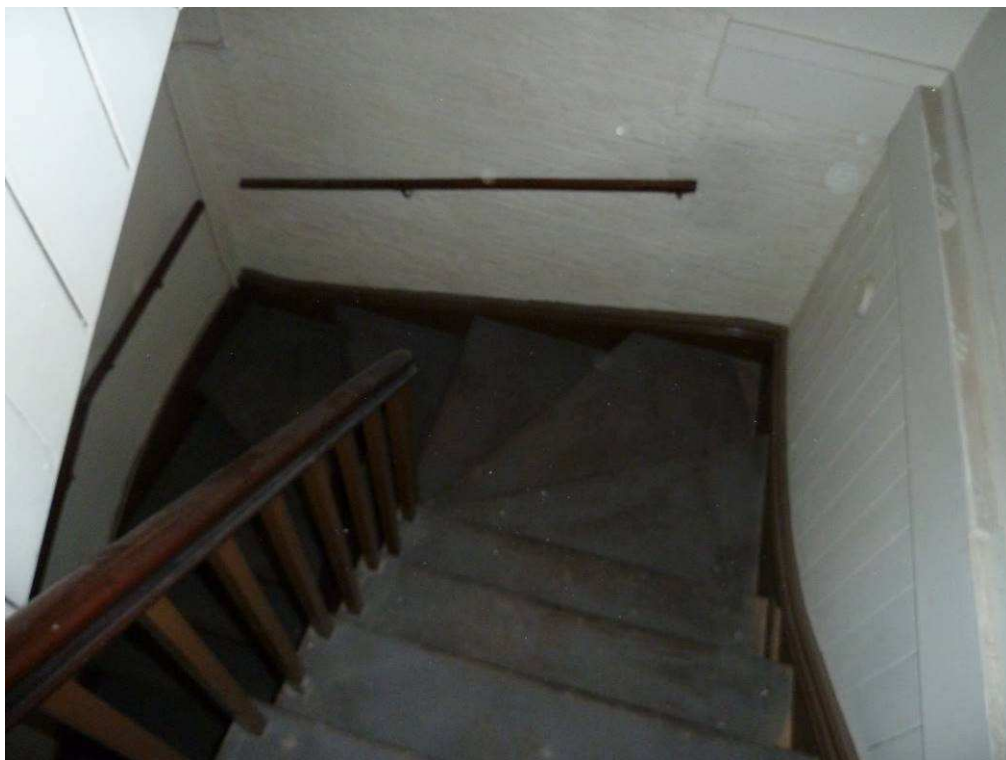
**PHOTO 2:**

Rear stairs with mid-winders

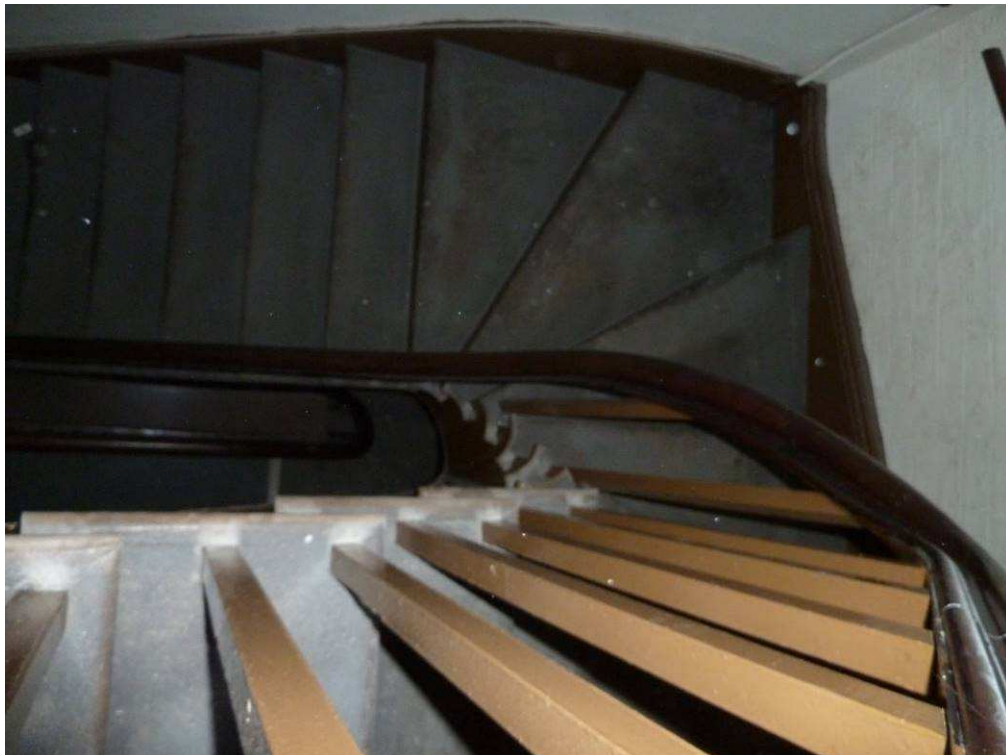
**PHOTO 3:**

Rear stairs with mid-winders

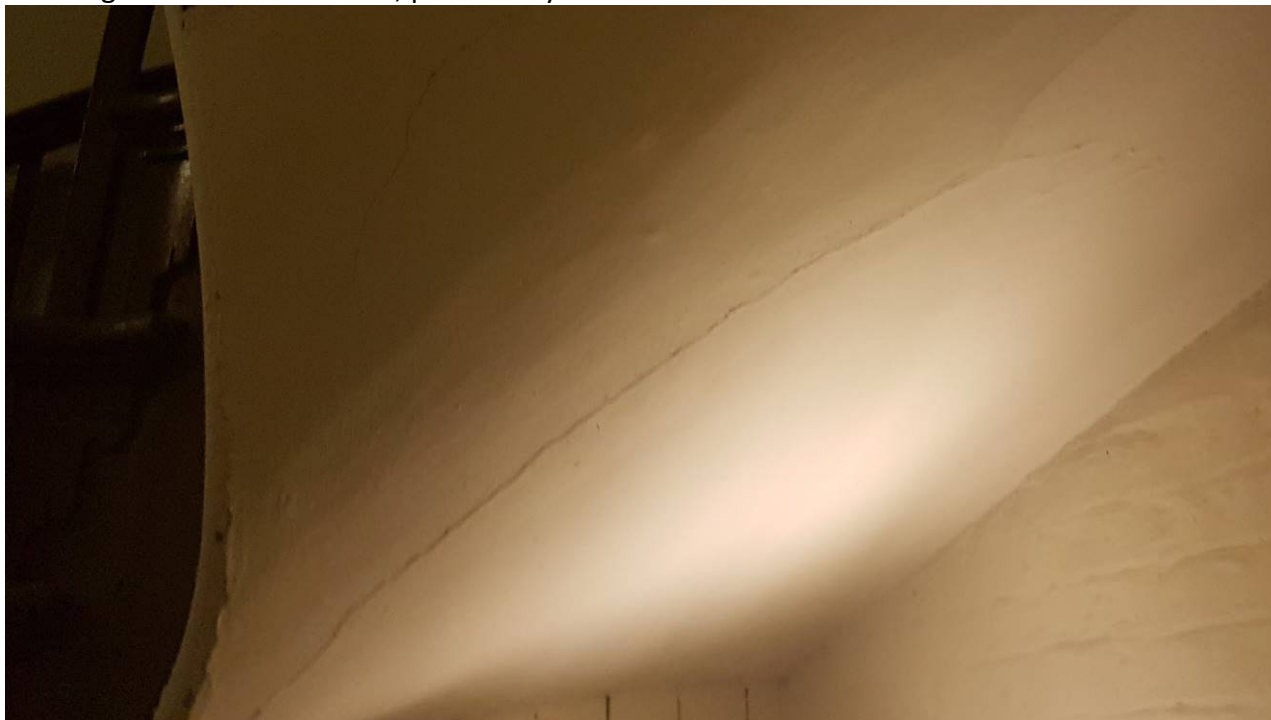
**PHOTO 4:**

In its current state, the rear stairs pose an unsafe environment to users, partly due to their unevenness and out of level, but also due to the cracking noted towards the central winder areas. It is unknown how the structure has been affected and it is unlikely the stairs will be capable of the 3.0 kN/m<sup>2</sup> required of a communal residential stair.

Cracking to a number of areas, particularly to winder areas.

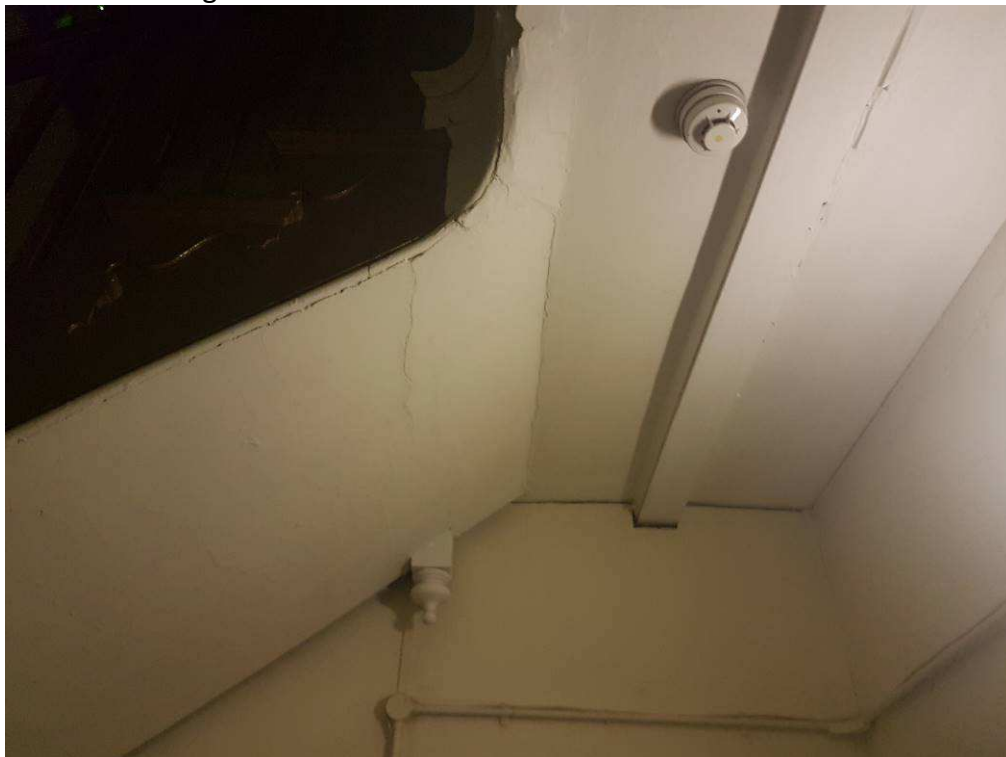
**PHOTO 5:**

Beam to landing areas

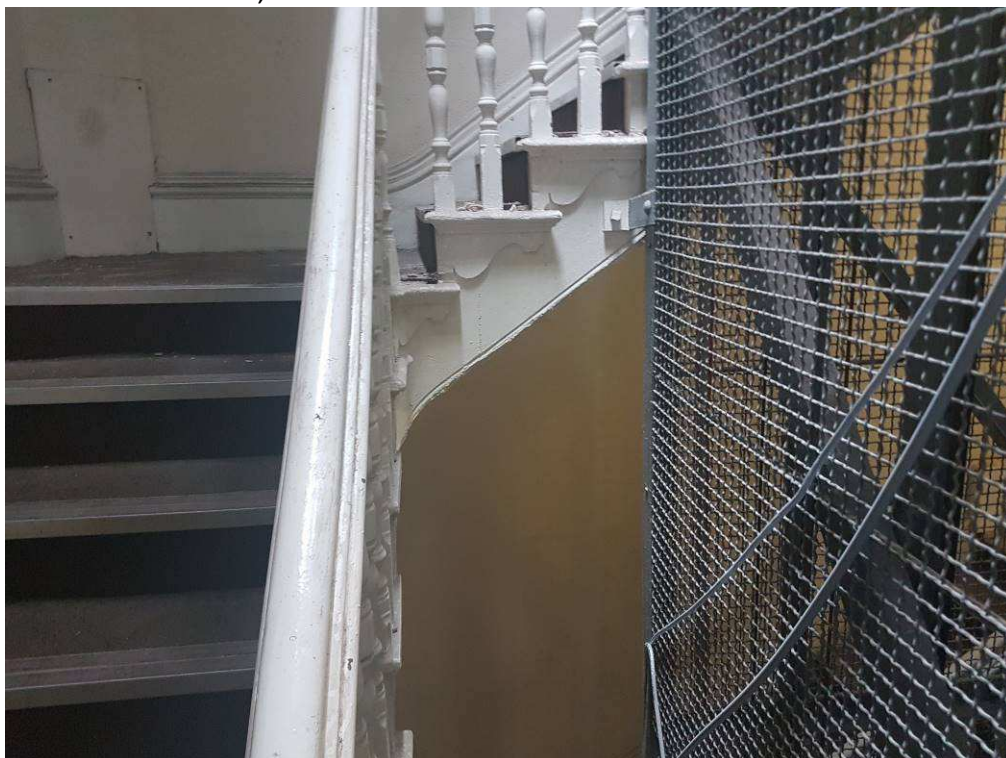
**PHOTO 6:**

It is possible the lift structure that has been installed at a later date, is in some way providing a small element of support to the stairs, although this should not be relied upon (Photo 7).

Main internal stairs, with lift structure to central area
