**Condition Survey of Pavement Lights**  
**at**  
**Cheetwood House, Newton Street, Manchester, M1 1FZ**

## **Introduction**

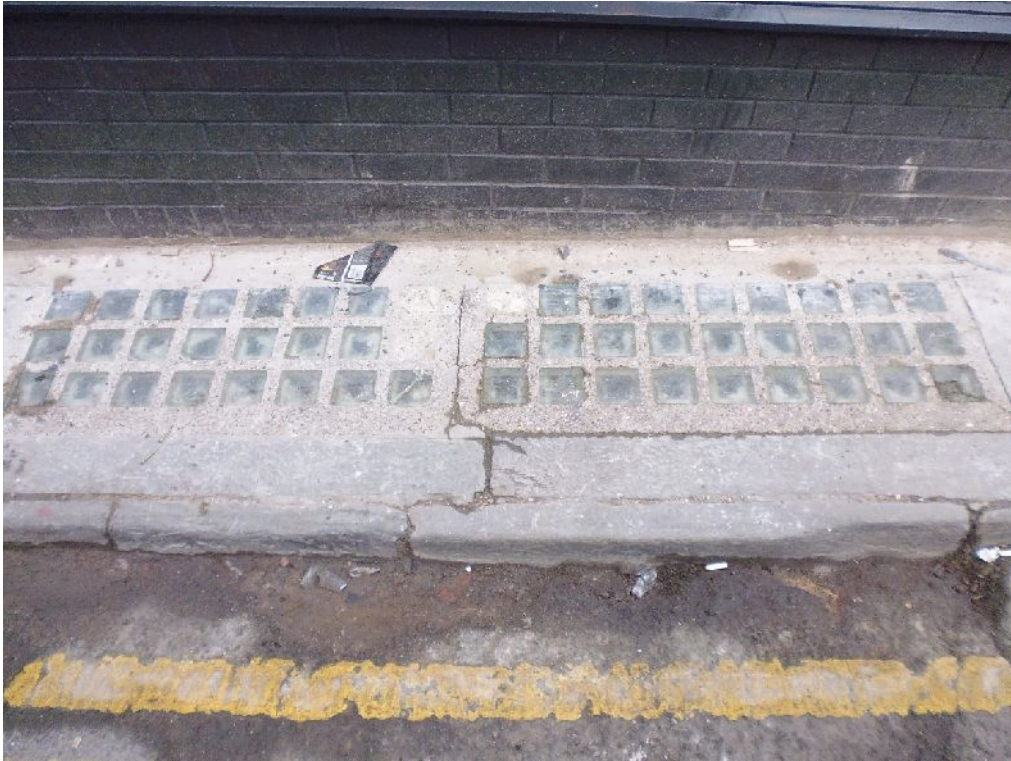
Pavement Light 1 - 2380mm x 500mm. Note the slight cracking to the concrete surround and some damaged glass blocks.

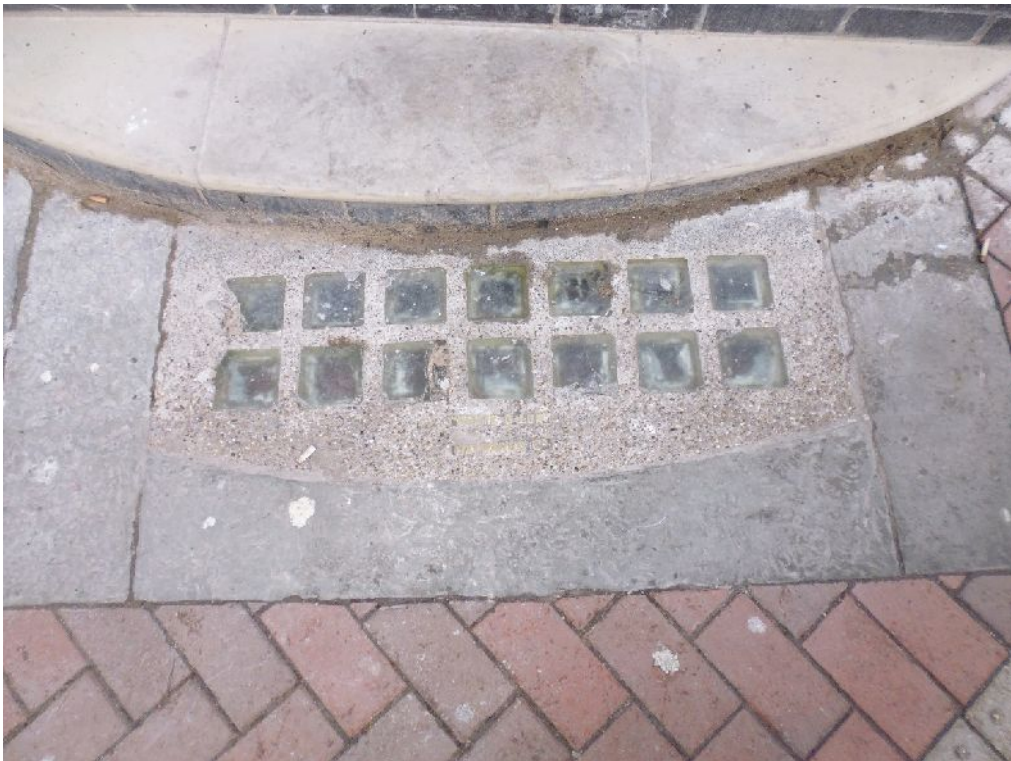
Pavement Light 2 - 1070mm x 400mm. Note the slight damage to the glass blocks.

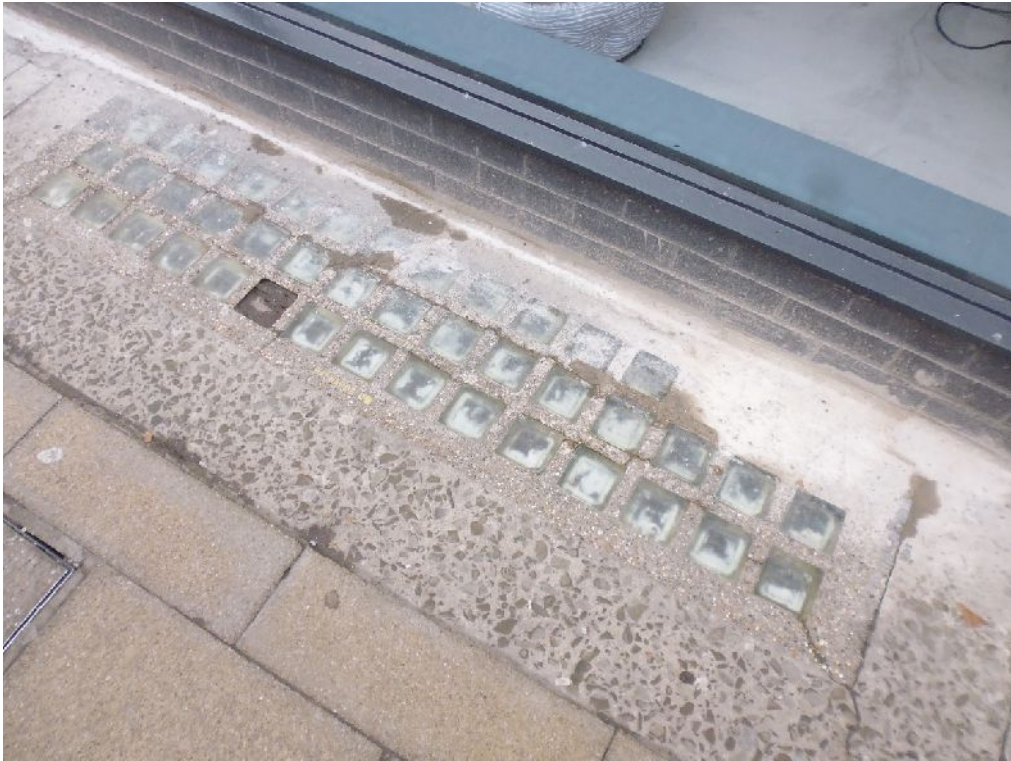
Pavement Light 3 - 2100mm x 500mm. Note the slight cracking to the concrete surround and some damaged glass blocks.

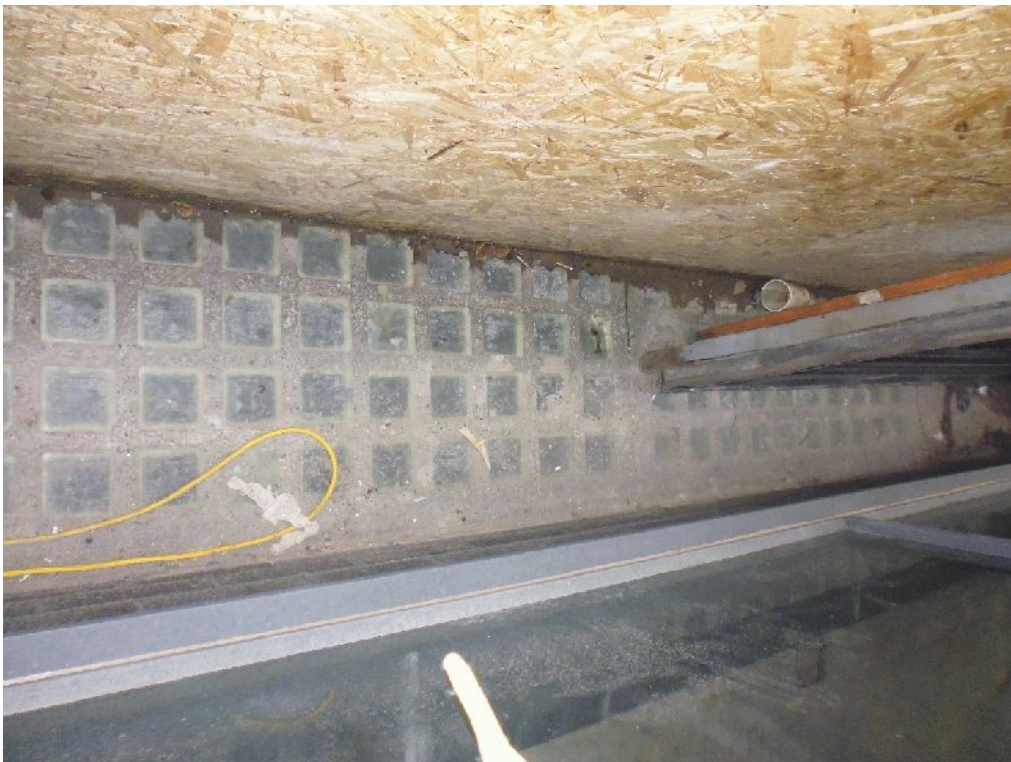
Pavement Light 4 - 2850mm x 600mm. Note the damaged glass blocks in various locations.

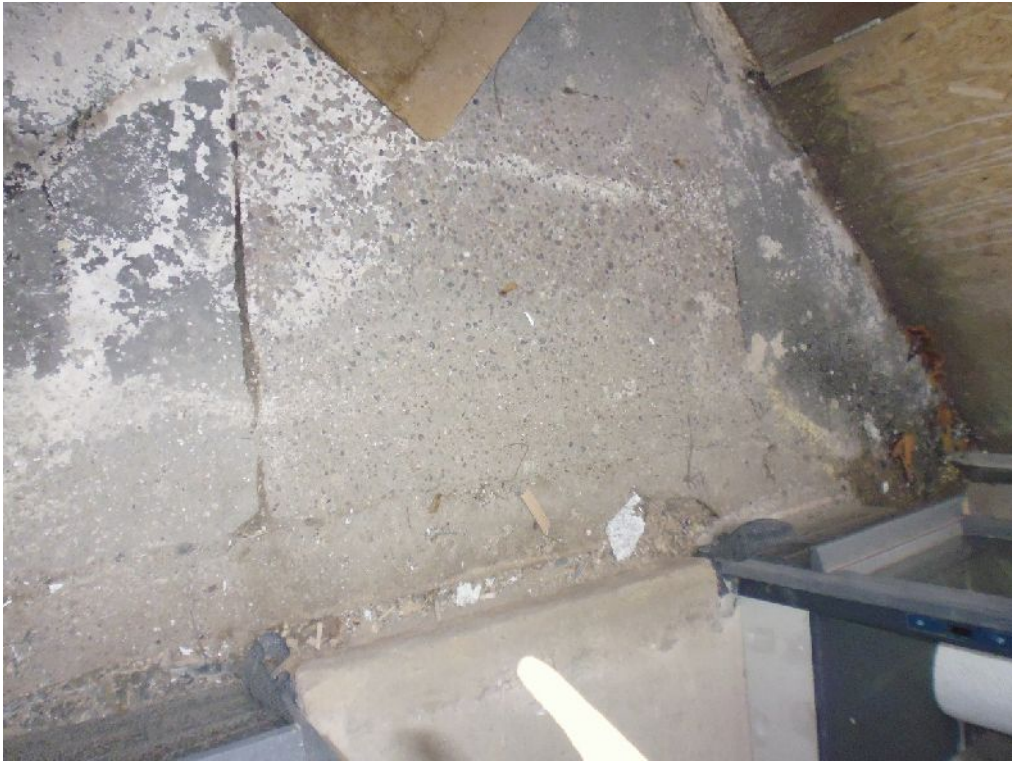
Pavement Light 5 - 1070mm x 400mm. Note the pavement light has been covered with concrete. The sizes etc. are similar to Pavement Light 2.

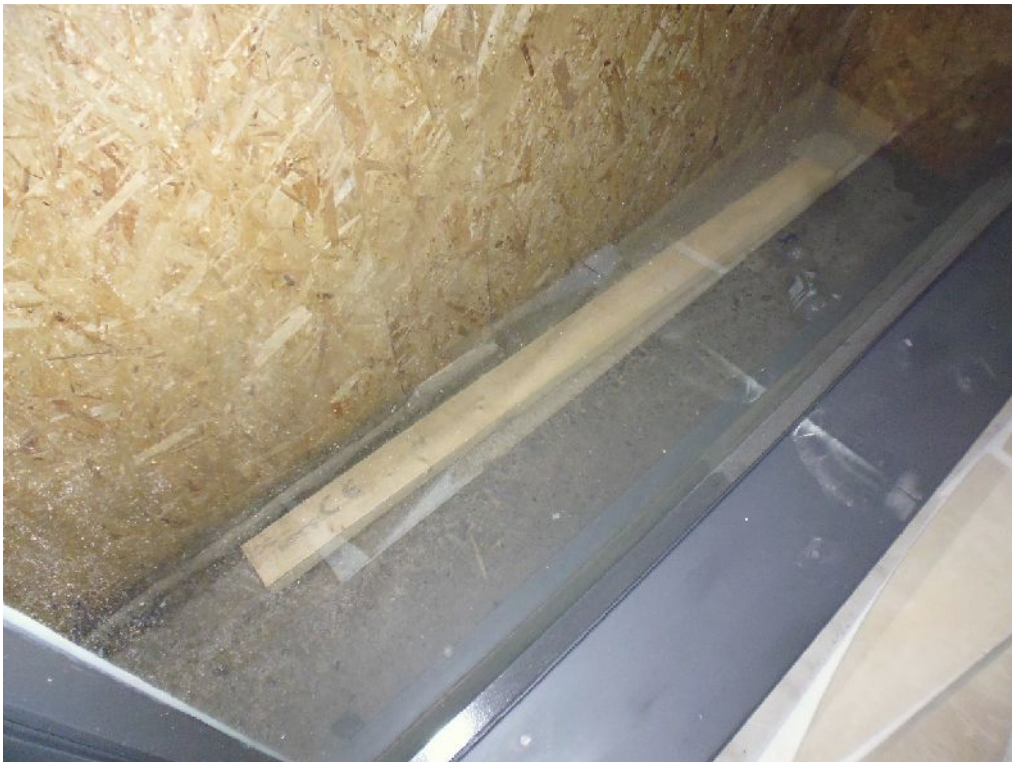
Pavement Light 6 - 2380mm x 500mm. Note the pavement light has been covered with concrete. The sizes are similar to Pavement Light 1.

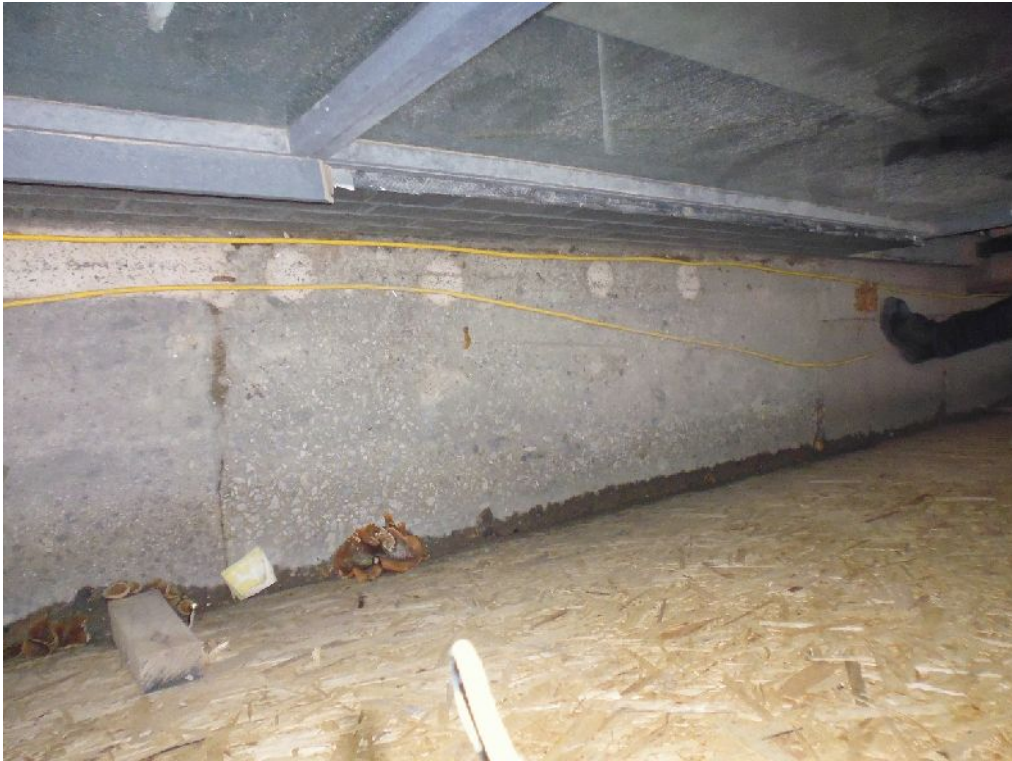
Pavement Light 7 - 1700mm x 600mm. Note the pavement light has been covered with concrete.
