Invek Surveys Ltd

Green End Development

03 December 2019

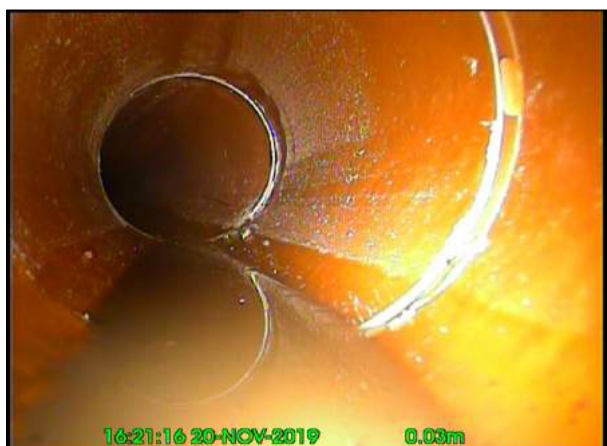
Photo: 3\_2A  
 0m, Clear water level, 10% of the vertical dimension

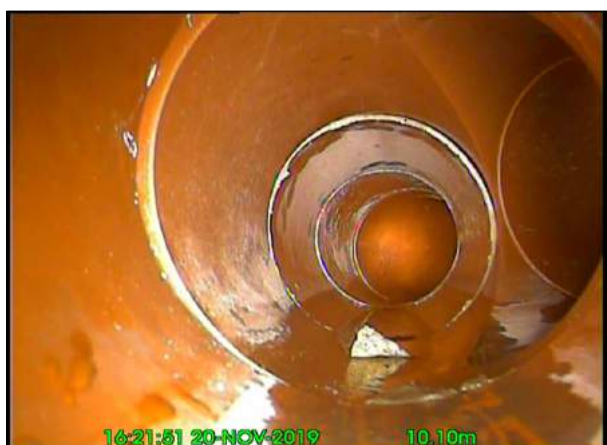
Photo: 3\_4A  
 10.3m, Connection other than junction, at 3 o'clock, diameter 150mm

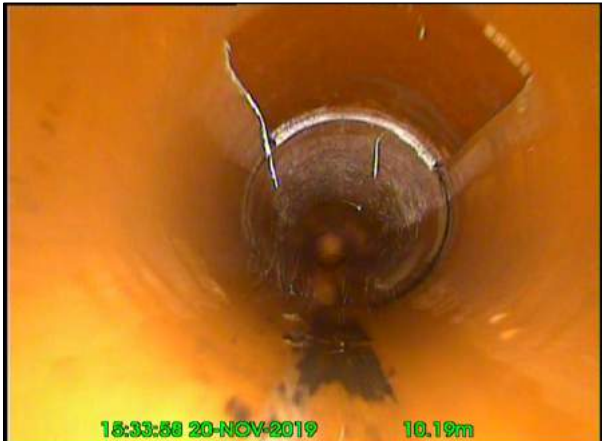
Photo: 6\_7A  
 10.4m, Point repair, hole repaired, from 11 to 1 o'clock, Start

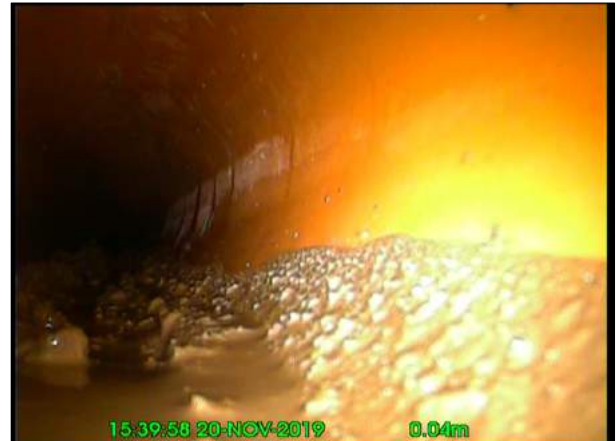
Photo: 7\_3A  
 0m, Settled deposits, fine, 10% cross-sectional area loss, Start

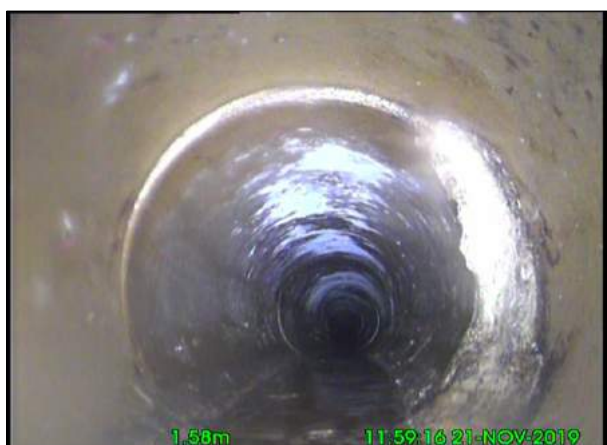
Photo: 11\_3A  
 1.9m, Attached deposits, encrustation at joint, from 1 to 5 o'clock, 10% cross-sectional area loss

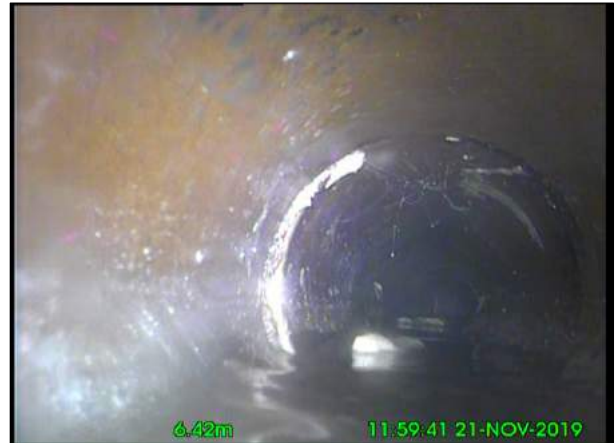
Photo: 11\_8A  
 6.6m, Joint displaced, medium

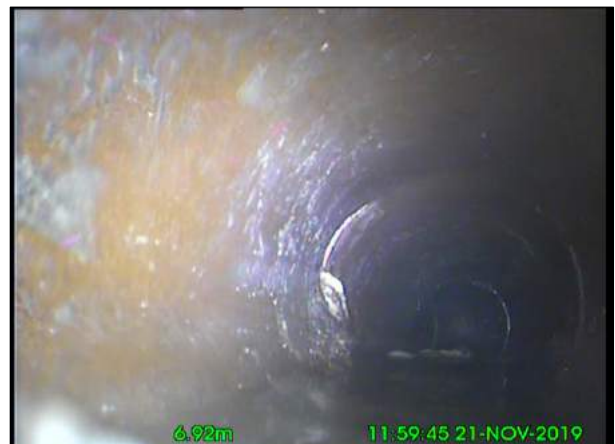
Photo: 11\_9A  
 7.3m, Attached deposits, encrustation at joint, from 6 to 9 o'clock, 15% cross-sectional area loss

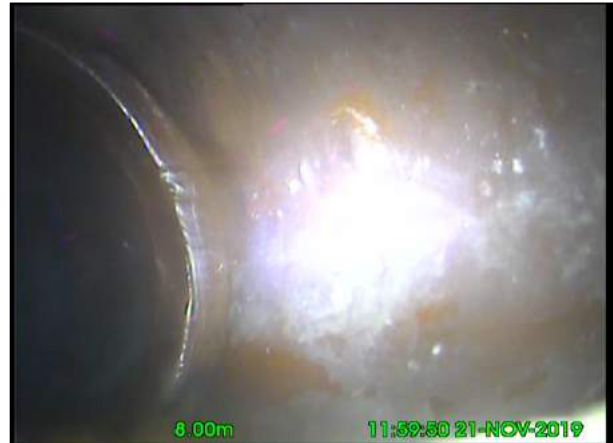
Photo: 11\_10A  
 8.2m, Joint displaced, large

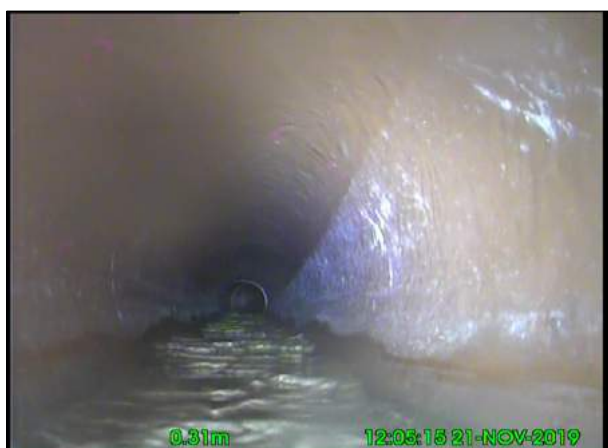
Photo: 12\_4A  
 0.4m, Settled deposits, fine, 15% cross-sectional area loss, Start

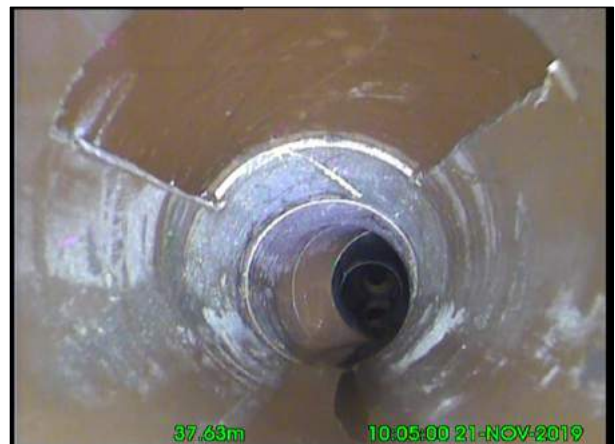
Photo: 15\_19A  
 37.7m, Point repair, hole repaired, from 10 to 2 o'clock, Start

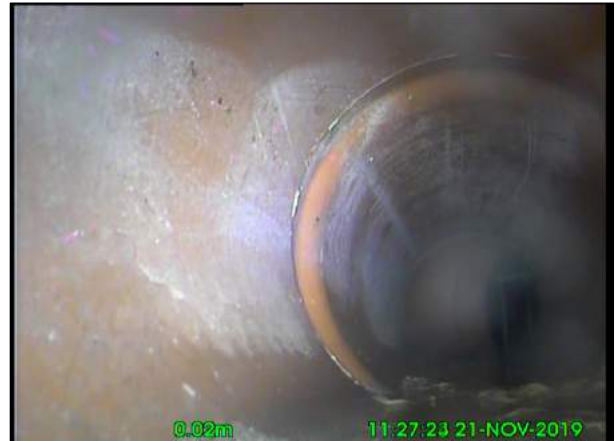
Photo: 18\_3A  
0m, Settled deposits, fine, 10% cross-sectional area loss, Start

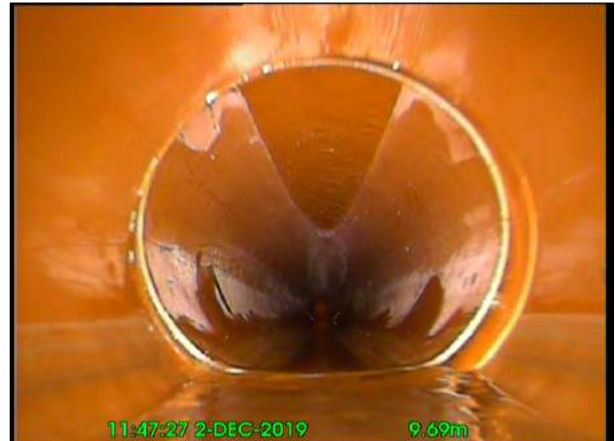
Photo: 19\_7A  
 9.7m, Joint displaced, medium

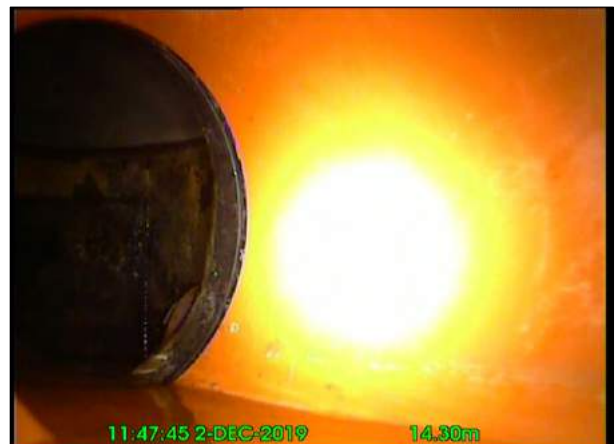
Photo: 19\_8A  
 13.1m, Joint displaced, medium

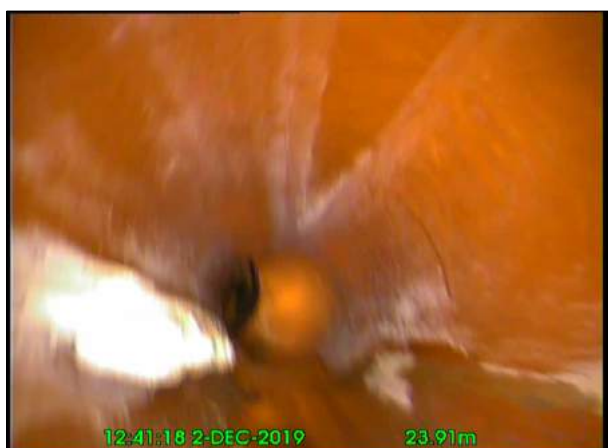
Photo: 20\_12A  
 24m, Attached deposits, encrustation, from 8 to 9 o'clock, 10% cross-sectional area loss

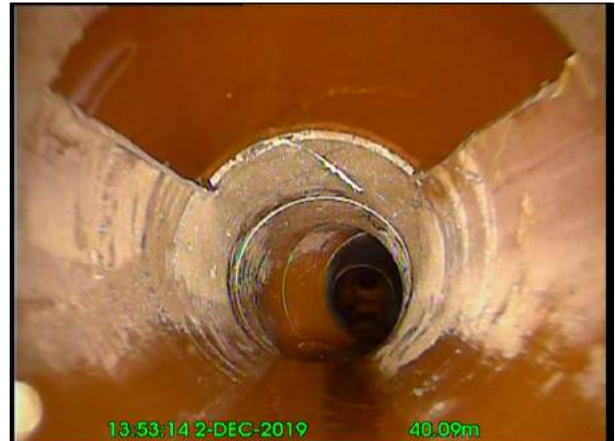
Photo: 24\_19A  
 40.2m, Point repair, hole repaired, from 10 to 2 o'clock, Start

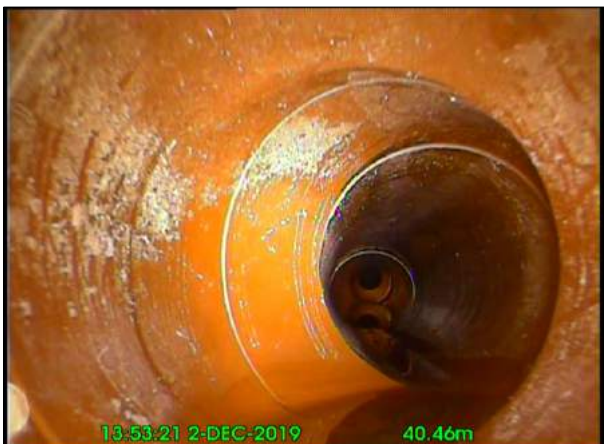
Photo: 24\_20A  
 40.46m, Point repair, hole repaired, from 10 to 2 o'clock, End
