EXTERNAL FACADE SURVEY  
TO  
79 MOSLEY STREET, MANCHESTER, M2 Q  
REPORT – OCTOBER 2019

Date: 18<sup>th</sup> October 2019

79 MOSLEY STREET MANCHESTER EXTERNAL FACADE SURVEY 2019

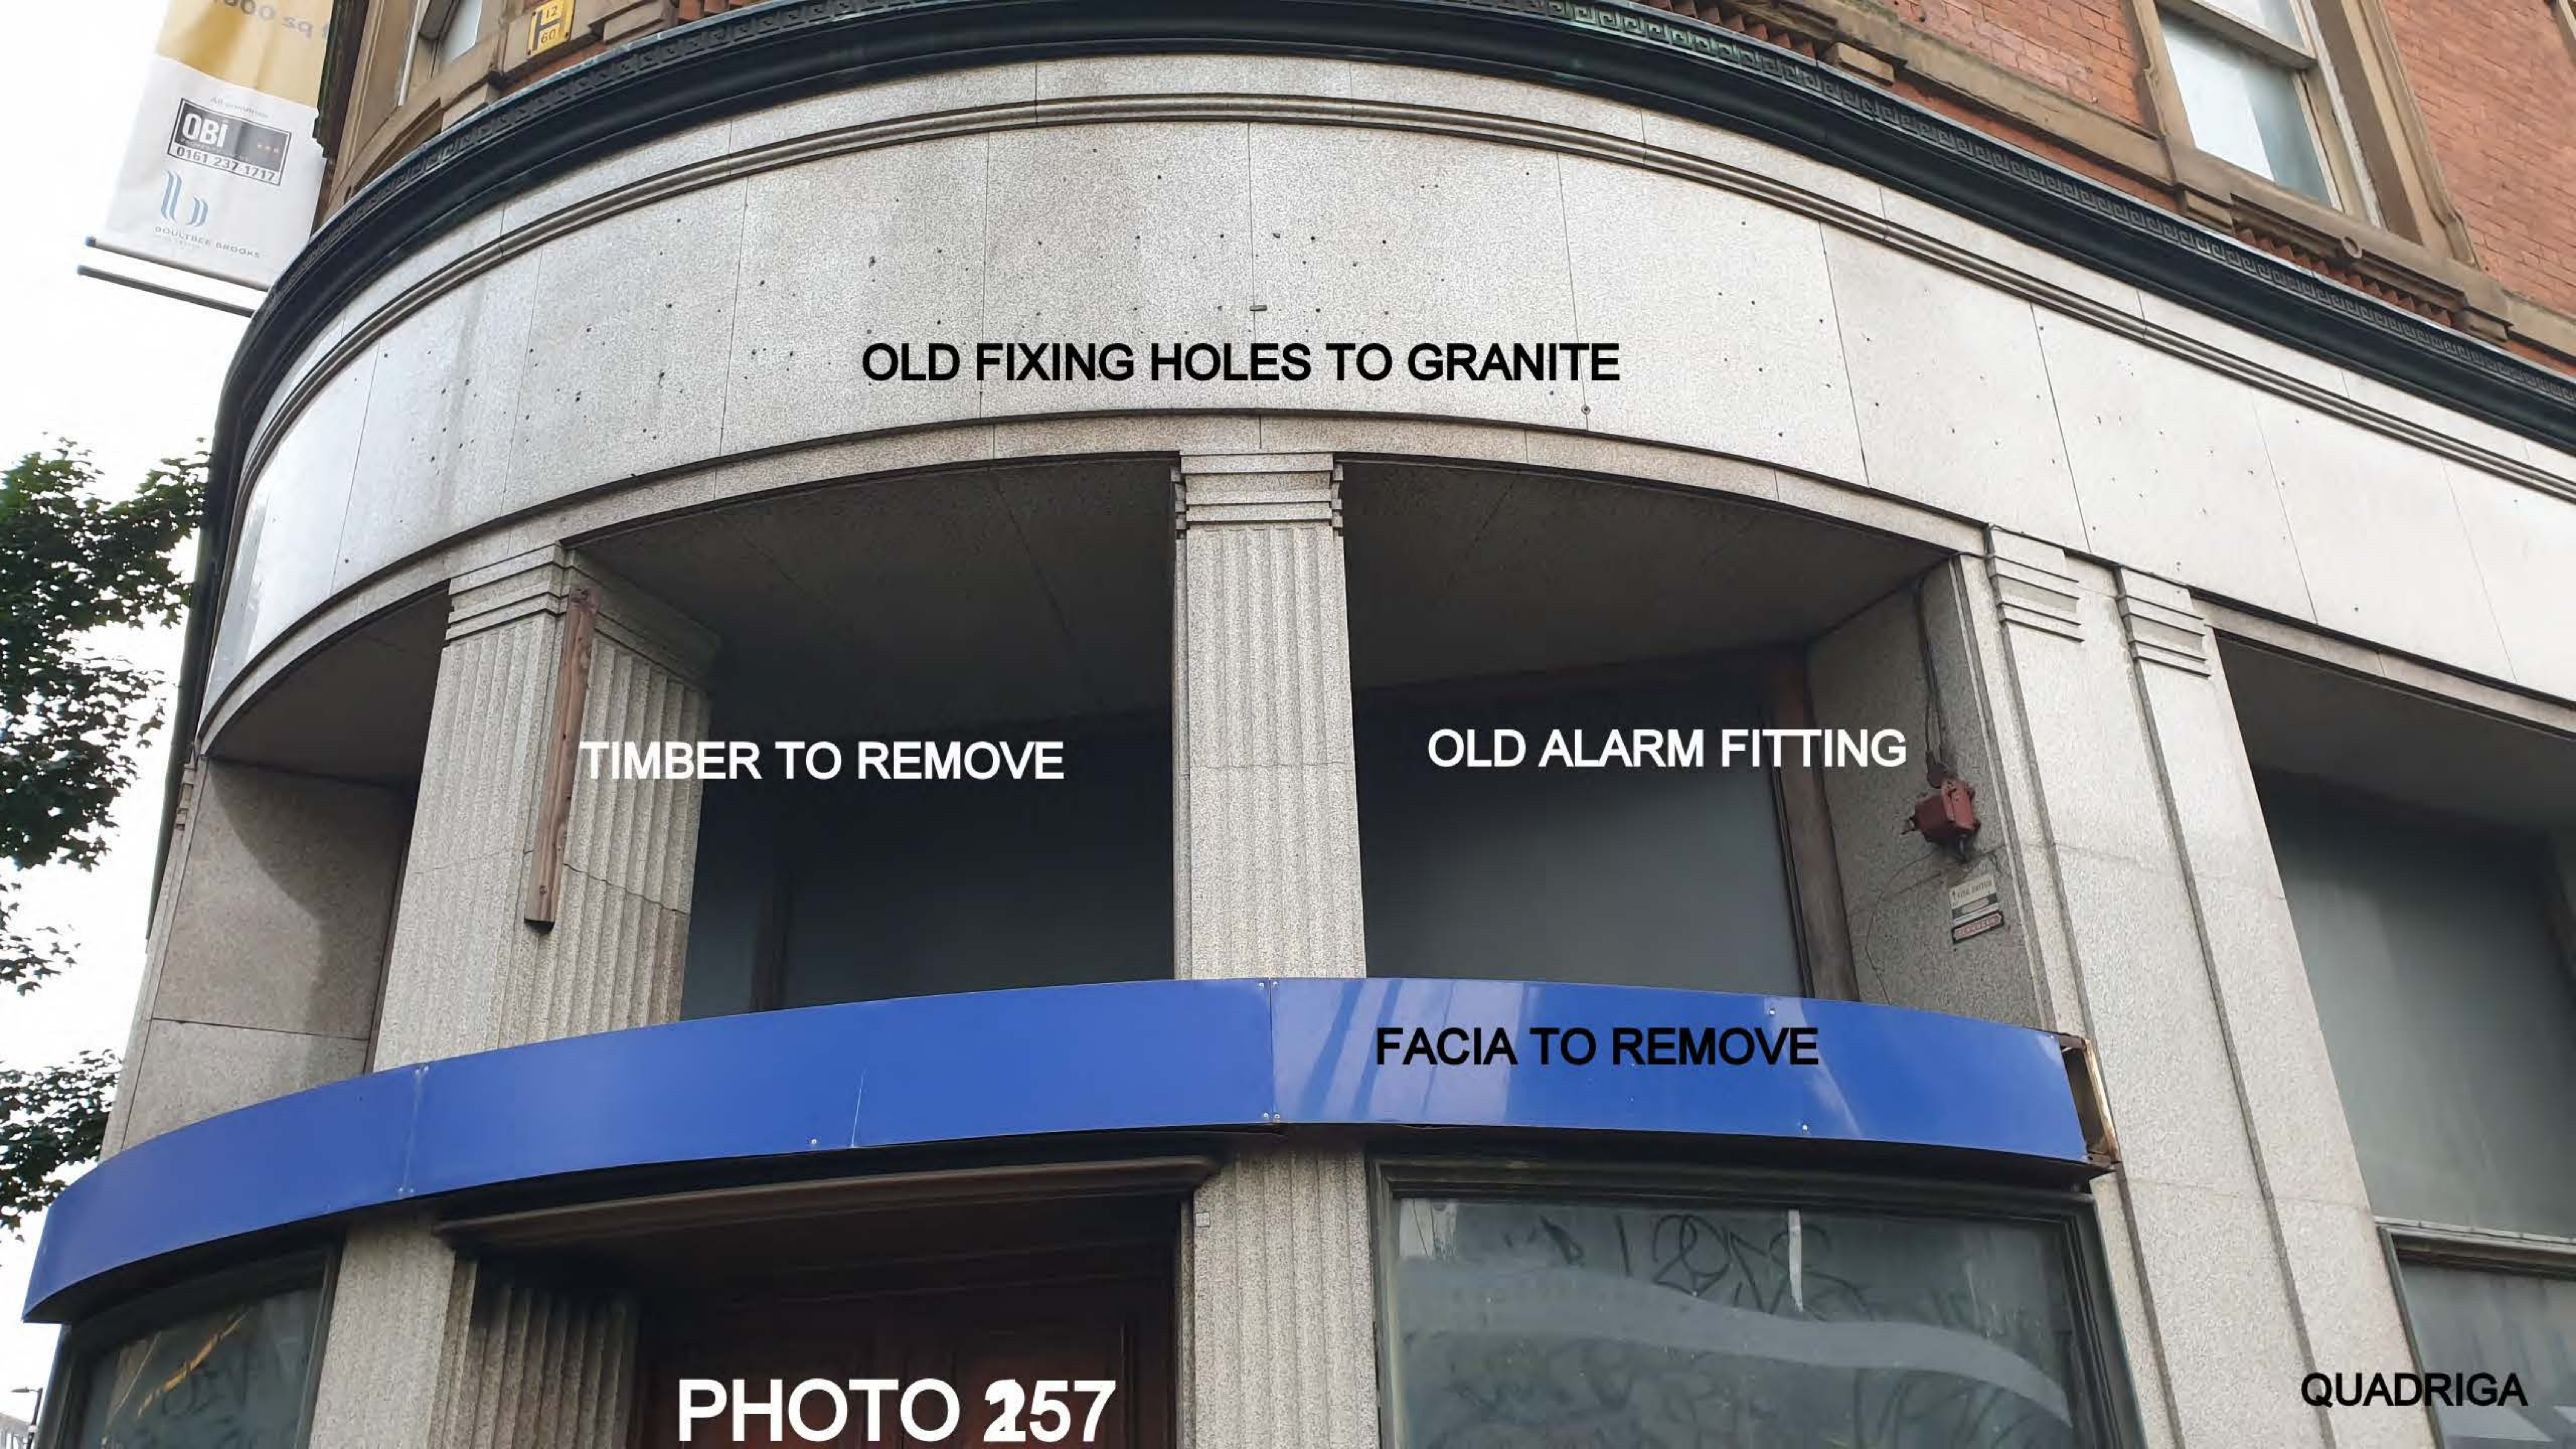
**PHOTO 505**

**OLD FIXING HOLES TO GRANITE**

**TIMBER TO REMOVE**

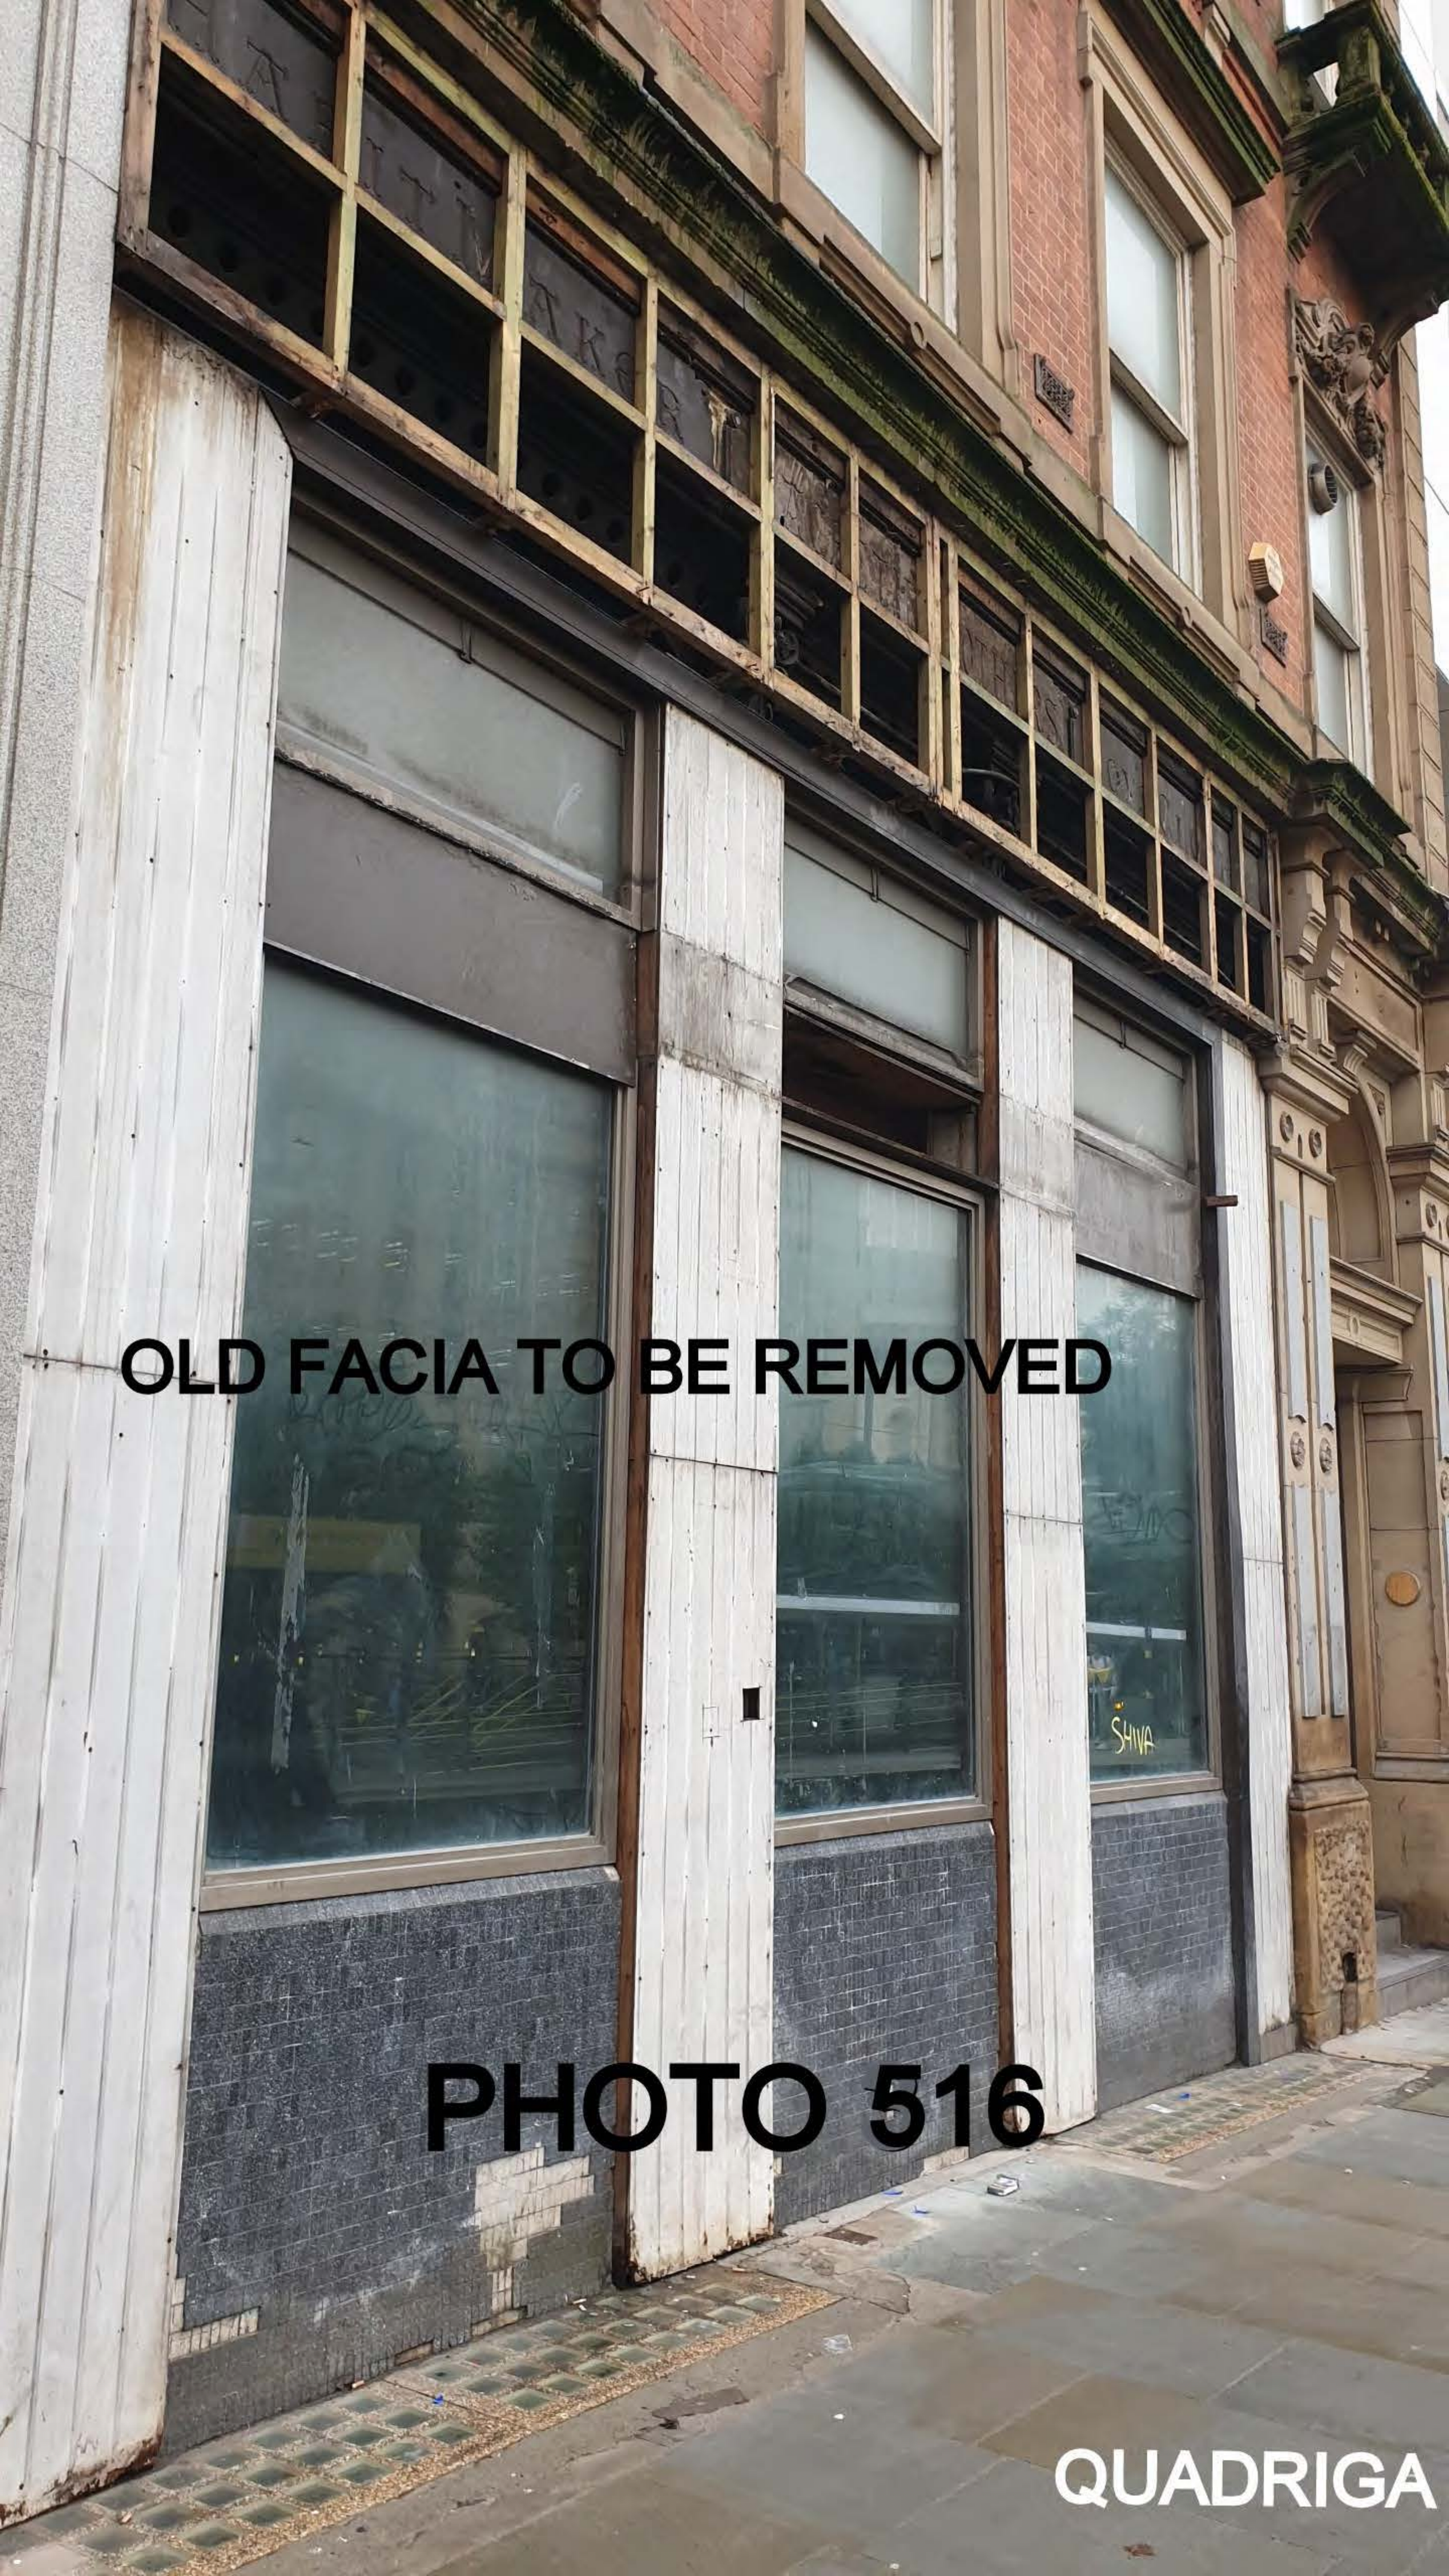
**PHOTO 516**

**OLD FACIA TO BE REMOVED**

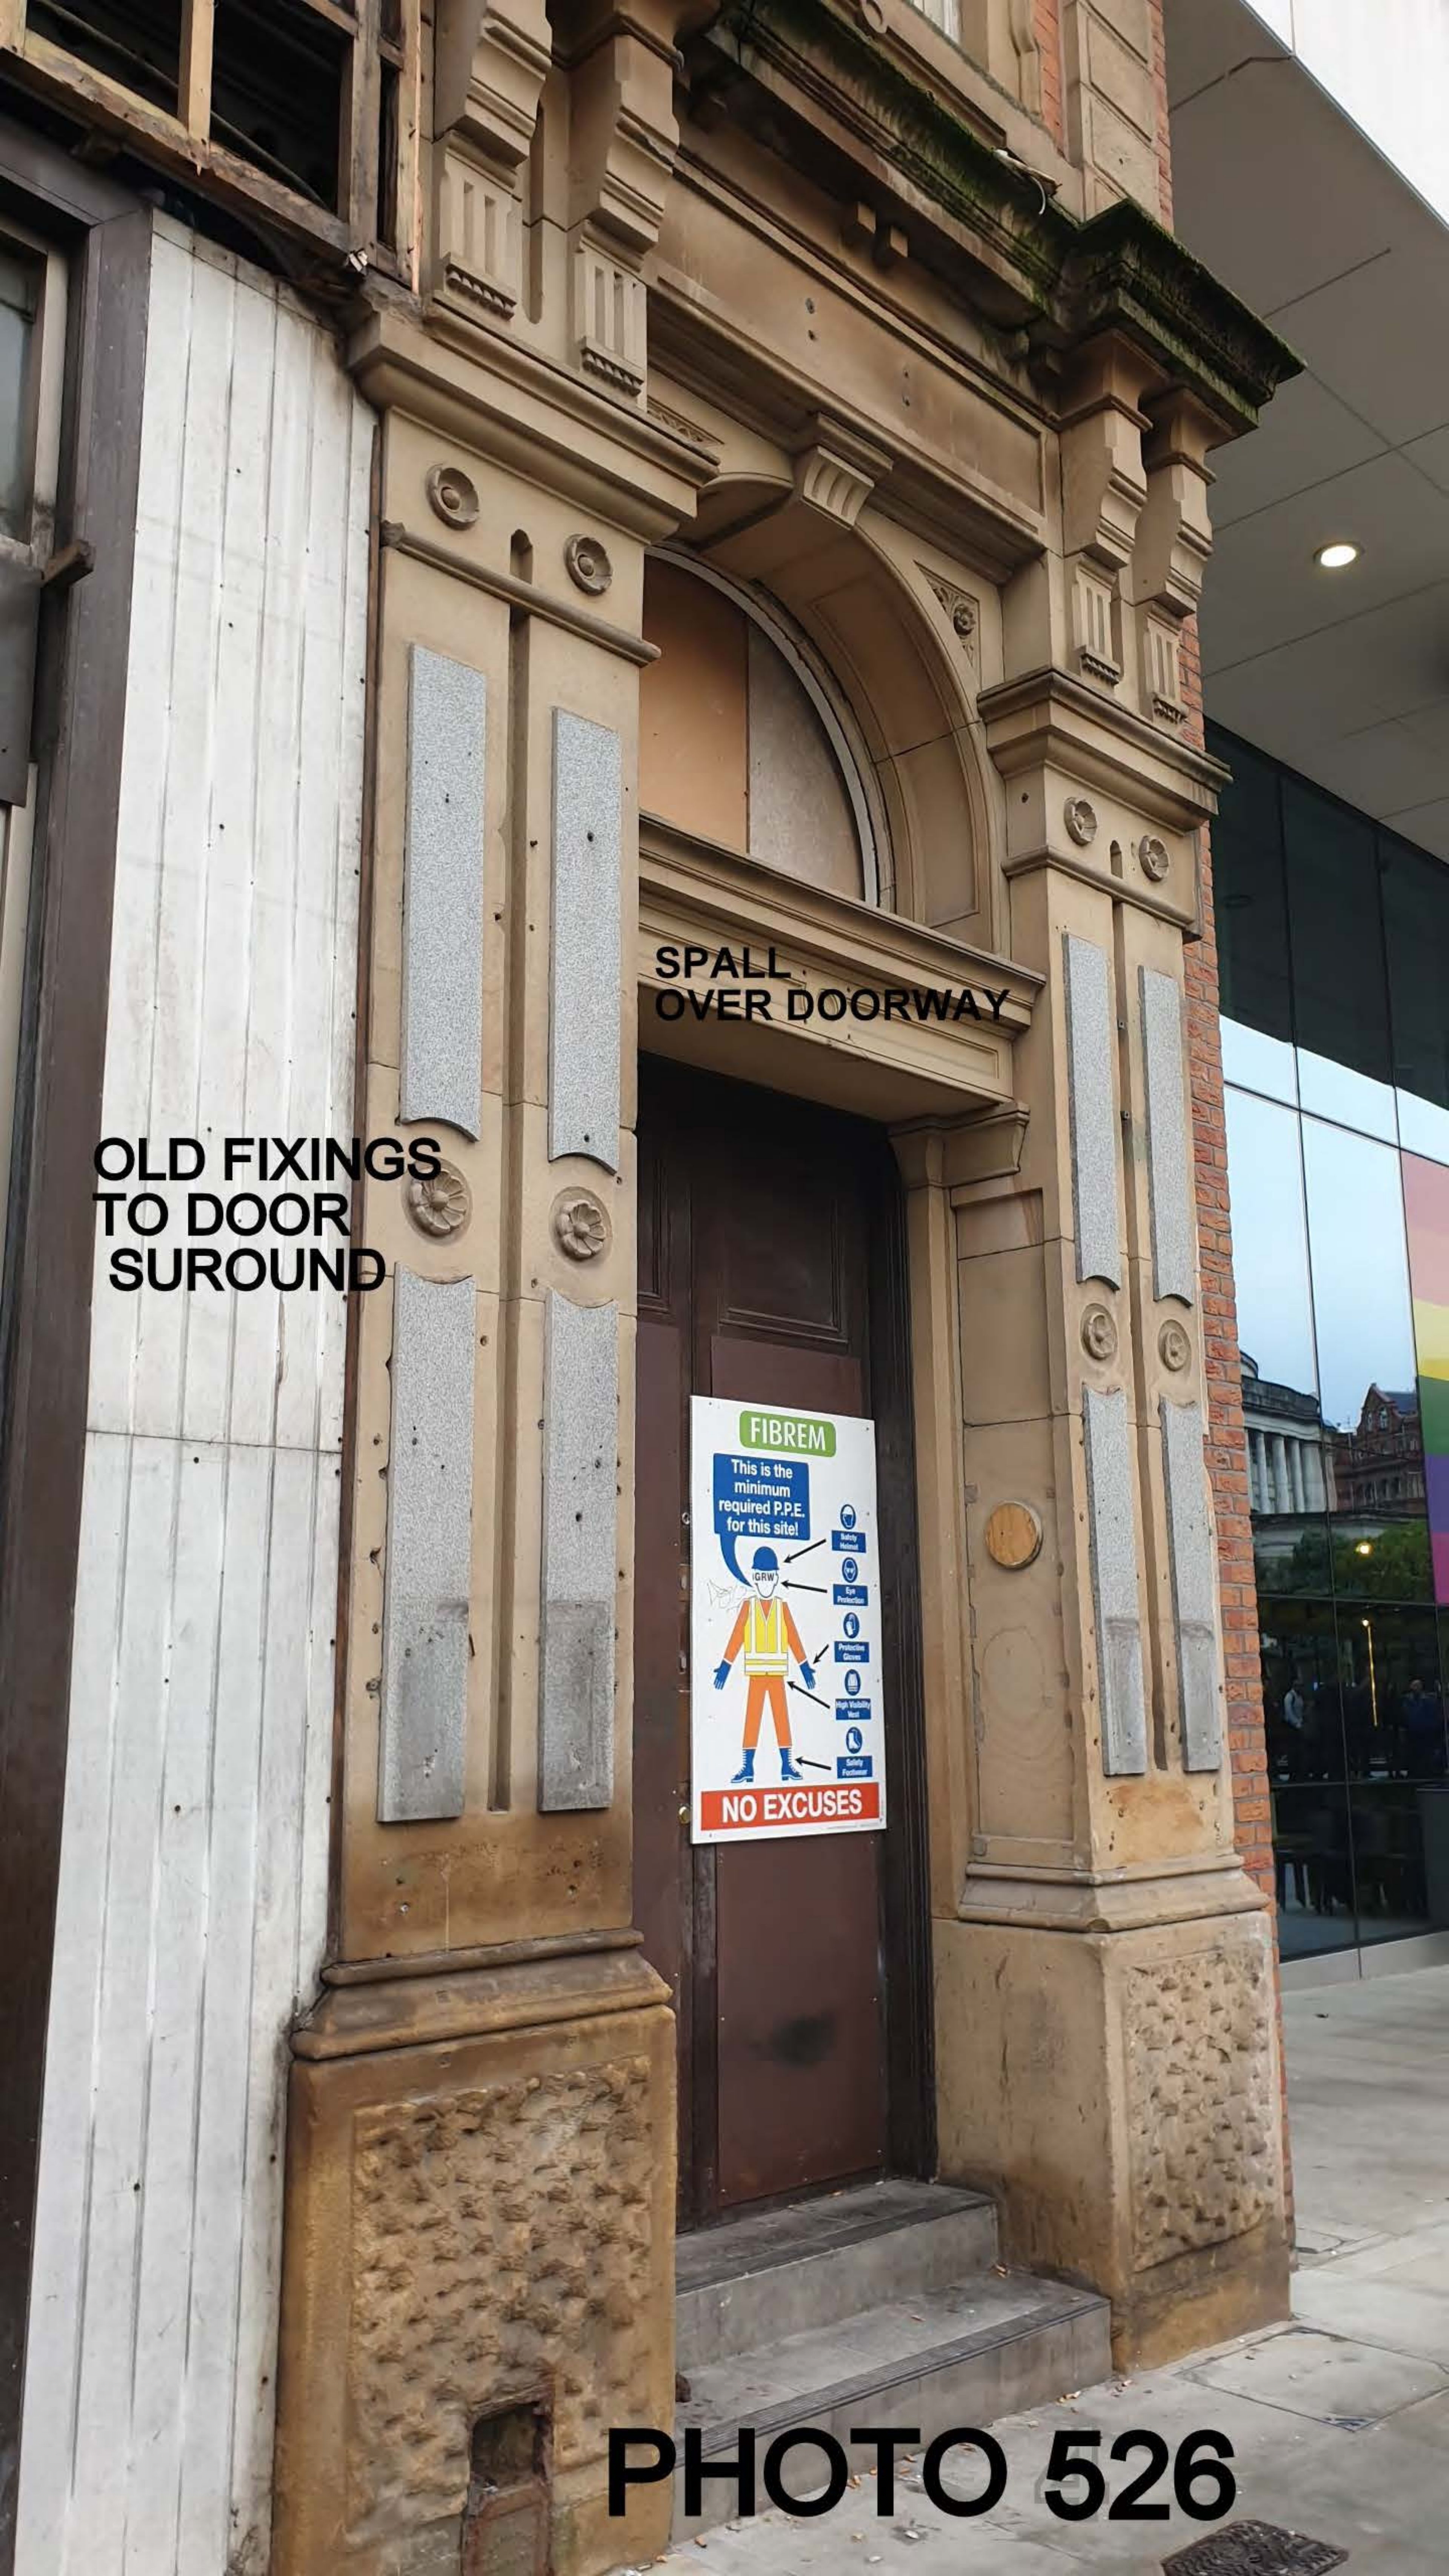
SPALL  
OVER DOORWAY

OLD FIXINGS  
TO DOOR  
SUROUND

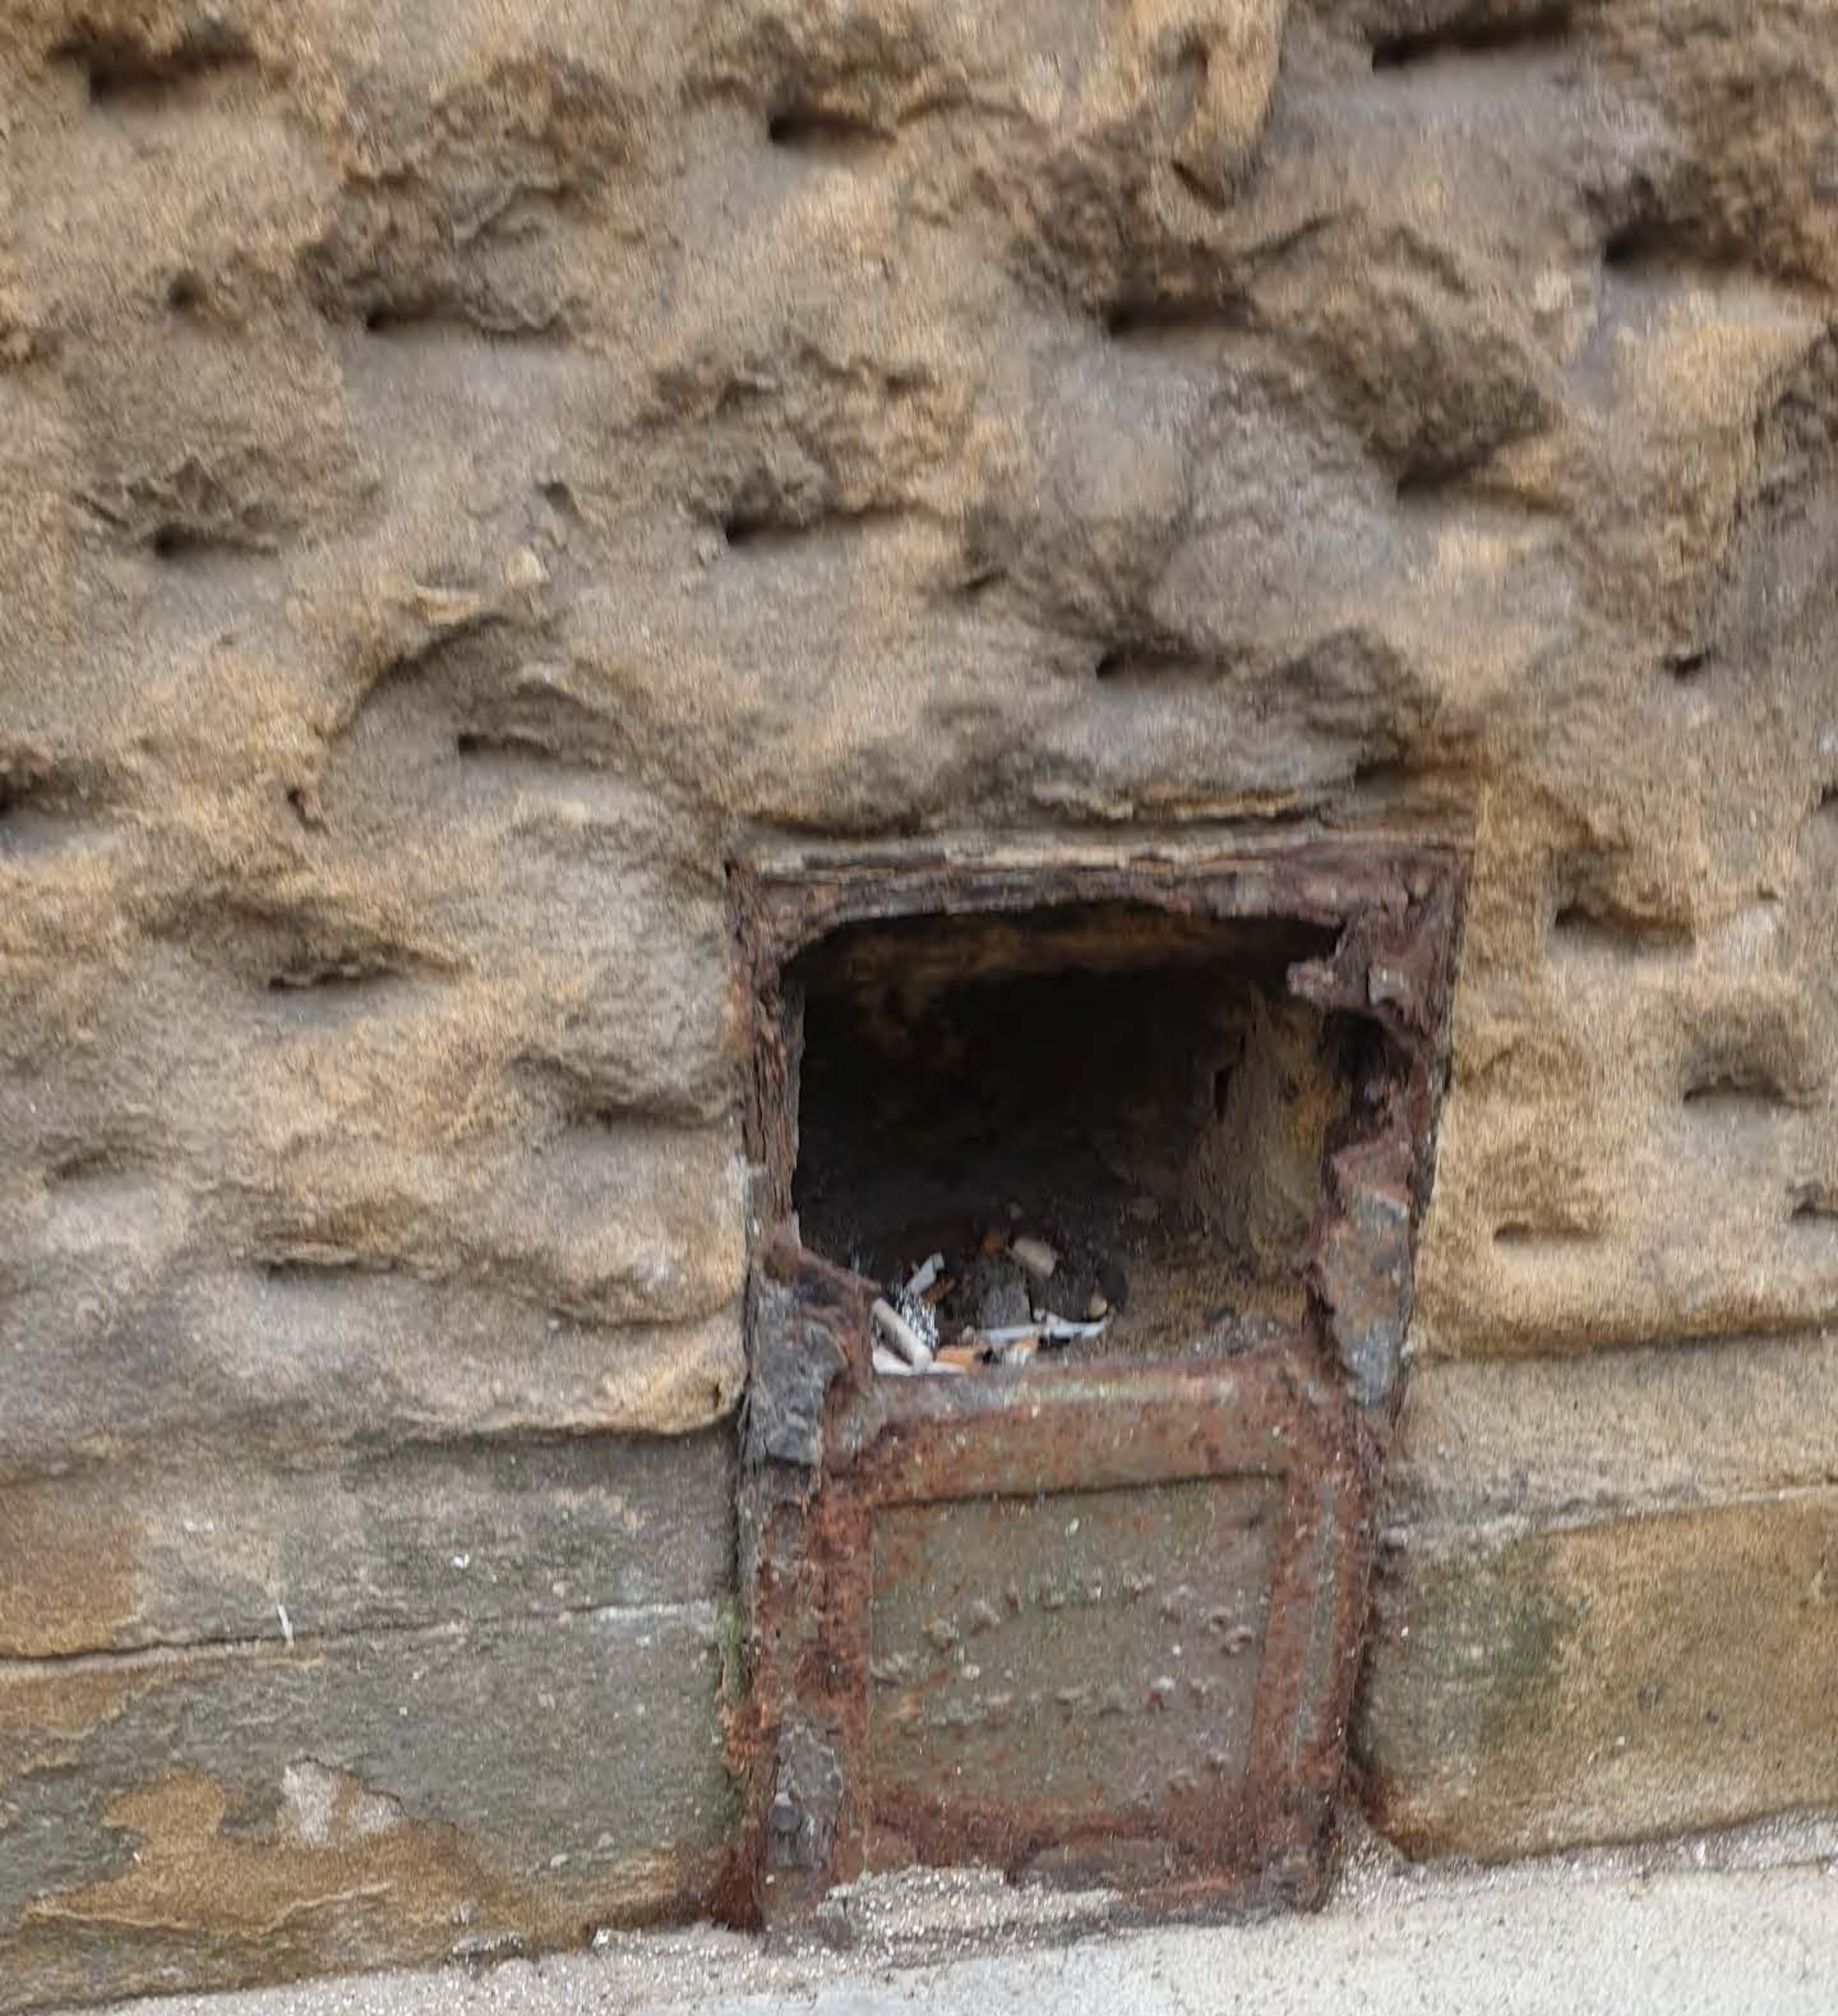
**PHOTO 743**

**CORRODED AND DAMAGED  
SHOE SCRAPE**

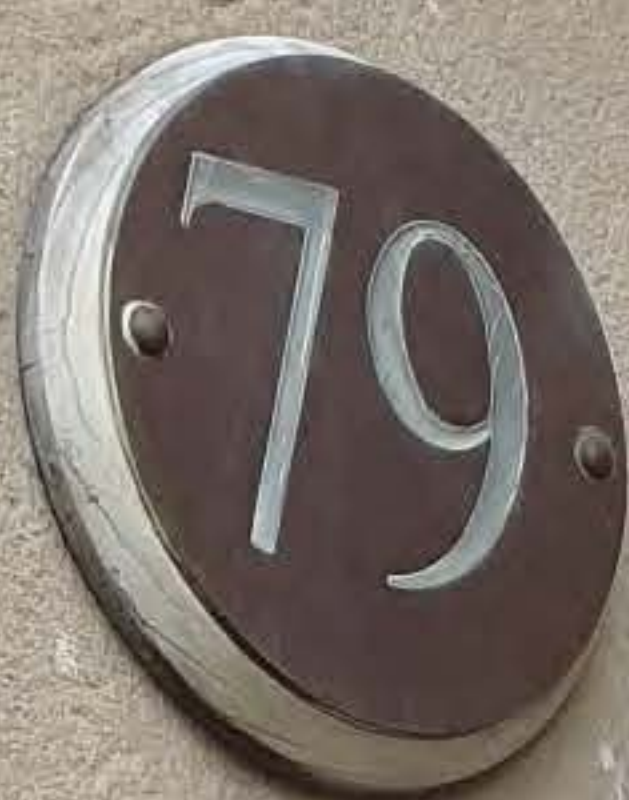
**PREVIOUS OLD  
FIXING  
REPAIRS**

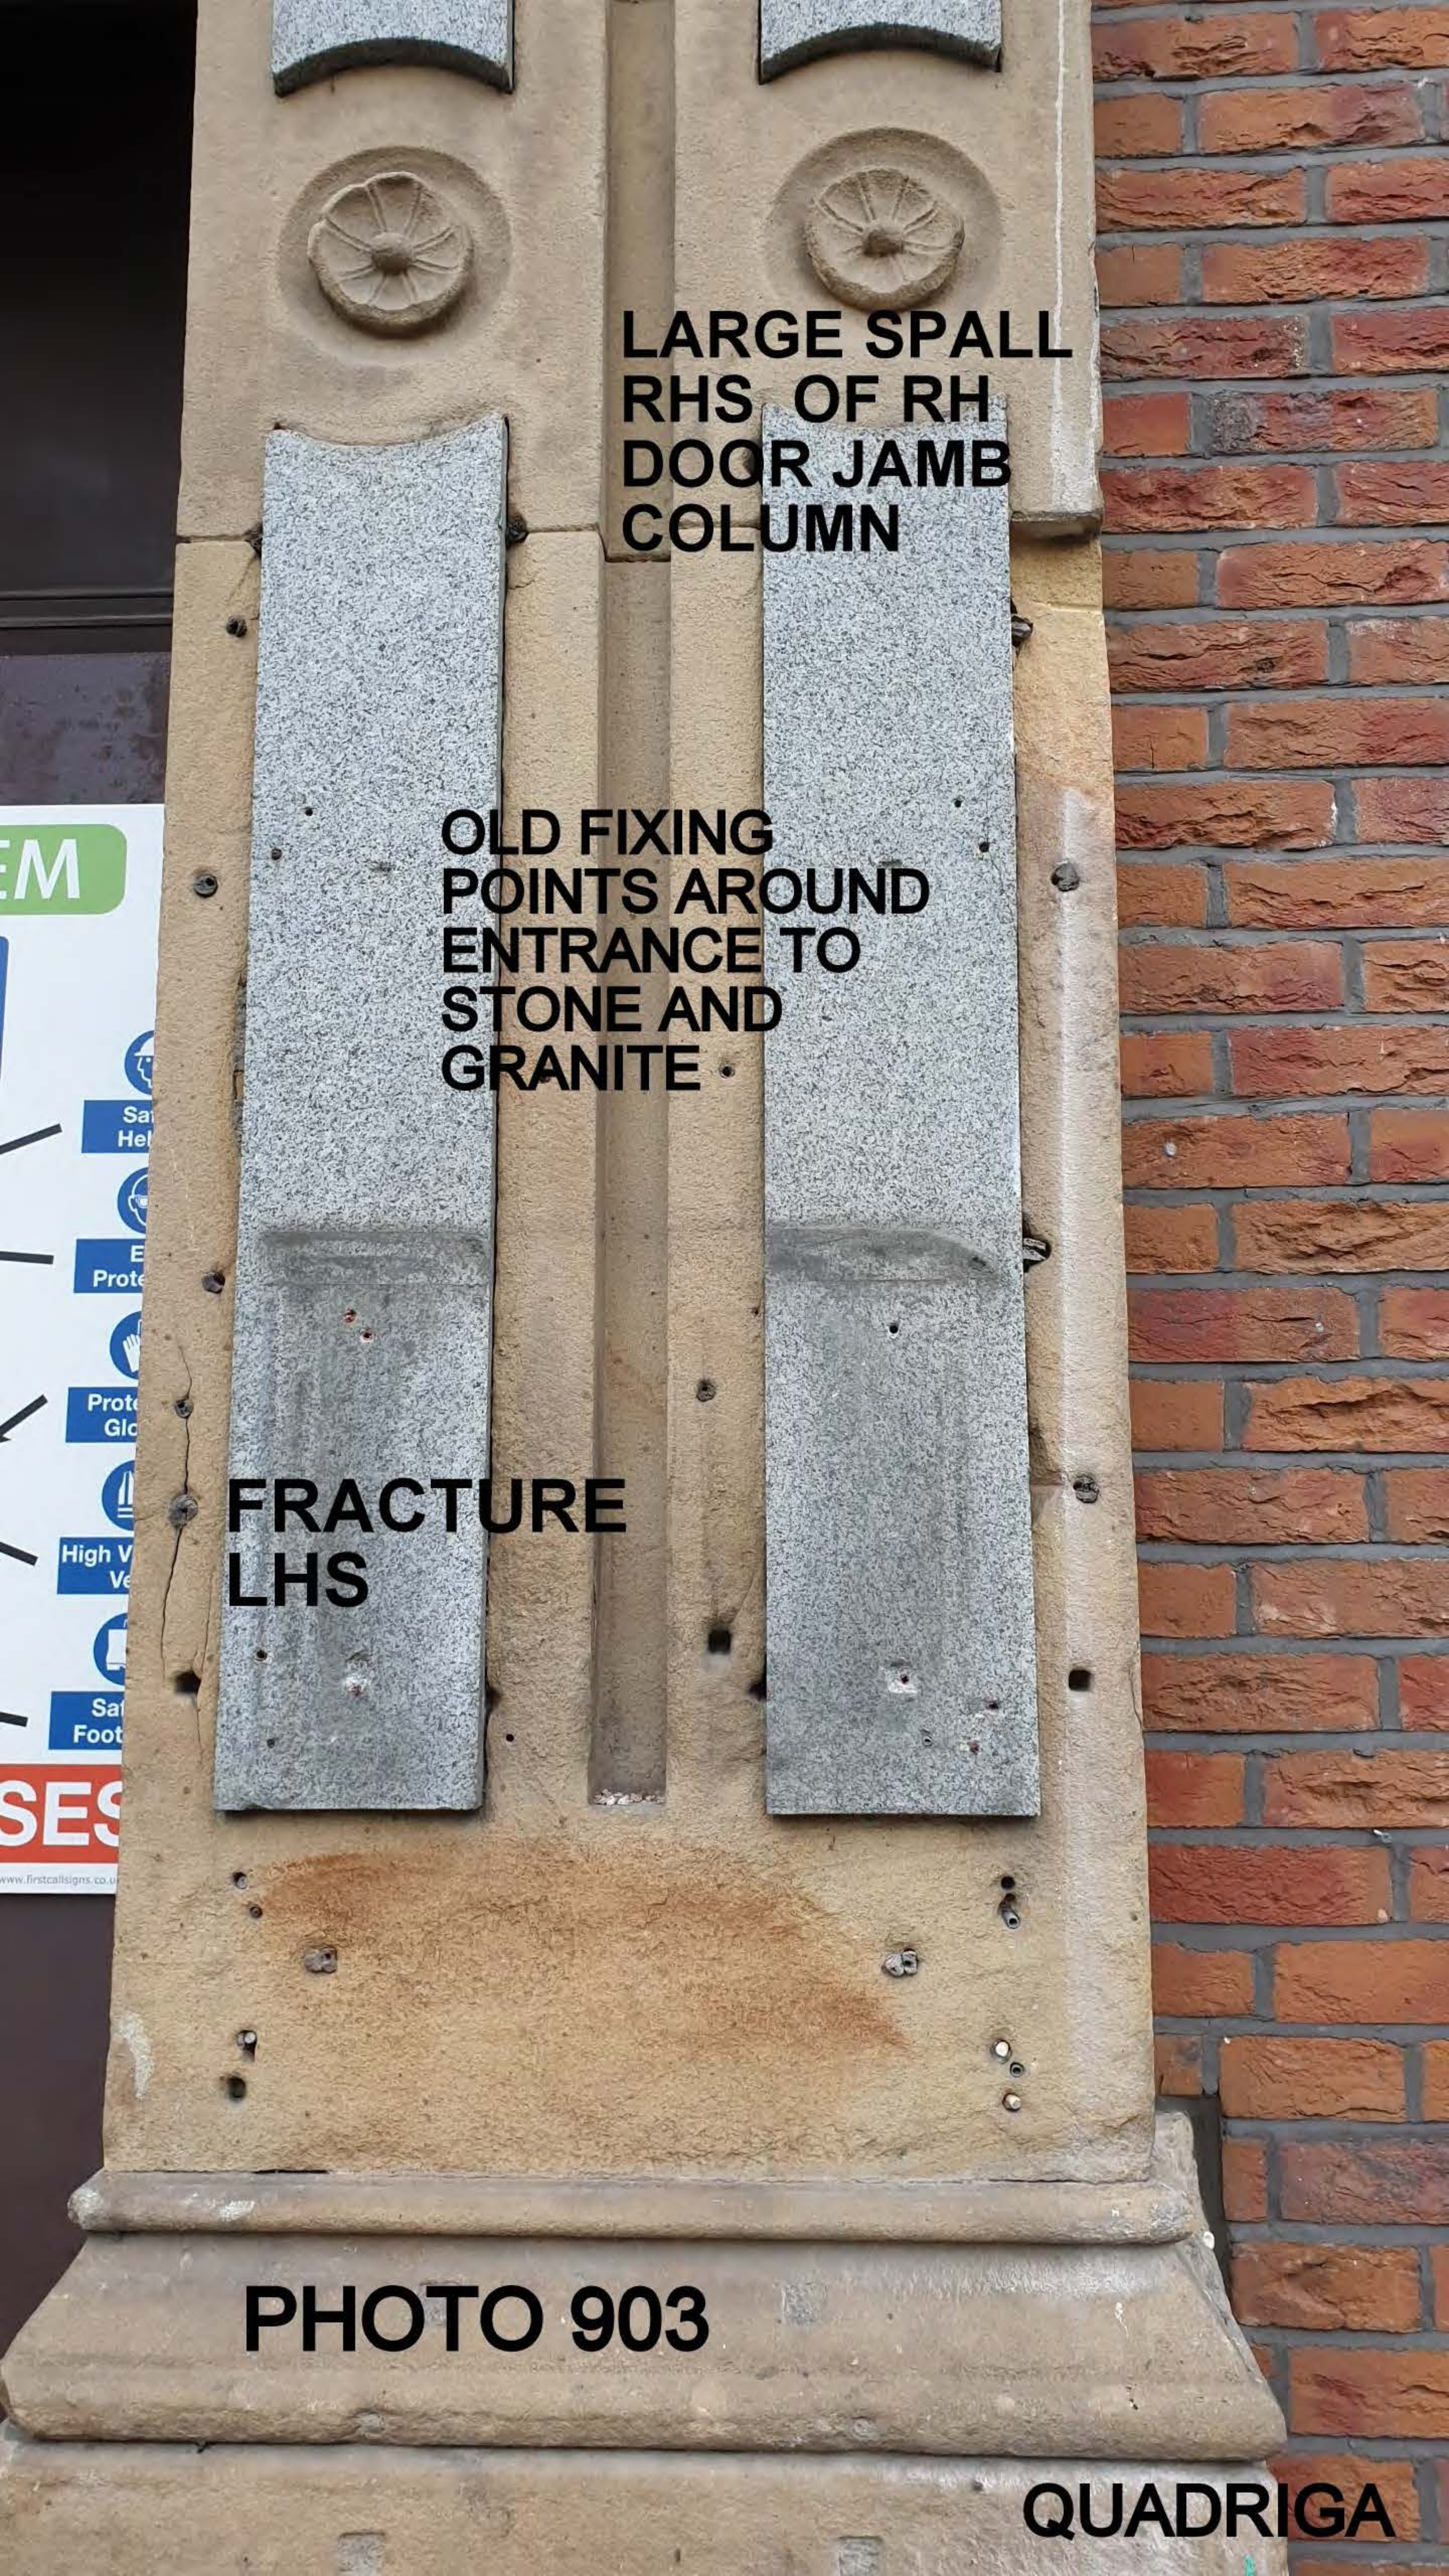
**PHOTO 903**

**LARGE SPALL  
RHS OF RH  
DOOR JAMB  
COLUMN**

**OLD FIXING  
POINTS AROUND  
ENTRANCE TO  
STONE AND  
GRANITE**

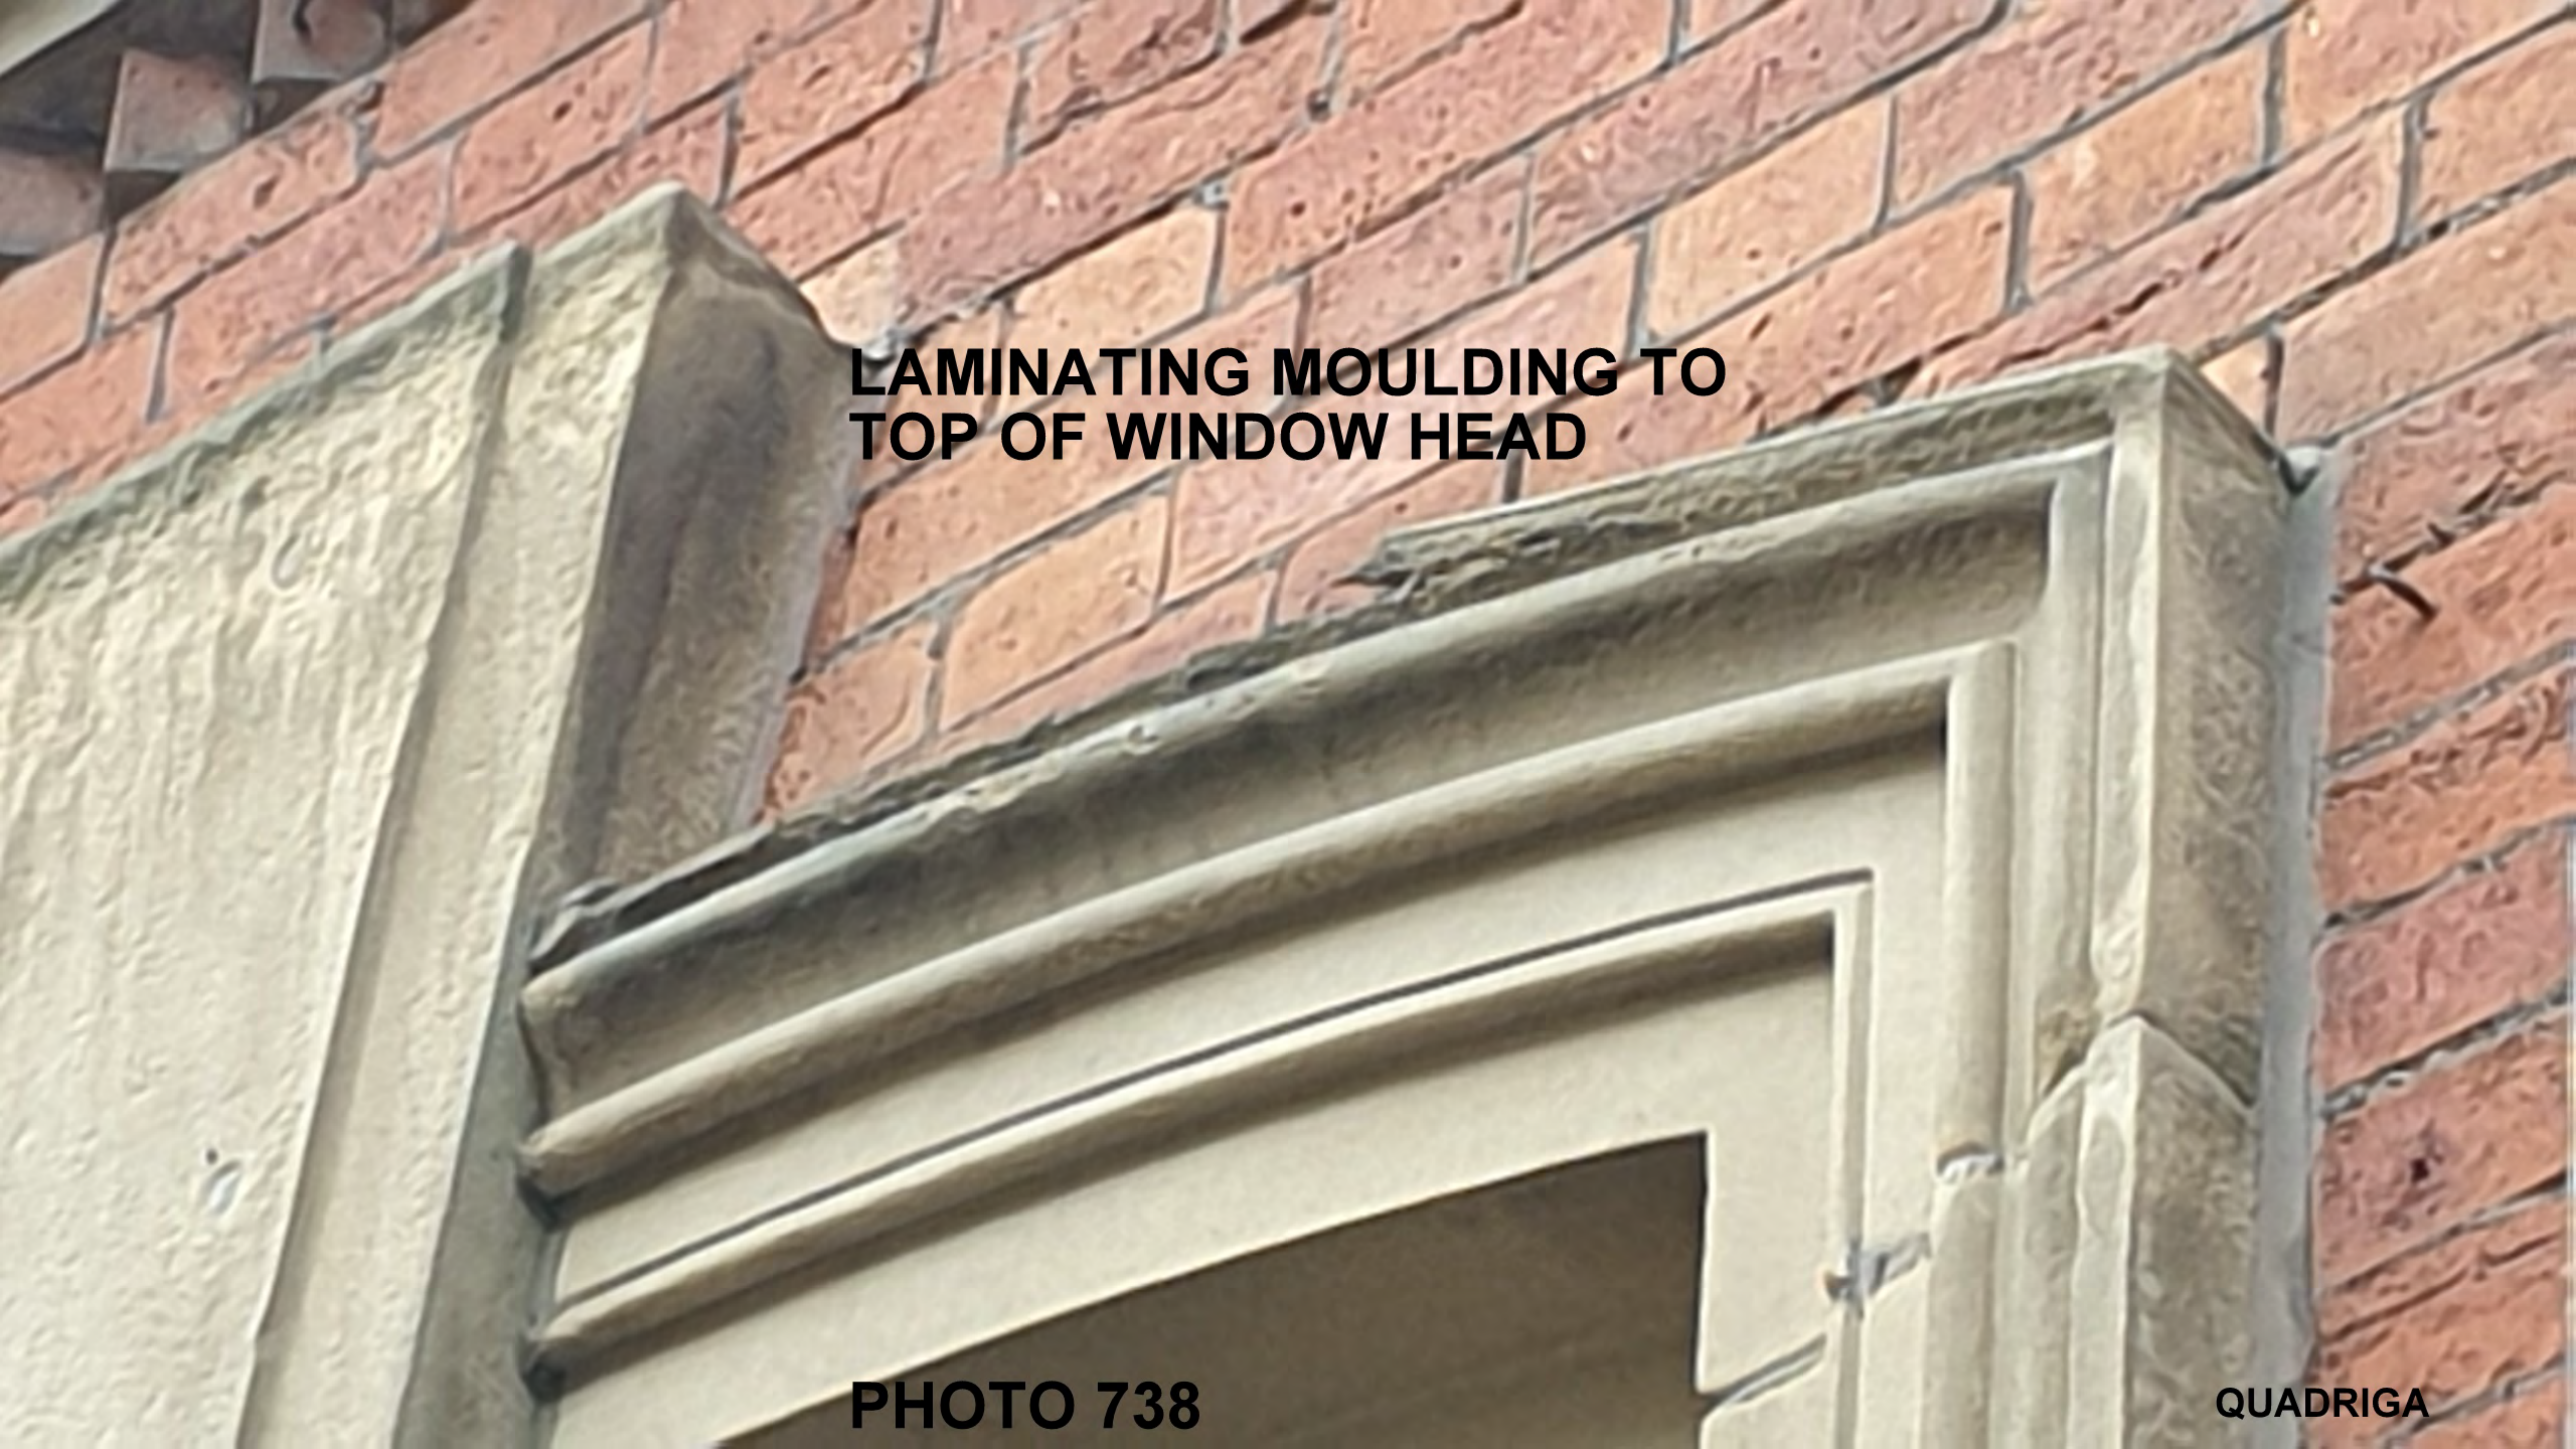
PHOTO 947

**LAMINATING MOULDING TO  
TOP OF WINDOW HEAD**
