EXTERNAL FACADE SURVEY  
TO  
79 MOSLEY STREET, MANCHESTER, M2 Q  
REPORT – OCTOBER 2019

Date: 18<sup>th</sup> October 2019

79 MOSLEY STREET MANCHESTER EXTERNAL FACADE SURVEY 2019

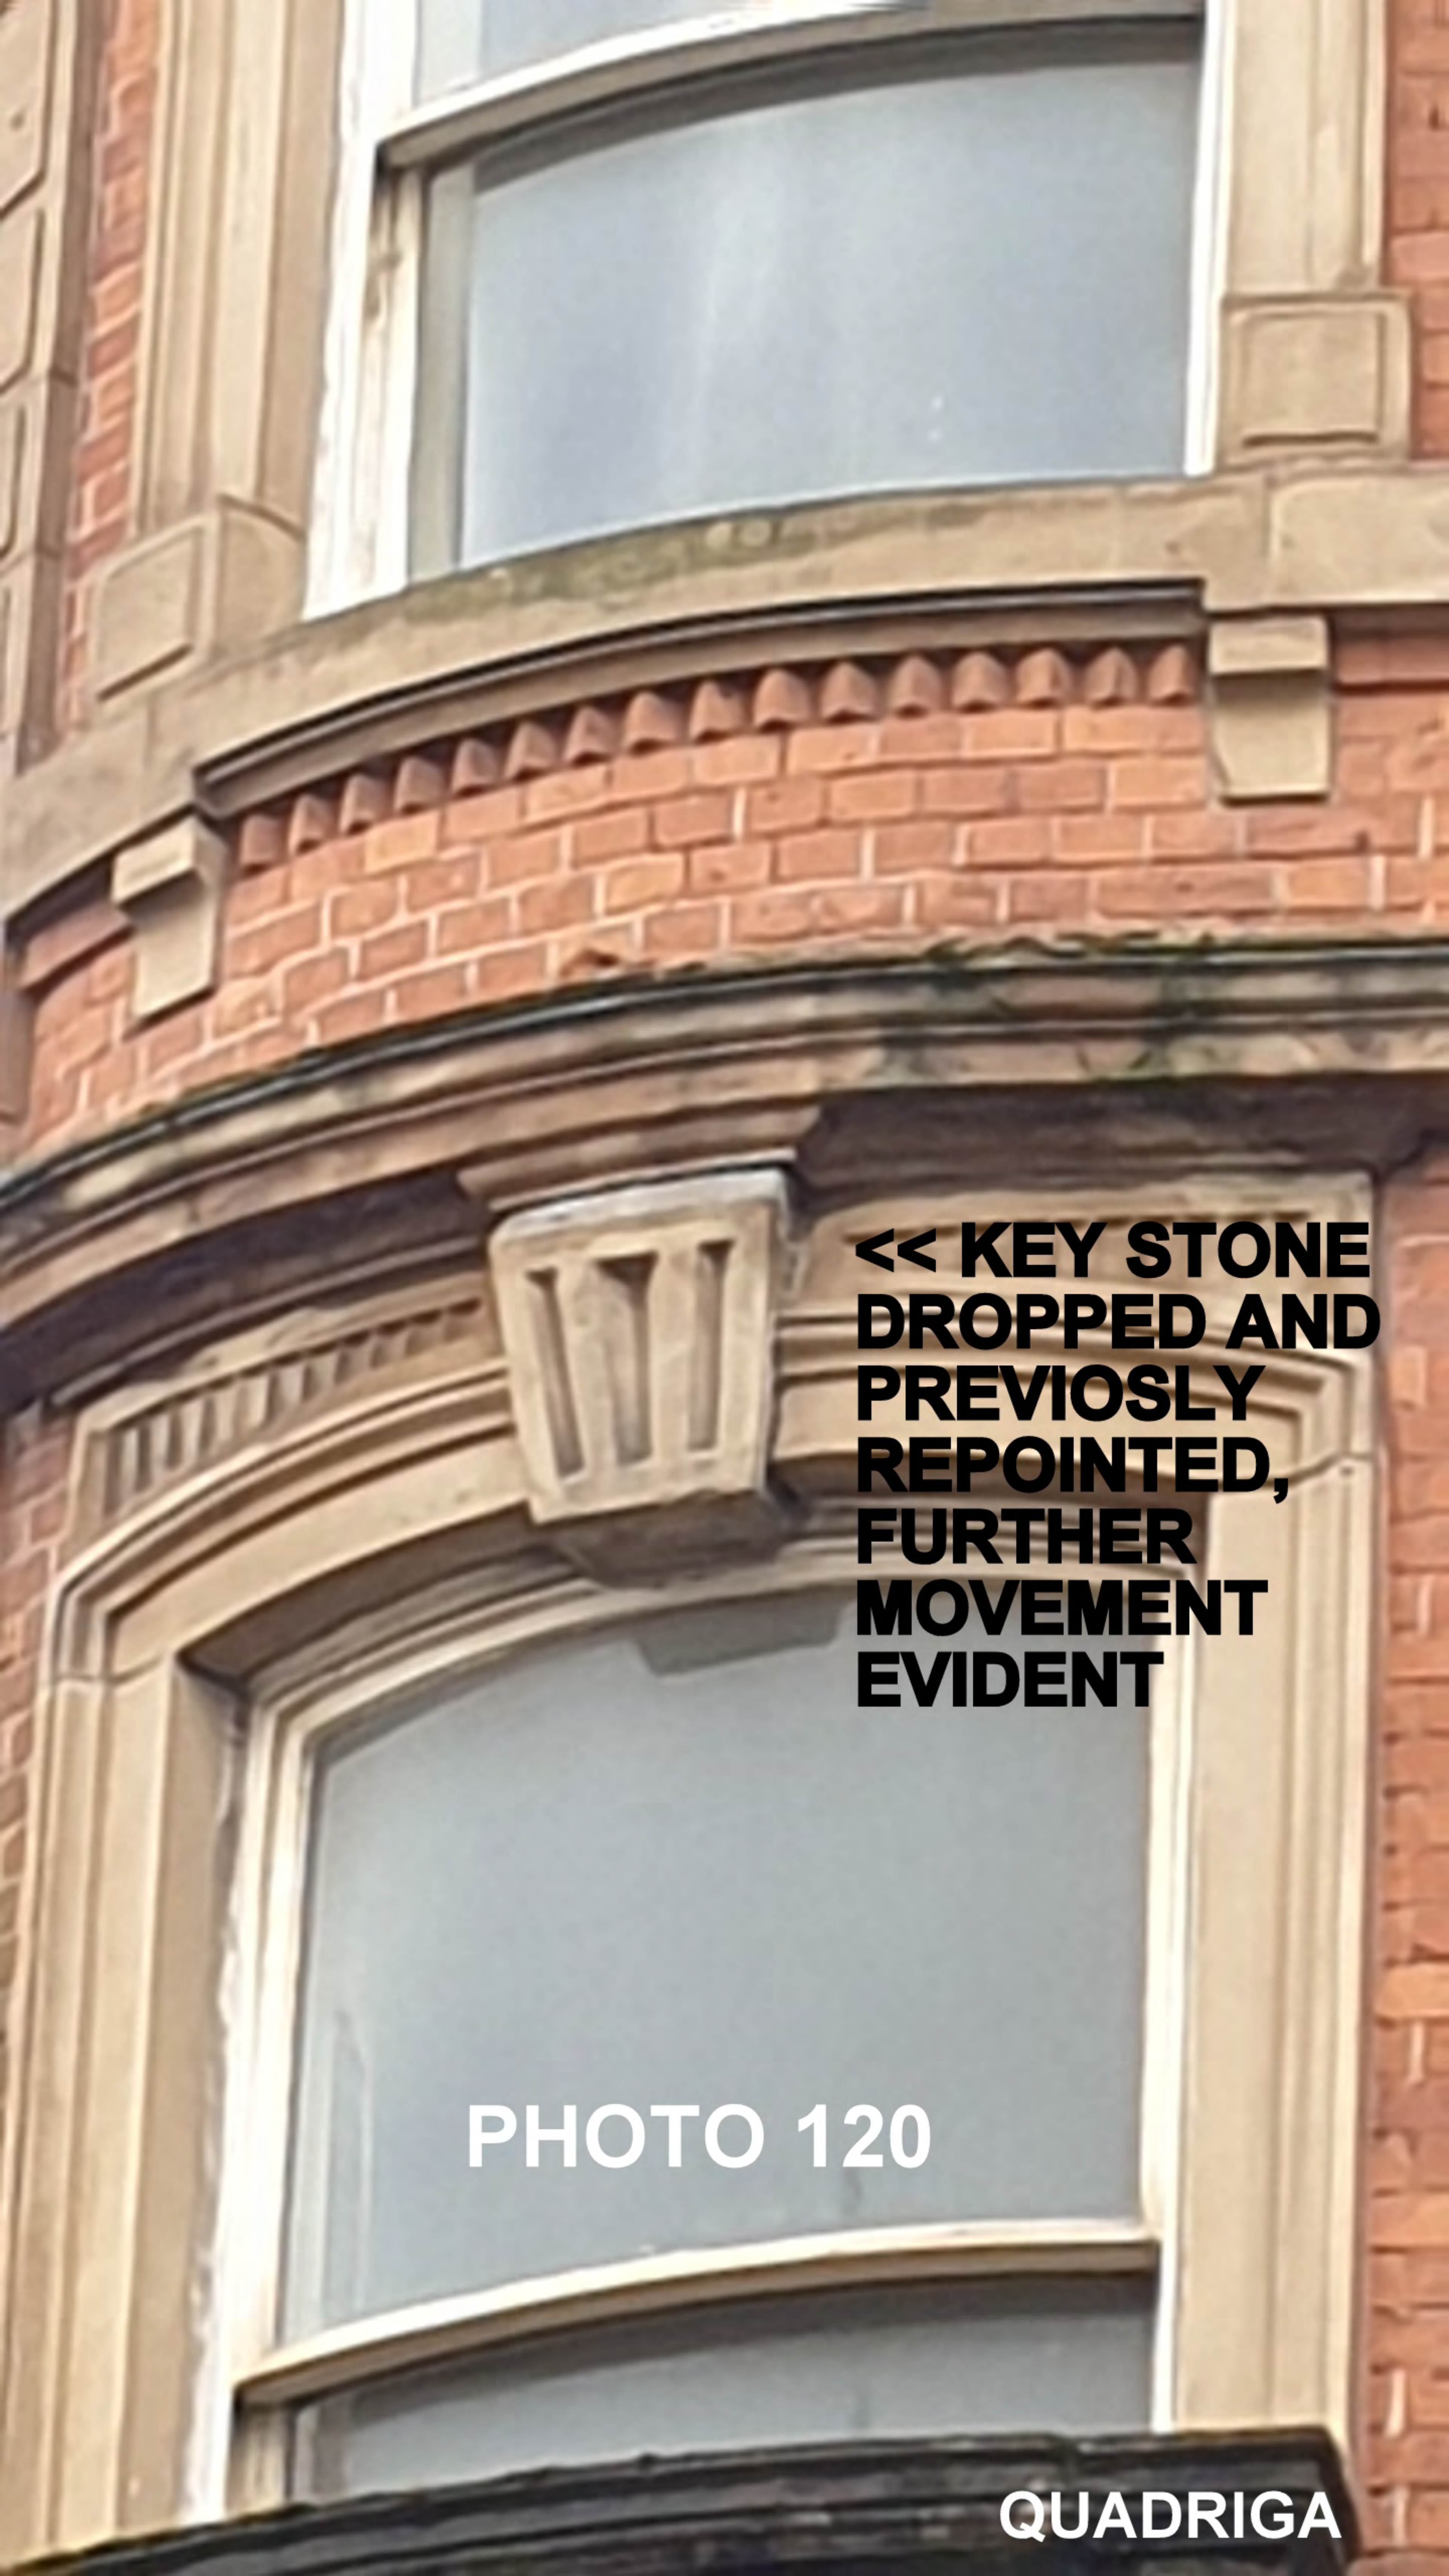
**PHOTO 120**

**<< KEY STONE  
DROPPED AND  
PREVIOUSLY  
REPOINTED,  
FURTHER  
MOVEMENT  
EVIDENT**

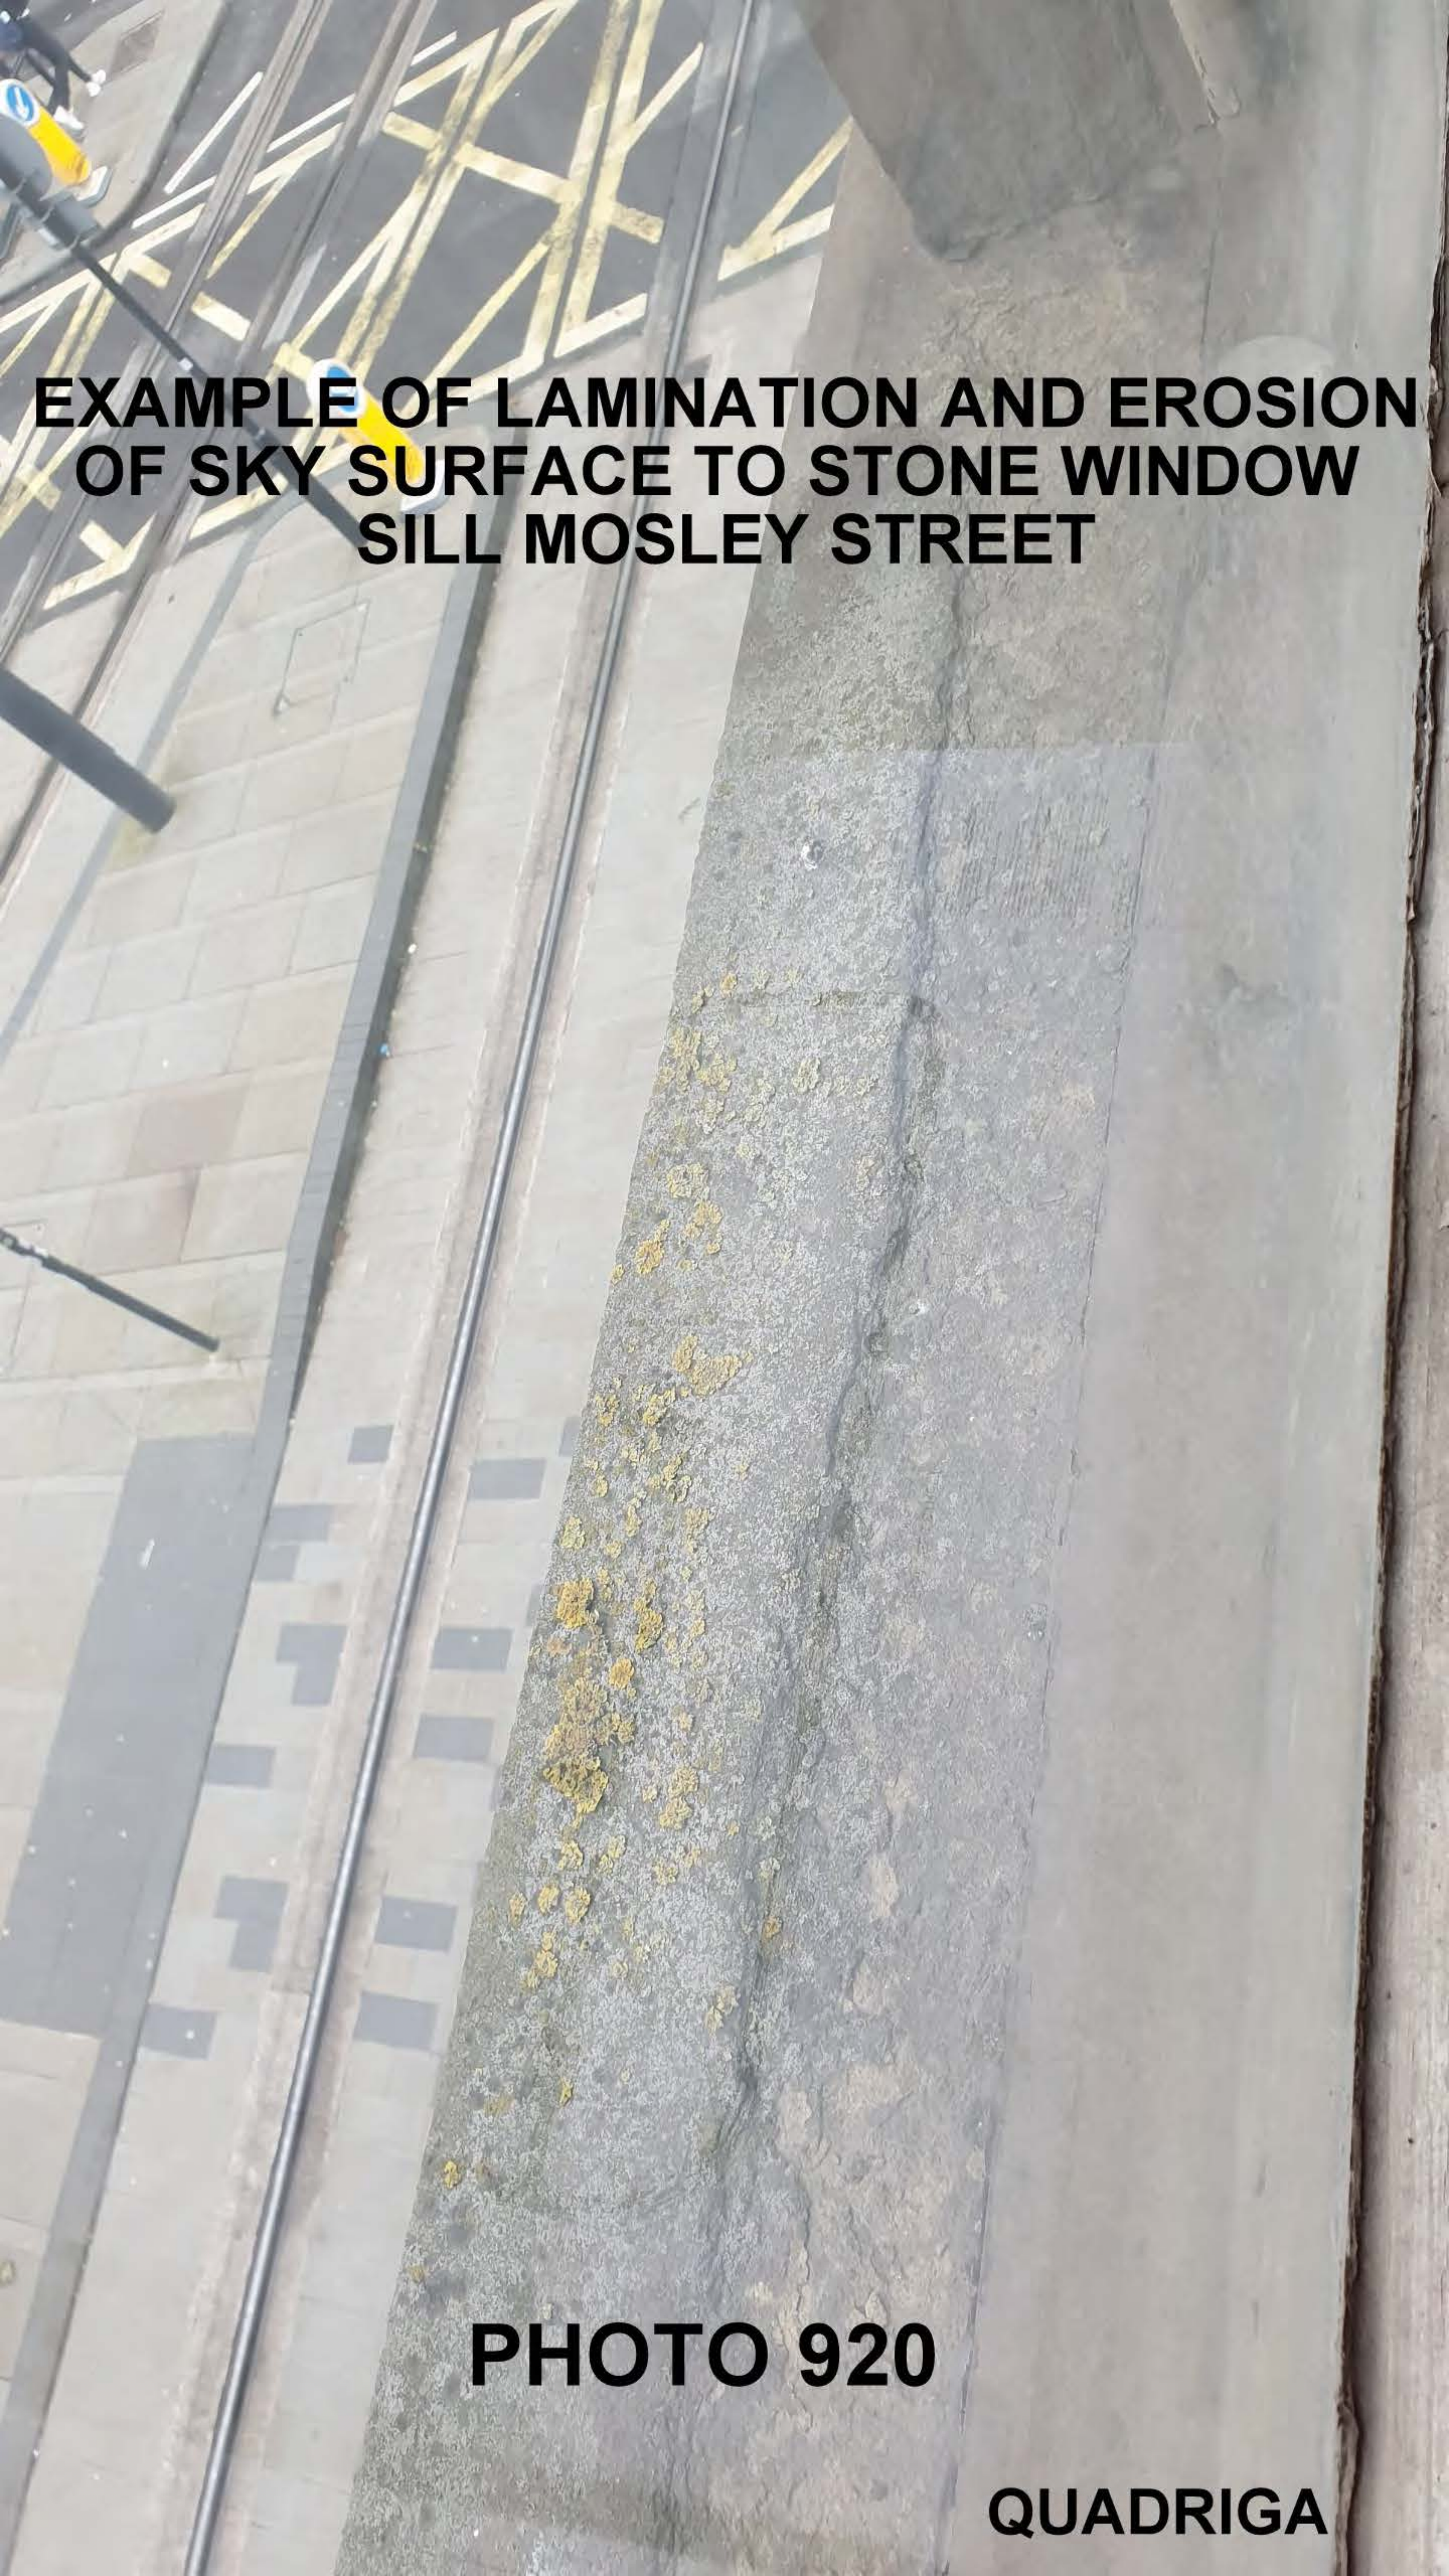
**PHOTO 920**

2.2.7 Areas of heavier surface decay to the stonework where water run off could be affected have been considered for insitu mortar repairs. (common location sky surfaces to window sills).

**EXAMPLE OF LAMINATION AND EROSION  
OF SKY SURFACE TO STONE WINDOW  
SILL MOSLEY STREET**

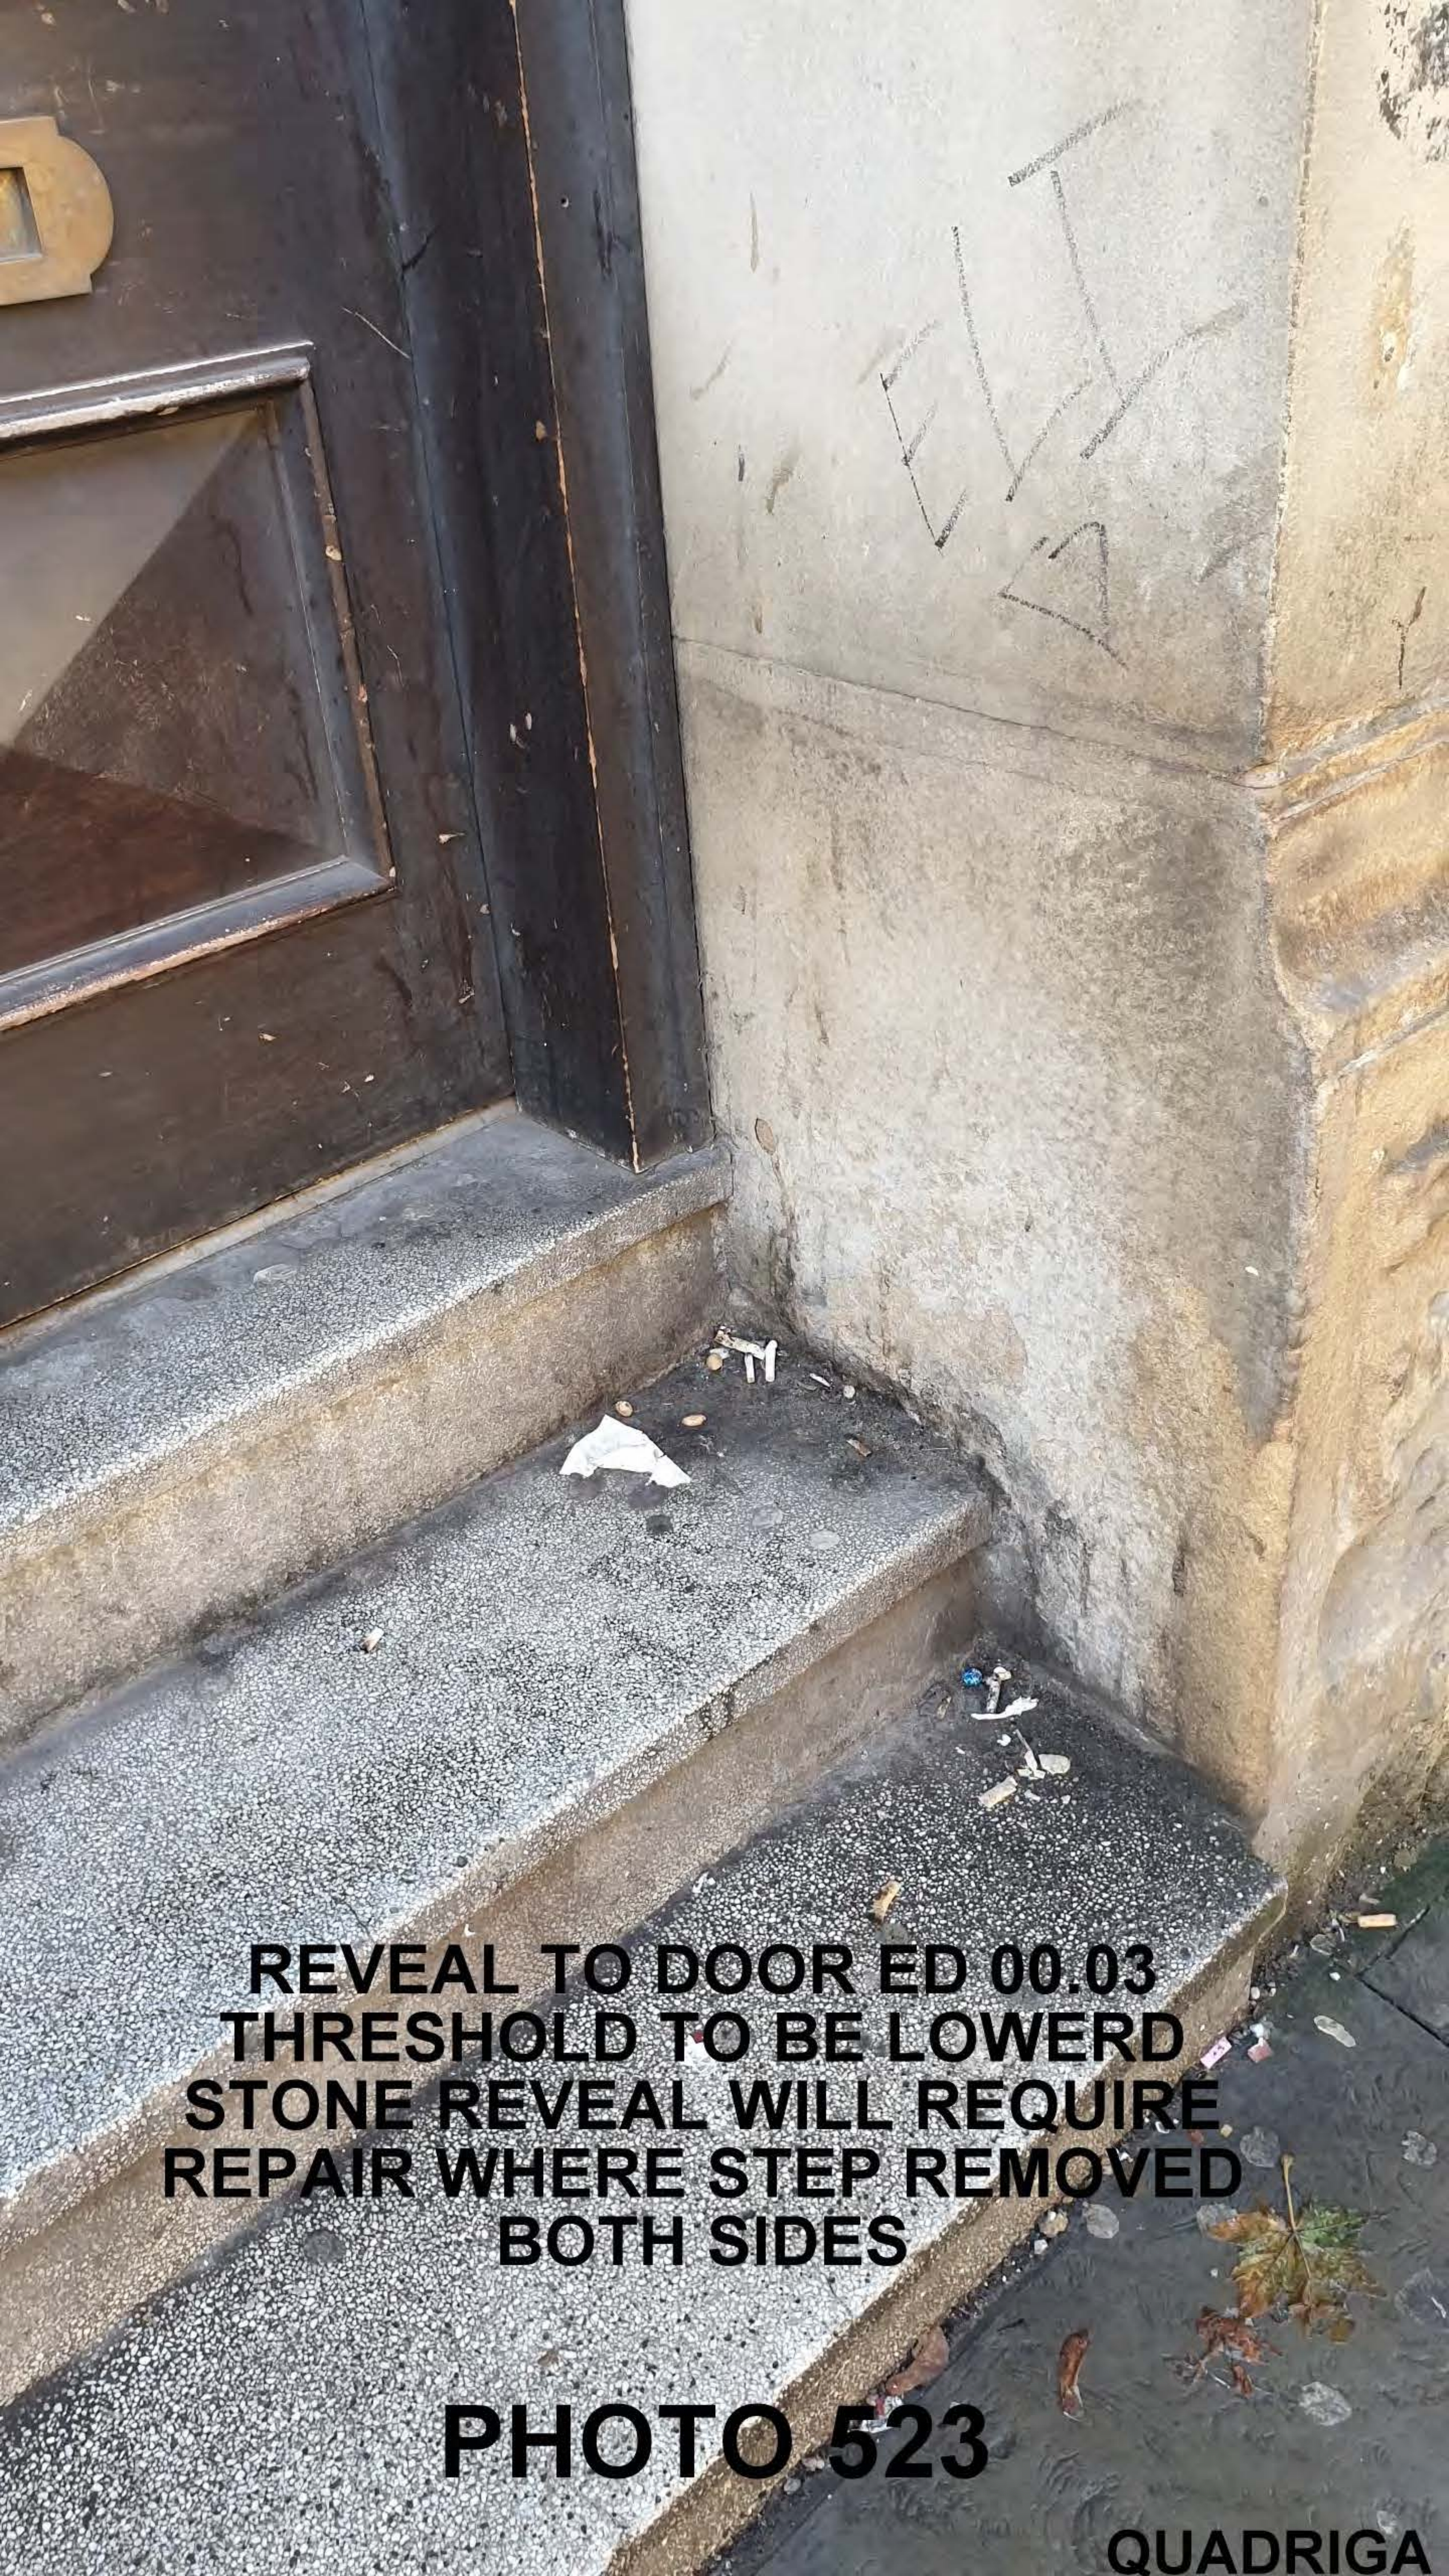
**PHOTO 523**

**REVEAL TO DOOR ED 00.03  
THRESHOLD TO BE LOWERD  
STONE REVEAL WILL REQUIRE  
REPAIR WHERE STEP REMOVED  
BOTH SIDES**

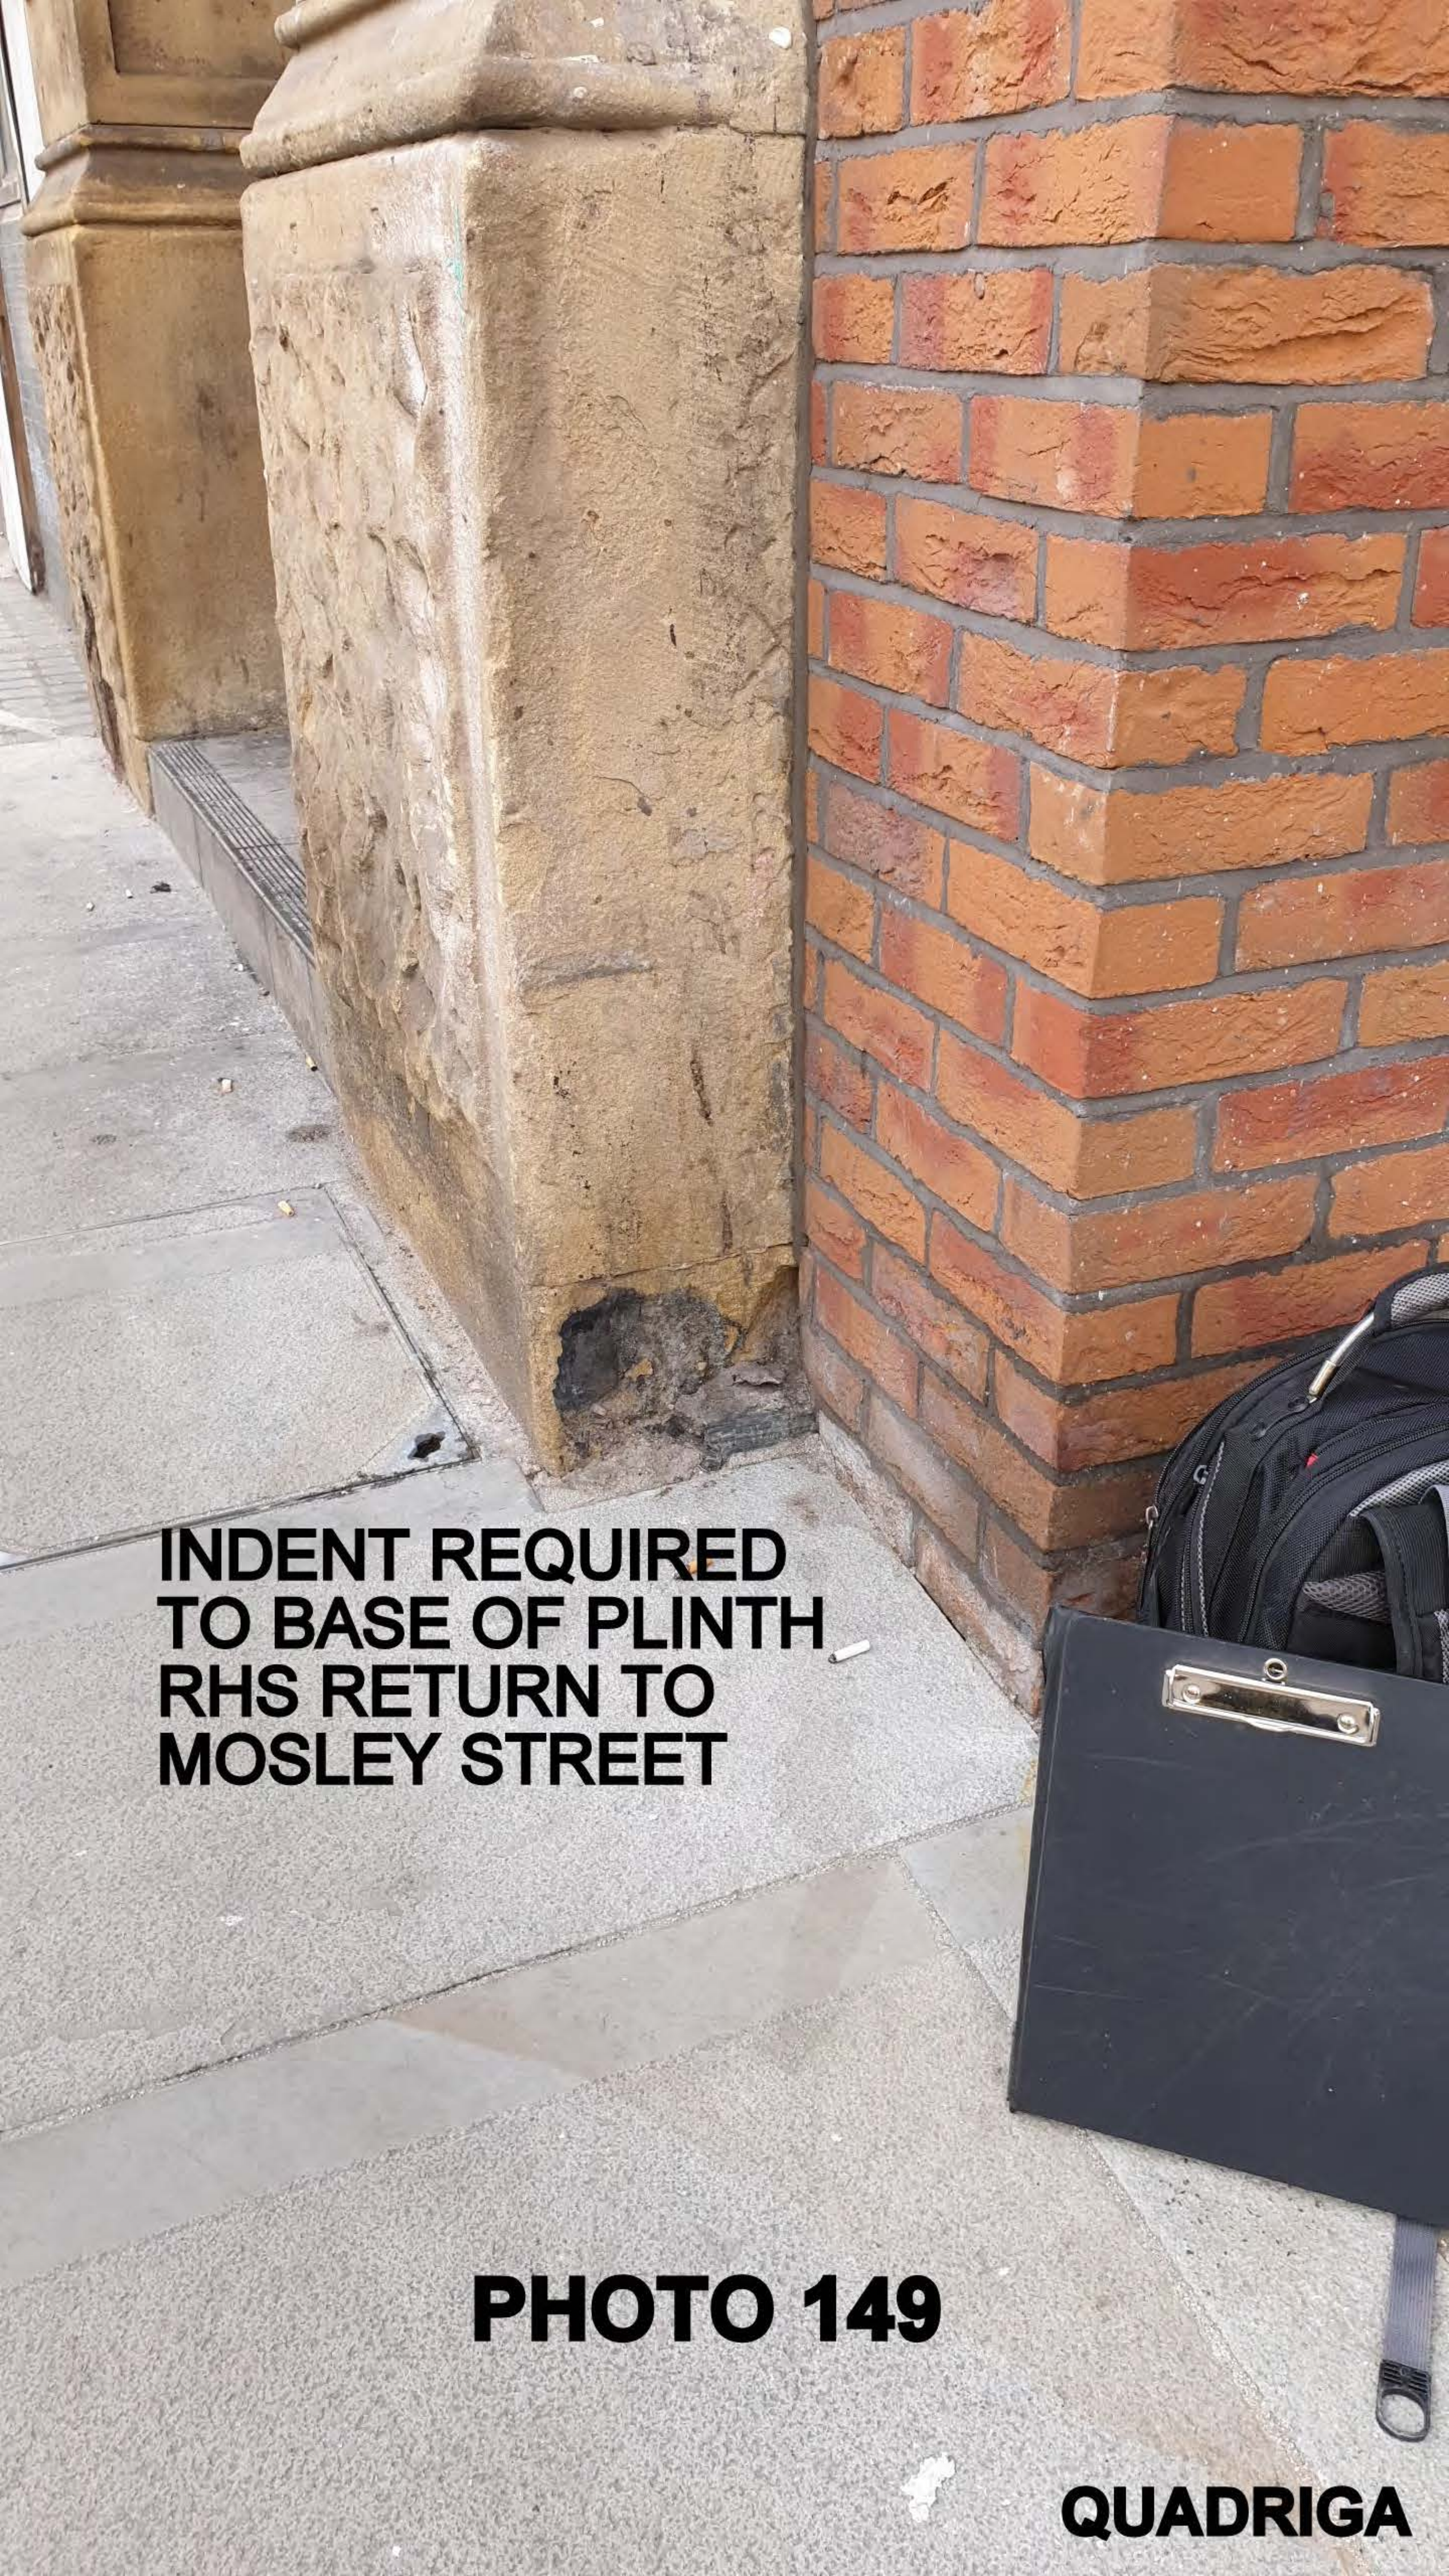
**PHOTO 149**

**INDENT REQUIRED  
TO BASE OF PLINTH  
RHS RETURN TO  
MOSLEY STREET**

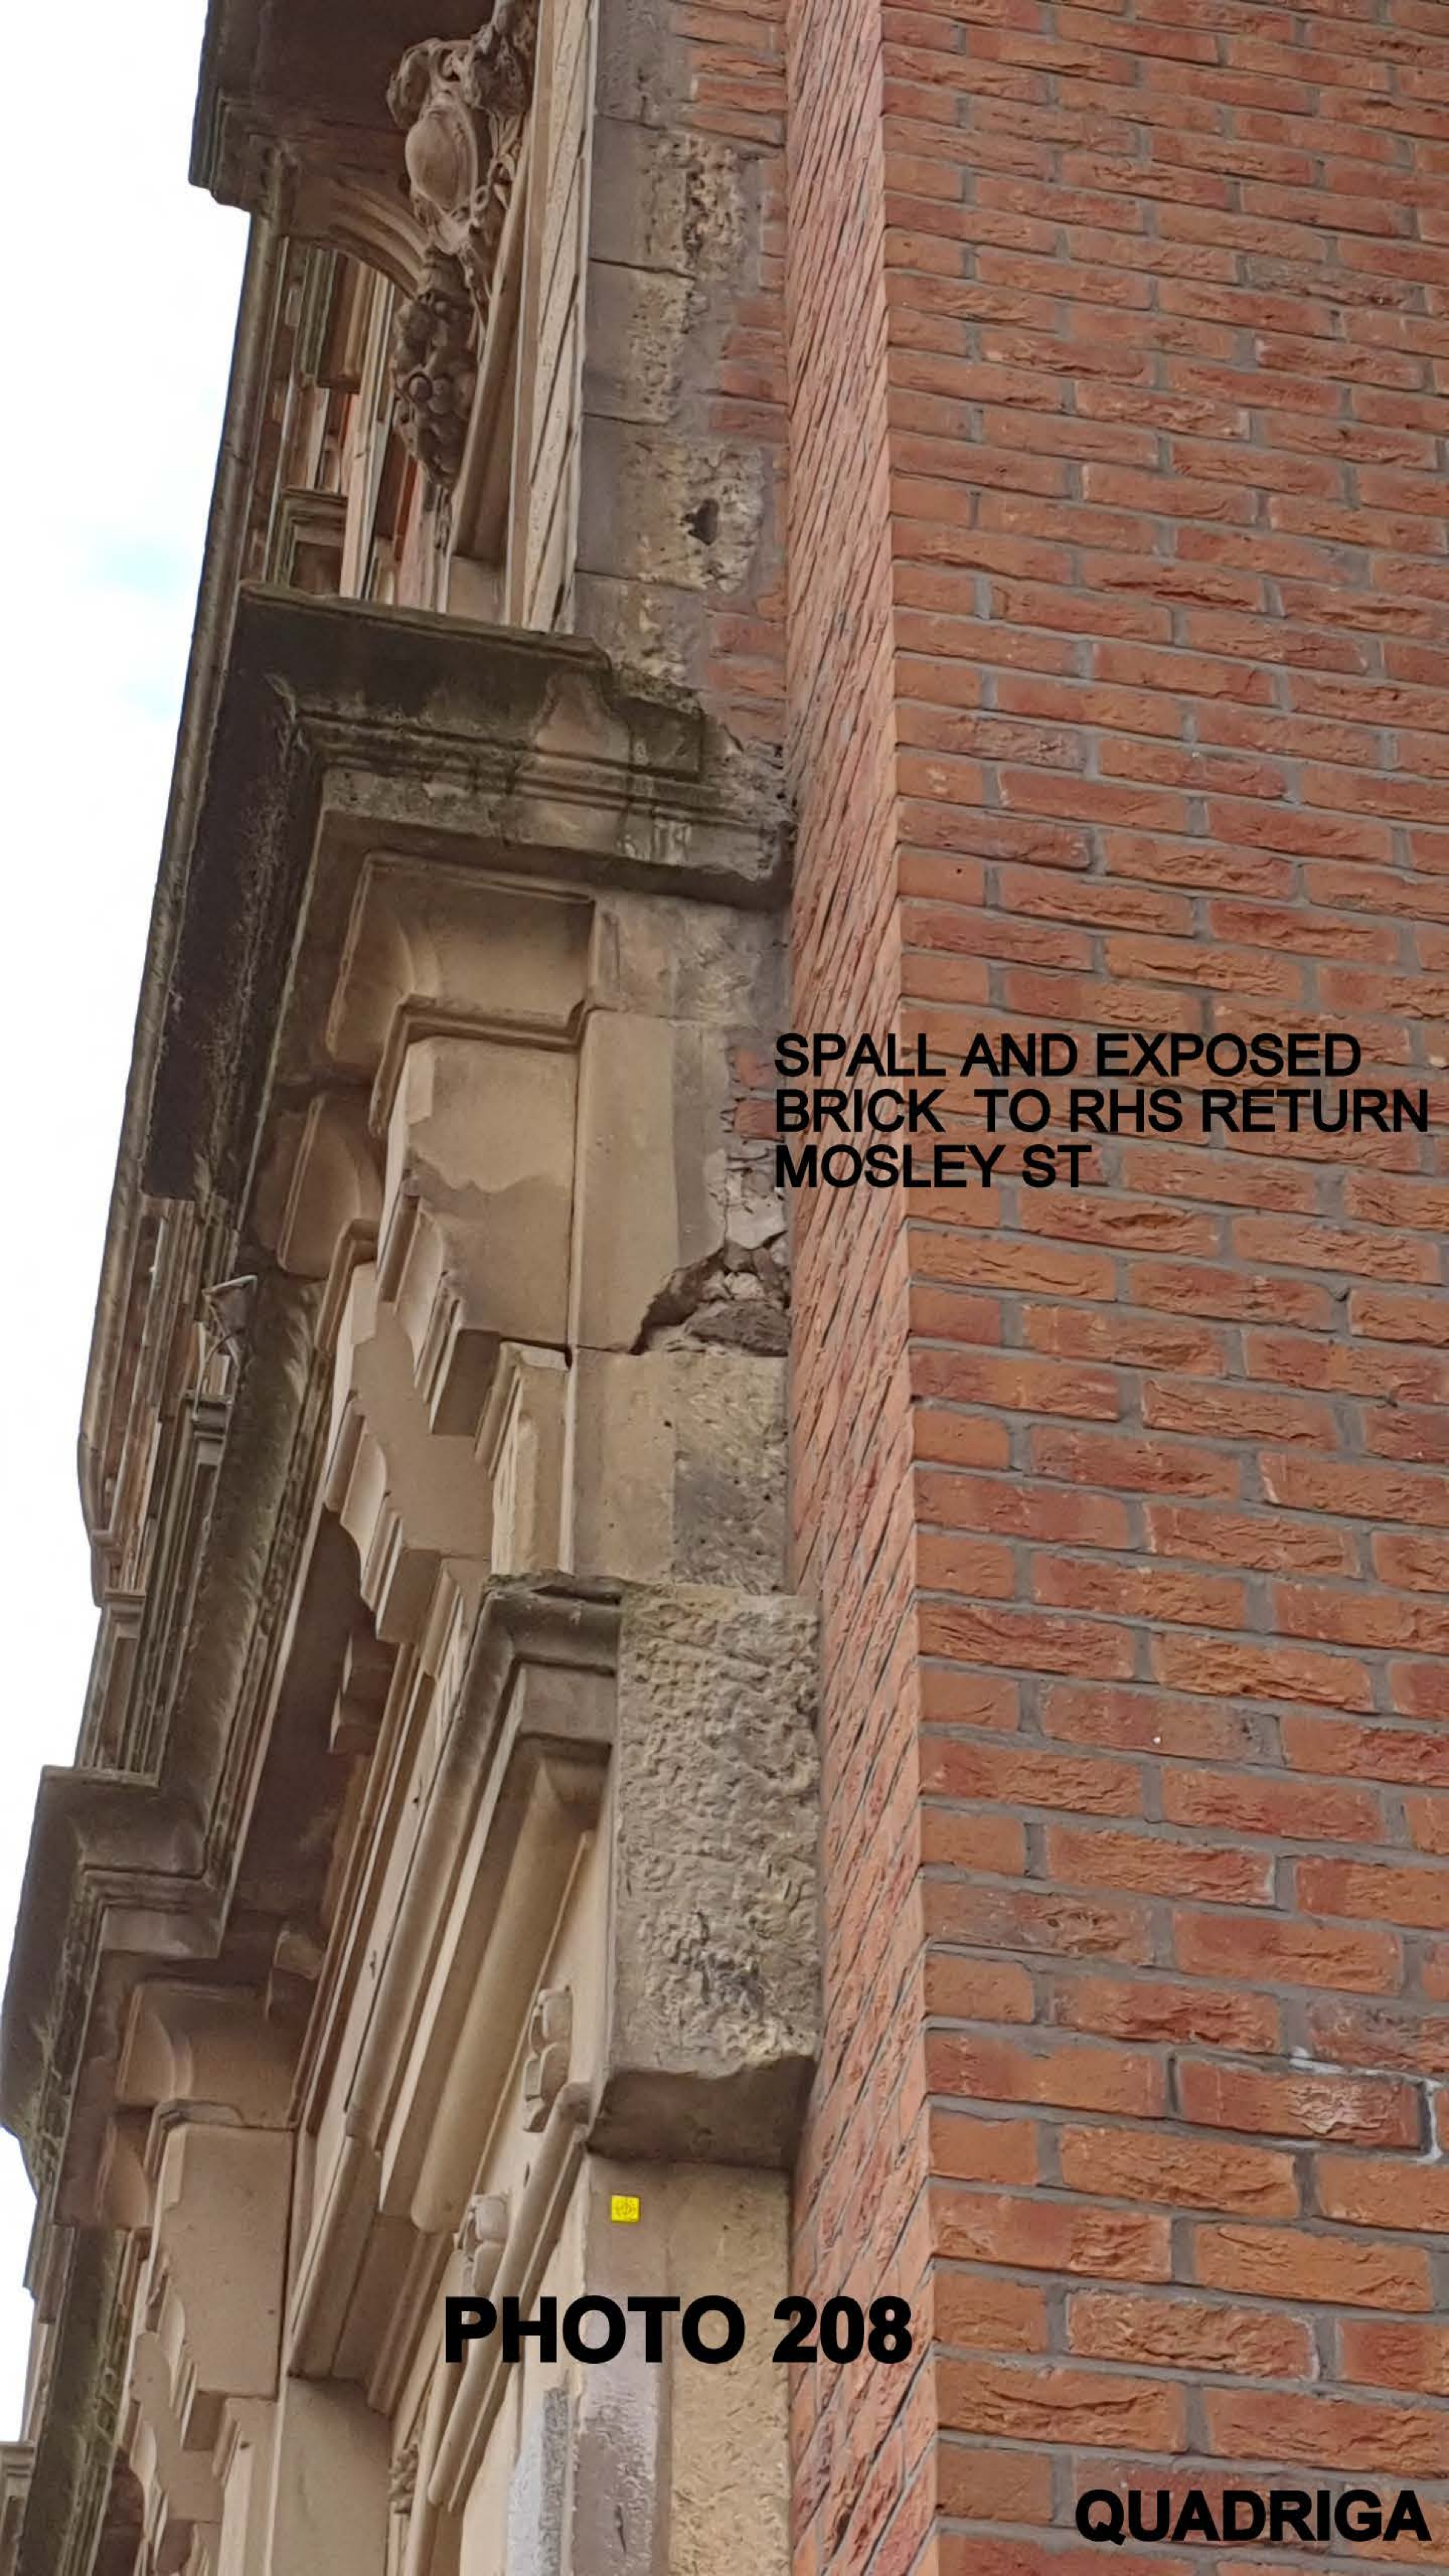
**PHOTO 208**

**SPALL AND EXPOSED  
BRICK TO RHS RETURN  
MOSLEY ST**

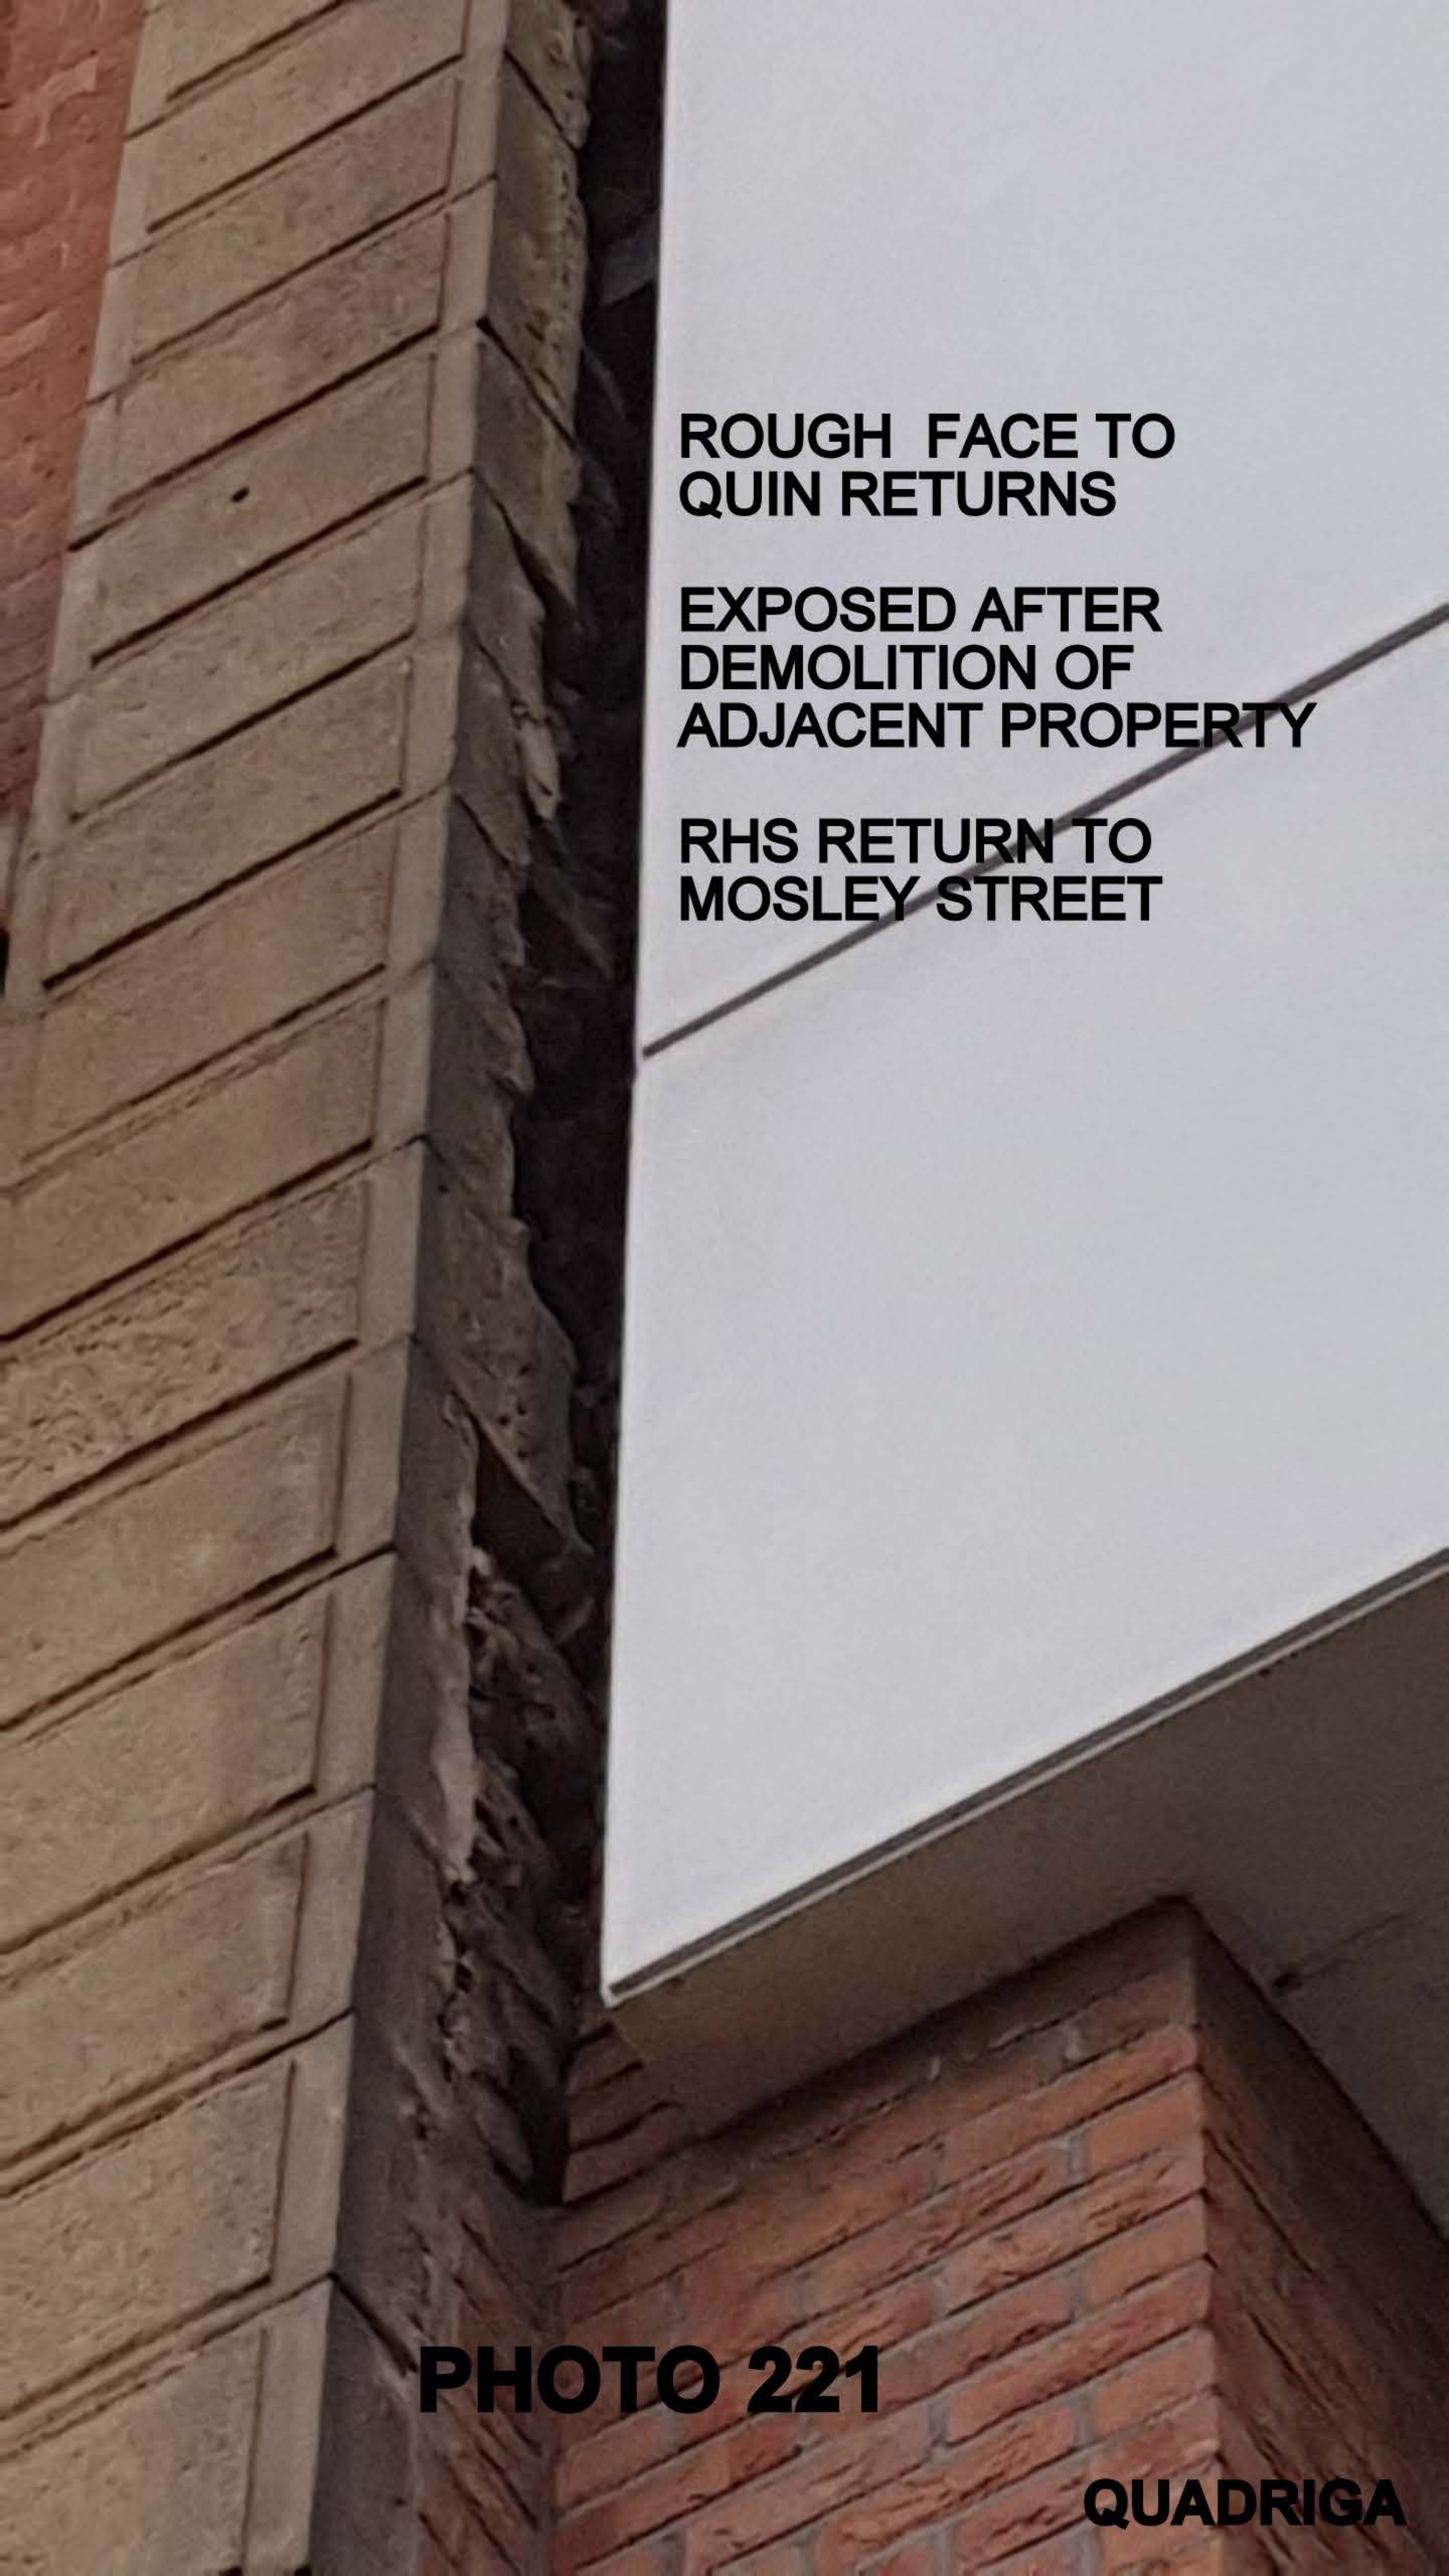
PHOTO 610

**ROUGH FACE TO  
QUIN RETURNS**

**EXPOSED AFTER  
DEMOLITION OF  
ADJACENT PROPERTY**
