# Paint Inspection Report

| Project Name | REAR GABLES GMEX CENTRE | Project No. | 2197 |
| Location | MANCHESTER | Date | 05/12/2016 ( mon) |
| Client Name | GMEX | Inspector | W.JOHNSON |

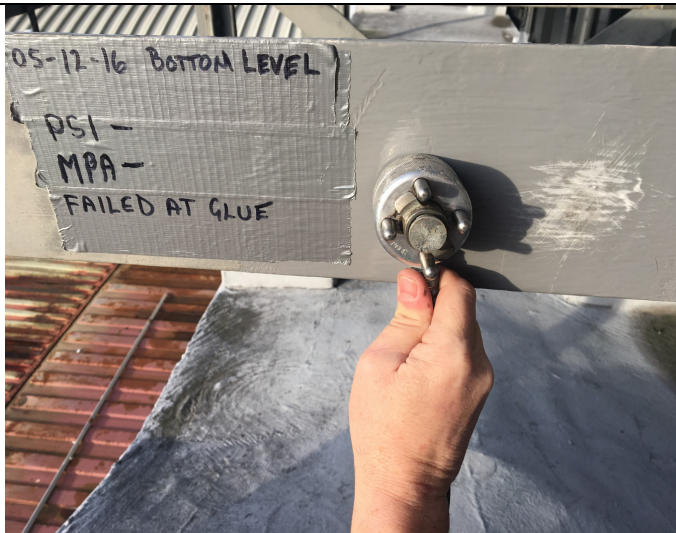
| DRY FILM THICKNESS REPORT | | | | ACTION TAKEN IN THE RESULT OF INSPECTION FAILURE | | |
|---|---|---|---|---|---|---|
| Min (µm) | | | Kit No. | | one section failed to produce a value due to glue failure | none |

failed at glue (no result obtained)

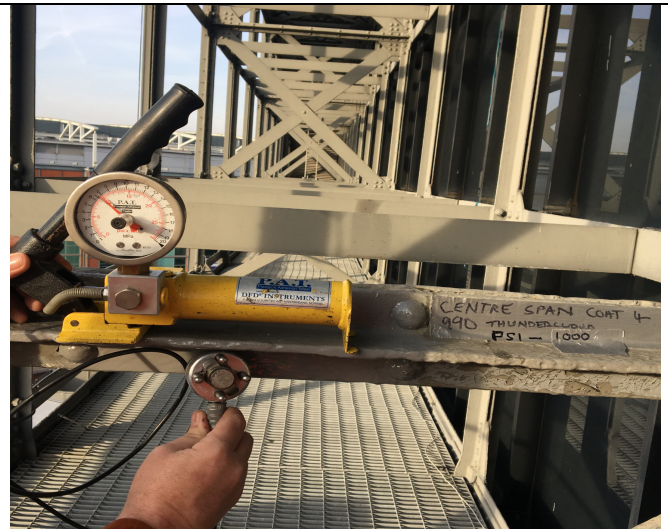
failed at 1000 psi

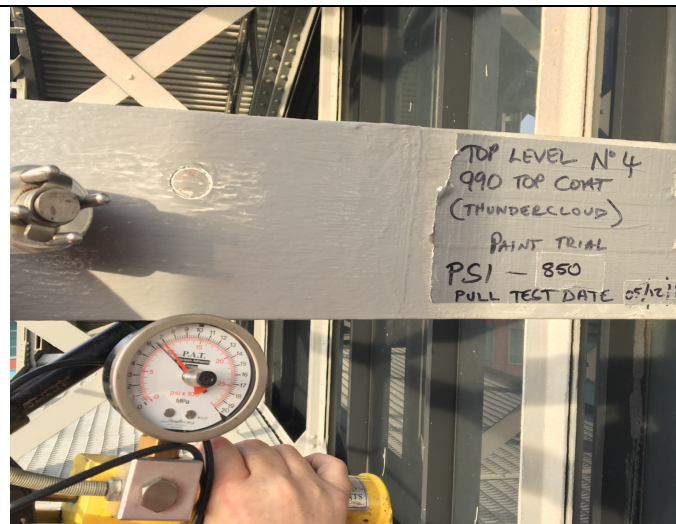
Failed at 850 psi

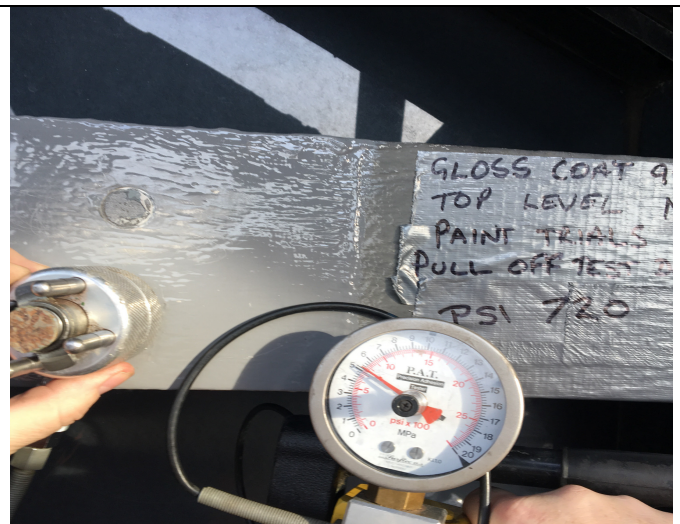
Failed at 720 psi.
