**18/18a KINGSLEY ROAD,  
WYTHENSHAW, MANCHESTER**

**PRELIMINARY BAT ROOST  
ASSESSMENT**

Report No: RT-MME-128973

Date: November 2018

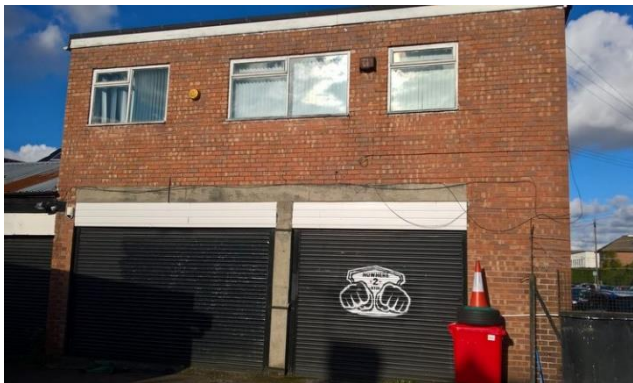
To the south east was a two-storey flat roofed section (Plate 1) with a corrugated pitched roof section immediately adjoined this to the west (Plate 2). Four large metal shutter doors spanned the length of both of these sections, and the first floor of the flat roofed section had windows which were well-sealed (Plate 3). Some gaps were identified underneath the wooden fascias on the southern side of the two-storey section, but they were too high to be fully inspected. They were observed using binoculars and a torch and although no evidence of bat ingress was recorded they were found to be clear of cobwebs.

**Plate 1: Flat Roofed, Two-Storey Section to the South-east.**

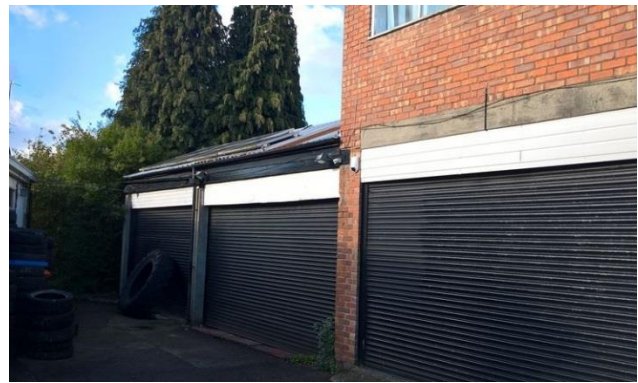
**Plate 2: Corrugated Pitched Roof Section to the South-west with Metal Shutter Doors.**

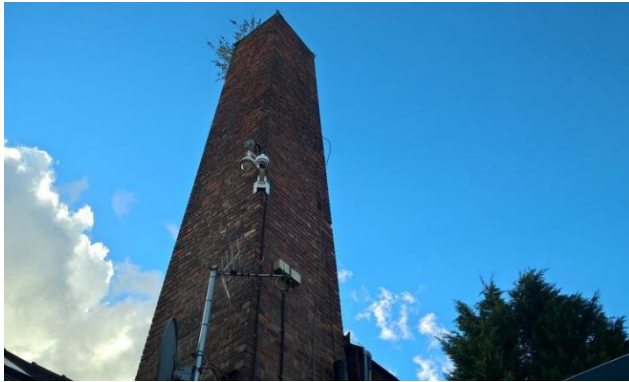
**Plate 11: The Tall Chimney with Crumbling Brickwork to the North.**

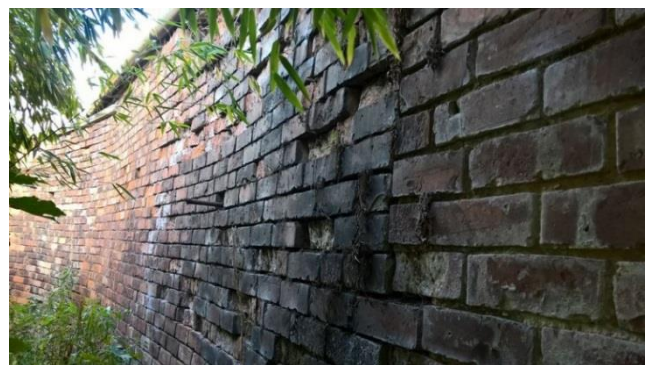
The western side of Building 1 ran very close to the fences of the adjacent residential gardens and some scrub vegetation was present (Plate 4), meaning that a visual assessment of the roof on this side could not be undertaken. Missing fascia/soffit boards were noted close to the southern end. A brick wall ran along the northern end of the western boundary and crumbling brickwork was noted within the wall approximately half way along its length (Plate 5), some of which was cobwebbed. Where the brickwork was crumbling, gaps were also noted underneath the coping stones along the wall top, which provided a potential roosting feature for bats.

**Plate 5: Missing/Degraded Brickwork on the Western Side of the Building**

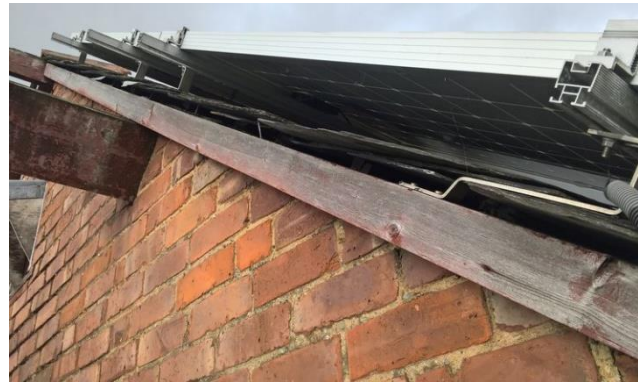
**Plate 13: Gaps at the Eaves of Central Office Section**

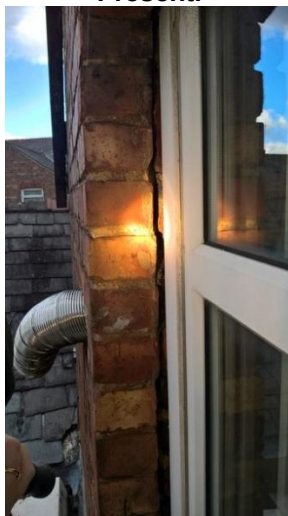
**Plate 14: Gaps Around the Central Office Window (Southern Elevation).**

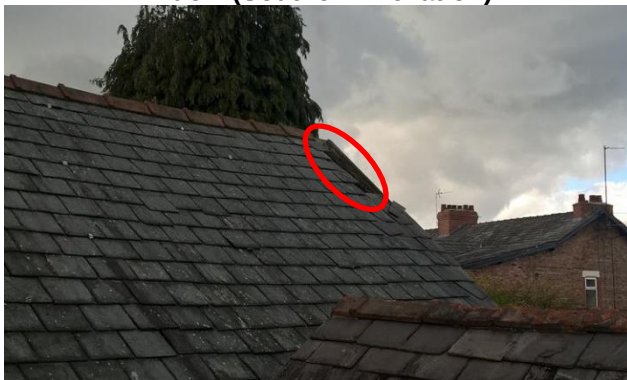
**Plate 16: Hole in North-west Corner of Sewing Workshop Roof.**

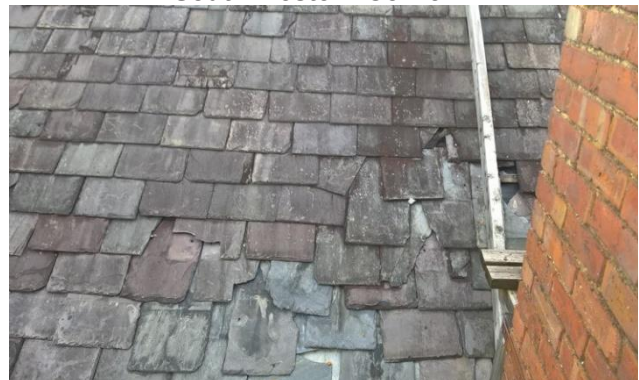
The sewing workshop to the south-west appeared to be of similar construction to the central office, but the exterior could only be seen from a northern aspect. Although the roof tiles were generally in good condition along the northern elevation of the sewing room, a large hole was noted in the roof (where tiles were missing) towards the north-western corner (Plate 16). The long section of the building along the western side could only be seen from the eastern elevation, and once again, a number of the slate tiles here had slipped (Plate 17), and gaps were noted beneath the ridge tiles.

**Plate 17: Slipped Slate Tiles on Eastern Elevation of Western-most Roof Section.**

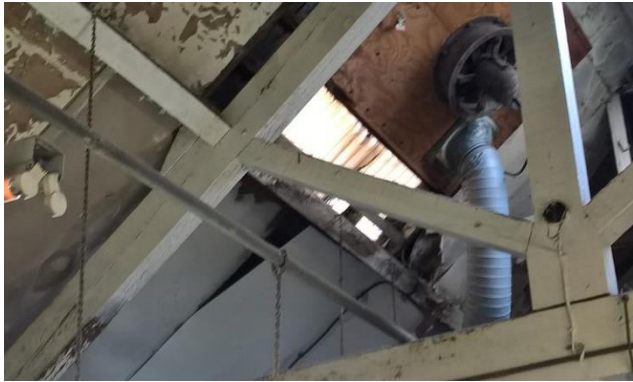
**Plate 22: Lifted Ceiling Boards and Plastic Sheeting.**

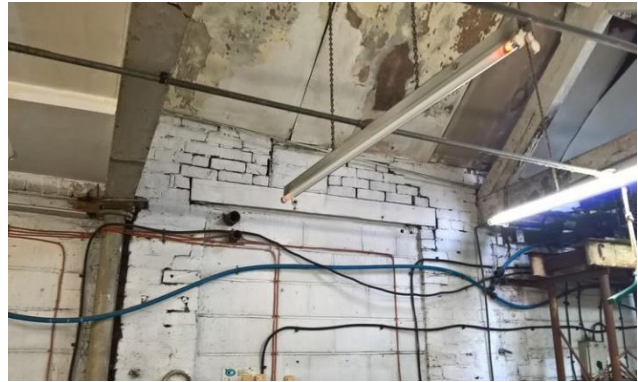
**Plate 23: Gaps in Brickwork**

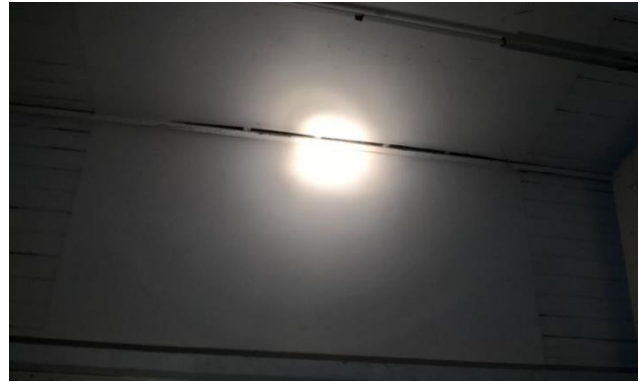
**Plate 29: Gaps Recorded at the Roof Apex.**

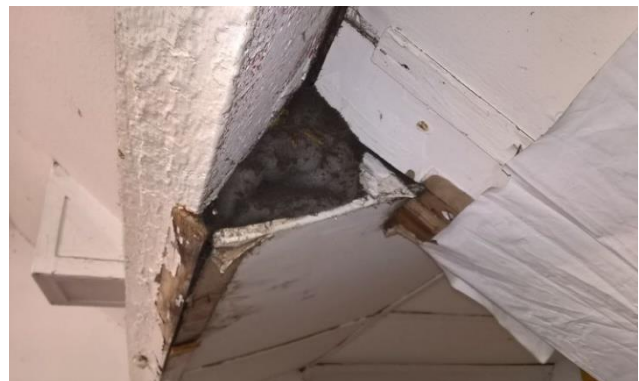
A sewing room was present on the first-floor above the storage area to the south-west of the building. This was open to the loft space and the ceiling was lined with wooden boarding (Plate 31), with skylights installed to the south of the room. The walls and wooden boarding was generally in good condition but there was some exposed insulation to the south (Plate 32).

**Plate 32: The Exposed Insulation to the South-east of the Sewing Room.**

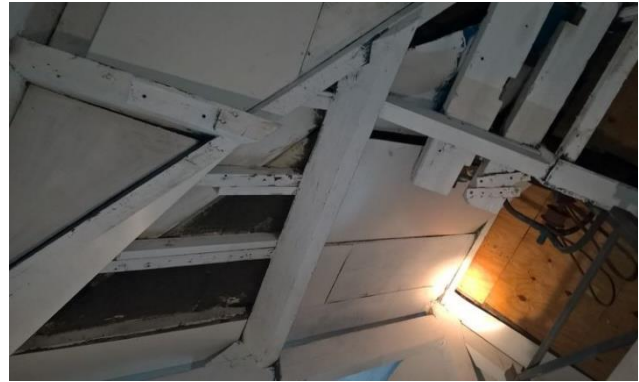
**Plate 34: The Wooden Boards which were Intact but Lifting.**

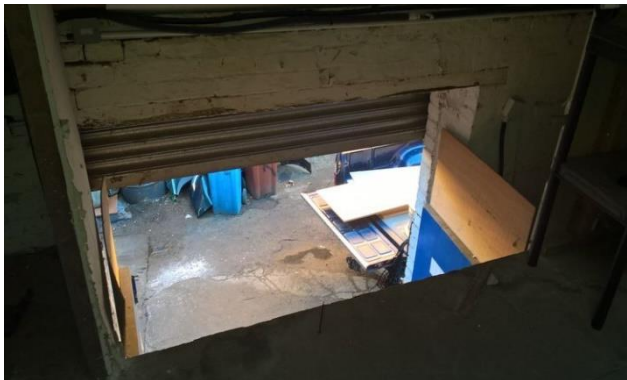
A workshop was present towards the centre and north of the building, and this had two-storeys. On the ground floor the rooms were in use as workshops, offices and a kitchen, all of which were well-sealed. The whole first floor area above the workshop was used as storage space with wooden boards and beams lining the roof (Plate 33). The wooden boards were generally intact, but some were lifting (Plate 34). The ridge and brickwork were largely cobwebbed but light could be seen through the ridge gaps suggesting potential access points were present. A mezzanine was present at the northern end of this storage area which had a large gap leading down to the ground floor/adjacent yard, used as a loading bay (Plate 35).

**Plate 35: Large Gap in the Mezzanine Leading to the Ground Floor and Northern Yard.**

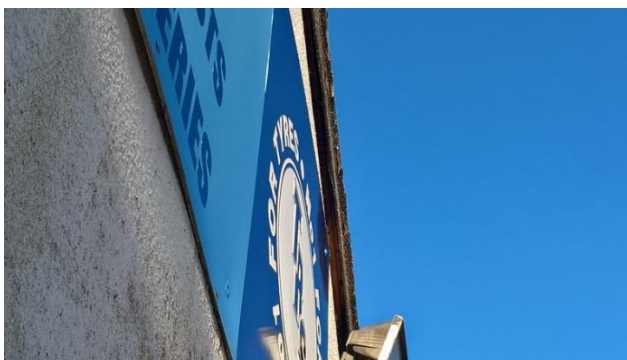
**Plate 41: Gaps Behind Barge Board Eastern Gable End.**

During the field survey, a small gap was noted around the barge board on the eastern elevation of the building, which could not be fully inspected, but appeared clear of debris. As the remainder of the building was considered largely unsuitable for bats, the building was determined to have low bat roost potential.

No. 18a Kingsley Road has been identified as having low potential to support roosting bats. Bat Surveys: Good Practice Guidelines, published by the Bat Conservation Trust (Collins, 2016), recommends for structures with low bat roosting potential that at least one survey (consisting of either a dusk emergence survey or a dawn re-entry survey) be undertaken during the peak season for emergence/re-entry surveys (May to August) to determine the presence/absence of roosting bats within the structure. Should this survey confirm the presence of roosting bats, it will be necessary to undertake additional surveys in order to inform a Natural England licence application. In addition, should the survey identify the presence of significant levels of bat activity at the site, it may be necessary to undertake further survey visits to comprehensively assess the value of the site to bats.

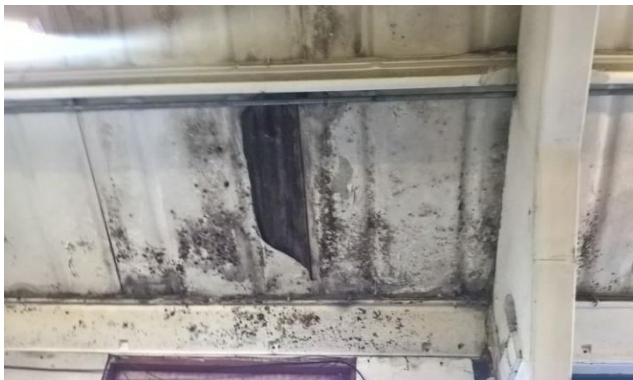
**Plate 43: Concrete Composite Coating Peeling Away from the Corrugated Metal Roof**

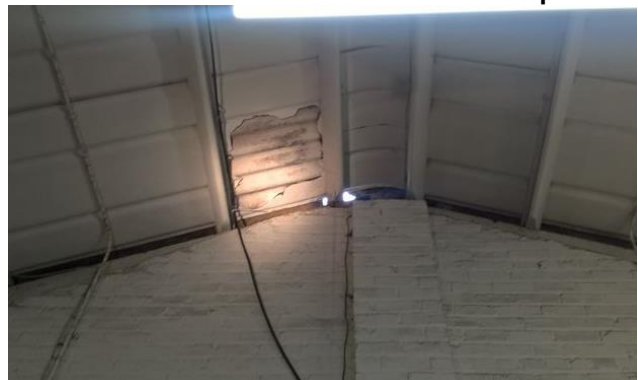
**Plate 44: Peeling Concrete Composite Coating and Gaps at the Western Gable End**
