# PLOT VERIFICATION REPORT

## Environmental Cover System Validation

| <b>Site Name</b> | Levenshulme Road, Gorton | | |
| <b>Plot Number</b> | 4 | <b>Inspected By</b> | FP / JW |

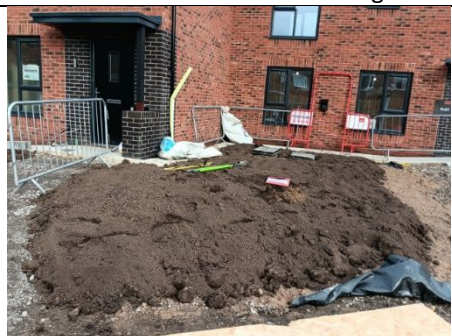
| View of front garden. | View of membrane and soil in capping layer excavation in front garden area. | Depth measurement of the capping layer in front garden (c.450mm). |

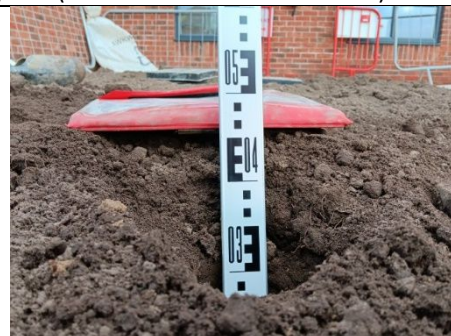
| Location | Topsoil Depth (mm) | Subsoil Depth (mm) | Membrane | Total Depth (mm) | Required Depth (mm) | Pass (✓) or Fail (x) |
|---|---|---|---|---|---|---|
| Front | 200 | 250 | Yes | 450* | 600 | ✓* |

Note: \*Due to the presence of services the full 600mm capping layer could not be achieved in the front garden. LKC consider that as the services are backfilled with pea gravel, 450mm of topsoil and subsoil placed over a geotextile membrane is sufficient given the small size and anticipated minimal use of this strip of landscaping.

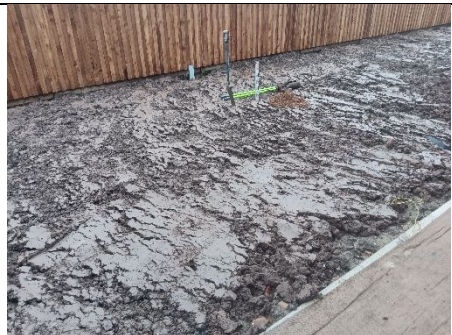
| View of rear garden. | View of membrane and soil in capping layer excavation in rear garden area. | Depth measurement of the capping layer in rear garden (c.600mm). |

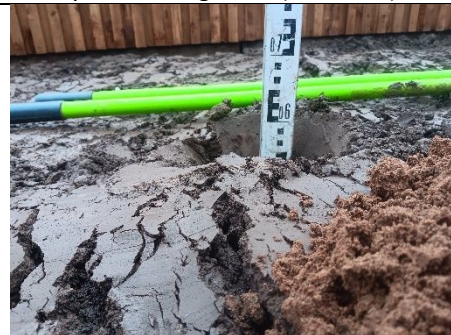
| Location | Topsoil Depth (mm) | Subsoil Depth (mm) | Membrane | Total Depth (mm) | Required Depth (mm) | Pass (✓) or Fail (x) |
|---|---|---|---|---|---|---|
| Rear | 200 | 400 | Yes | 600 | 600 | ✓ |
