## Lock 87, Rochdale Canal Design & Access

# Lock 87, Rochdale Canal

## Design & Access

This statement has been prepared to support the application for listed building consent for works of maintenance at lock 87, a grade II listed building (list entry number: 1247580), on the Rochdale Canal in Manchester.

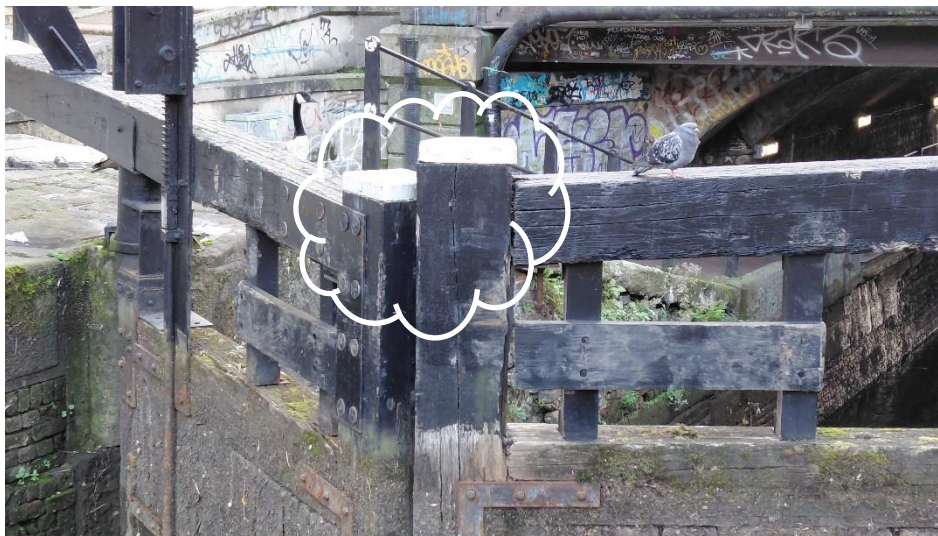
The poor condition is due to progressive decay on several elements of the lock gates (including top bars and the end tenons of the top bars; the heel posts below the collar and at the upper waterline and the balance beam end tenons) and the appearance of shakes on the lower bars, heel posts and balance beams. Decay to the gate planking has caused leakage through the gates and, when the lock gates are under pressure, beneath the gates at the cill.

Figure 2 shows the mismatch in height between the two mitre posts caused by excessive wear of the pot that the left-hand gate is sat in and hinges on and by the gradual loosening of joints despite reinforcement.

*Figure 2 Bottom gates (condition)*

The existing bottom end lock gates are to be replaced with new gates of the same design and material. The new gates will be constructed of oak timber. The replacement is like-for-like.

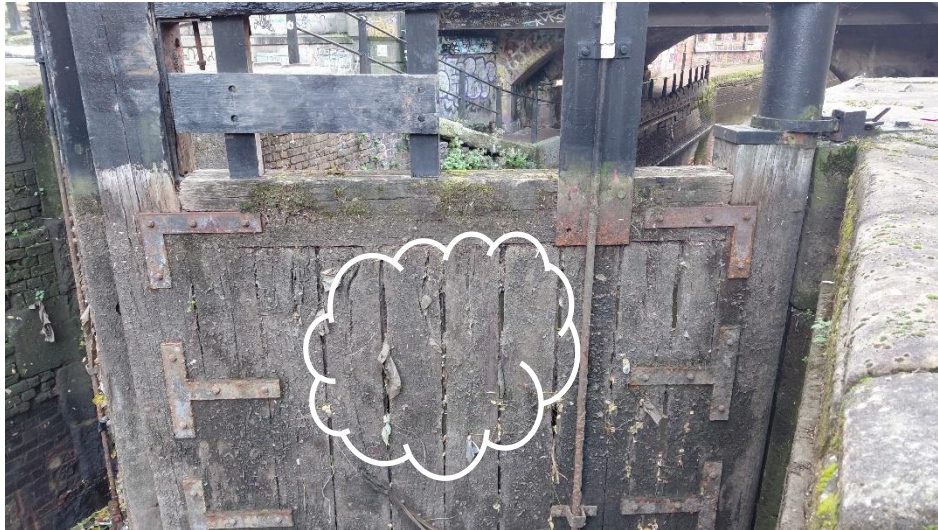
Figure 3 shows decay of the lock gate boards creating gaps between the boards reducing the gates ability to hold water. This condition will allow water to escape through the gate, wasting water and delaying passage for the boater.

*Figure 3 Bottom gates (condition)*

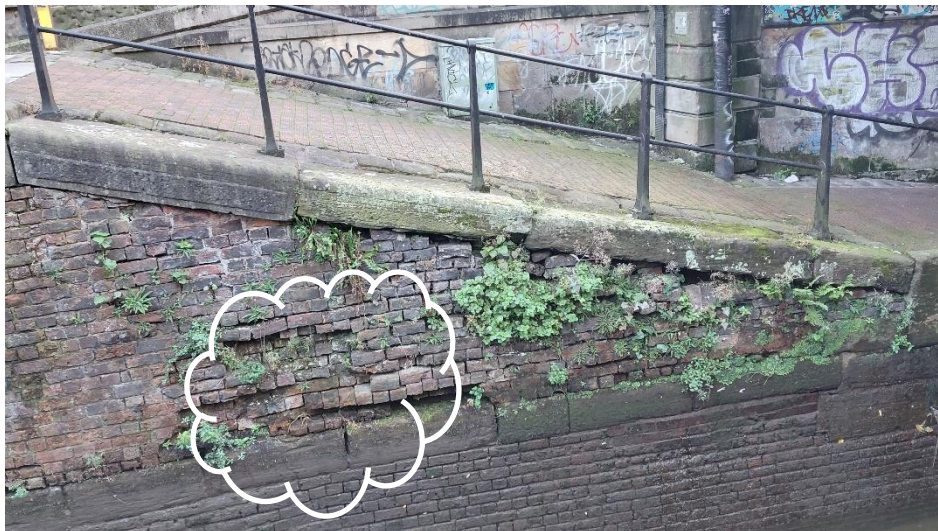
There are areas of missing and unstable brickwork in the lock chamber forebay (the approach to the lock) and in other areas of the lock chamber, including the lock gate recesses. These areas are to be repaired. Figures 4 and 5 illustrate these areas.

*Figure 4 Missing and unstable brickwork (towpath side forebay) to be repaired*

We will recover bricks that are on the canal bed and where their condition allows, we will use them in the repair. The shortfall will be made up with new bricks following the existing coursing and observing the existing bond.

Where new bricks are required it is proposed to use Furness Natural Orange (9" x 3", matching the existing brick dimensions) supplied by Furness Brick & Tile Co Ltd, Askam-in-Furness. This brick has been used on several occasions to repair brick lock chambers in the Manchester area. It was selected following a site visit to Manchester canals by a representative from Furness Brick. A sample can be seen in figure 6.

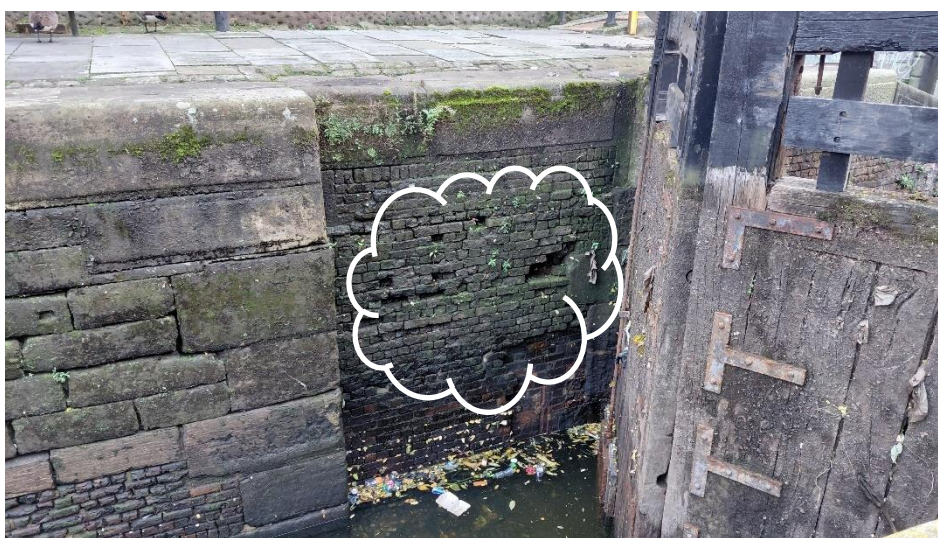
*Figure 5 Missing brickwork (towpath side gate recess) to be repaired*

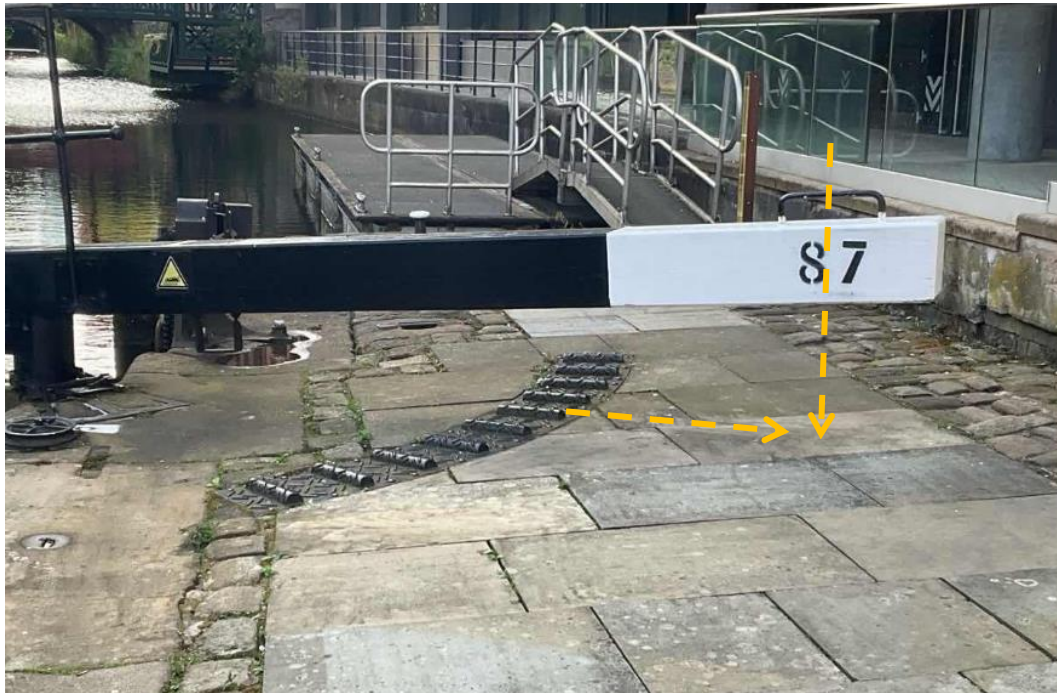
The heel grips on the towpath side at the top of the lock are misaligned with the balance beam of the lock gate. To take full advantage of the lever of the lock gate and to reduce the effort required to operate the lock gate, reducing the likelihood of injury caused by manual handling, the heel grips should be placed at the end of the lock gate balance beam beneath the lock gate handle.

*Figure 7 Heel grips top gate, towpath side to be moved*

The existing heel grip plate will be lifted and moved to the correct position directly beneath the balance beam handle. This will require the heel grip plate to be moved 1100mm to the right. The existing paving slabs, which are not original material, will be lifted and reused.

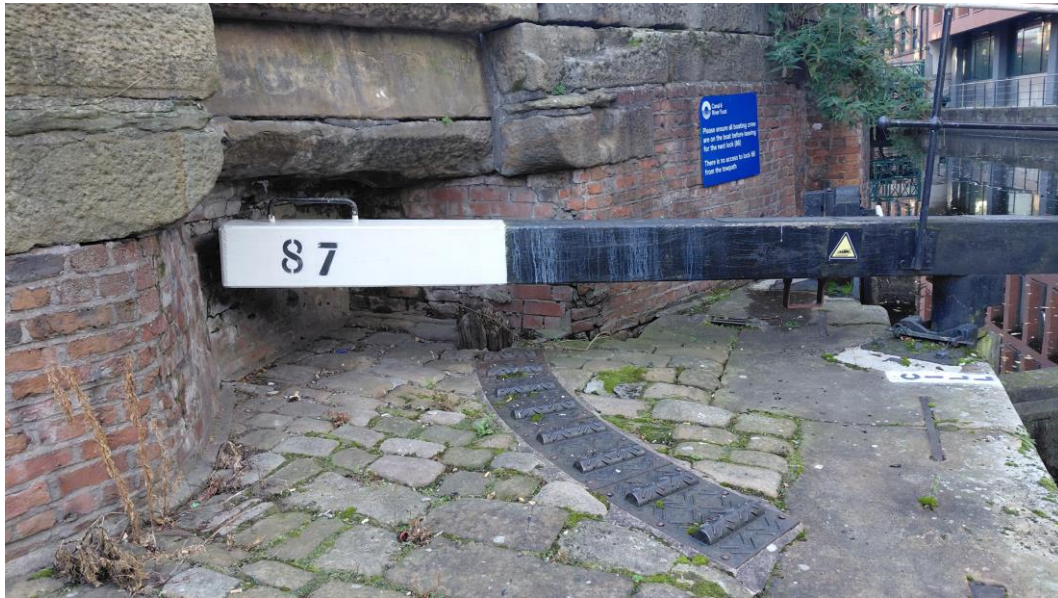
There is a trapping hazard between the lock gate balance beam and the adjacent retaining wall on the offside of the top lock gates (figure 8). There could be serious injury should an approaching boat strike a partially open gate whilst somebody stands between the partially open gate balance beam and the wall.

*Figure 8 Balance beam of the off-side top gate creates a trapping hazard against the wall*

It is proposed to reduce the balance beam length by 300mm to provide additional space between the balance beam and the wall. The balance beam handle will be moved 300mm to allow the beam to be shortened. A visualisation shows how this will appear (figure 9).

It is further proposed to attached a hazard warning sign on the wall adjacent to the lock gate balance beam to further reduce the likelihood of injury. The sign, illustrated at Figure 10, will be 380 x 280 mm. The sign complies with BS5499 Graphical Symbols & Signs and the Health and Safety (Safety Signs and Signals) Regulations 1996.
