## GAS MEMBRANE VALIDATION

| <b>Site Name: Belle Vue Stadium</b> | <b>Project Number: 12-123</b> |
| <b>Company Name: Countryside</b> | <b>Date: 31-05-2022</b> |

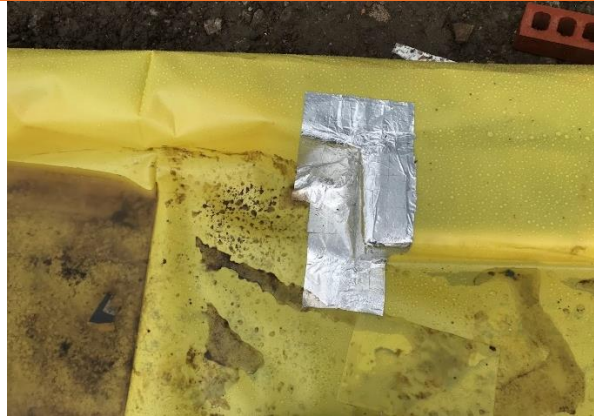
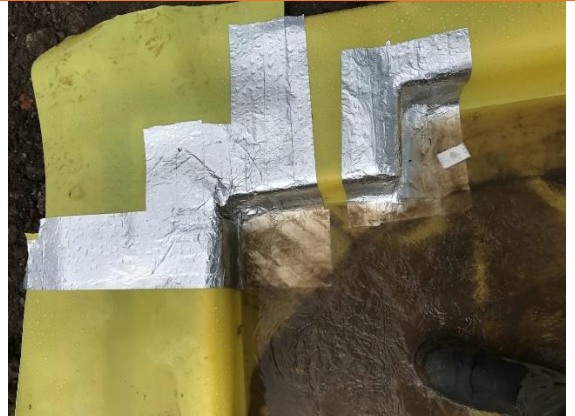
**Verification of Joints and Seals-Overlapped and sealed correctly**

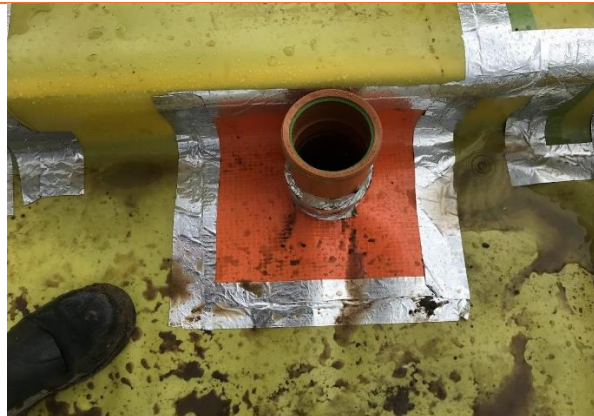
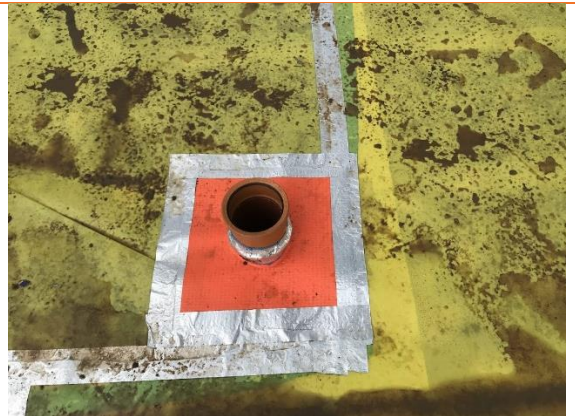
**Verification of Service Penetrations-Good Condition**

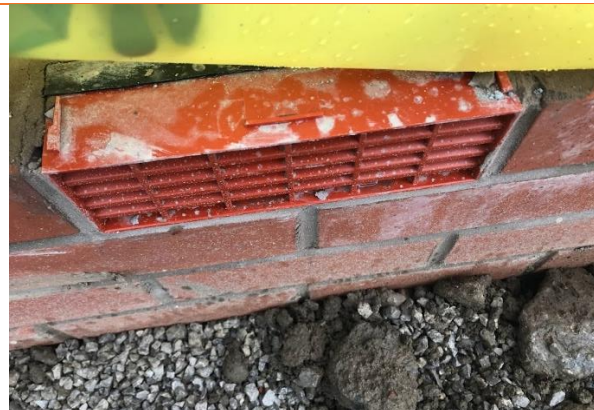
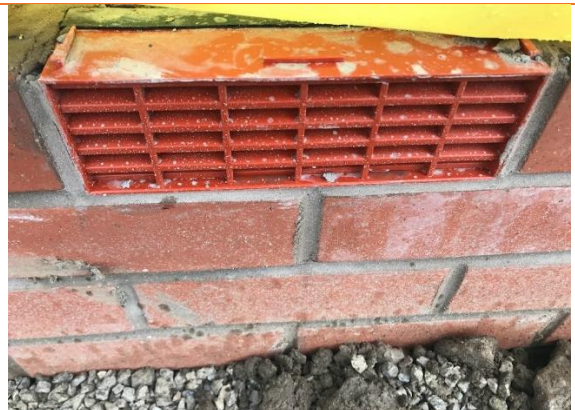
**Verification of Ventilation-Good Condition**

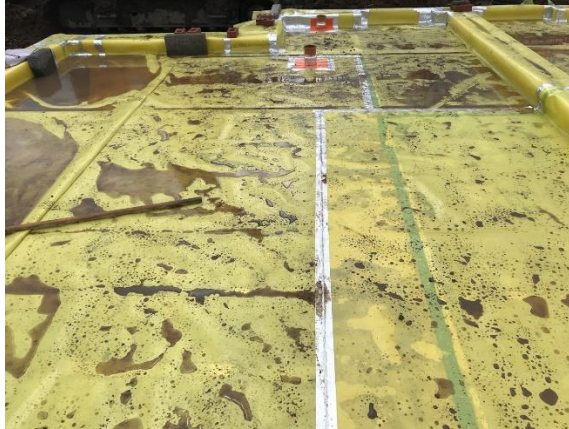
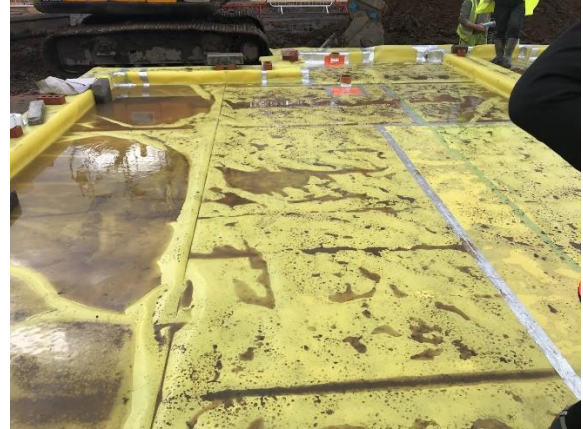
**Plot - 101**

**General Condition of Membrane-Good Condition**

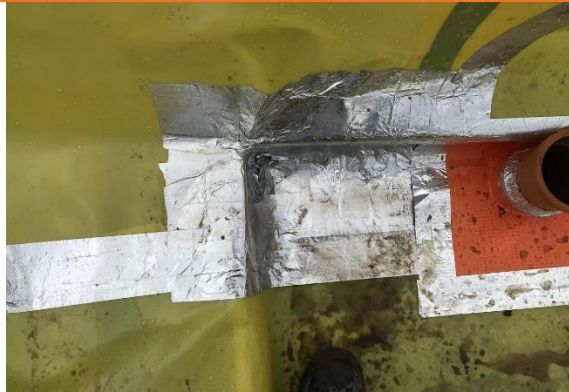
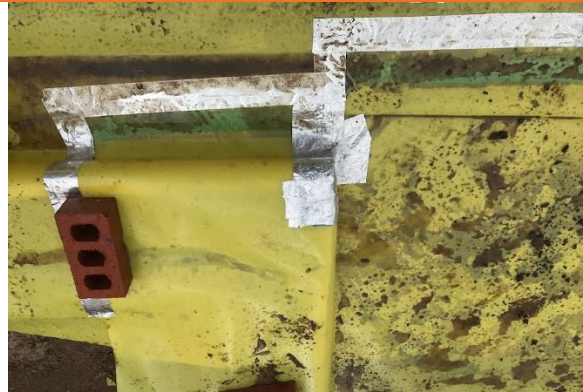
**Verification of Joints and Seals-Overlapped and sealed correctly**

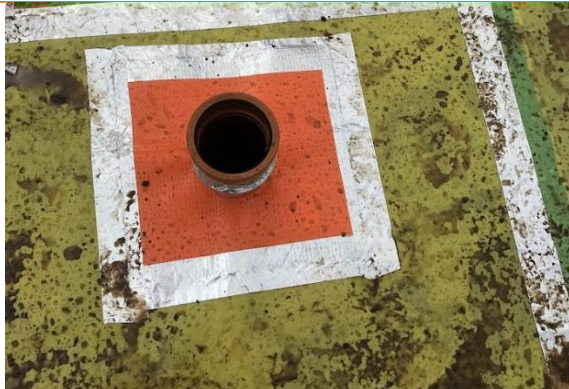
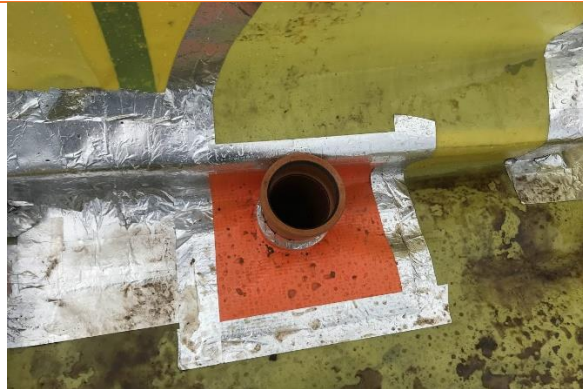
**Verification of Service Penetrations-Good Condition**

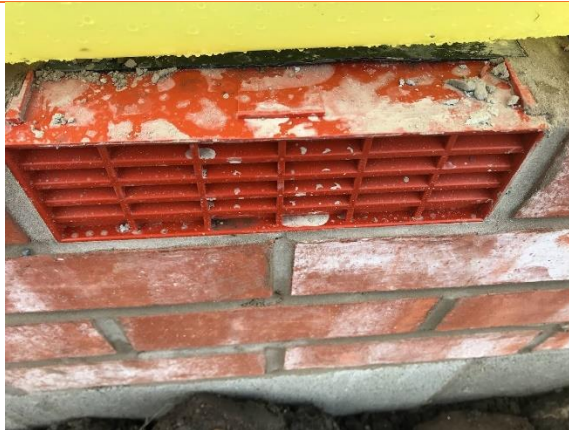
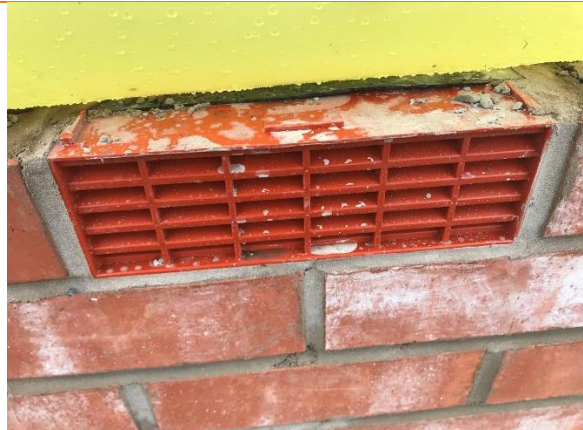
**Verification of Ventilation-Good Condition**
