**Photographic and strategy report to discharge conditions 3 and 4 of the Granted LBC application.  
Ref. no. 142258/LO/2025**

**Proposed installation of a new safety curtain and counterweight cradles to replace the existing safety curtain system.**

**Palace Theatre, Manchester**

Date: May 2025  
Ref: MJC25\_01\_016/GT  
Rev:

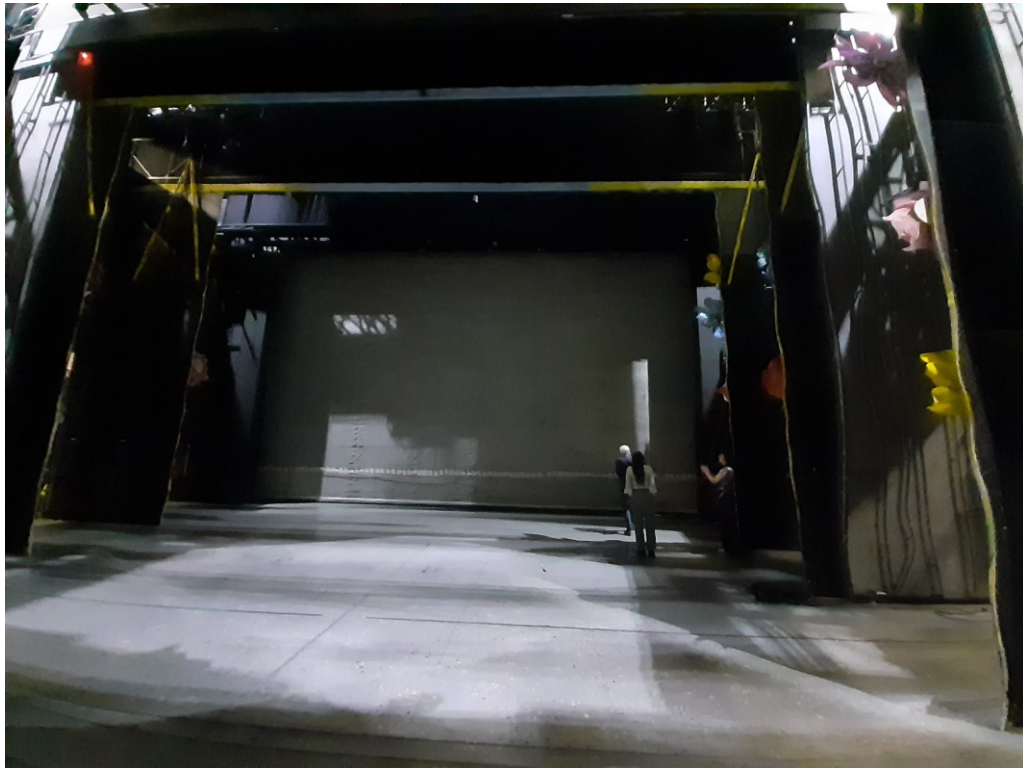
Photo 01 - Existing photograph looking towards the safety curtain from the back of the stage.

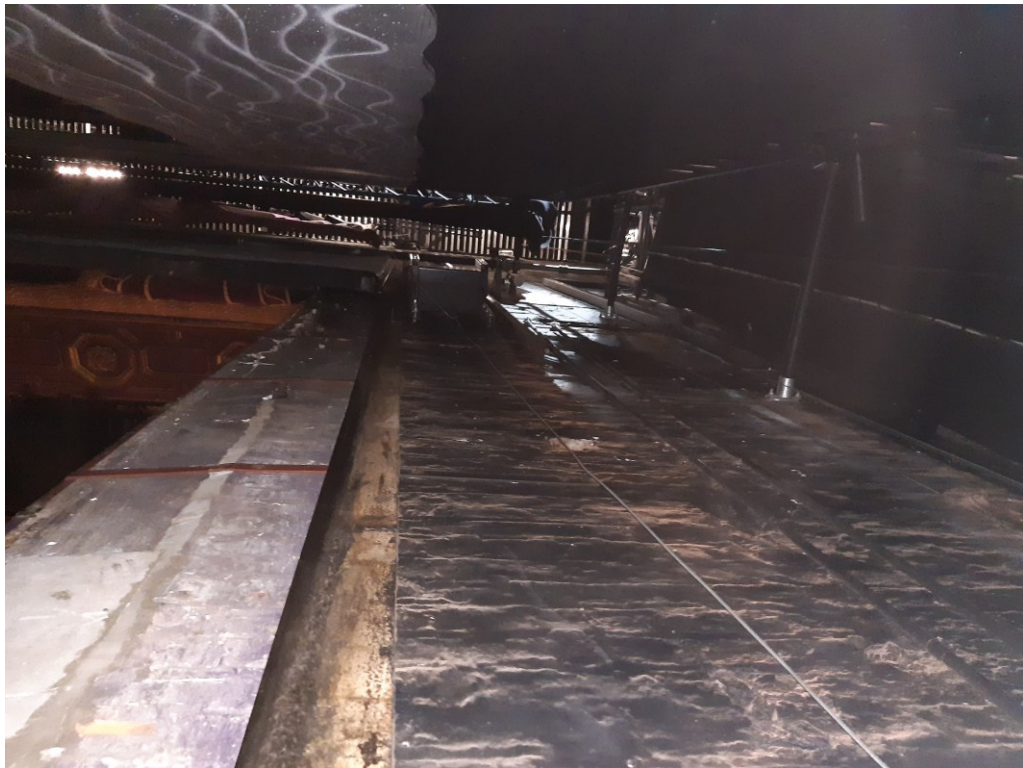
Photo 02 - Existing photograph looking up the B.O.H. wall stage left.

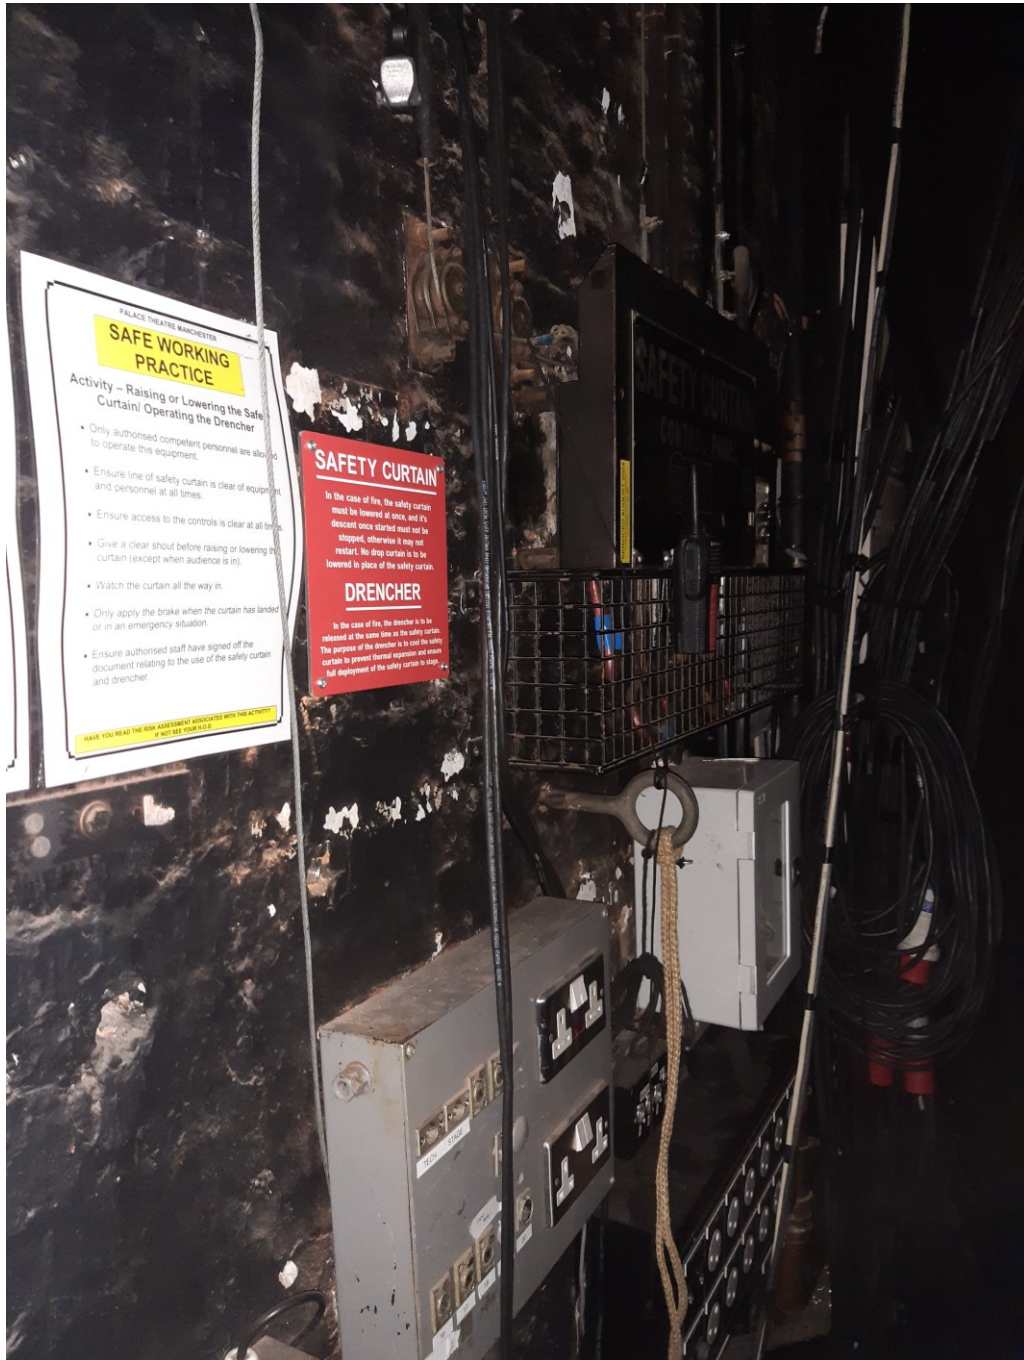
Photo 03 - Existing photograph looking towards the safety curtain control panel and drencher controls stage left.

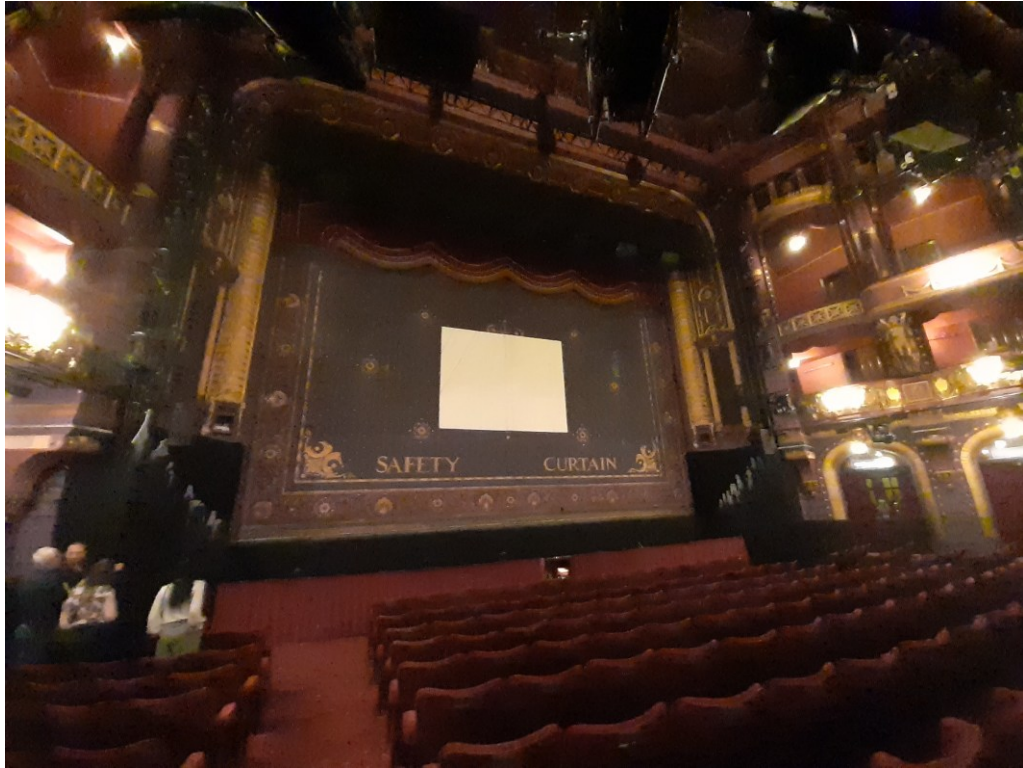
Photo 04 - Existing photograph looking towards the safety curtain from the Auditorium stalls level.

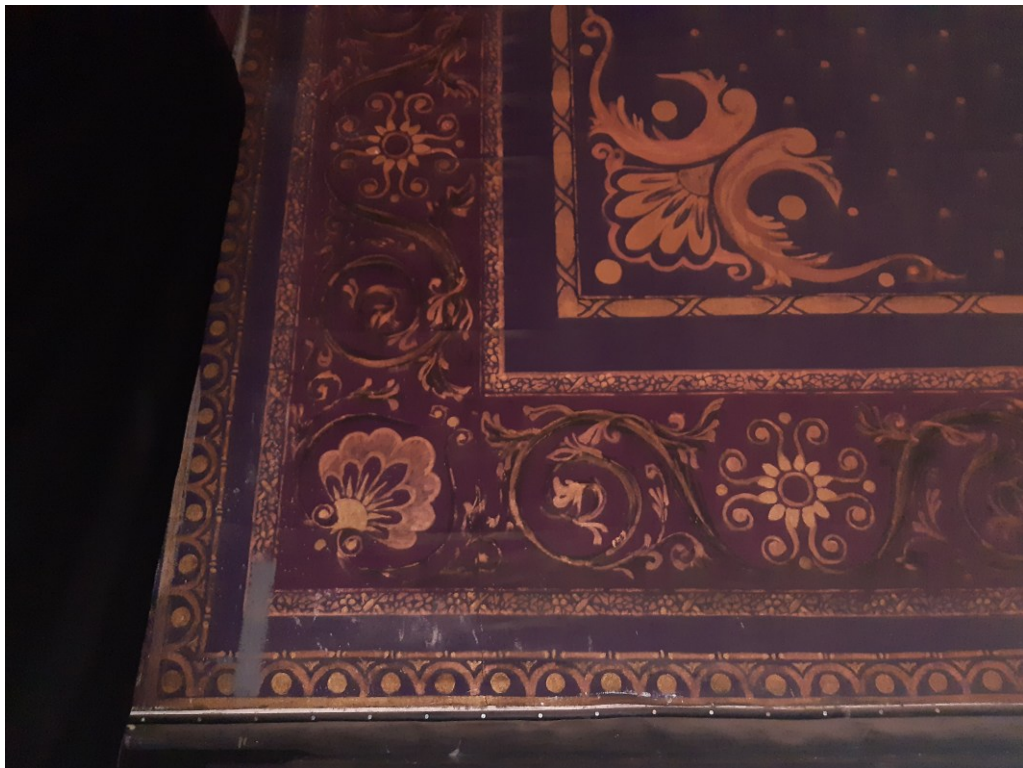
Photo 05 - Existing photograph looking at the safety curtain from the auditorium showing the corner details.

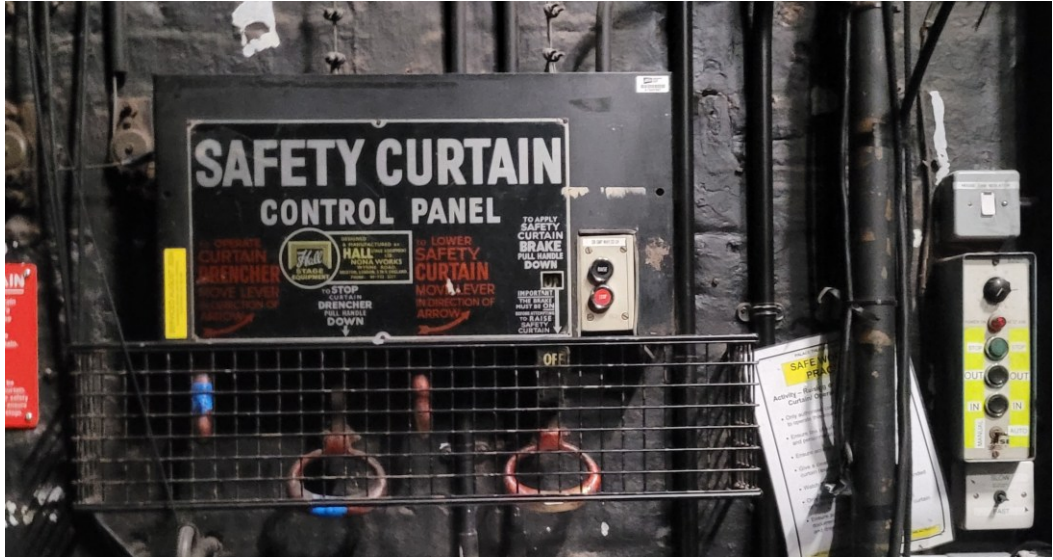
Photo 06 - Existing close-up photograph looking at the existing safety curtain control panel.

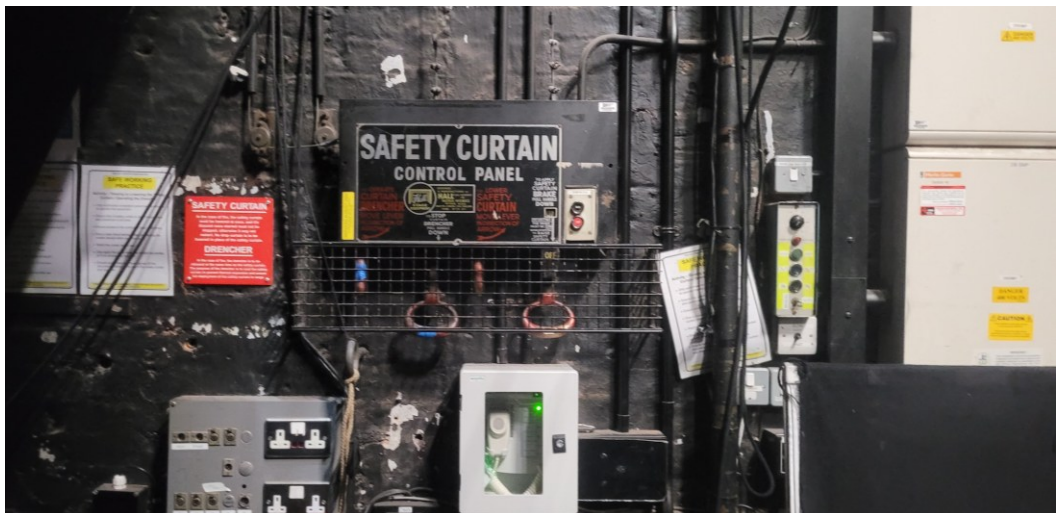
Photo 07 - Existing photograph looking towards the safety curtain control panel and drencher controls and surrounding electrical boxes stage left.

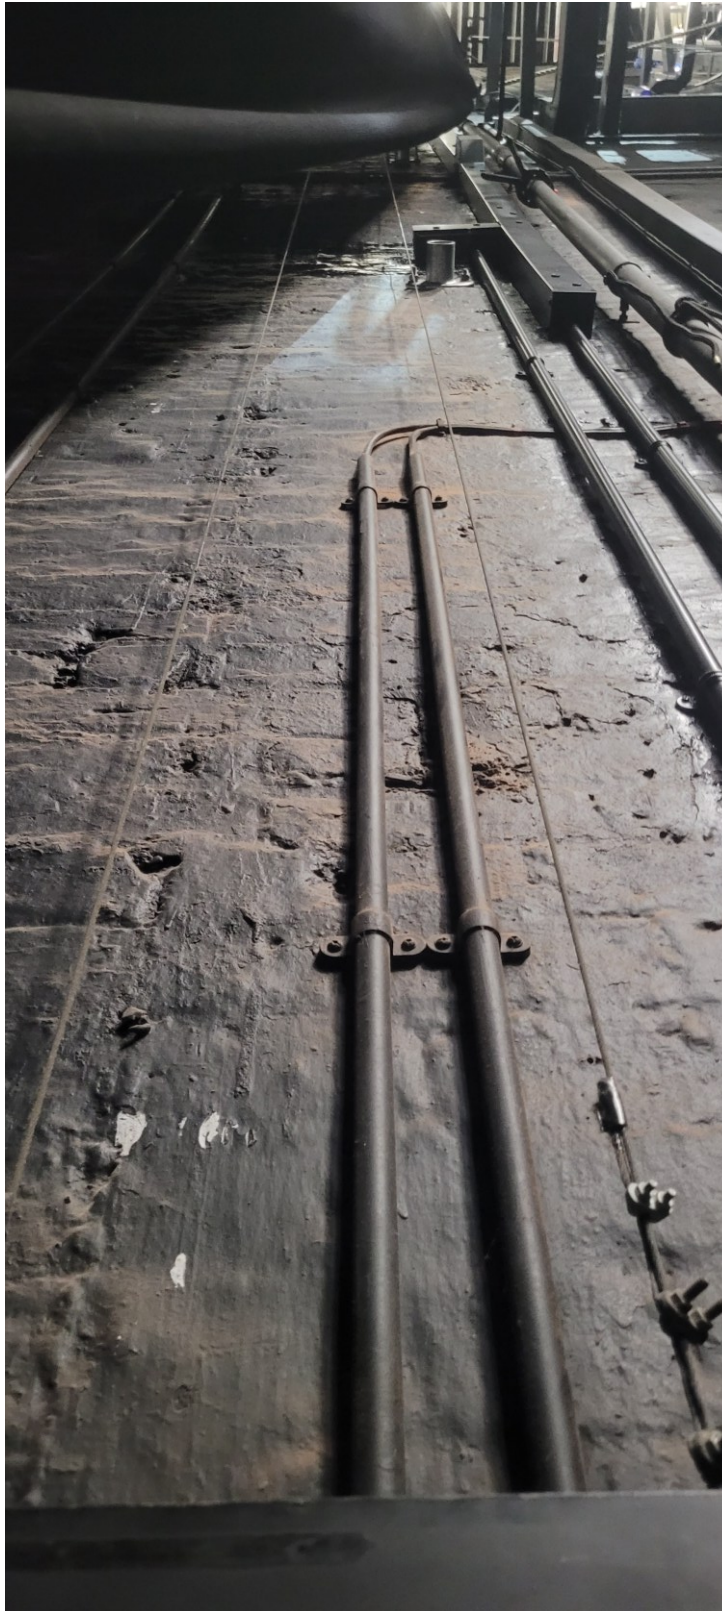
Photo 08 - Existing photograph looking up at the wall above the safety curtain control panel stage left.

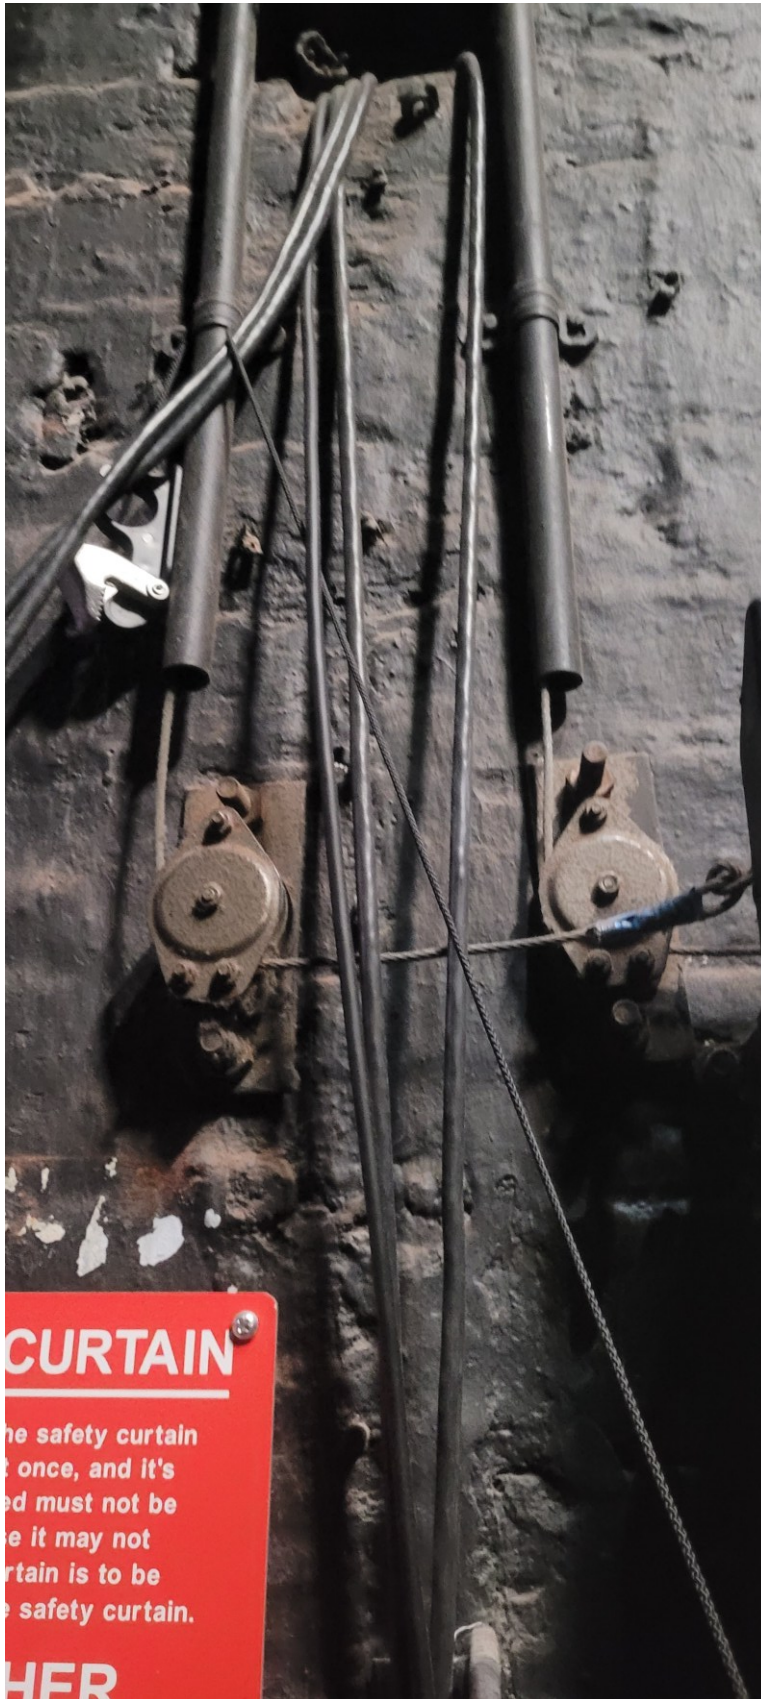
Photo 09 - Existing photograph showing safety curtain cables - stage left.

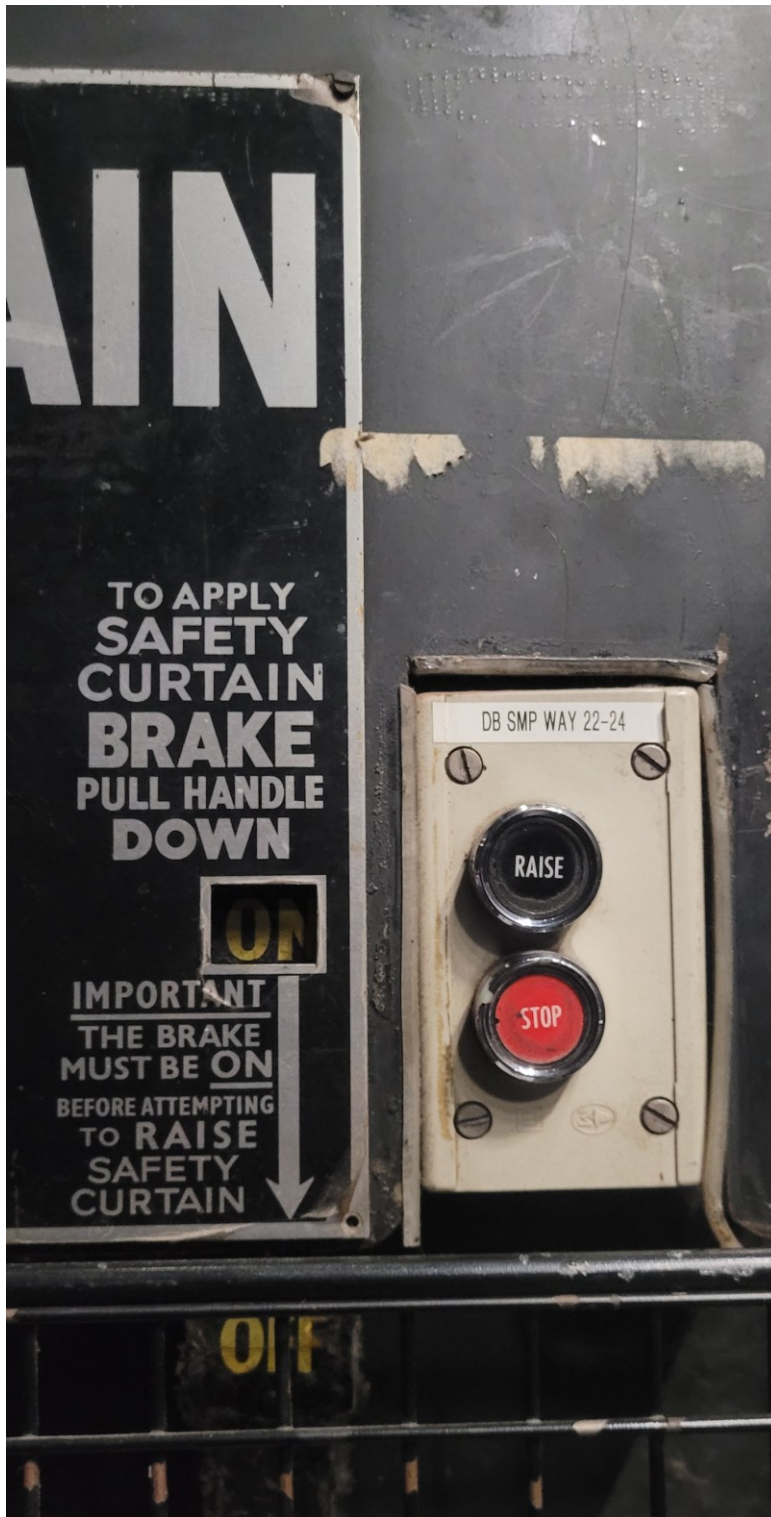
Photo 10 - Existing photograph showing close up of the safety curtain control panel stage left.

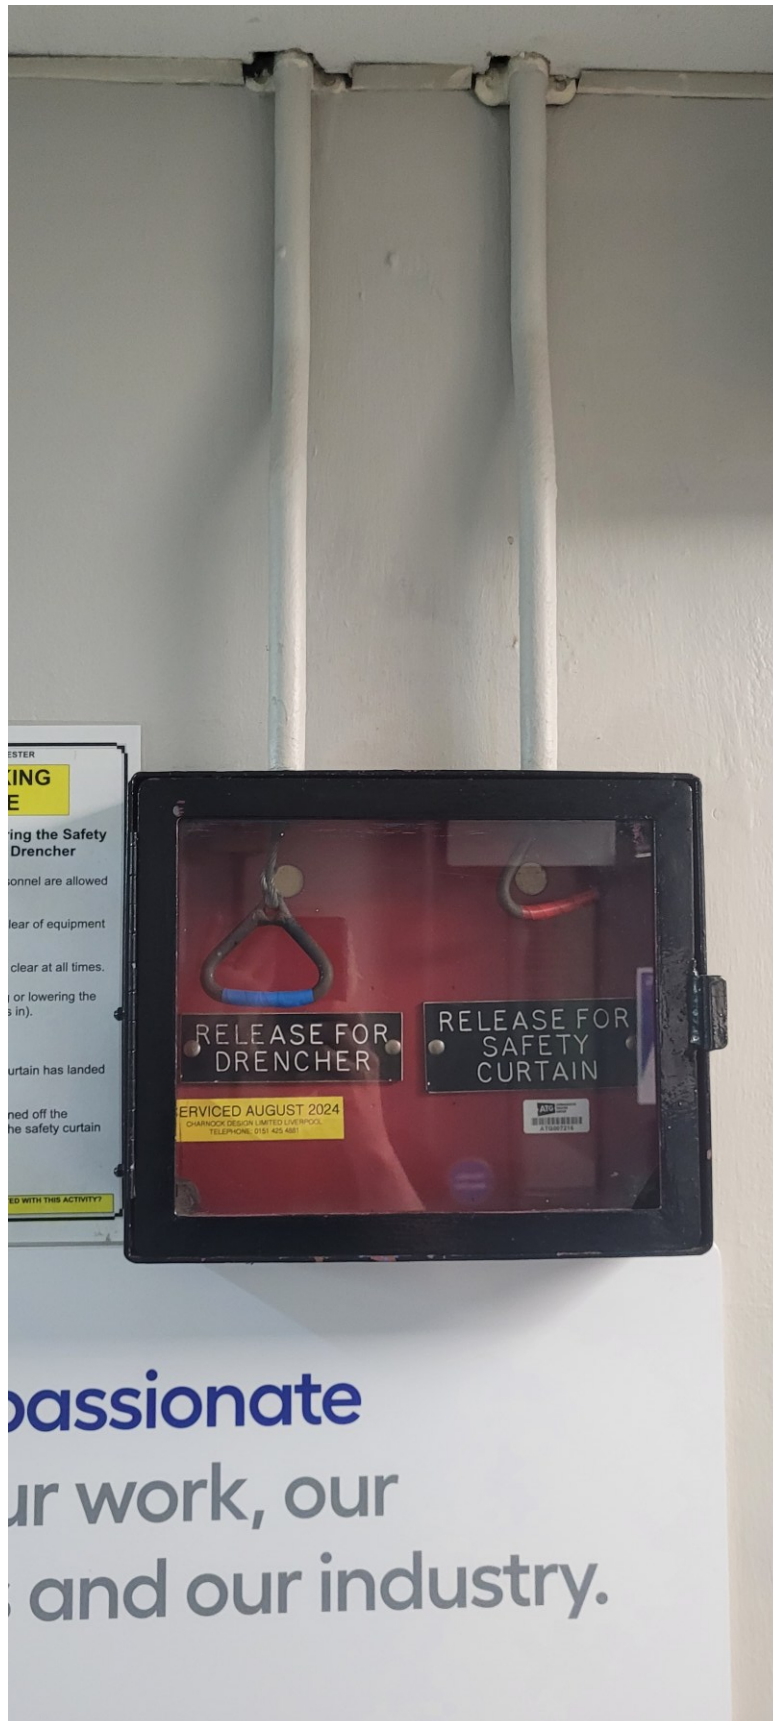
Photo 11 - Existing photograph showing releases for drencher and safety curtain in corridor adjacent to the Stage door office

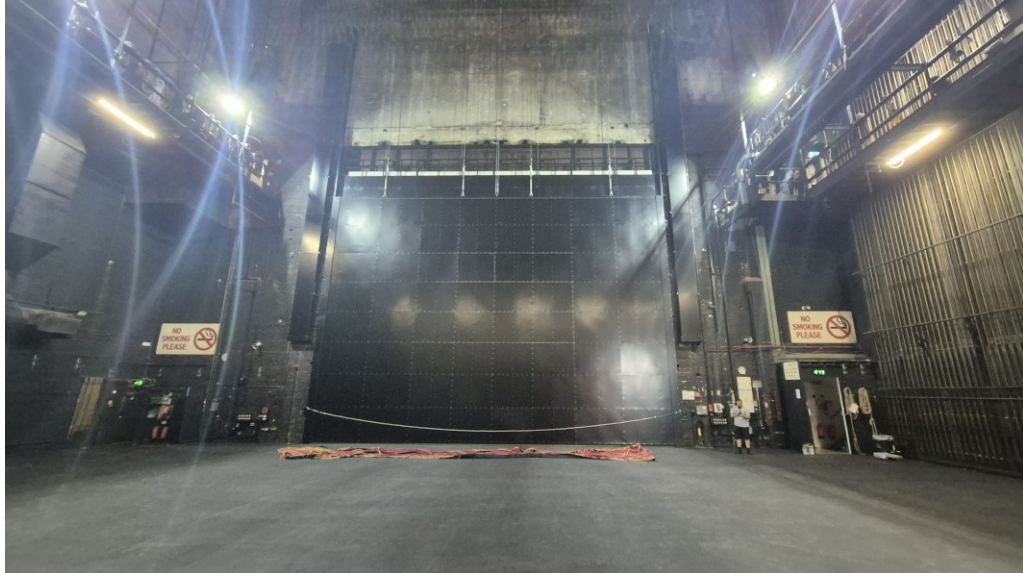
Rear of new safety curtain.

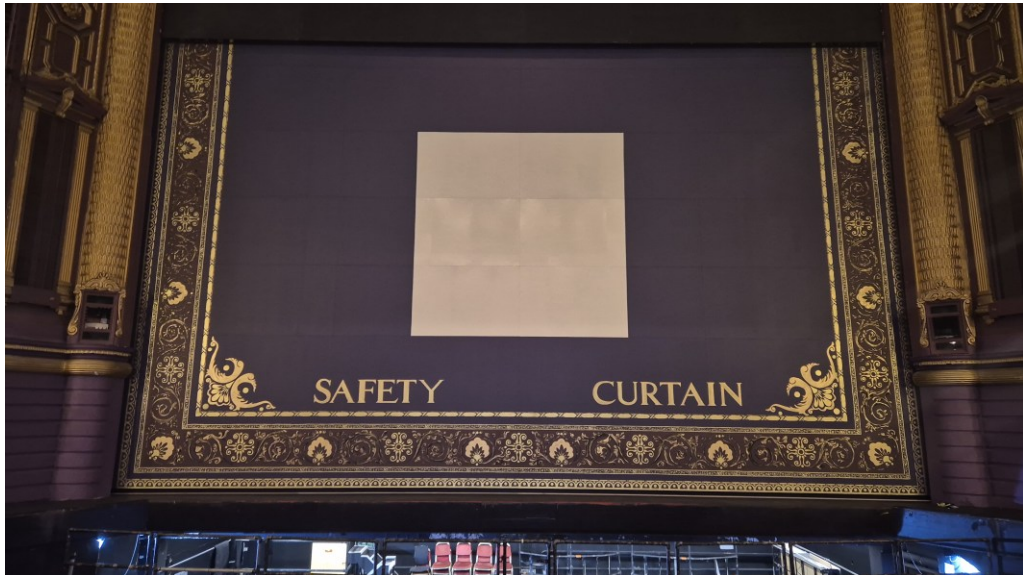
Front of new painted safety curtain.

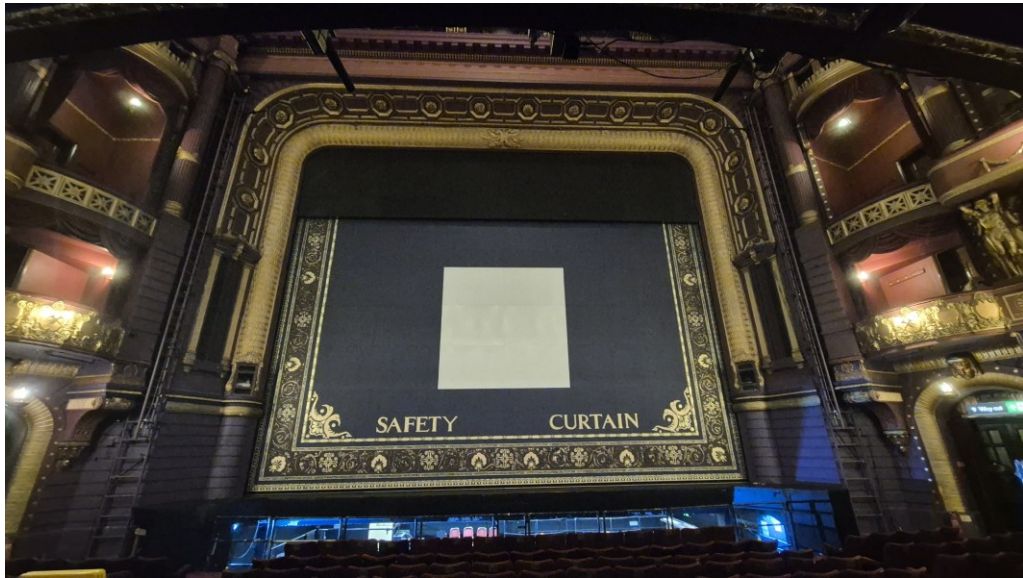
Front of new safety curtain showing new pelmet in position.

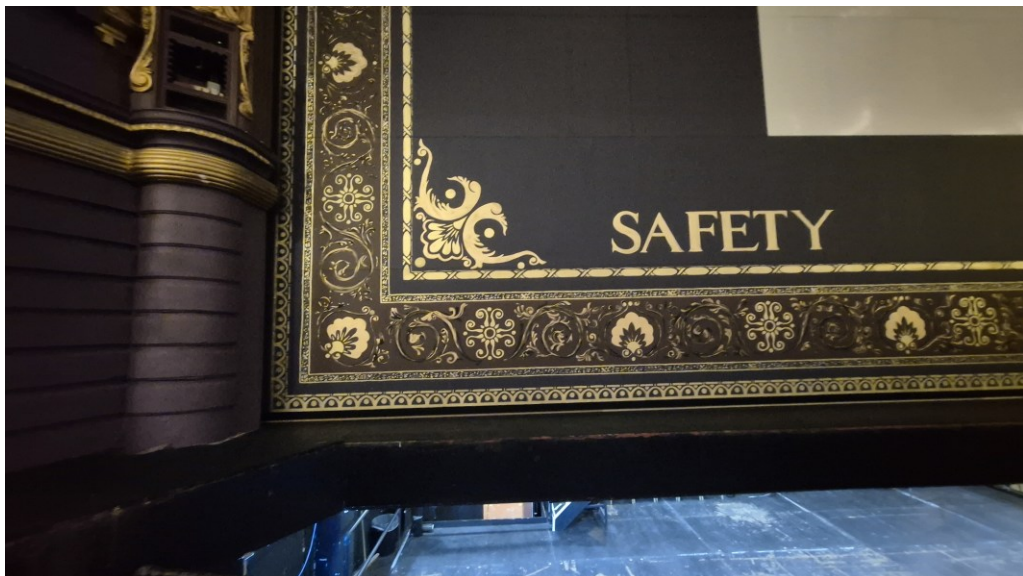
Front corner of new painted safety curtain.

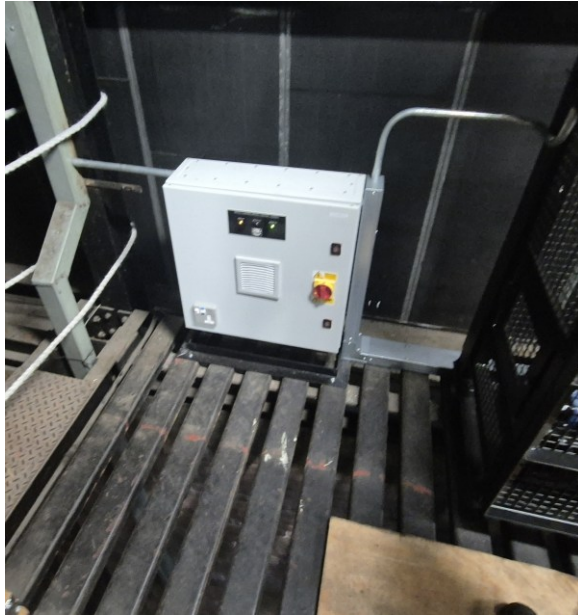
New MCC unit and  
motorized winch  
for safety curtain.

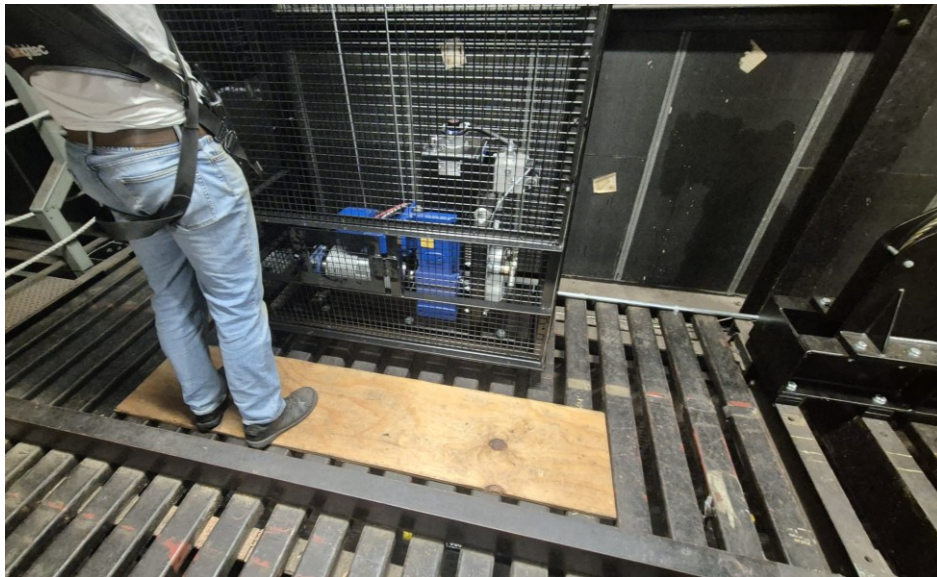
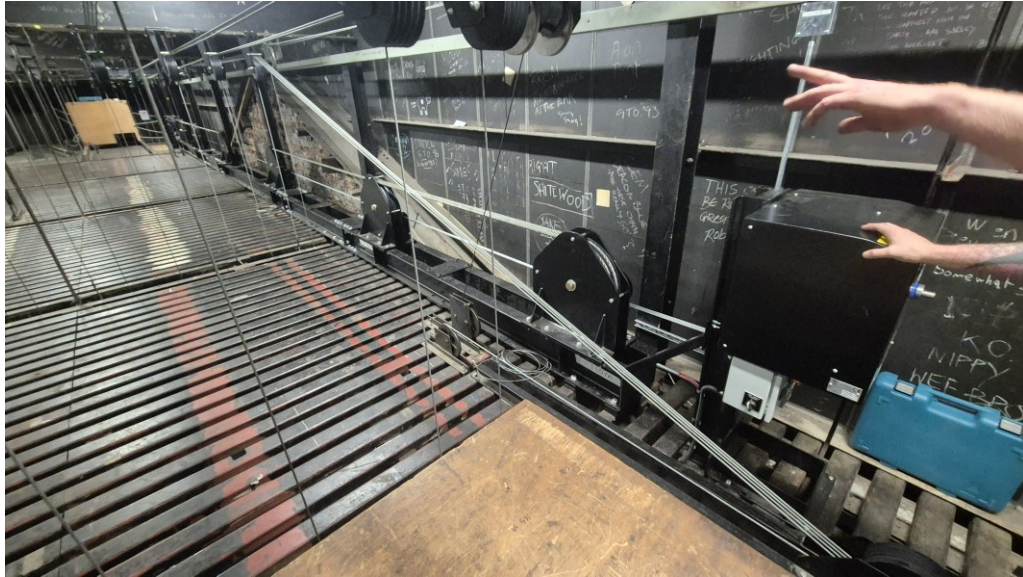
New pelmet hoist (on right) also shows new PFC's and pulleys across rear of the proscenium wall at grid level, which supports the new safety curtain and pelmet.

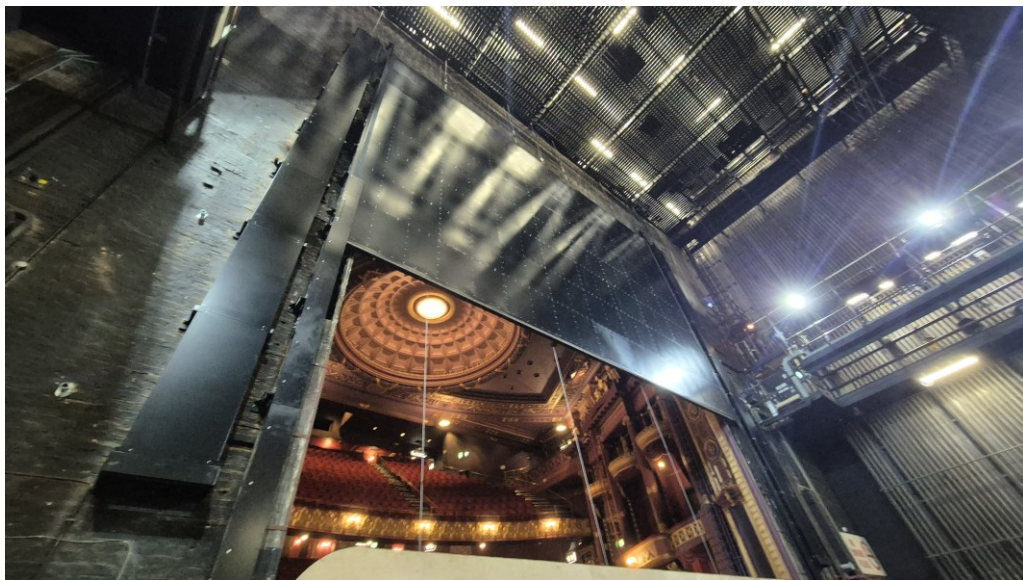
Rear of new safety curtain showing counterweight cradle to left side of stage.

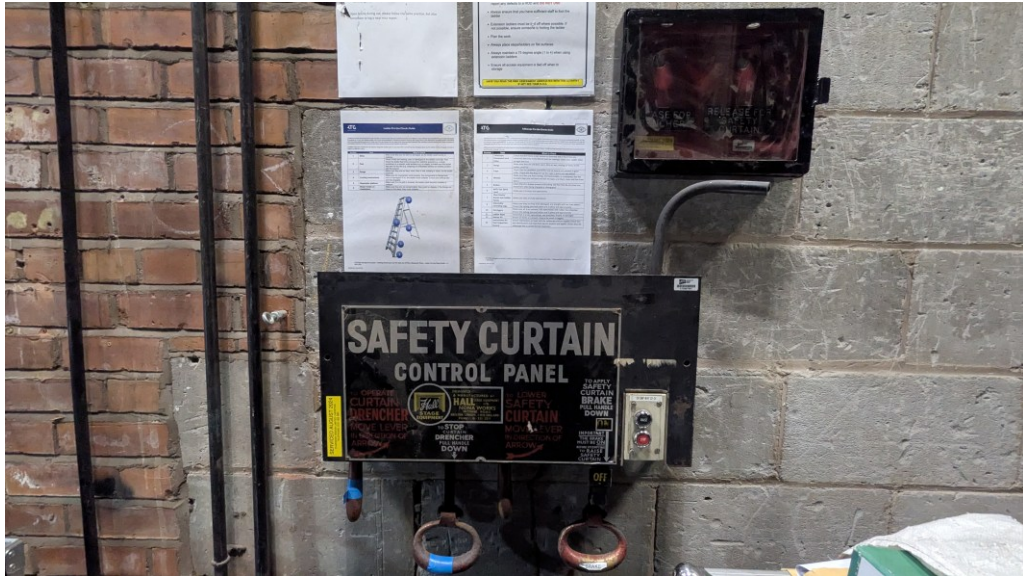
Relocated old safety curtain control panel and release box.
