# Elizabeth Street, Cheetham Hill

## Phase 4 Validation Report

**Curtins Ref: 080139-CUR-XX-XX-T-GE-00006**

Site Address: Land off Elizabeth Street, Cheetham Hill, Manchester, M8 8BB

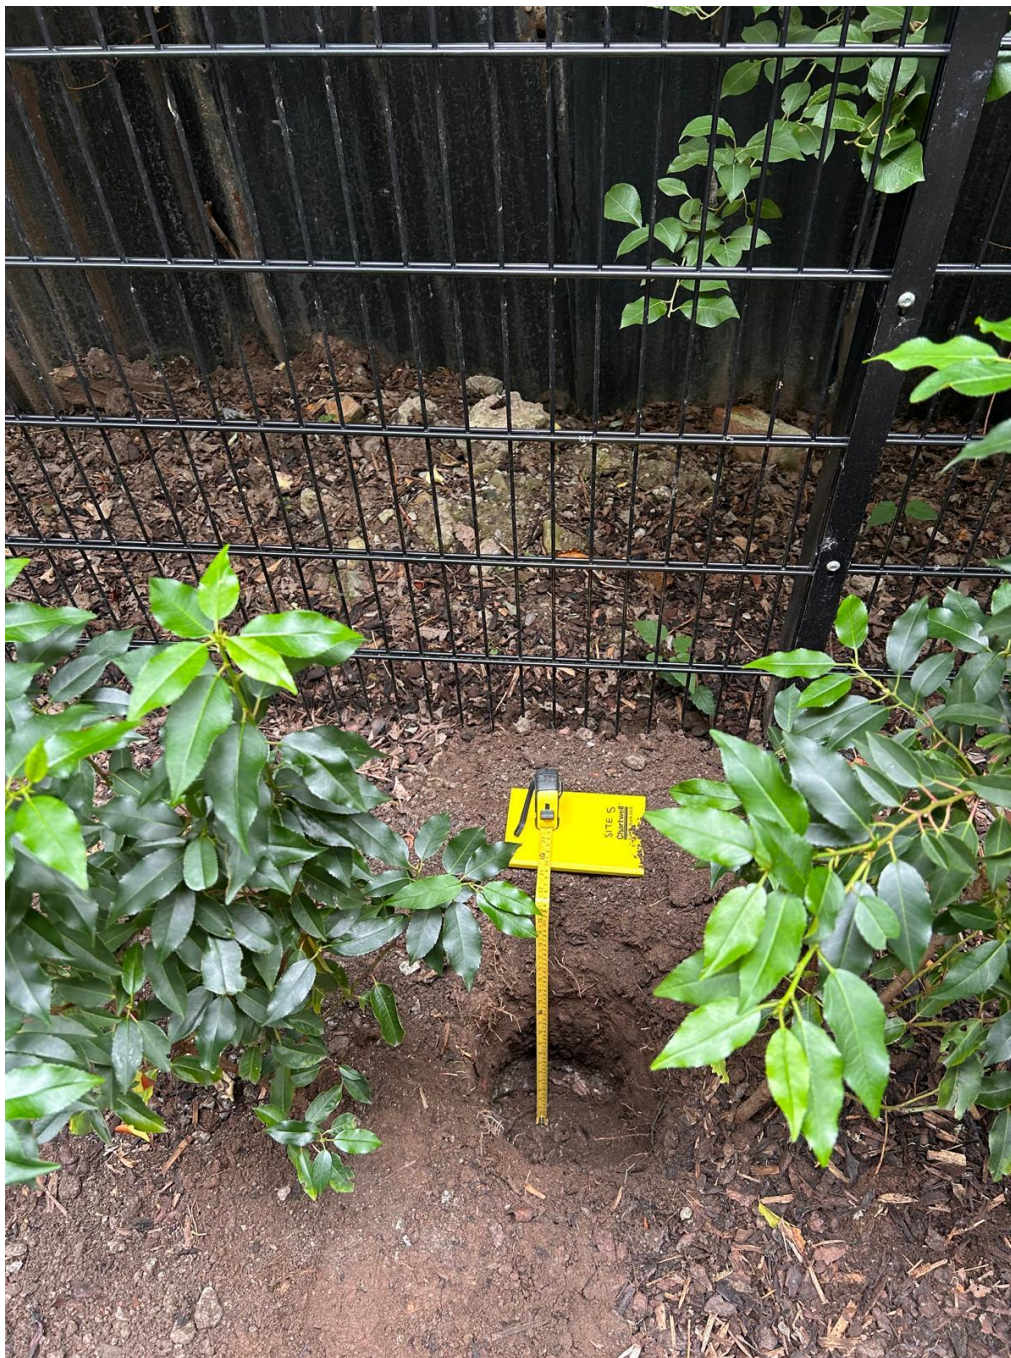
| Location: | TP0A |

| Notes: | Wider location of TP0A |

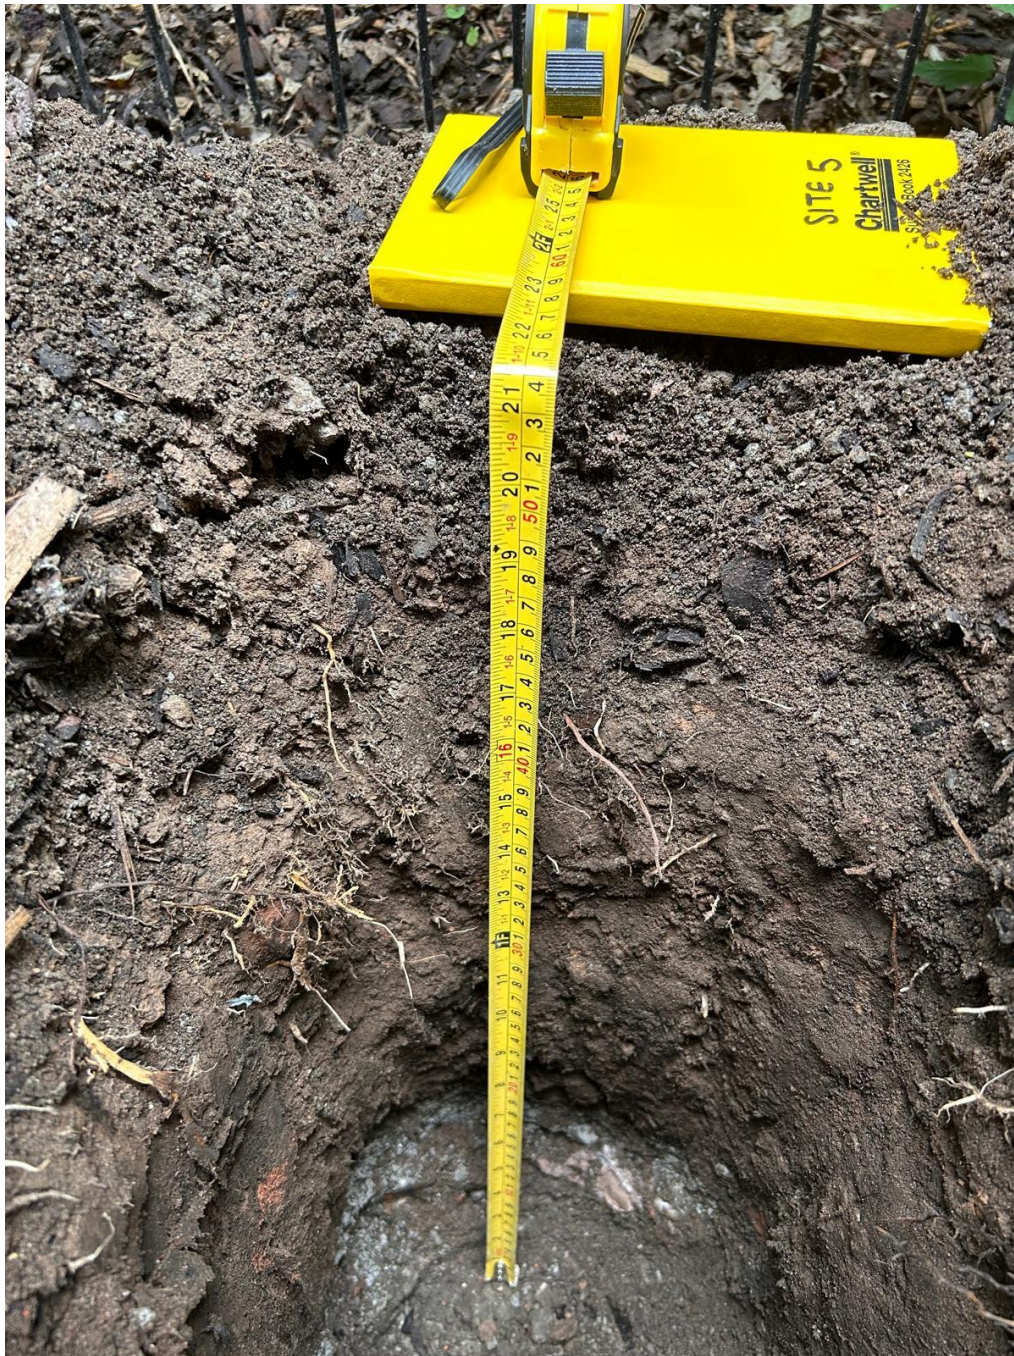
| Location: | TP0A |

| Notes: | Soil depth of TP0A |

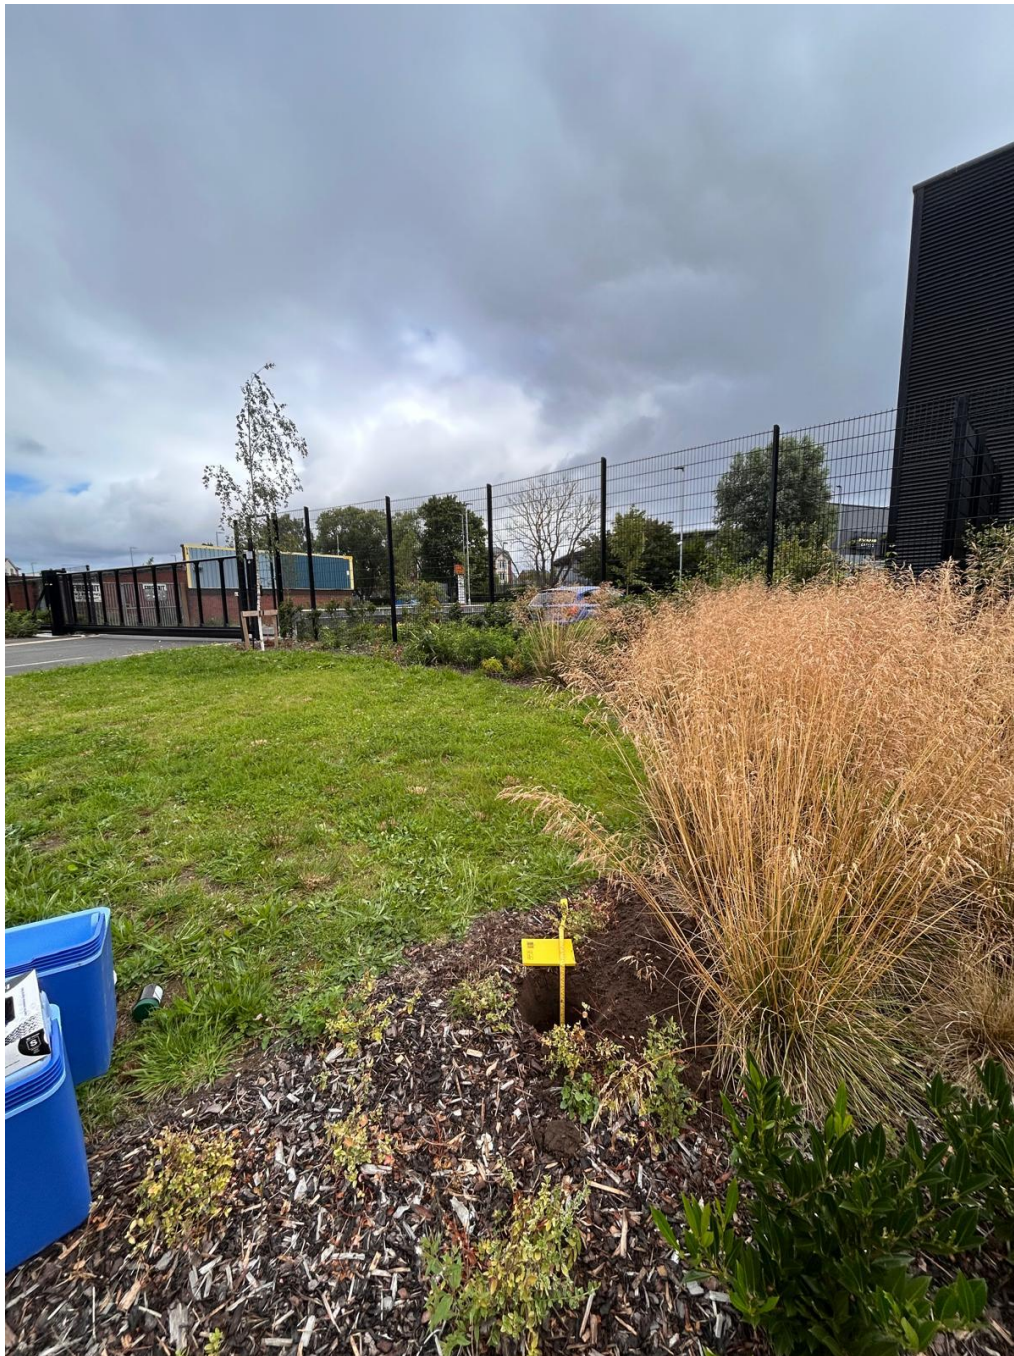
| Location: | TP0B |

| Notes: | Wider location of TP0B |

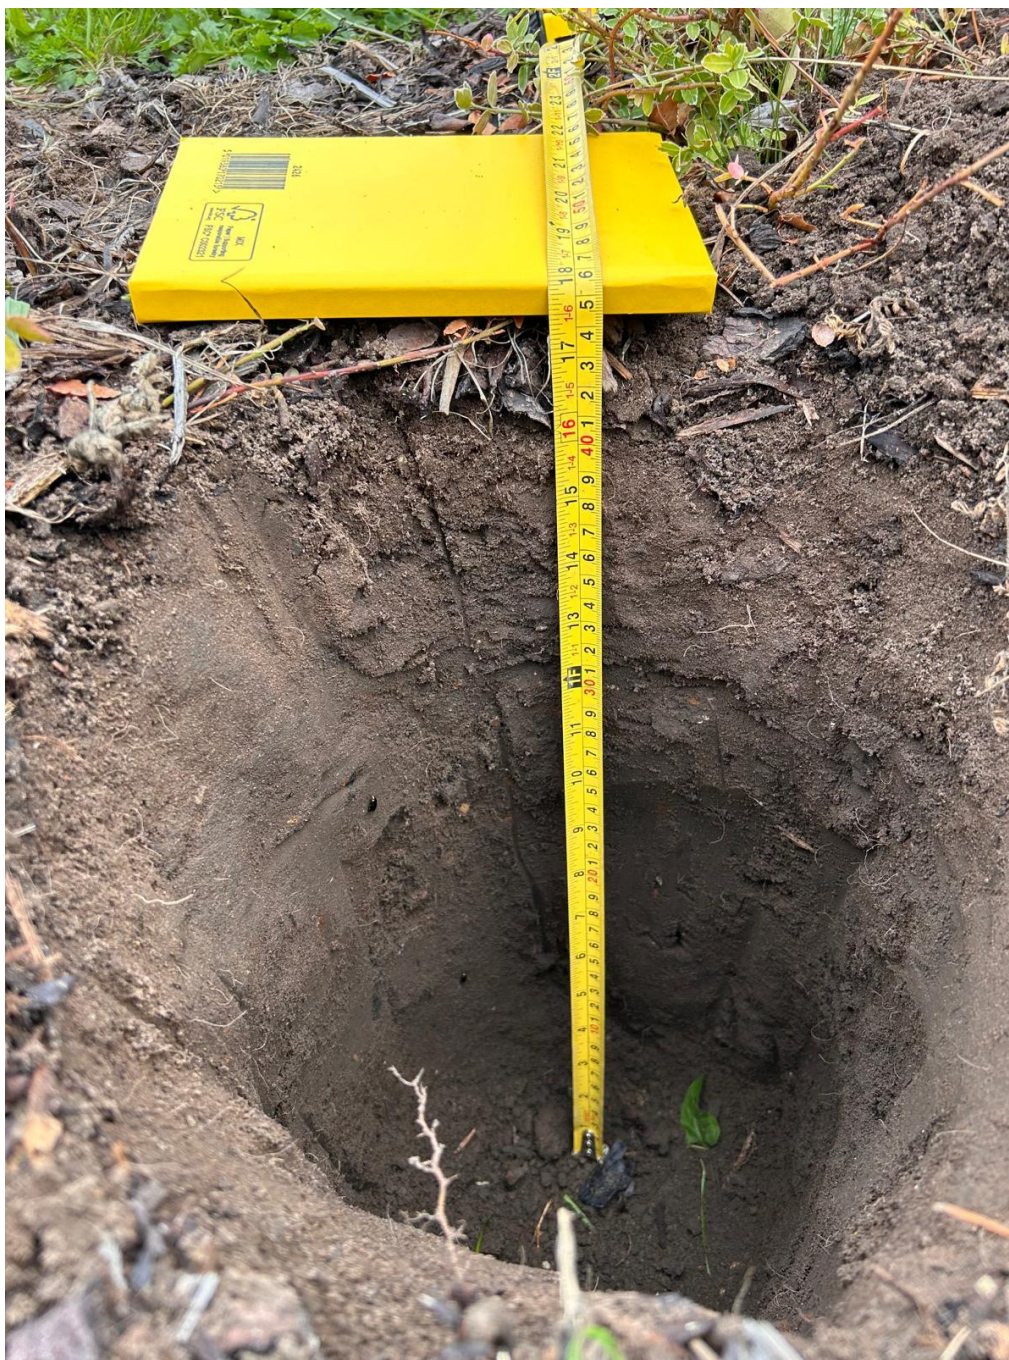
| Location: | TP0B |

| Notes: | Soil depth of TP0B |

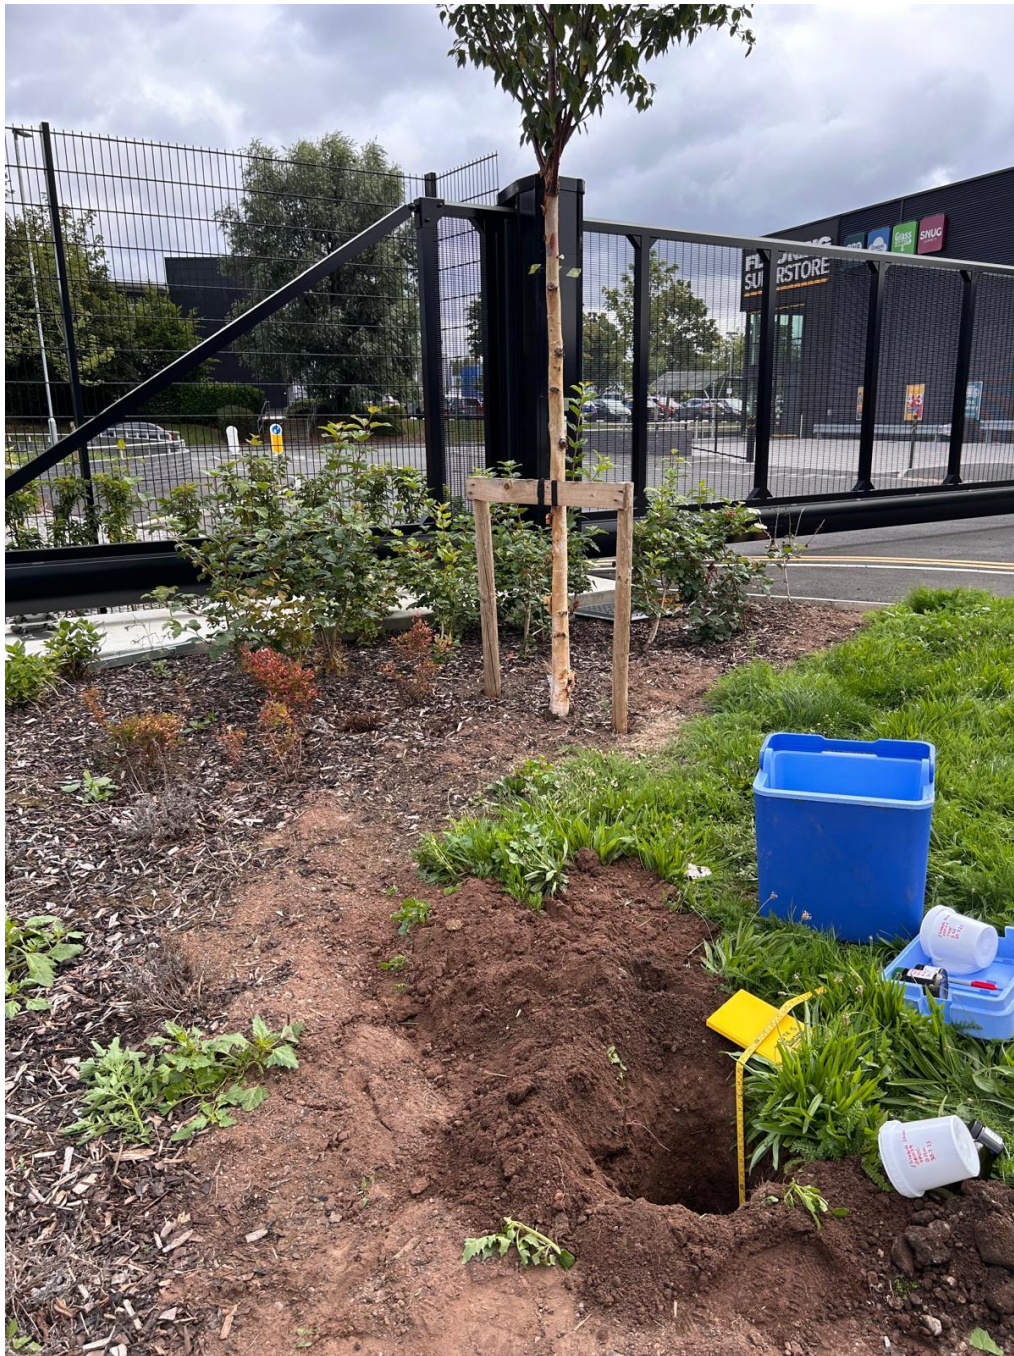
| Location: | TP0C |

| Notes: | Wider location of TP0C |

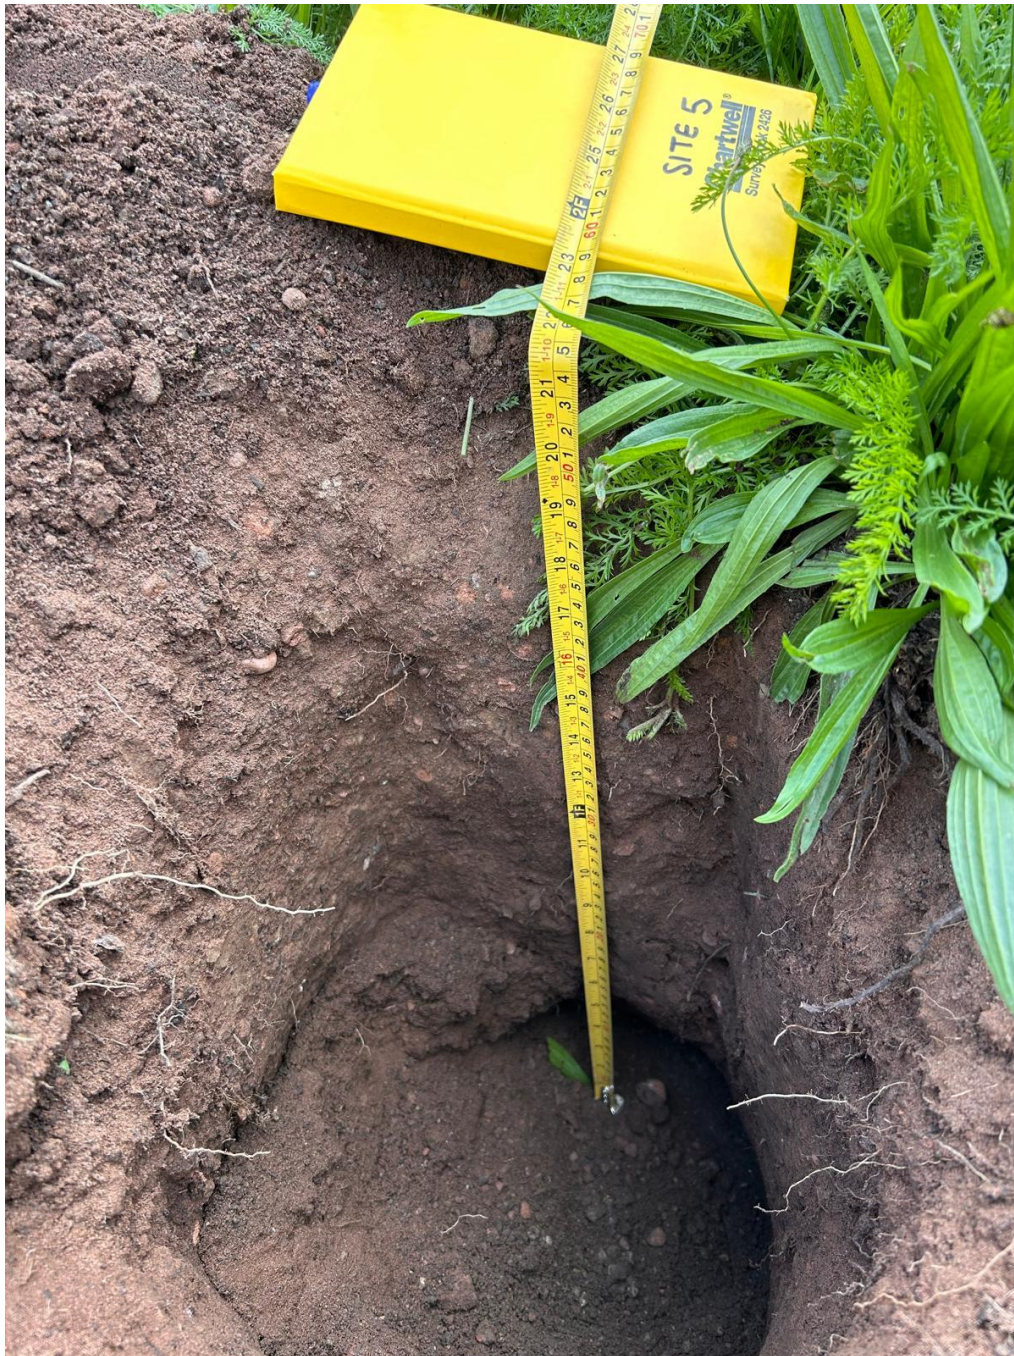
| Location: | TP0C |

| Notes: | Soil depth of TP0C |

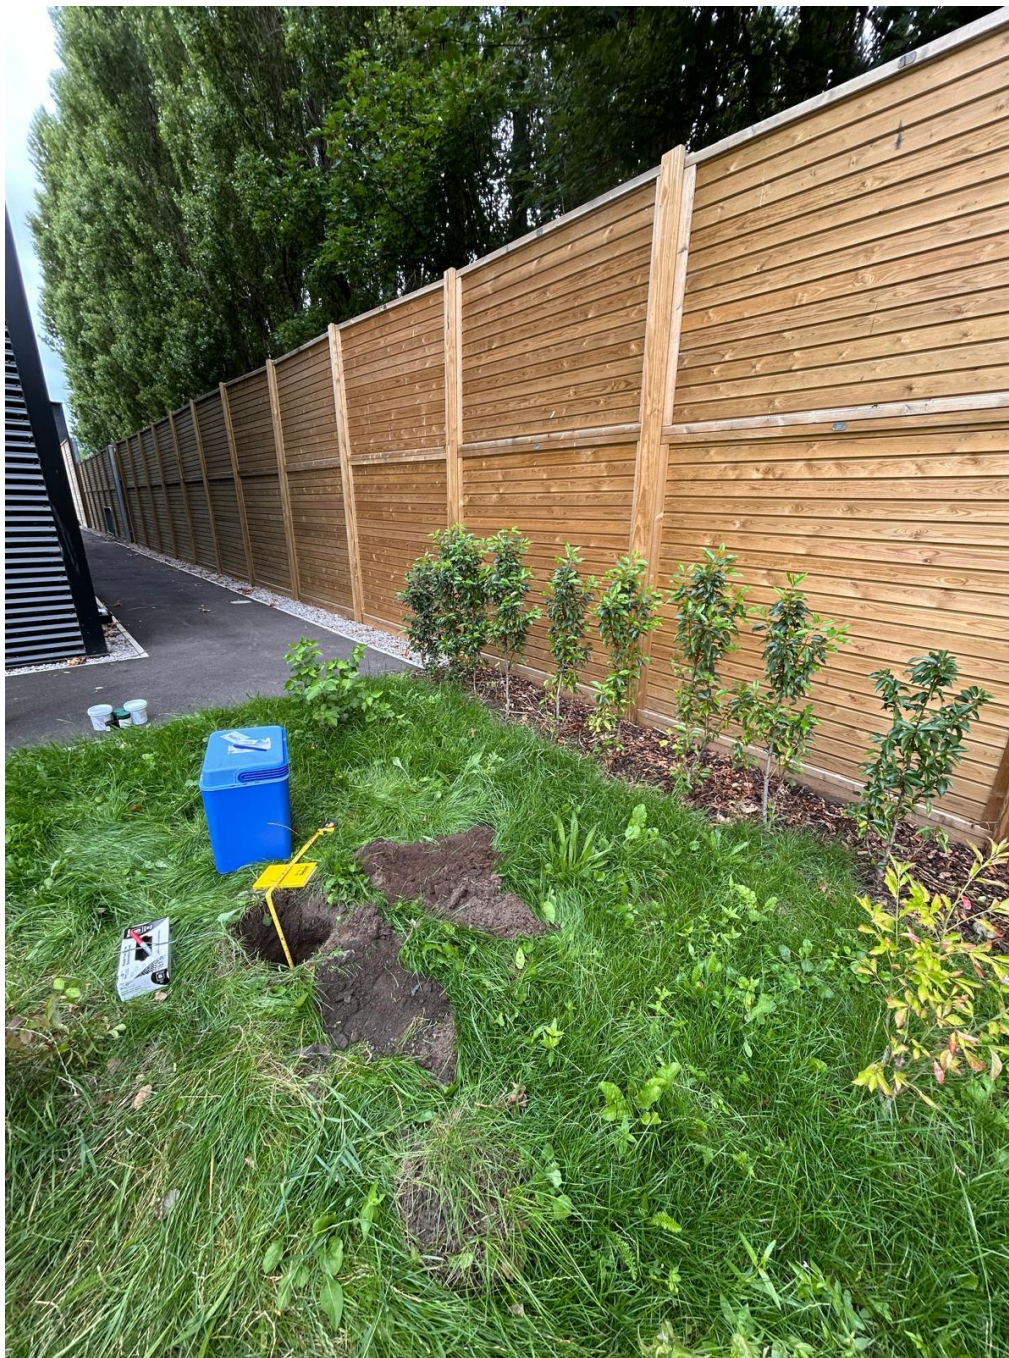
| Location: | TP0D |

| Notes: | Wider location of TP0D |

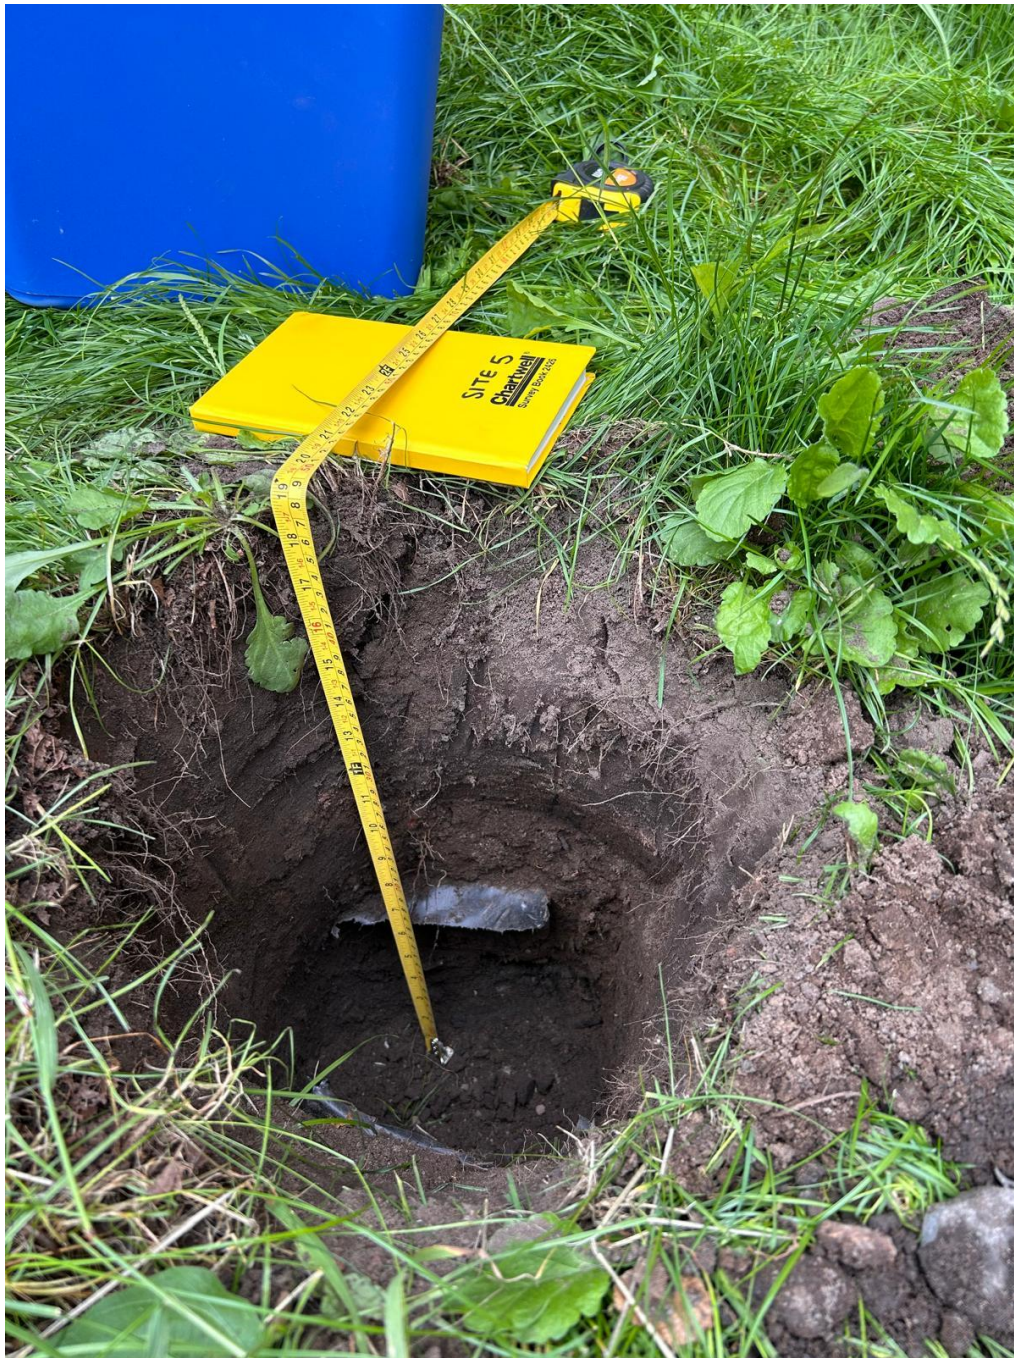
| Location: | TP0D |

| Notes: | Soil depth of TP0D |

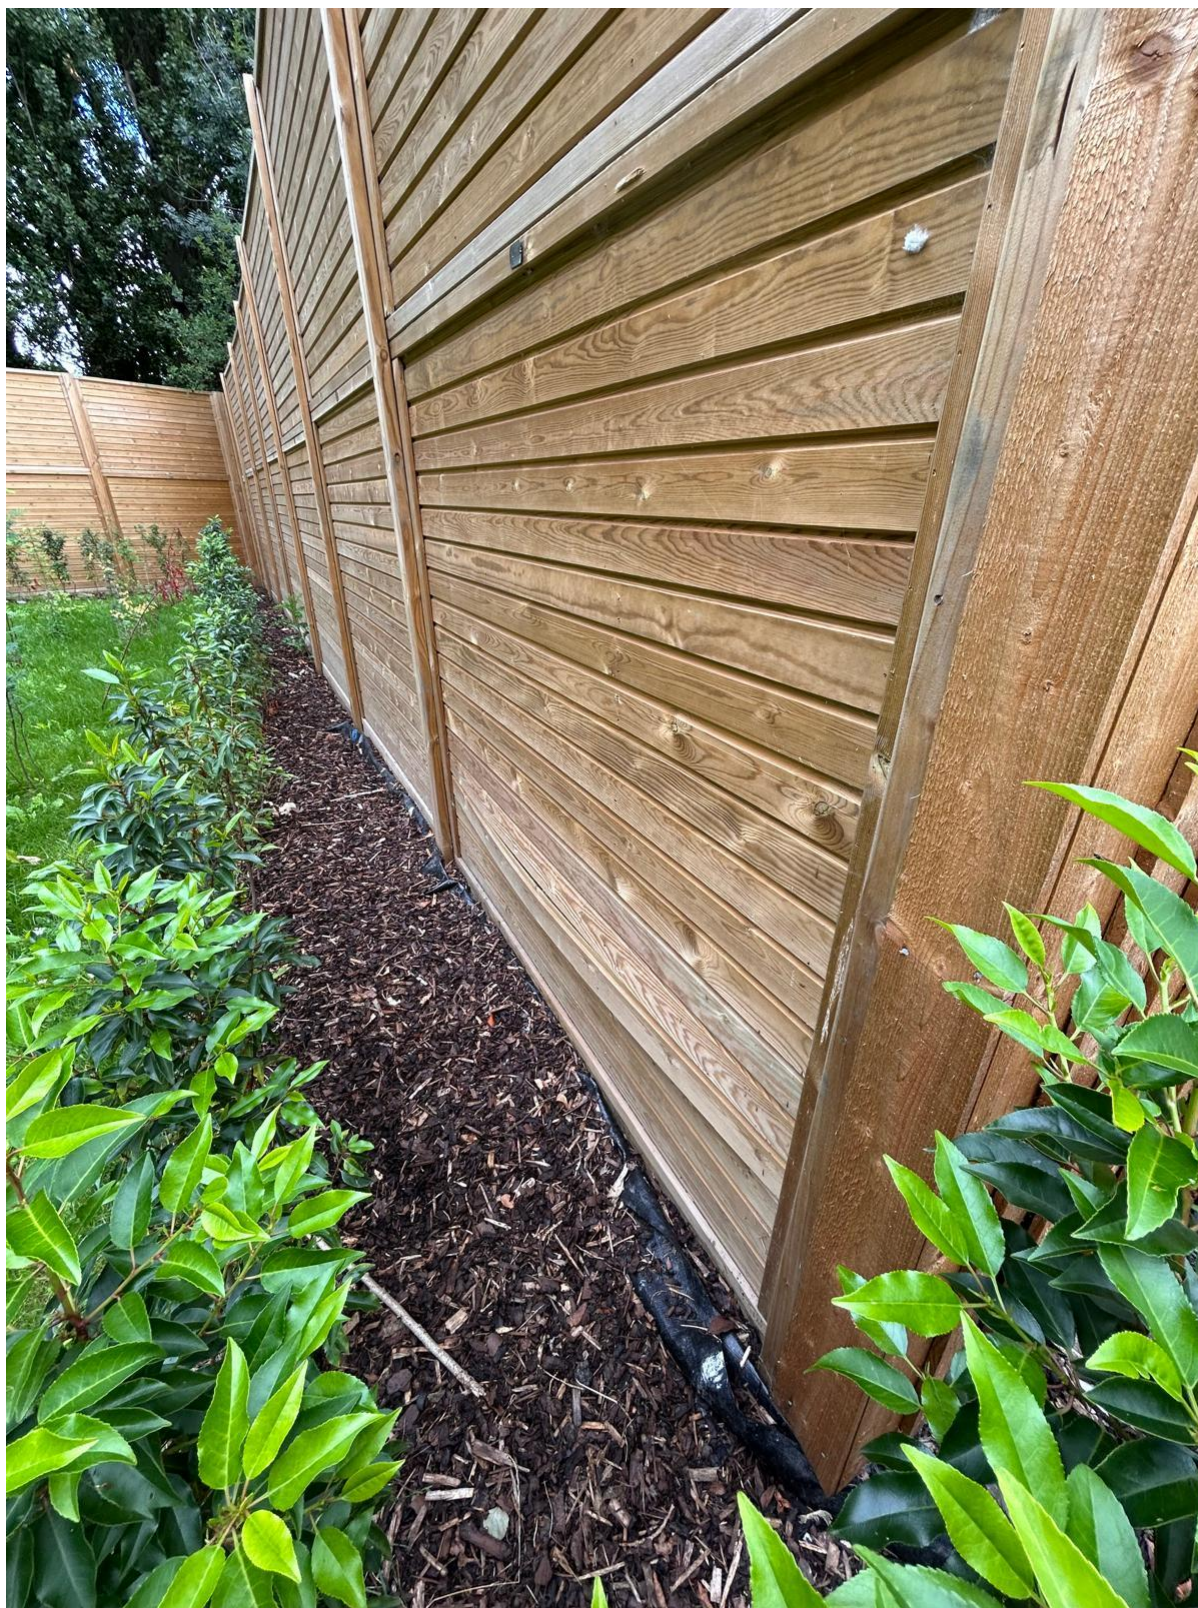
| Location: | North-west of the site |

| Notes: | Photo of the Prohibitive Access Fence barrier with black visqueen |

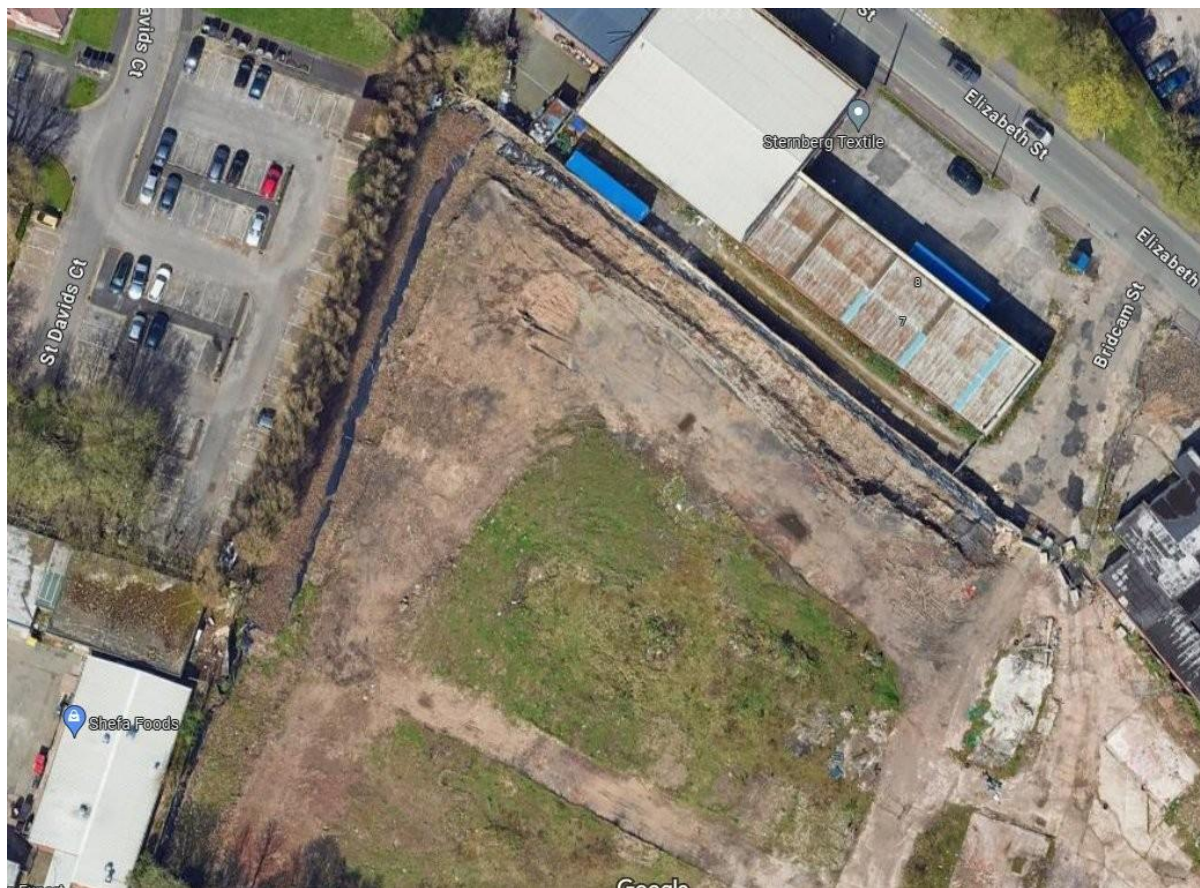
| Location: | Unit 9 Area |

| Notes: | Knotweed Barrier |

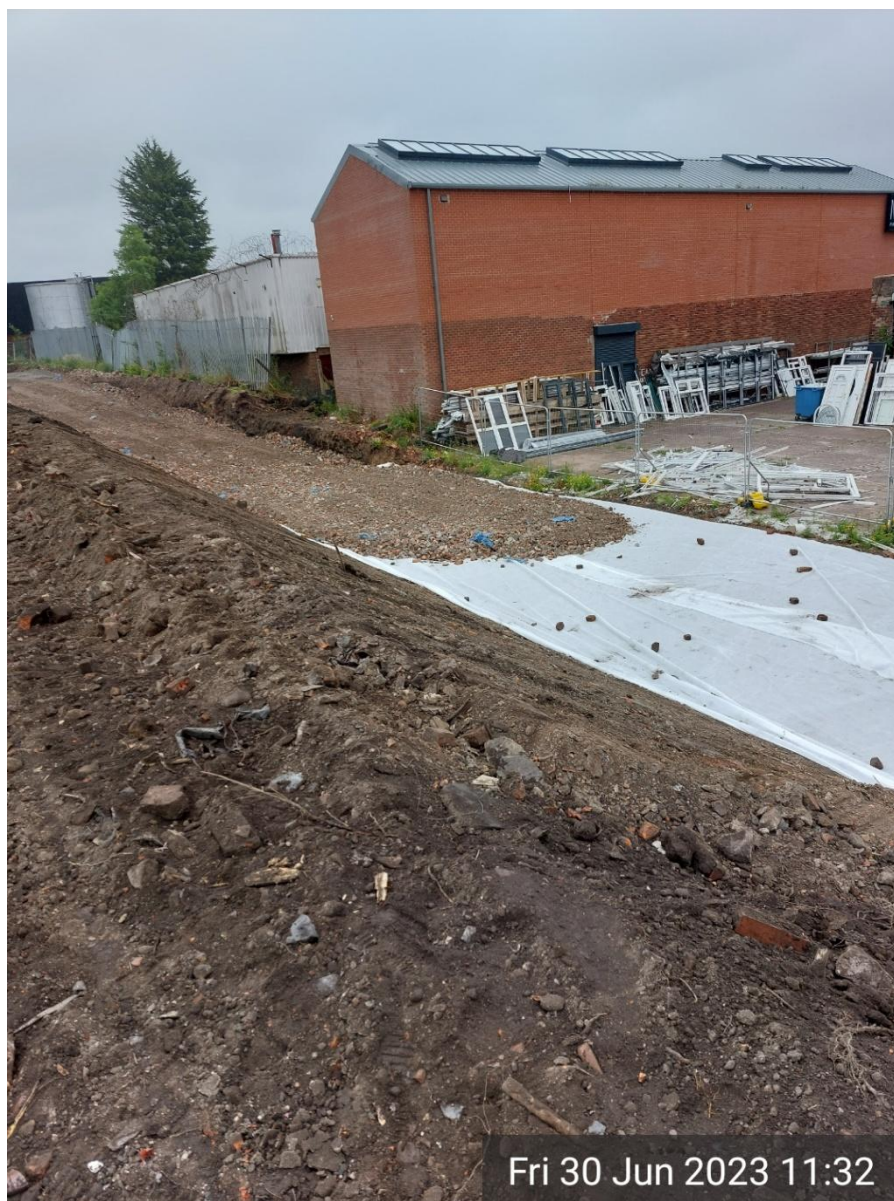
| Notes: | Ground Remediated to Lower Areas |

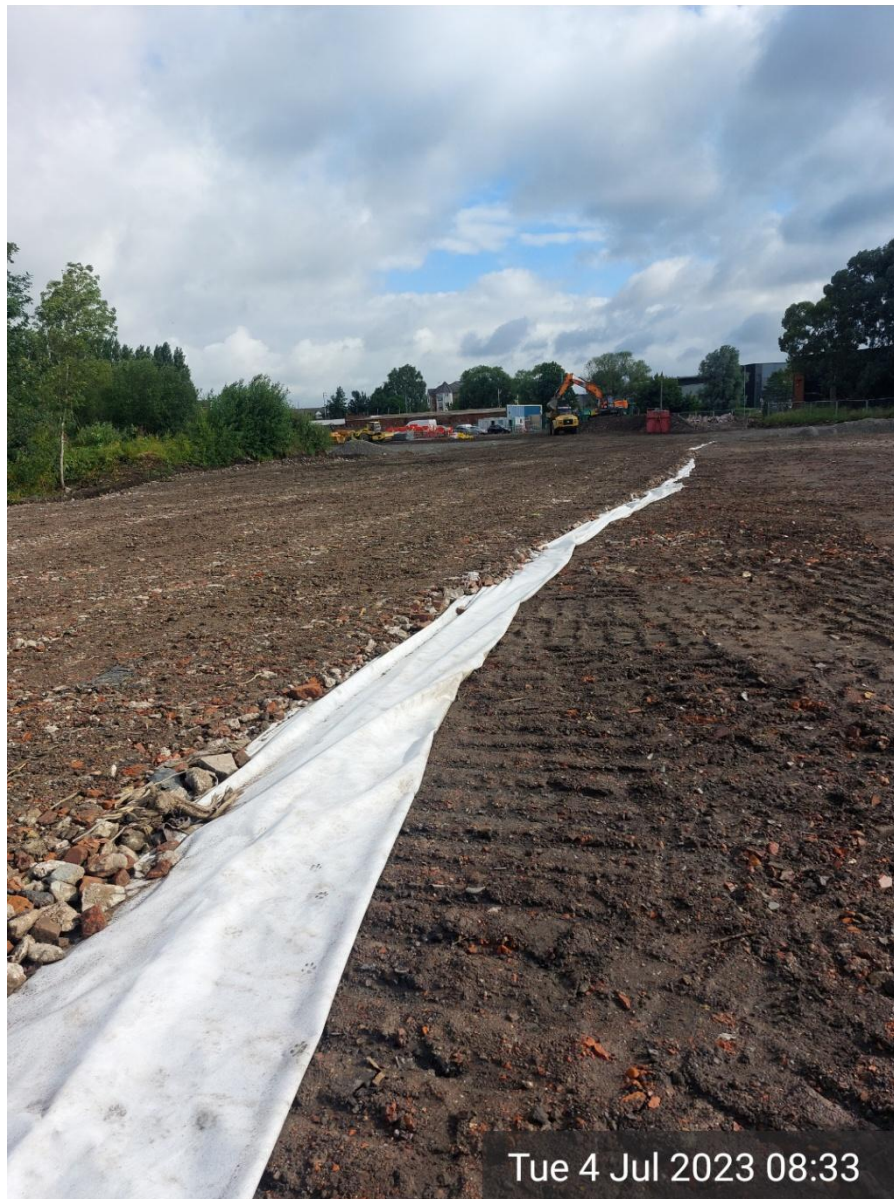
| Notes: | Capping taken over Planter Bed to left side |

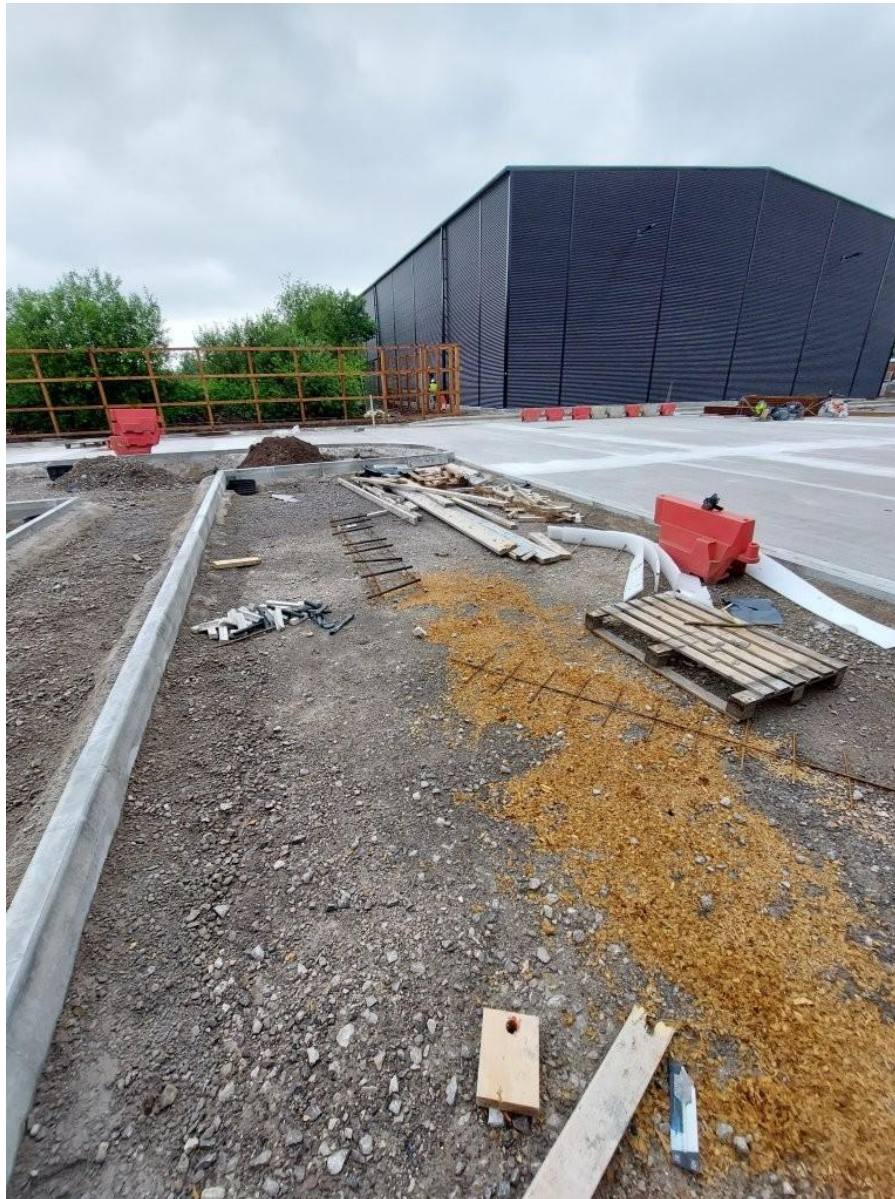
| Notes: | Planting bed Unit 2-3 |

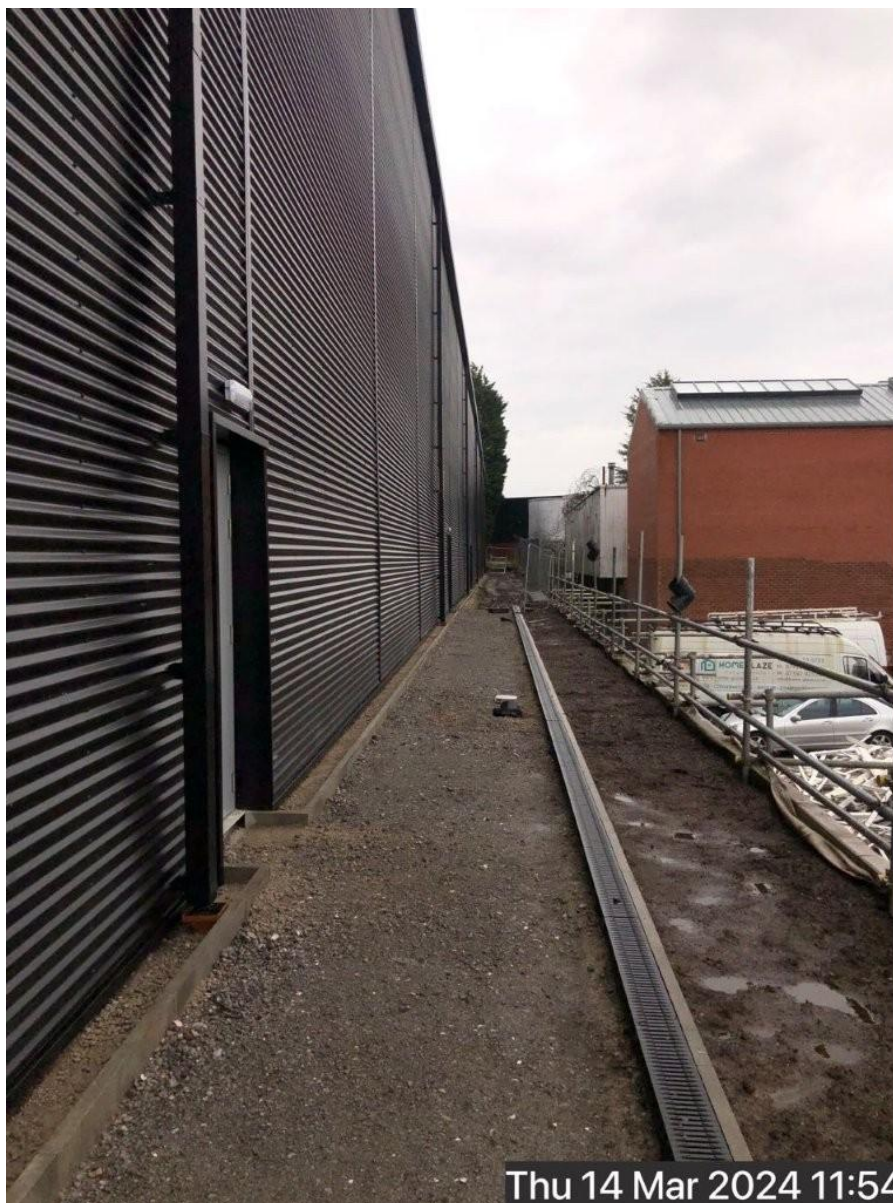
| Notes: | Rear Planting Bed Units 2 – 3 |

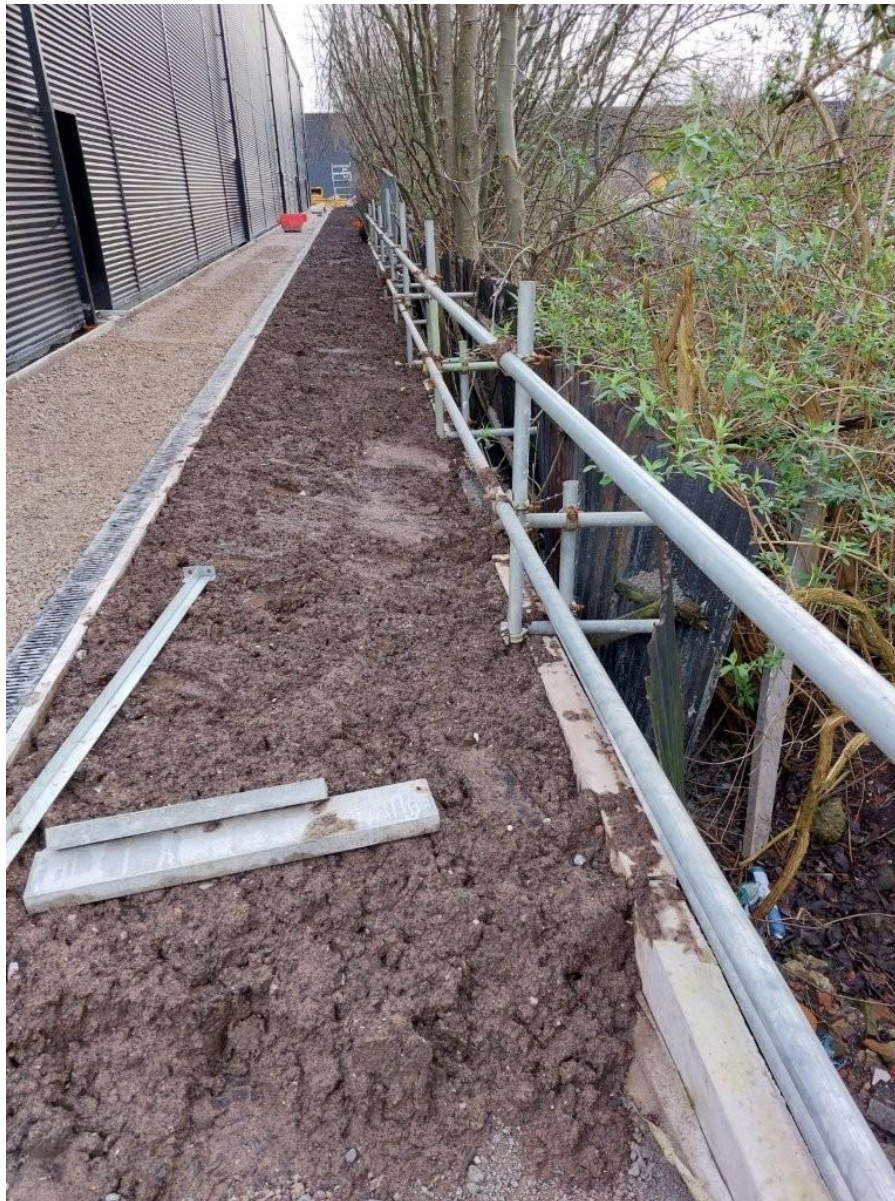
| Notes: | Unit 4 – 8 Planter Dig |

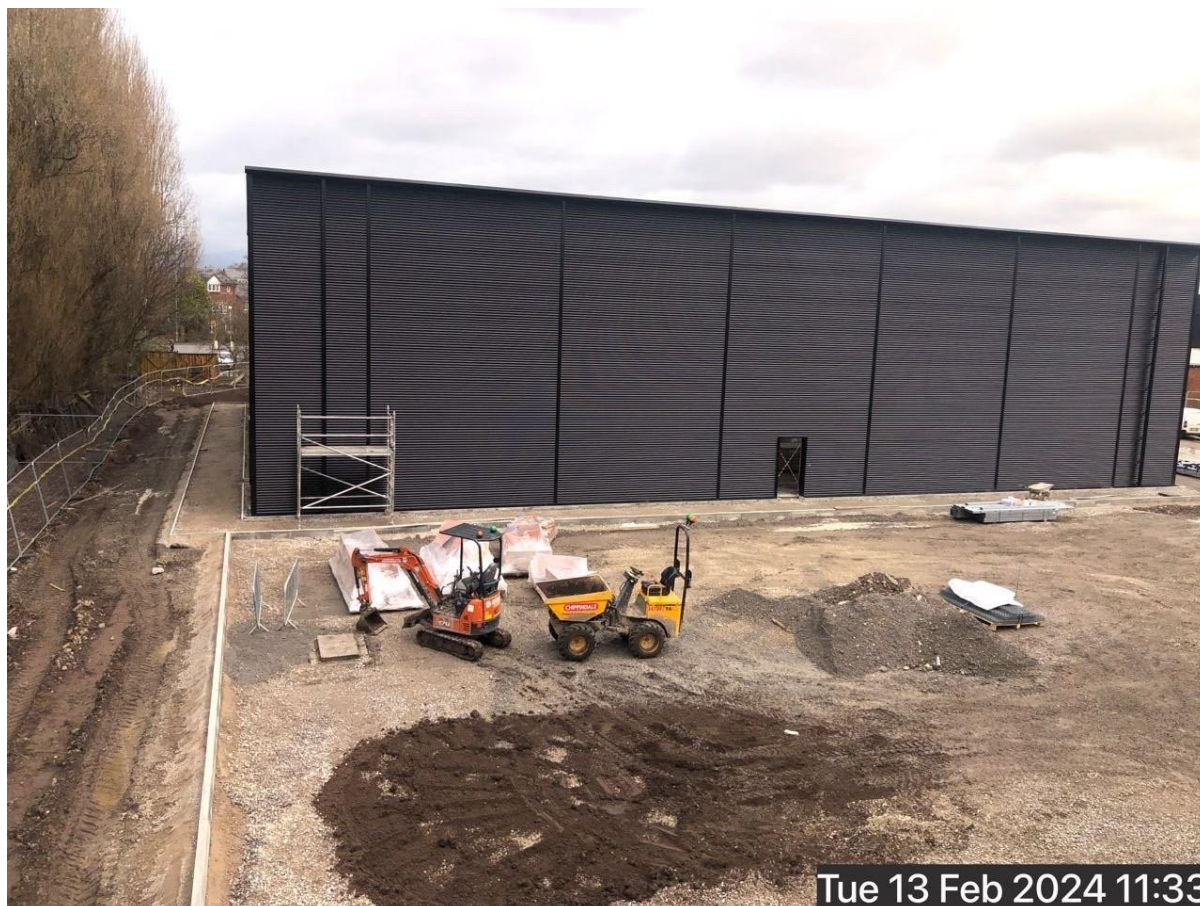
| Notes: | Unit 9 Planter Depth |

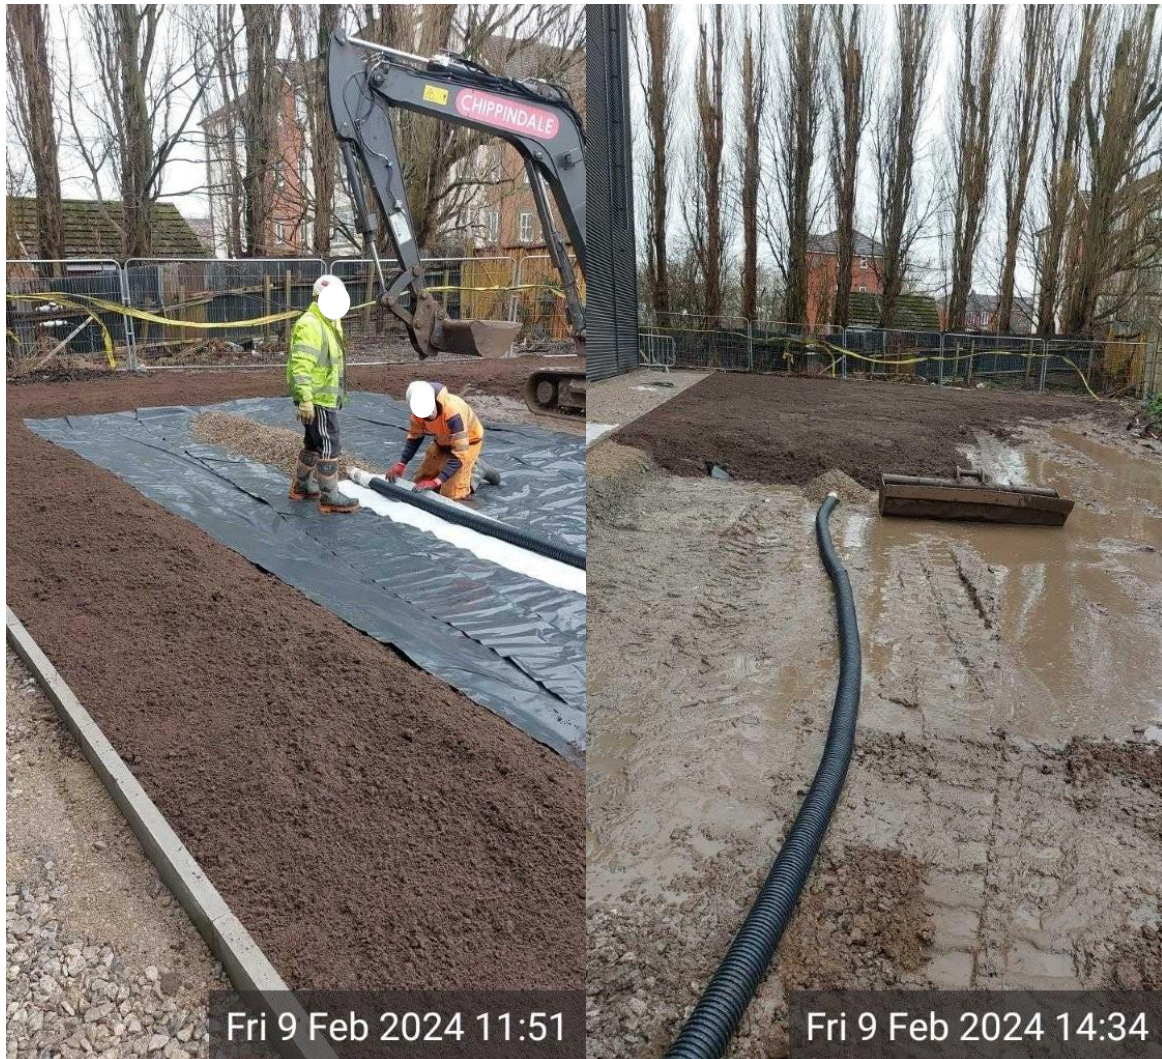
| Notes: | Rain Garden installation |

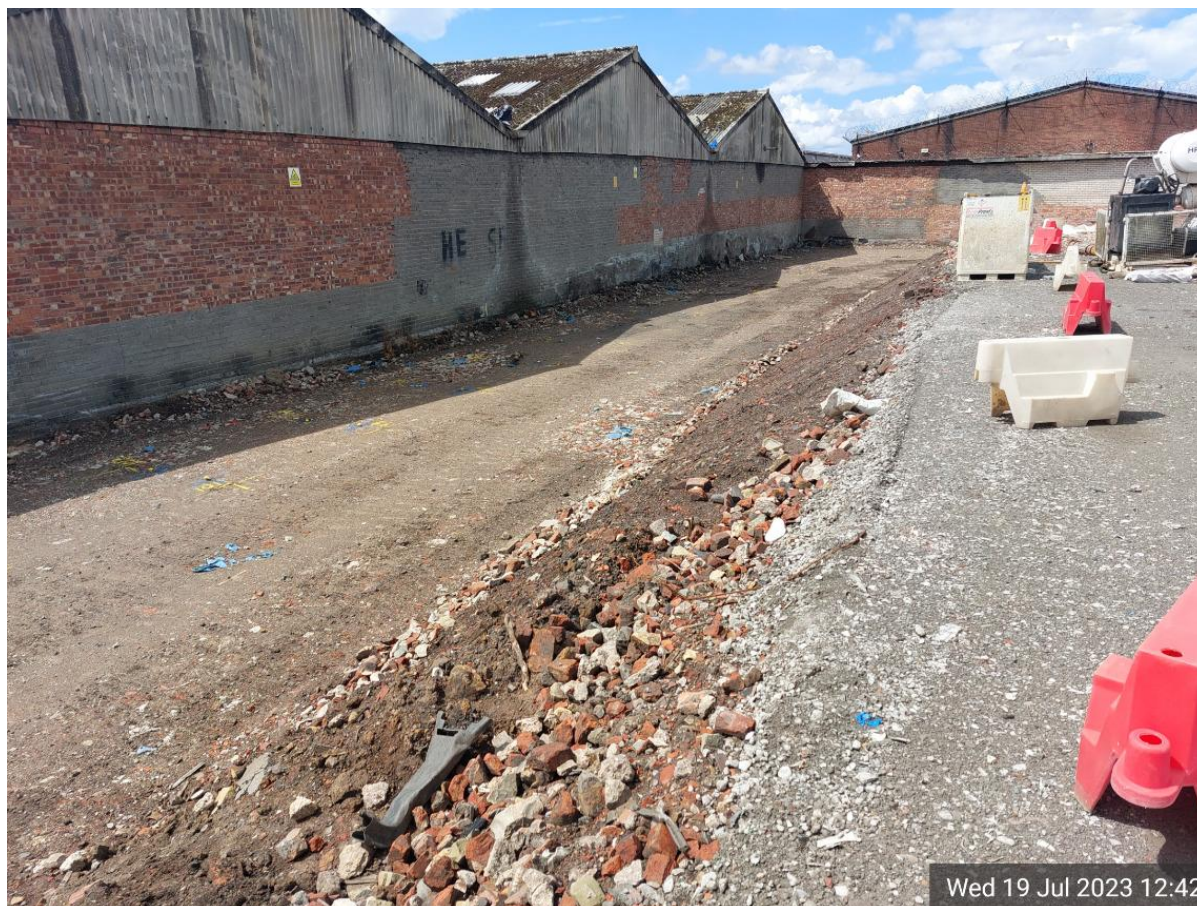
| Notes: | Remediated Ground at the Retaining Walls |
