# Elizabeth Street, Cheetham Hill

## Phase 4 Validation Report

**Curtins Ref: 080139-CUR-XX-XX-T-GE-00006**

Site Address: Land off Elizabeth Street, Cheetham Hill, Manchester, M8 8BB

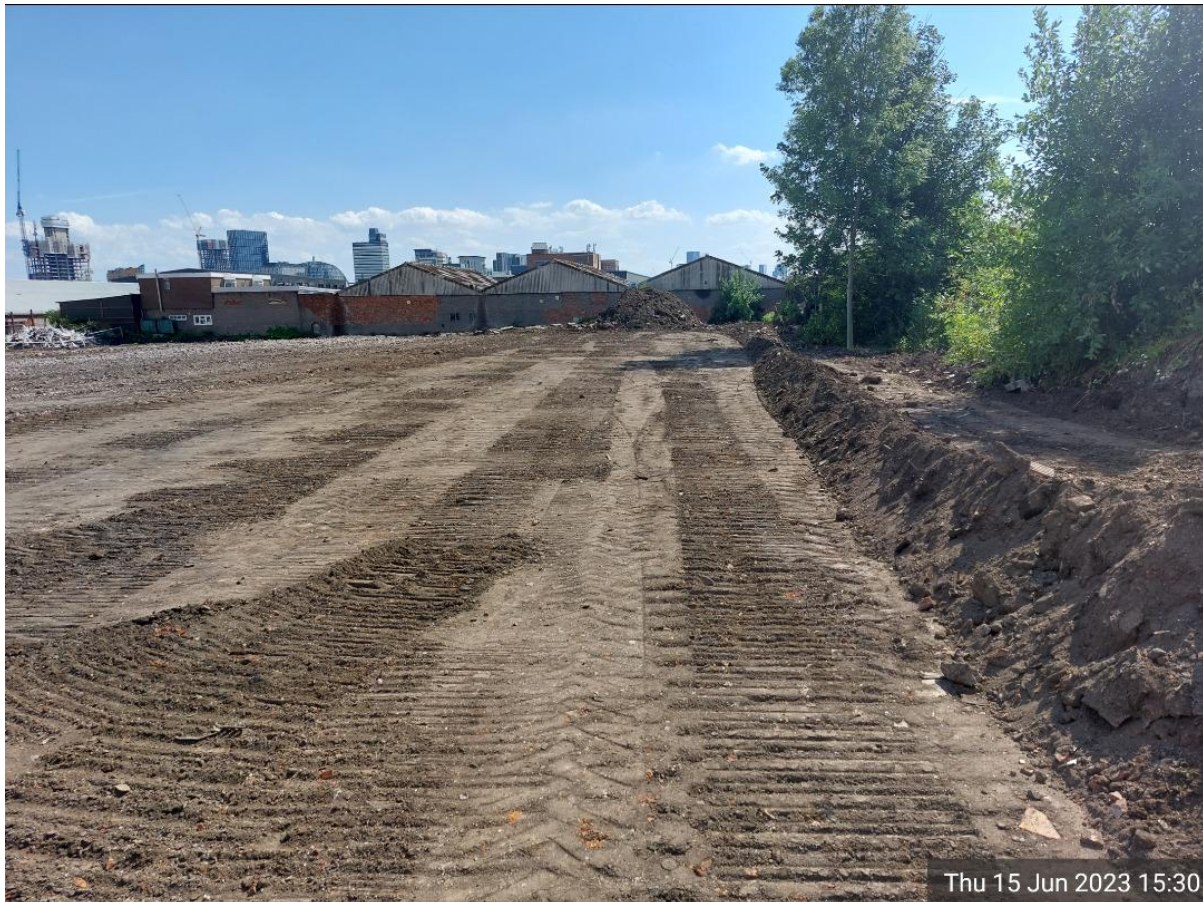
| Notes: | Remediated Ground taken to Boundary |

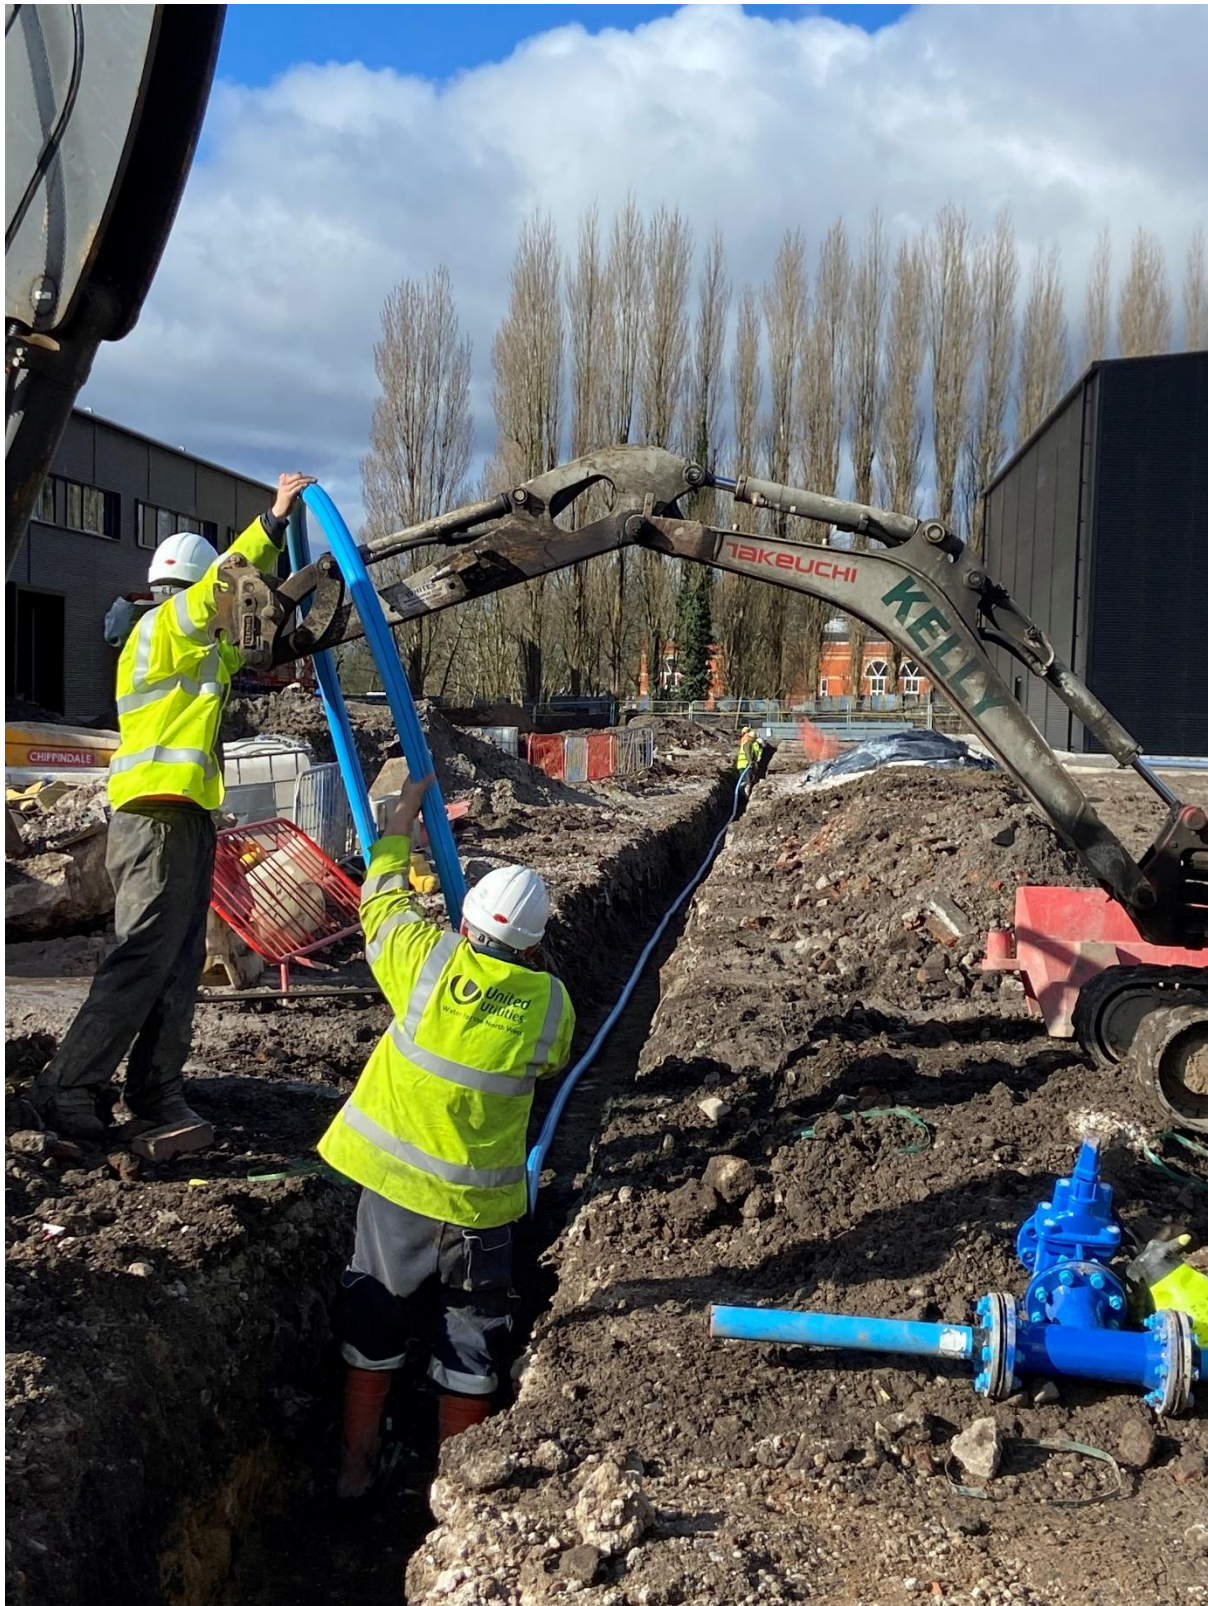
| Notes: | Installation of Protectaline Barrier Pipe |

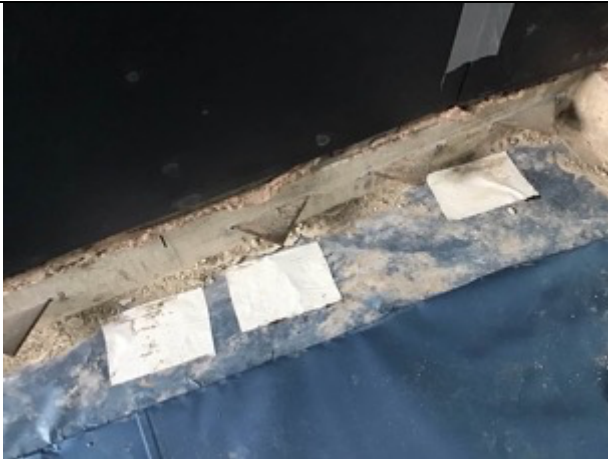
Unit 2 patch repairs

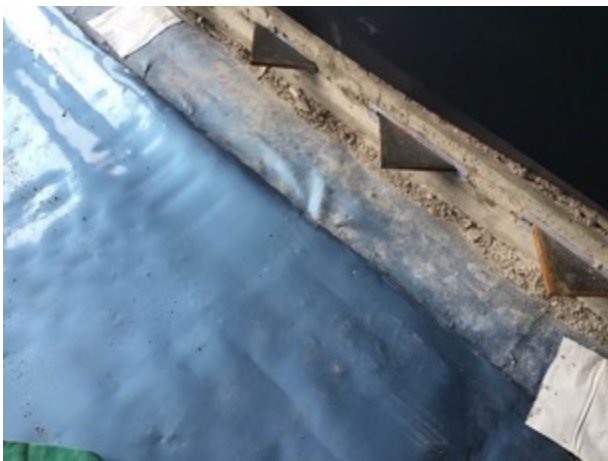
Unit 3 membrane sealed to core area existing membrane

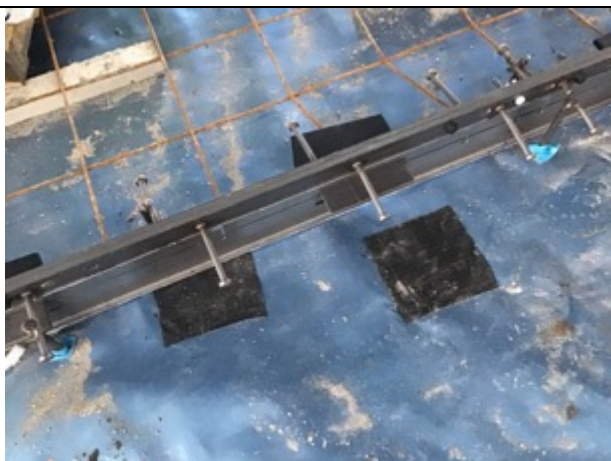
Sealed patch repairs

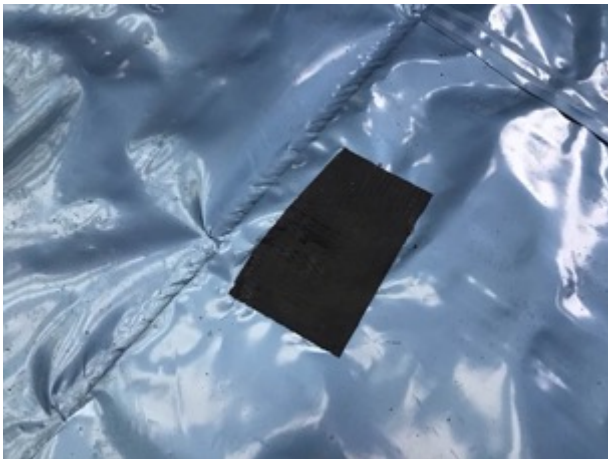
Sealed patch repair

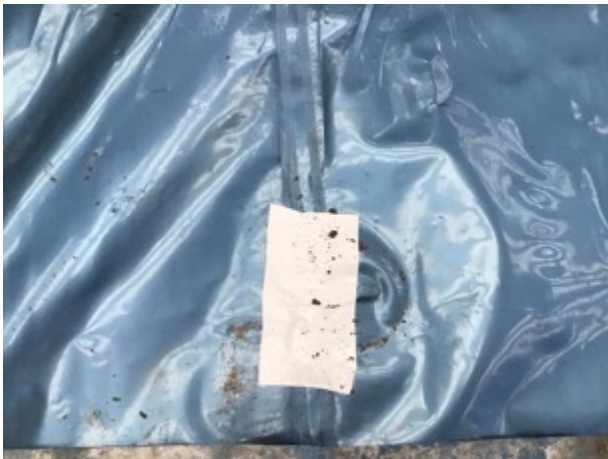
Sealed patch repair

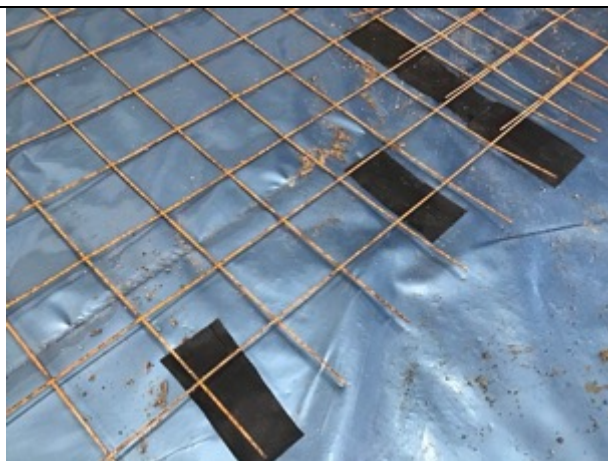
Sealed patch repairs

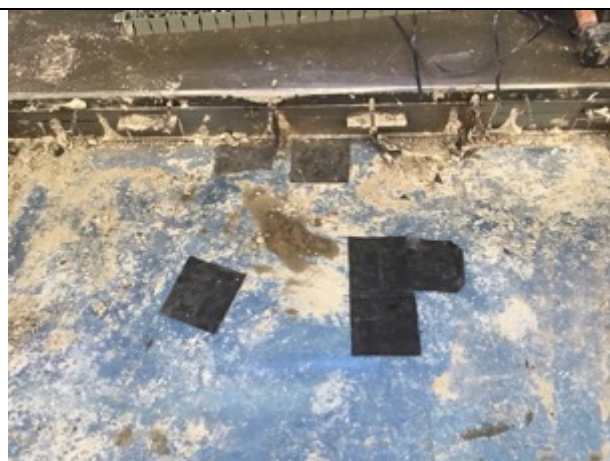
Sealed patch repairs

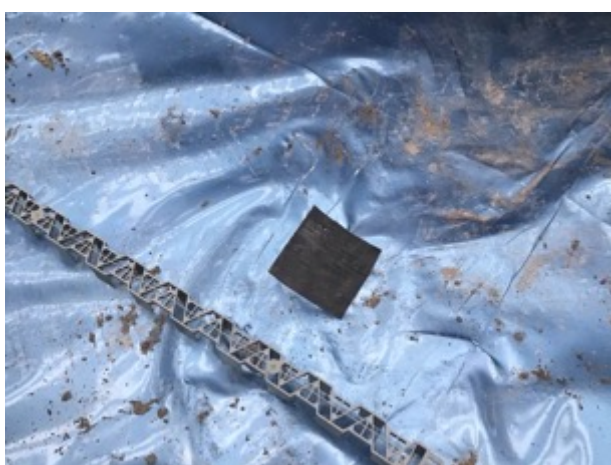
Sealed patch repair

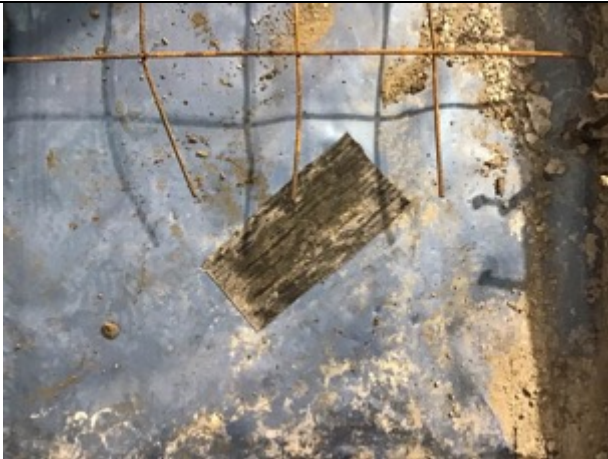
Patch repair

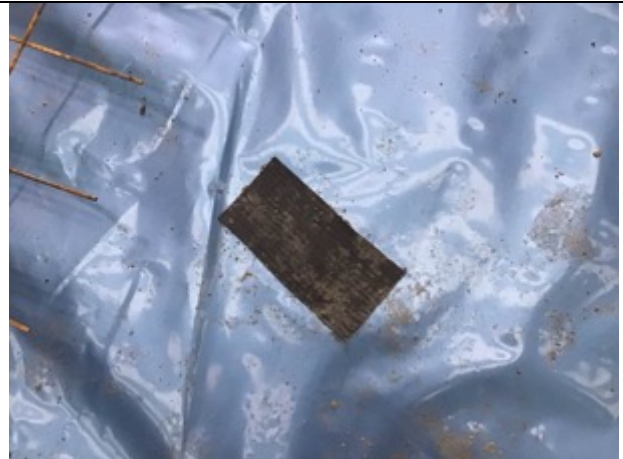
Patch repair

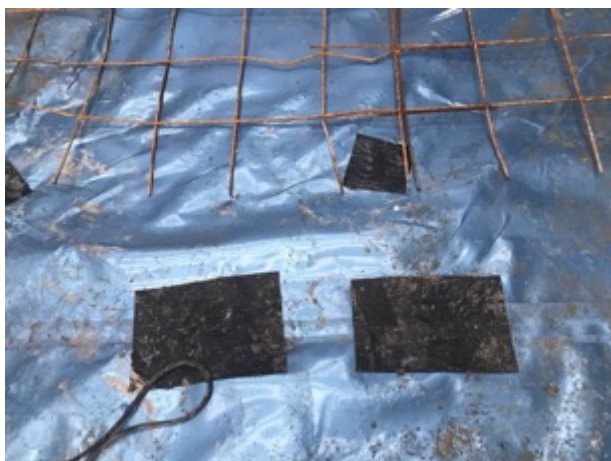
SAGM patch repairs
