Date: 22<sup>nd</sup> August 2024  
Reference: 15-974 V10

## GAS MEMBRANE VALIDATION – BENNETT STREET

| <b>Project Name:</b> | Bennett Street |
| <b>Plot:</b> | 119 - 122 |

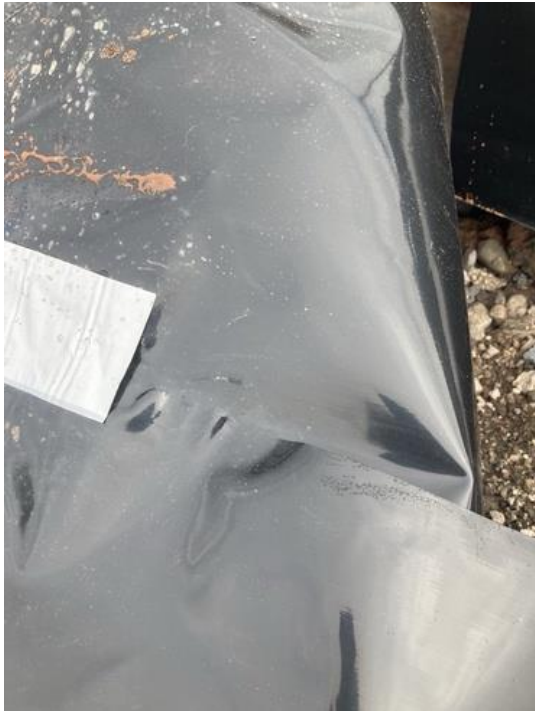
Photo 1

| <b>Gas Membrane Condition: Open punctures, tears, rips, stretching, Presence of debris, Repairs, Signs of weakness such as raised or sunken indentations, Protection plan in place to restrict access to lain gas membrane? IF FAIL DESCRIPTION IN ACTIONS AND PHOTOS REQUIRED</b> | Pass |
| <b>Are welds complete?</b> | Yes |
| <b>Are Joints lapped and sealed in accordance with manufacturer's requirements/ specification?</b> | Yes |

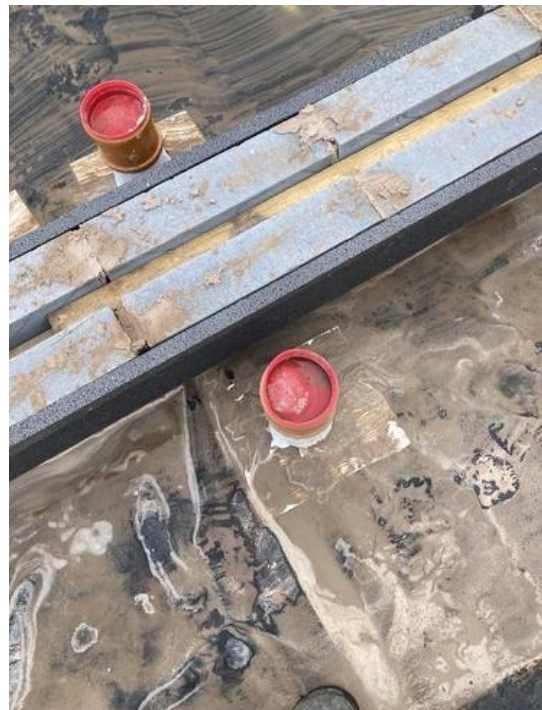
Photo 4

| <b>Service entries seals: Top hats seal arrangements fixed around service entries? Use of Jubilee clips or Bitumastic Sealant</b> | Pass |
