**GAS MEMBRANE VALIDATION**

| <b>Site Name: Belle Vue Stadium</b> | <b>Project Number: 12-123</b> |
| <b>Company Name: Countryside</b> | <b>Date: 25-05-2022</b> |

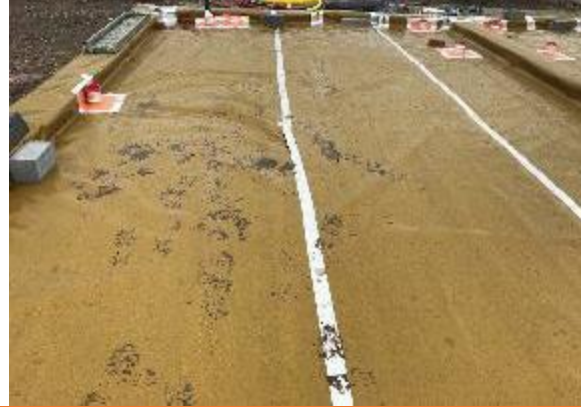
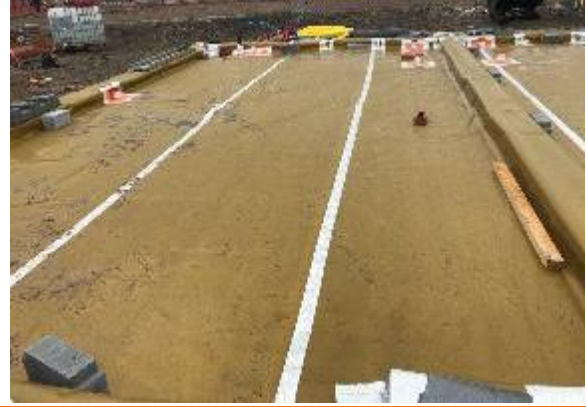
**Plot - 89**

**General Condition of Membrane-Good Condition**

| Slab / membrane condition (is membrane clear of debris or insulation) | Good |

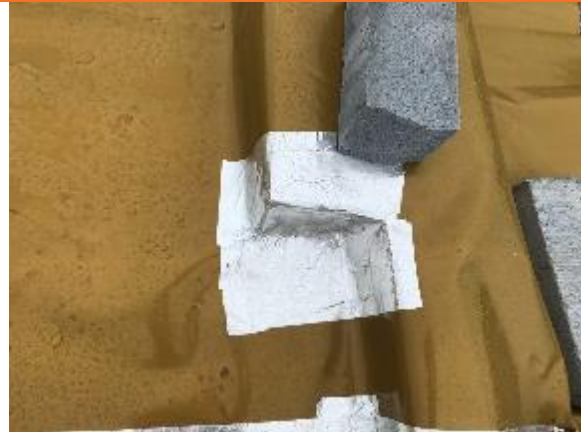
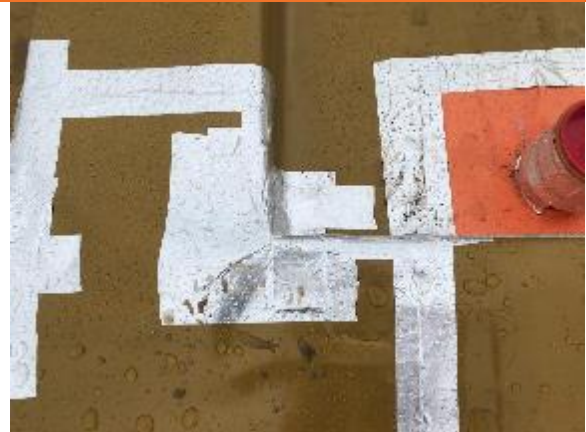
**Verification of Joints and Seals-Overlapped and sealed correctly**

| Membrane joints inspected has Double –sided butyl tape been used? | yes |

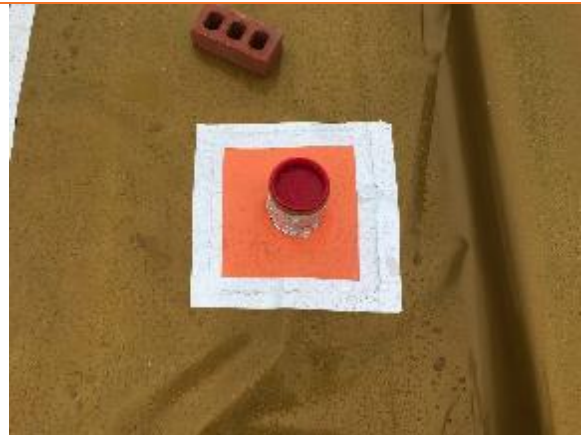
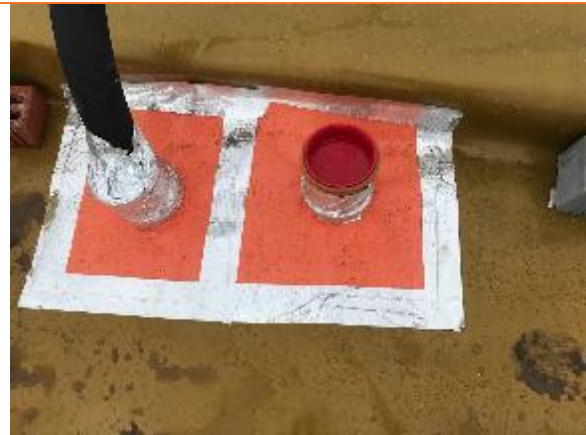
**Verification of Service Penetrations-Good Condition**

| Service entries – Jubilee clips, Top hats installed correctly | yes |

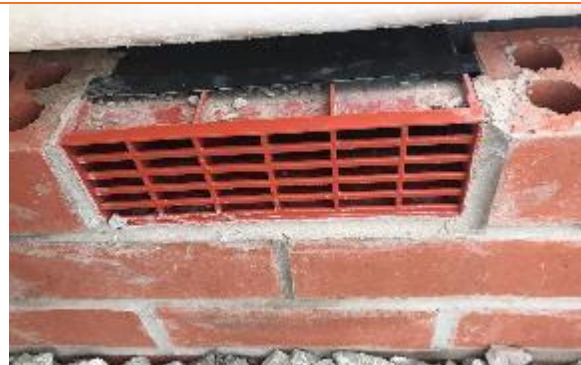
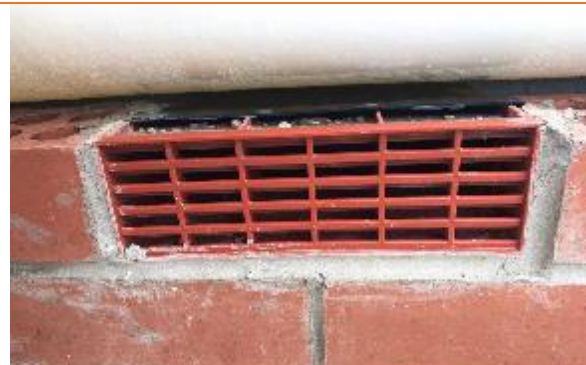
**Verification of Ventilation-Good Condition**

| External Wall Air bricks Present? | yes |

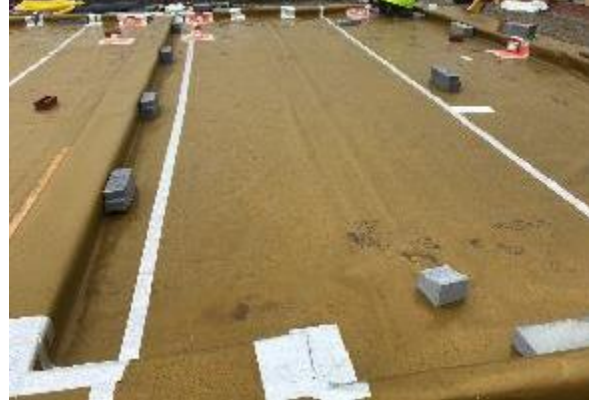
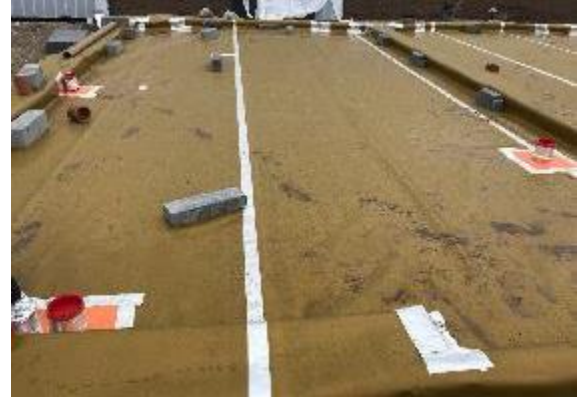
**Plot - 90**

**General Condition of Membrane-Good Condition**

| Membrane Type | Comments |
|---|---|
| Slab / membrane condition (is membrane clear of debris or insulation) | Good |

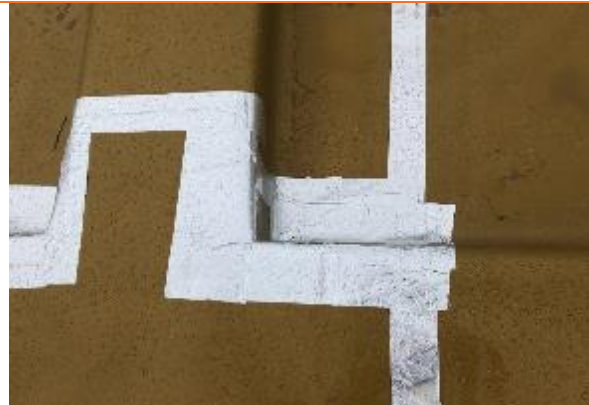
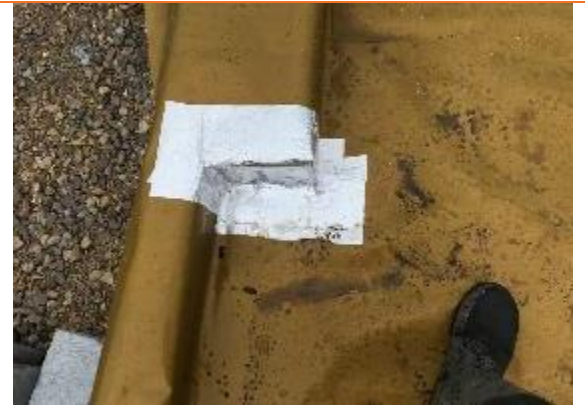
**Verification of Joints and Seals-Overlapped and sealed correctly**

| Membrane Type | Comments |
|---|---|
| Membrane joints inspected has Double -sided butyl tape been used? | yes |

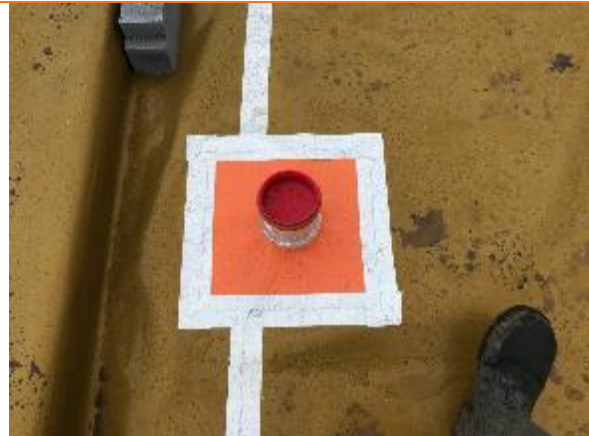
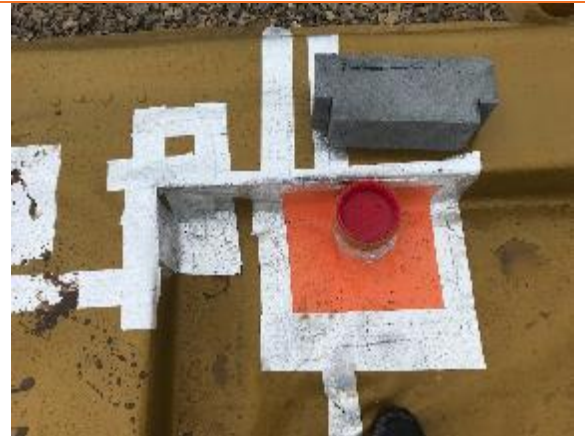
**Verification of Service Penetrations-Good Condition**

| Membrane Type | Comments |
|---|---|
| Service entries - Jubilee clips, Top hats installed correctly | yes |

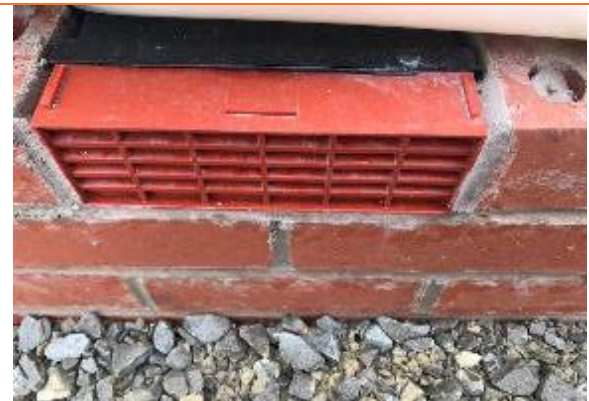
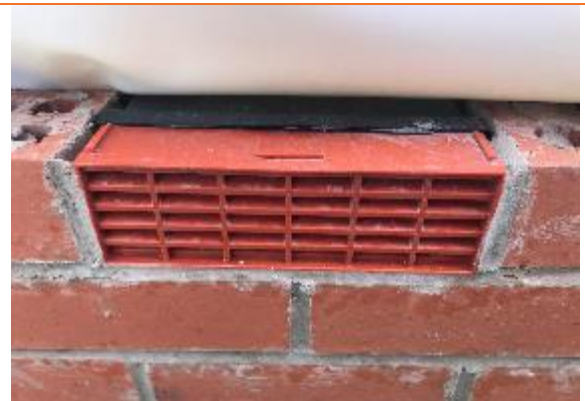
**Verification of Ventilation-Good Condition**

| Membrane Type | Comments |
|---|---|
| External Wall Air bricks Present? | yes |

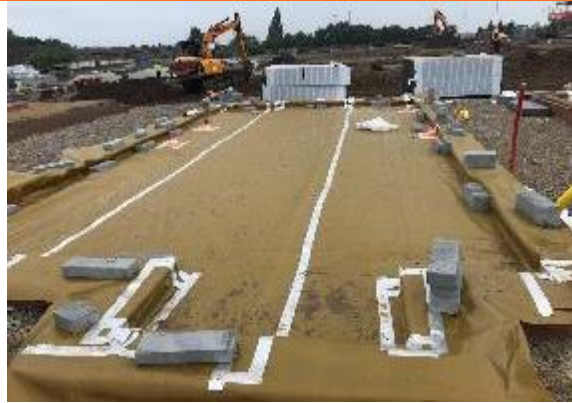
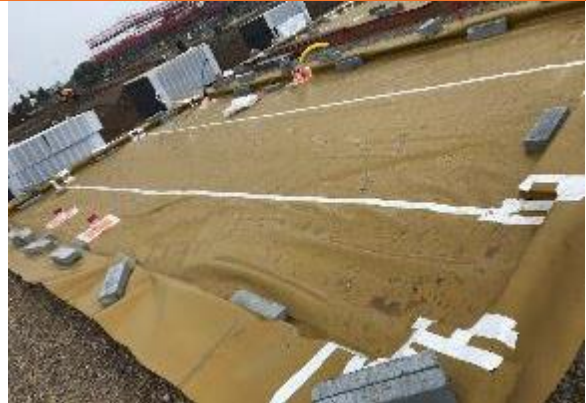
**Plot - 91**

**General Condition of Membrane-Good Condition**

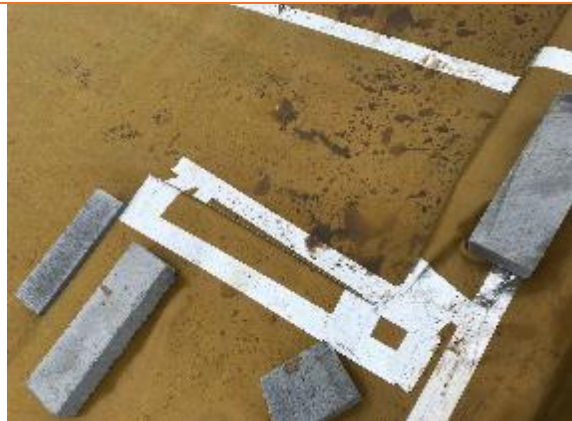
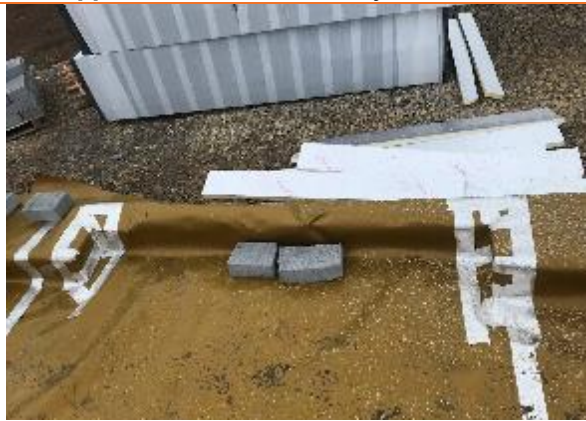
**Verification of Joints and Seals-Overlapped and sealed correctly**

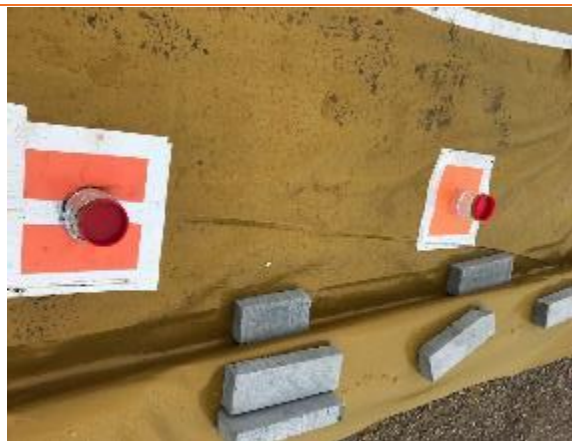
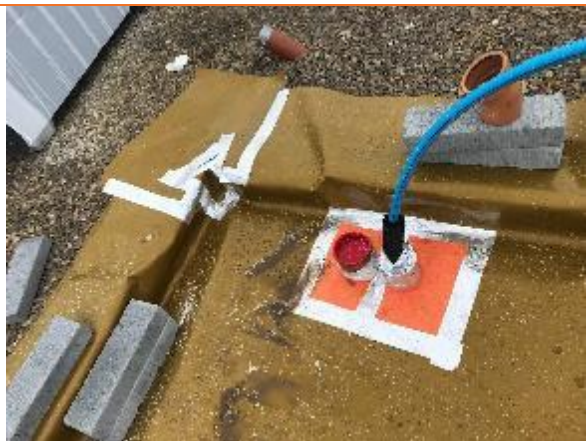
**Verification of Service Penetrations-Good Condition**

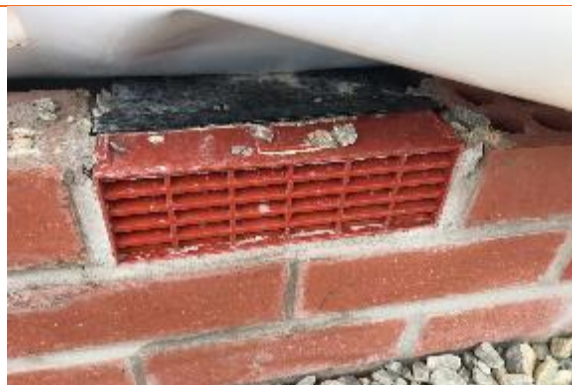
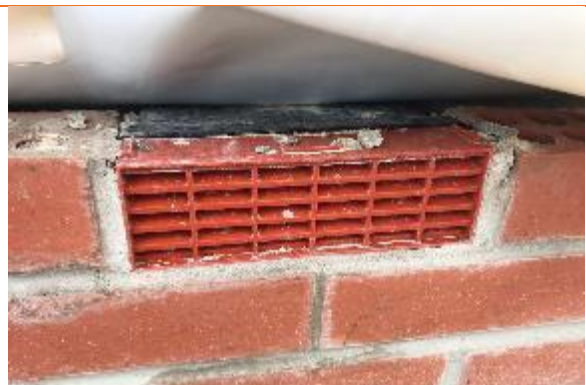
**Verification of Ventilation-Good Condition**
