## GAS MEMBRANE VALIDATION – BENNETT STREET

| <b>Project Name:</b> | Bennett Street |
| <b>Project Number:</b> | 15-974 |
| <b>Plot:</b> | Apartment Block 2 |

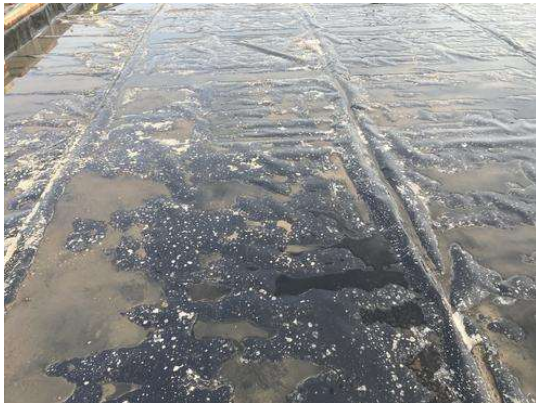
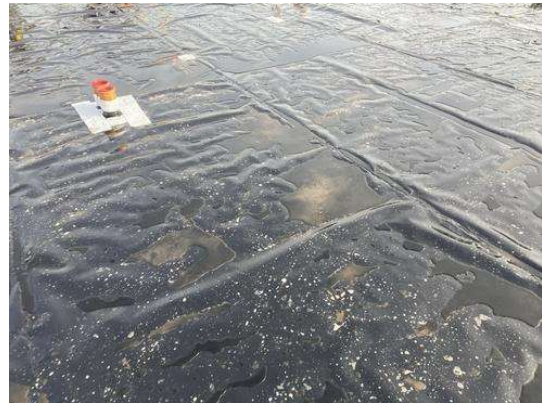
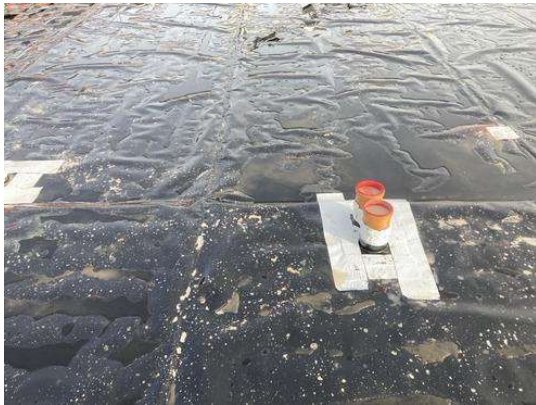
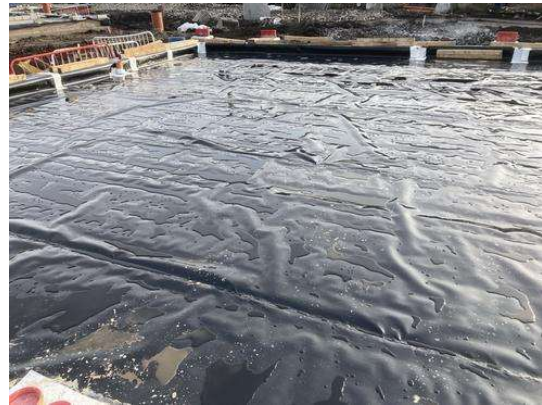
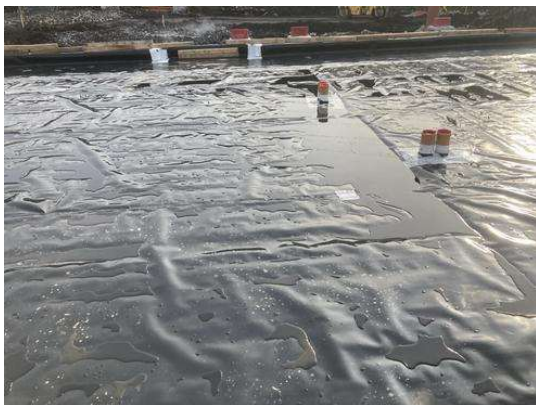
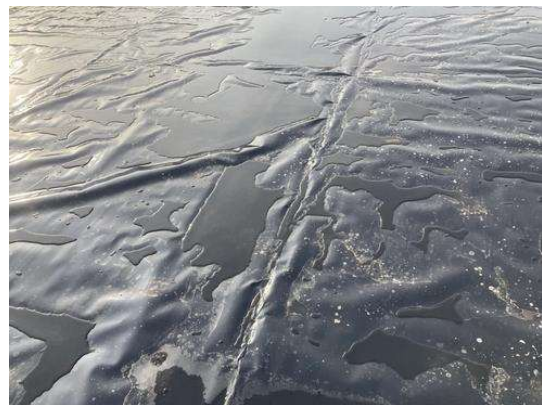
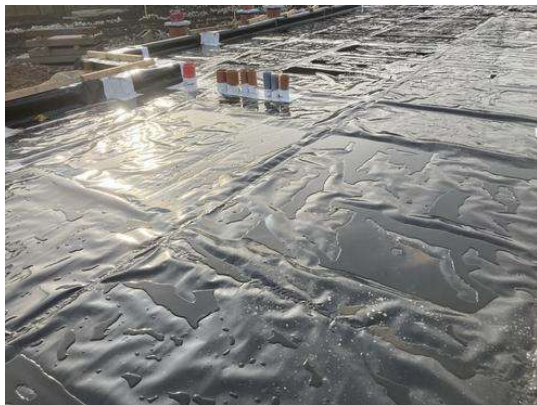
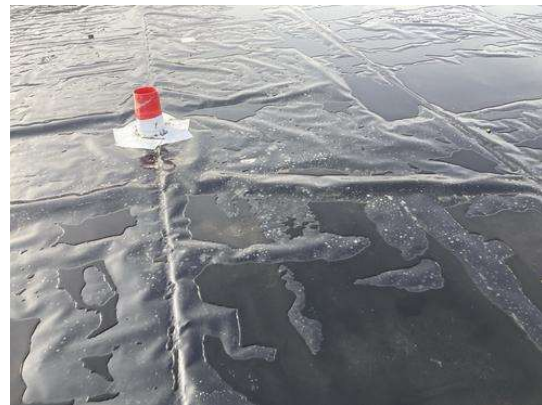
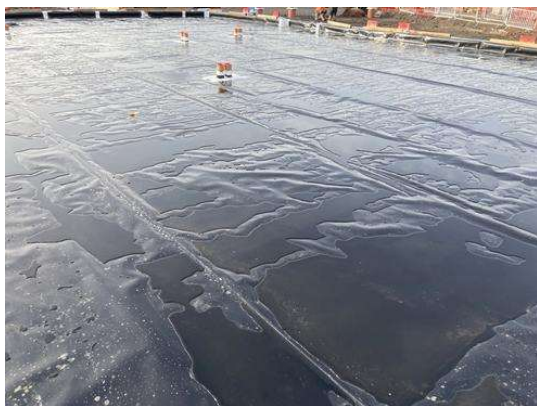
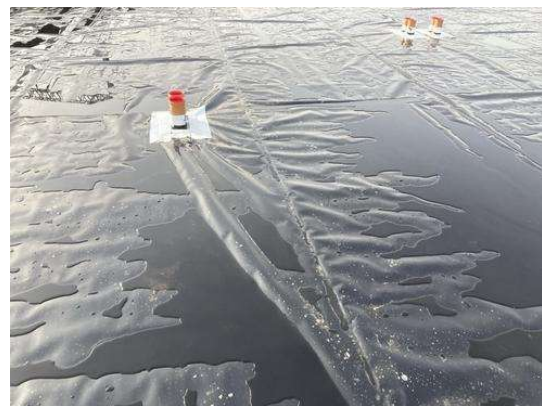
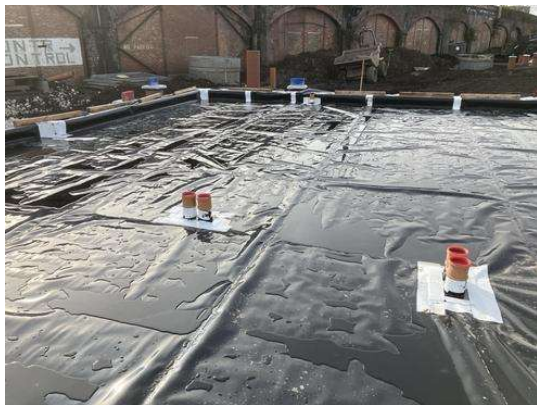
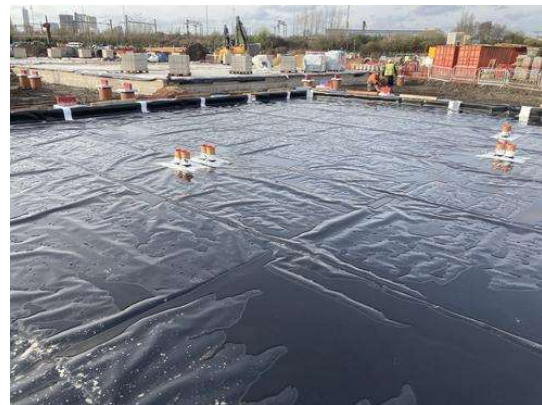
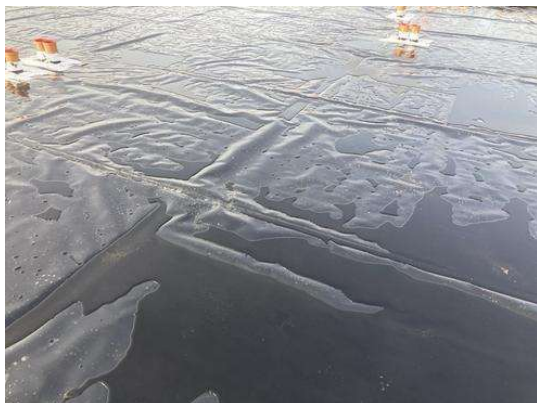
**Gas Membrane Condition: Open punctures, tears, rips, stretching, Presence of debris, Repairs, Signs of weakness such as raised or sunken indentations, Protection plan in place to restrict access to lain gas membrane? IF FAIL DESCRIPTION IN ACTIONS AND PHOTOS REQUIRED**

Pass

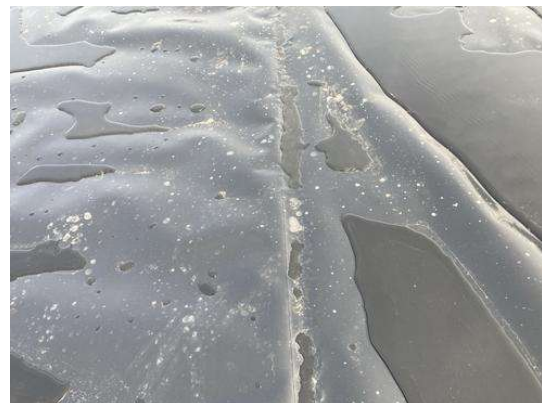
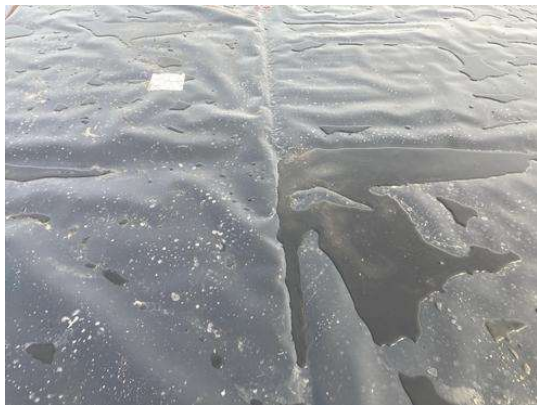
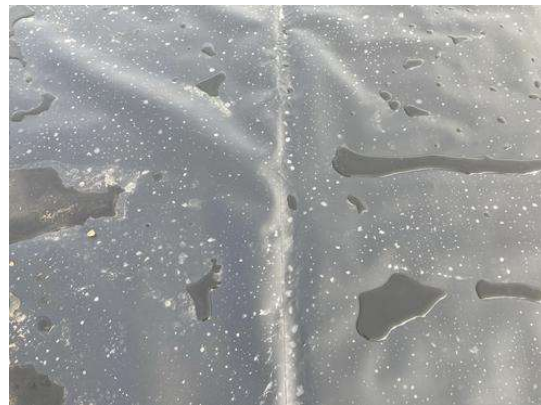
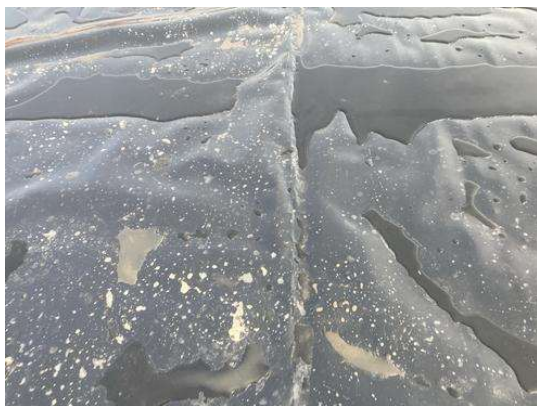
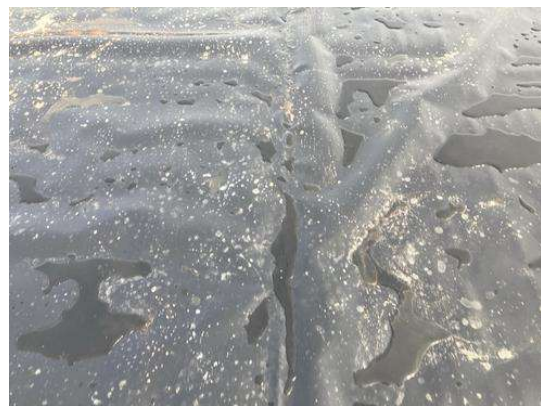
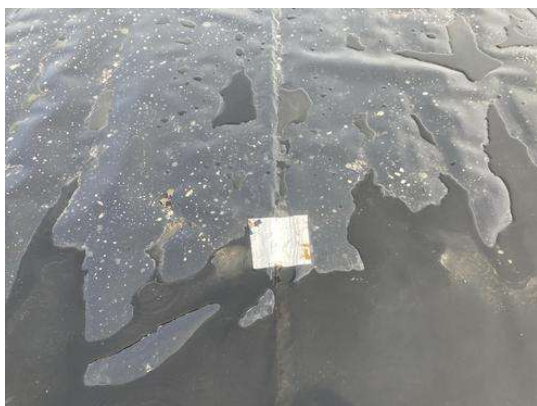
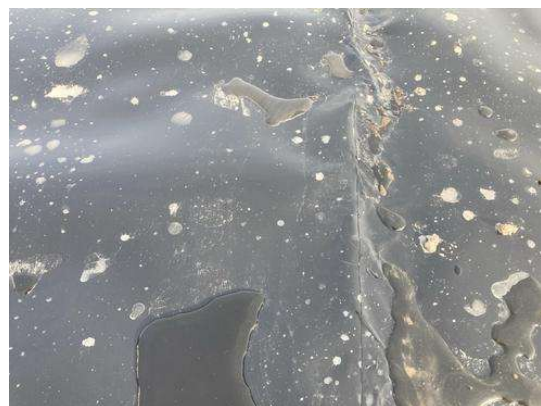
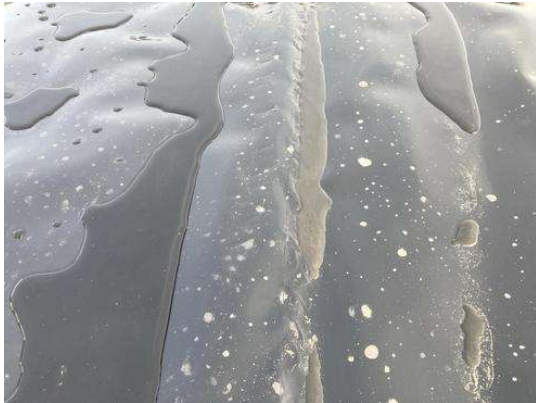
**Laps, welds, and joints seals: Joints lapped and sealed in accordance with manufacturer's requirements/ specification? Minimum overlap insured? Sections taped twice? Are welds complete? Appropriate joining/double-sided tape used, Folds running in line with joints? (no joints cutting across folds)**

Pass

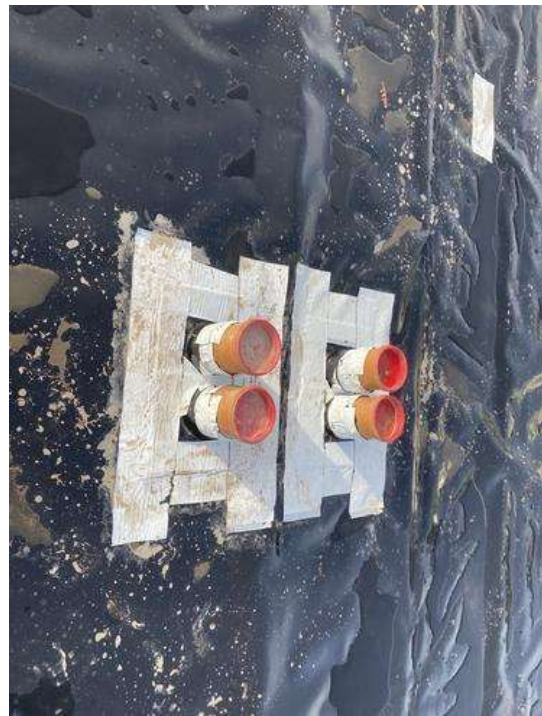
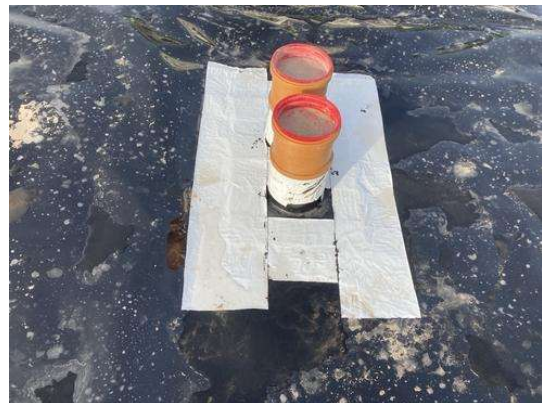
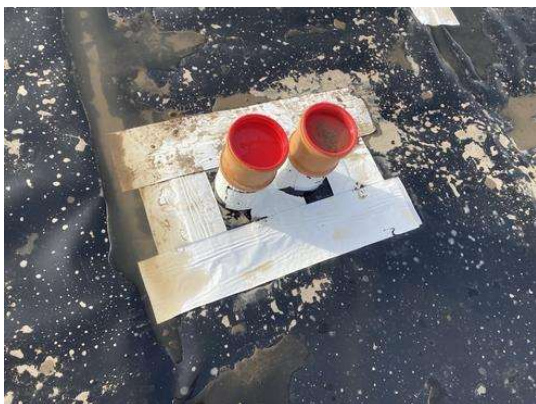
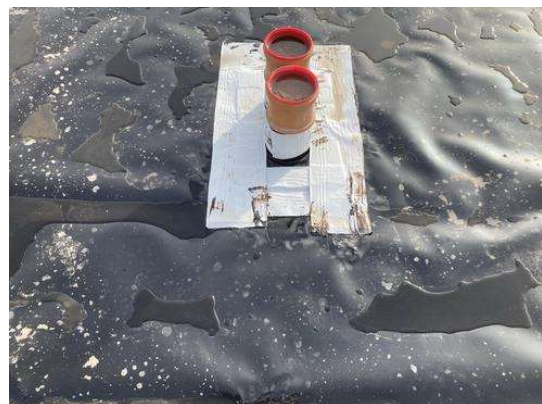
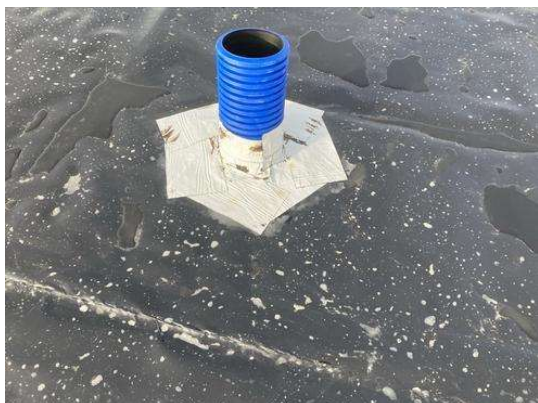
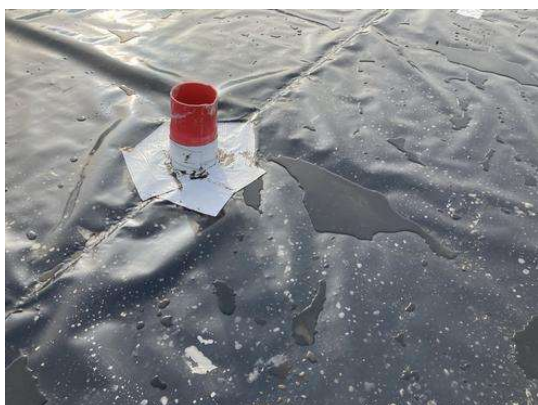
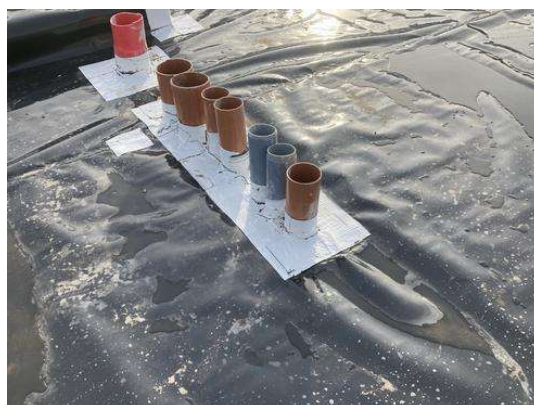
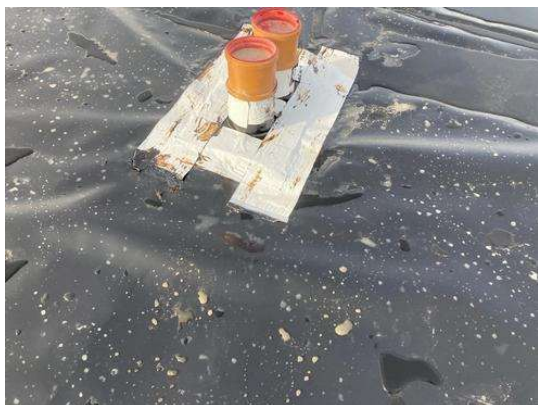
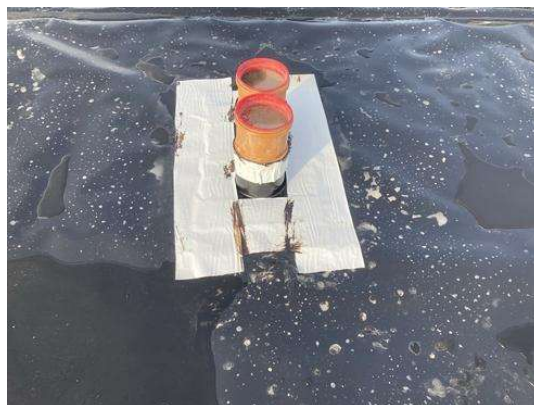
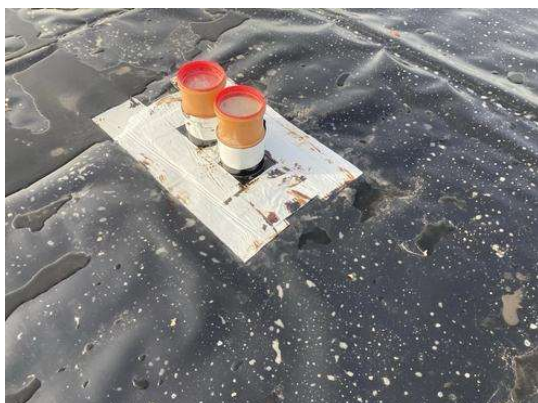
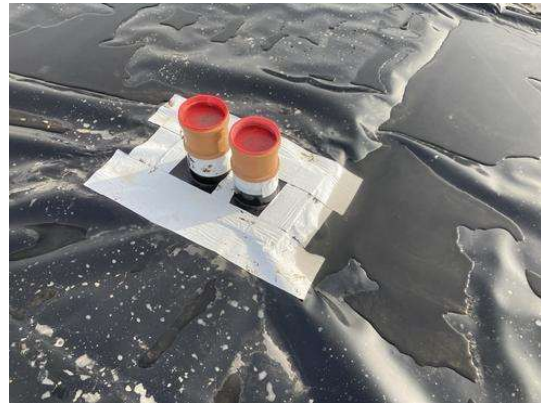
**Service entries seals: Top hats seal arrangements fixed around service entries? Use of Jubilee clips?**

Yes

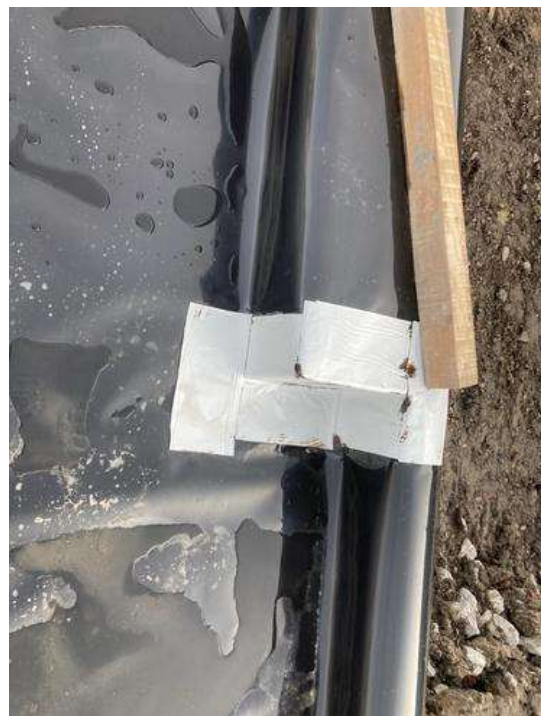
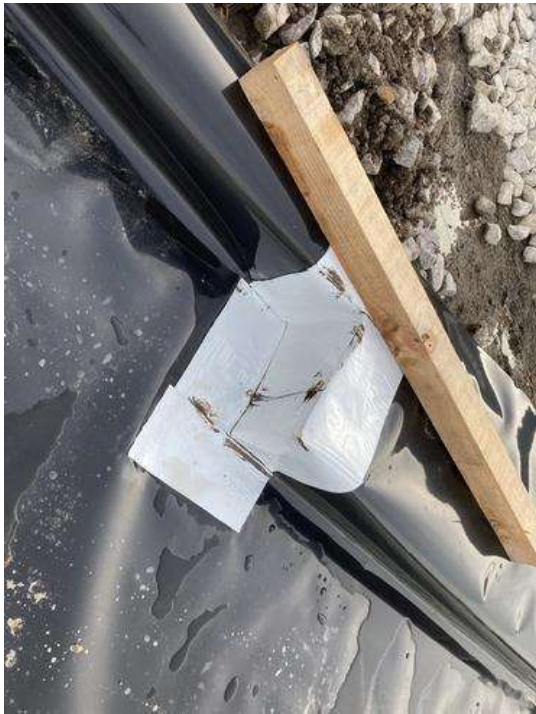
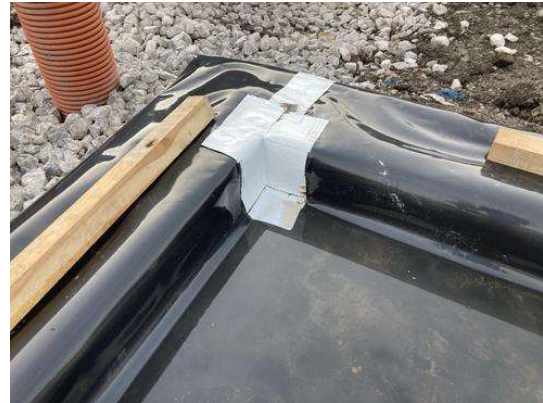
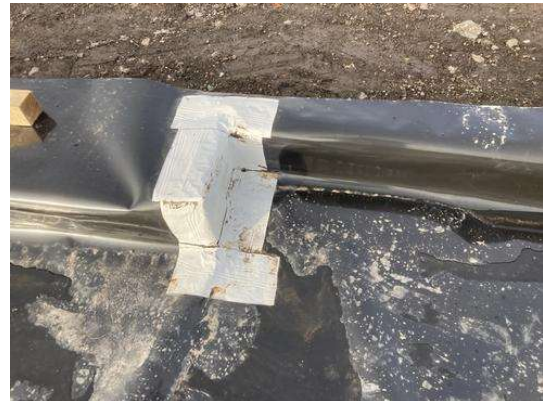
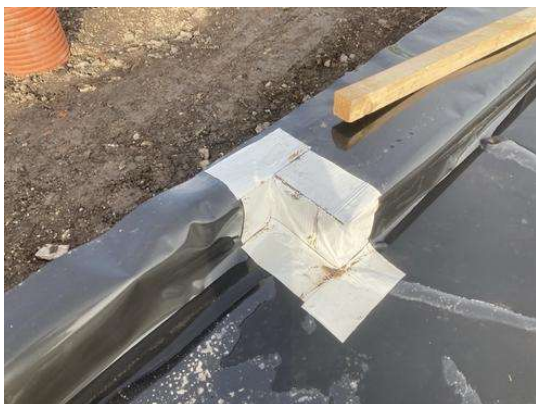
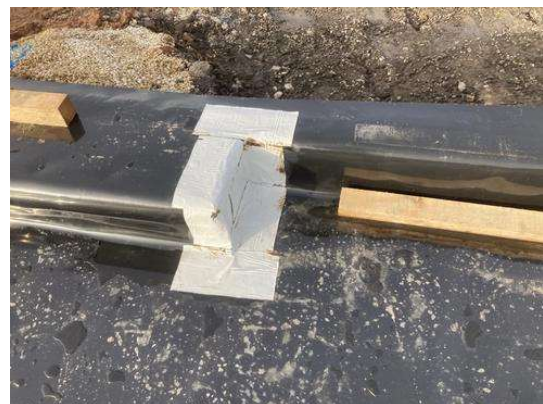
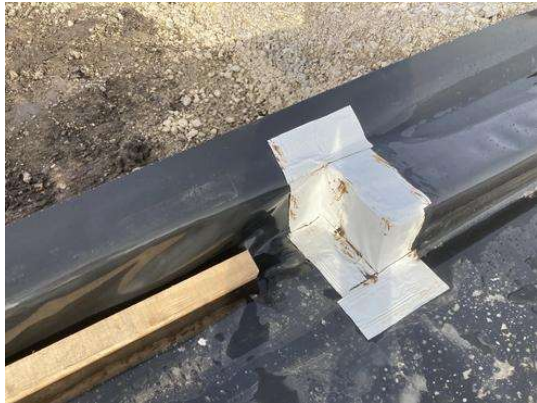
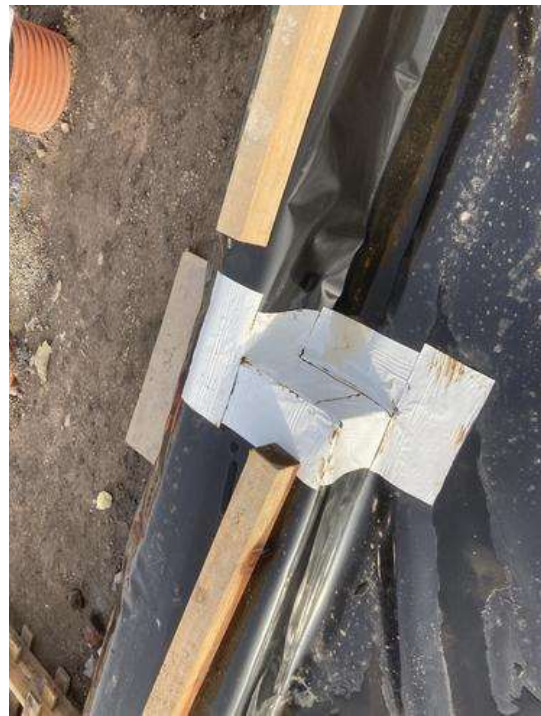
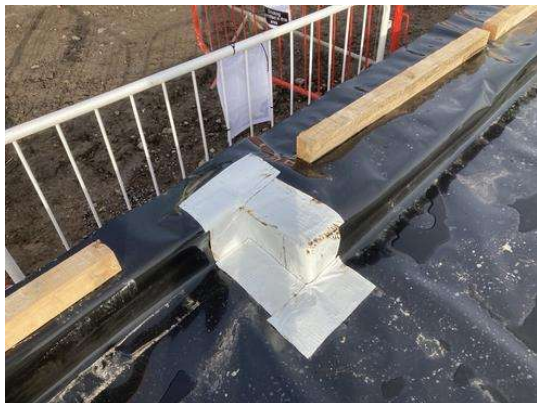
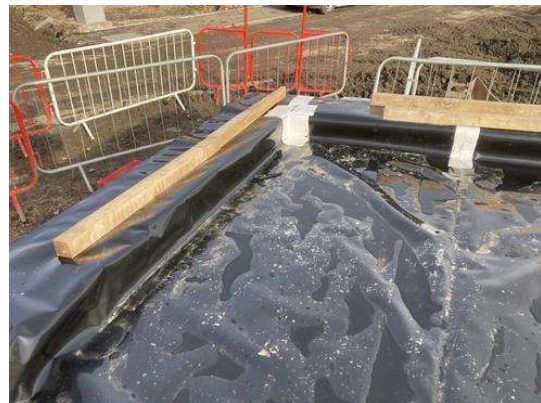
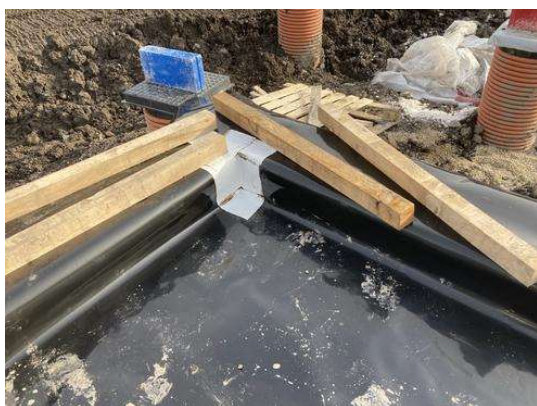
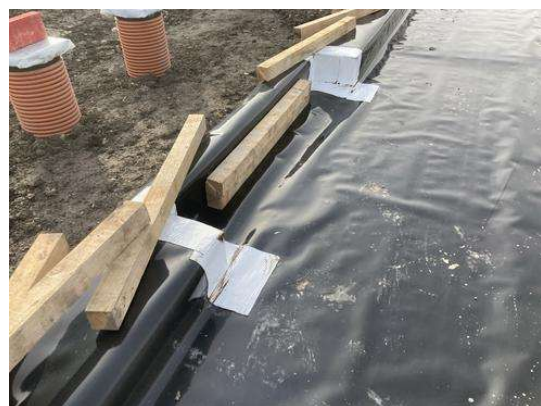
**Corners / Internal joints: Check all corners are correctly formed or contractor has used preformed corners.**

Pass

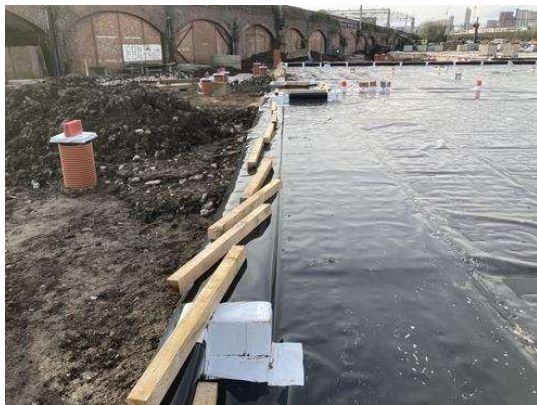
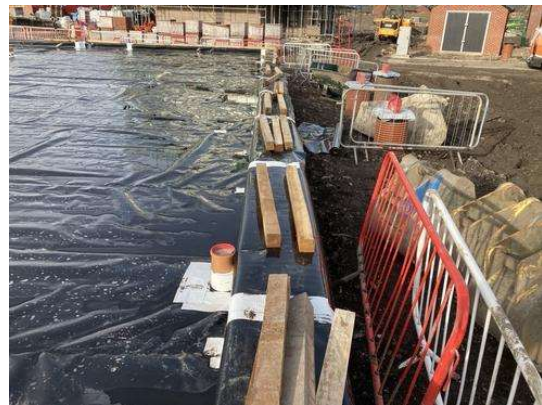
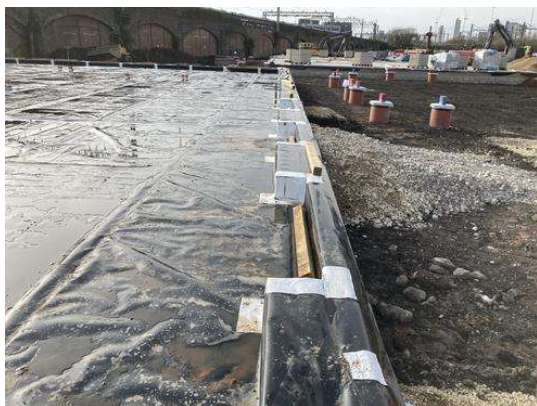
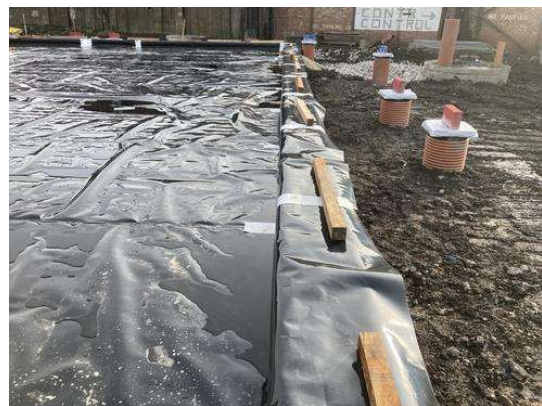
**Extent of Coverage: Is the membrane covering the entire plot? Does membrane span over outside walls?**

Yes

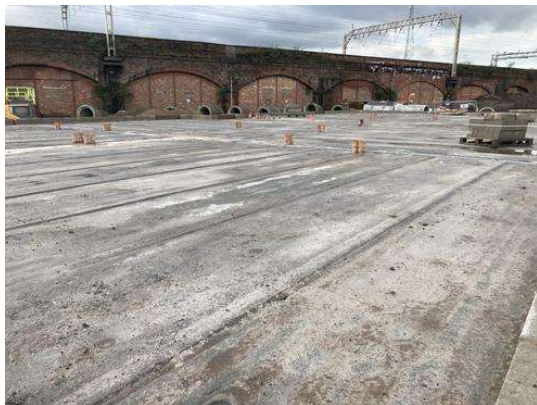
**Condition of sub-grade and underside of gas membrane: Check that the subgrade does not contain rough/uneven surfaces, is appropriately clean and that there are no hard/sharp objects. That protective sand blinding or geotextile (if specified) is present and meets the design criteria.**

Pass

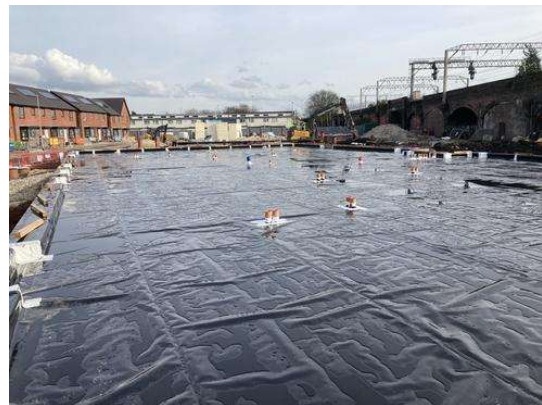
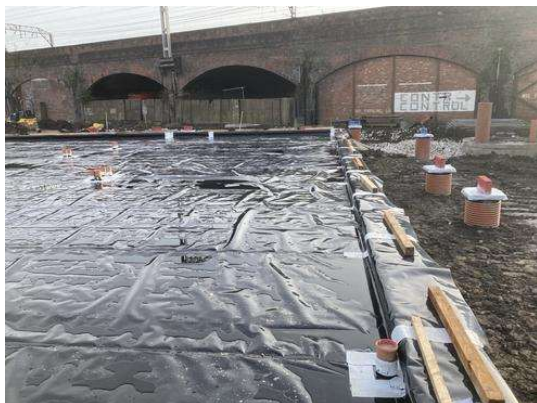
**Slab / membrane condition (is membrane clear of debris or insulation): Can membrane be fully seen and photographed – ask contractor to remove an debris so membrane can be fully seen an inspected – this is a requirement of NHBC and local authorities.**

Pass

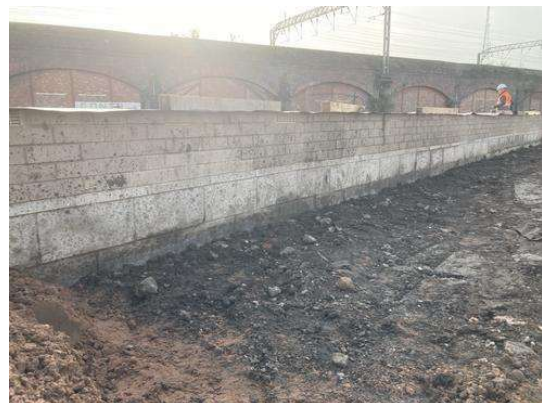
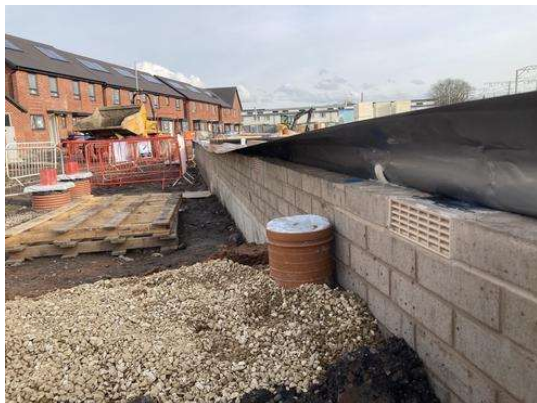
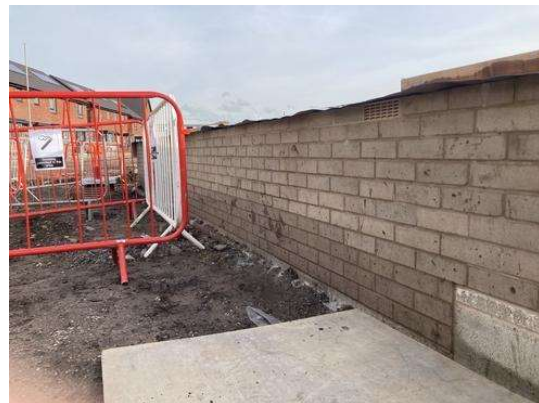
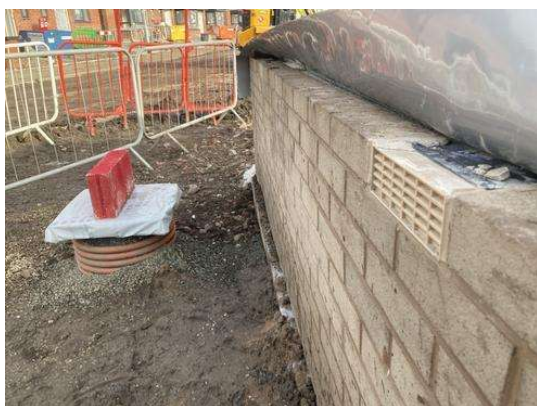
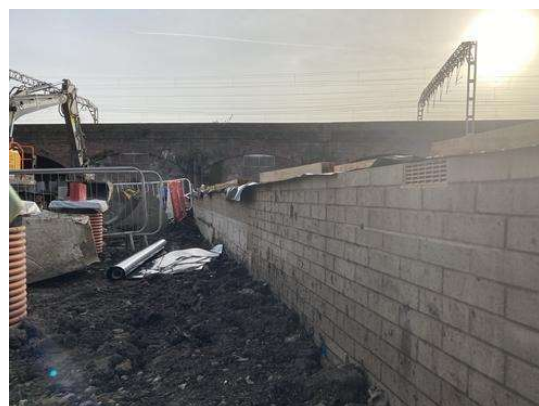
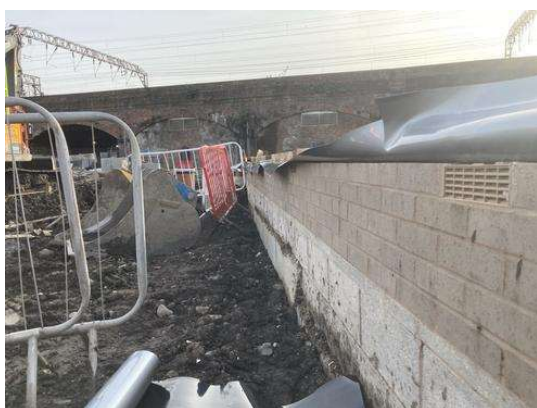
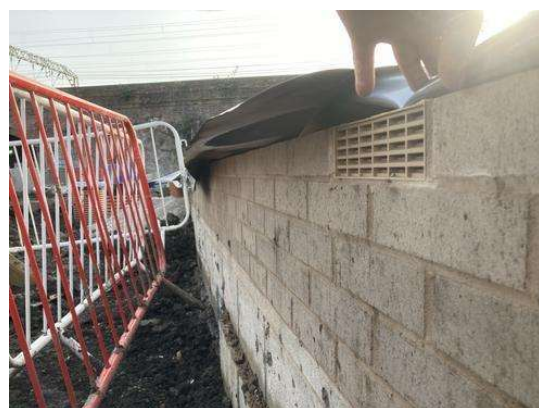
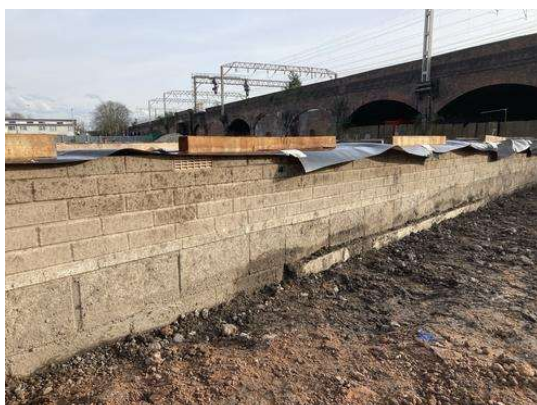
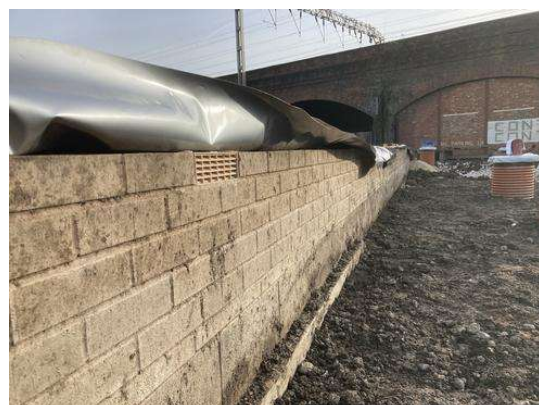
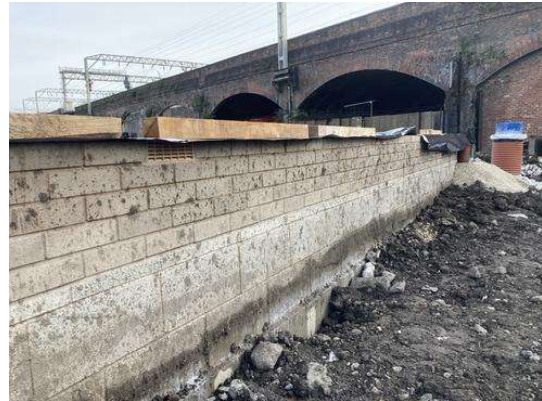
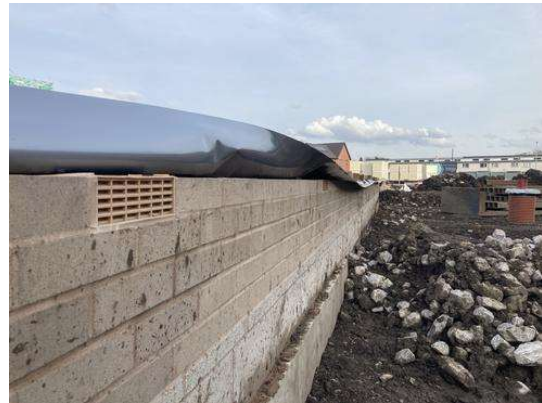
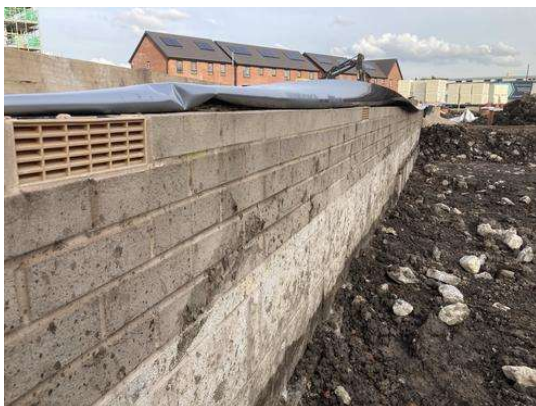
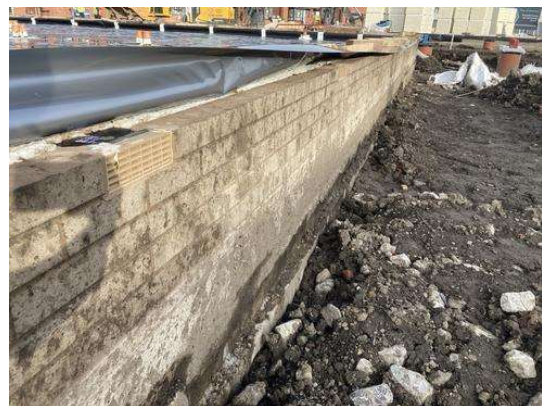
**External Wall Air bricks: Numbers, size. positions as design drawing? (Minimum of 3 walls)**

Pass

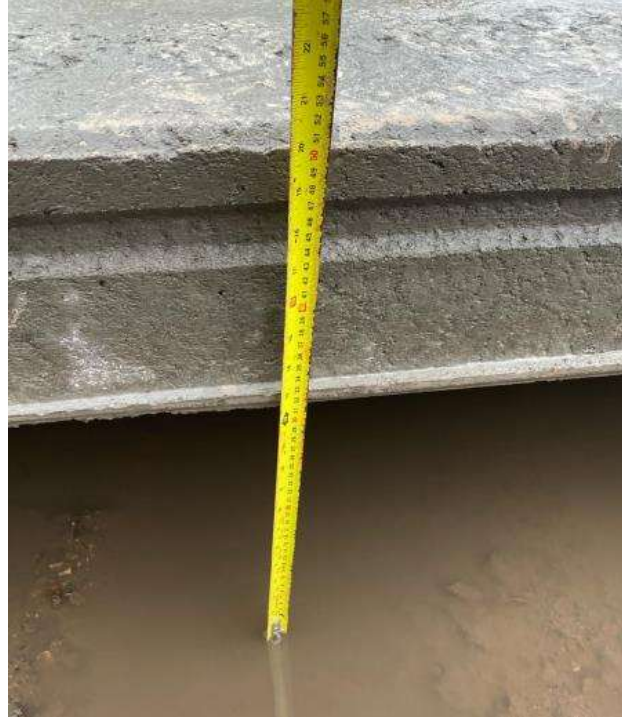
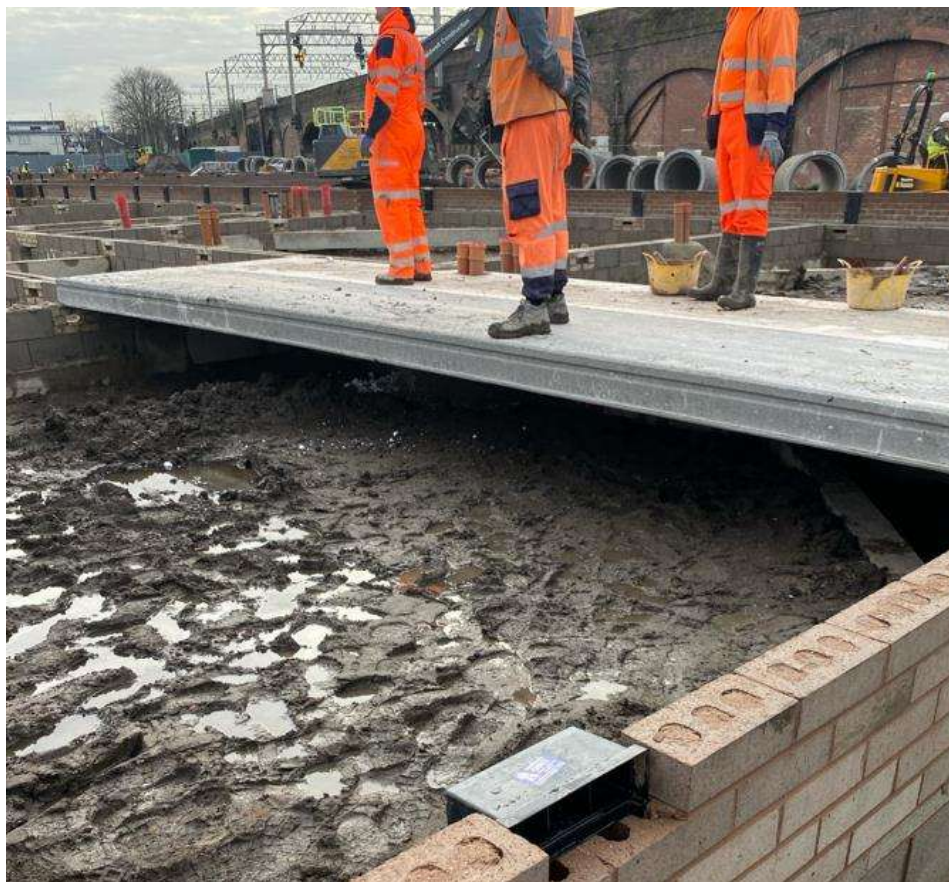
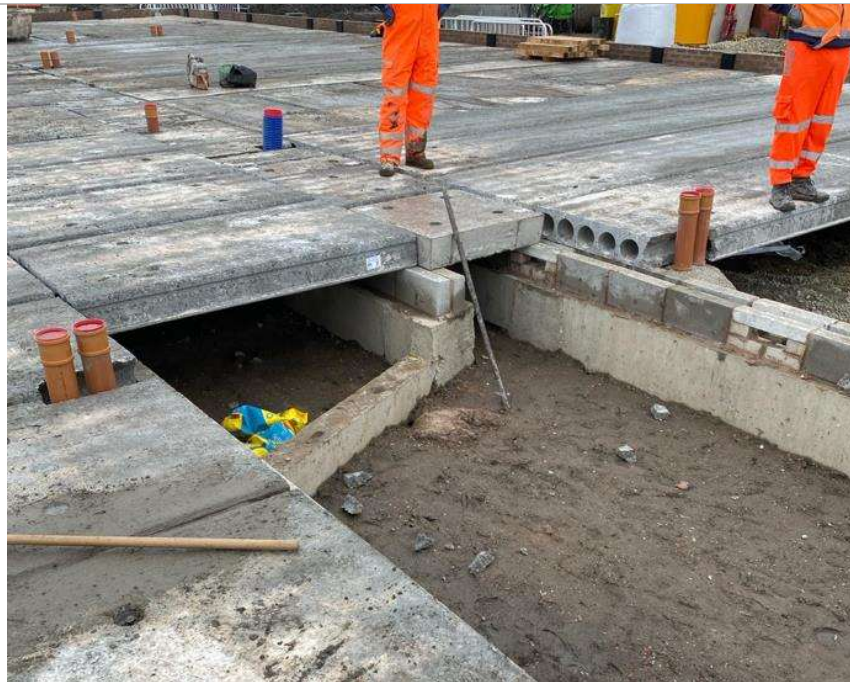
## **Apartment Block 2 Sub-floor Void Inspection**

As per the Build Phase Contamination Risk Mitigation Strategy (report ref: 15-974-R5), sub-floor voids require inspection and validation at 50% ratio of substructures completed. E3P undertook subfloor void inspections for Apartment Block 2, inspections confirmed there was a minimum void space of 150 mm for each plot. Validation photographs included within this letter.
