# CIS Tower Conservation Strategy – External and Internal Repairs and Cleaning.

**Devonshire (CIS Tower) Ltd.  
April 2025**

**CIS Tower – Conservation Strategy – Exterior and Internal Repairs, Maintenance and Cleaning.**

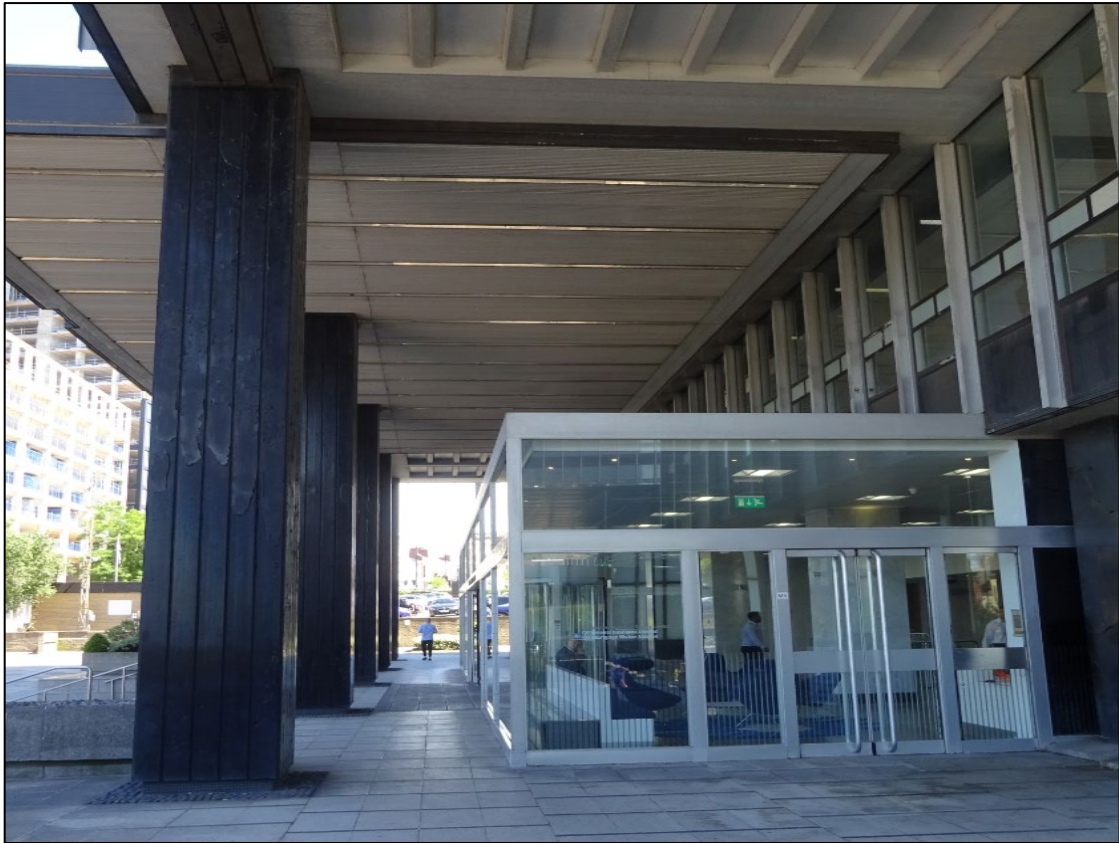
- viii) The later **redcoration of the aluminium cladding** has failed and is peeling away from the metal. In some minor locations, vegetation has grown to the perimeter of the roof. The principal roof supports a number of minor installations presumed to be redundant including lighting and satellite dishes.

**Figure 1. View of Miller Street frontage.**

- The metal-cladding to the Miller Street columns to be restored as as necessary.
- ix) Where vegetation has grown locally this will be carefully removed and disposed of, including all root systems. The affected areas will be treated with an approved herbicide as noted in Section 3 above before making good on a like for like basis with a felt patch and / or a local concrete repair using FOSROC or an equal approved system if the underlying substrate has been damaged.

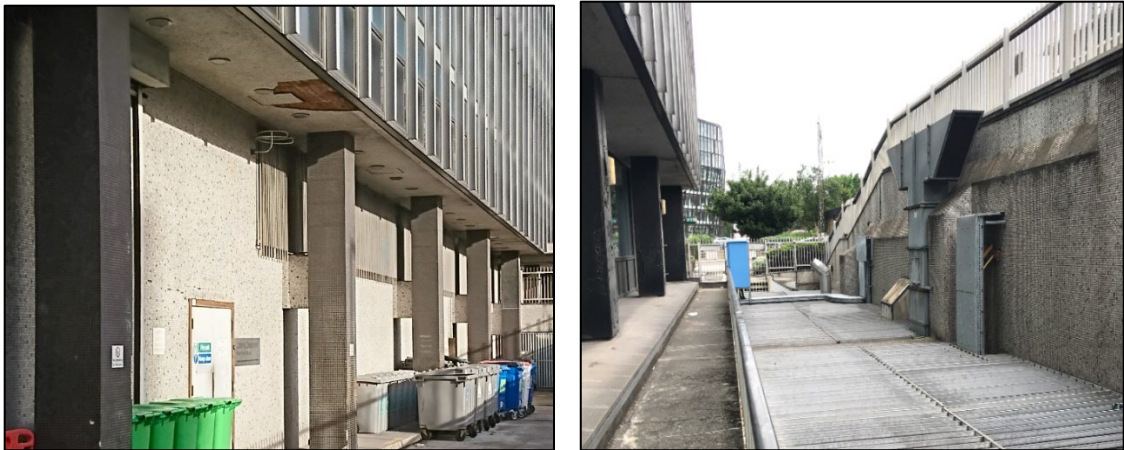
**Figure 2.** A view of the retained tiles to be cleaned and consolidated (Riga Street light-well).

- iii) The mosaic tiling is generally in poor condition and that within the basement light-well is heavily stained by pollution / biological staining, the latter especially near to ground level.

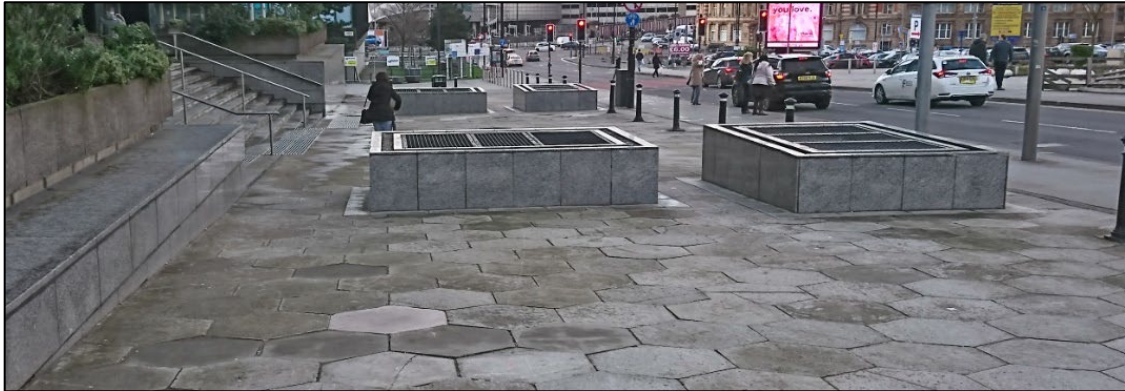
**Figure 3 .** The hexagonal, paving and lighting units will be replaced to facilitate the enhanced accessibility of the entrance.

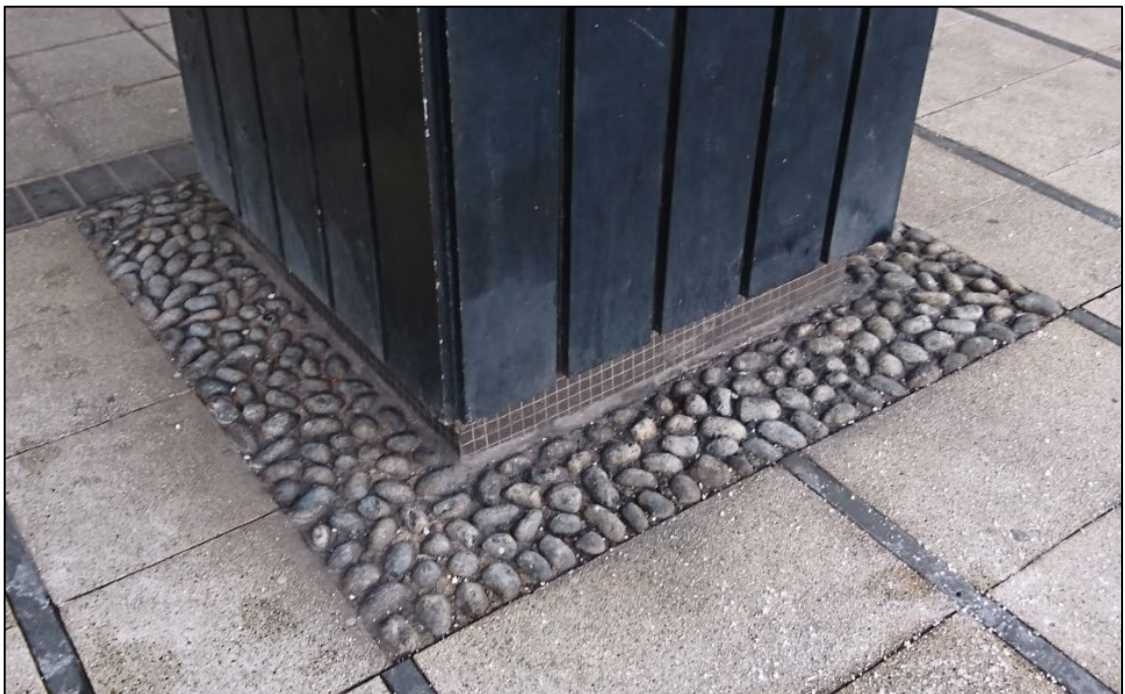
**Figure 4.** The column cladding, tiling and base pebble detail will be cleaned and retained to provide a clear edge to the new paving.

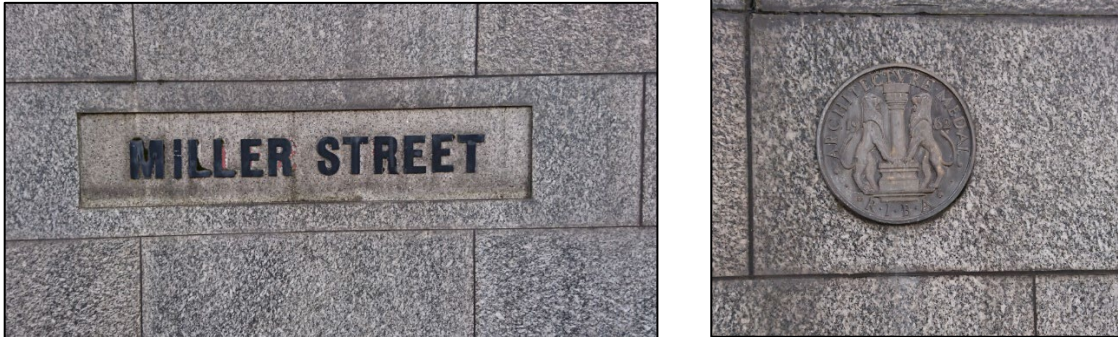
**Figure 5.** The street signage and plaques will be retained and re-used in the new frontage.

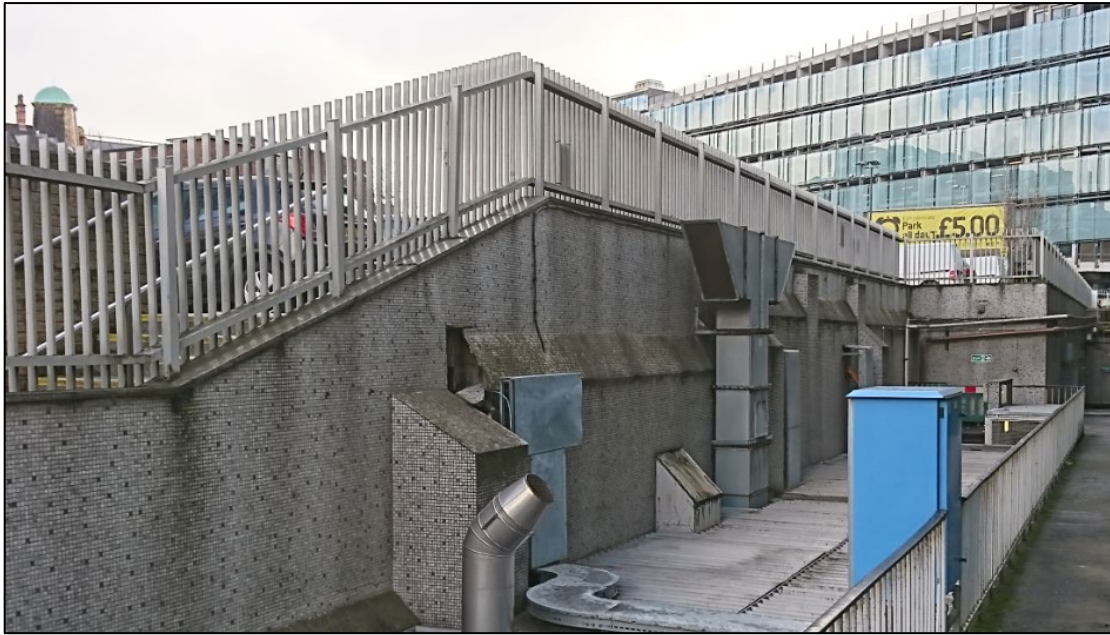
**Figure 6.** The enclosing steel railings to the Riga Street lightwell and Hanover Street will be retained and redecorated.

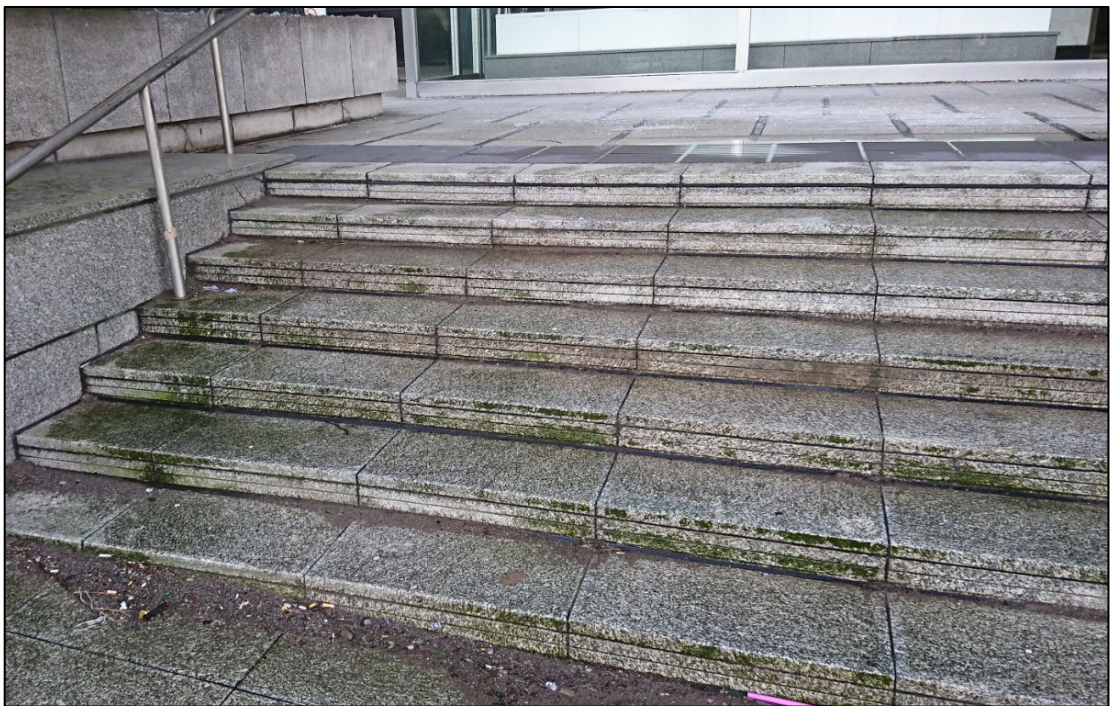
- viii) The **steel handrails** are in fair condition and with little visible defects. The steps have biological staining and some further mechanical impact damage. The concrete paving is largely in good condition as a non-original.

**Figure 7.** The steps will be lifted to facilitate the enhanced entrance.

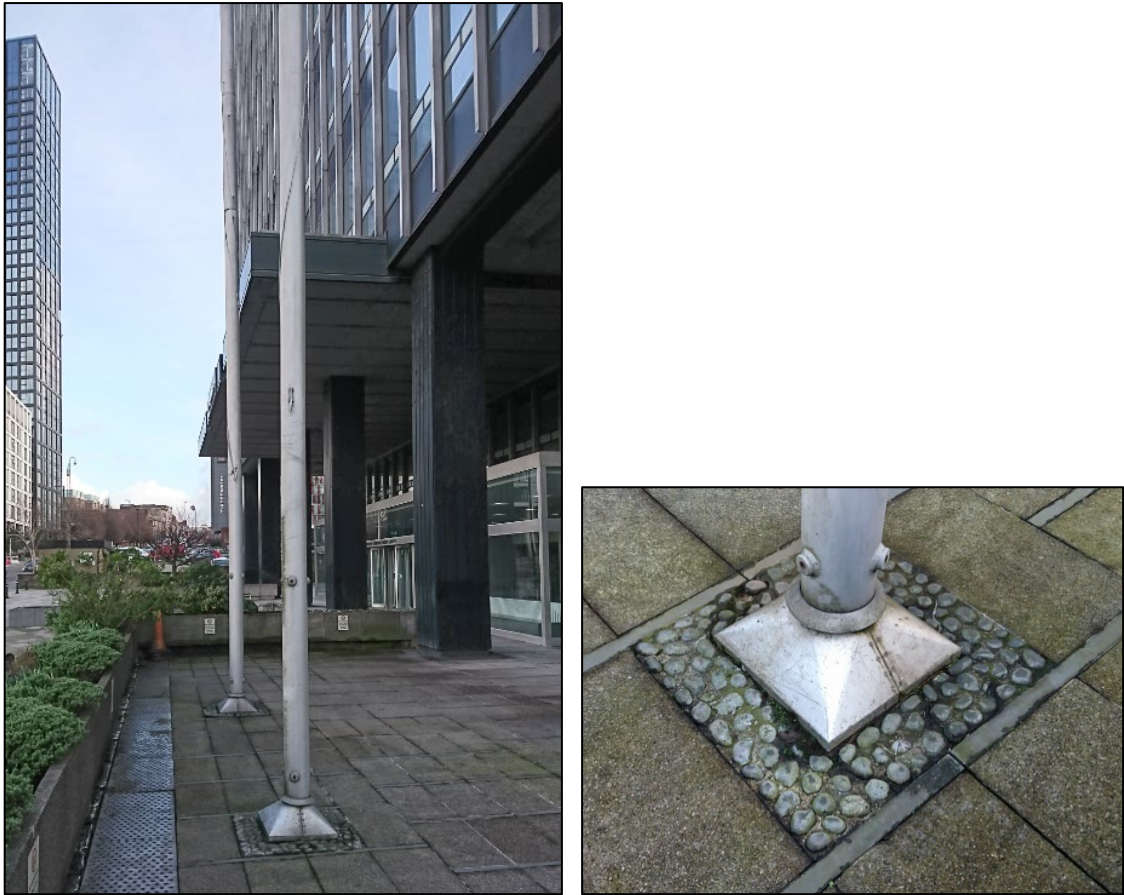
**Figure 8.** The flagpoles will be retained as features of the frontage, with an appropriate base detail to complement the base of the columns.

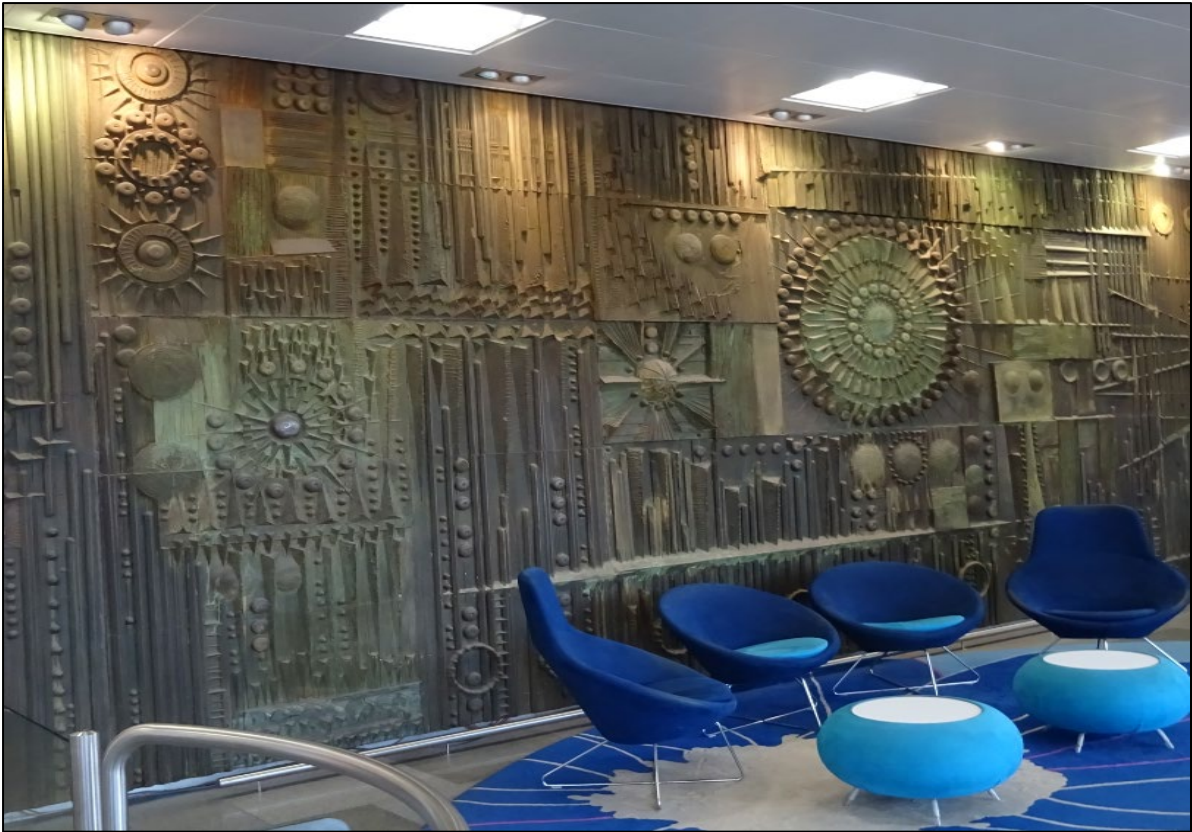
**Figure 9.** The William Mitchell wall mural will be refurbished and relocated within the expanded entrance hall (see Also Appendix 3).

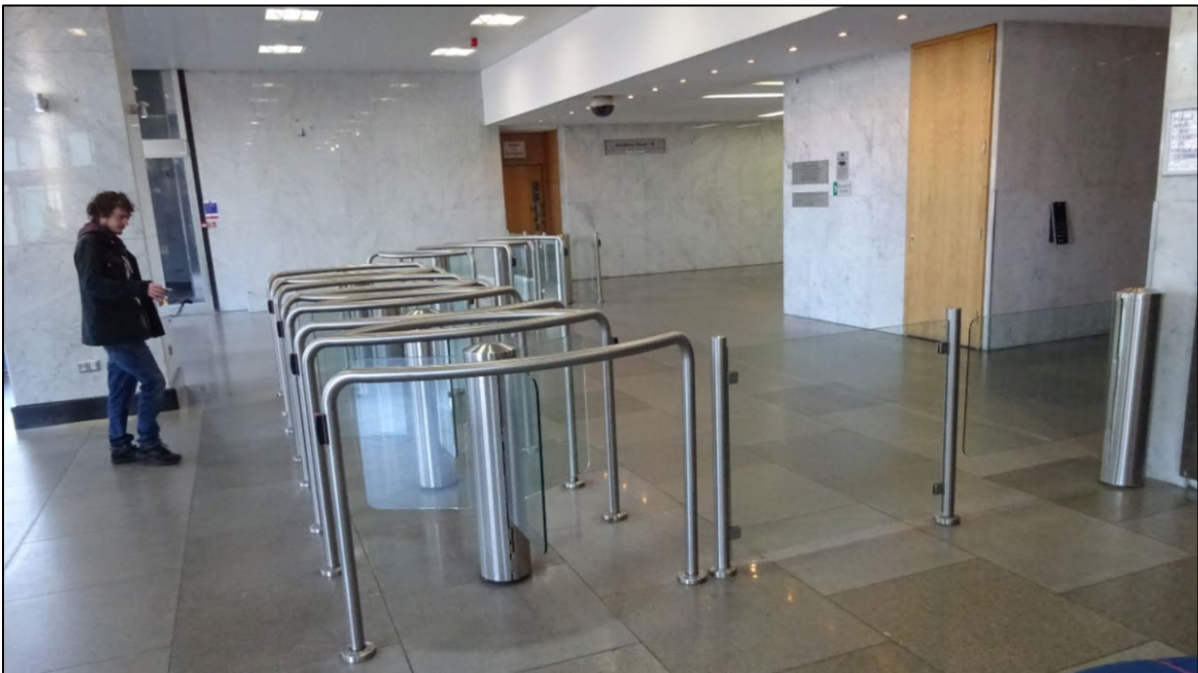
**Figure 10.** The granite floor will be replaced with a more coherent fabric, following removal of the access controls.

- vii) The **granite tile floor to the entrance hall** is to be replaced with an appropriate material to create a more cohesive finish, remove the probable asbestos engrained underside and **accommodate the new security and access control measures**. The replacement material will retain the current high-quality colour and appearance.

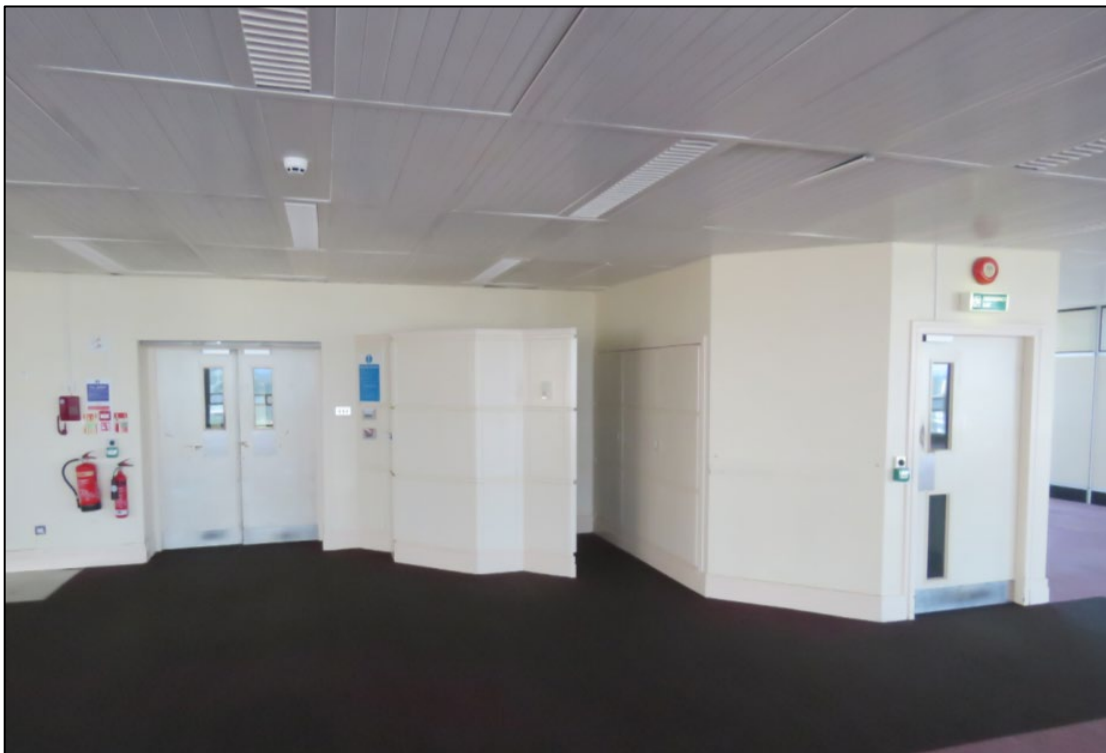
**Figure 11.** Typical office floor (14<sup>th</sup>- floor of the Miller Street tower). The offices will be subject to general refurbishment of the non-original fabric (comprising ceilings, plaster walls, carpets and partitions).

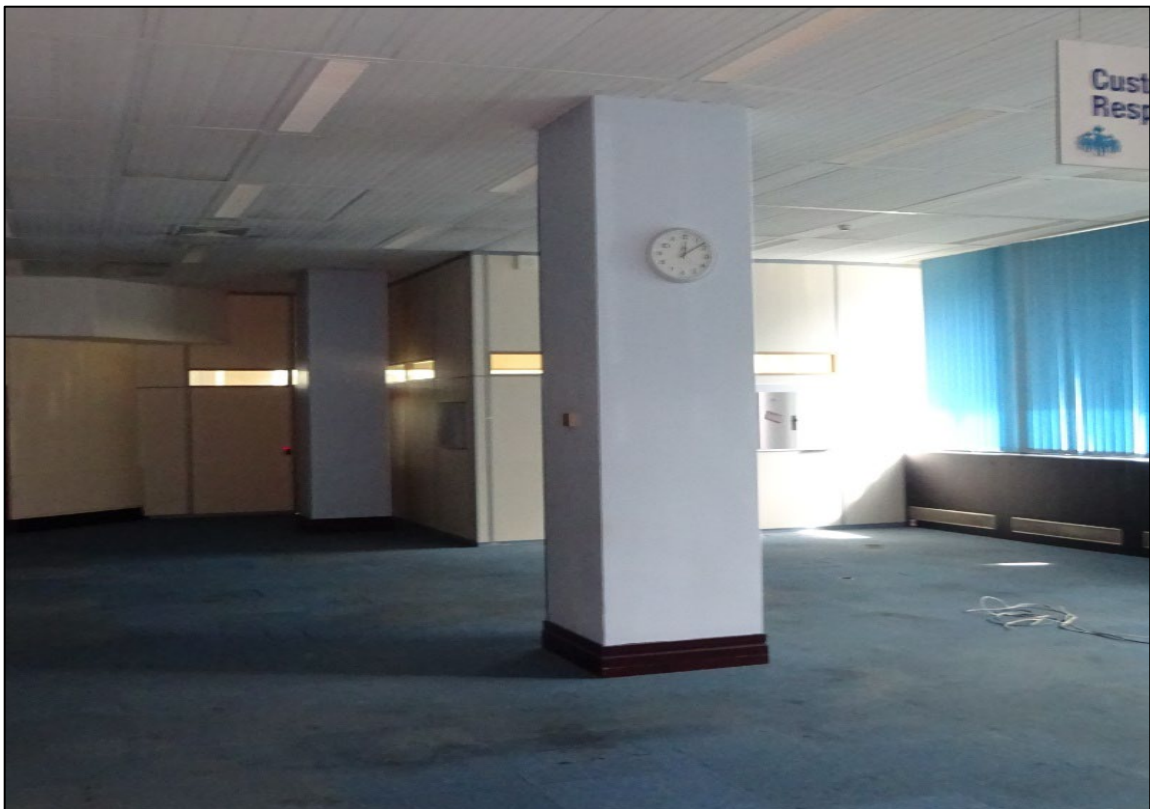
**Figure 12.** Typical Podium floor office space. All fabric components shown (ceilings, floors, cladding to columns) is non-original and will be made good as necessary.

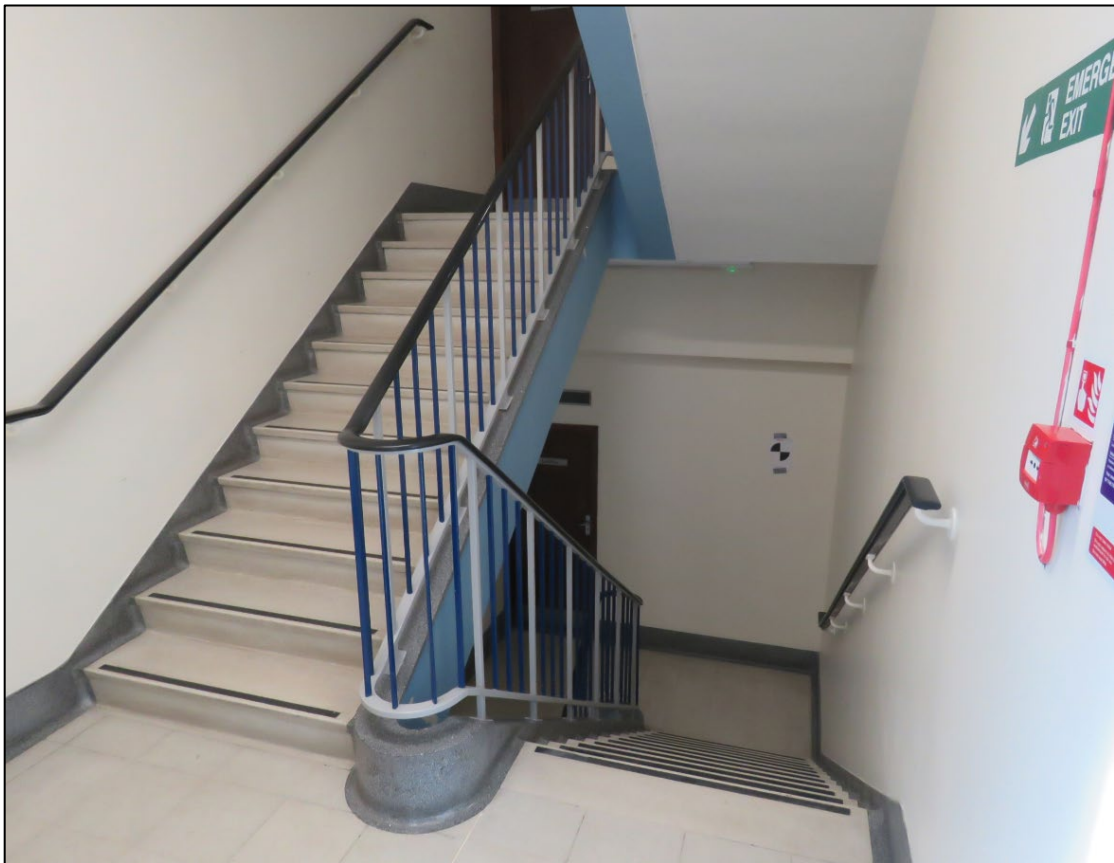
**Figure 13.** Typical stair core on the office floors with functional terrazzo tiled floors and painted steel balustrades and vinyl handrails in generally good condition.

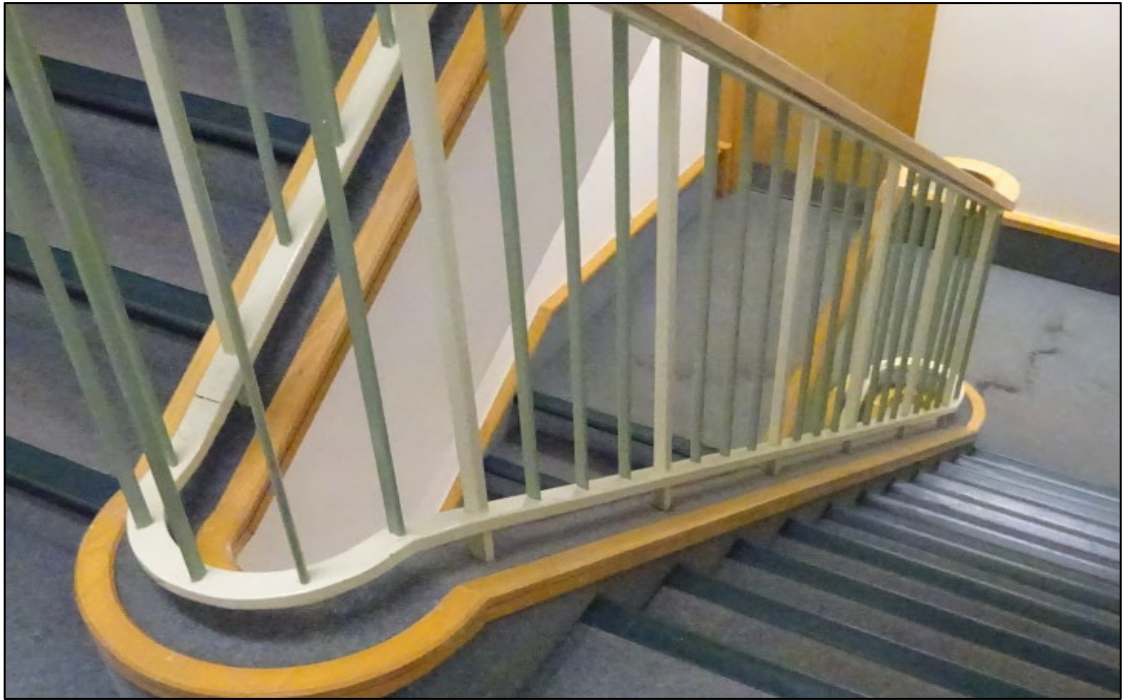
**Figure 14** The non-original carpets and handrails to the service stairs on the upper-floors (level 24 and 25).

- vi) Floor tiles are non-original. The proposals seek to remove the non-original carpets / handrails to the stairs from L23-L25 and revert to the same stair finishes on the levels below.
- vii) Metal / plastic nosing's should be retained but will need to comply with the slip resistance values required to meet modern standards.
- viii) New nosing's should be appropriate for its function but in keeping with the ancillary nature of the stair cores.

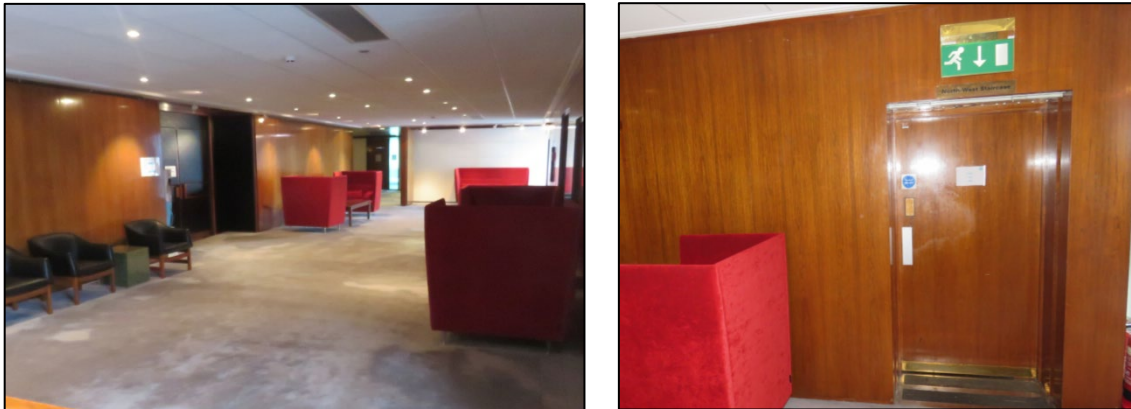
**Figure 15.** The 23<sup>rd</sup> Floor will be refurbished, retaining the extant cherry wood cladding and details. Note that the ceilings are non-original.

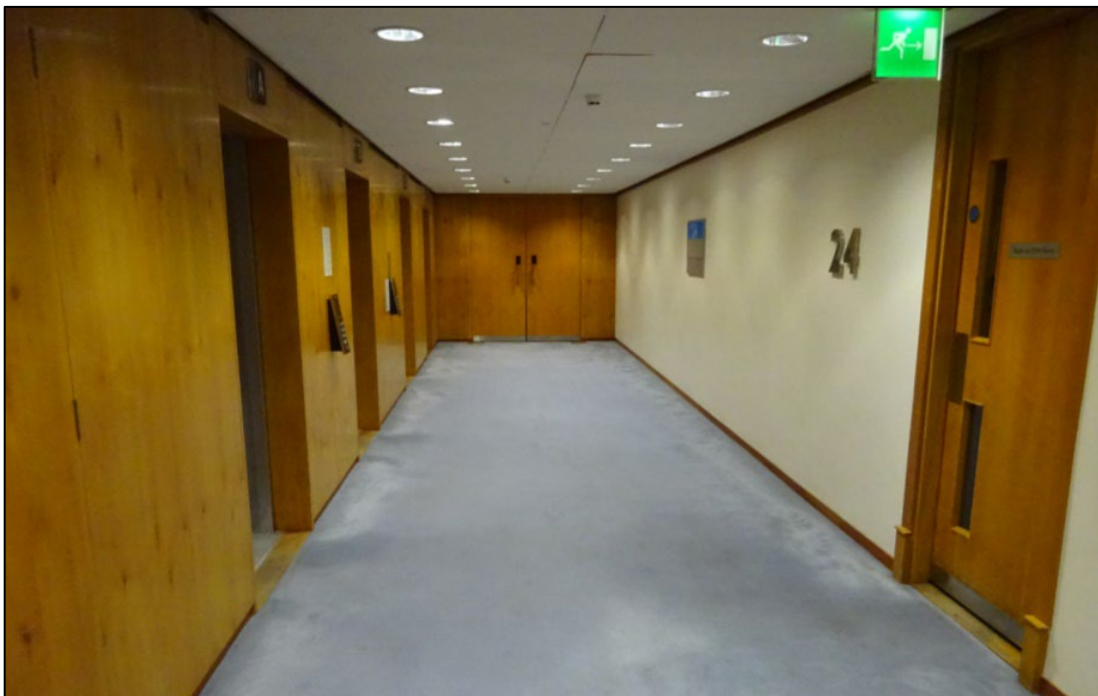
**Figure 16.** The lift lobby to the 24<sup>th</sup> Floor with original doors and panelling to be refurbished.
